CROSS Safety Report

Failure of cantilevered stone staircase

This month we present a report concerning the partial collapse of a cantilevered stone staircase without warning during a renovation at a stately home built around 1830.

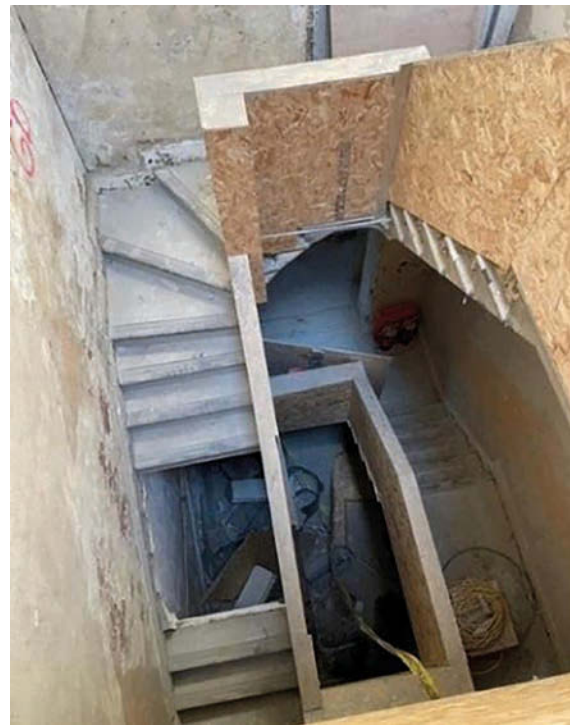
During the collapse incident, four steps of a flight of a staircase sheared off at the face of the wall (**Figure 1**). The trigger for the collapse appears to have been the load of one pedestrian, two people having traversed the same steps moments before without incident. The four dislodged masonry steps and the person on the staircase at the time fell onto the flight directly below. This appears to have caused the immediate failure of six further steps of this lower flight.

↑ **FIGURE 1:** A hole in the staircase where four steps collapsed onto the flight below

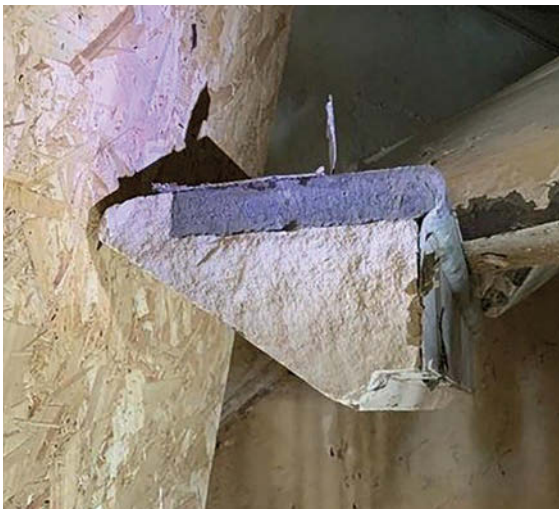
The staircase was being used for the movement of personnel and lightweight materials during the refurbishment works. No excessive loading of the stairs had been reported. Dry rot filaments were, however, visible on the fracture surface of the lowest of these four steps. **Figure 2** shows the fracture of a step where it failed. The tread area and leading edge of each step was inset with a round-nosed slate

The presence of the dry rot filament growth across the fracture surface

indicated that this fracture existed for some time prior to the collapse. This fracture surface and the 'clean' fractures of all the other failed steps, were close to the face of the wall into which the steps were built and are all broadly coincident with the ends of the cut-in slate. The rebate cut into each limestone step to receive the wearing slate, narrows the stone section and creates a point of stress concentration at the face of the wall in each step.

The reporter concluded that it appears likely that the staircase was weakened by the fracture of one individual step. It was clear that the group of four steps in the upper flight collapsed under the load of one person. The collapse was perhaps due to a combination of the reduced torsional capacity resulting from the single fracture, the historical introduction of the slate nosings, and the impaired tensile strength due to more recent wetting or saturation of the masonry. Four steps fell onto the flight immediately below. Here, the sudden impact load resulted in the fracture of a further group of six steps which then also fell to the floor. The partial collapse of the staircase did result in

↓ **FIGURE 2:** Section through failed step at fracture position
