THE QUINDÍO, COLOMBIA EARTHQUAKE OF 25 JANUARY 1999

A FIELD REPORT BY EEFIT

August 2000

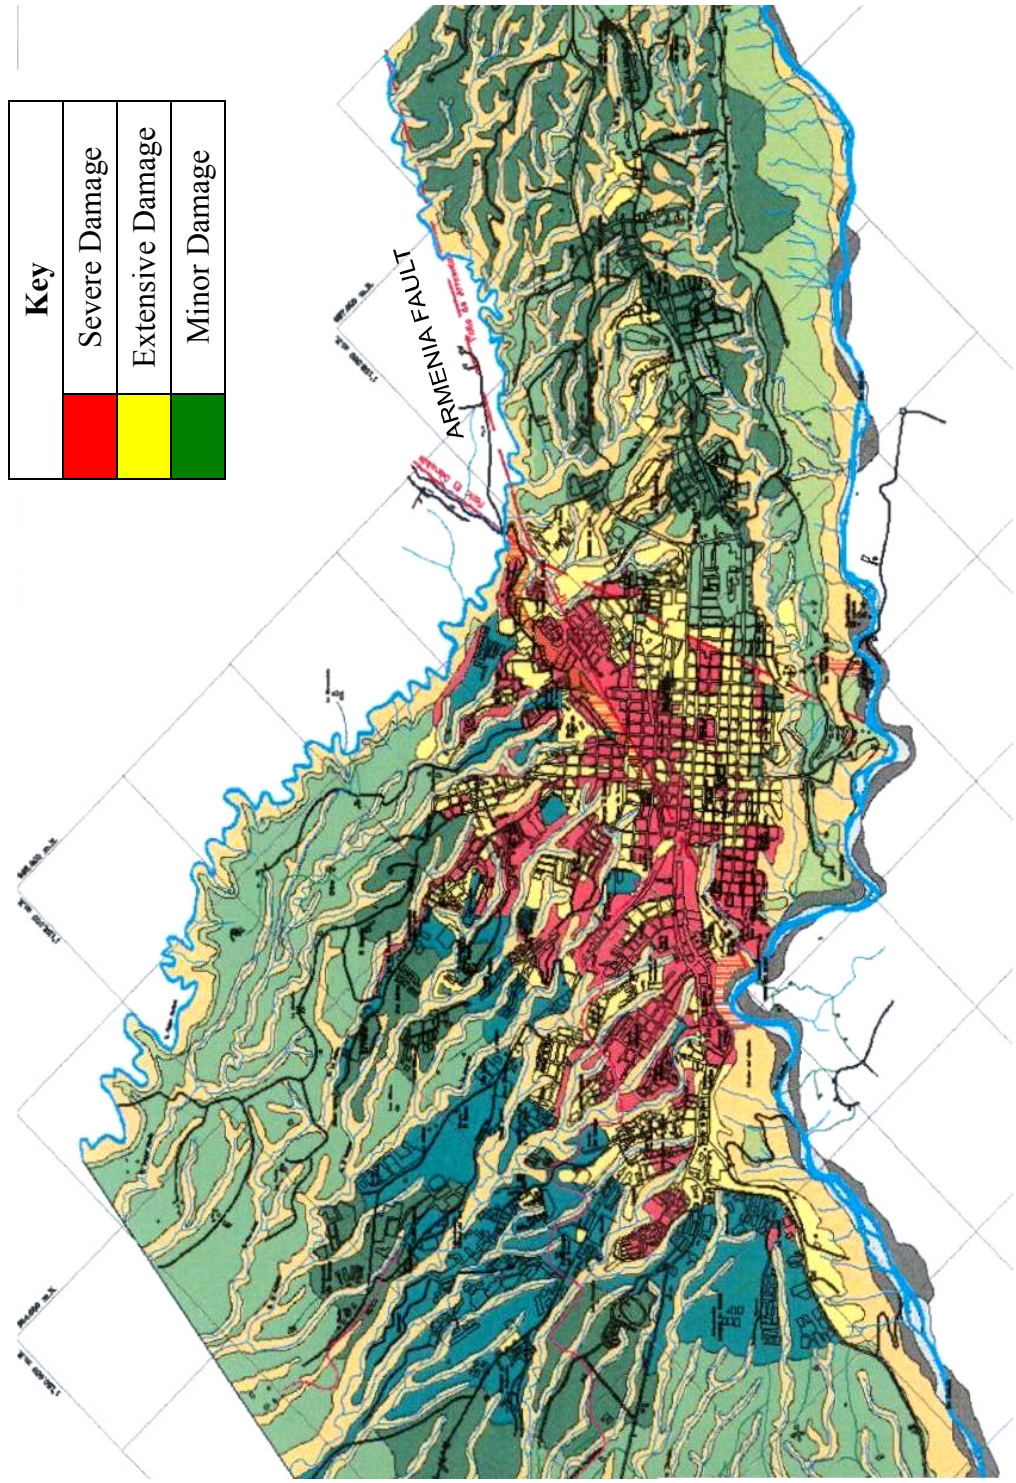
Figure 3.2: Distribution of damage in Armenia (Ingeominas)

It has been suggested by Ingeominas [8] that movement of the Armenia Fault, shown on Figure 3.2, may have contributed to the high level of damage observed in its vicinity. However, a number of other explanations could be given to this localisation of the damage, particularly as the rupture is believed to have occurred on one of two other faults, as discussed in Section 2.5. Reference 4, in particular, suggests that it was due to poor ground conditions in the form of anthropic fills adjacent to the fault escarpment.

The south-western part of the city contains many poor neighbourhoods and the dominant types of construction are non-engineered traditional bahareque and load bearing masonry structures, both described in Chapter 5. They were very extensively damaged with a proportion of buildings severely damaged or destroyed as high as 80% [6] (Figure 3.2 & Figure 3.3).

The overall proportion of structures collapsed or damaged beyond repair was approximately 40% [6] (Figure 3.2). All of these severely damaged structures, apart from one further described in Section 4.2.1, had been built prior to the 1984 seismic regulation.

favourable in this part of the city, although no detailed records of site investigations were available. The level of damage was much lower in this area, with less than 20% of the structures collapsed or damaged beyond repair [6] (Figure 3.2).

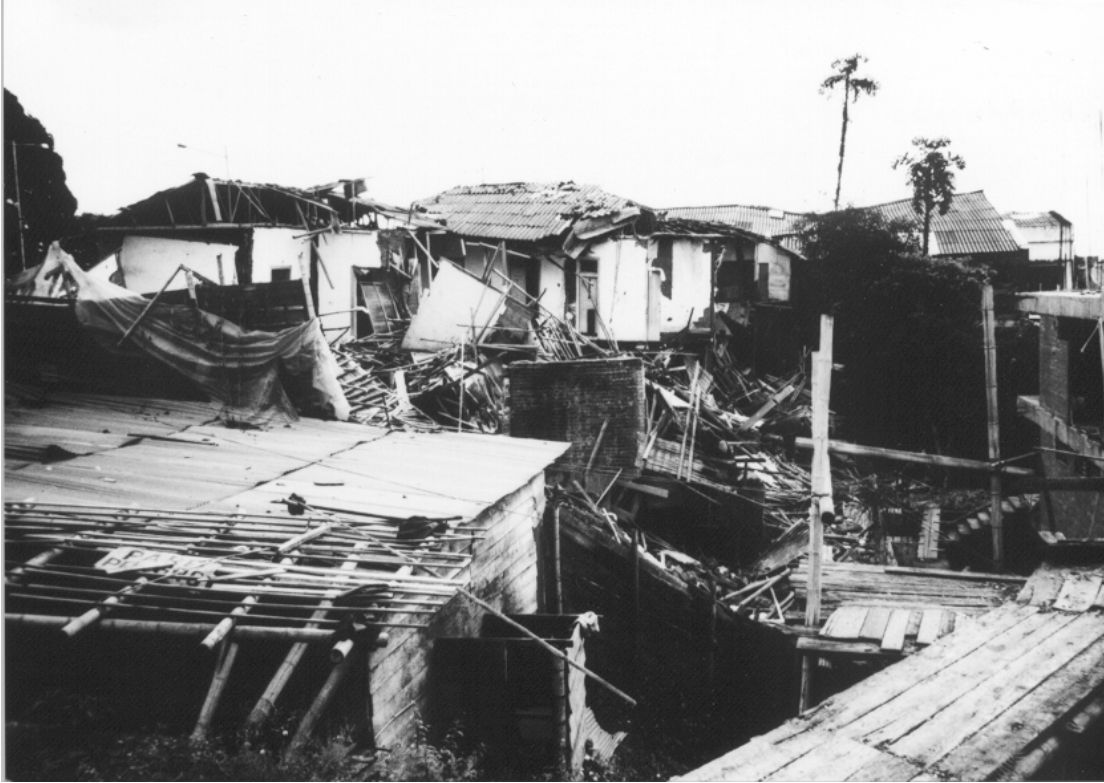
Figure 3.3: Traditional bahareque structures – Armenia (south)

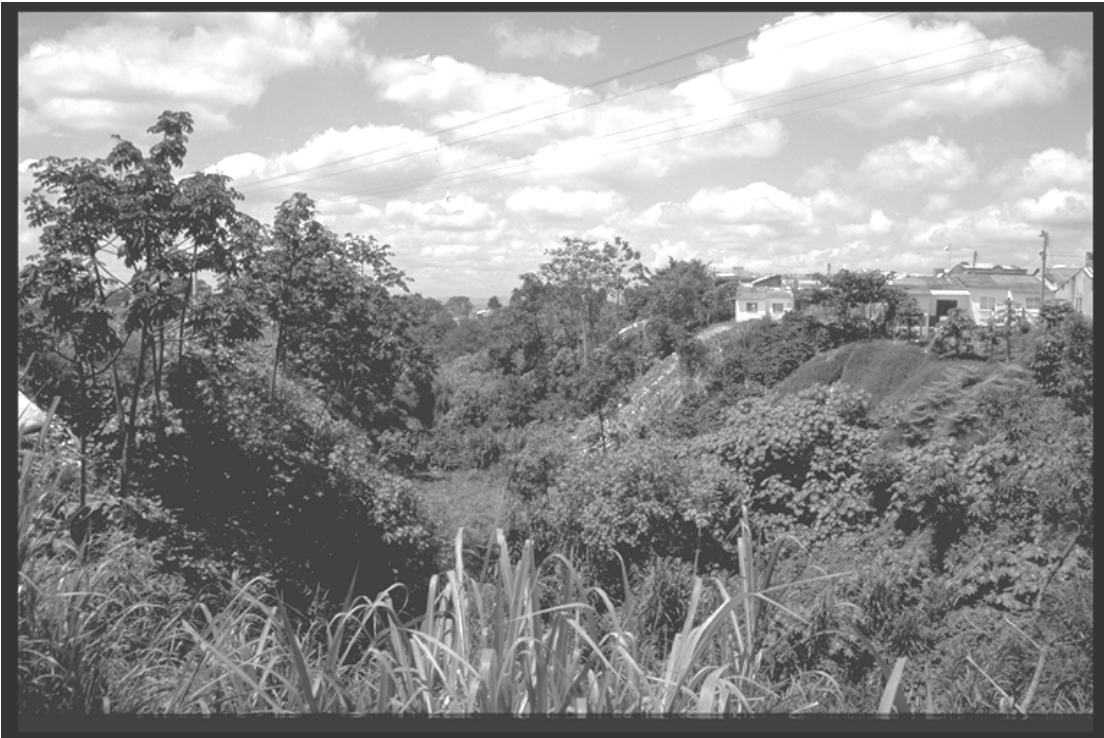
This part of the city contains many ridges and partially filled steep valleys. The structures located on the ridges experienced particularly high levels of damage. Firstly, this might have been caused by further amplification of the ground motion. Reference 3 calculates the seismic wavelength in the top deposit as approximately 30m, which roughly corresponds to the height of a number of the ridges. In addition, partial ground failure led to damage of foundations of those structures near slope edges as shown in Figure 3.4. These structures would not have respected the local regulation specifying a minimum distance of 10m from the point where the slope exceeds 25°. The downhill part of the foundation would often bear on poor fill brought from the excavation of the uphill part of the foundation. Partial ground failure in that fill often resulted in distress of the structure.

Figure 3.4: Ground failure affecting structure at top of slope

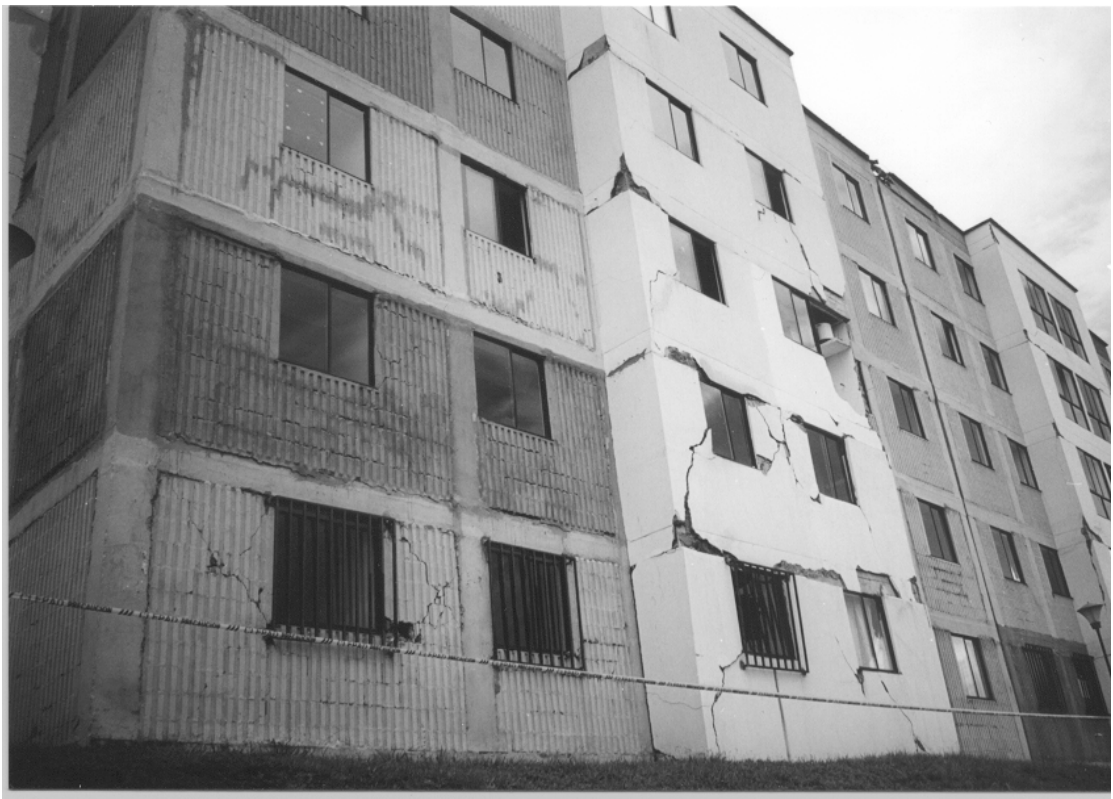
Figure 3.6: Non-structural damage – Pereira

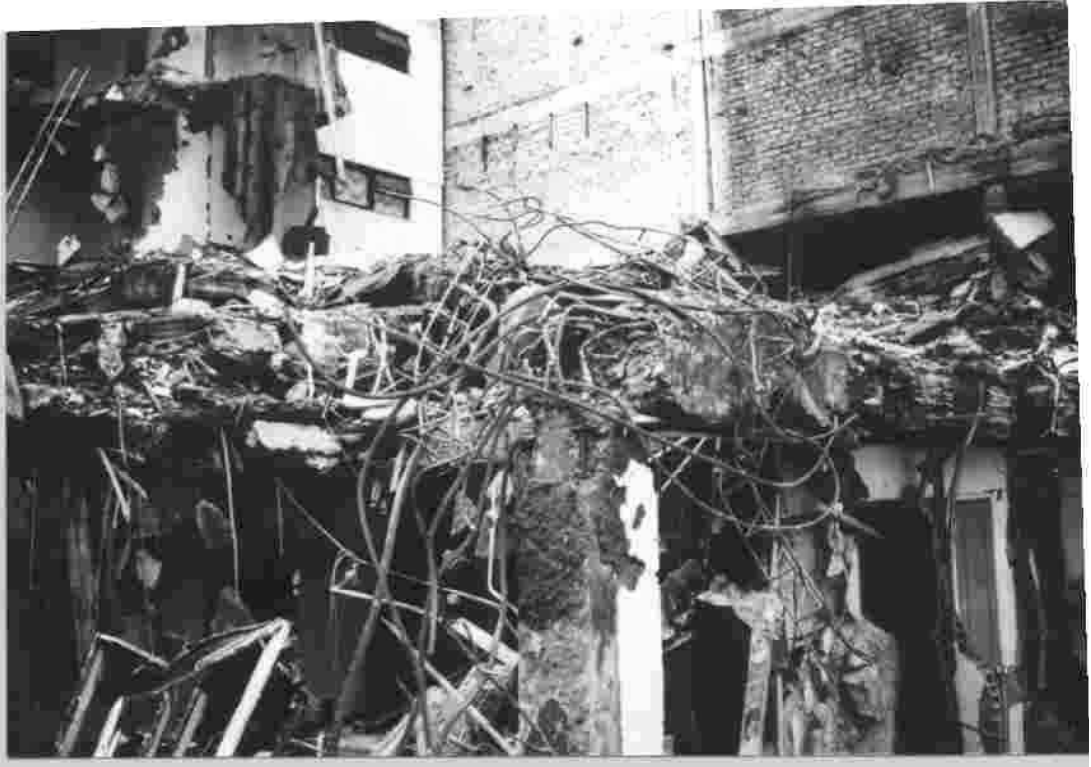
Figure 4.3: Complete collapse of post-1984 structure

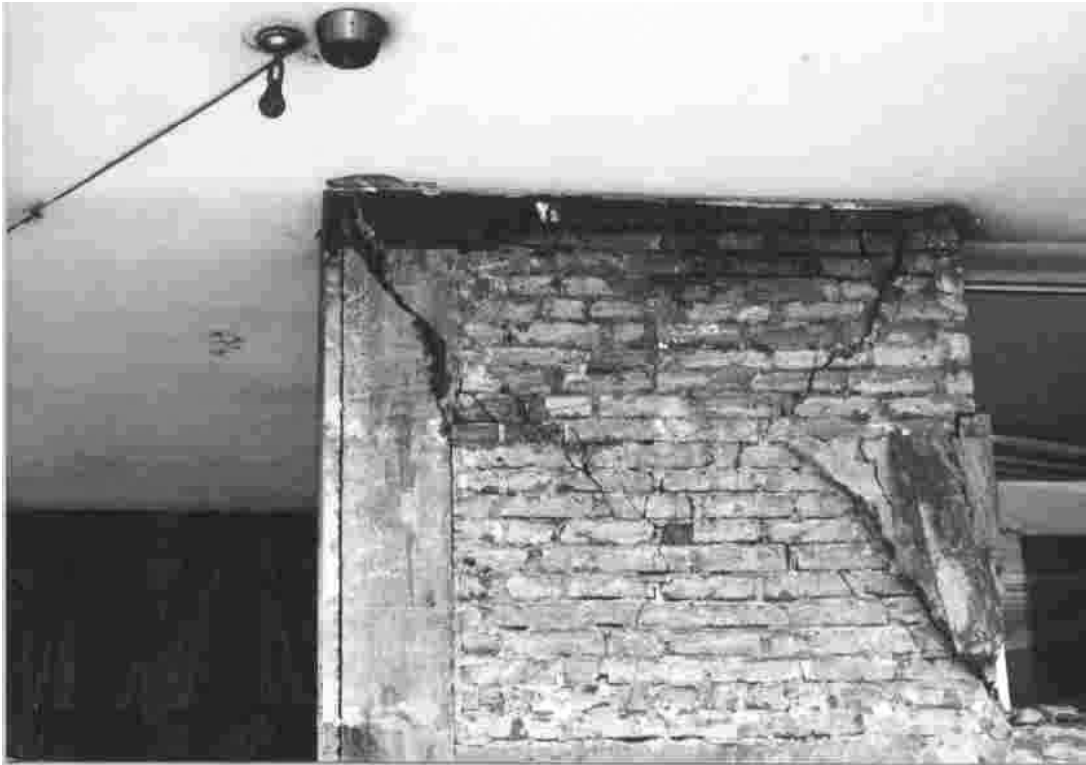
Figure 4.5: Shear failure of column

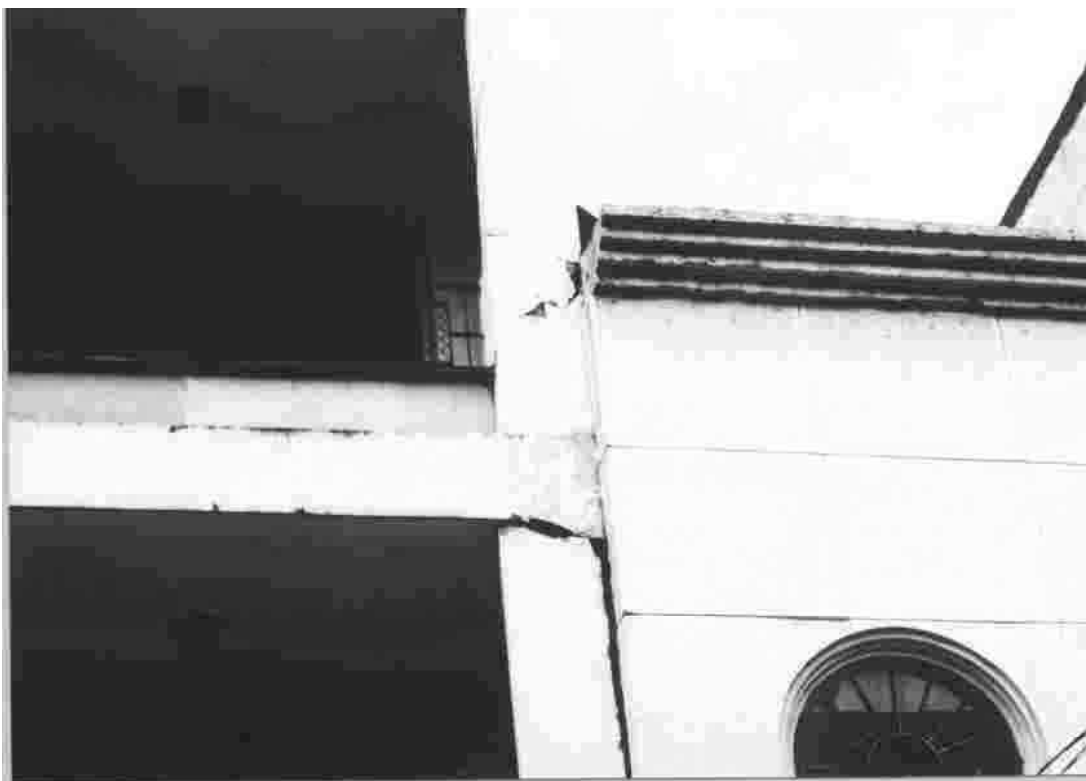
Figure 4.6: Shear failure of column

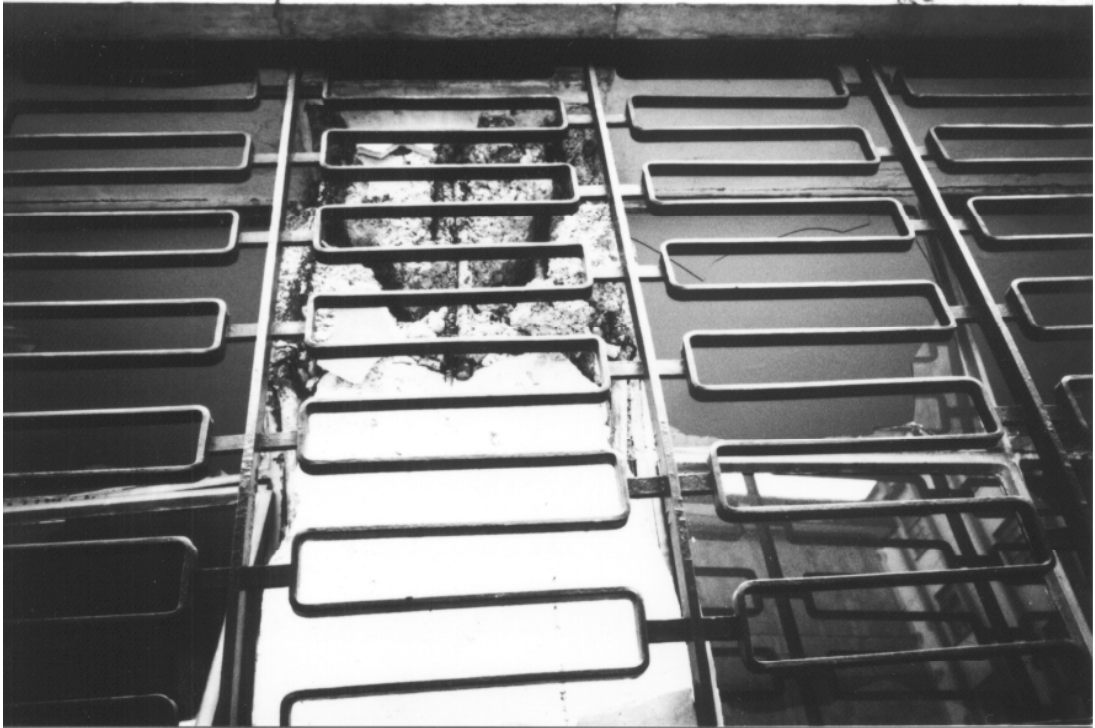
Figure 4.7: Compression failure of column

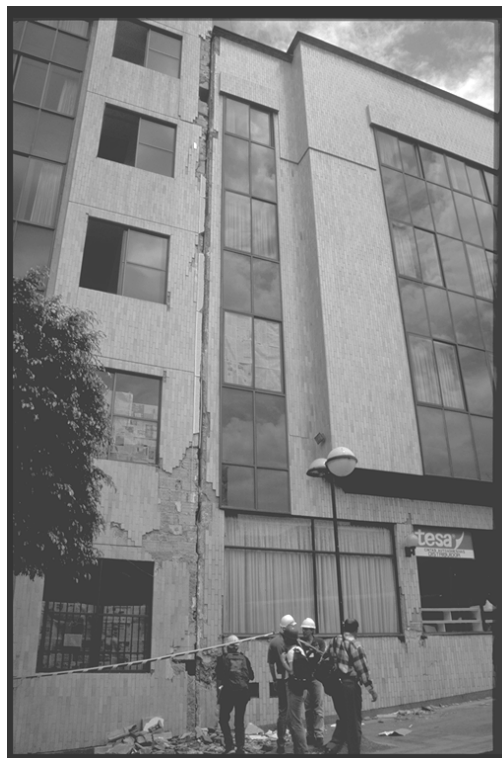
Figure 4.8: Pounding between adjacent structures

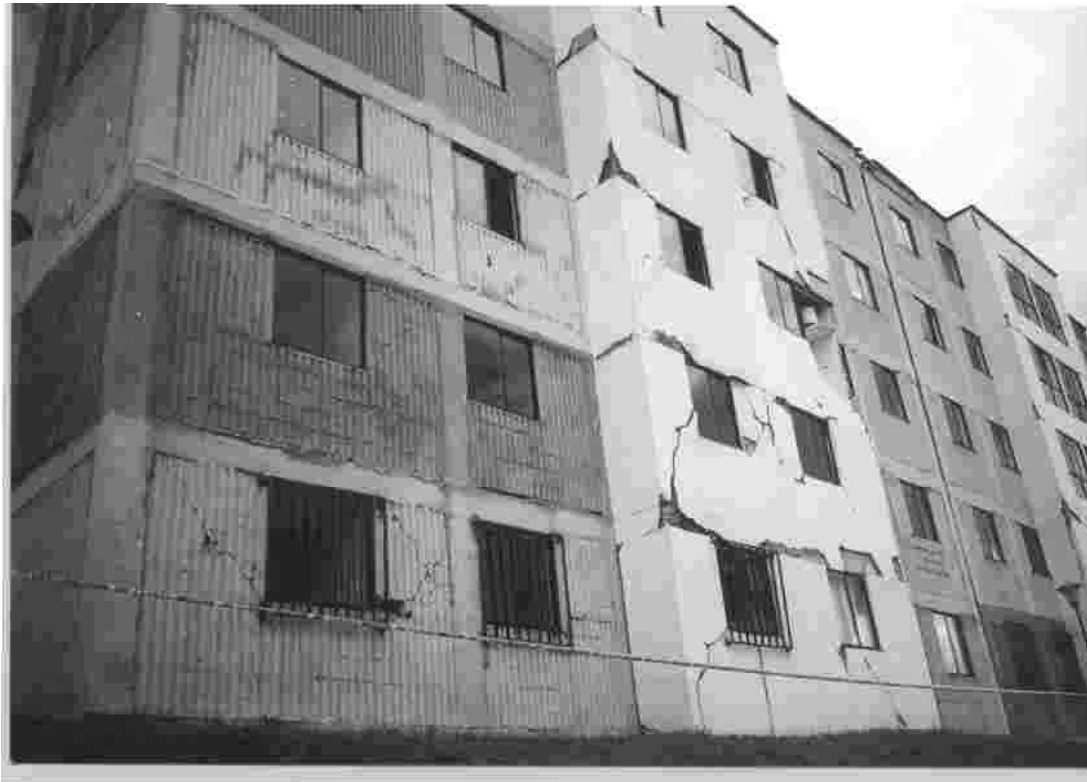
Figure 4.14: Non-structural damage of recent structure

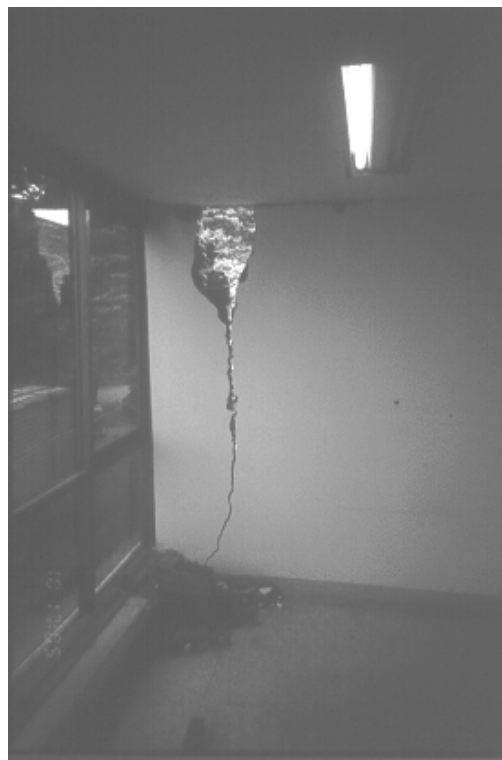
Figure 4.20: Cracking to external infill wall panel

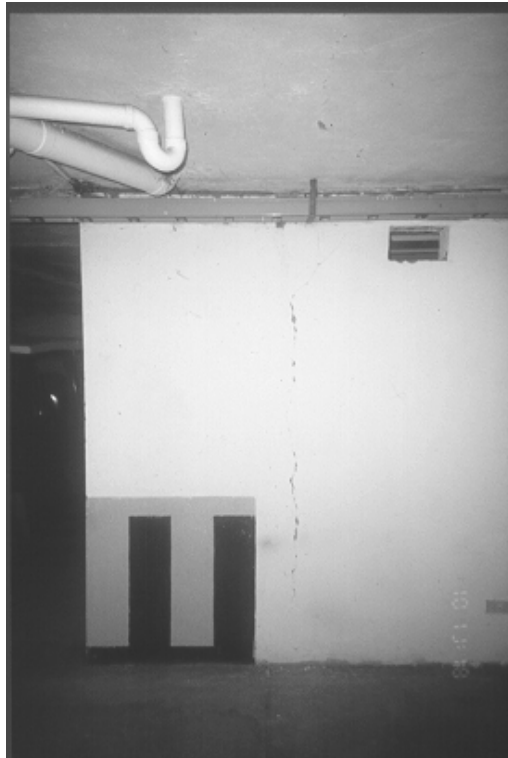
Figure 4.21: Cracking at interface between structural concrete shear wall and masonry partition wall at basement level

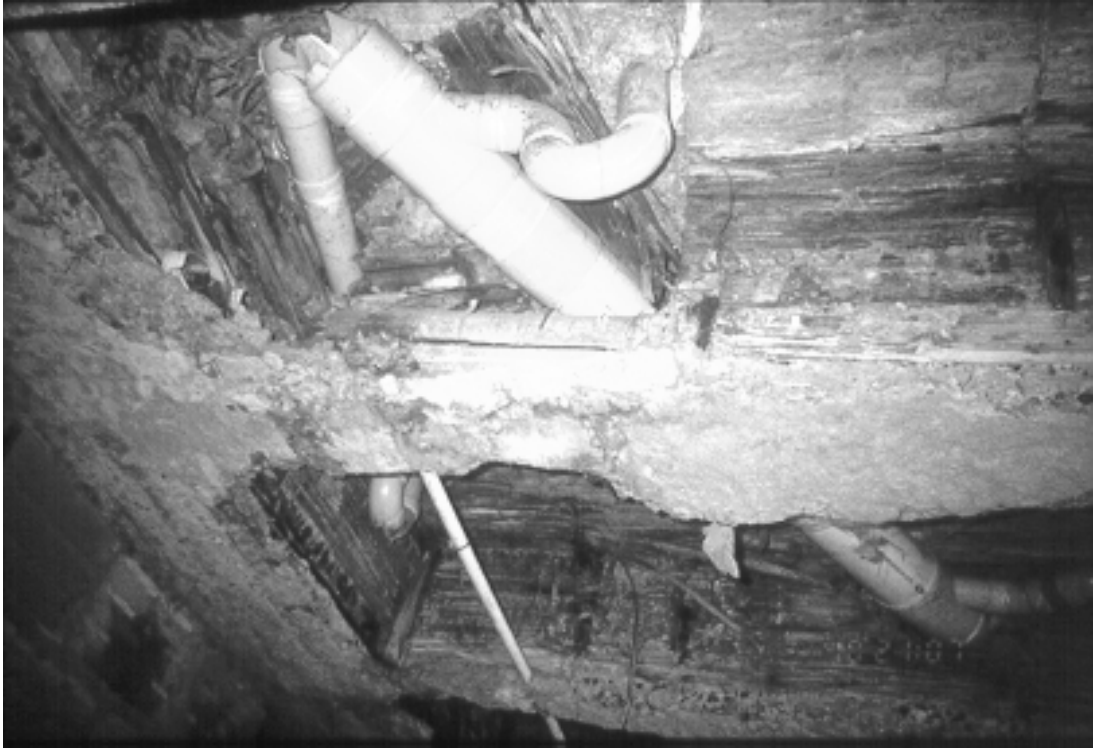
Figure 4.23: Concrete floor rib detail, showing poorly located service pipework

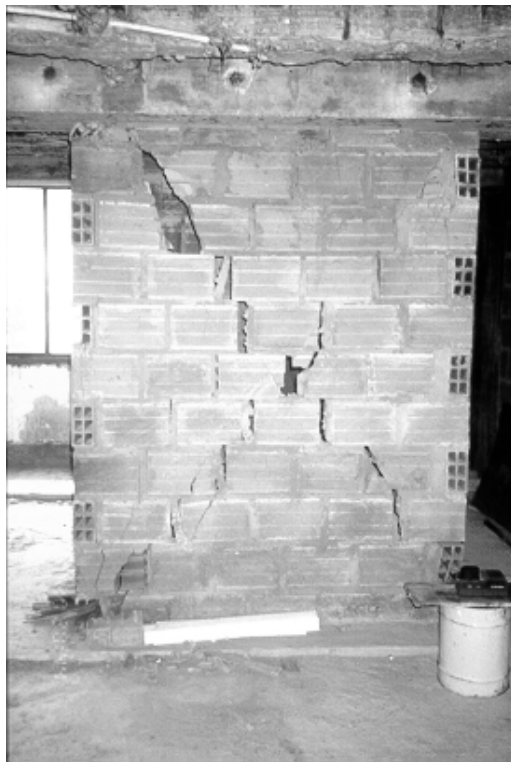
Figure 4.28: Shear cracking to internal non-loadbearing wall

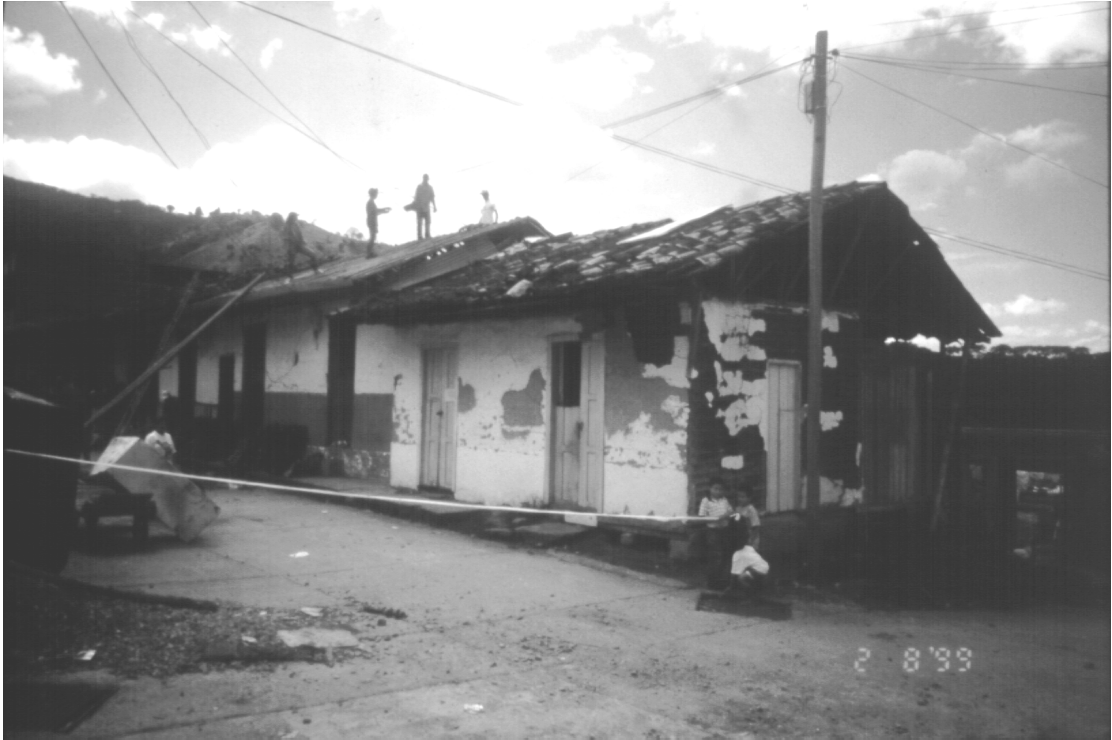
Figure 5.3: Separation of walls and roof of a bahareque construction in Córdoba

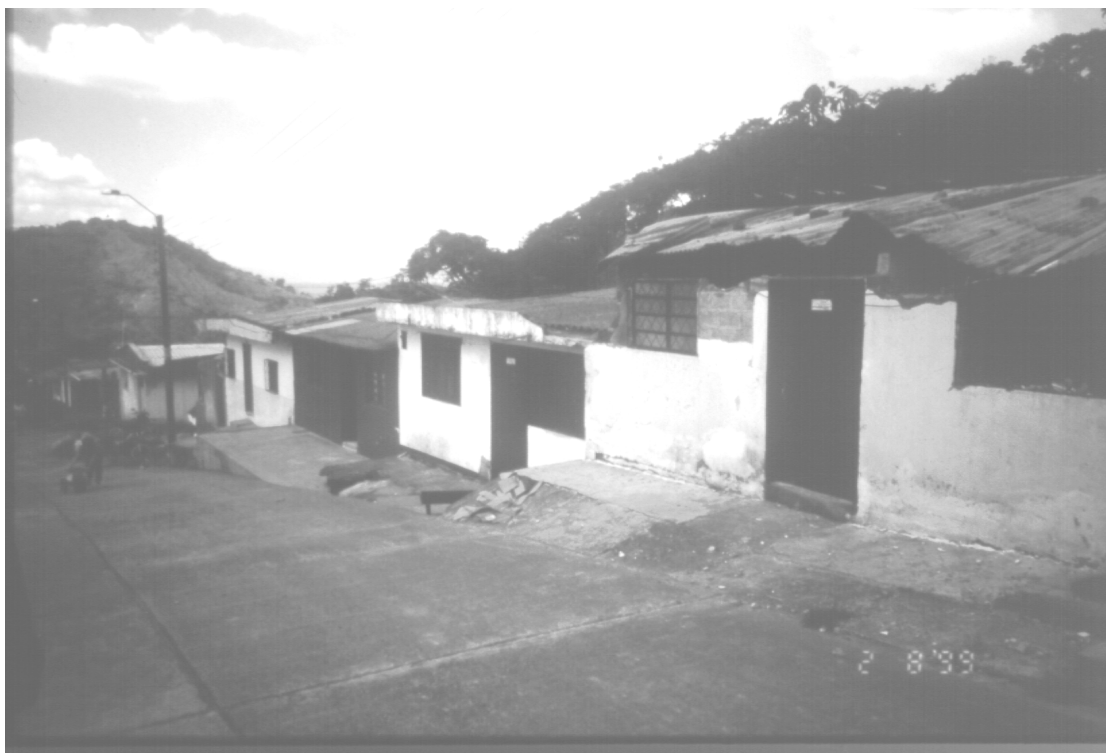
Figure 5.6: Single storey masonry buildings. Note section of wall missing in nearest building.

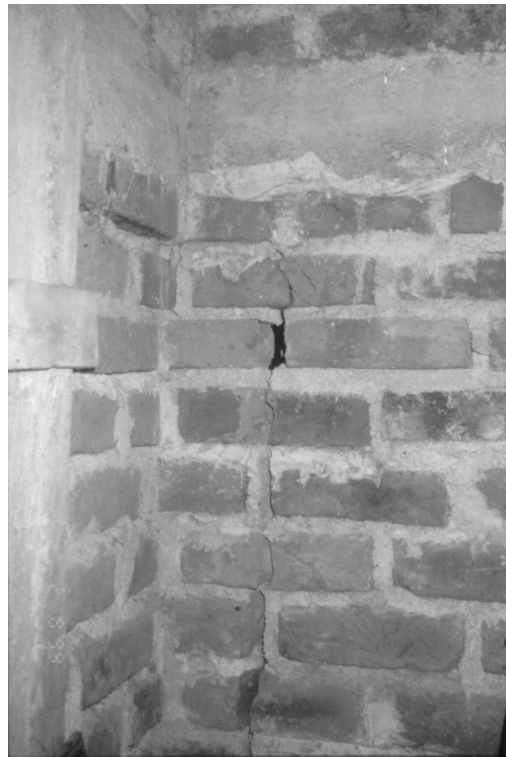
Figure 5.8: Ring beam at roof level, successful in halting the propagation of cracking in the corner of the masonry wall

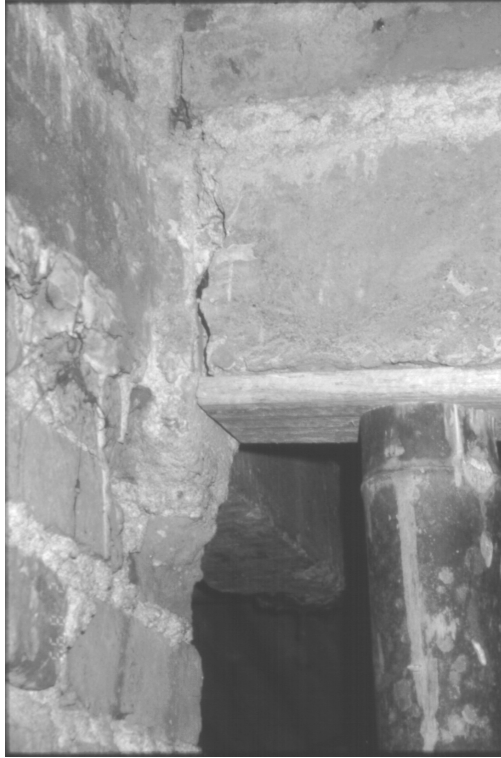
Figure 5.9: Concrete ring beam has sheared here. Note bamboo used as a temporary prop.

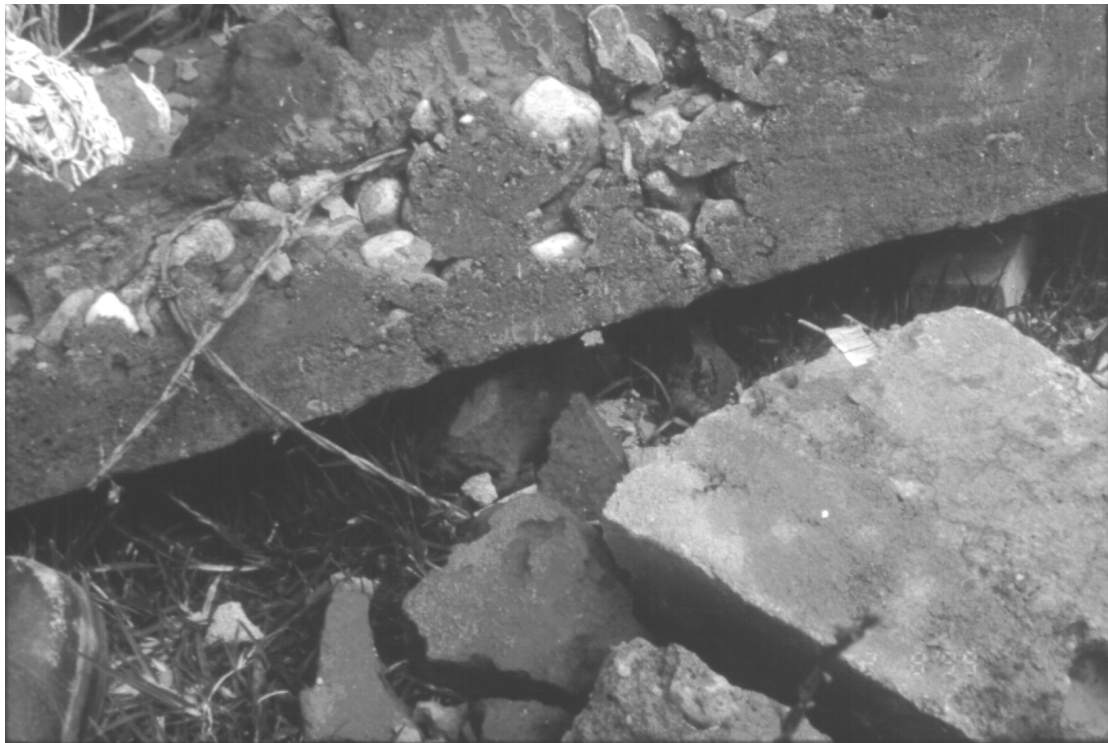
Figure 5.10: Example of poor quality control. Concrete lintel with barbed wire being used as the main tension reinforcement.

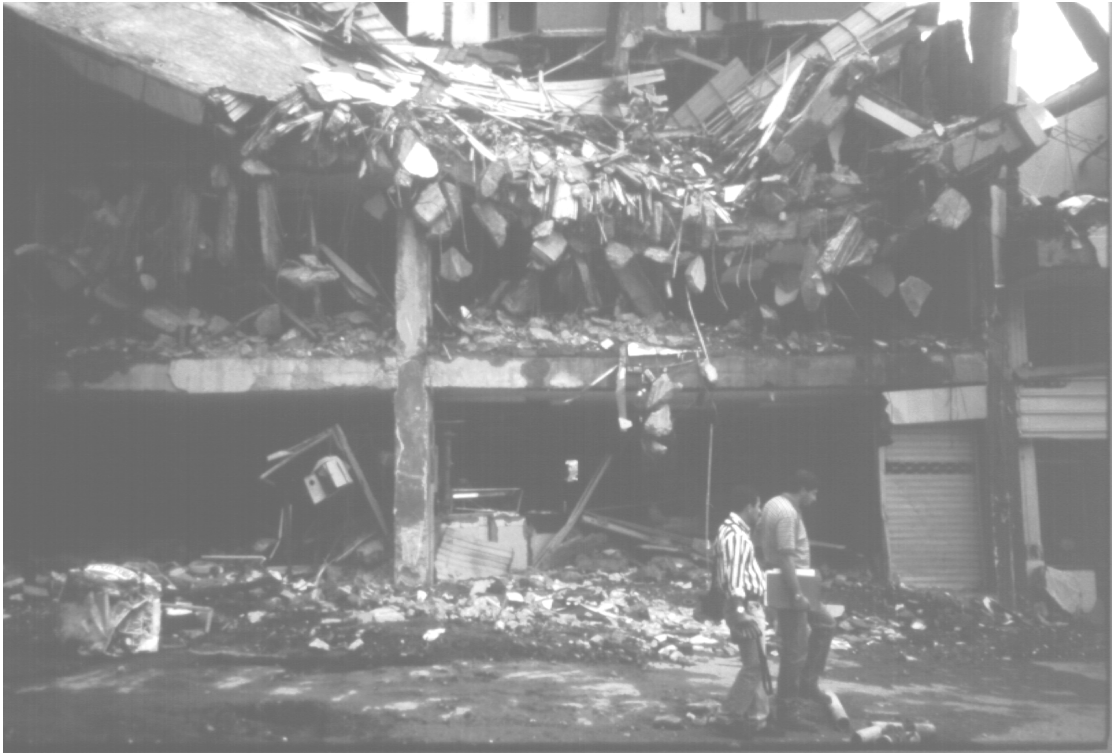
Figure 5.11: The fate of many concrete framed buildings

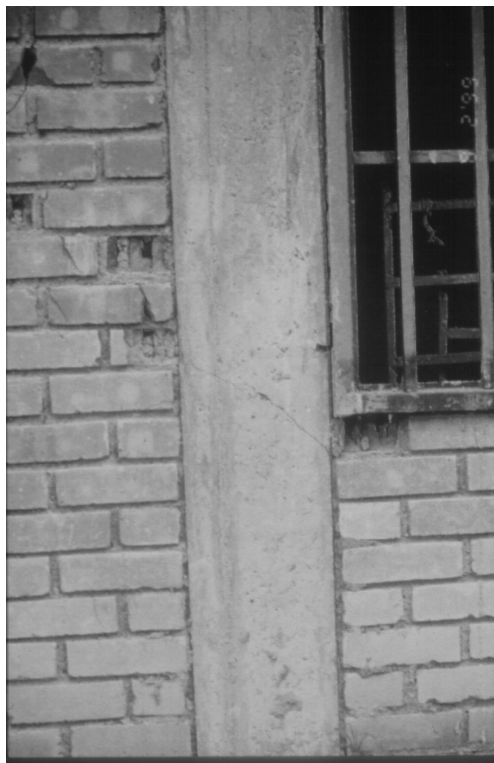
Figure 5.14: 'Short column' shear failure

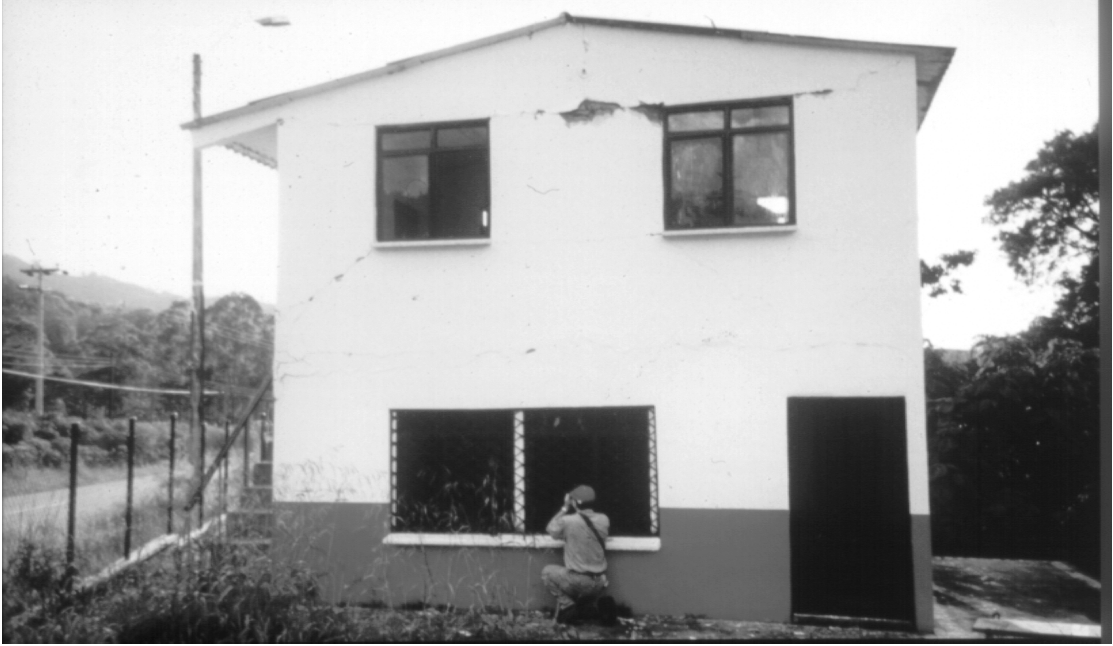
Figure 5.19: Damage to a masonry building at the bamboo centre

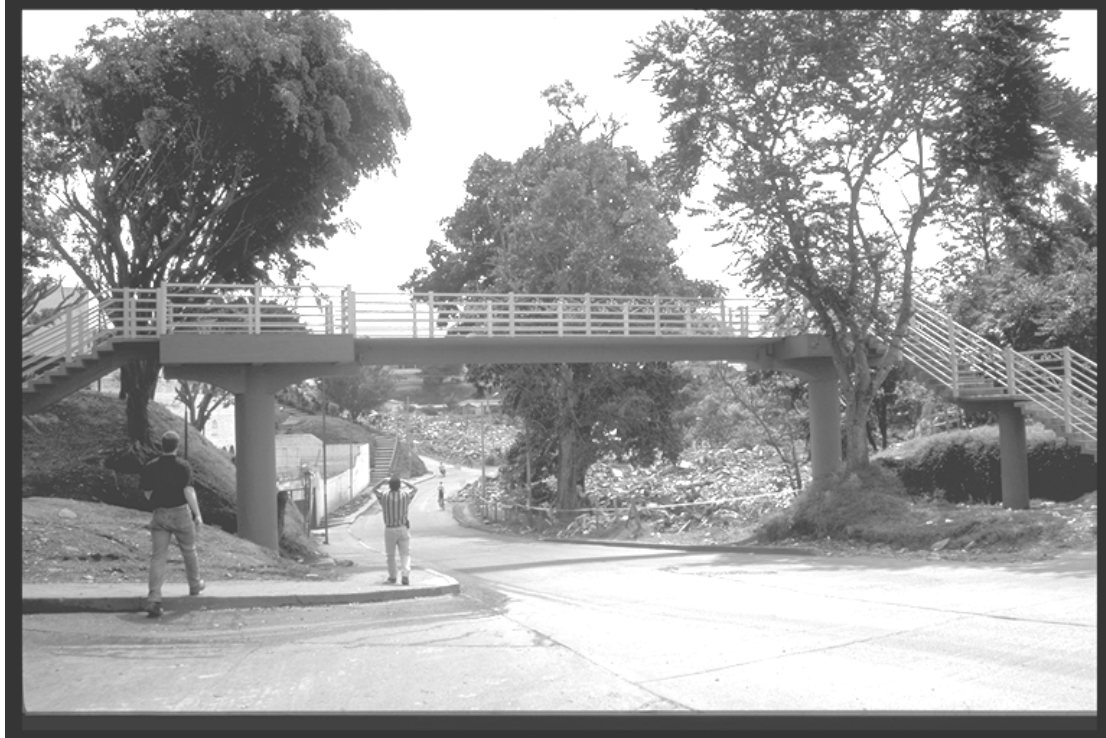
Figure 7.13: Damaged footbridge in south-west of Armenia

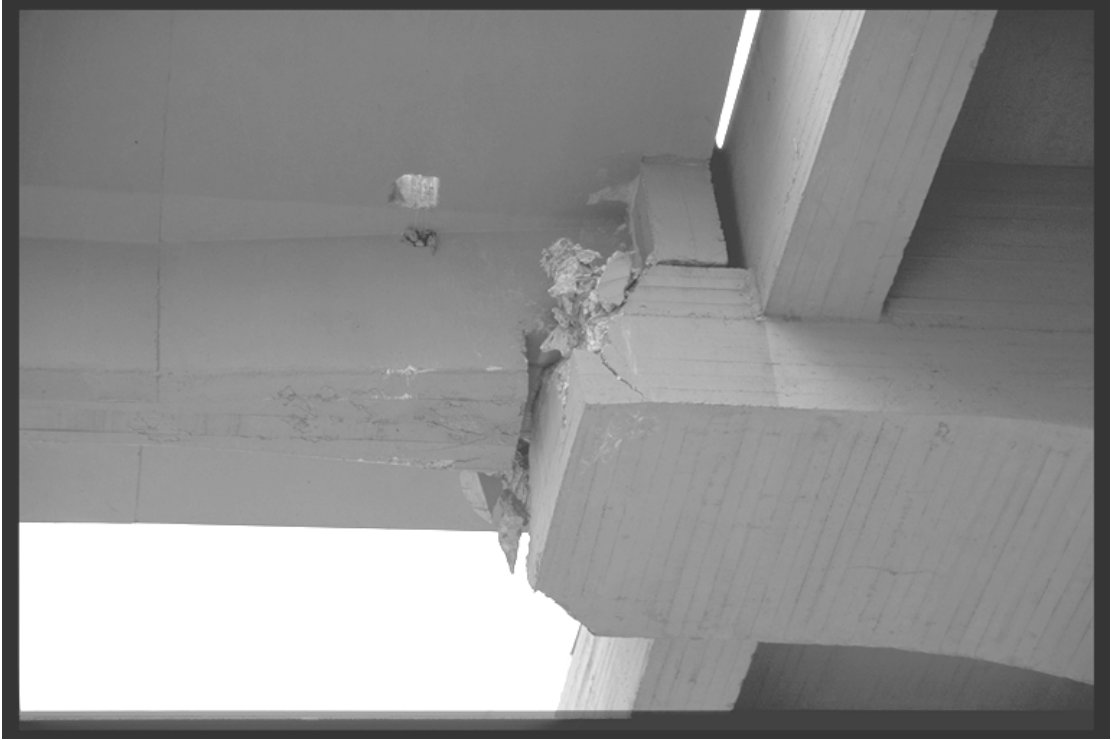
Figure 7.15: Detail of footbridge shear key damage – longitudinal displacement

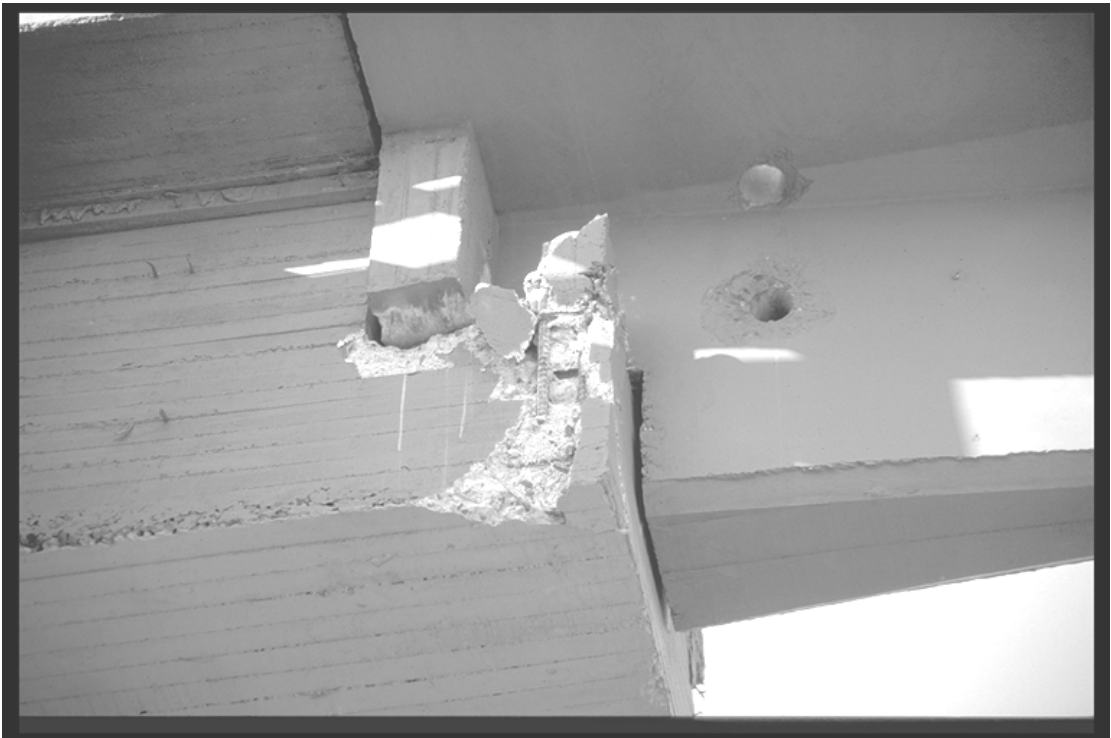
Figure 7.16: Detail of damage of similar footbridge – transverse displacement

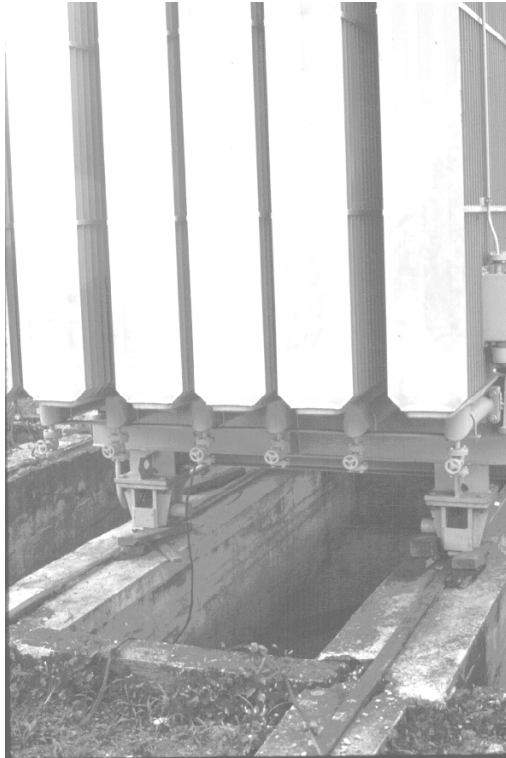
Figure 7.17: Replacement of damaged electric transformer of Regivit substation in Armenia, with damaged concrete wall shown on the lower right

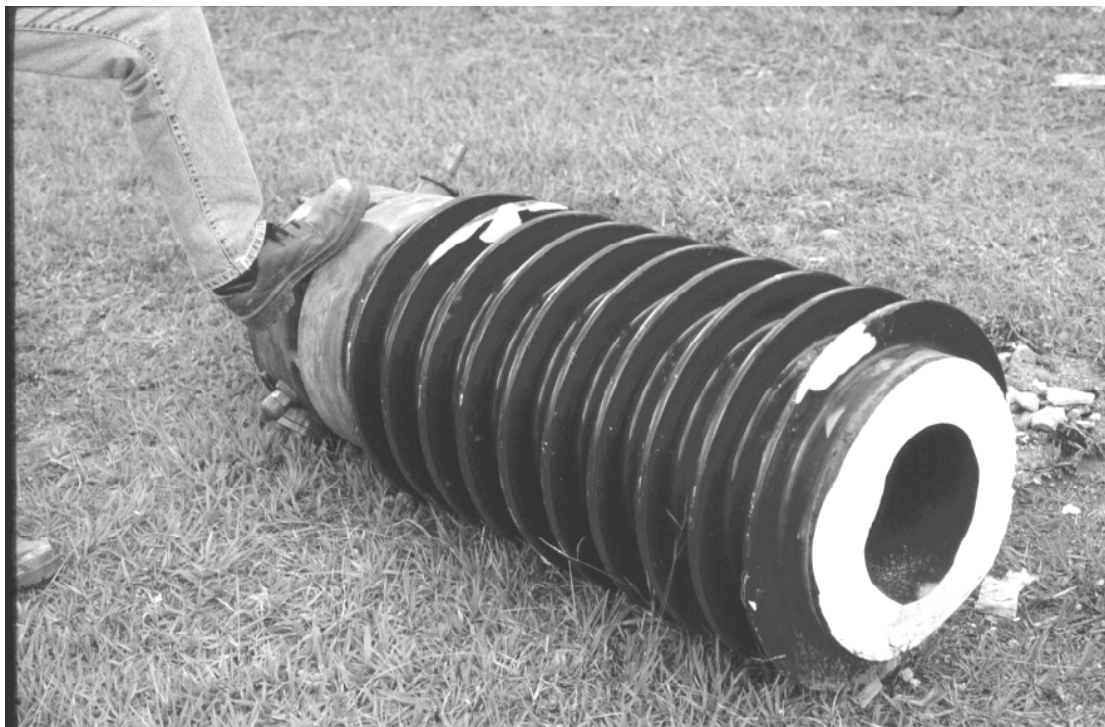
Figure 7.18: Ceramic electric isolator sheared off at the base at the Armenia Regivit substation

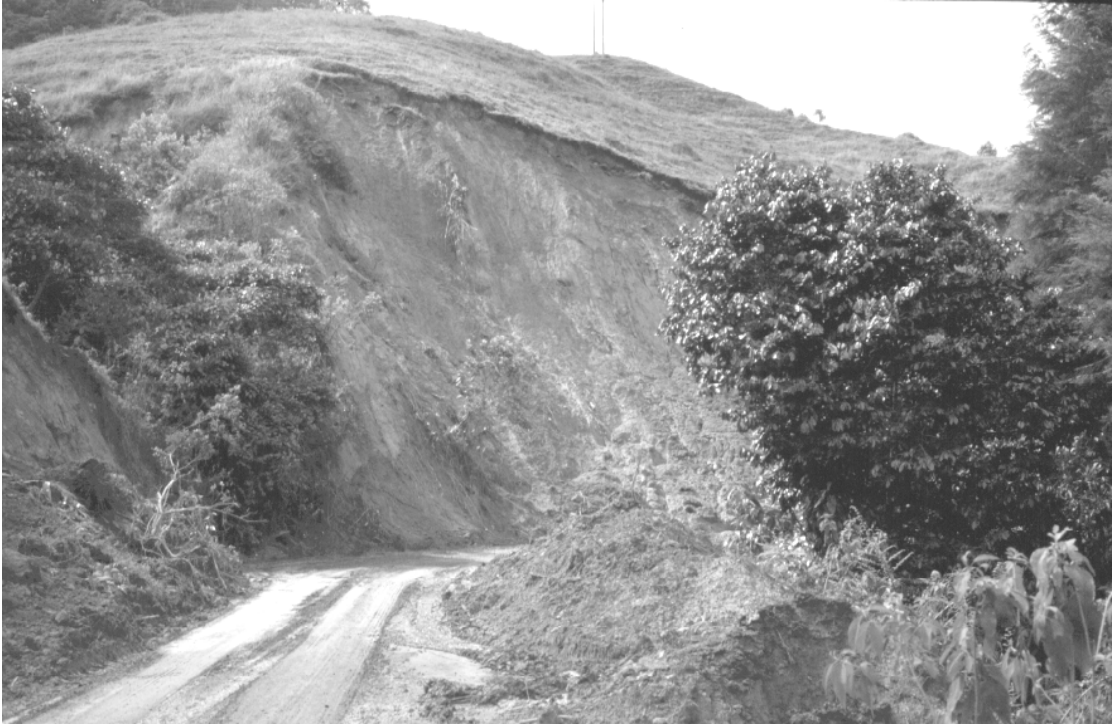
Figure 7.19: Landslides on the road to Pijao

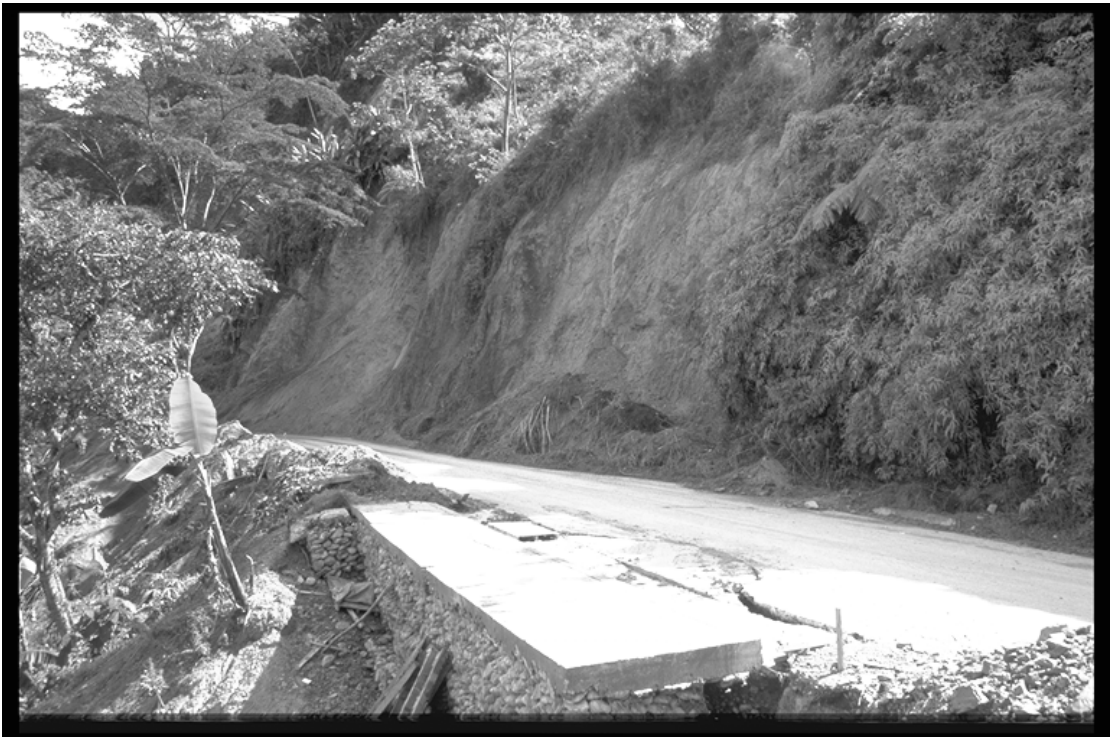
Figure 7.20: Partial failure of gabion retaining wall on the road to Pijao

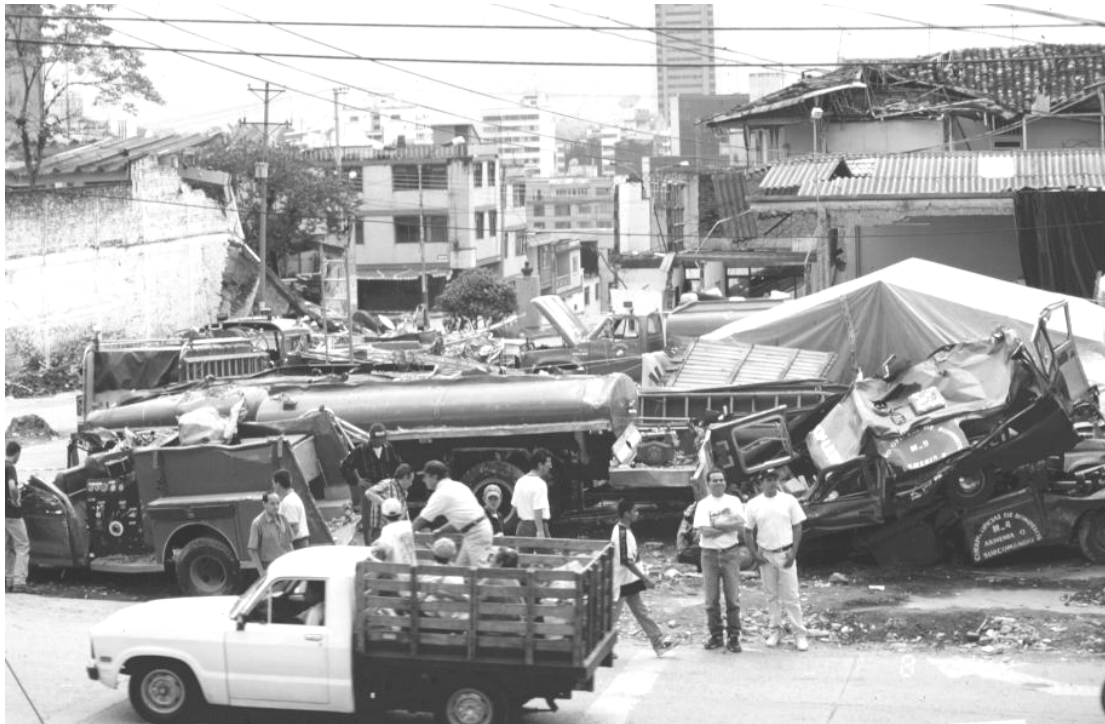
Figure 7.21: Collapse of Armenia fire station, showing heavy damage to equipment
