THE QUINDÍO, COLOMBIA EARTHQUAKE OF 25 JANUARY 1999

A FIELD REPORT BY EEFIT

August 2000

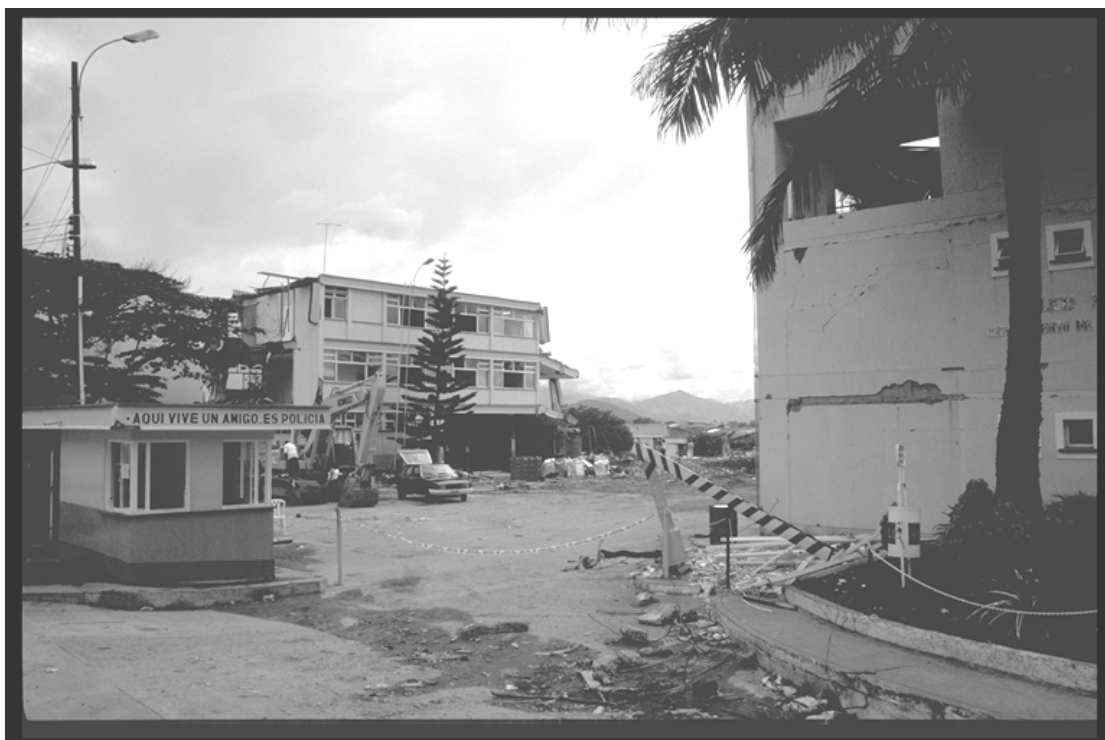
Figure 7.22: The police station in Armenia. The central block (centre of photo) had completely collapsed.

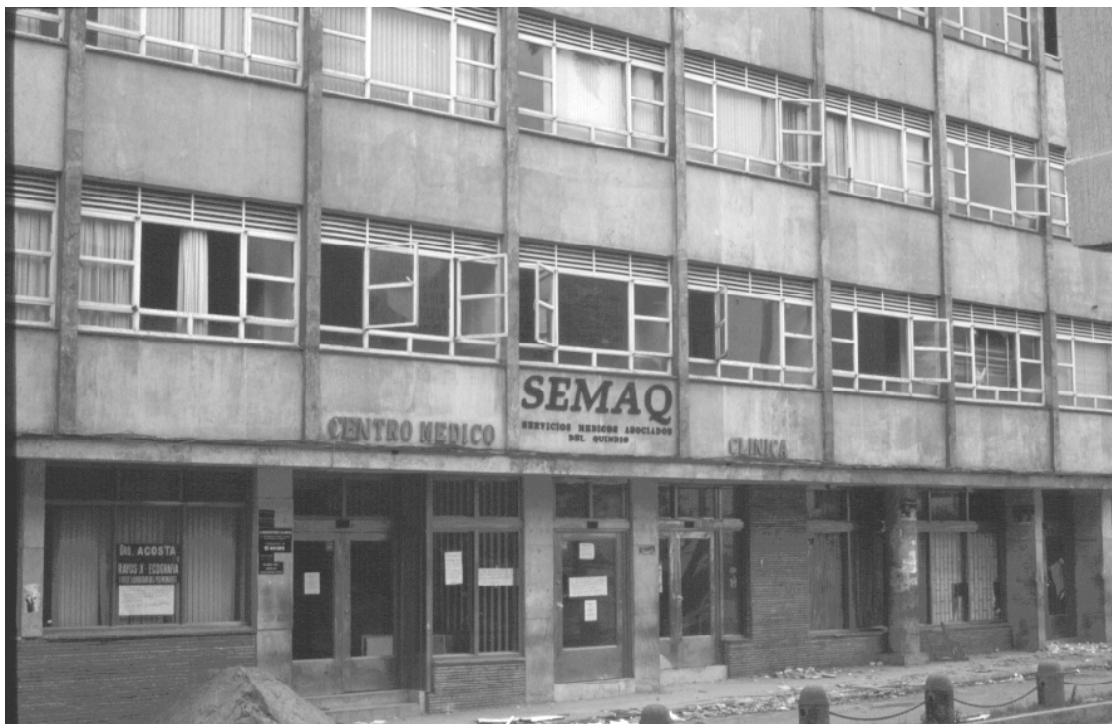
Figure 7.24: Hospital in Armenia city centre (pre-1984 design), closed due to non-structural damage after the earthquake

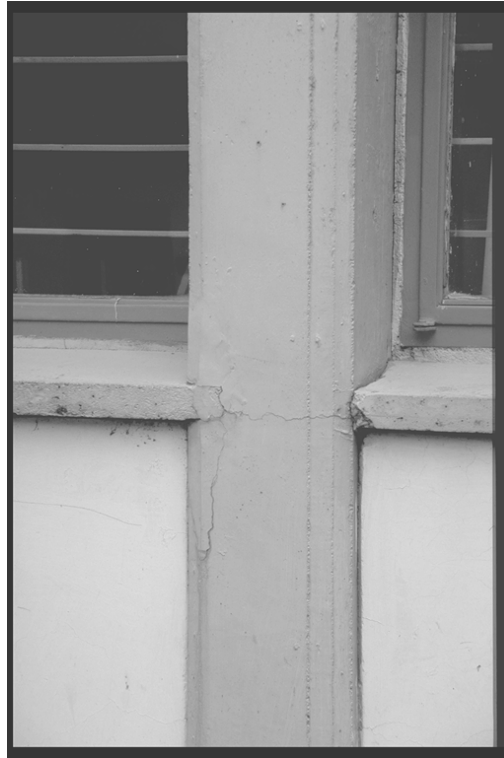
Figure 7.27: School in Pijao: Shear cracks in columns at top of infill

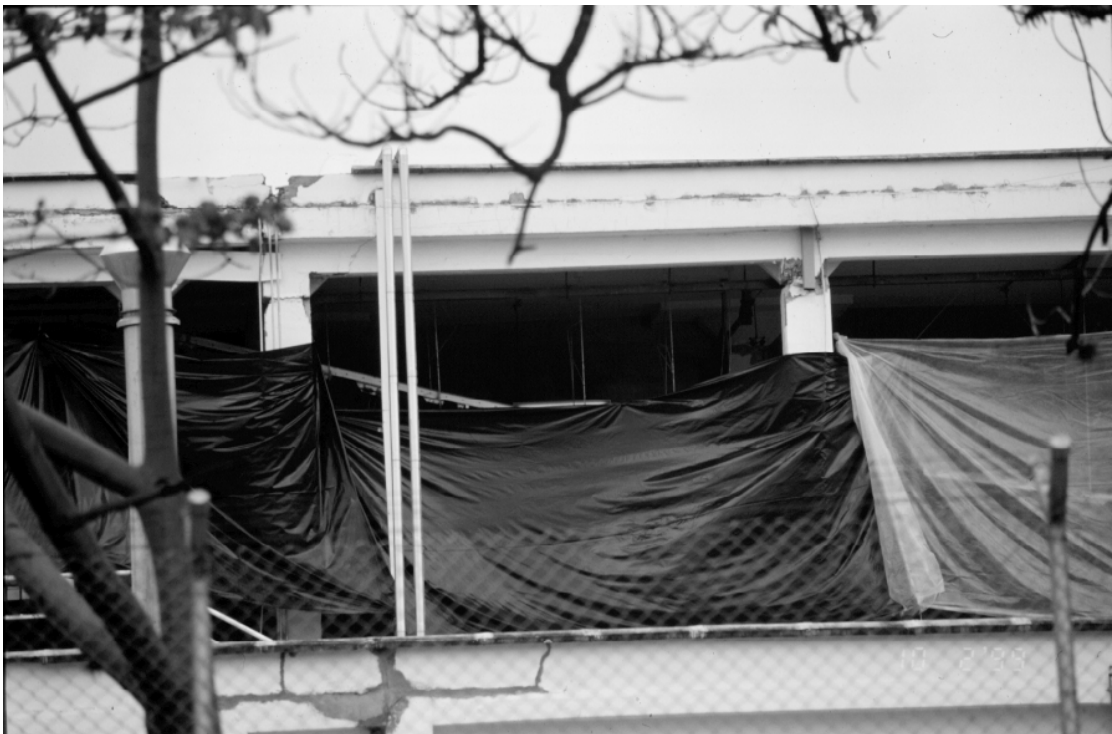
Figure 7.28: Failure of columns at the top of the second storey of a Dosquebradas industrial facility
