2007 August 15 Magnitude 7.9 Earthquake near the Coast of Central Peru

Earthquake Field Investigation Team (EEFIT) Field Mission, 5-12 SEPTEMBER 2007 / Final Report

Fabio TAUCER, Joint Research Centre (Editor and Team Leader)
Dr John ALARCON, Arup
Emily SO, University of Cambridge

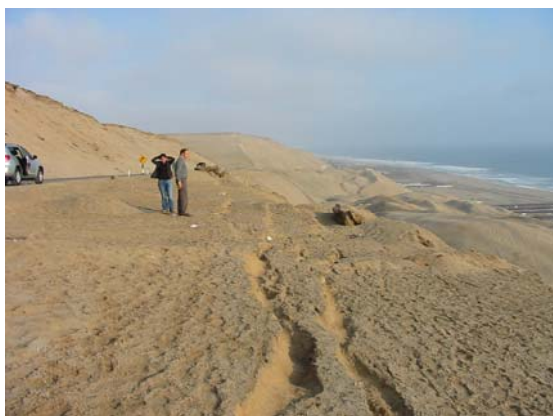
A section with slope instability was observed along the Pan-American Highway at approximately 10 km north of Cincha Alta (see point No.1 in Figure 3.7 and Figure 3.8). The landslide covered an area of approximately 50 x 10 m, affecting a soil mass (quaternary deposits of predominantly granular material) of up to 10,000 m³. The largest vertical displacement of the scarp was measured at 0.4 m (Figure 3.9). Evidence of few shallow landslides was observed in the stretch between Chíncha Alta and Pisco, but the material had been removed at the time of the visit.

Figure 3.8 Scarp of landslide on the Pan-American Highway; two tension cracks are observed at the bottom of the picture

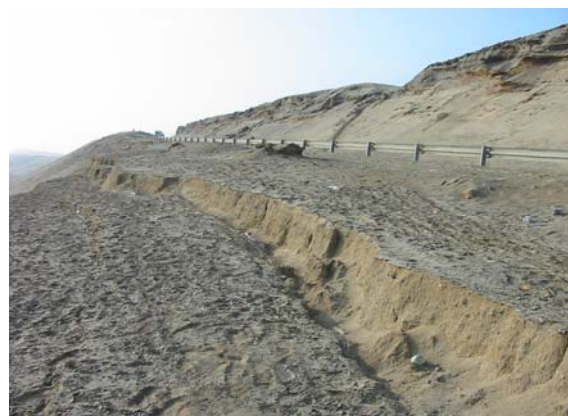
Figure 3.9 Detail of landslide scarp; the largest vertical displacement was measured at 0.4 m

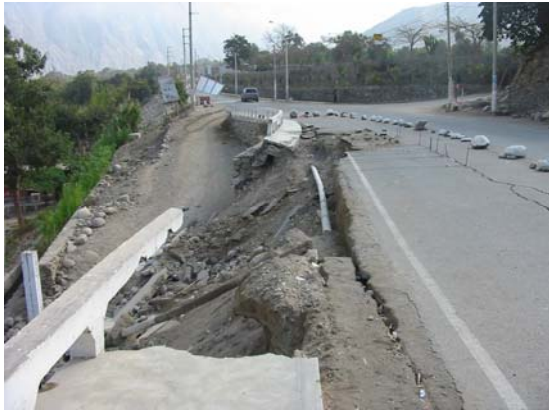
A 4 metre high stone retaining wall that supported a 20 m stretch of the road between Lunahuaná and Imperial failed at approximately 2 km from Lunahuaná (Figure 3.7); tension cracks were evident on the road, which led to closure of one traffic lane.

Figure 3.10 Stone retaining wall failure close to Lunahuaná

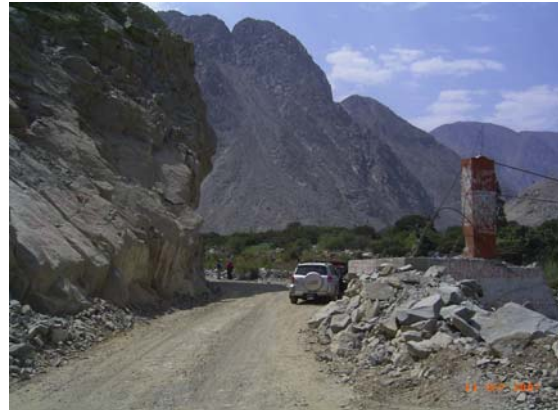
Figure 3.11 Rock fall that hit the abutment of a pedestrian bridge crossing the Cañete river (see point No.2 in Figure 3.8 for location)

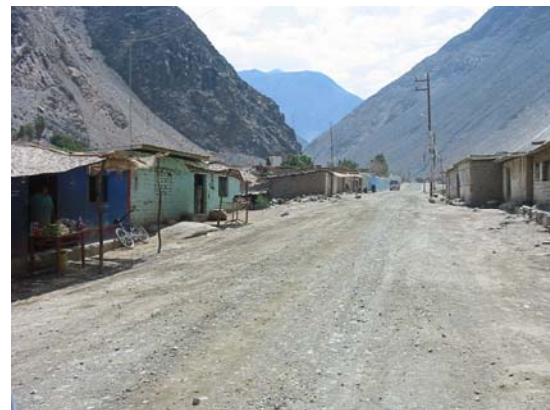
Figure 3.13 Debris fall in the mountain area along the Cañete river valley

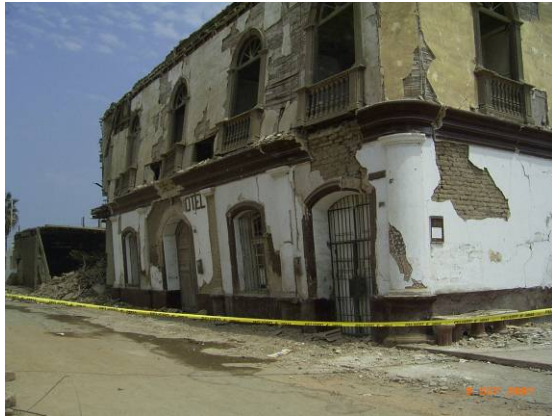
Figure 5.1 Pisco historic waterfront: damaged adobe building with *quincha* at second storey

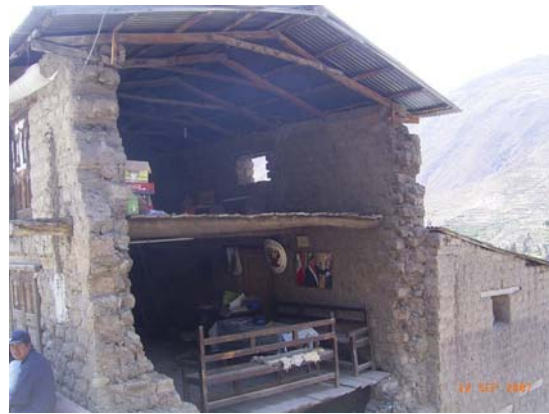
Figure 5.9 Two storey adobe house damaged in Huangáscar

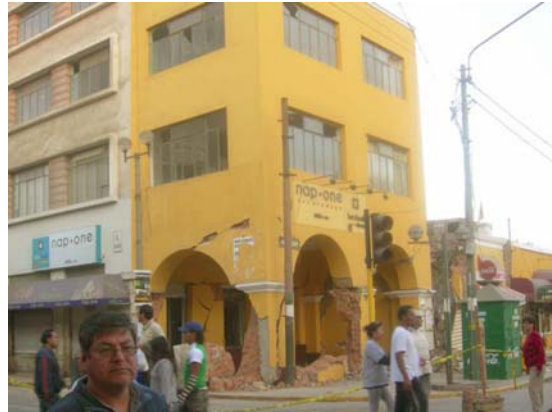
At the Plaza Mayor in Ica, a large institutional building of masonry construction with a series of arches at the front was reported with no damage along one of the sides of the square (Figure 5.14), whereas at the opposite side of the square, the same type of building (probably of newer construction, as evidenced by the larger, square windows) had failed at the corner (Figure 5.15), probably due to pounding from an adjacent, taller RC building, confirming the brittle mode of failure of these structures.

Figure 5.15 Severely damaged masonry structure in Plaza de Armas, Ica, at corner next to a RC building (Photo: Dr. Ing. Jorge E. Alva Hurtado, *Universidad Nacional de Ingeniería, Peru*)

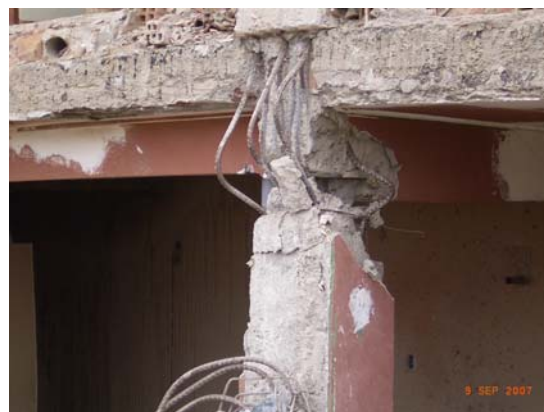
Figure 5.28 Detail of column failure in shear of the building structure of Figure 5.27

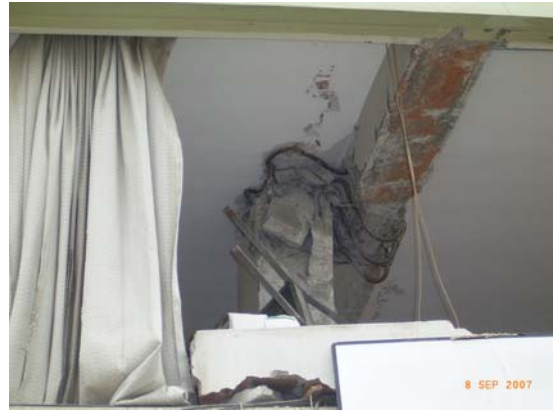
Figure 5.30 Detail of column failure from the building shown in Figure 5.29

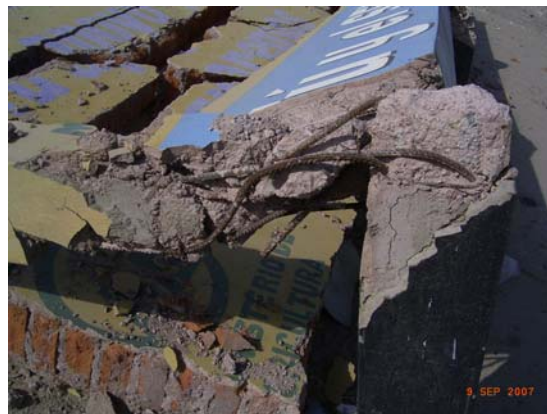
Figure 5.36 Detail of the RC columns of the Pozo Santo billboard, showing 12 mm diameter steel rebars with practically no confinement

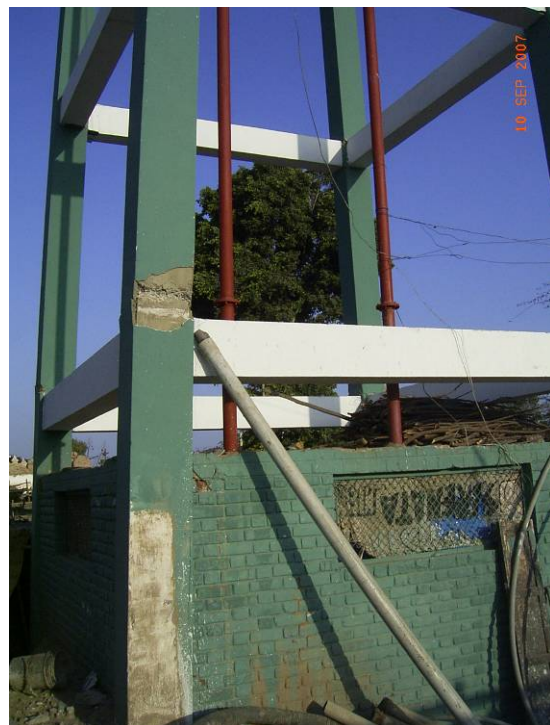
Figure 8.4 Damaged column next to infill wall, joint showing insufficient reinforcement.

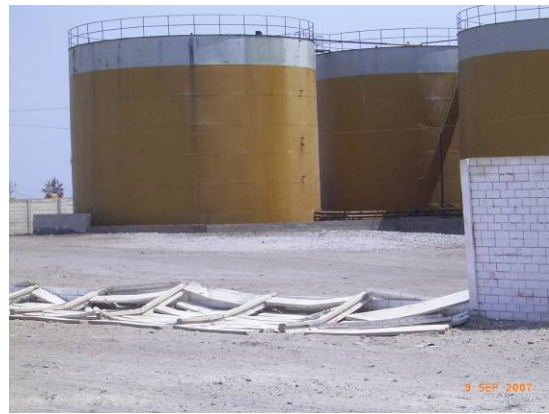
Figure 9.2 Toppled RC prefabricated perimeter walls and undamaged steel tanks along the coast near Pisco

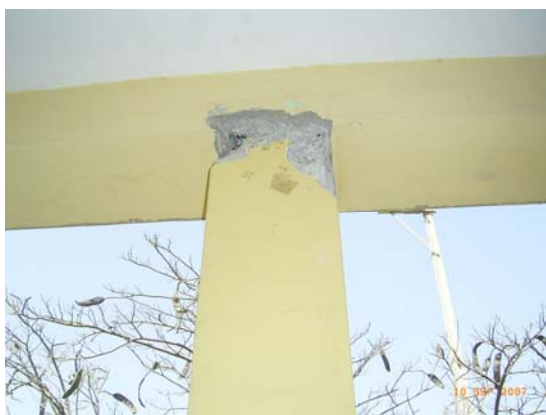
Figure 10.3 *Gran Unidad Escolar San Luís Gonzaga*: column failure at top end

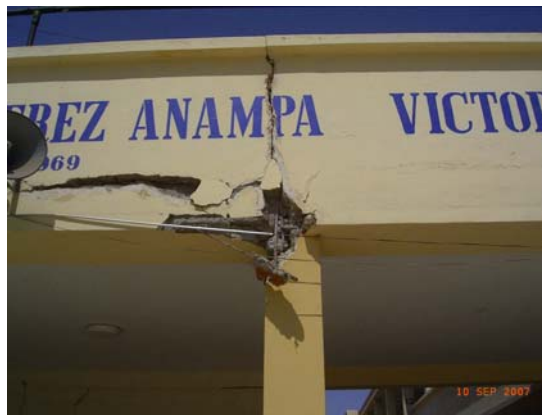
Figure 10.4 *Gran Unidad Escolar San Luís Gonzaga*: column failure at top end; roof parapet activated a strong-beam-weak-column mechanism

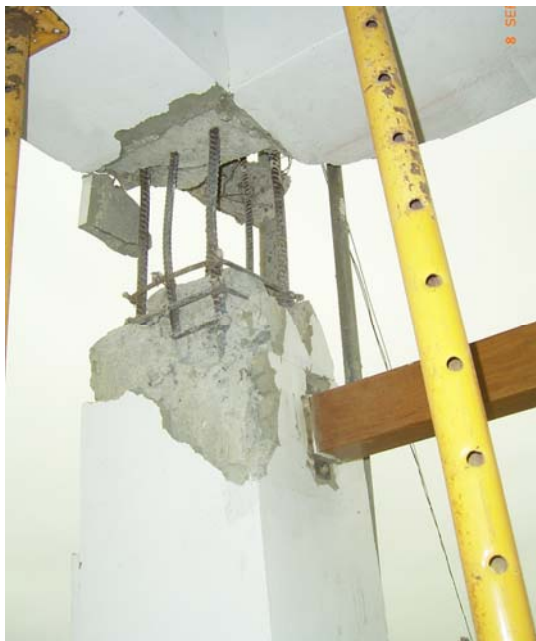
Figure 10.7 Pisco: School building showing failure of column at top end at the second storey, due to insufficient shear reinforcement and activation of a strong-beam-weak-column mechanism

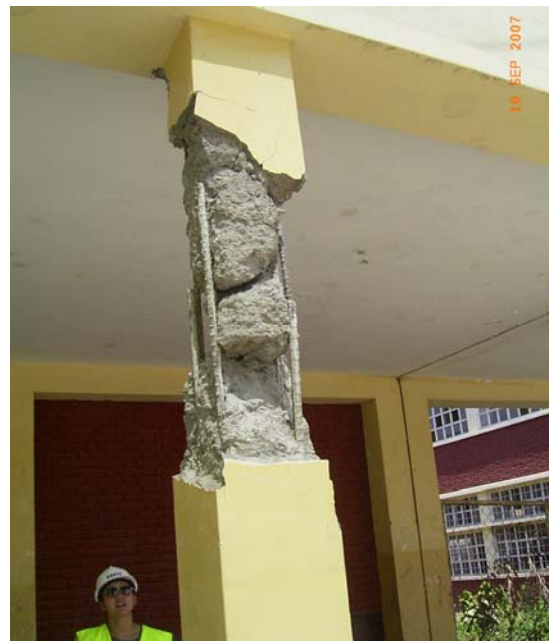
Figure 10.8 *Gran Unidad Escolar San Luis Gonzaga*: column failure in shear due to insufficient shear reinforcement and low quality of concrete

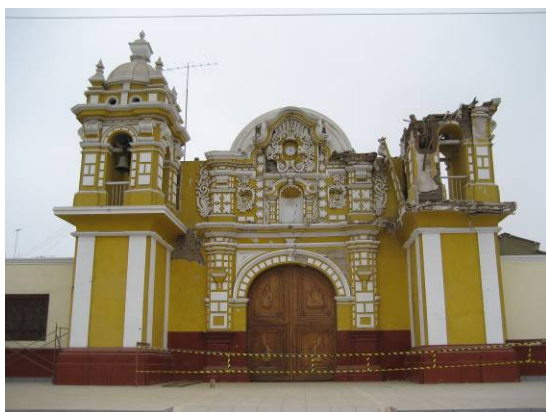
Figure 12.9 XVII century chapel in Hacienda San José near El Carmen with damaged bell tower.
