**THE M_w 6.4 ALBANIA
EARTHQUAKE ON
THE 26TH NOVEMBER 2019**
A FIELD REPORT BY EEFIT
OCTOBER 2020

Anton Andonov, Mott MacDonald

October 2020

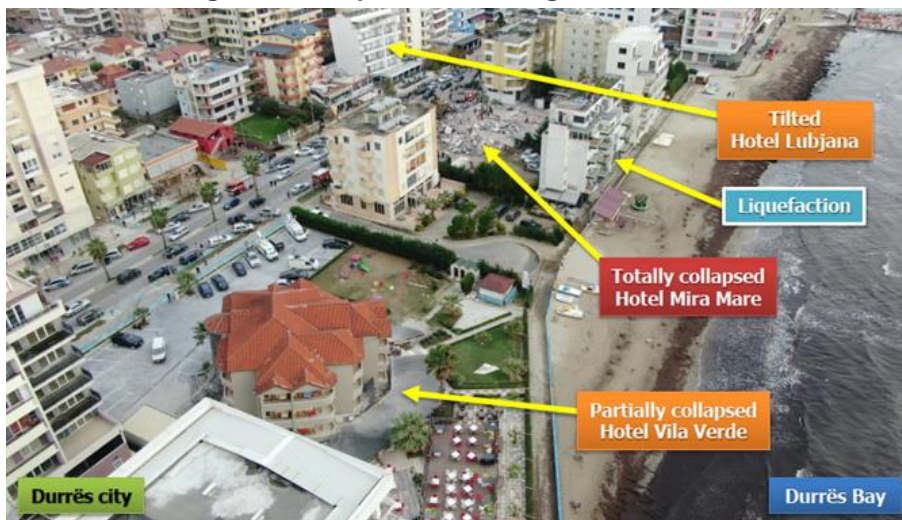
Figure 2.7: Liquefaction along Durrës beach

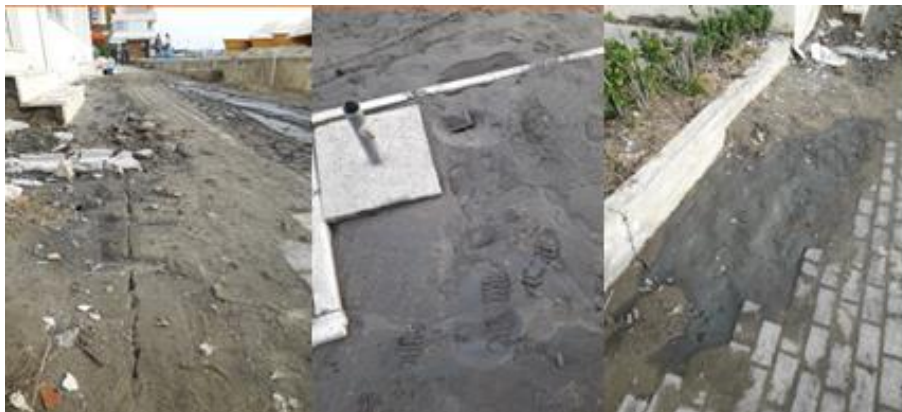
Figure 2.8: Surface manifestation of liquefaction along Durrës beach

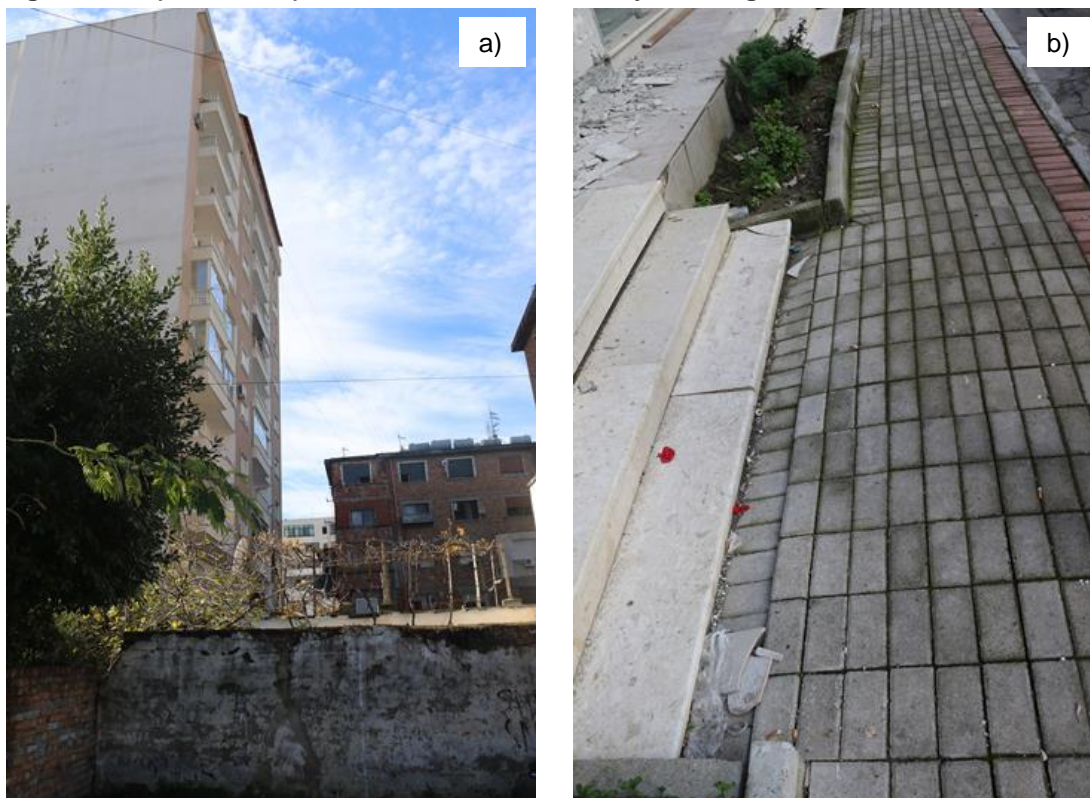
Figure 2.9: a) Tilt and b) subsidence of multi-storey building due to soil reconsolidation

The observed liquefaction and ground subsidence cases were in the areas of the city covered by either soft Holocene marshy deposits – clays, silts, sands and peats or Holocene marine sands as shown in the geological map of Durrës – Figure 2.10 after Shkëlqim et al [2.8].

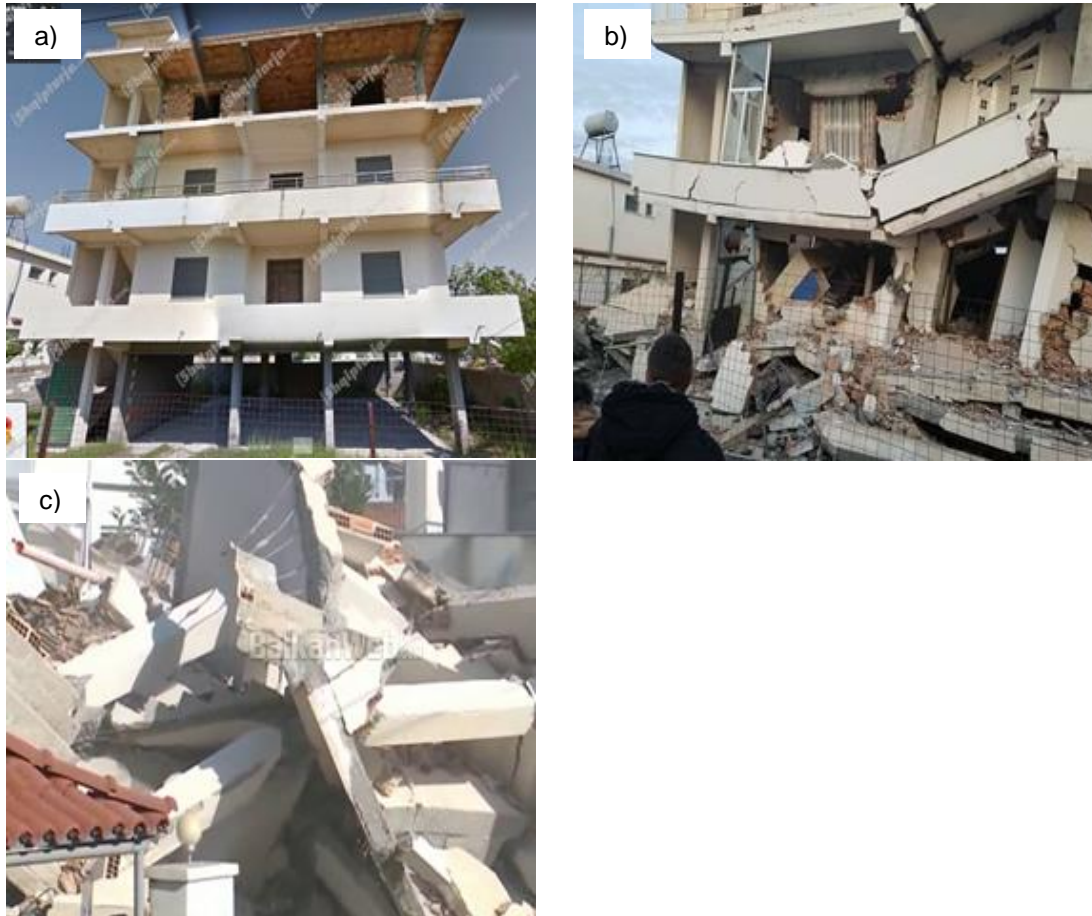
Figure 5.12: Four-storey RC building in Durrës that caused 8 fatalities

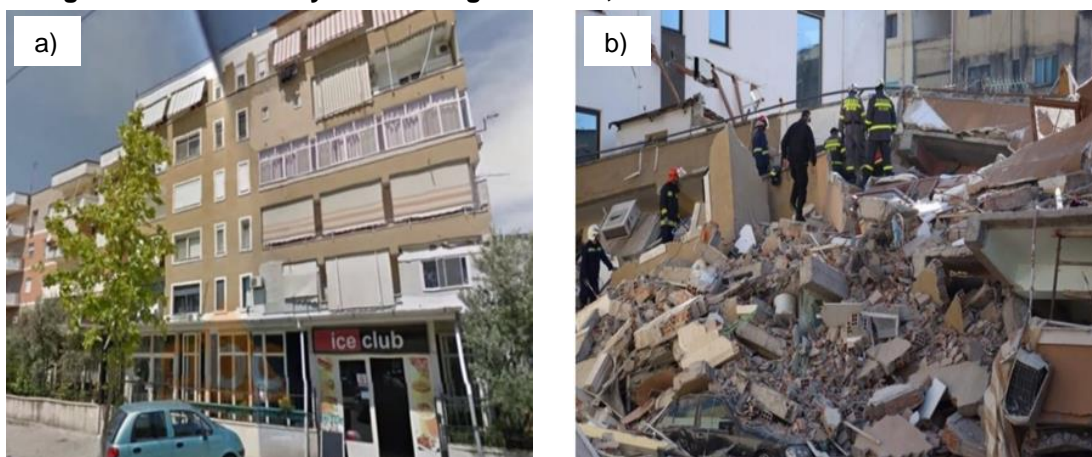
Figure 5.13: Six-storey RC building in Durrës, built in 1996 that caused 7 fatalities

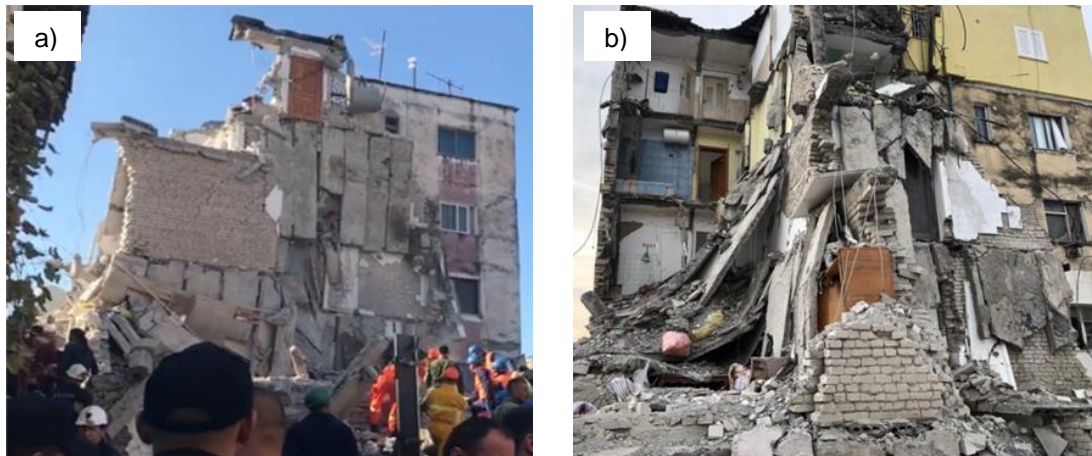
Figure 5.19: Two five-storey calcium-silicate masonry buildings in Kodër-Thumanë that caused 24 fatalities

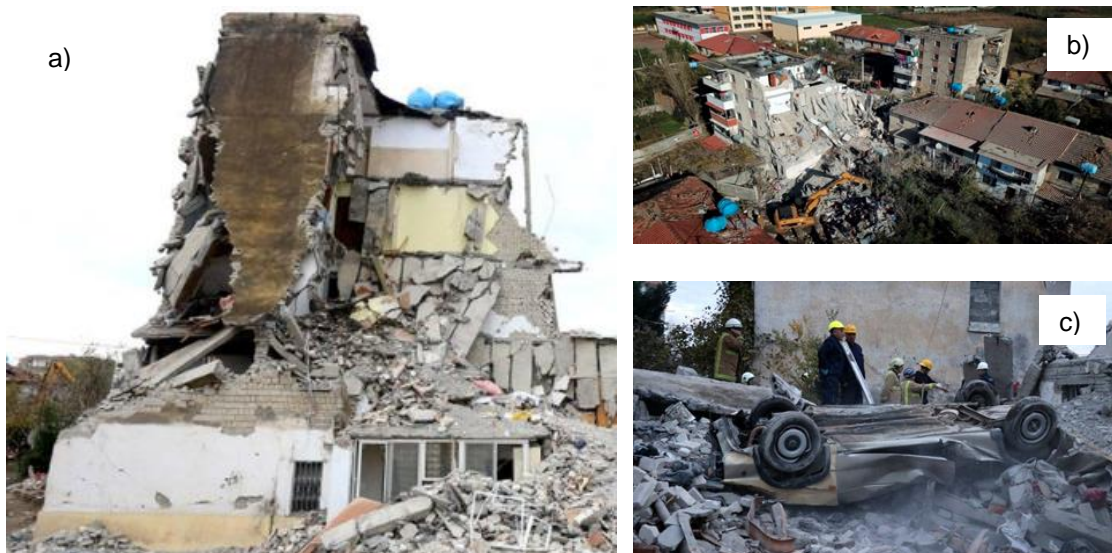
The only pre-1990 URM buildings which collapsed during the seismic event in November 2019 were made of solid silicate bricks and hollow core precast concrete slabs. These were located in Thumanë, see Figure 7.6. This was one of the most damaged towns, where a total number of 24 deaths were registered due to the collapse of two buildings of this typology (one 3-storey and two 5-storey buildings). The causes of collapse for these buildings are associated with the poor mechanical properties of the silicate bricks and the lack of connections between the precast concrete slabs and the bearing walls failing in overturning.

Figure 7.6: a) Collapsed 5-storey URM building in Thumanë; b) view from the air of the collapsed building in Thumanë; c) destruction in the town of Thumanë, one of the worst affected areas

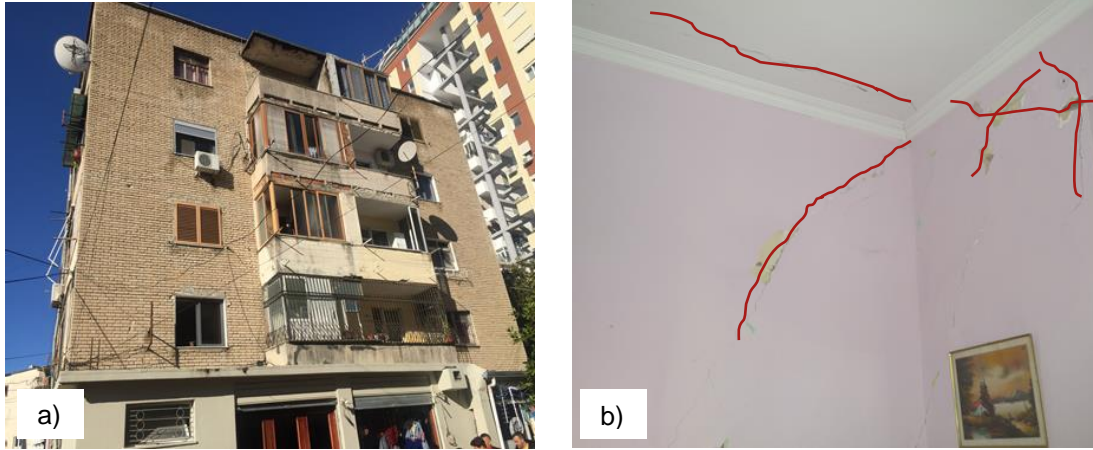
Buildings made of silicate bricks with hollow core precast concrete slabs were also inspected in the city of Lezhë, located in the northwest of Albania, about 50 km from the epicentre. In this area, damage to the buildings was not considered severe, and was only observed in a few cases. The 5-storey building in Figure 7.7, representative of the typical pre-1990 URM structures inspected in this area, was built in built in 1974. The building was tagged “red” as unsafe by local engineers, although no damage was observed on external bearing walls and only light cracks were detected on internal bearing walls. The damage observed by internal inspection consists of shear diagonal and X-shape cracks on bearing walls, and horizontal cracks on ceilings highlighting a displacement in the prefabricated panels in the slabs.

Figure 7.7: a) 5-storey pre-1990 URM buildings made of silicate bricks and hollow core precast concrete slabs, inspected in Lezhë (red tagged by local engineers), b) typical light shear cracks observed on internal bearing walls

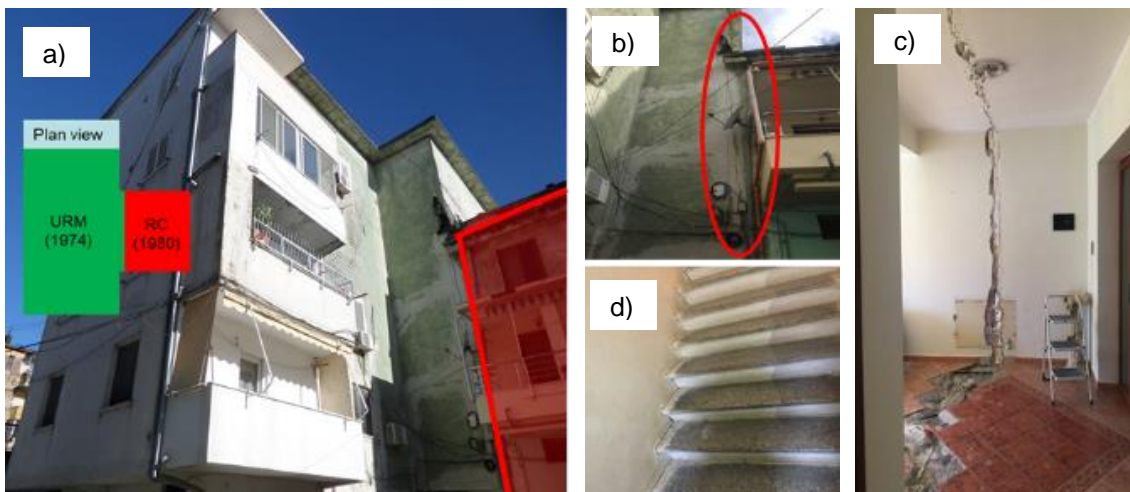
More severe damage was observed on silicate brick buildings with hollow core precast concrete slabs which had undergone to large interventions carried out with an inadequate seismic design. Figure 7.8 reports the damage due to the extension of the 5-storey building built in 1974 (see green plan in Figure 7.8a) with a 4-storey building from RC built in 1980 (see red plan in Figure 7.8a). The different stiffness the URM and RC buildings caused severe pounding damage visible on the external bearing walls (Figure 7.8b), the cracks along the opened gap between buildings observed during the internal inspection (Figure 7.8c), and the detachment of the staircase due to torsion (Figure 7.8d).

Figure 7.8: a) 5-storey pre-1990 URM buildings made of silicate bricks and hollow core precast concrete slabs, inspected in Lezhë (red tagged by local engineers), b) pounding damage between the URM building and RC building, c) gap opening, and d) detachment of the staircase

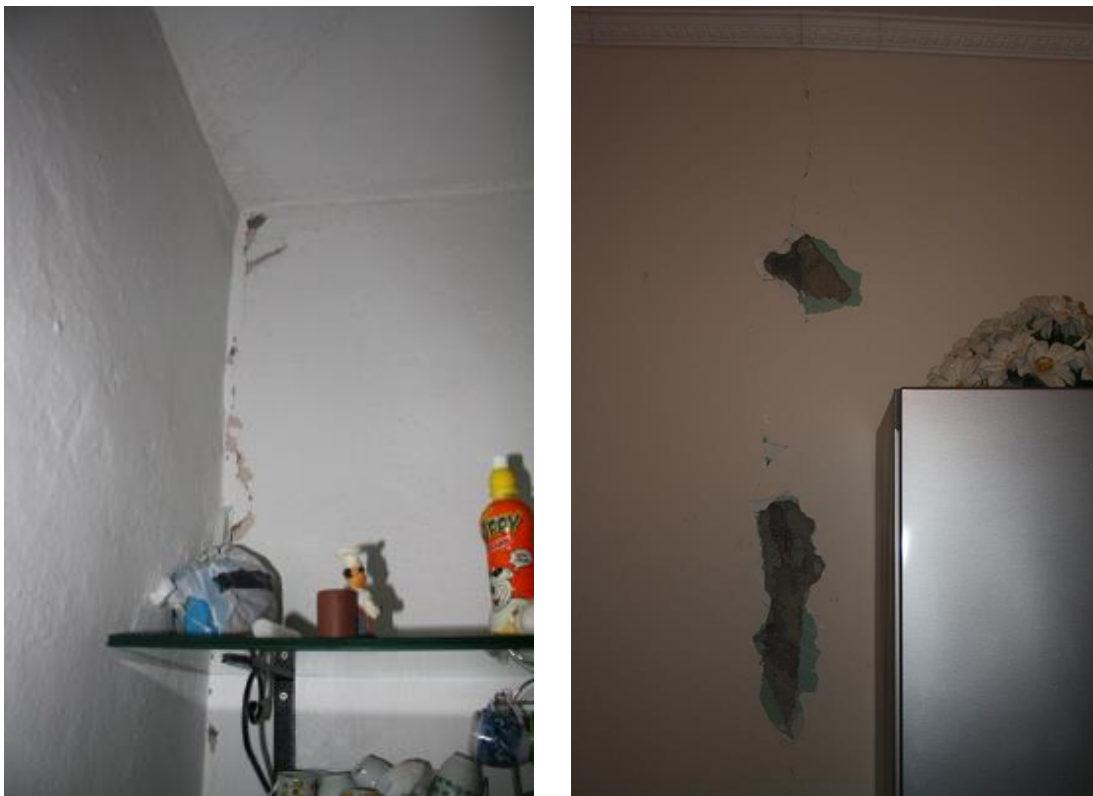
Figure 7.14: LPBs in Laç (Module 1, two sections): Vertical cracks formed in the interface between wall panels

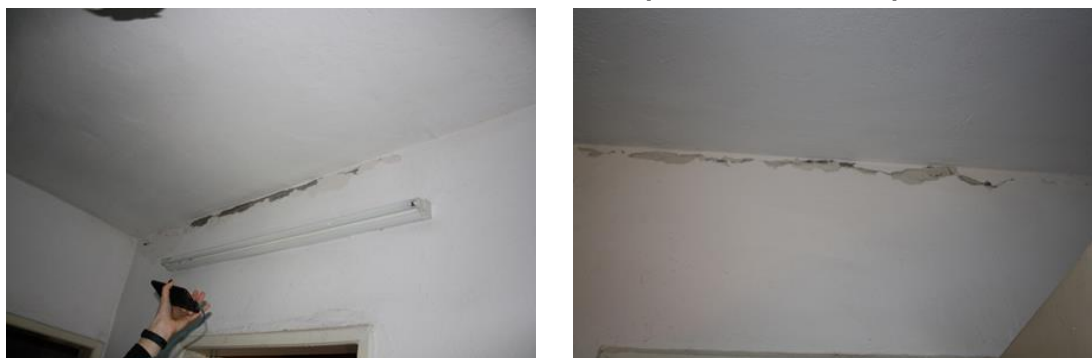
Figure 7.16: LPBs in Durrës (Module 2 with one, two & three sections): horizontal cracks formed in the interface between the wall panel and the floor panels

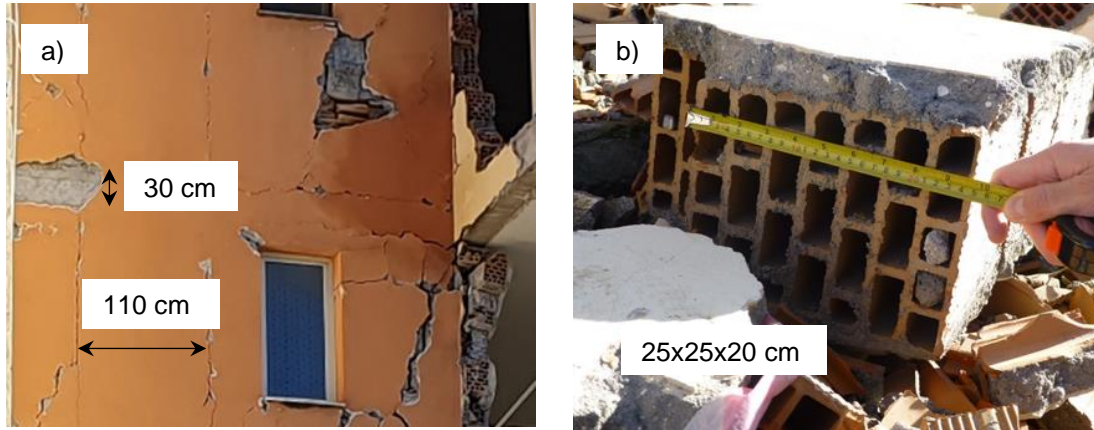
Figure 7.20: Typical 2000s multi-storey RC building compliant with KTP-N.2-89: a) cracks in the plaster and identification of beams and columns; b) dimension of the hollow bricks for the infill panels

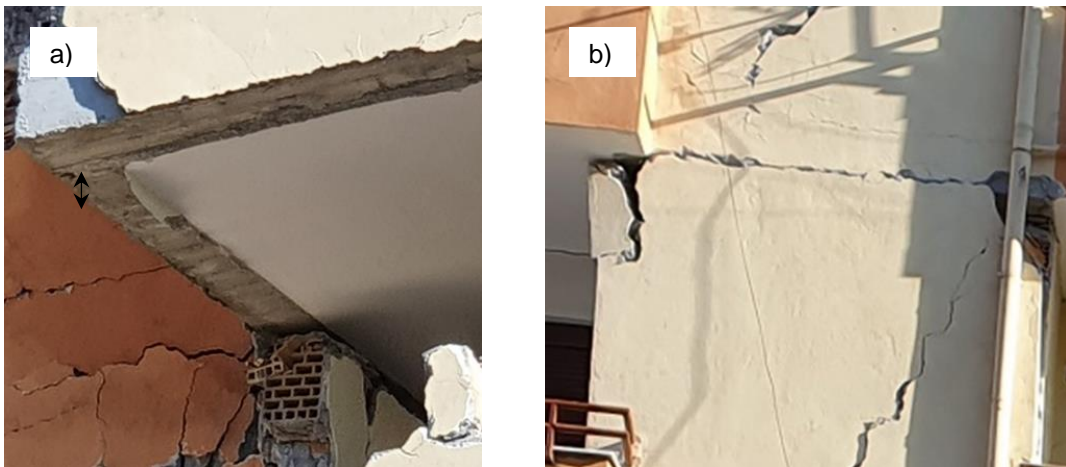
Figure 7.21: Typical 2000s multi-storey RC building compliant with KTP-N.2-89: a) collapse of the infill panel; b) detachment of the infill panel and formation of horizontal cracks

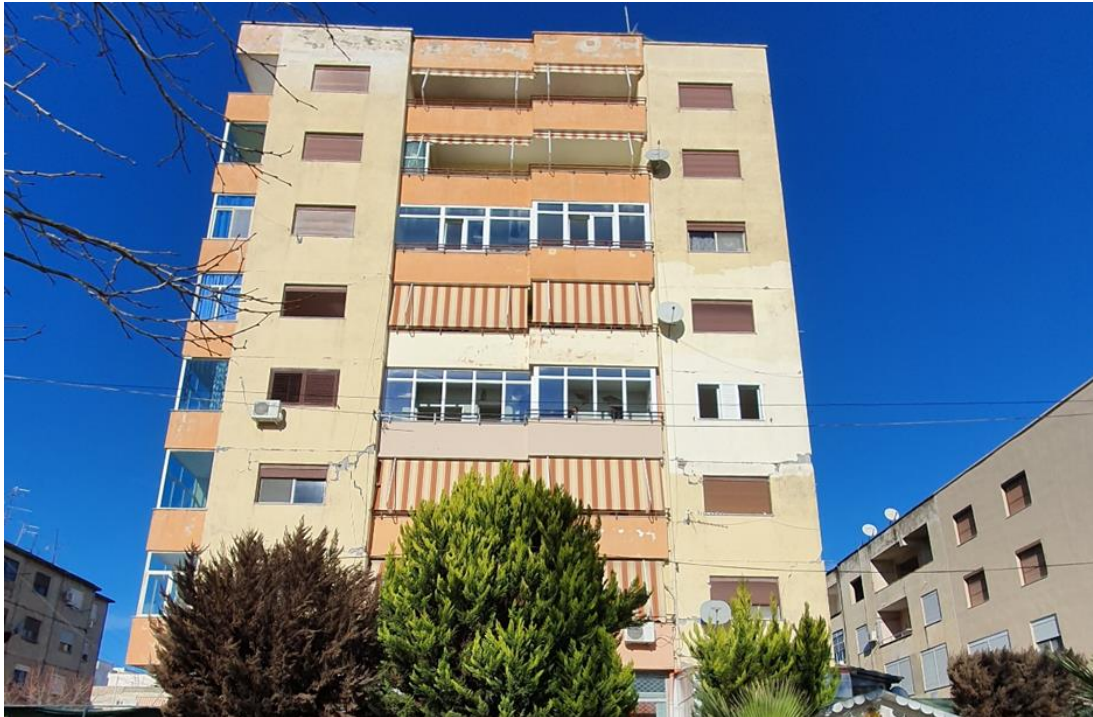
Figure 7.22: Typical 2000s multi-storey RC building compliant with KTP-N.2-89: damage layout on the eastern façade of the building

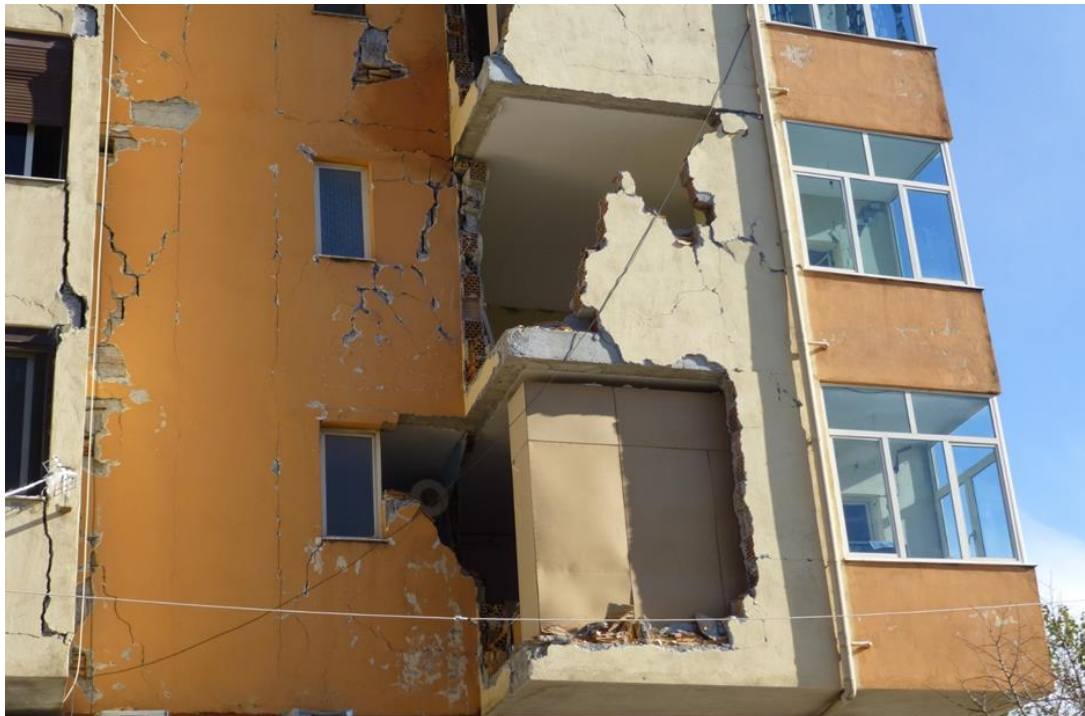
Figure 7.23: Typical 2000s multi-storey RC building compliant with KTP-N.2-89: damage layout on the eastern façade of the building, closeup

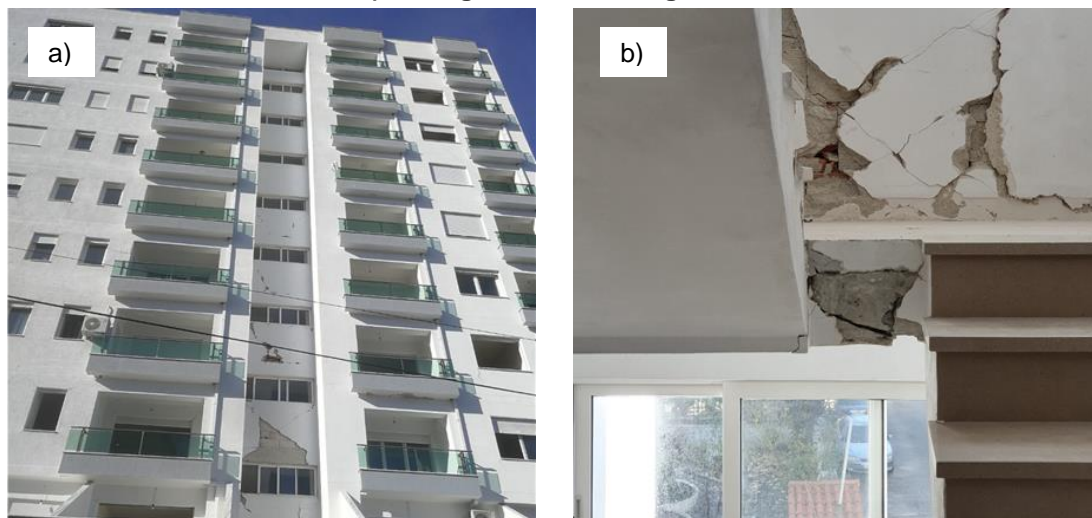
Figure 7.25: Typical post-2010 multi-storey RC building compliant with KTP-N.2-89 with integrated aspects of Eurocode 8: a) exterior damage related to the interaction with the stairs; b) damage on the landing of the stairs

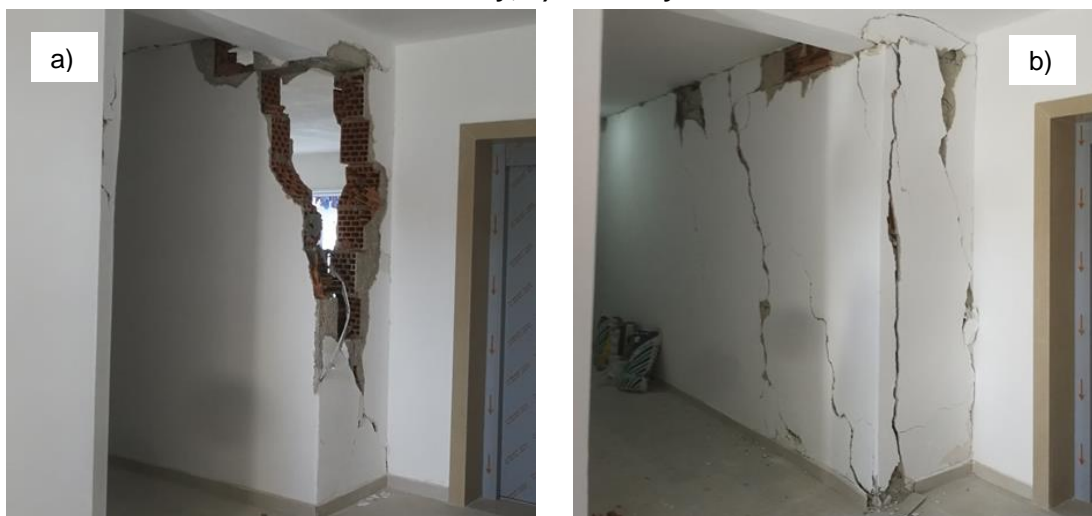
Figure 7.26: Typical post-2010 multi-storey RC building compliant with KTP-N.2-89 with integrated aspects of Eurocode 8. Unconfined internal infill showing damage at the a) 2nd storey; b) 5th storey

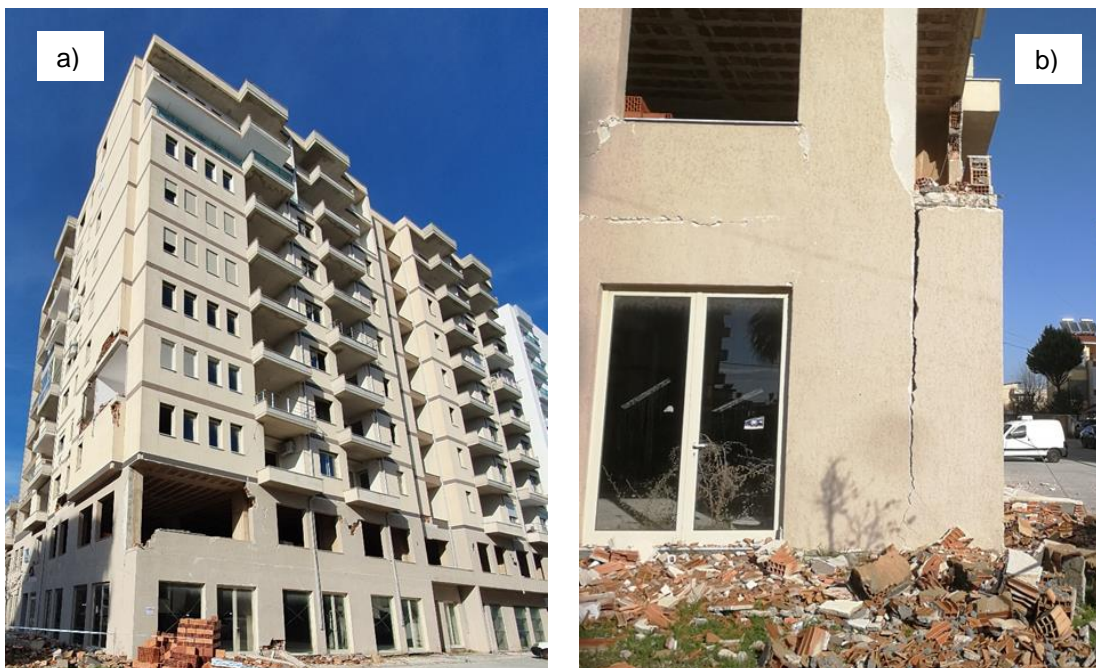
Figure 7.27: Typical post-2010 multi-storey RC building compliant with KTP-N.2-89 with integrated aspects of Eurocode 8. a) exterior damage due to torsion; b) failure of unconfined infill

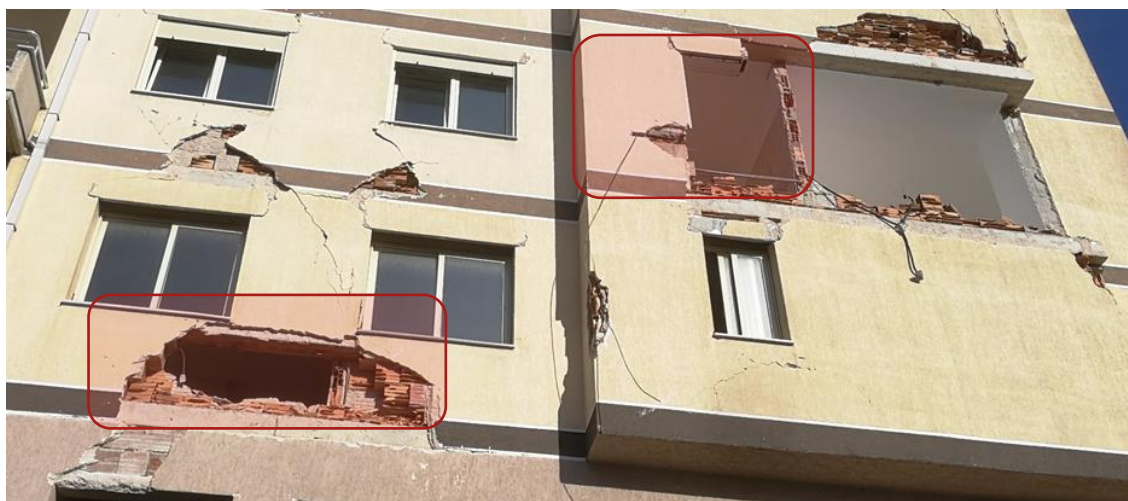
Figure 7.28: Typical post-2010 multi-storey RC building compliant with KTP-N.2-89 with integrated aspects of Eurocode 8. Effects of the belt beams in confined and unconfined infills.

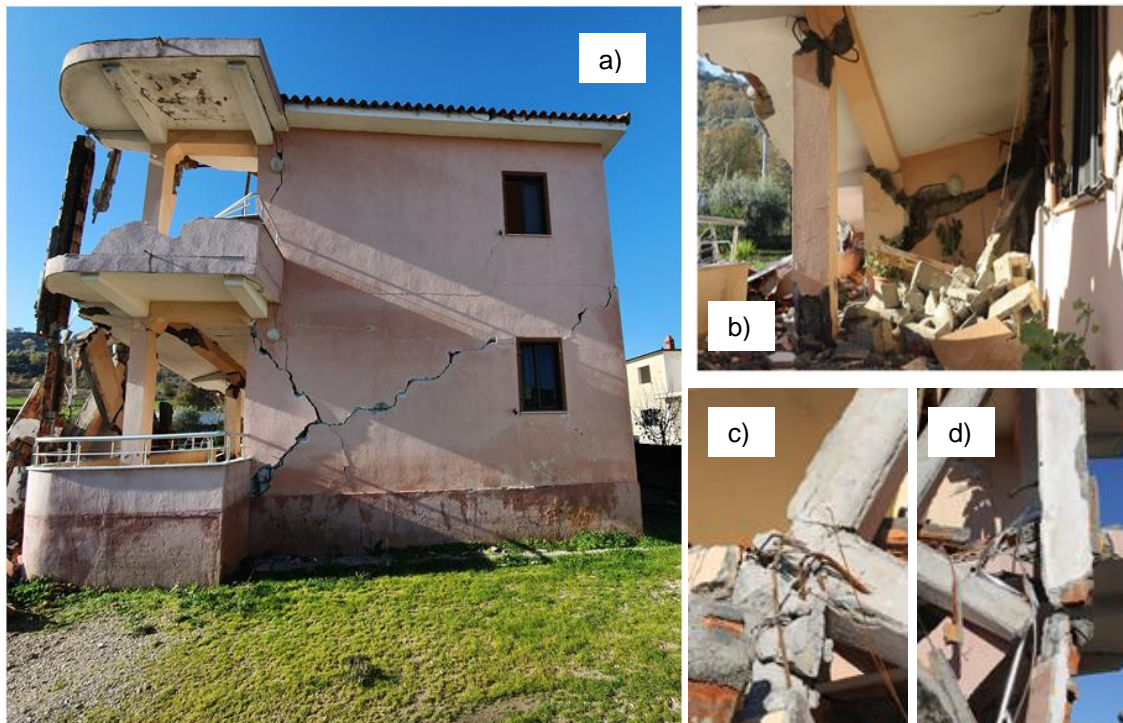
Figure 7.31: Collapsed single family rural house in Bubq: a) severely damaged side façade b) internal view of the failed portico, c) and d) details of the poor reinforced columns of the portico at the joint connections.

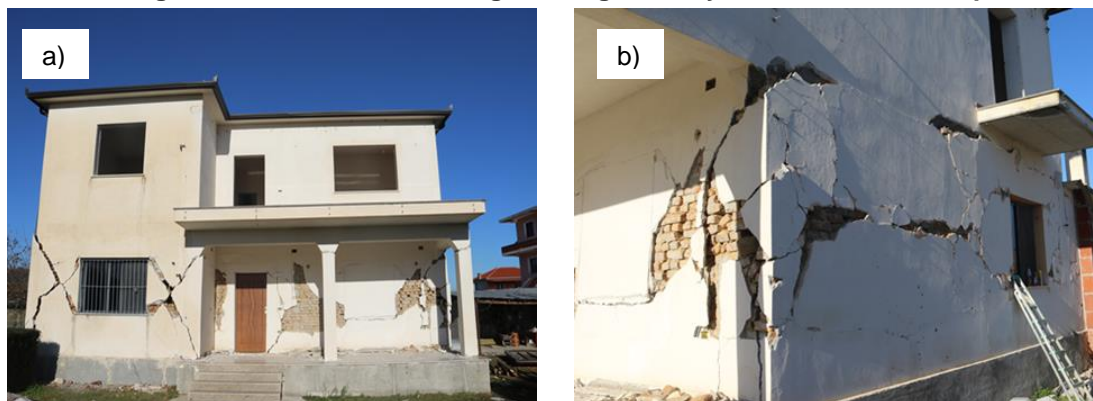
Figure 7.32: Extensive damage in single-family rural house in Bubq

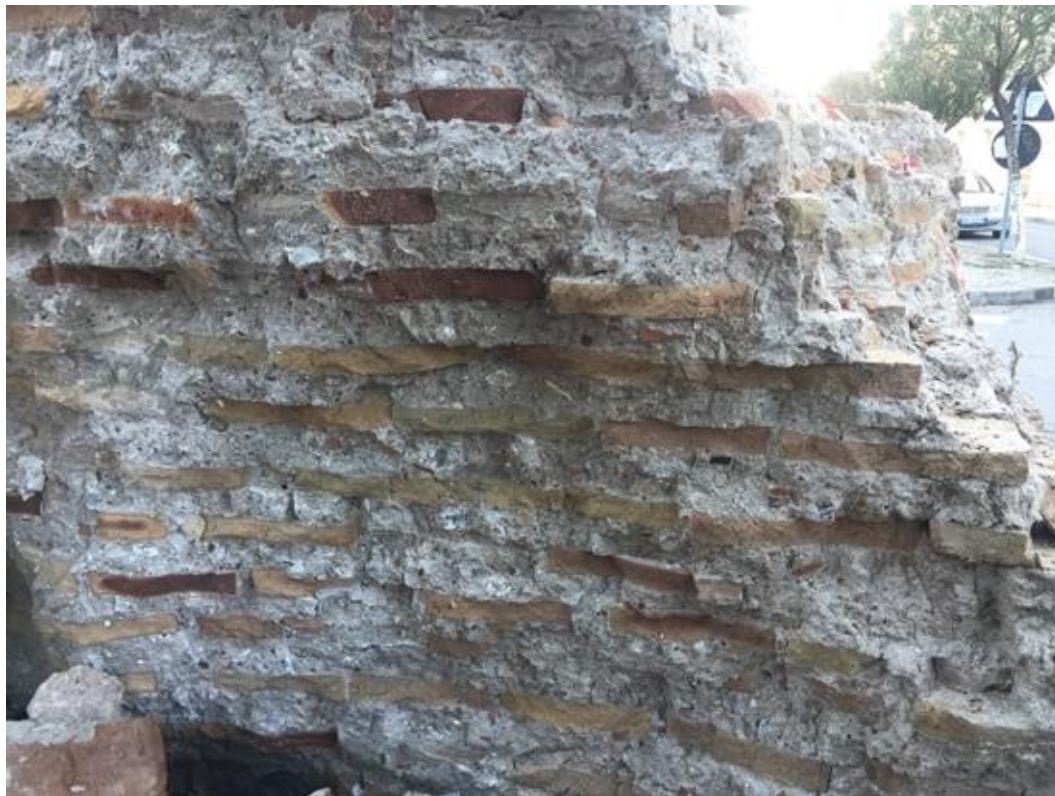
Figure 7.37: Close view of the collapsed masonry in Durres

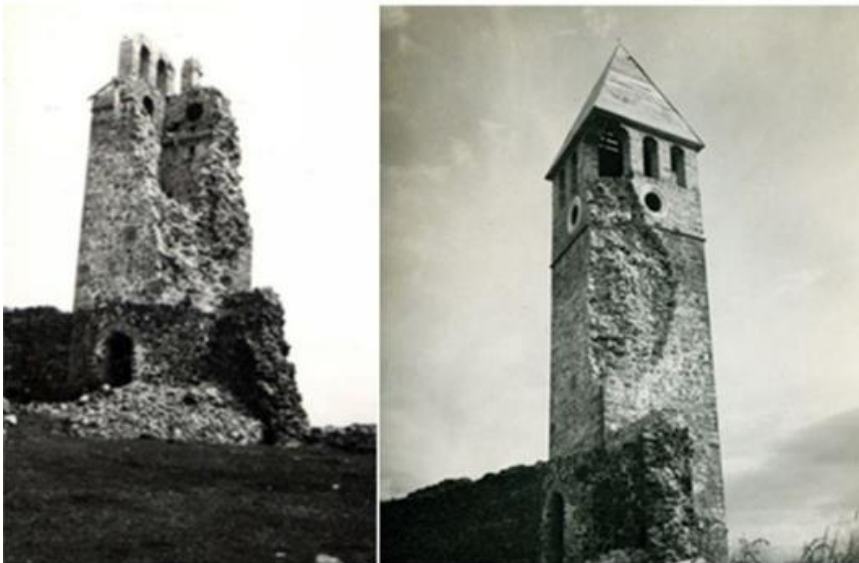
Figure 7.46: Damage suffered by the Prezë castle clock tower at different times [7.18]
