CROSS Safety Report

Dangerous glass infill panels on balustrade

This month we present a report about the structural stability of cantilever glass infill panels between a steel post and handrail balustrade system at a high-level apartment block.

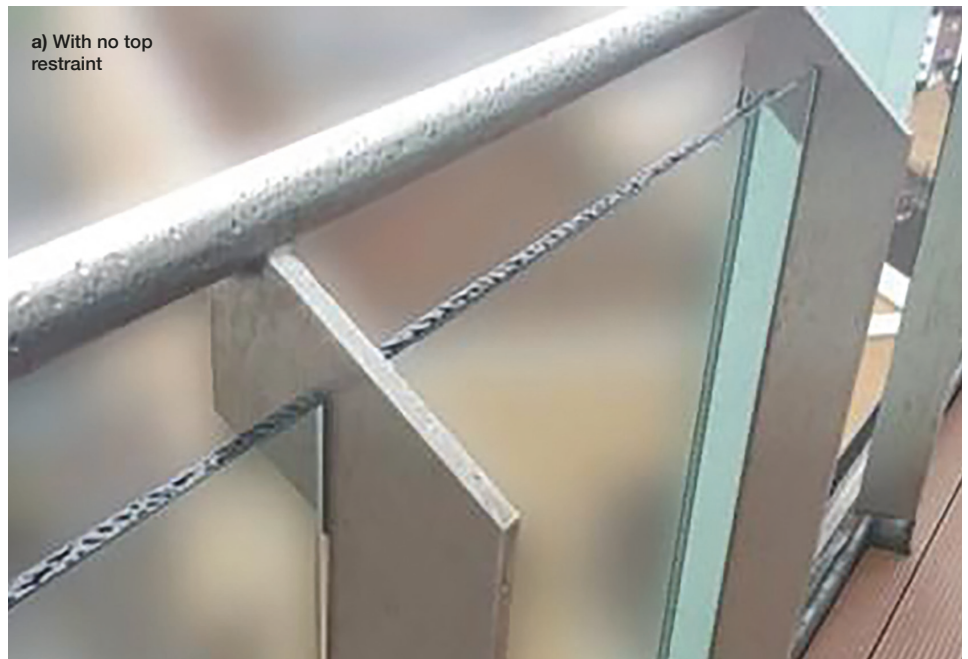
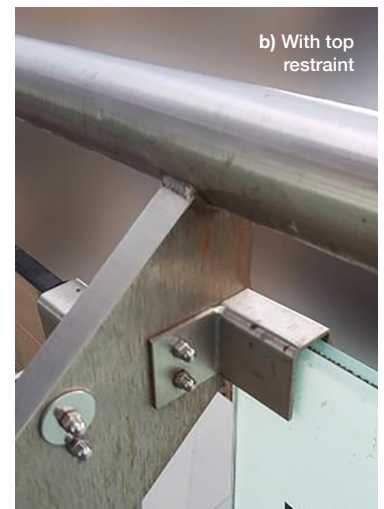
FIGURE 1:
Glass infill panel

- | The glass infill panels are set into a mastic filled channel at the base which in places is deteriorating.
- | Some infill panels are laminated, and some are non-laminated.
- | The steel post and handrail balustrade system is not connected to the glass infill panels.

According to the reporter, in the event of a failure at the base, there is no secondary fixity to prevent complete failure of the glass sheet (**Figure 1a**). The height of the apartment means that patio furniture can get blown right round three sides of the block of flats by wind. In the event of impact from the furniture, the non-laminated glass could shatter.

Here, the glass simply cantilevers from a mastic filled channel at the base, which is not a robust detail, and does not provide safety either for residents or passers-by.

Cantilevers always require care and glass cantilevers particularly so. The risk is that if the glass breaks from impact then; firstly, there would be a large gap below the balustrade rail through which someone could fall and, secondly glass shards or granules could fall on the ground below. Another possibility would be that a panel was dislodged outwards, without breaking, but with the same consequences.

The reporter feels that all the non-laminated sheets of glass need to be replaced with laminated glass. They feel a secondary top fixing bar in stainless steel should be added to exploit the existing post and rail system. This would hold the top of all the glass sheets given what appears to be the deterioration of the single base fixing. Remedial work was undertaken to fix the top edges of the glass sheets to the posts, on flats with the same detail (Figure 1b).
