CROSS Safety Alert

Lessons learned from the 2018 Florida bridge collapse during construction

This month we present key elements of a CROSS Safety Alert from December 2020 detailing the failures and lessons learned from the Florida bridge collapse in 2018.

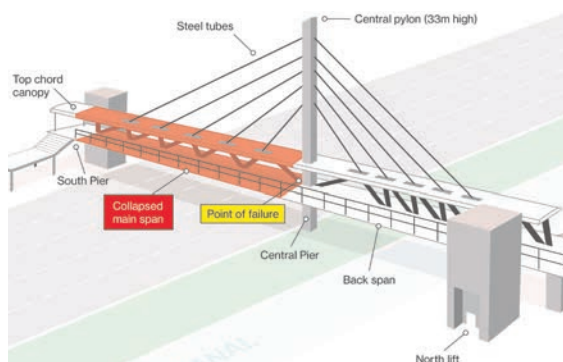
The Florida International University procured a new footbridge to connect facilities over a main road, and a bespoke reinforced concrete post-tensioned structure was developed (**Figure 1**). This comprised two spans, one with a 53m long reinforced concrete truss main span and a similar, but shorter, second span. The self-supporting pylon and steel tubes are non-structural architectural features.

FIGURE 1: Illustration of Florida bridge structure showing main span
