**THE M_w 9.0 TŌHOKU
EARTHQUAKE AND TSUNAMI OF
11TH MARCH 2011
A FIELD REPORT BY EEFIT**

A FIELD REPORT BY EEFIT

Mr. Antonios Pomonis, *CAR Limited, Global Earthquake Model* (Team Leader)

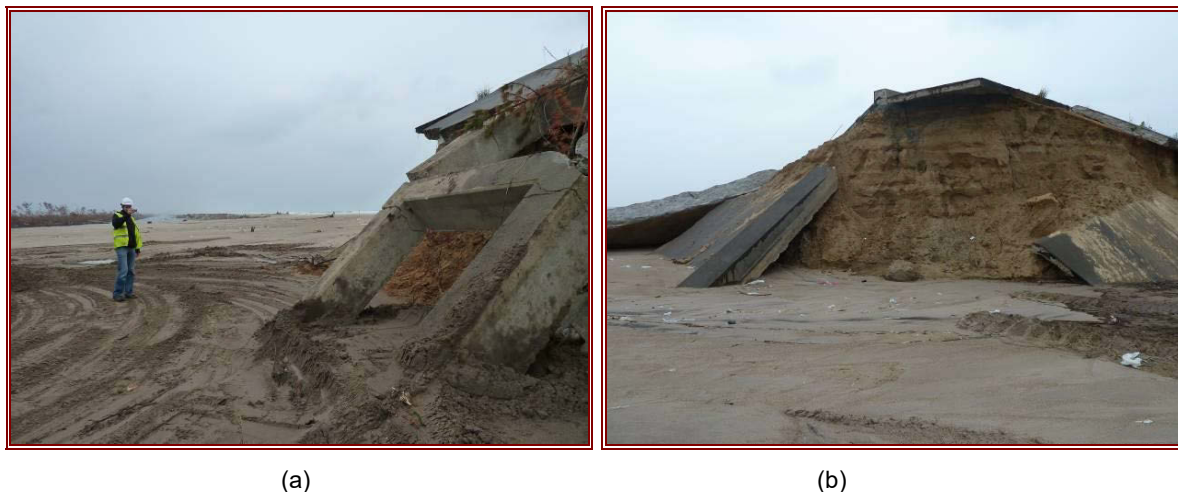
Figure 6.15 Catastrophic failure of the concrete block revetment at Yamamoto-cho.

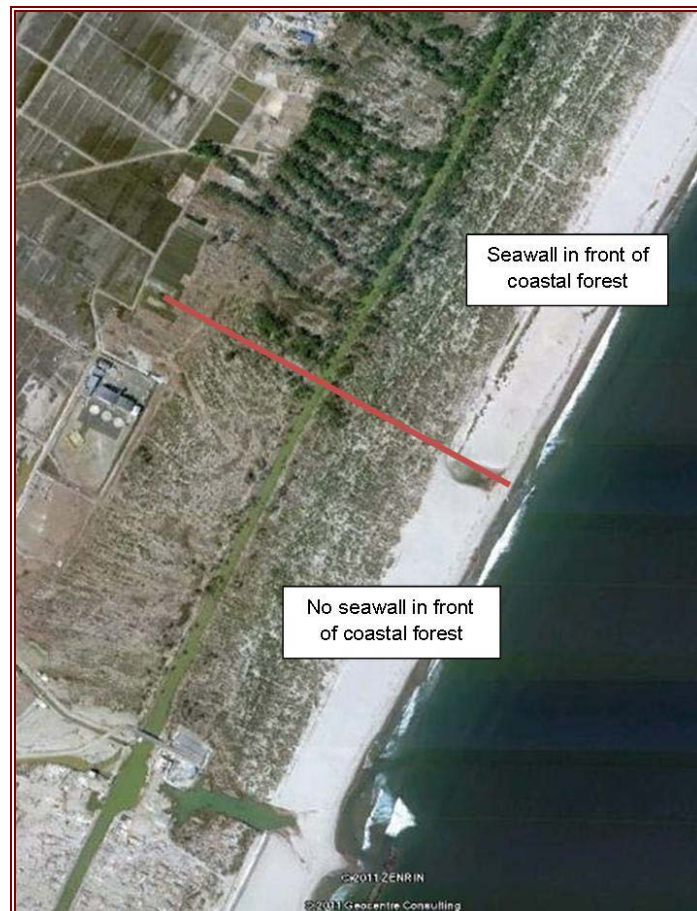
Figure 6.20 Apparent mitigating influence of the sea wall at Arahama Beach.

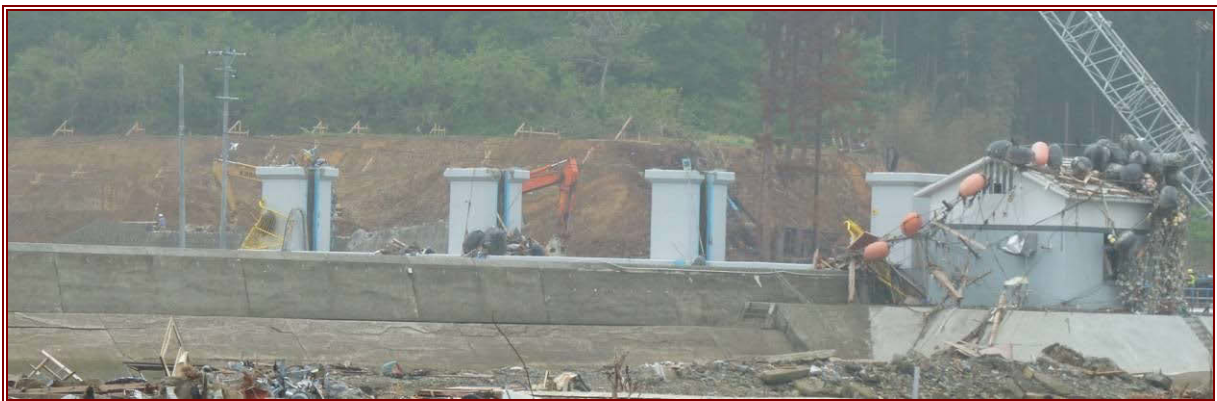
Figure 6.25 Damaged tsunami gates on the Mizushiri River in Minamisanriku.

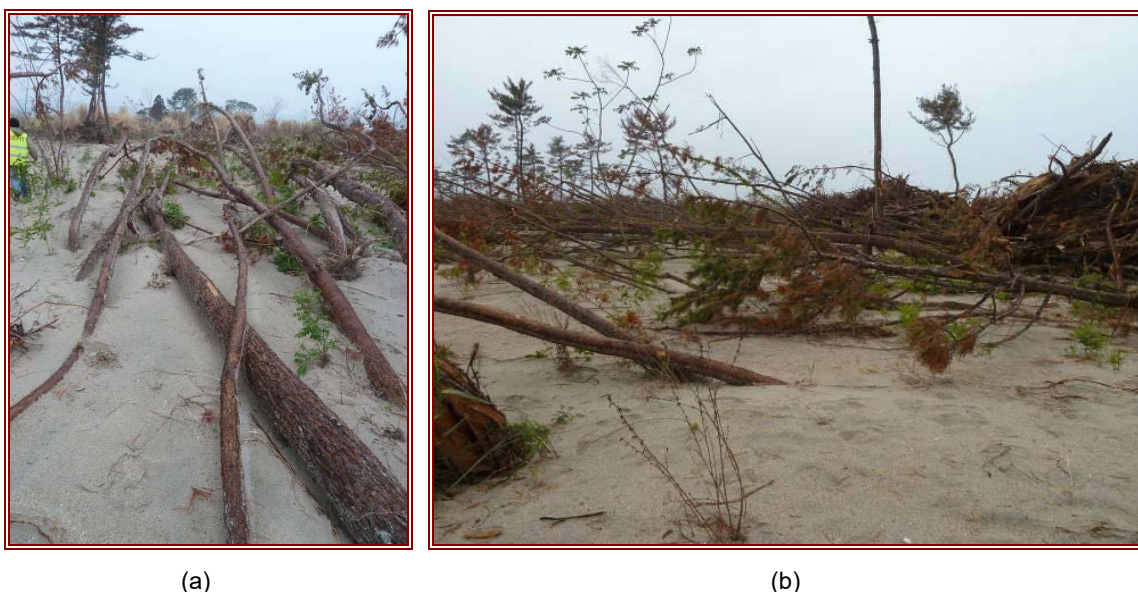
Figure 6.27 Pine trees of the coastal forest at Yamamoto-cho, flattened by onshore tsunami flow.

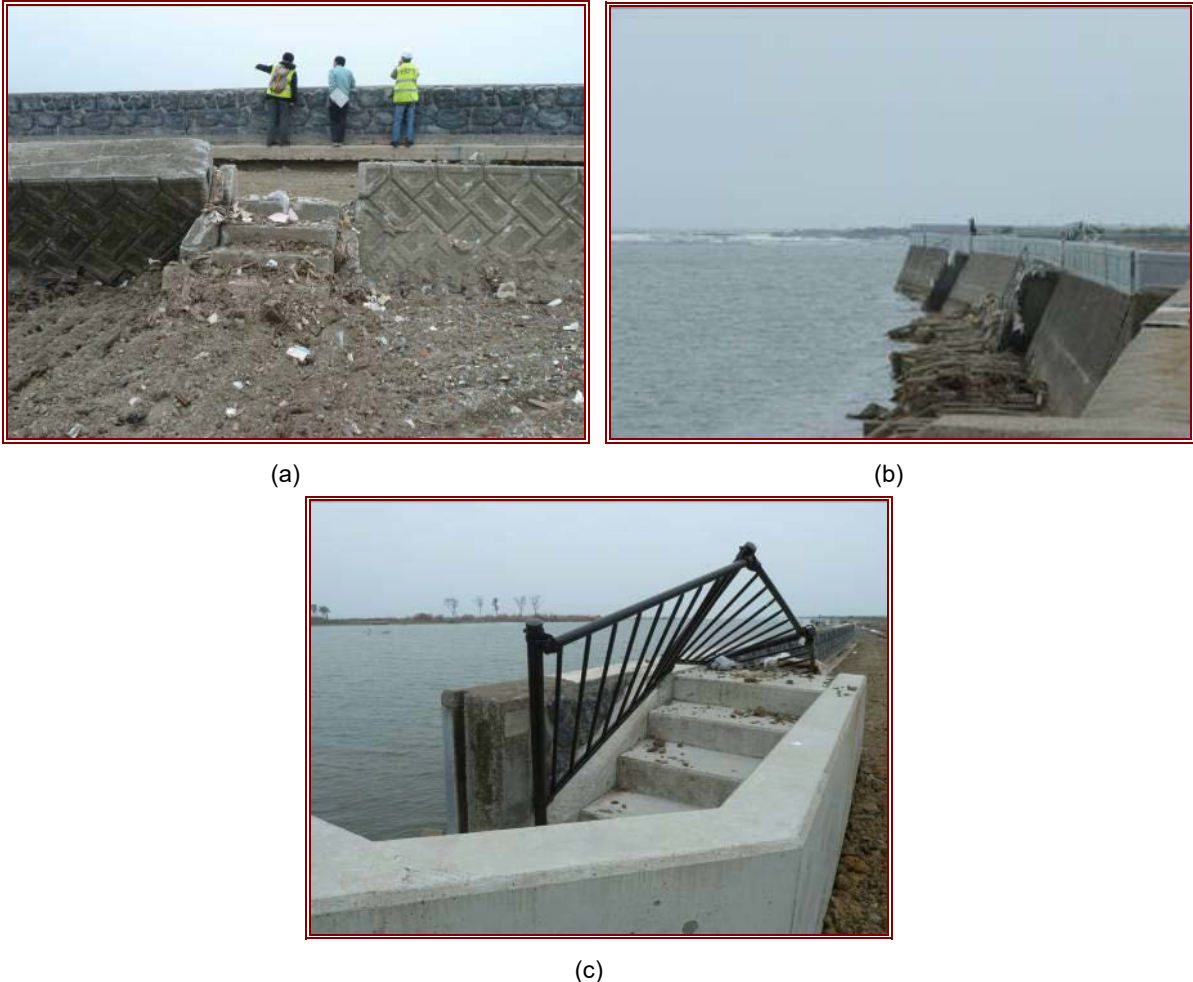
Figure 6.28 Damage to river defences on the south side of the Natori River in Yuriage.

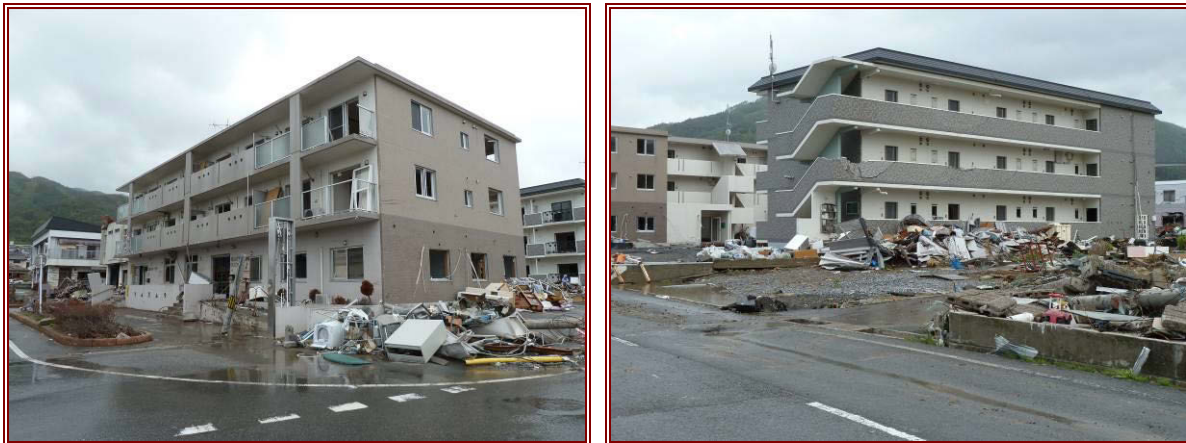
Figure 7.20 (left) RC shear wall building with separate front and rear entrances in the seaward and inland side. Seaward view is shown. The building flooded all the way to the top but its structure remained almost intact.

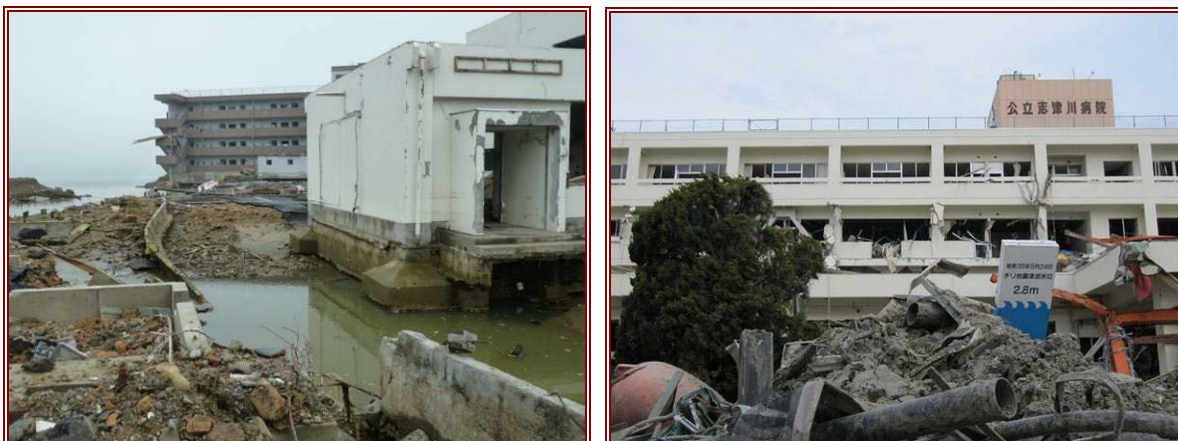
Figure 7.33 (left) Significant scour in Shiomi-cho, adjacent to the former gymnasium building, 100 m from the sea. Significant scour also occurred at the apartment block (a designated vertical evacuation structure) visible in the background. This structure is discussed further in section 10.3.3.

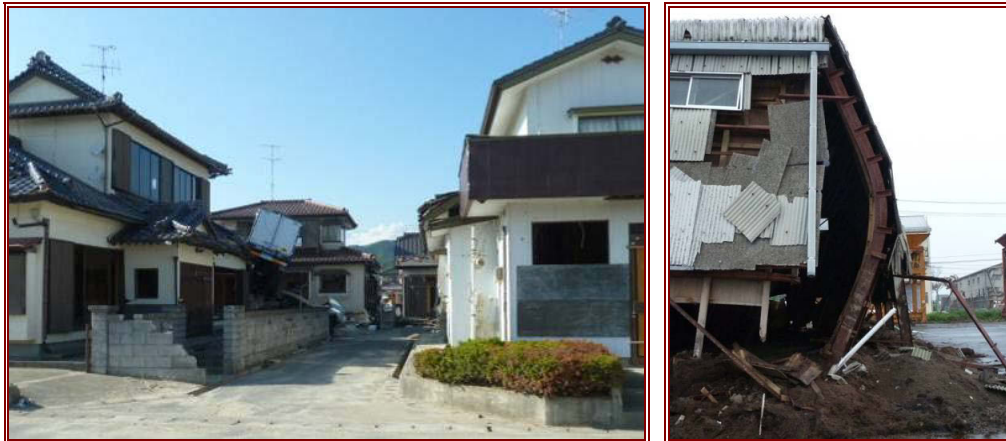
Figure 7.49 (left) Lorry trailer deposited on the first floor roof of house (centre of photo) but otherwise minor damage to the adjacent timber frame structures. Collapsed timber frame structures were also recorded at this observation point.

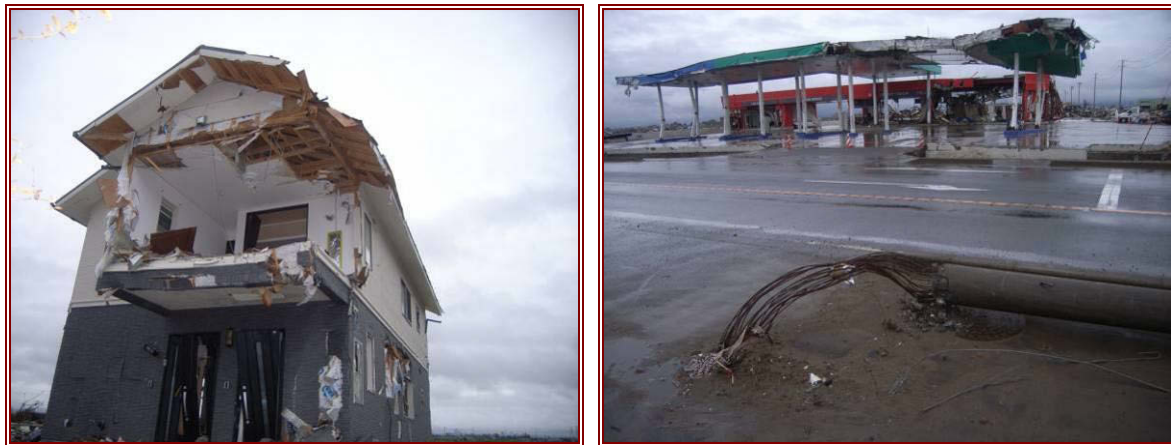
Figure 7.51 (left) Many timber houses sustained heavy damage or partial / complete collapse (D4).

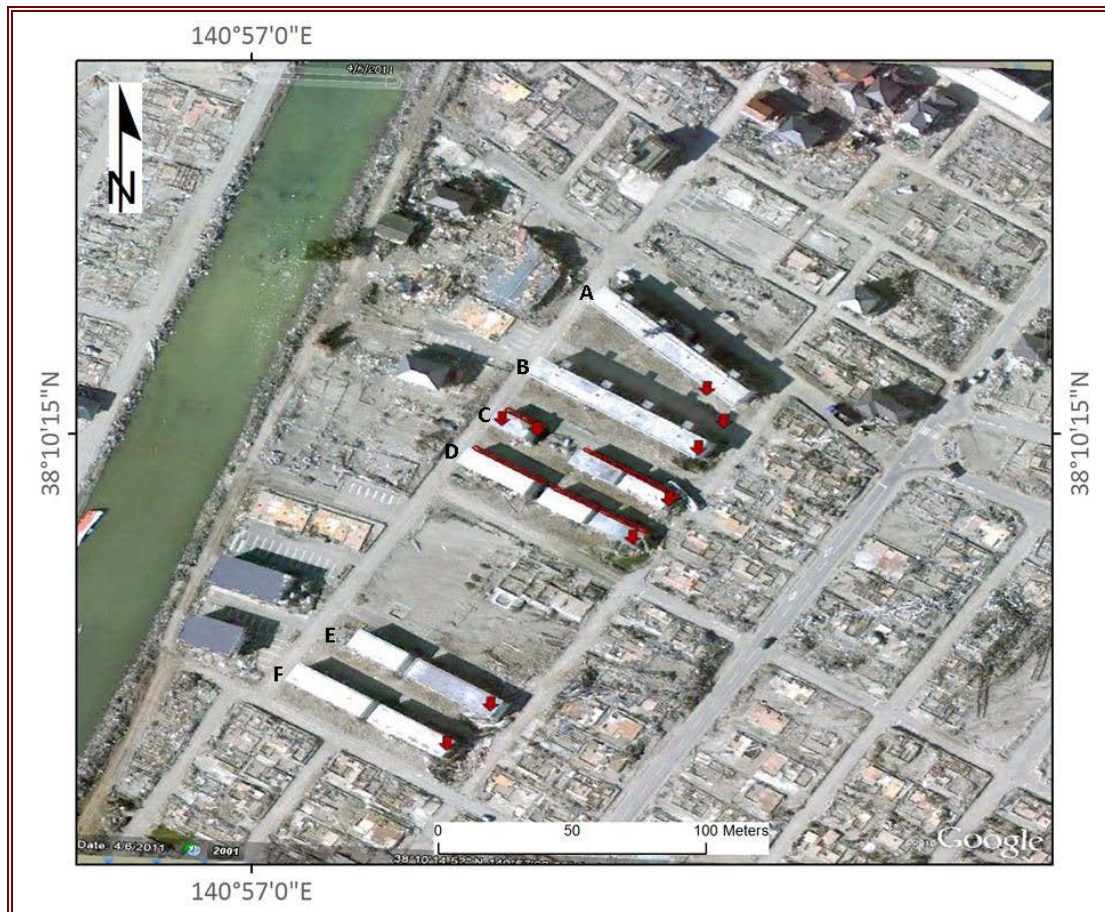
Figure 7.63 Aerial photograph of apartments in Natori with significant scour at the seaward end and northern side of each building. Scour is indicated by red polygons along the northern side of buildings, and red arrows (primarily at the south-eastern ends).

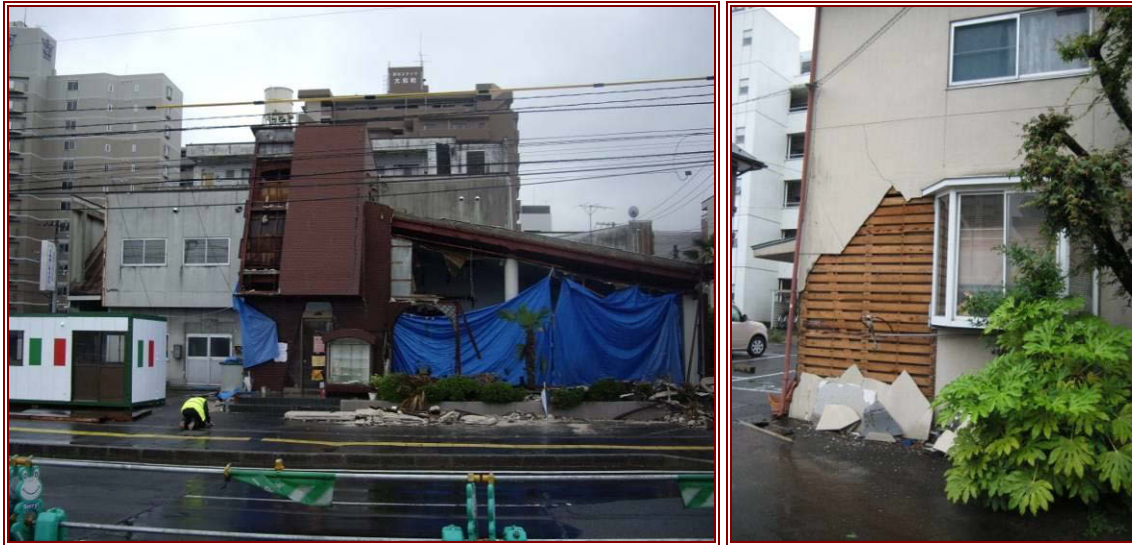
Figure 8.6 Earthquake-induced damage on low-rise wooden structures

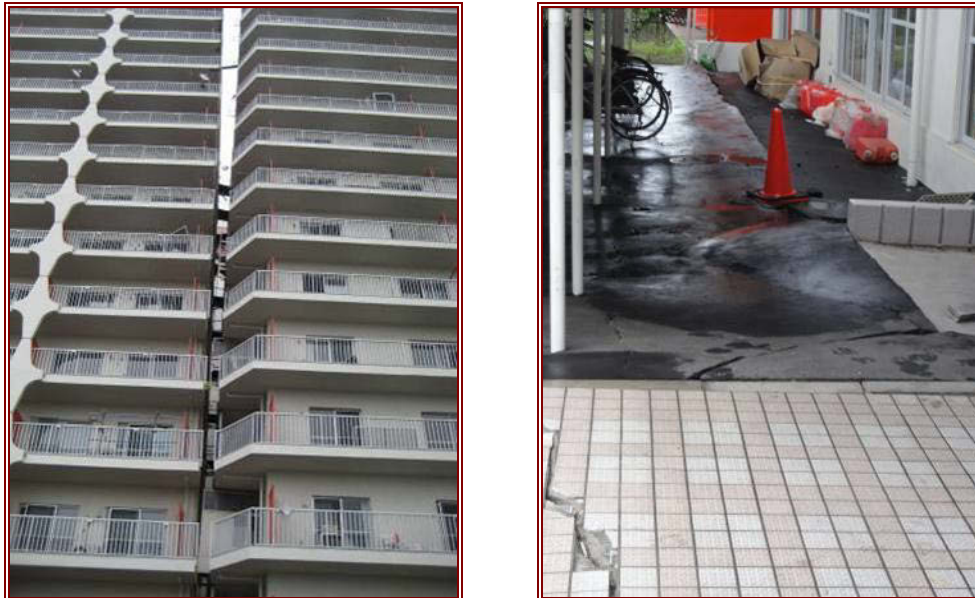
(a) Left block has tilted due to differential settlement (b) Ground settlement adjacent to building

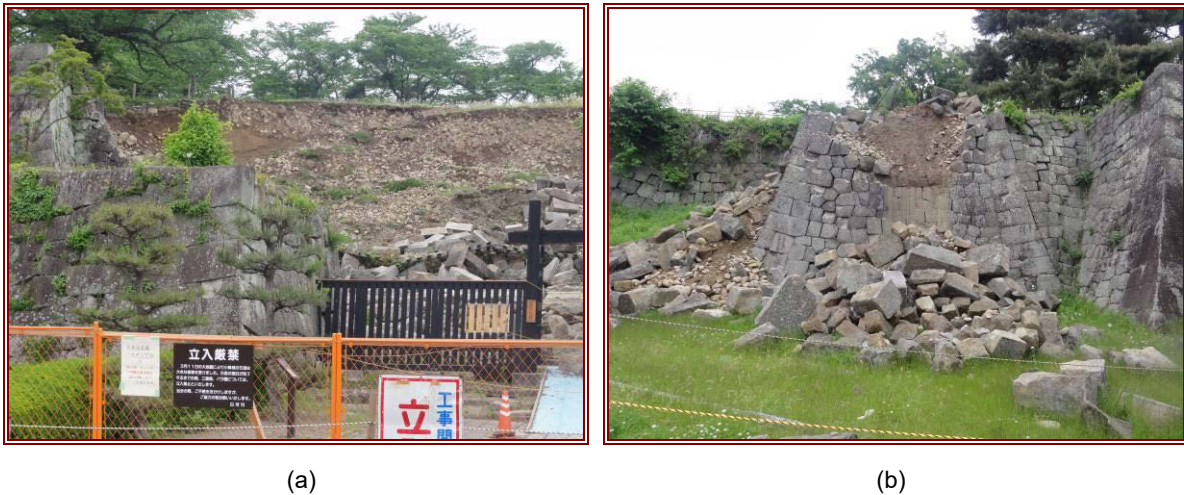
Figure 8.9 Cobble wall failure and landslides around the perimeter of the embankment in the Komine Castle.

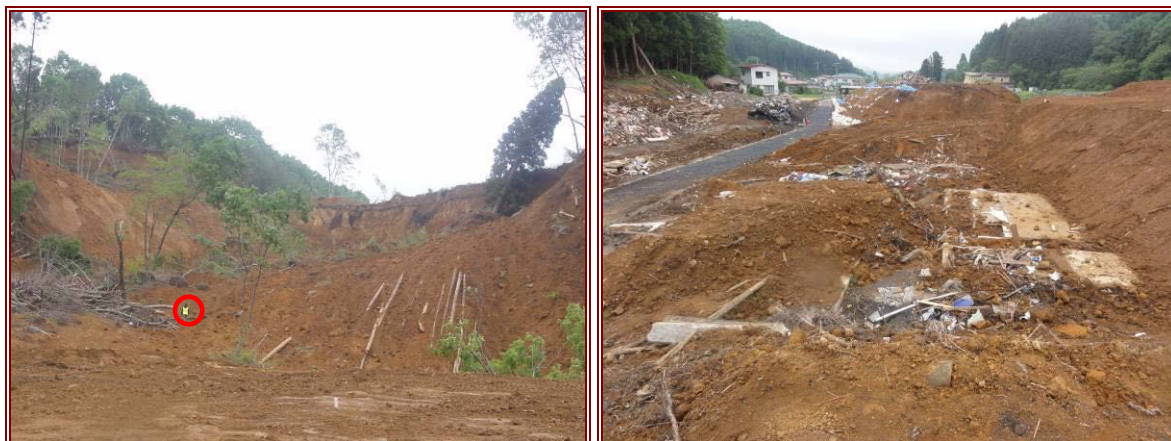
(a) View of landslide (EEFIT member circled in red)

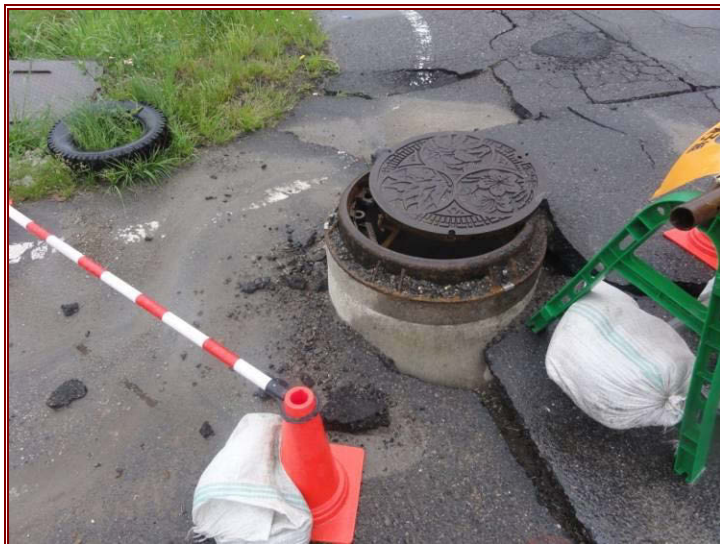
(a) Uplift of manhole

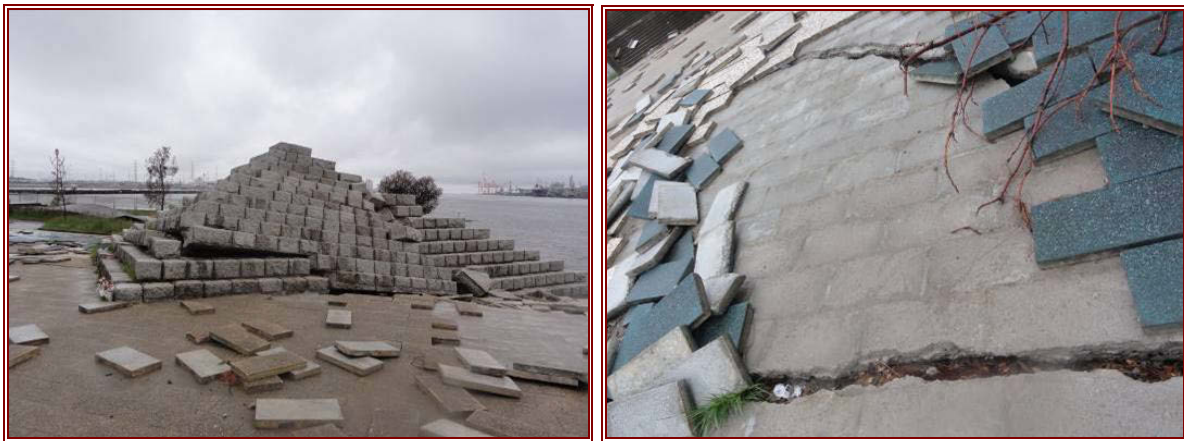
(a) Lateral spreading at the port edge

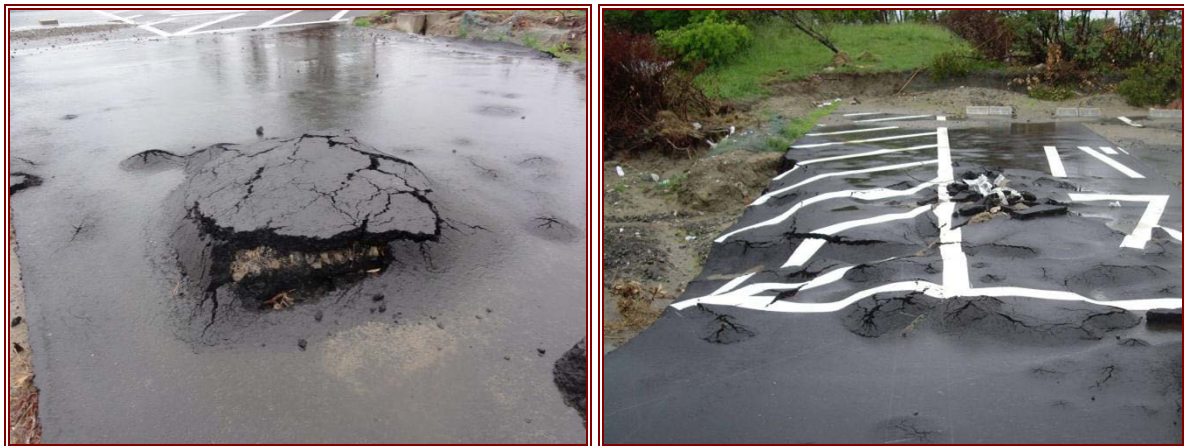
(a) Uplift of tarmac

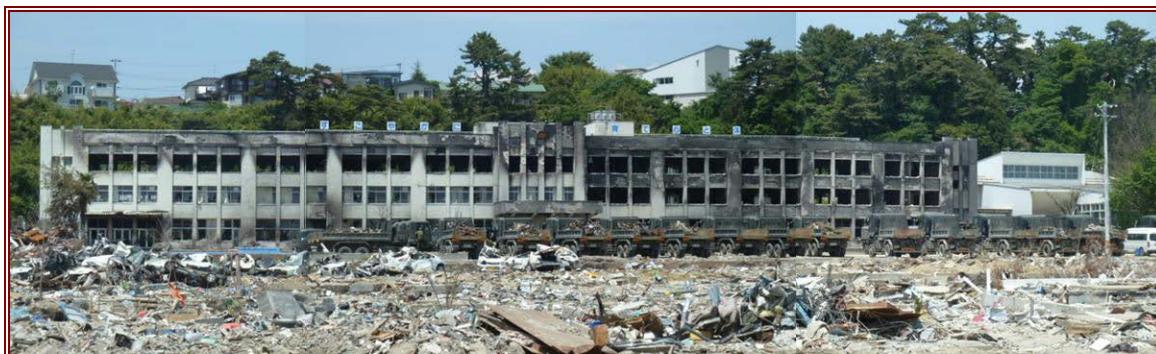
Figure 10.8 Fire damaged school, Ishinomaki City. It is not known whether this building was used as an evacuation refuge during the tsunami.

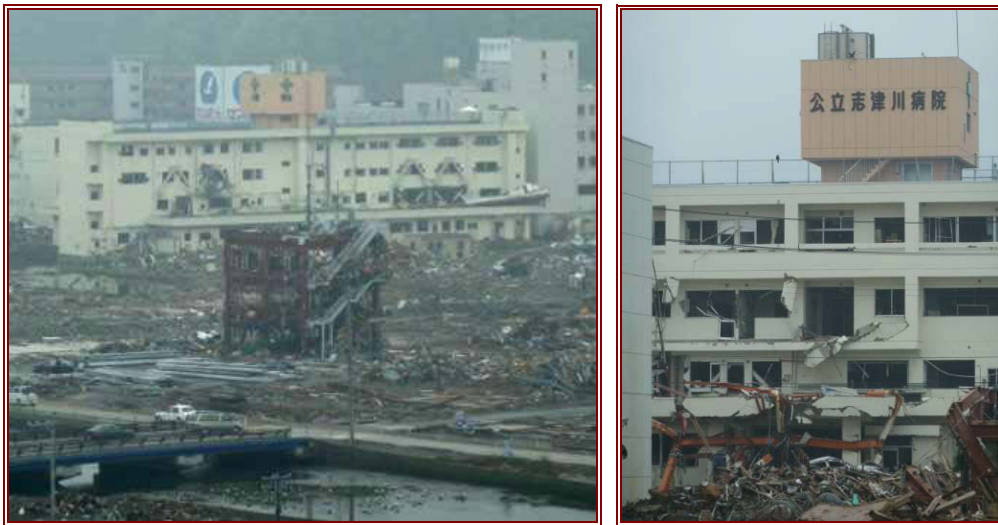
Figure 10.16 (left) View of the hospital (landward side) with steel bracing and damage to third storey visible.

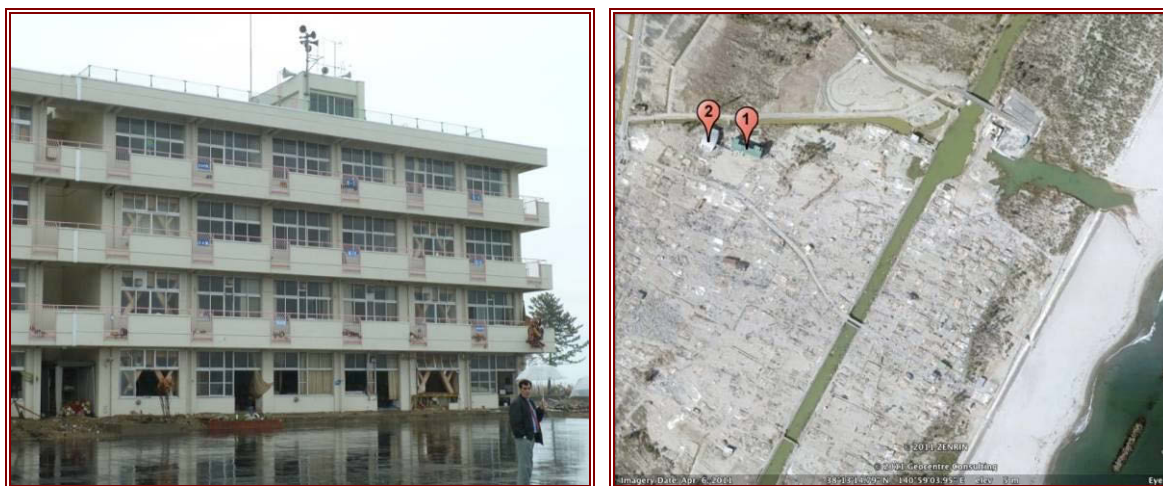
Figure 10.22 (left) The south face of Arahama Elementary School. Sirens and steel bracing are visible (2 instances, in the lower three storey windows), as is damage to the ground floor.

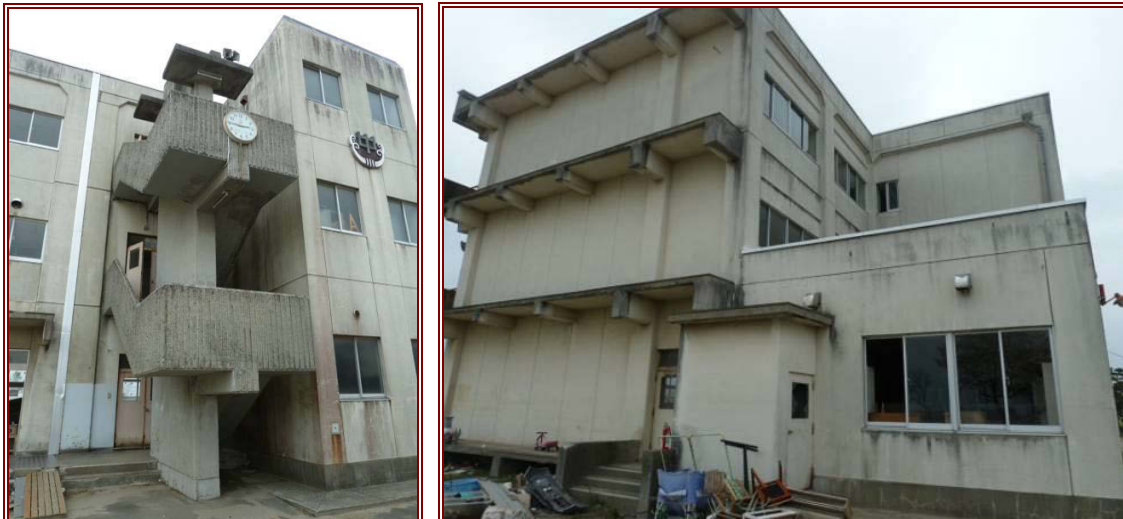
Figure 10.24 (left) Minor earthquake damage at seismic detailing of Yuriage Junior High School: the staircase moved independently of the main building, and horizontal movement was accommodated in the separation joint shown by the vertical silver strip from ground to roof level.

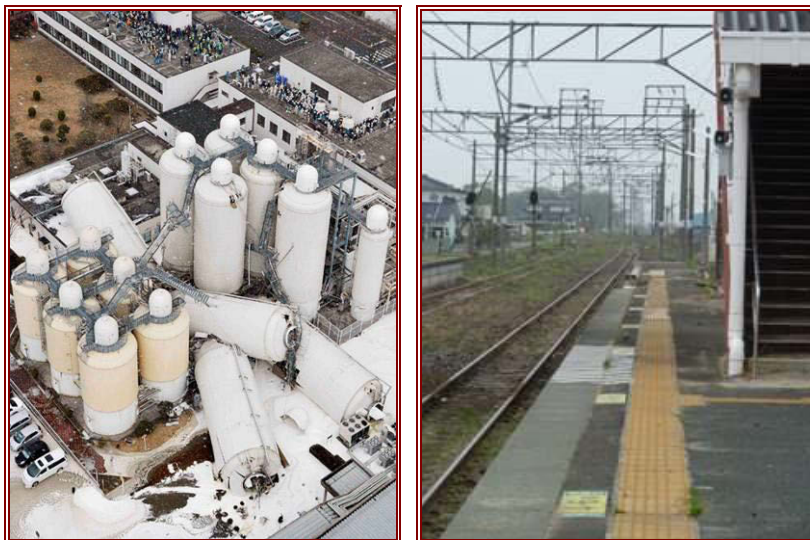
Figure 11.3 (left) Kirin Beer Factory at Sendai port is one of many damaged industrial facilities within the tsunami zone, adding to industrial contaminants within tsunami debris (Blog, 2011).
