# THE $M_w$ 7.8 GORKHA, NEPAL EARTHQUAKE OF 25 APRIL 2015

A FIELD REPORT BY EEFIT

August 2019

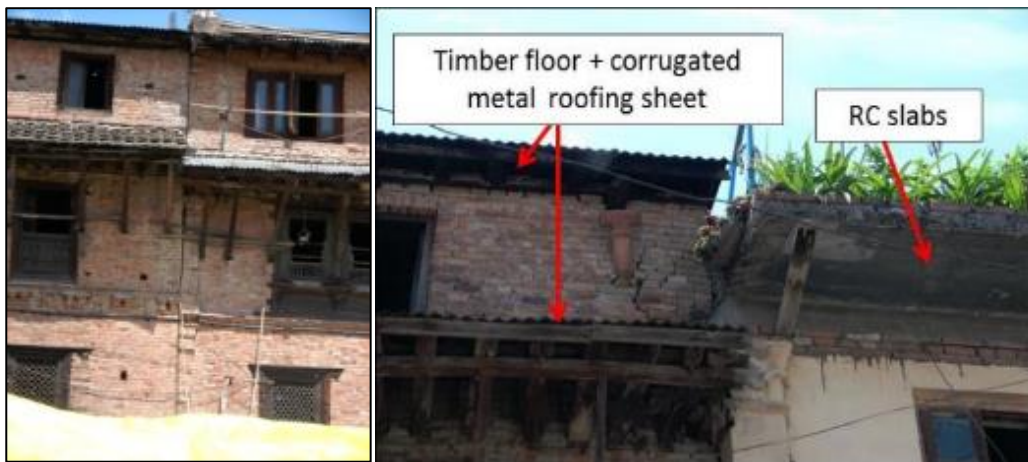
Figure 3-7 Absence of seismic gaps between buildings.

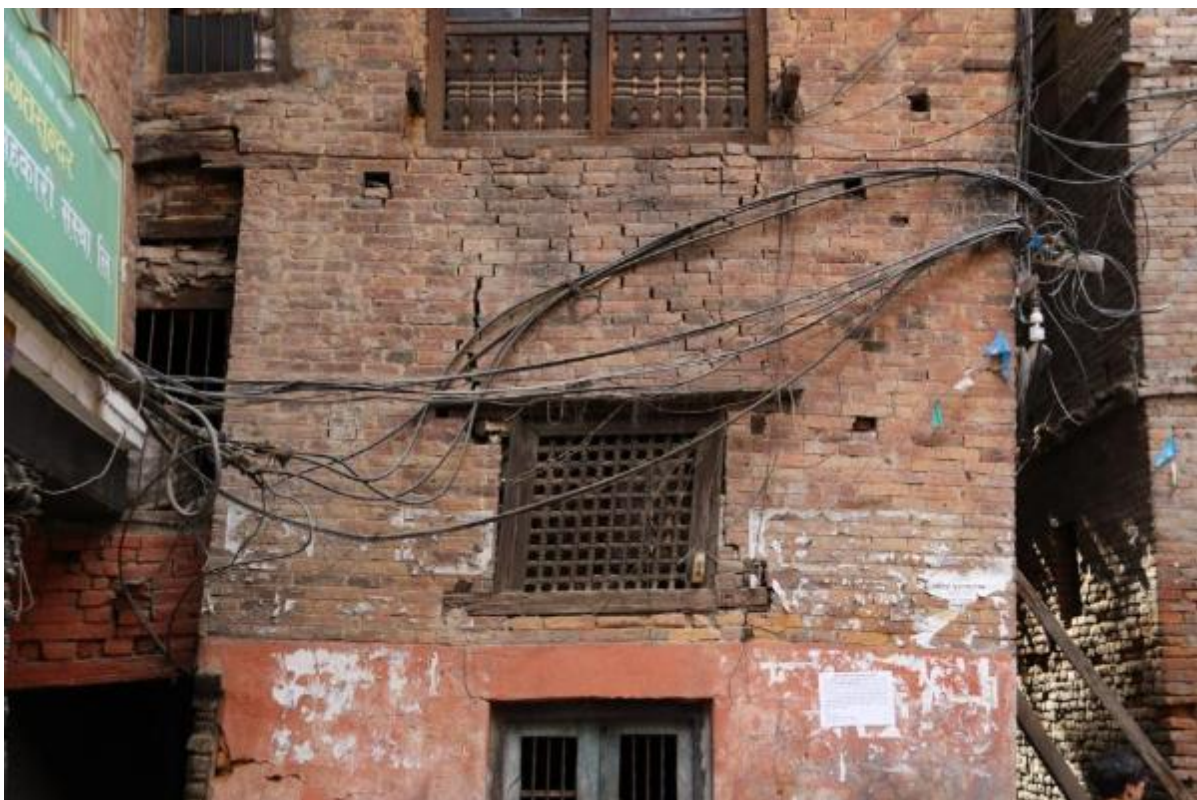
Figure 4-6 Example of In-plane shear failure of a typical Newari residence.

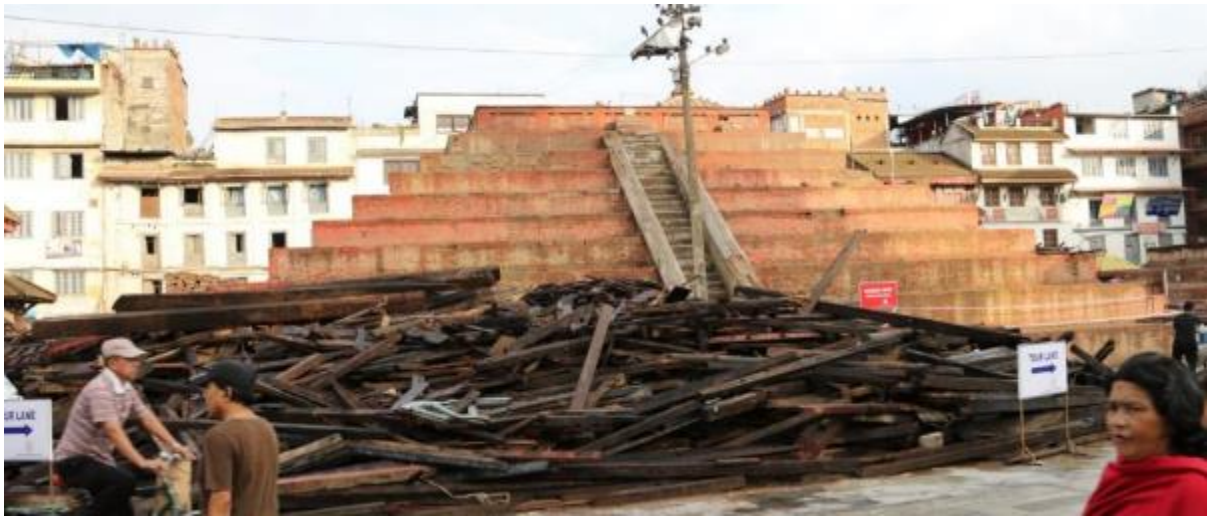
Figure 4-7 Pedestal of a temple.

Example of pedestal where a temple used to stand, with well-sorted building materials ready for re-use.

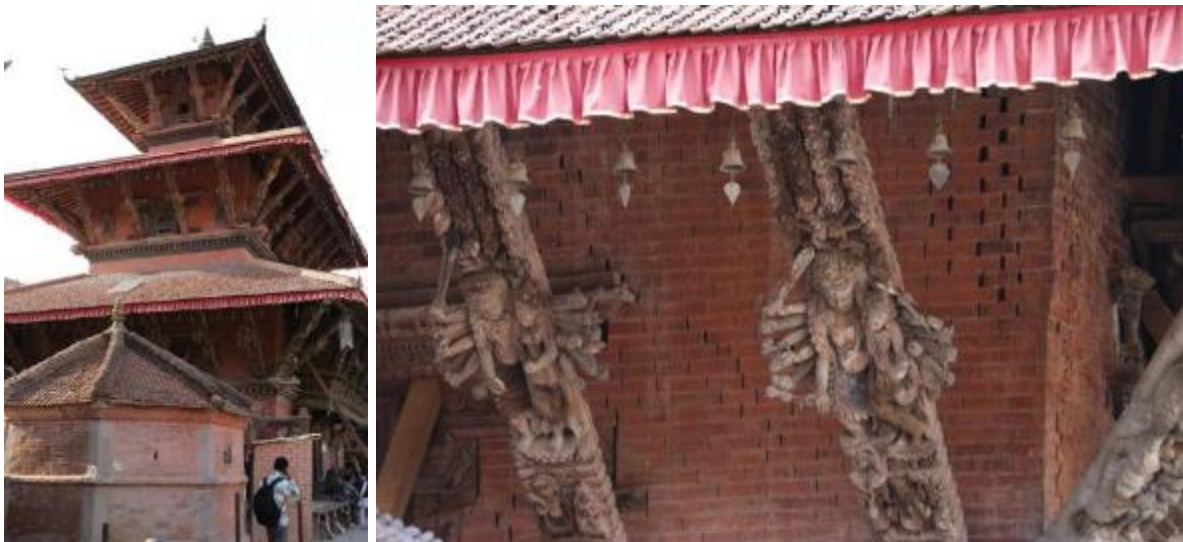
Figure 4-8 Multi-tiered dega.

Example of a multi-tiered dega, or temple (left), which survived the earthquake but exhibited in-plane damage and evidence disconnection at corners (magnified view of top storey, right).

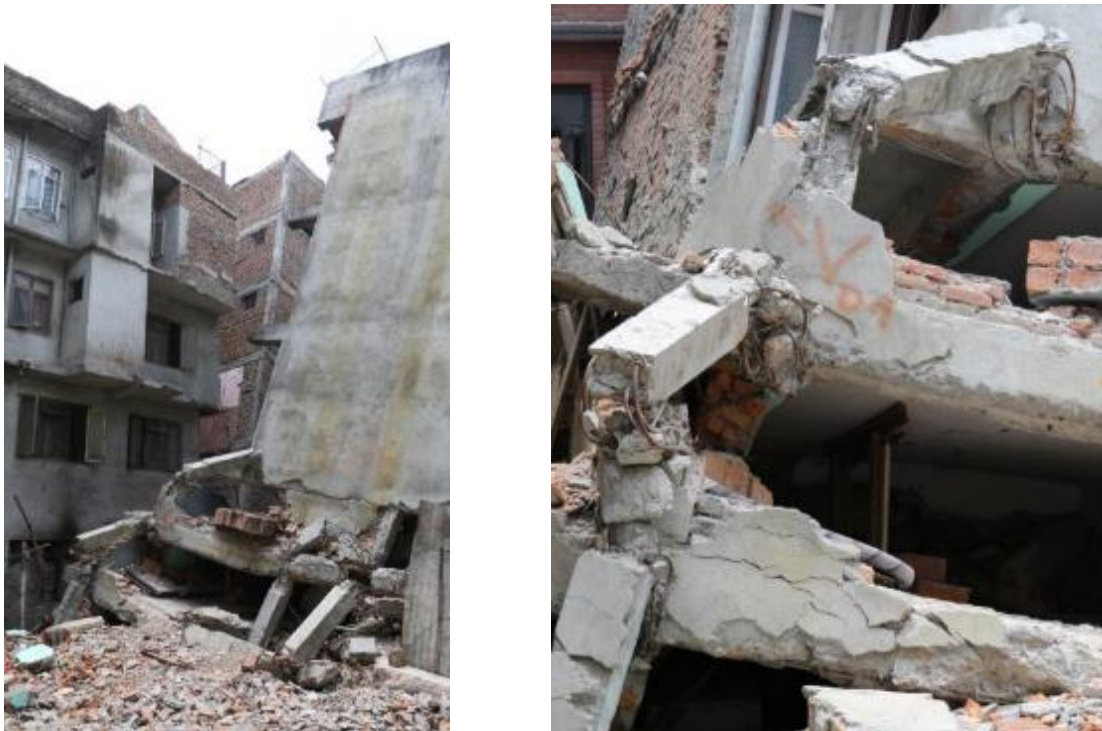
Figure 4-13 exemplifies the observed collapses with complete failure of the bottom storeys.

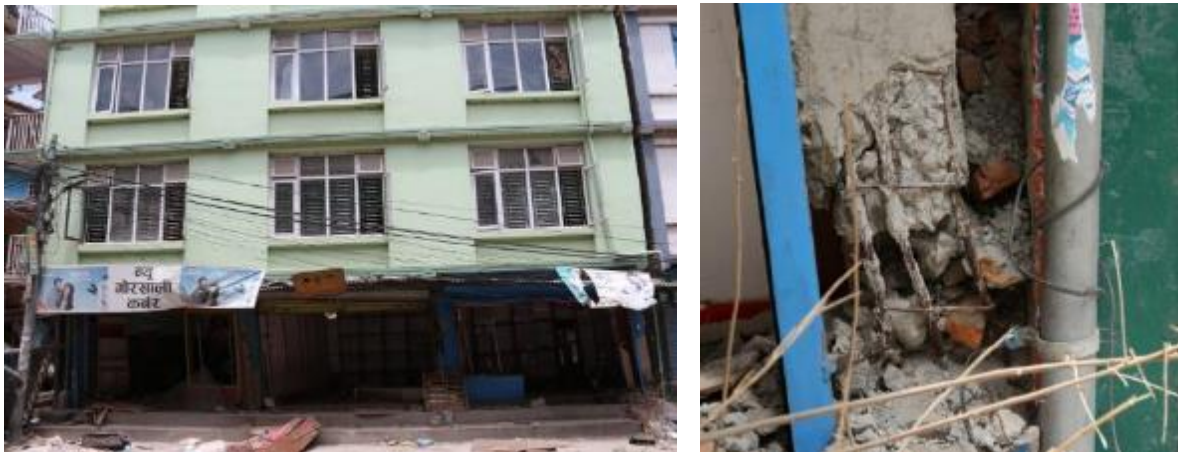
Figure 4-12. Examples of combined foundation bearing capacity failure. Left: Four storey building with soft storey failure. The gap to the right of the building did not exist before the earthquake. Right: Close up view of failure at the base of the right ground floor column.

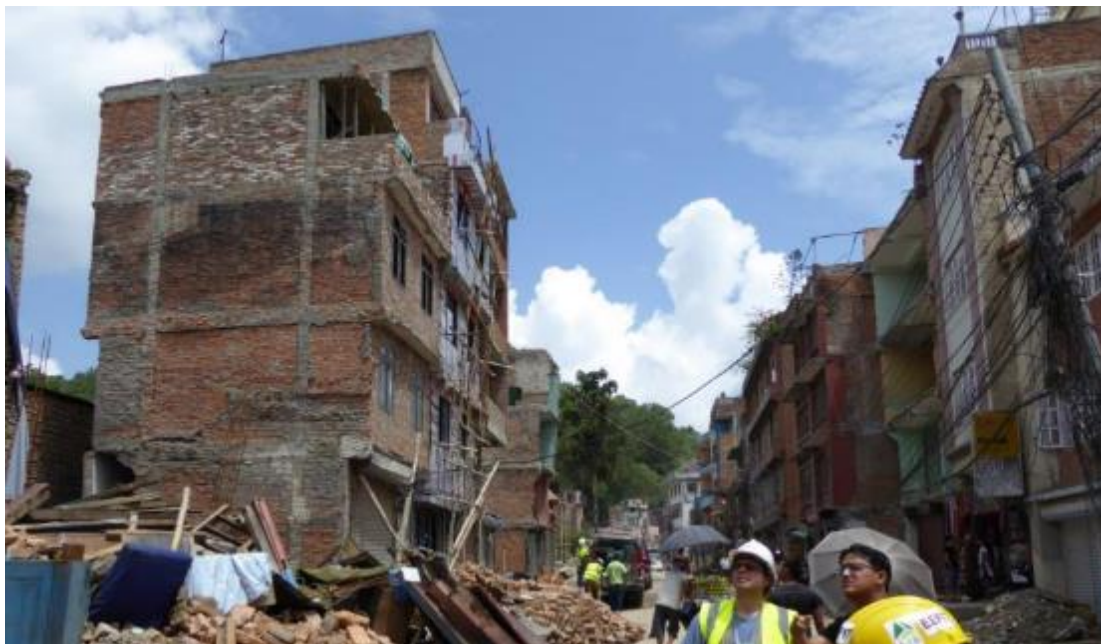
Figure 4-14 Examples of top-heavy concrete structures. Examples of top-heavy concrete structures, where upper floors cantilever out and the concrete frames do not extend to the corners of the building.

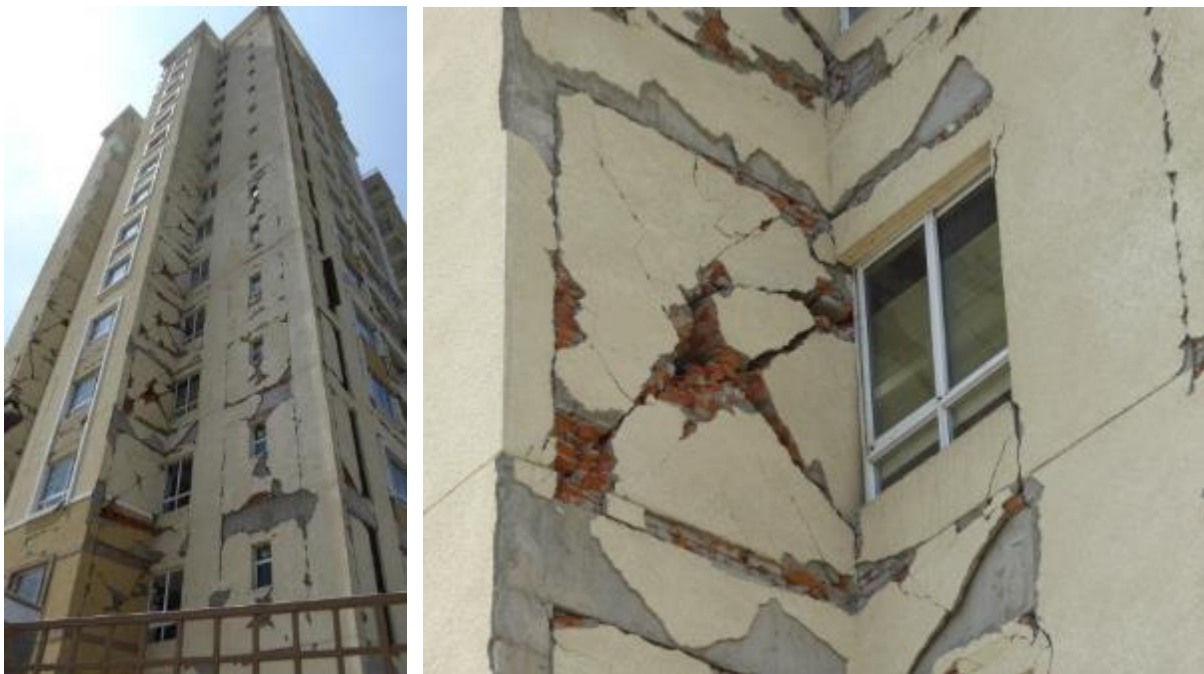
Figure 4-15 the Park View Horizon Apartments in Dhapasi.

In some instances, local severe damage was observed to individual buildings, while surrounding buildings appeared unaffected by the earthquake. The most striking example of this was the pancake collapse of Morgan College (see Figure 4-19) in the Tokha region of Kathmandu. The seven-storey structure was only a few years old, and it was still standing after the main earthquake but collapsed in an aftershock 45 minutes later.

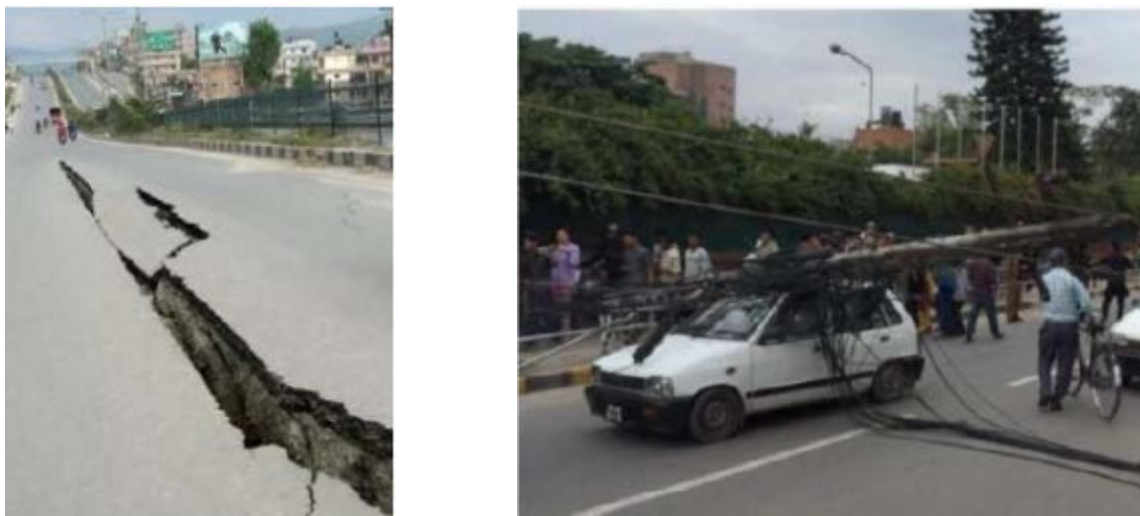
Figure 5-5 Infrastructure settled during the earthquake. Settlement damage to Araniko Highway (Goda *et al.* 2015) (Left). Foundational Collapse of a utility pole (Aydan and Ulusay 2015) (Right).

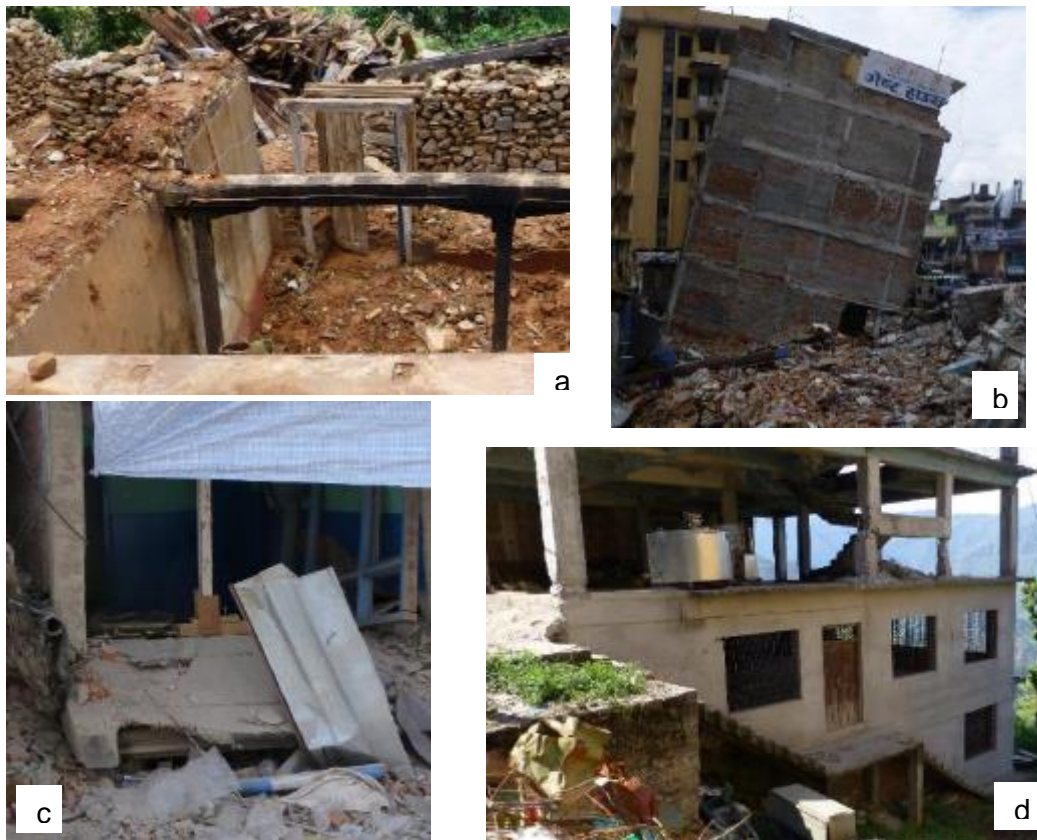
Figure 5-6 Failure of buildings that could be related to the foundation.

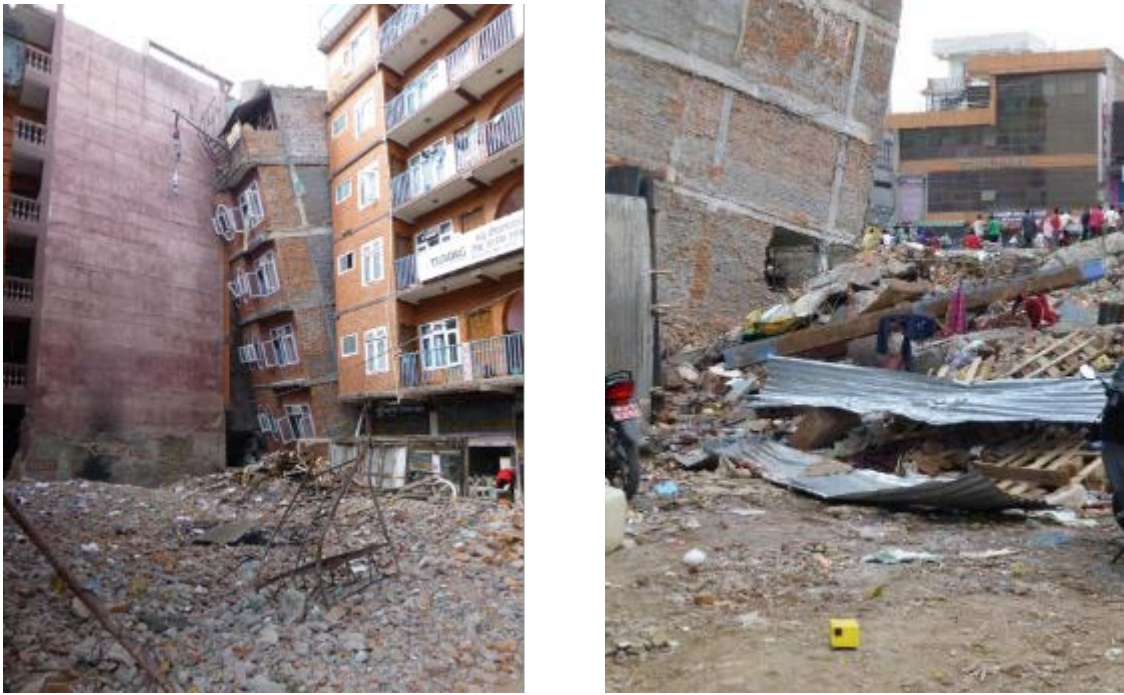
Figure 5-11 Fail at the base of the structure.

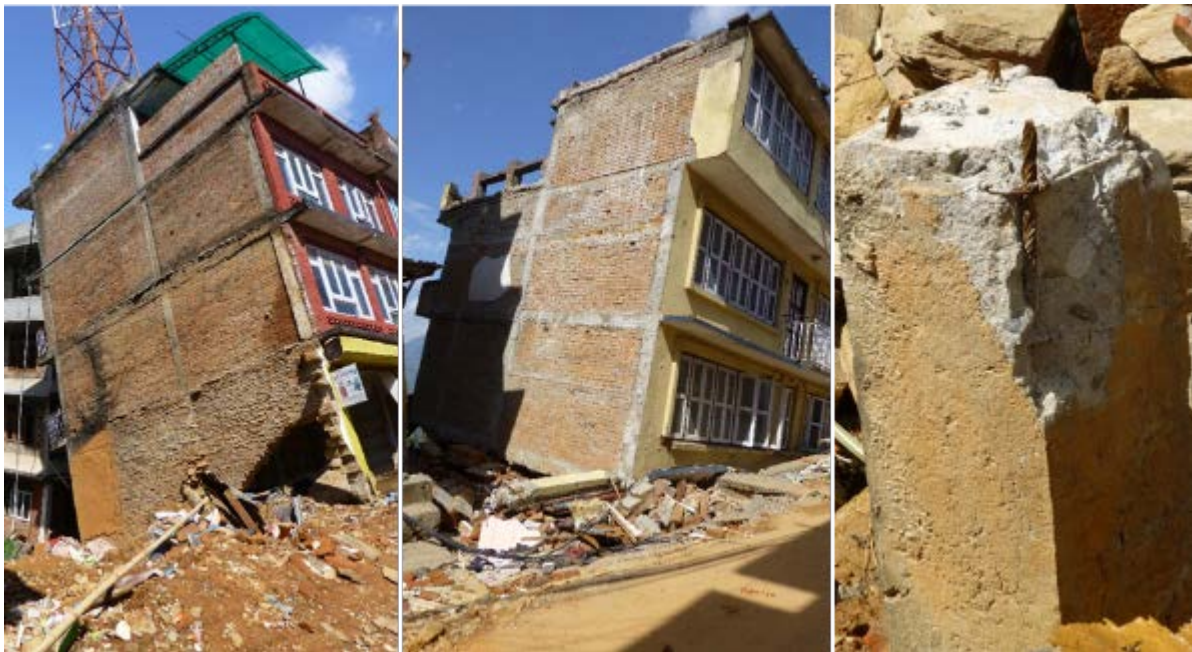
Figure 5-13 Building failures of Dolalghat region.

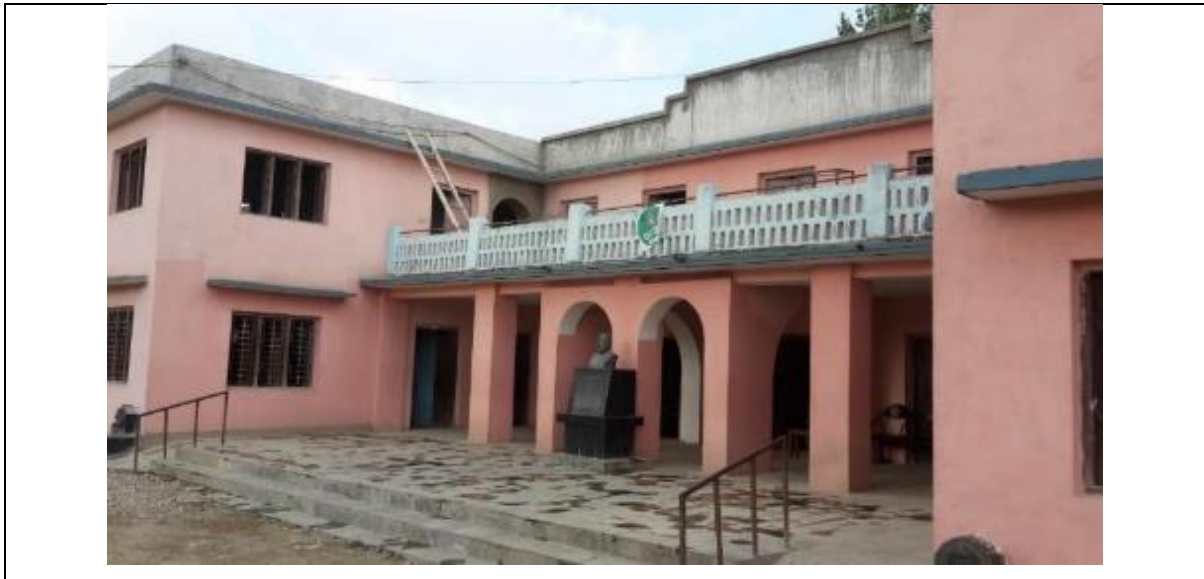
Figure 6-3 Adobe building with 2014 retrofit solution designed by NSET.

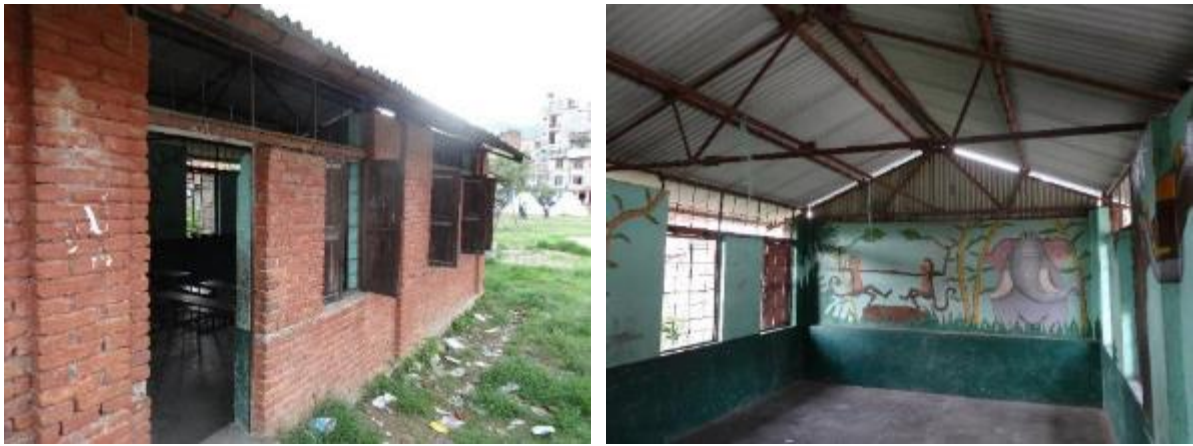
Figure 6-8 A fired clay brick school building with gable walls.

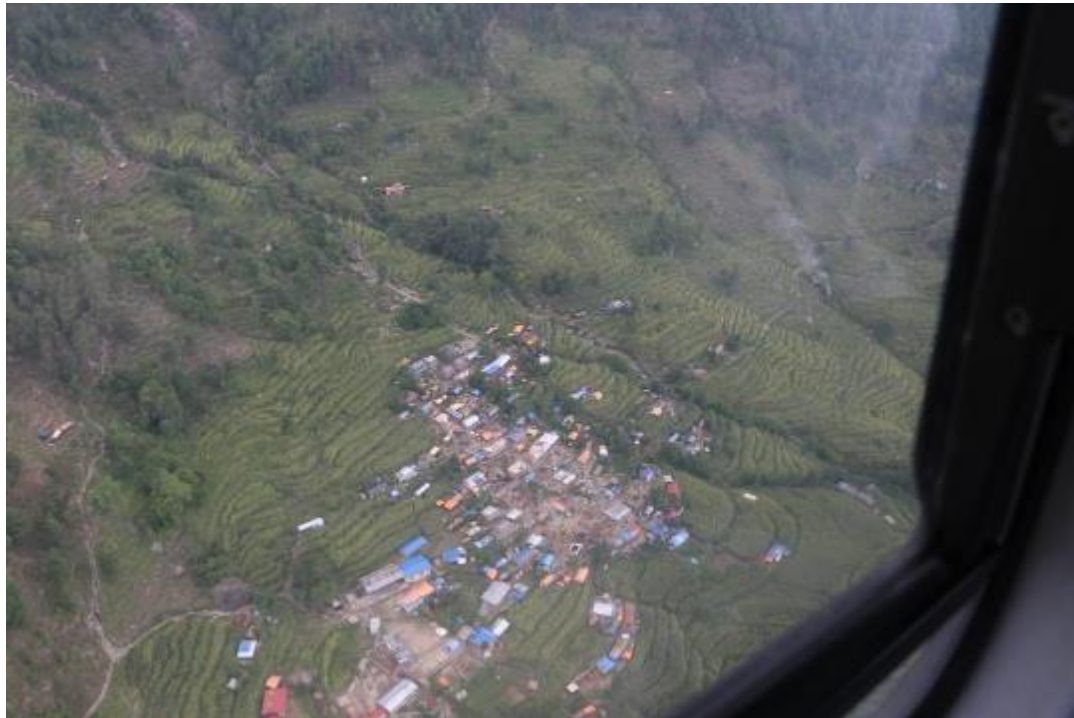
a) Badly affected village. This village sustained heavy levels of damage but this was not unusual in the villages that were overflown. The coloured roofs are usual (but not always) tarpaulins. These were necessary due to roofs collapsing when rubble masonry walls collapsed or sustained heavy damage.

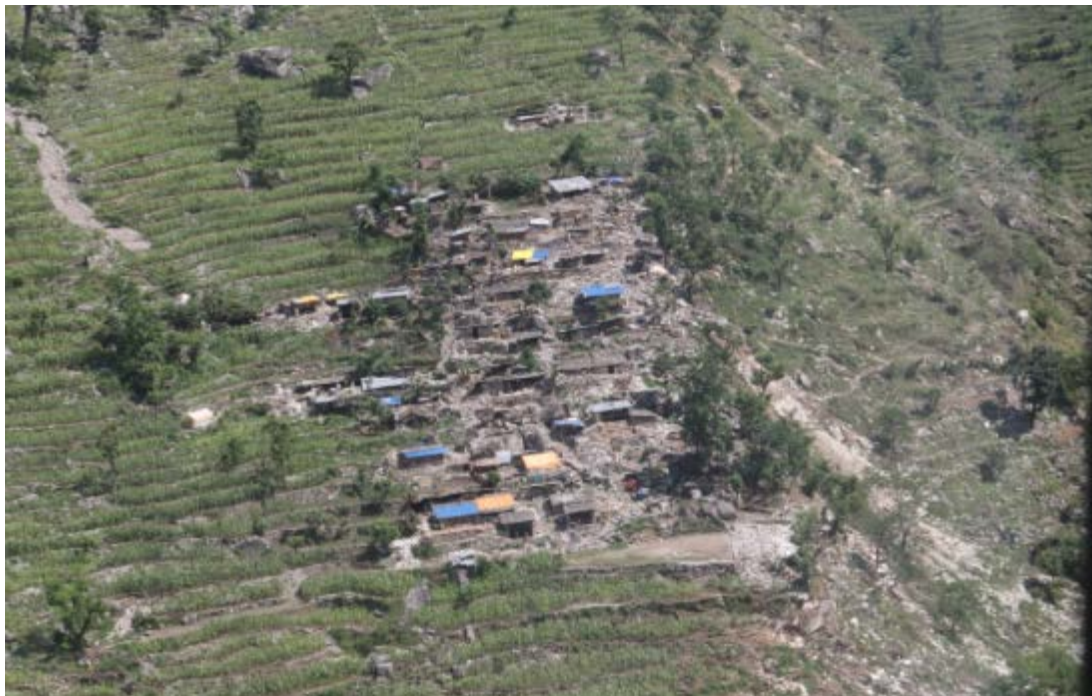
b) Very badly affected village. It is not known if this village was abandoned long before the earthquake and left to decay or whether it was caused by the earthquake, but the coloured roofs suggest the damage may have been recent.

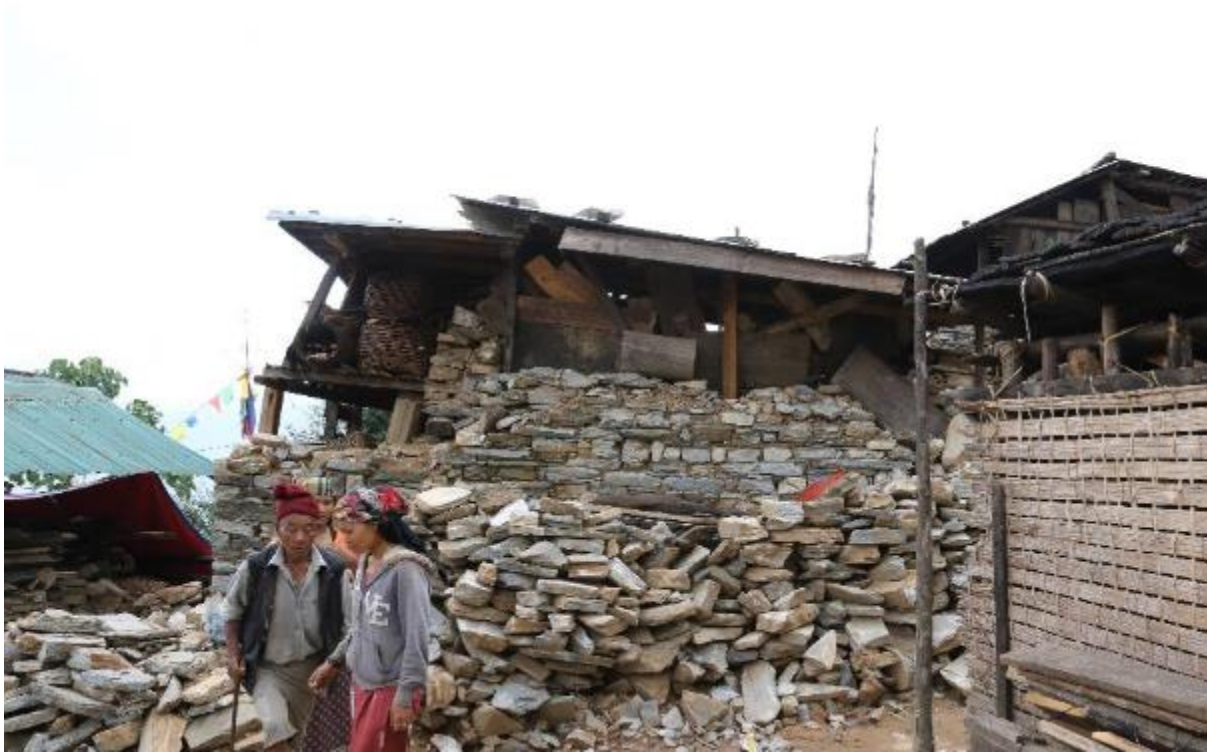
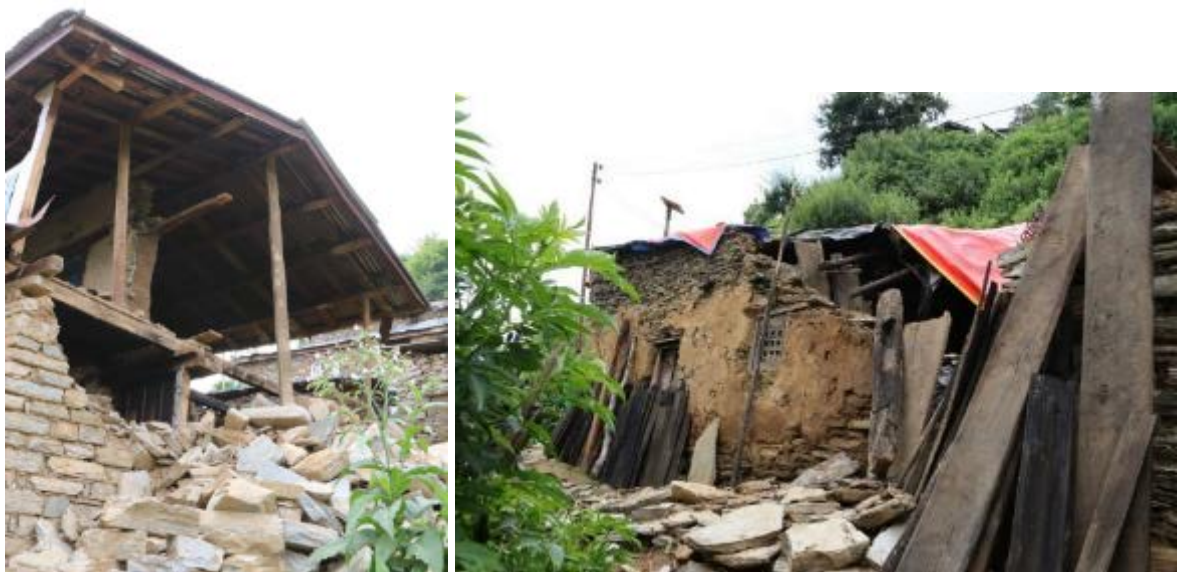
Figure 7-4 Examples of building and typical damage.

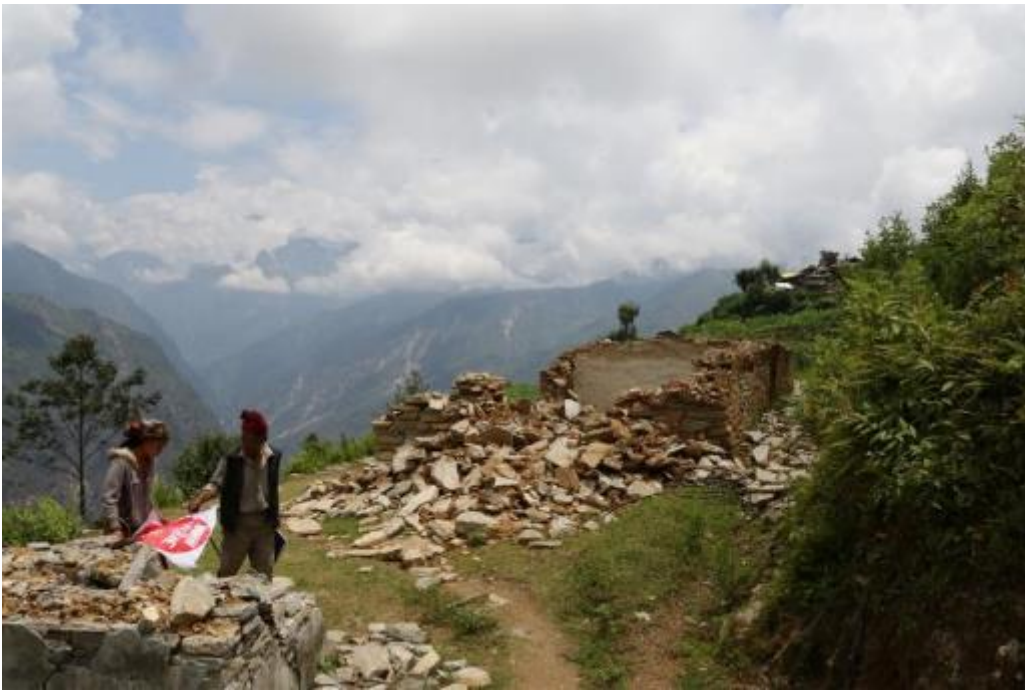
Figure 7-5 School building, showing complete collapse. This building was one of the most poorly constructed in the village with no cement used in the mortar.

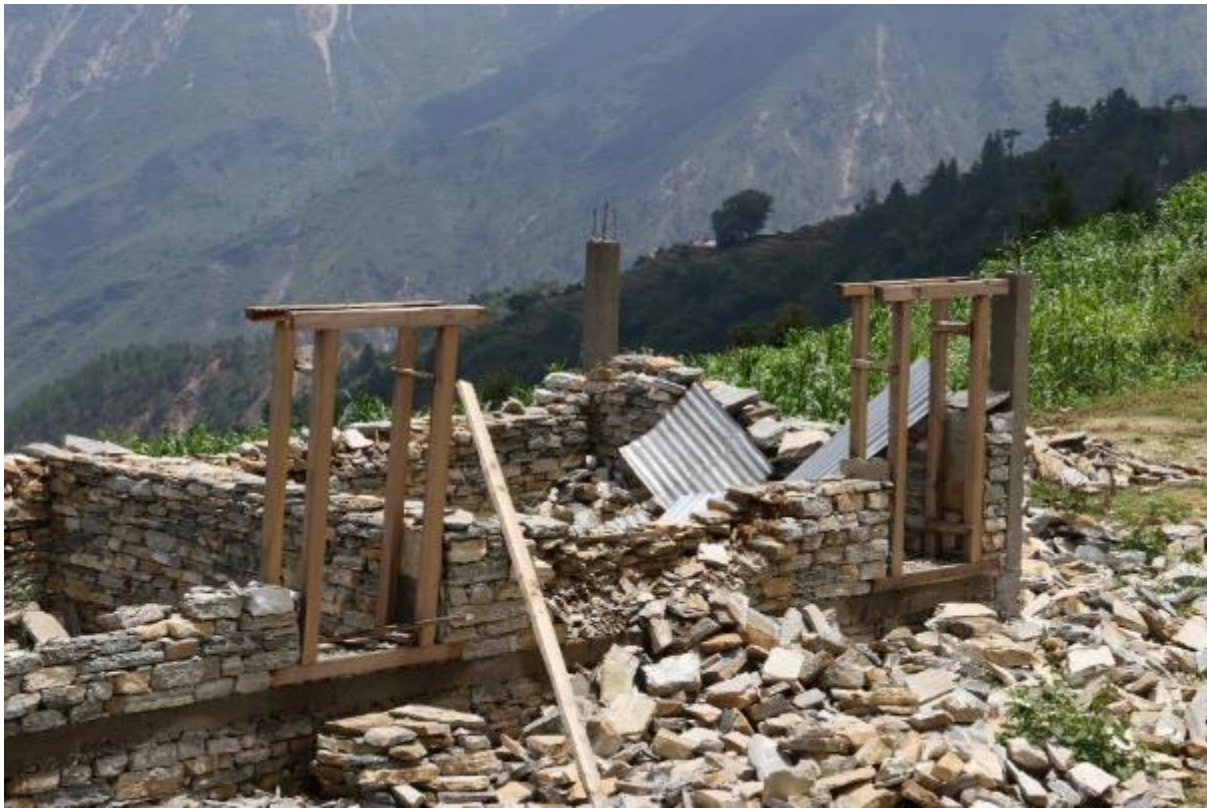
Figure 7-7 School building damaged.

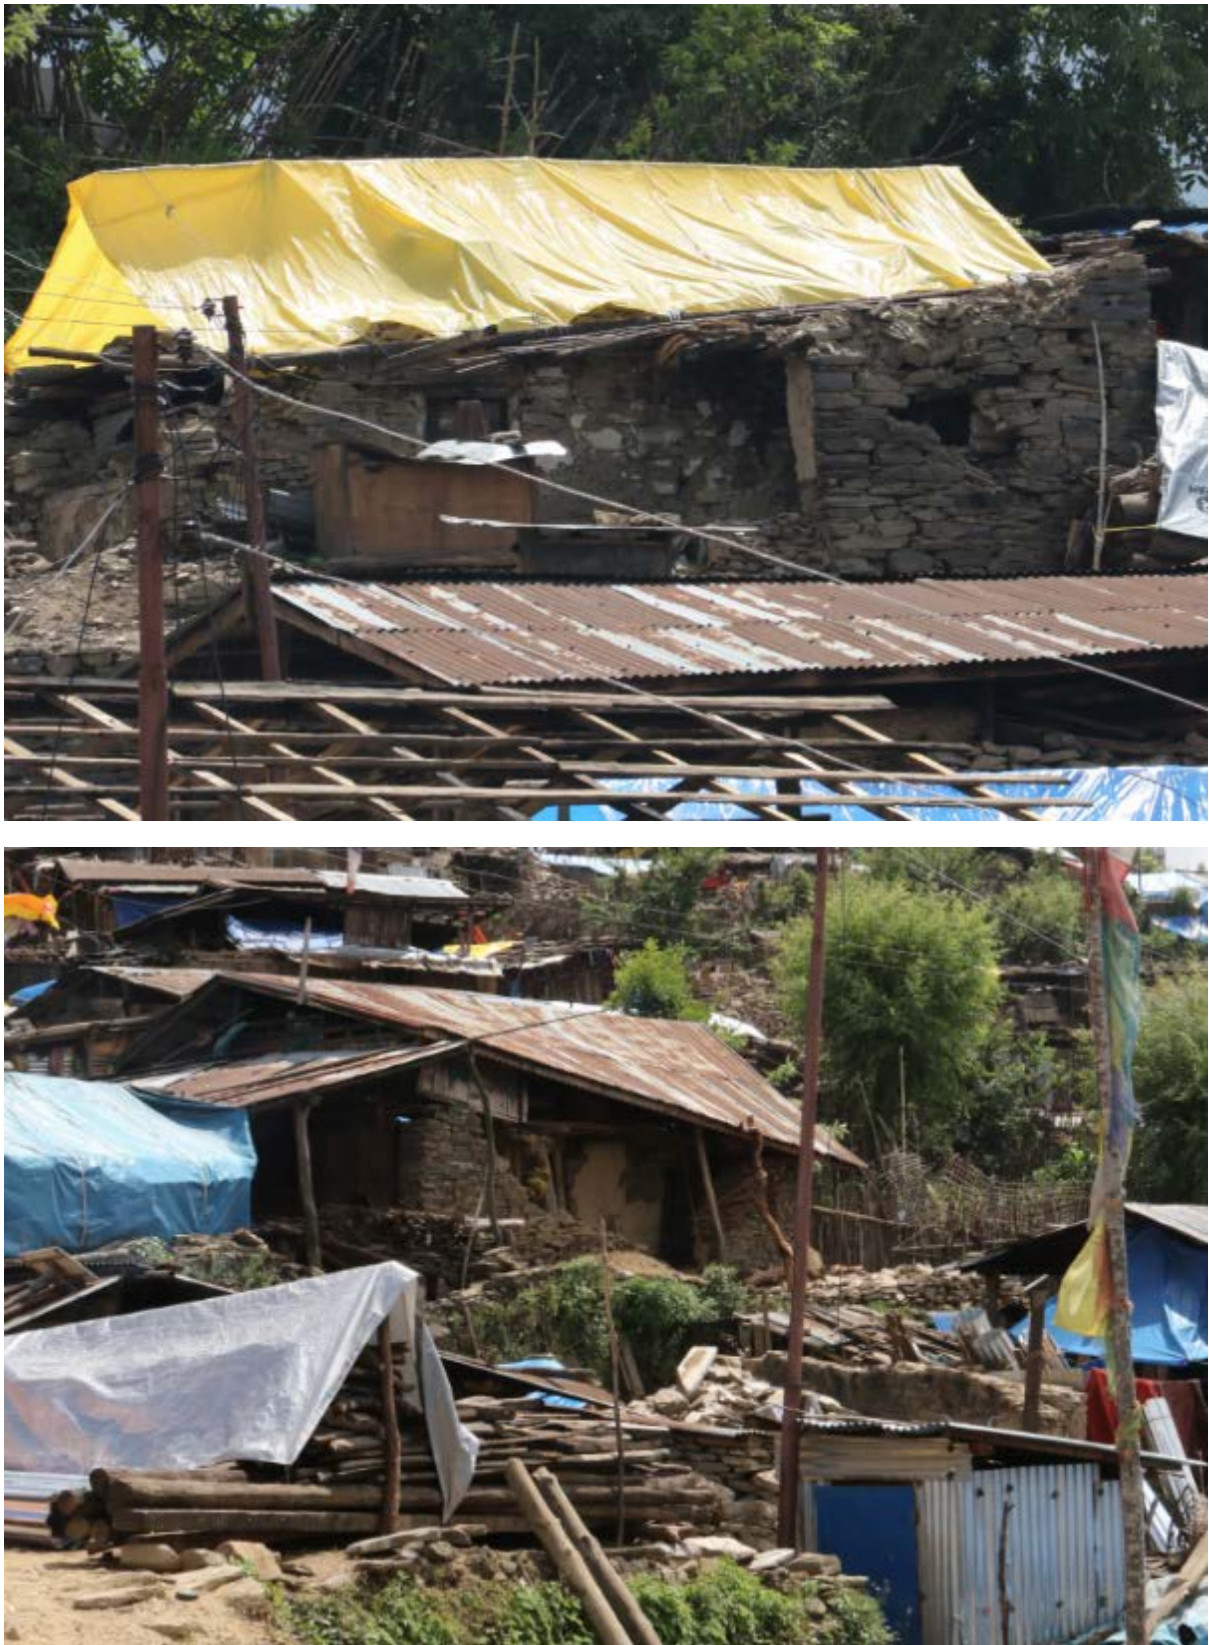
Figure 7-8 Building Damage in Lapsibot
