Engineering Aspects of
**THE MANJIL, IRAN EARTHQUAKE OF
20 JUNE 1990**

A FIELD REPORT BY EEFIT

OCTOBER 1990

Mahmoud R. Maheri
WS Atkins Engineering Sciences

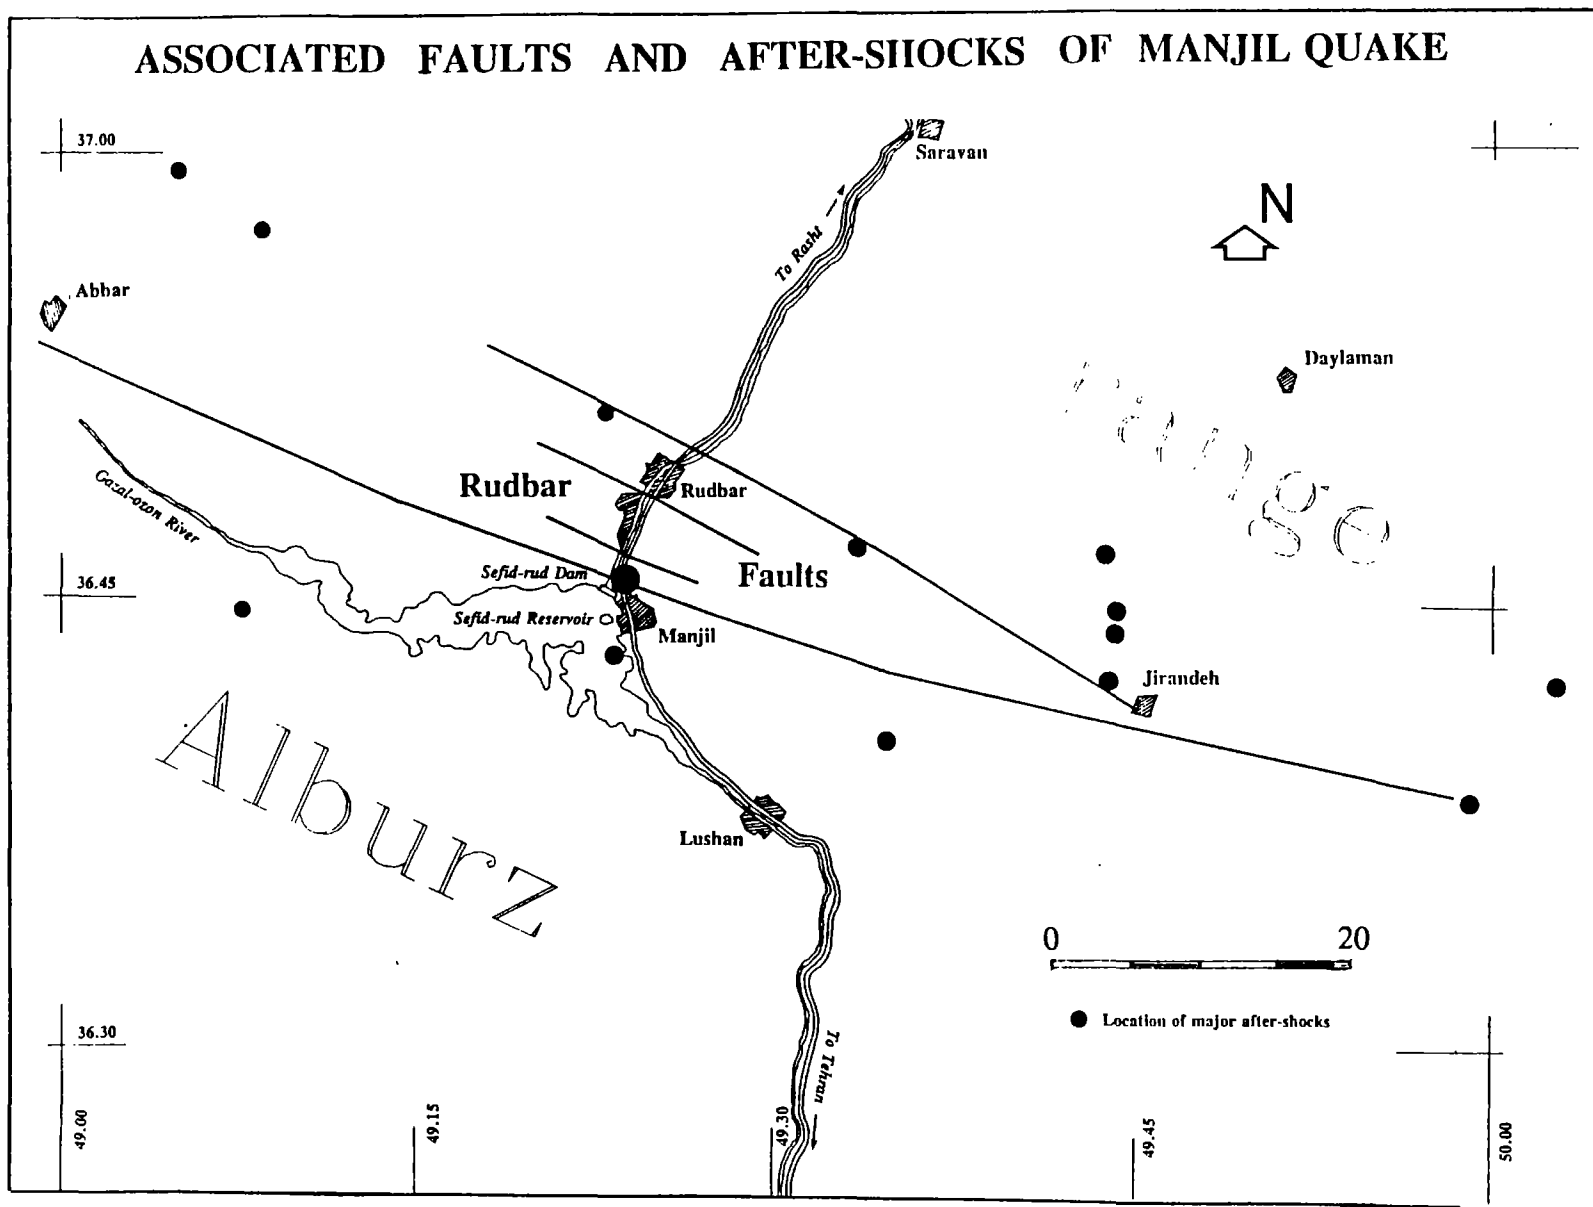
Fig. 2.2

ruptures between the old Rudbar fault and the new fault running north of Manjil (Fig. 2.2).

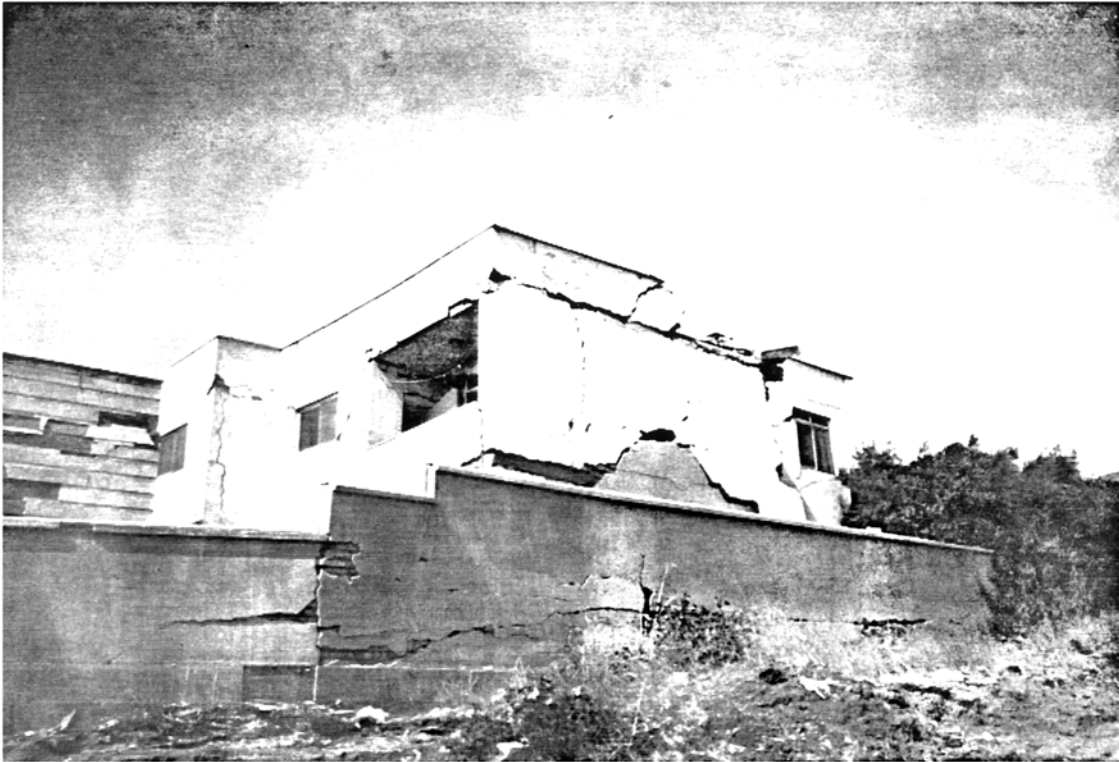
This is a two-storey un-reinforced masonry building with brick load-bearing walls. The main failure was in the long, transversely unsupported second floor south wall of the building with multiple out-of-plane bending cracks (Picture 3.1). Other failures include bending failure in parapet walls followed by overturning collapse of parts of those parapets, and separation of the perpendicular walls at their un-reinforced intersections.

Picture 3.1 Two-storey Brick House, Manjil
Multiple out-of-plane bending failures in the wall

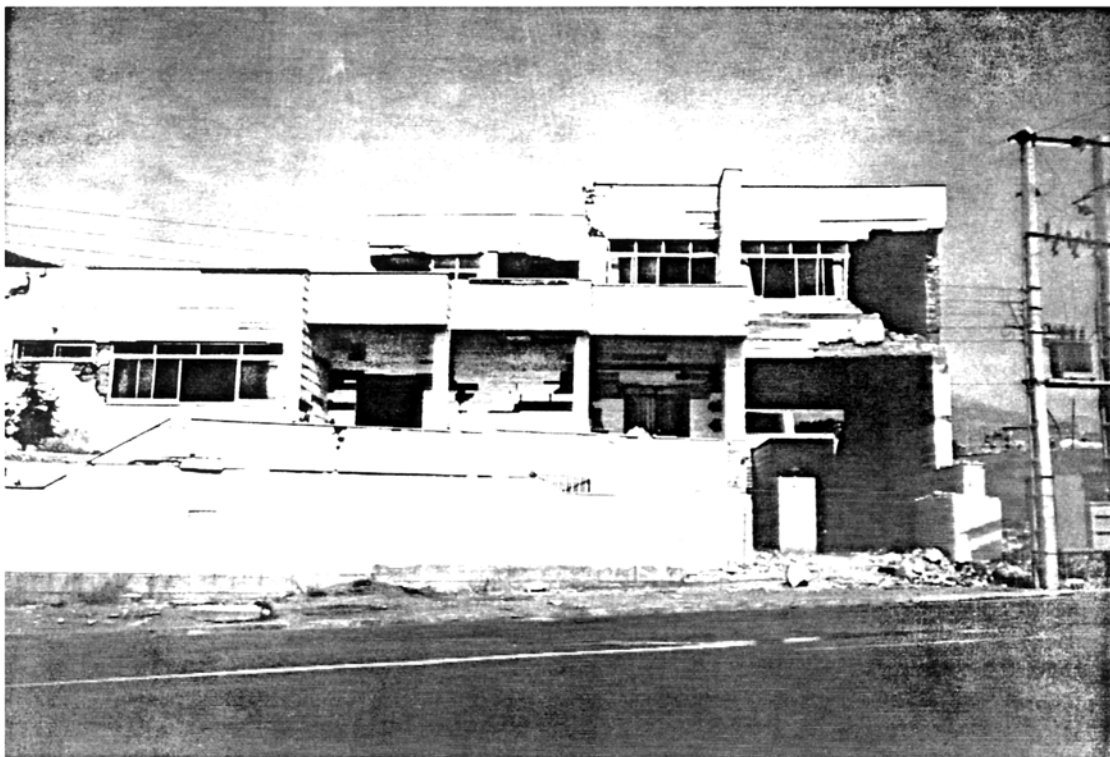
The damage to this two-storey brick masonry house (Picture 3.2) was relatively less than its surrounding buildings. Apart from the collapse of parts of the unrestrained non-load-bearing wall of the second floor, the main load-bearing walls and the roof remained intact. No sign of failure could be seen in the load-bearing walls of the ground floor.

Another major failure in the building is the collapse of one of the second floor load-bearing walls (just visible in Picture 3.2). However, the presence of the reinforced concrete ring-beam has prevented collapse of the supported roof. Other failures could be seen in the free-standing front wall of the house in the form of flexural failure (vertical crack in the middle) and bending failure (long horizontal crack).

Picture 3.2 Two-storey Residence, Manjil
Collapse of the non-load bearing second floor wall

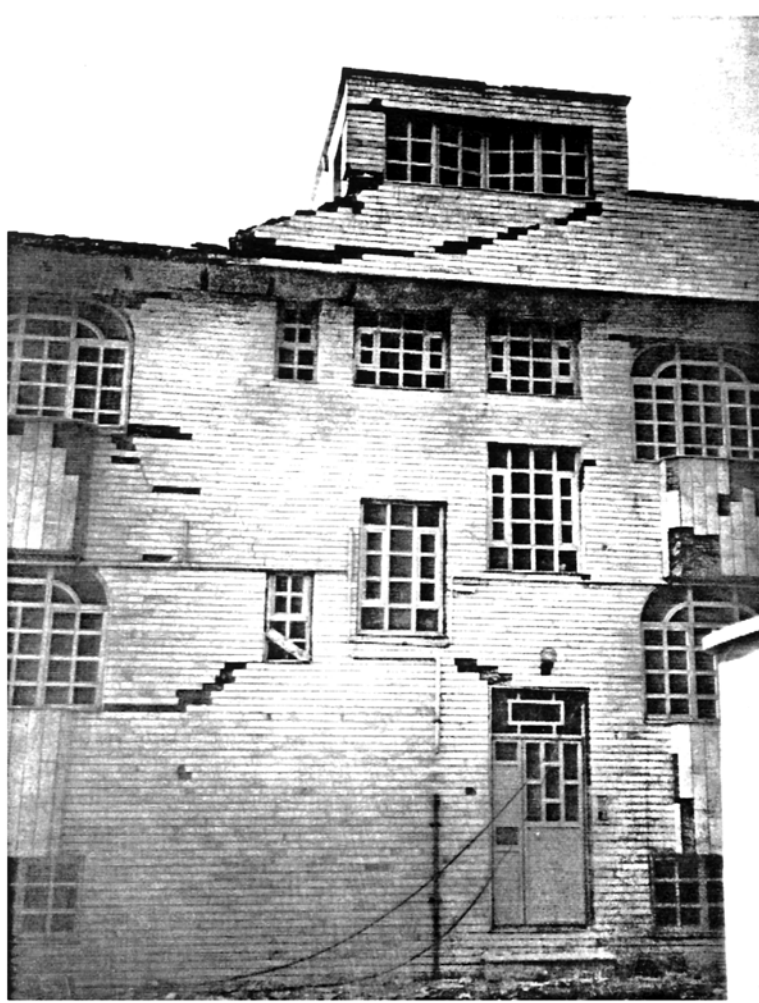
Despite its bizarre and complex architectural form, this masonry building maintained its integrity under the strong earthquake loading in Manjil (Picture 3.3). Its irregular architectural form however caused numerous failures in different forms. These include (Top down):

- a. Bending failures at the short, top floor, brick column.
- b. Shear failure in the wall of the top floor room.
- c. Overturning of parts of the long unsupported parapet wall.
- d. Multiple in-plane shear failures in the wider sections of the wall.
- e. Multiple out-of-plane bending failures in the narrower sections of the wall.

Picture 3.3 3-4 storey House, Manjil
Despite many failures due to its complex architectural form the building maintained its integrity

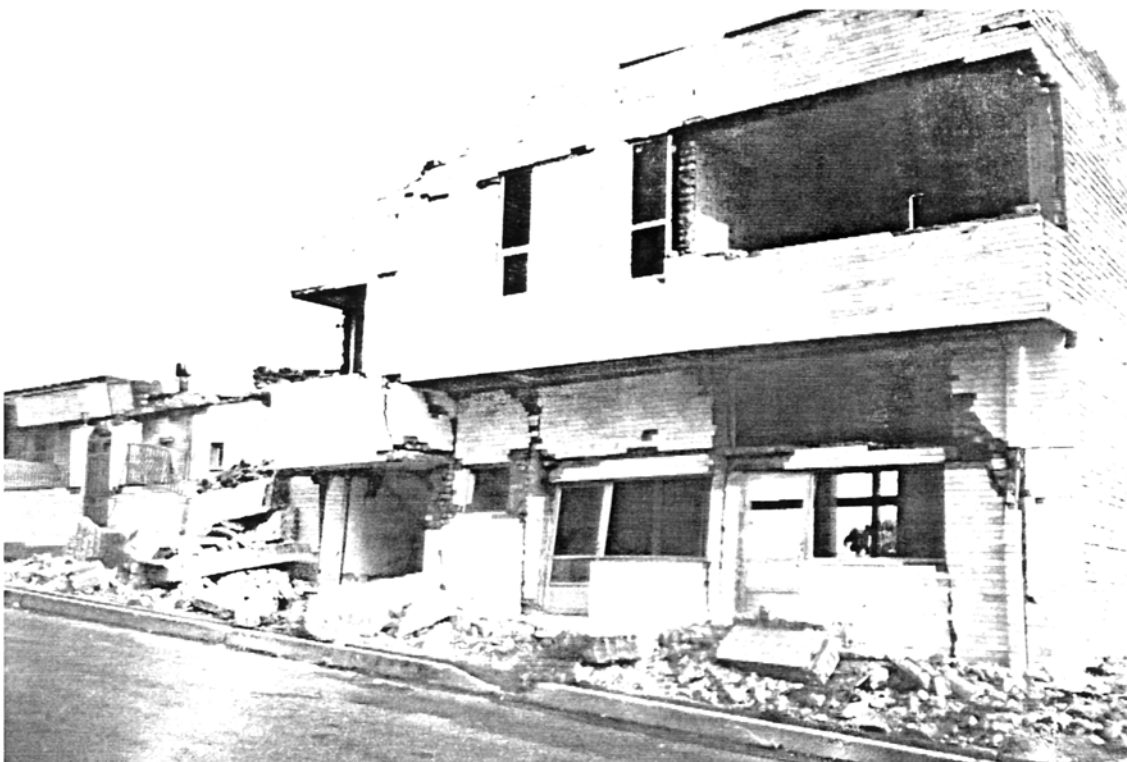
Picture 3.4 White Stone Clad House, Manjil
Window frame supporting the spandrel wall and the roof after failure of load-bearing steel frame

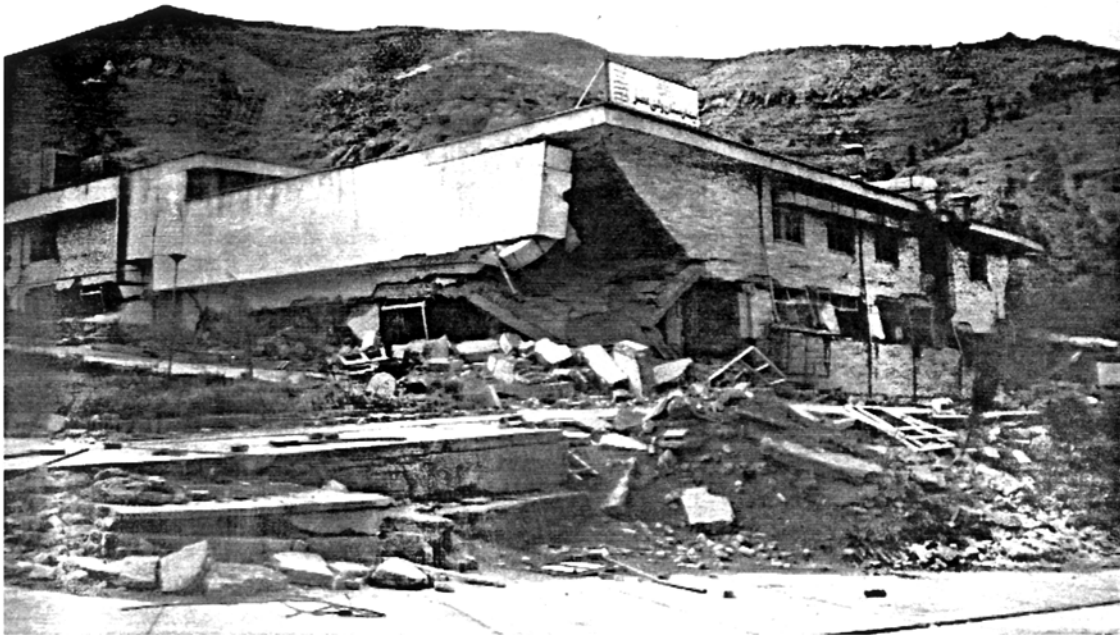
Picture 3.5 Vali-asr Hospital, Rudbar
Damage to the entrance of the main building

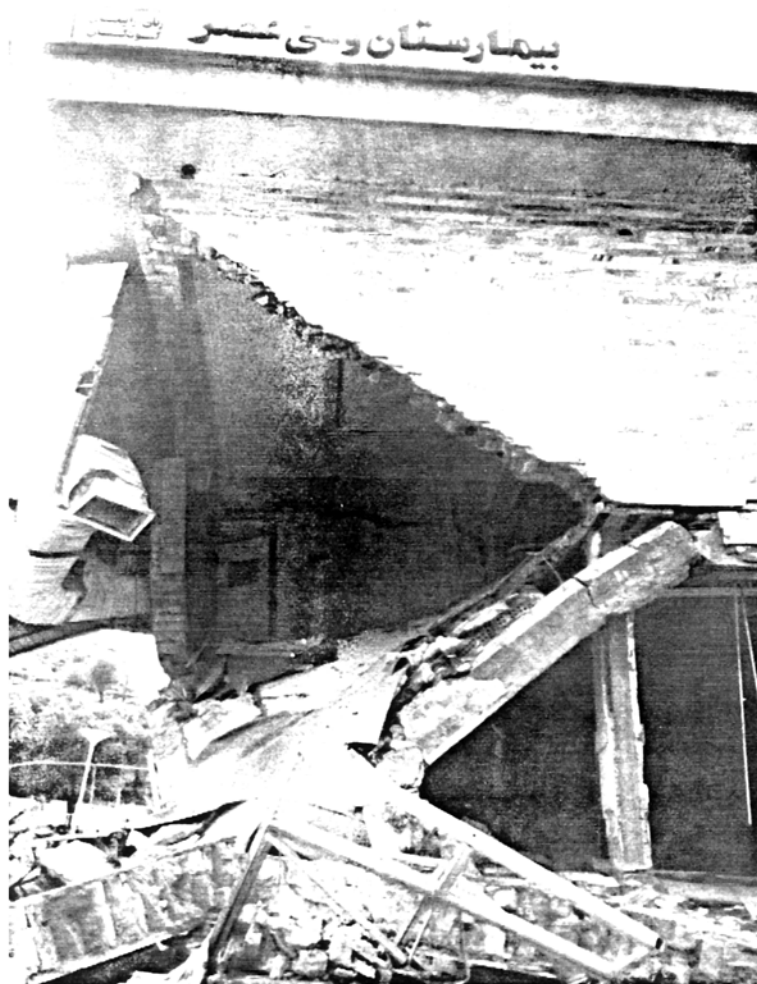
Picture 3.6 Vali-asr Hospital, Rudbar
excellent behaviour of roof concrete ring-beam after
collapse of main load-bearing elements at this corner

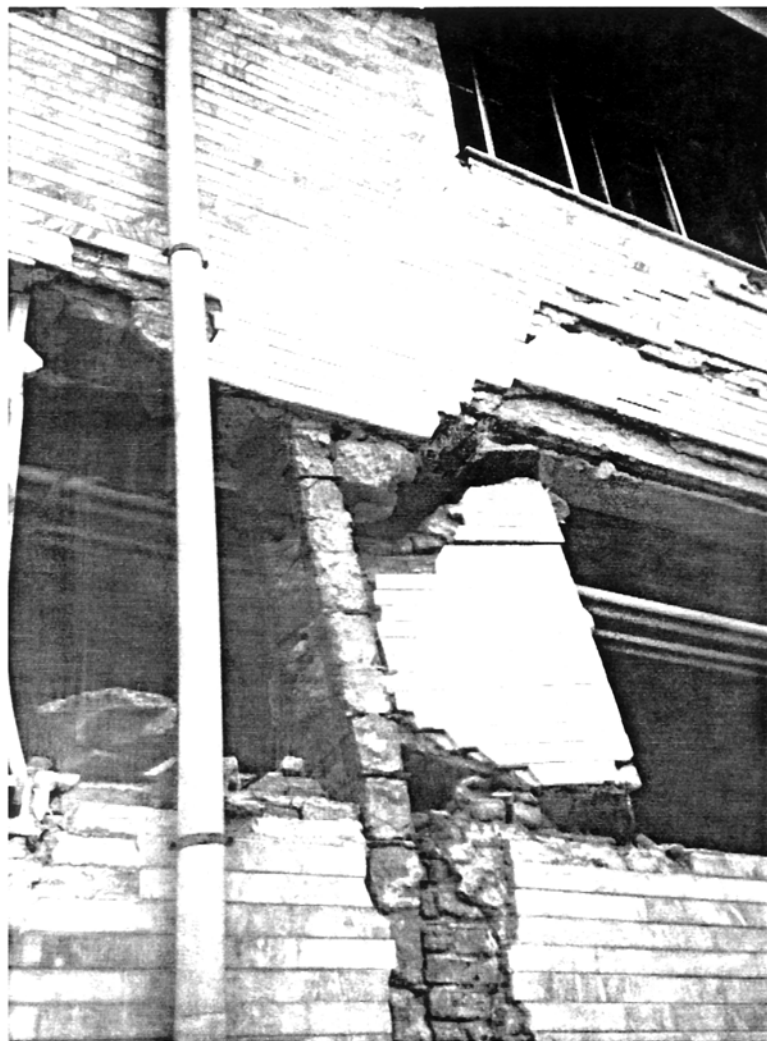
Picture 3.7 Vali-asr Hospital, Rudbar
Multiple fixed-end bending failures in columns of the main building

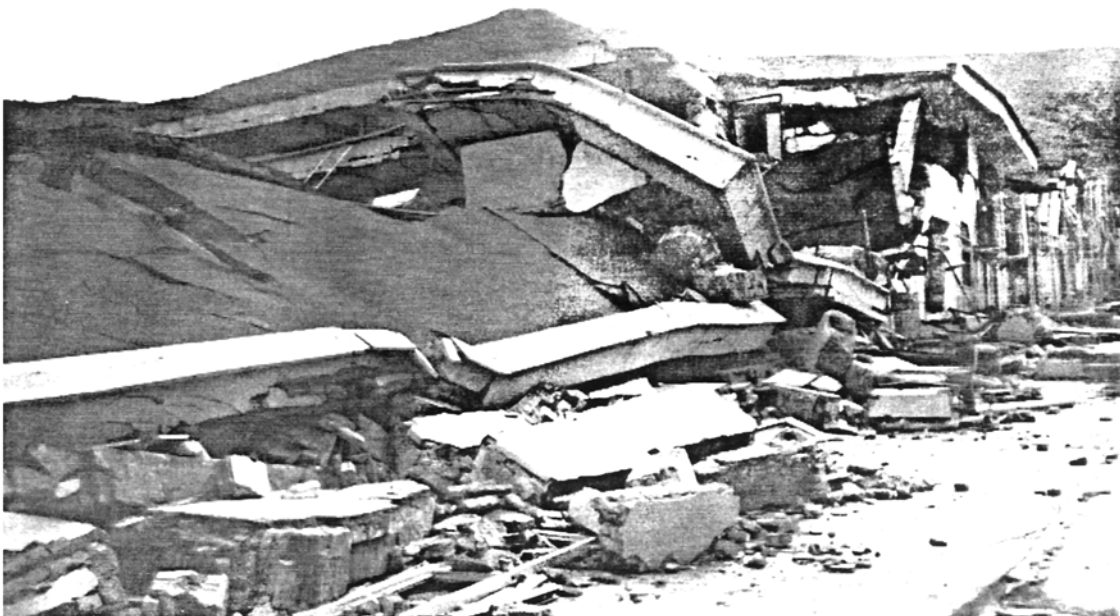
Picture 3.8 Vali-asr Hospital, Rudbar
Destruction of casualty department due to weak vertical supports

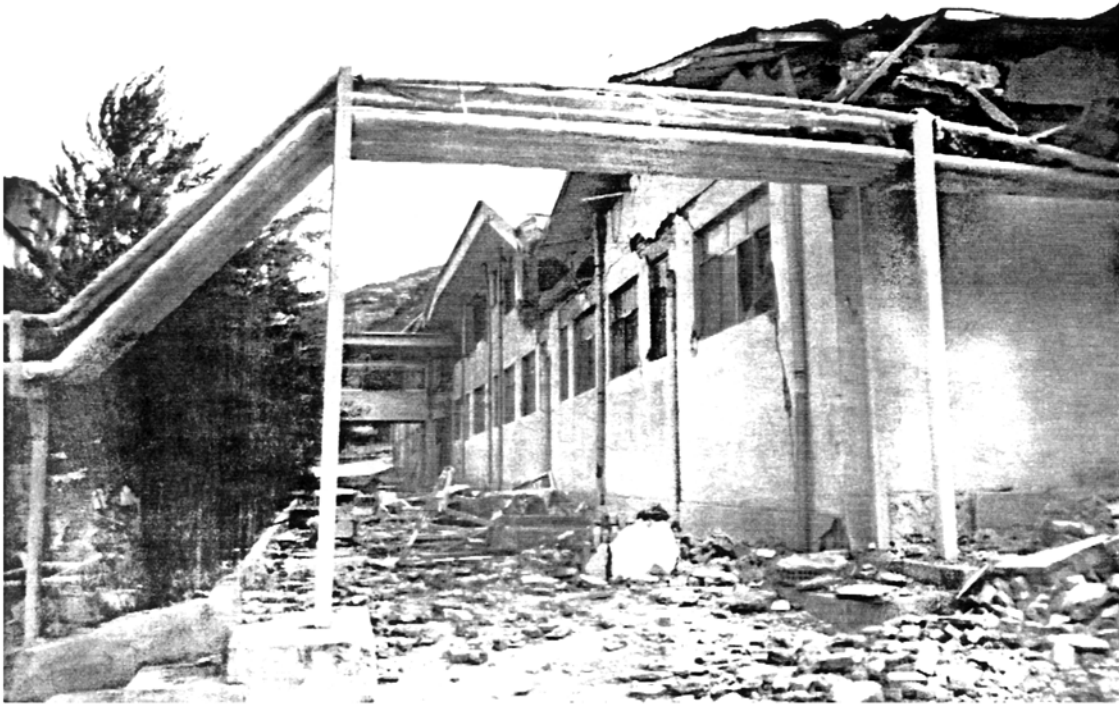
Picture 3.9 Vali-asr Hospital, Rudbar
Damage to the middle one-storey building

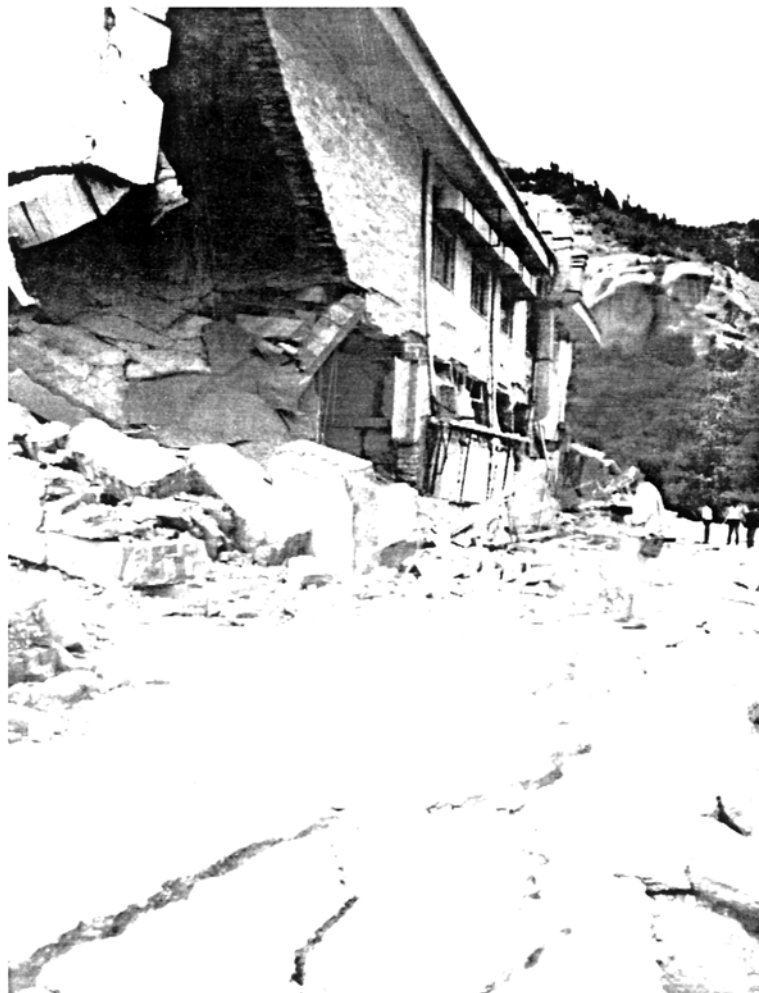
Picture 3.10 Vali-asr Hospital, Rudbar
Failure of built ground and the pavement concrete slabs

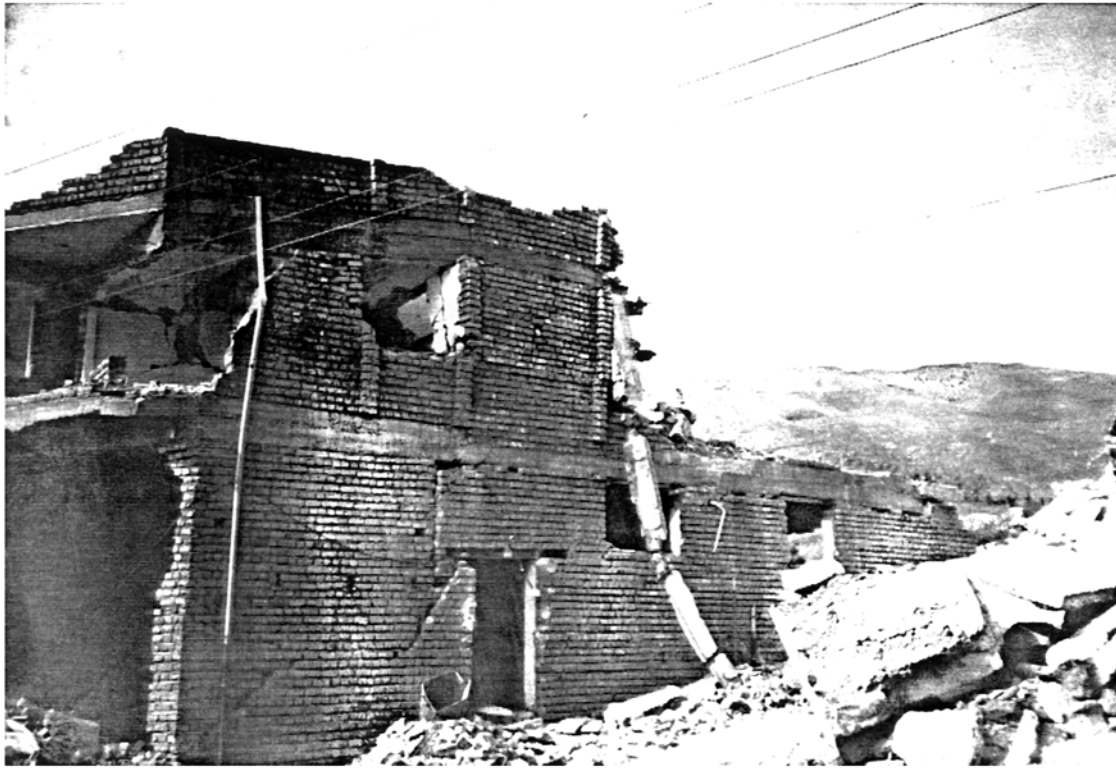
Picture 3.11 Two-storey Brick Building, Manjil
Collapse of the ring beam and roof of the east side
due to the complete loss of vertical support

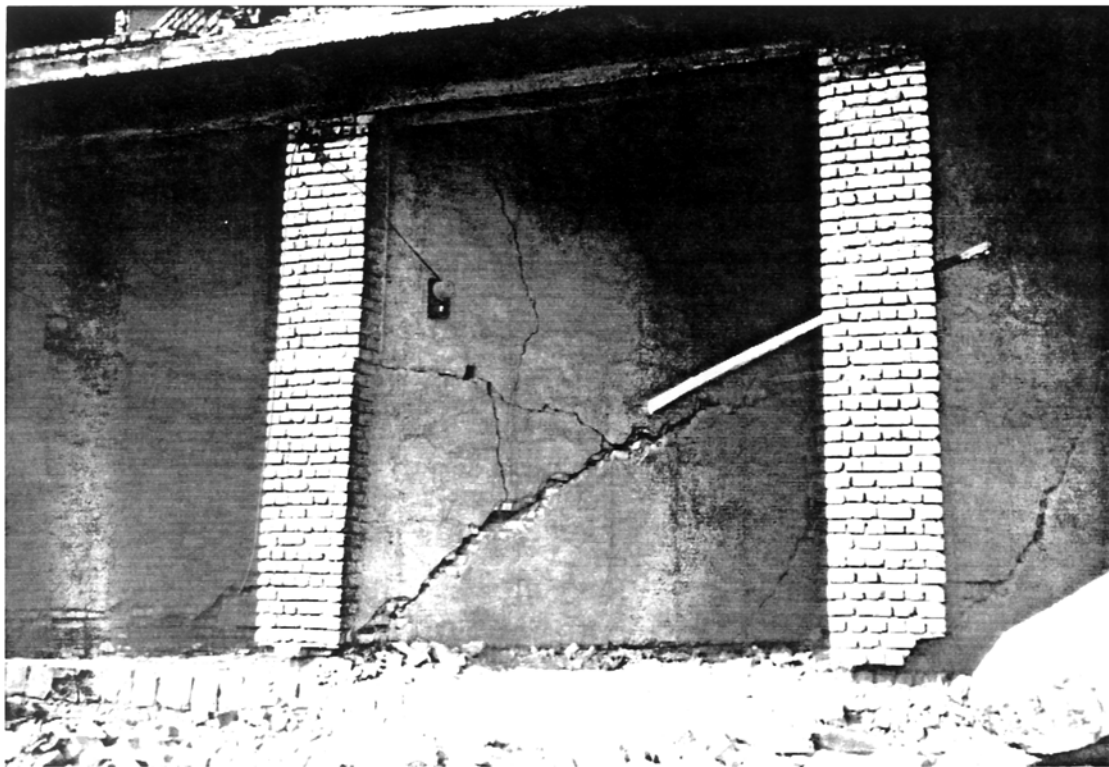
Picture 3.13 Two-storey Brick Building, Manjil
Shear failure in the ground floor walls

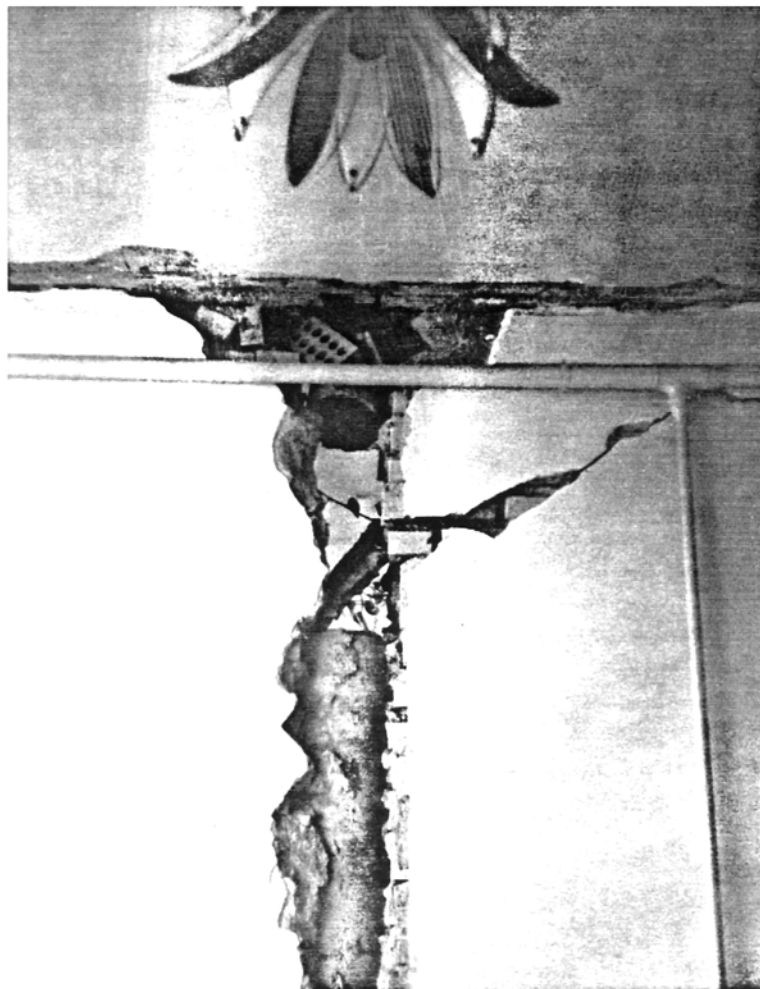
Picture 3.14 Two-storey Brick House, Manjil
Passage of chimney pipe through the wall has
contributed to the weakness of the wall

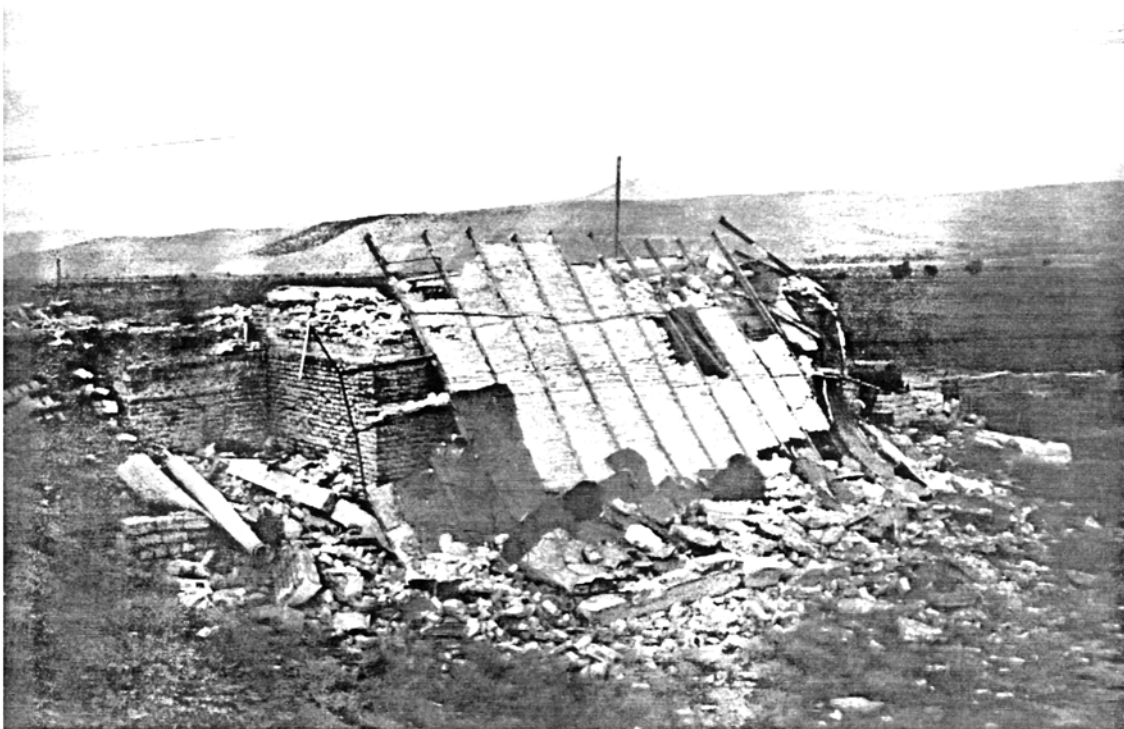
Picture 3.16 Two-storey Jack-arch Brick Building, Near Rudbar
Collapse of the roof due to inadequate vertical support but
steel bars keeping the I-beams and jack-arches together

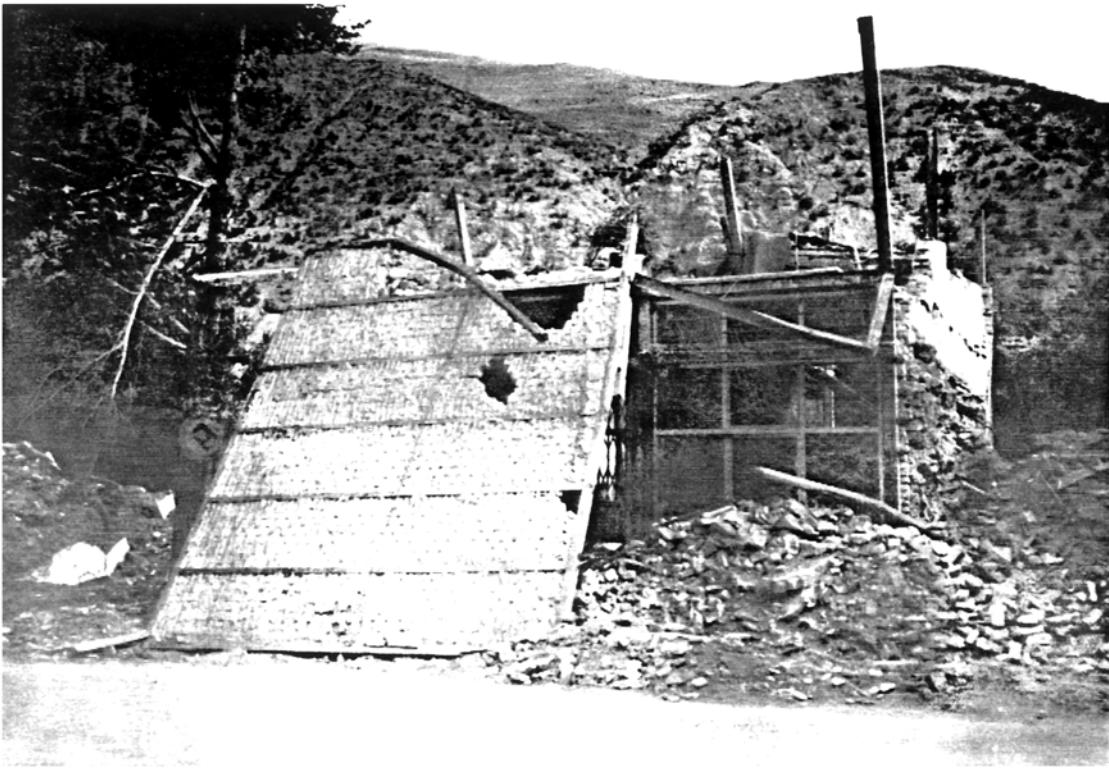
Picture 3.17 Steel Frame Jack-arch Roof Building, Rudbar
Despite ground shaking and free fall under its own weight the supported I-beams of the roof slab kept the jack arches in place

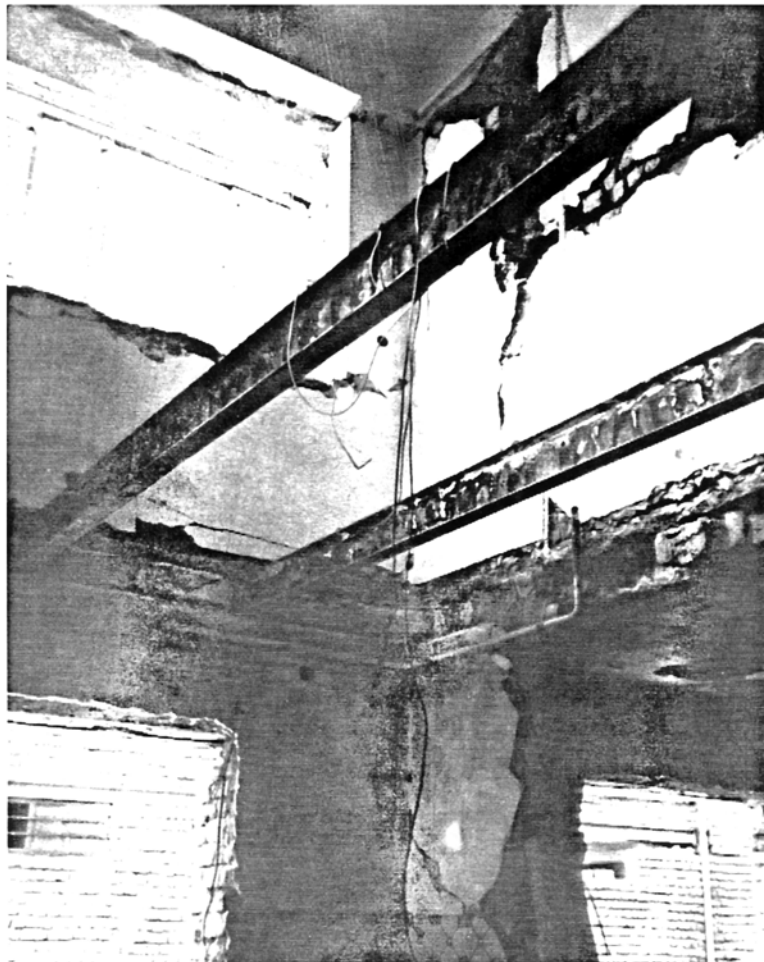
Picture 3.20 Three-storey Building, Manjil
First floor jack arches collapsed despite no
apparent separation of the supporting I-beams

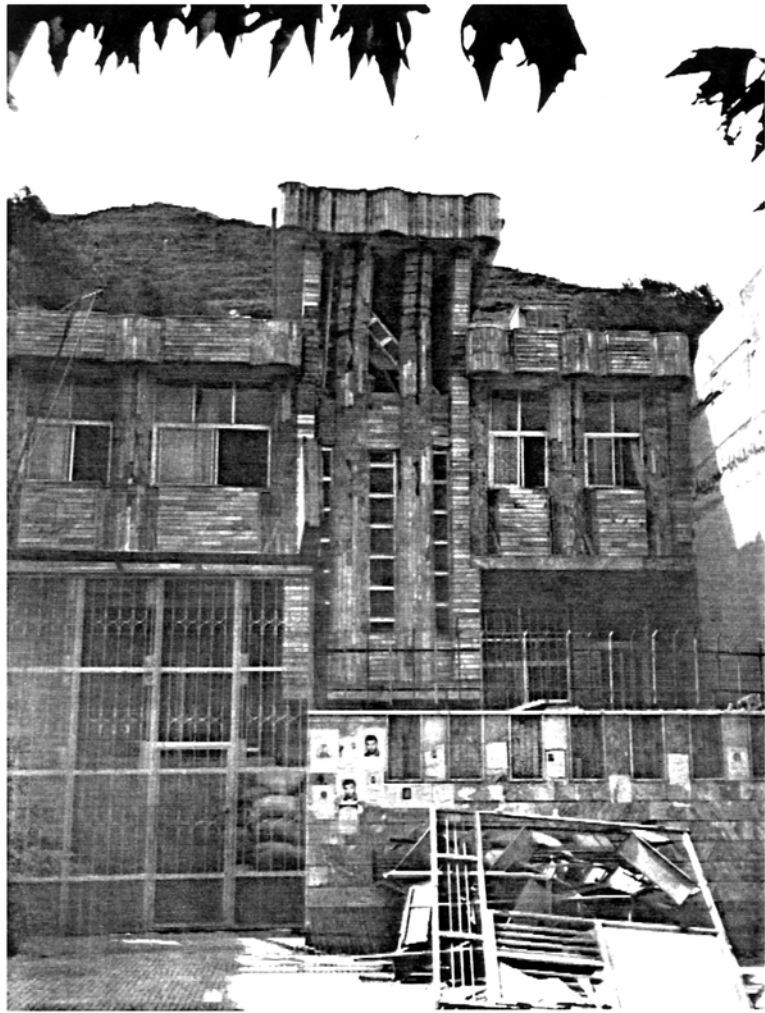
Picture 3.23 Damage to Two-three Storey Steel Frame Residence, Rudbar

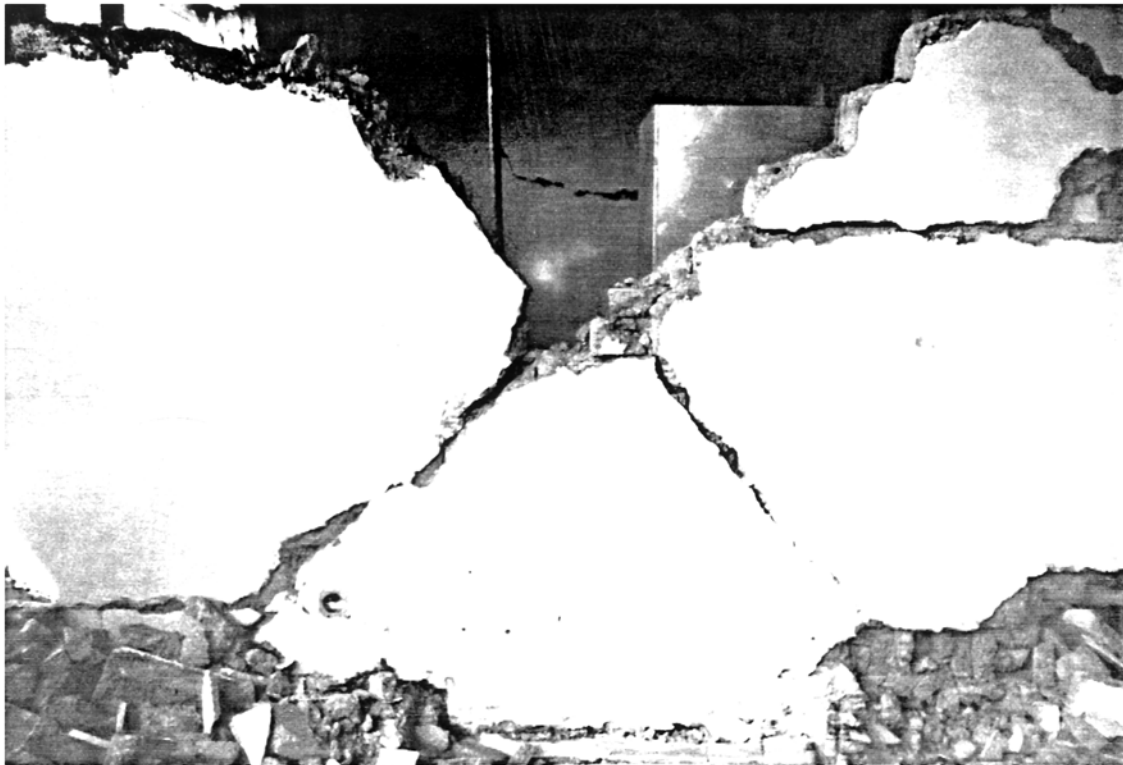
Picture 4.2 Telecom Centre, Manjil
Diagonal X shear failure in the shear wall followed
by flexural and overturning failures

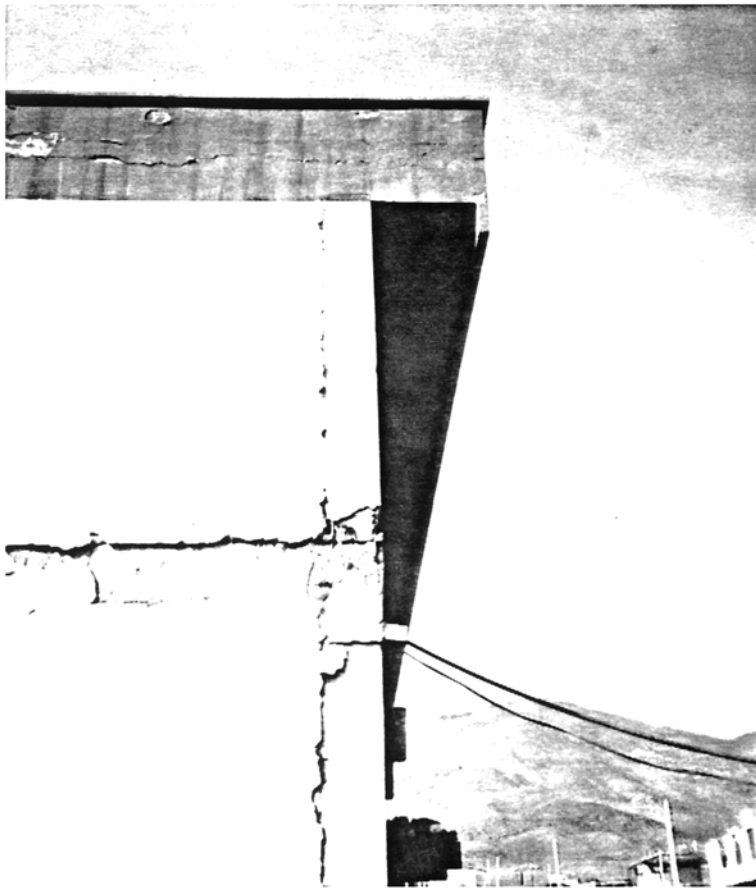
Picture 4.3 Telecom Centre, Manjil
Bending failure at the base of the upper floor column

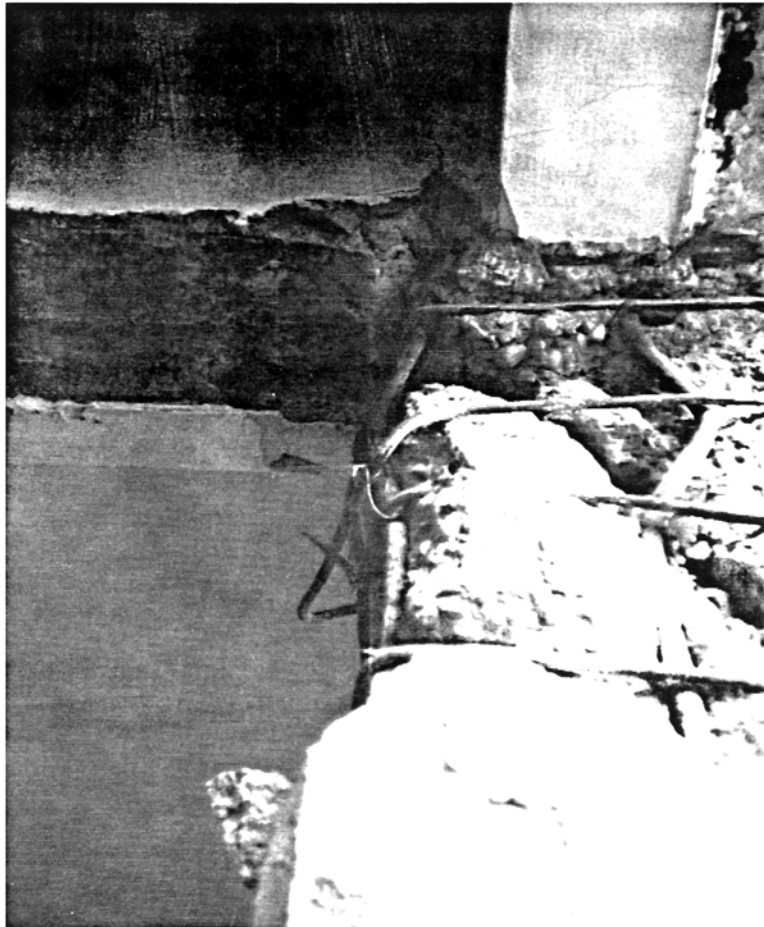
Picture 4.4 Telecom Centre, Manjil
Shear failure in the reinforced concrete column

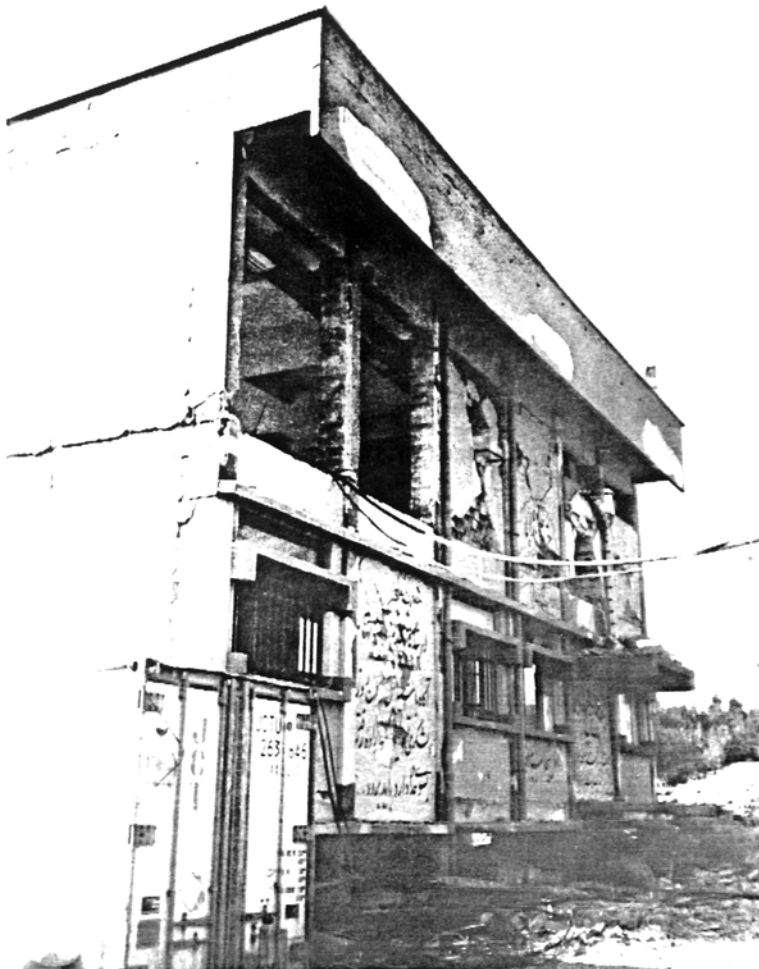
Picture 4.6 Telecom Centre, Manjil
View of east face of the building indicating lesser response at the south-east corner

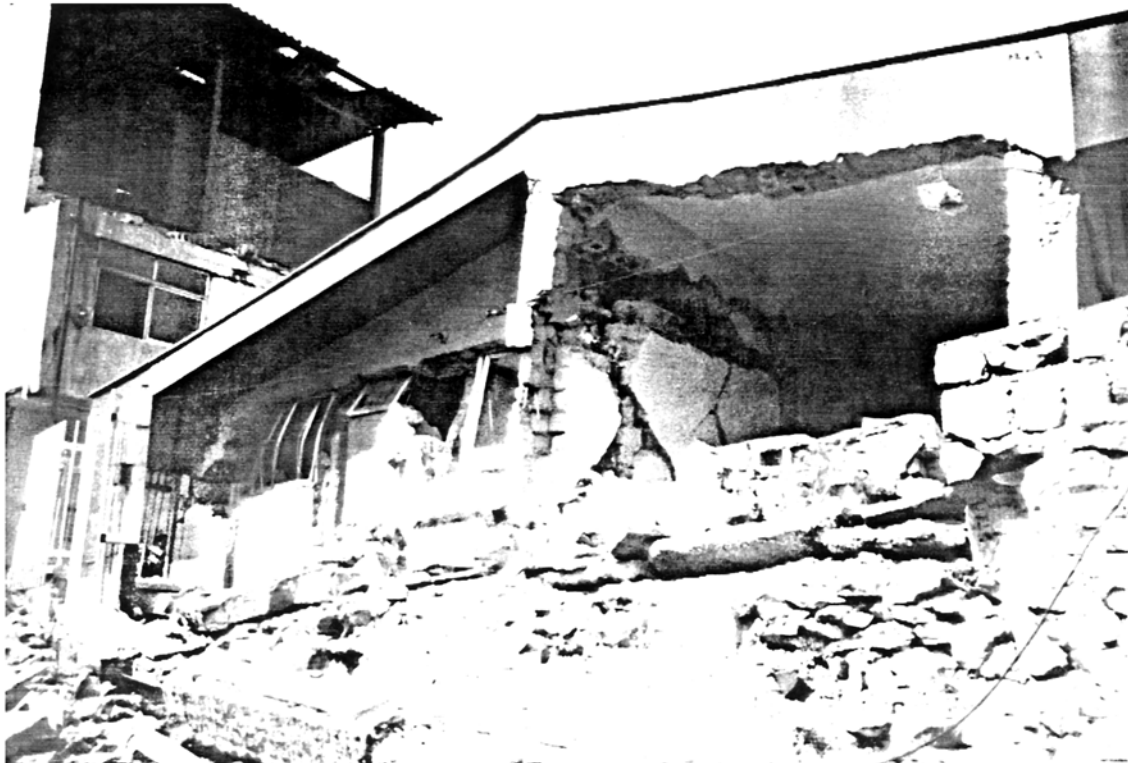
Picture 4.12 One-storey Reinforced Concrete Frame House, Rudbar
This relatively stiff house, founded on built ground suffered heavy damage due to high dynamic amplification

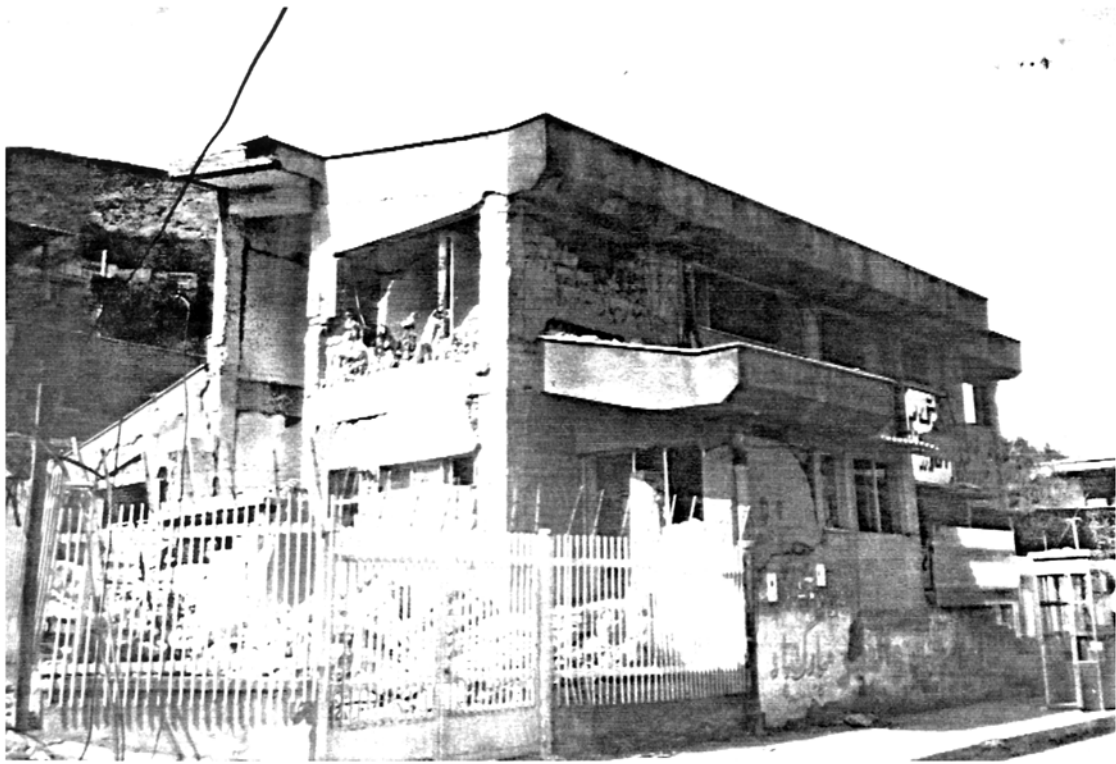
Picture 4.13 Telecom Building, Rudbar
Collapse of the infill masonry walls

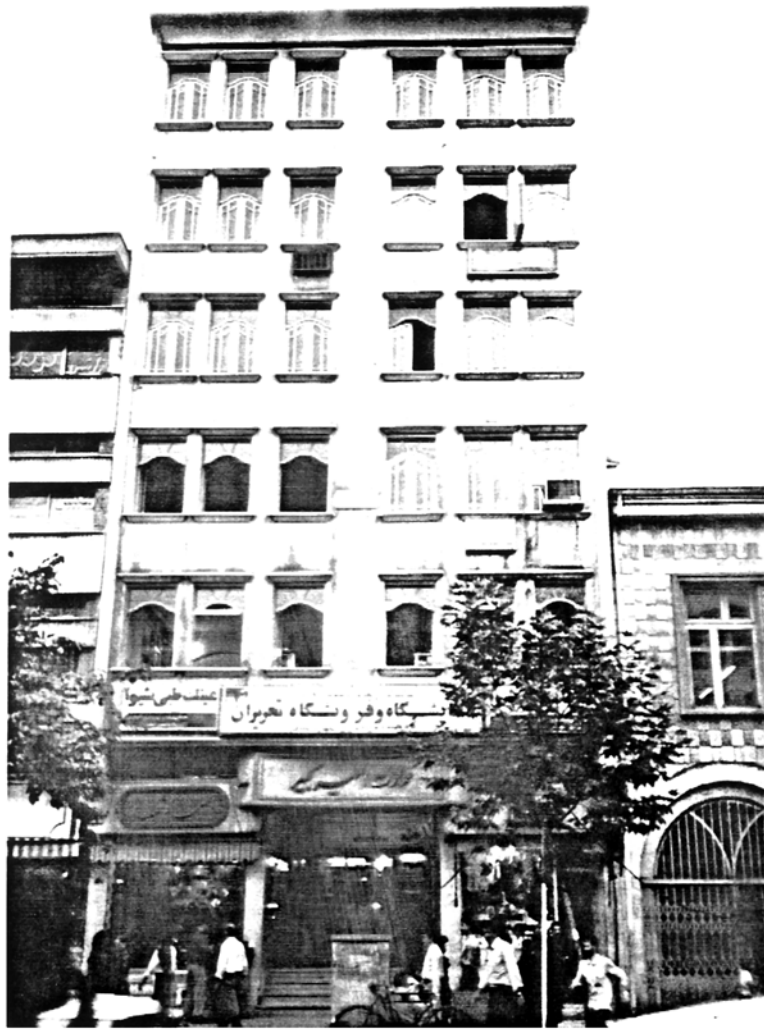
Picture 4.21 Six-storey Shop Store, Rasht
Shear failure in the central infill wall

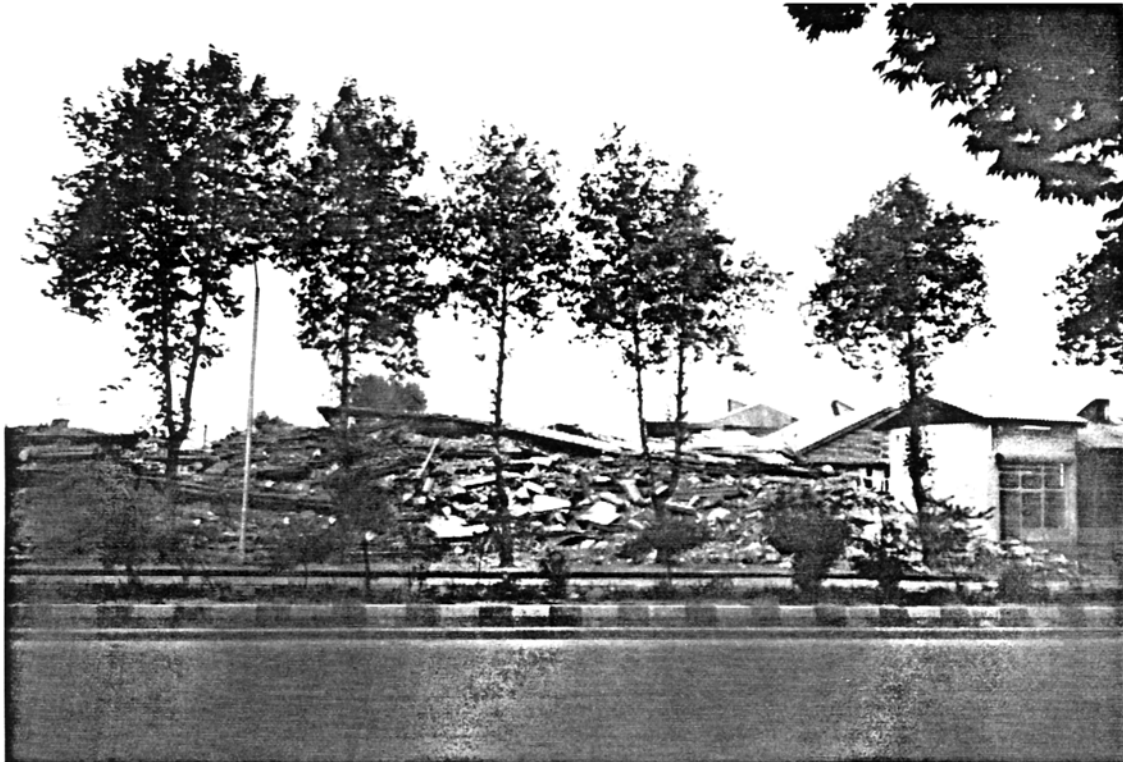
Picture 4.22 Six-storey Steel Frame Building, Rasht
Complete collapse of the building due to failure of welded joints
