Engineering Aspects of
**THE MANJIL, IRAN EARTHQUAKE OF
20 JUNE 1990**

A FIELD REPORT BY EEFIT

OCTOBER 1990

Mahmoud R. Maheri
WS Atkins Engineering Sciences

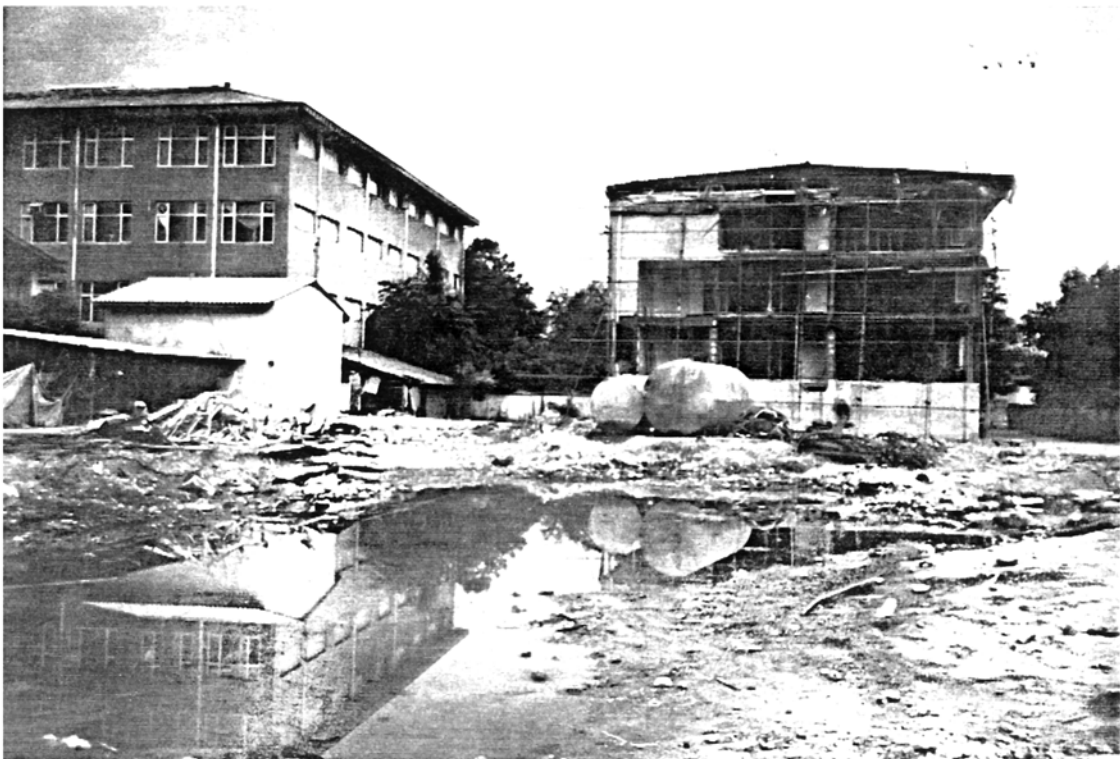
Picture 4.26 Site of a collapsed eight-storey steel frame building. Poor welded joints and weak steel columns the main causes of failure, Rasht

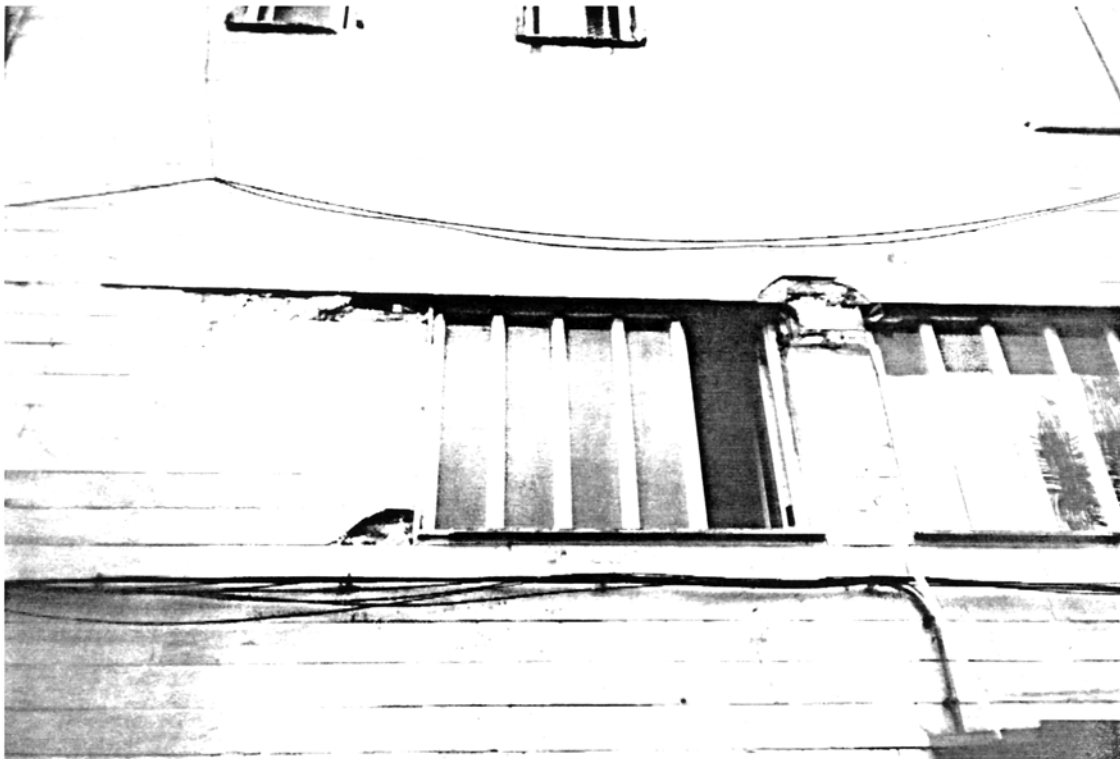
Picture 4.30 Telecom Building, Rasht
Failures in the infill walls and stone cladding

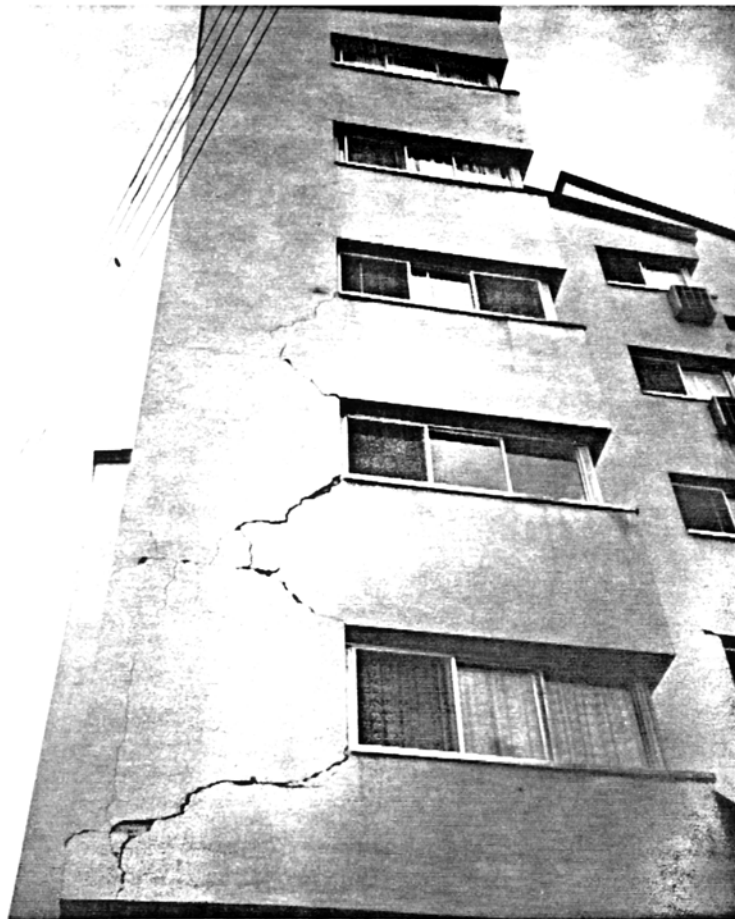
Picture 4.34 Nine-storey Apartment Block, Rasht
Shear cracks in the infill walls

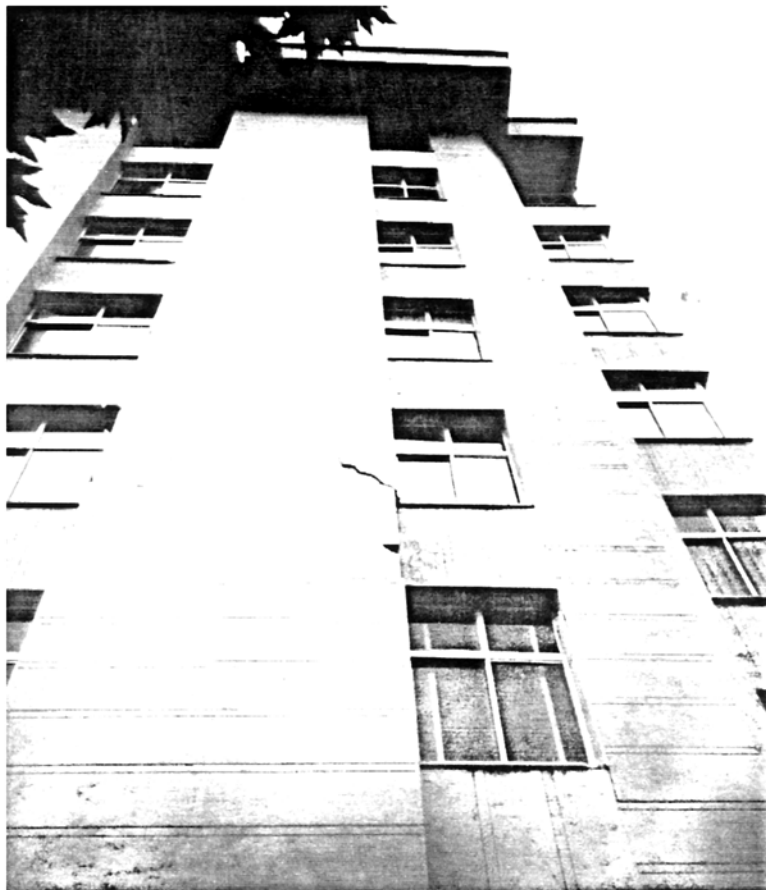
Picture 4.36 Eight-storey White Stone Clad Building, Rasht
Minor crack in the stone cladding the only damage in this building

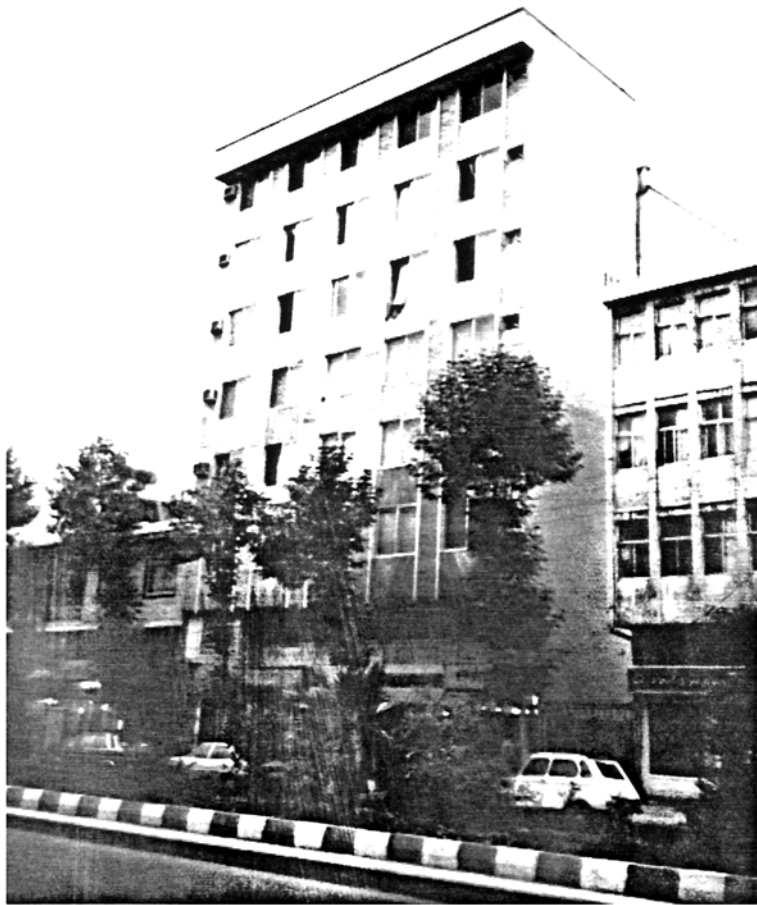
Picture 4.37 Eight-storey Grey Stone Clad Building, Rasht
Another well constructed reinforced concrete building
surviving the quake with minor damages

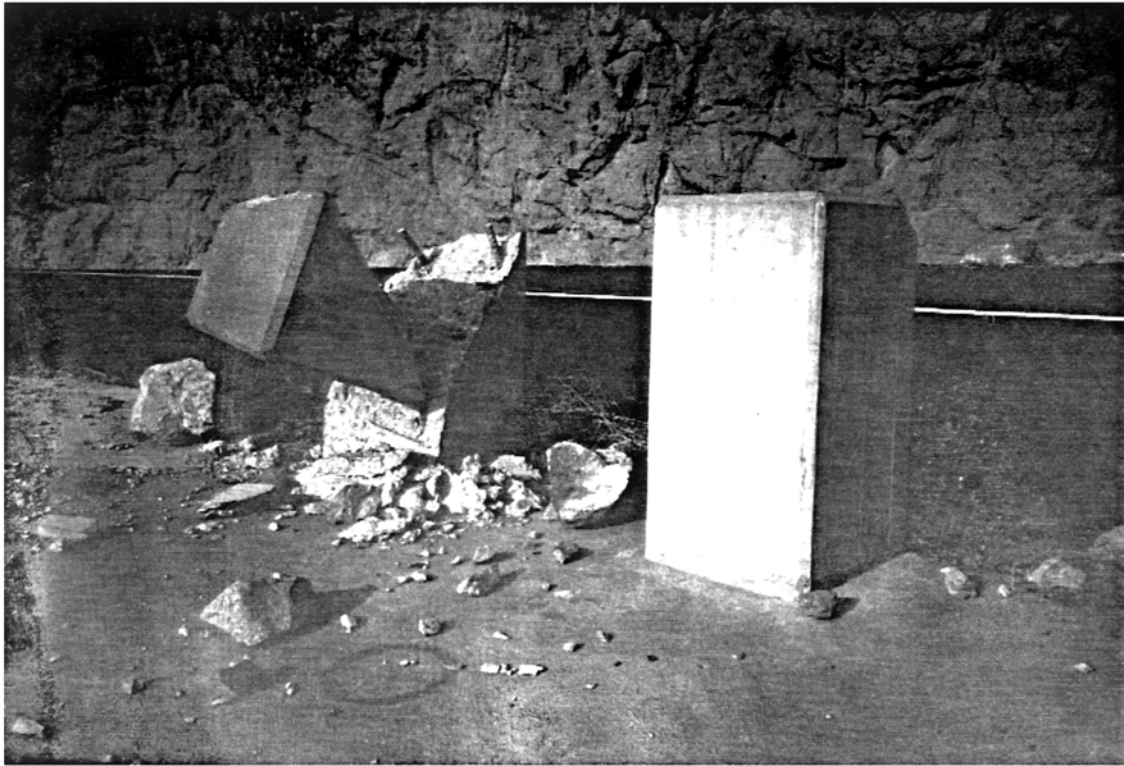
Picture 5.3 Sefid-rud Dam, Manjil
Shear failure in the reinforced concrete block at the side of the dam

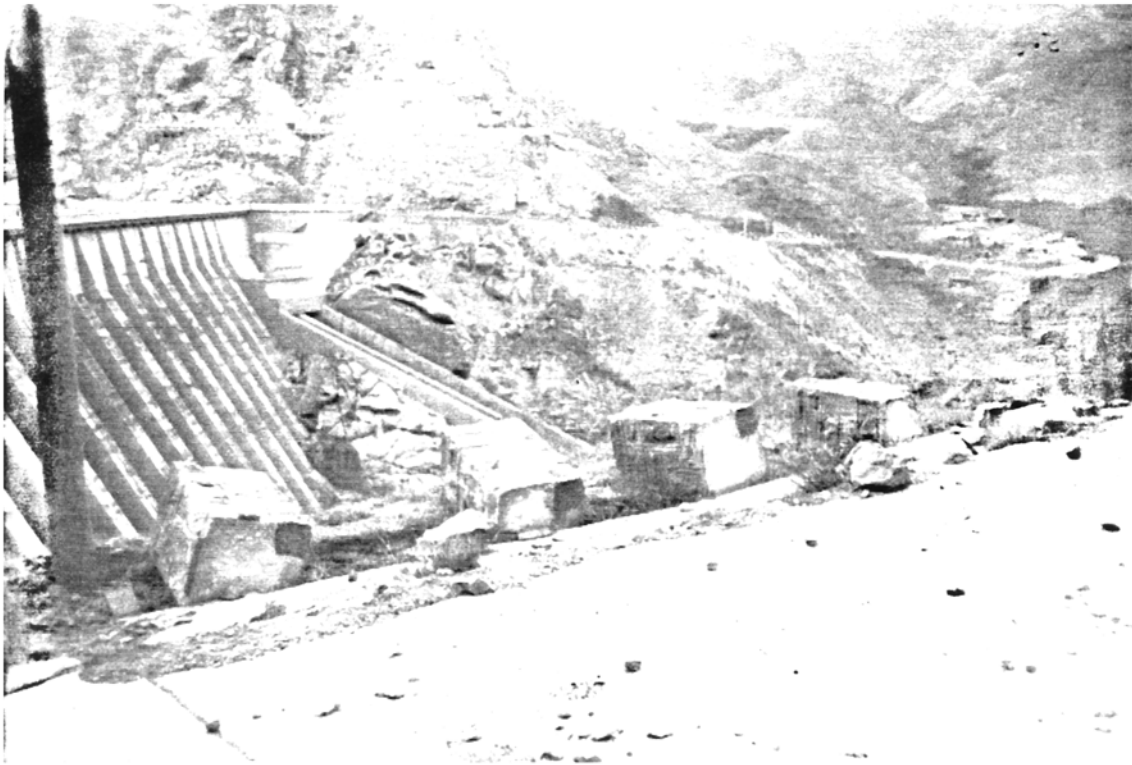
Picture 5.4 Sefid-rud Dam, Manjil
Overturning failure of stone masonry guard blocks

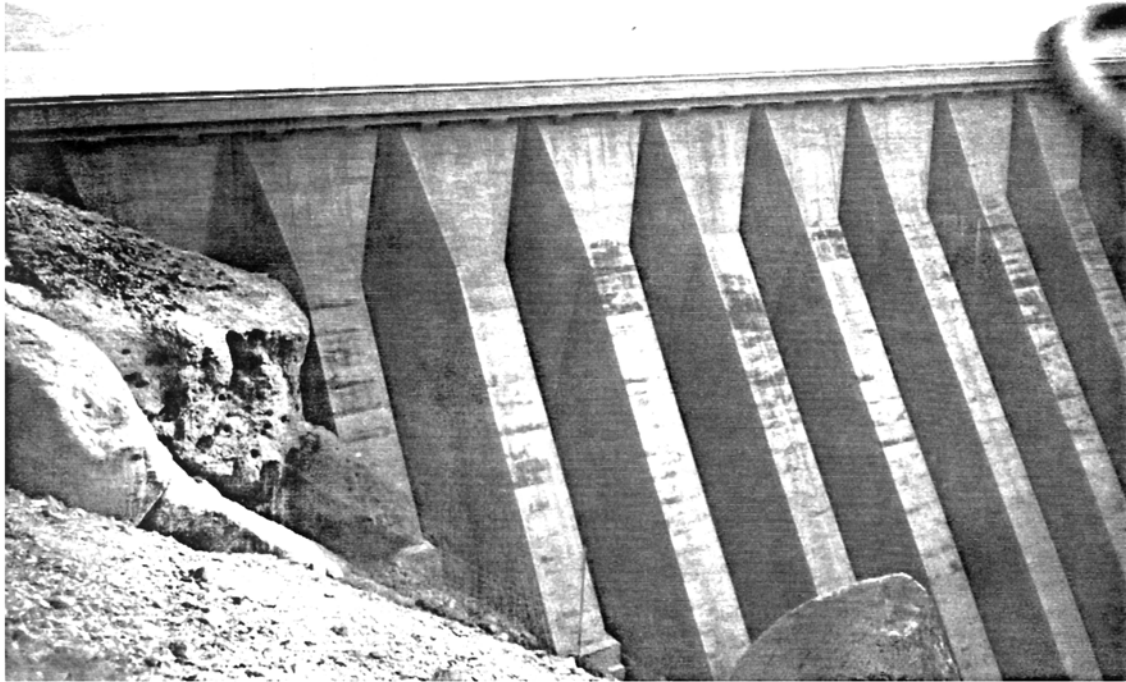
Picture 5.5 Sefid-rud Dam, Manjil
Horizontal cracks at the base of the crown and vertical cracks in buttresses not visible in the photograph

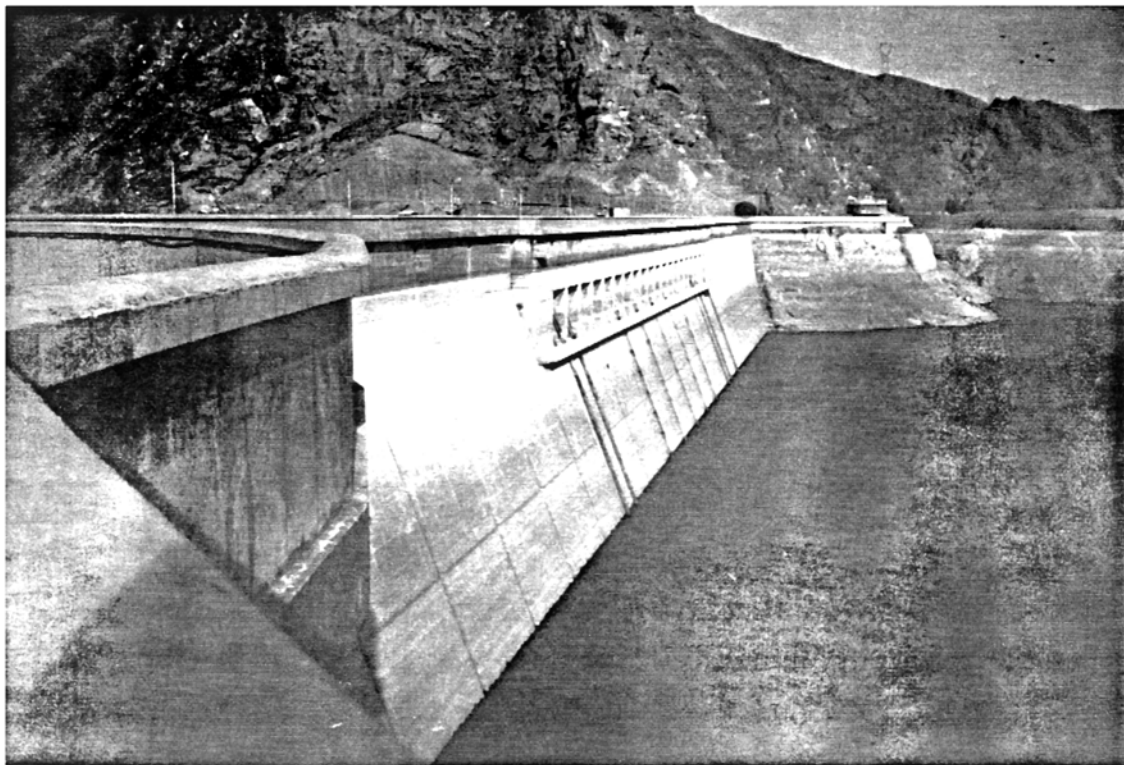
Picture 5.6 Sefid-rud Dam, Manjil
Some horizontal cracks can be observed in the upstream face of the dam

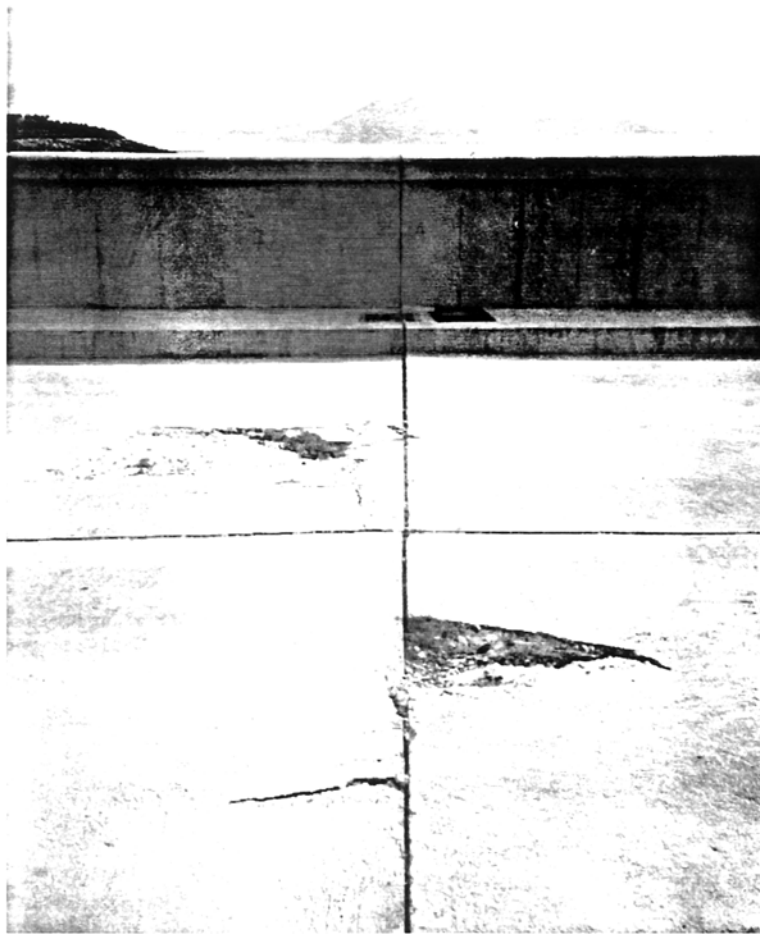
Picture 5.7 Sefid-rud Dam, Manjil
Spalling of concrete at the crest caused by pounding
action of adjoining sections of the dam

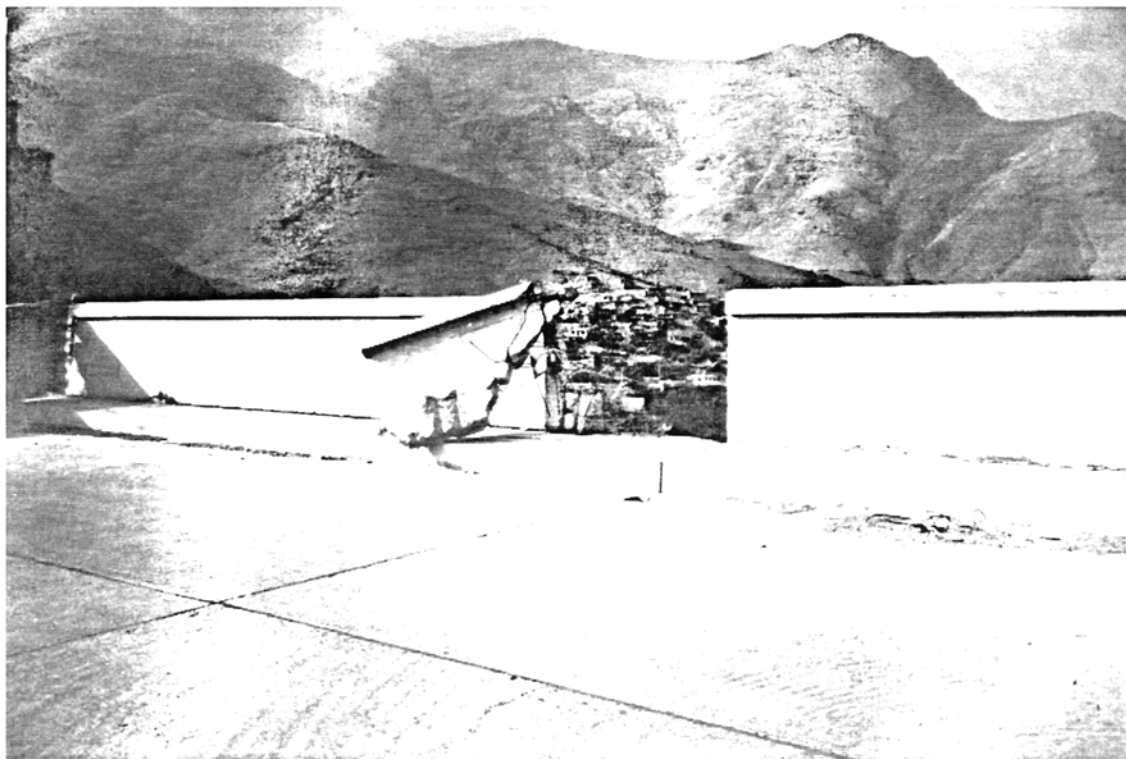
Picture 5.8 Sefid-rud Dam, Manjil
Flexural failure in the long, unsupported
reinforced concrete parapet wall

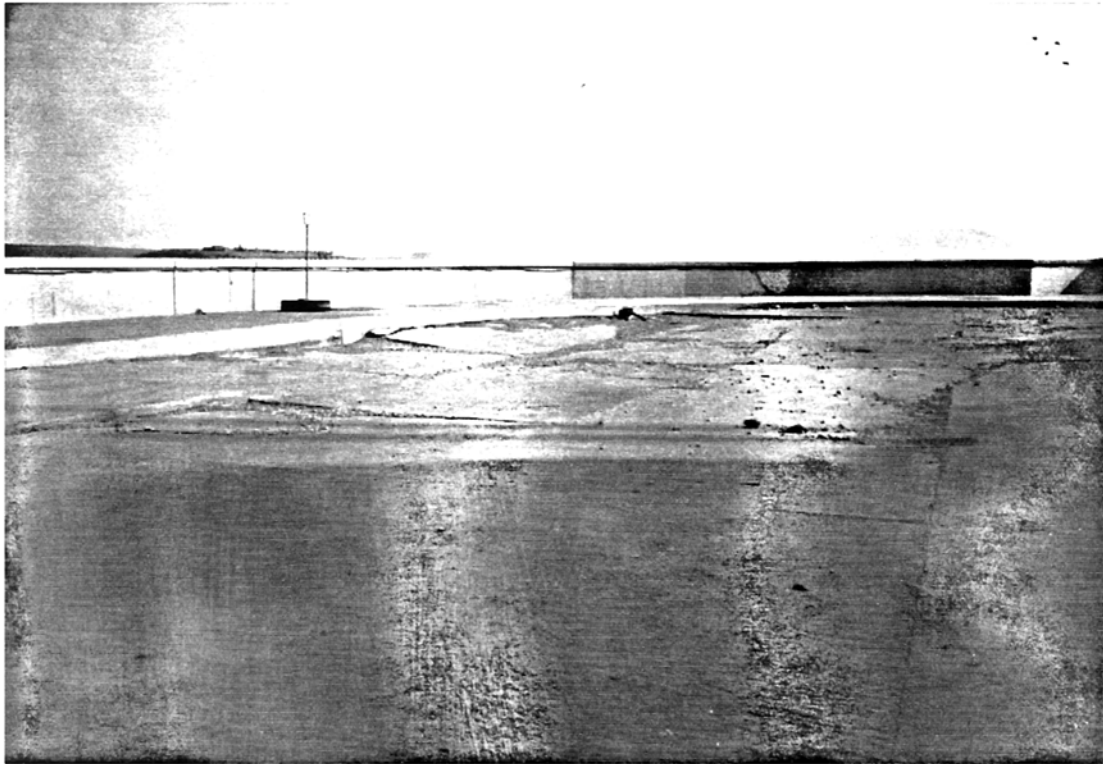
Picture 5.9 Sefid-rud Dam, Manjil
Subsidence of the fill at the west end adjoining
the concrete section of the dam

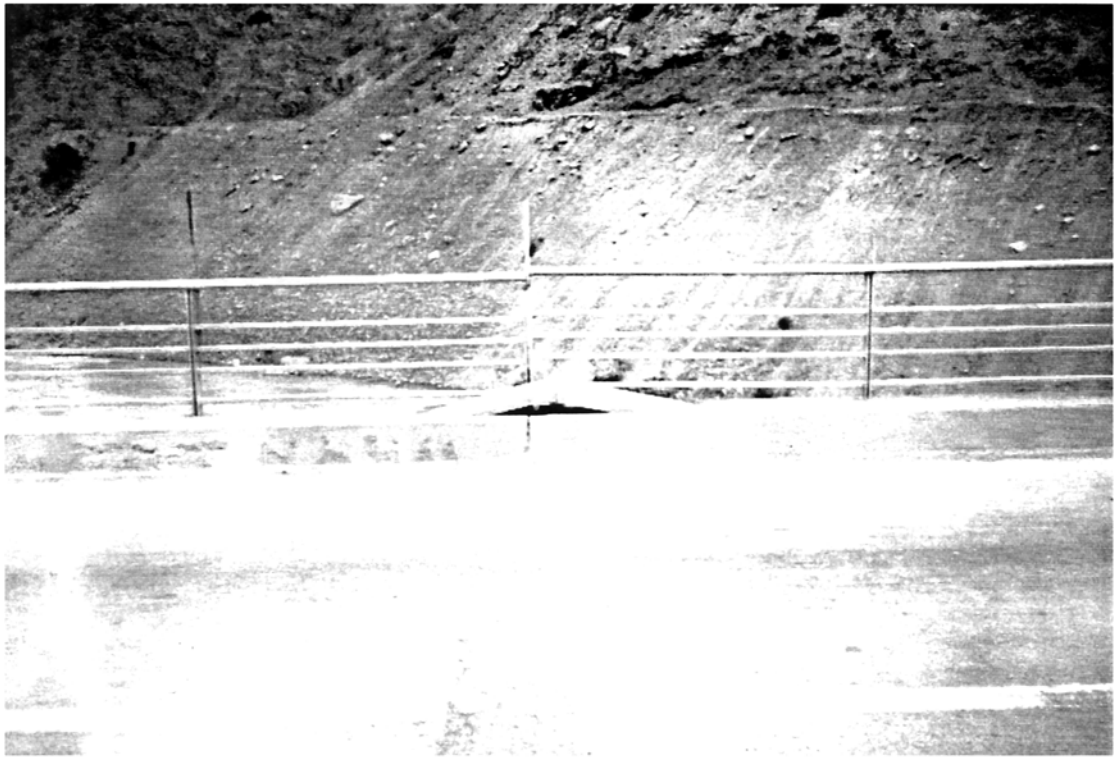
Picture 5.17 Concrete Bridge, Rudbar
Pounding failure at deck joints

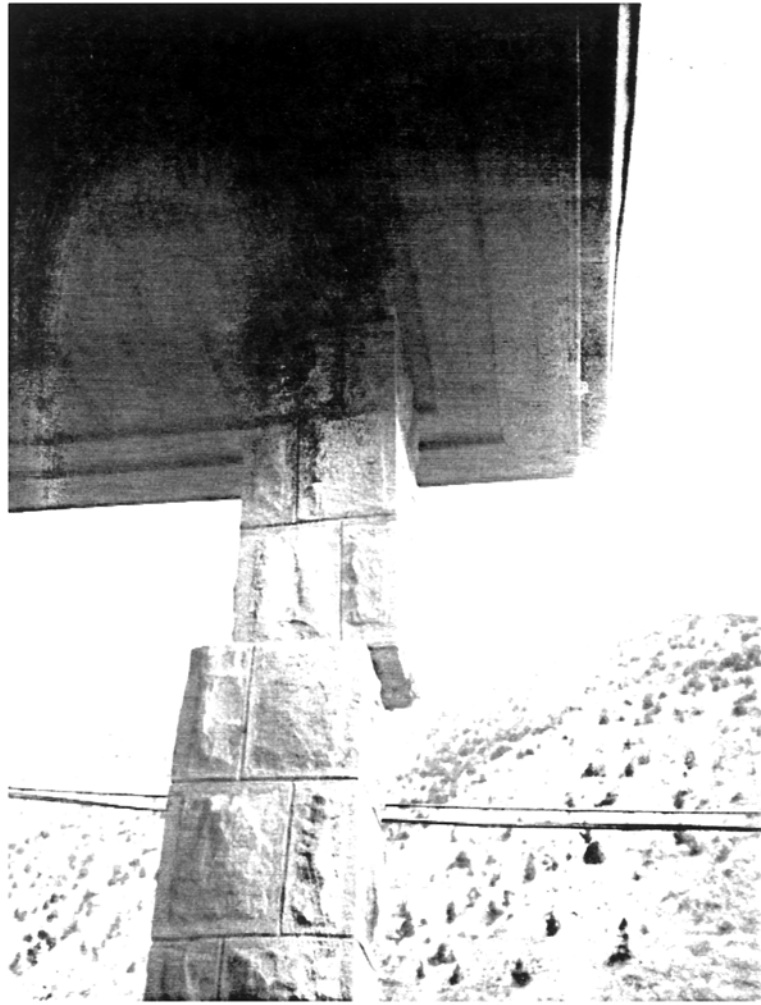
Picture 5.19 Concrete Bridge, Rudbar
Shear displacement at the masonry column of bridge guard house

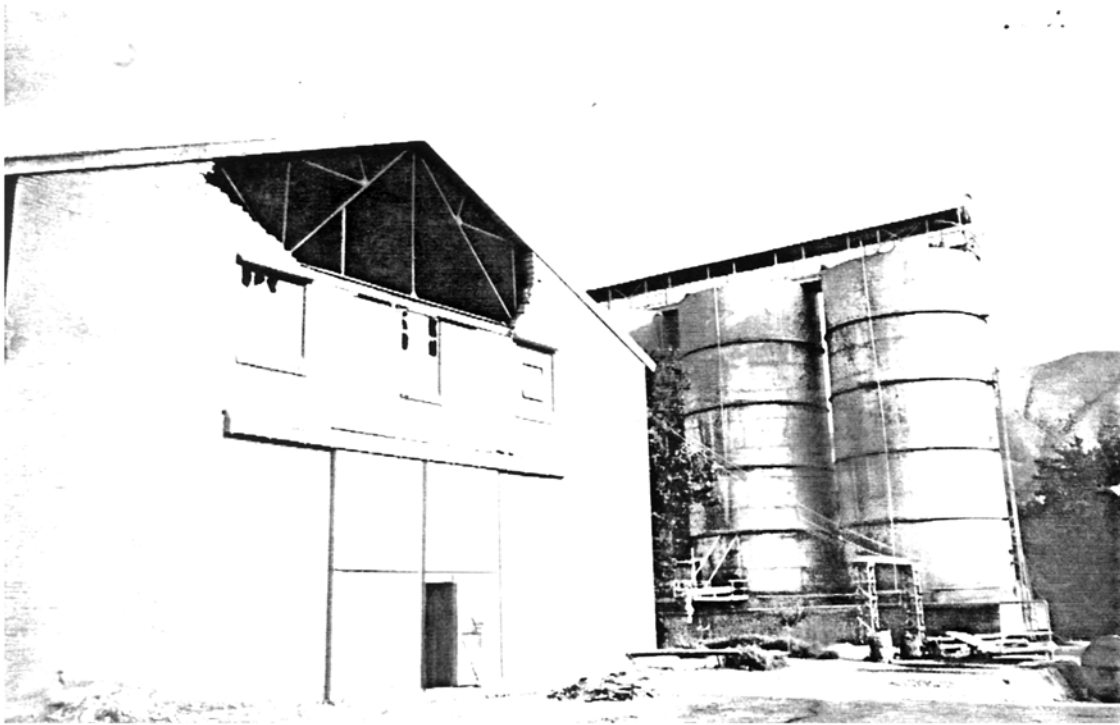
Picture 5.23 300-Tonne Cement Factory, Lushan
Collapse of un-reinforced brick masonry walls, typical damage to many of factory buildings and offices

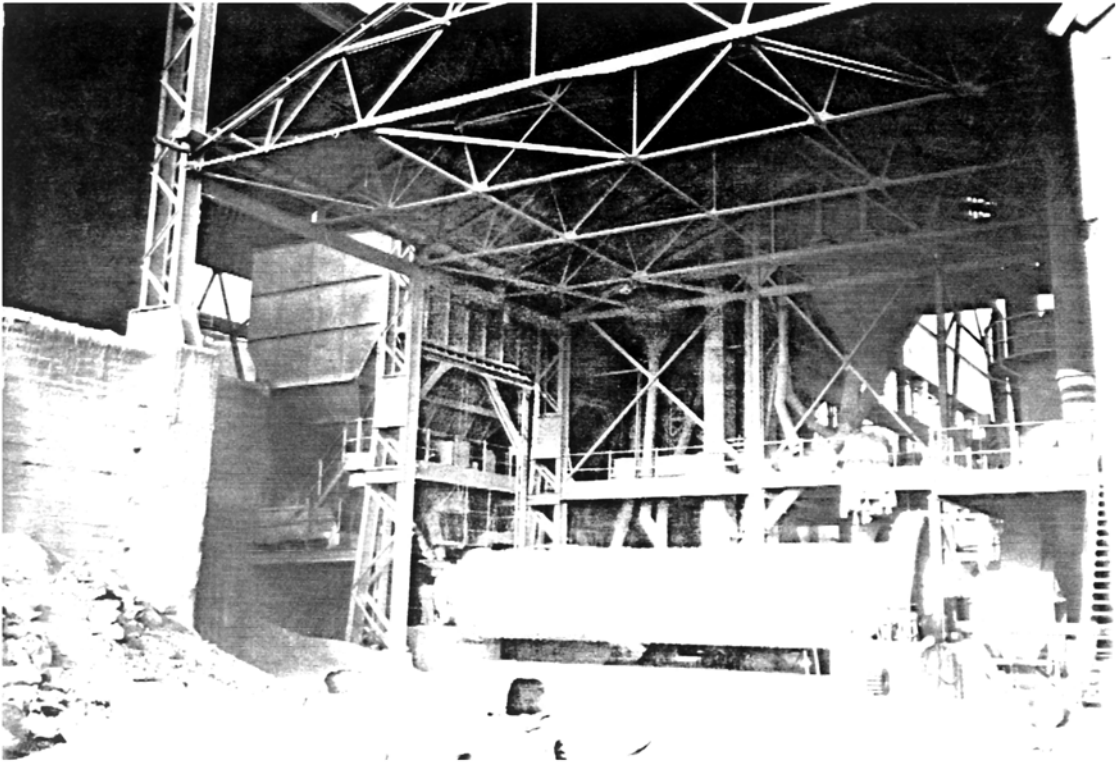
Picture 5.25 300-Tonne Cement Factory, Lushan
Damage to one of the grinders

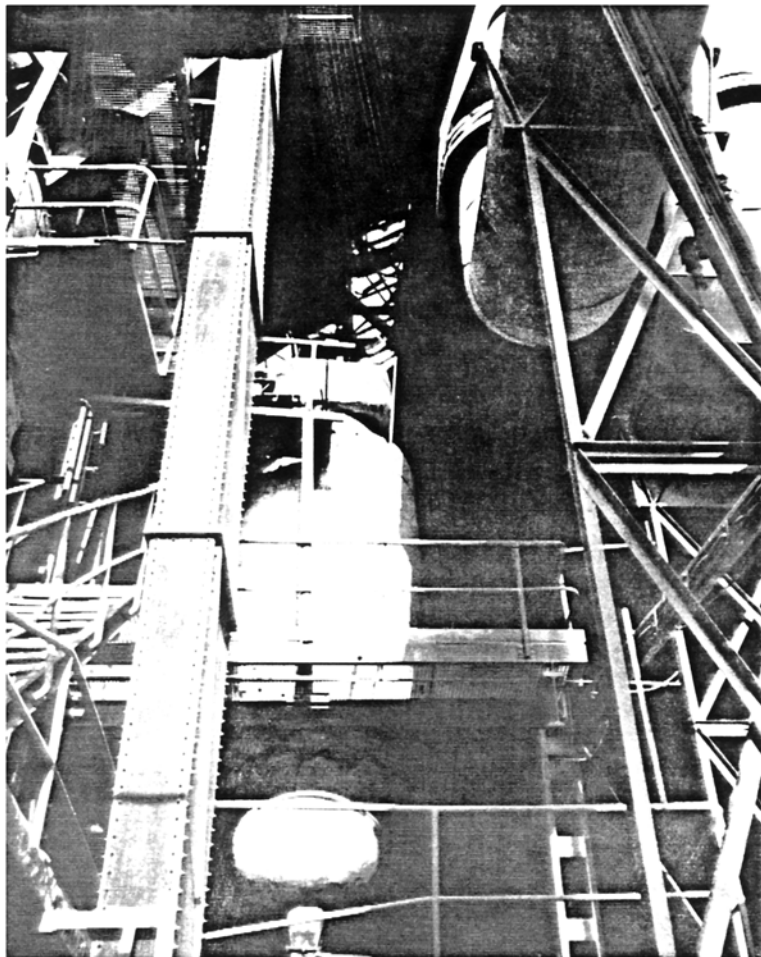
Picture 5.26 300-Tonne Cement Factory, Lushan
Damage to the roof and instalations

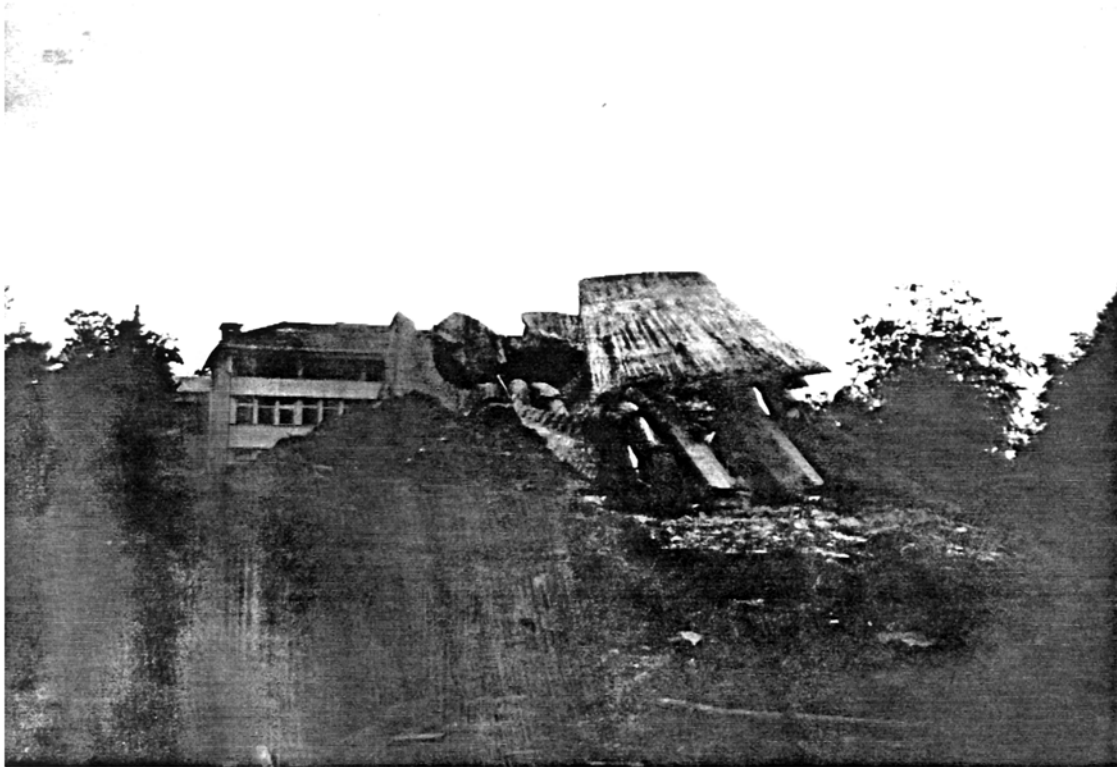
Picture 5.27 Concrete Water Tower No. 1, Rasht
Complete collapse of the tower due to the
bending failure in the shaft

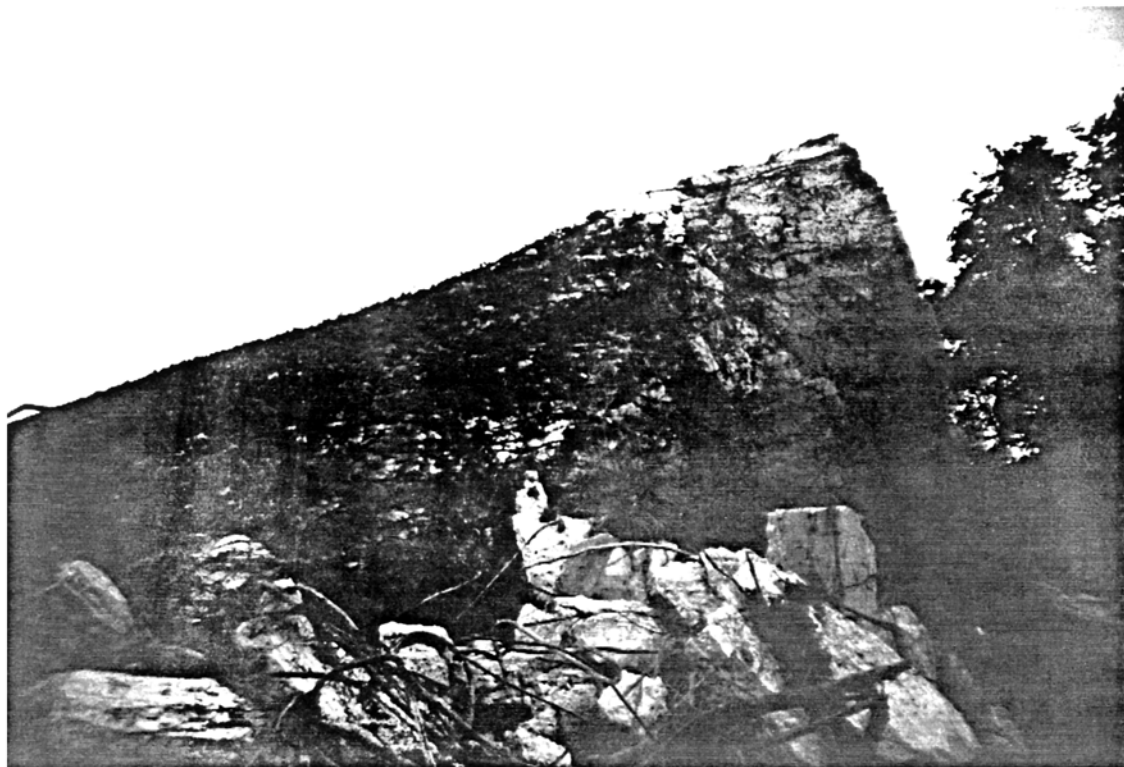
Picture 5.28 Concrete Water Tower No. 1, Rasht
Explosive compressive failure of concrete at the
lower section of the shaft during collapse

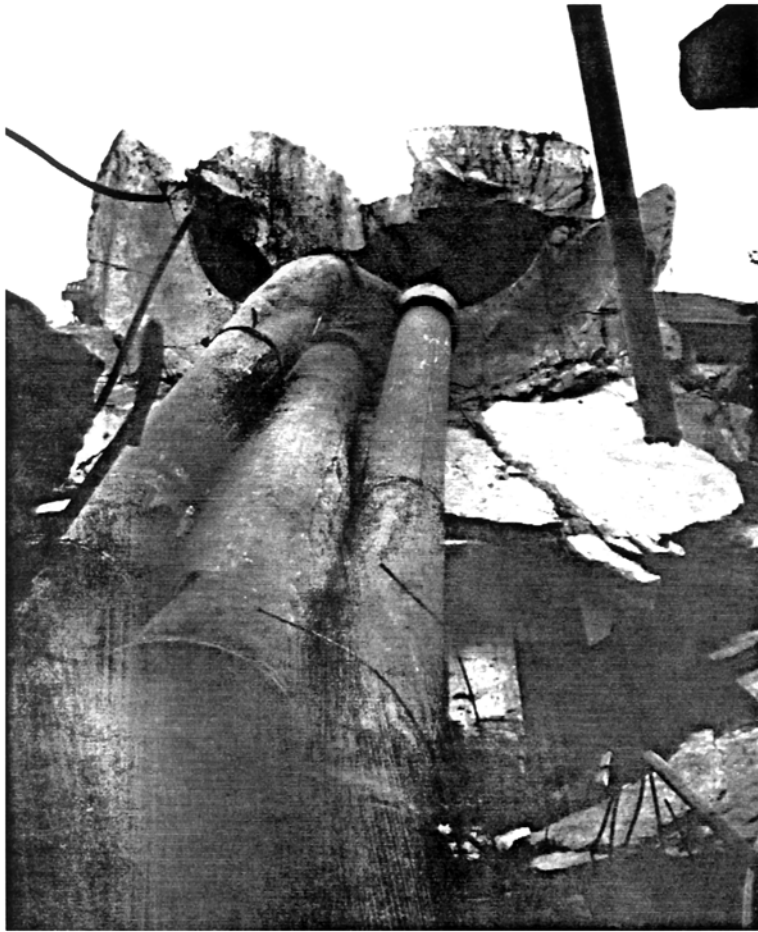
Picture 5.29 Concrete Water Tower No. 1, Rasht
Destruction of the shaft on impact

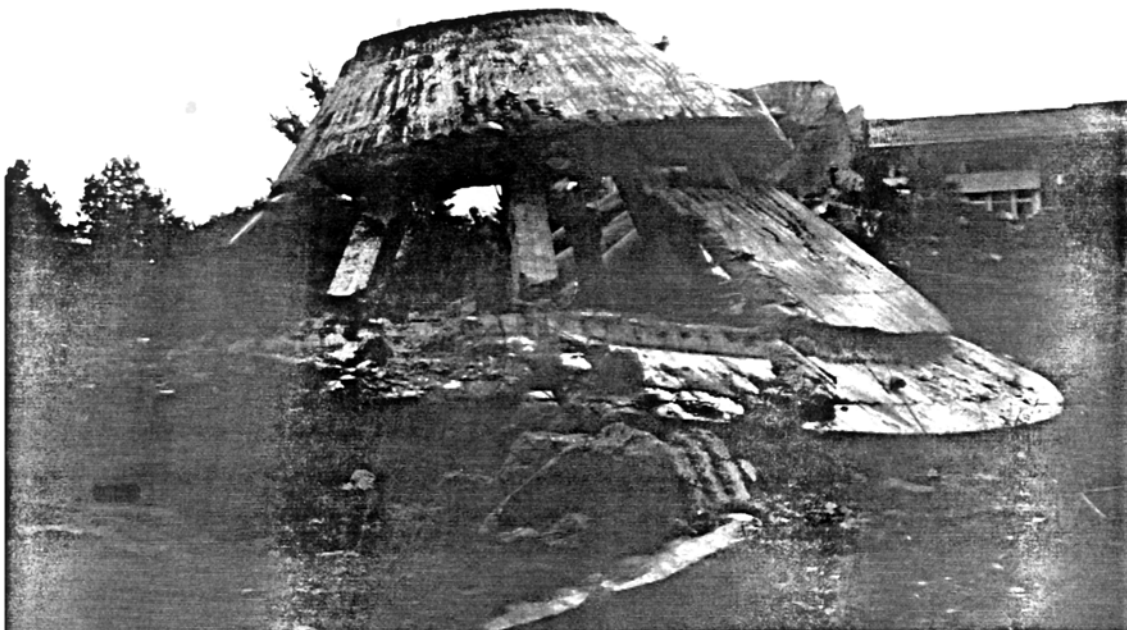
Picture 5.30 Concrete Water Tower No. 1, Rasht
Secondary bending and buckling failure of tank columns due to impact

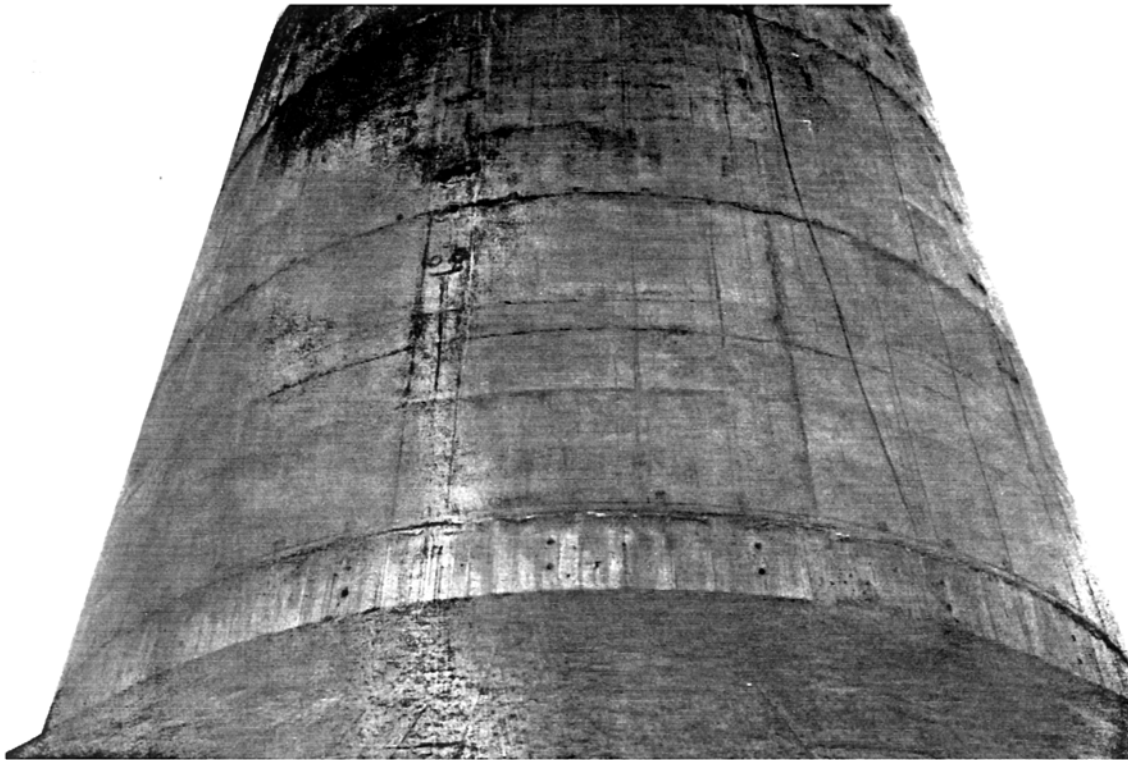
Bending failure in the form of horizontal cracks could be seen all around the circumference of the shaft (Picture 5.33). The level of this continuous ring-crack varied at different sections of the shaft's circumference between 1.45m and 2.25m above the base of the shaft (Picture 5.34). The adjoining horizontal cracks running at different levels were joined together by short vertical cracks. One exception to this cracking pattern was an inclined form at the staircase (The reinforcement arrangement in the shaft adjacent to the staircase accounts for this). As already

Picture 5.33 Concrete Water Tower No. 3, Rasht
Horizontal bending crack in the shaft coincides with the construction joint between the foundation and the shaft

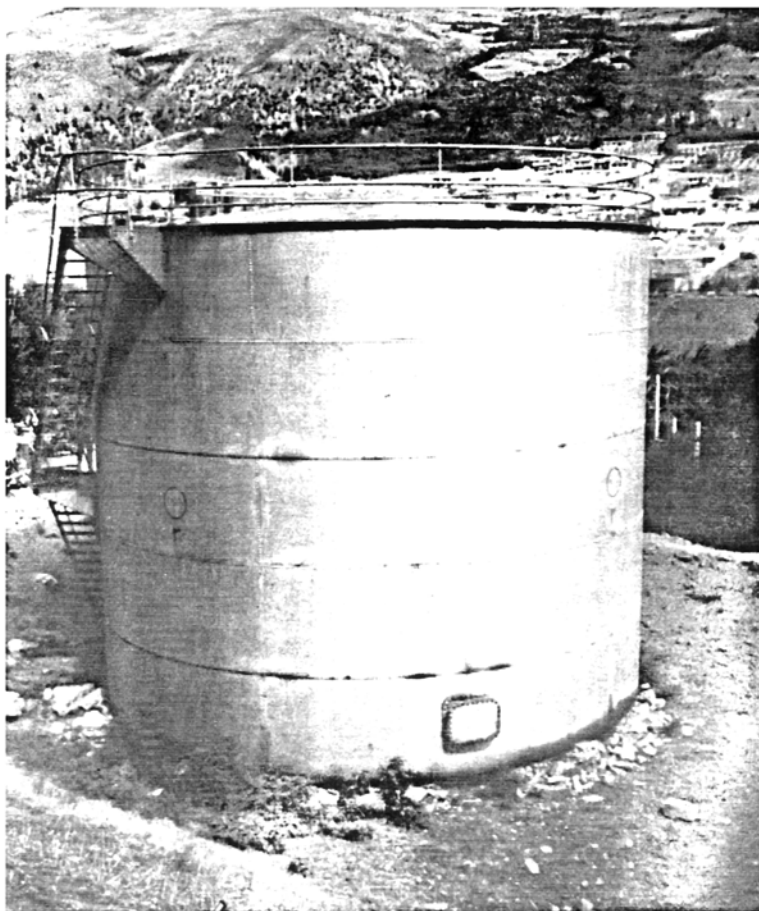
Picture 5.36 Petrol tank No. 3, Rudbar
Steel tank survived the quake but the brick footing did not

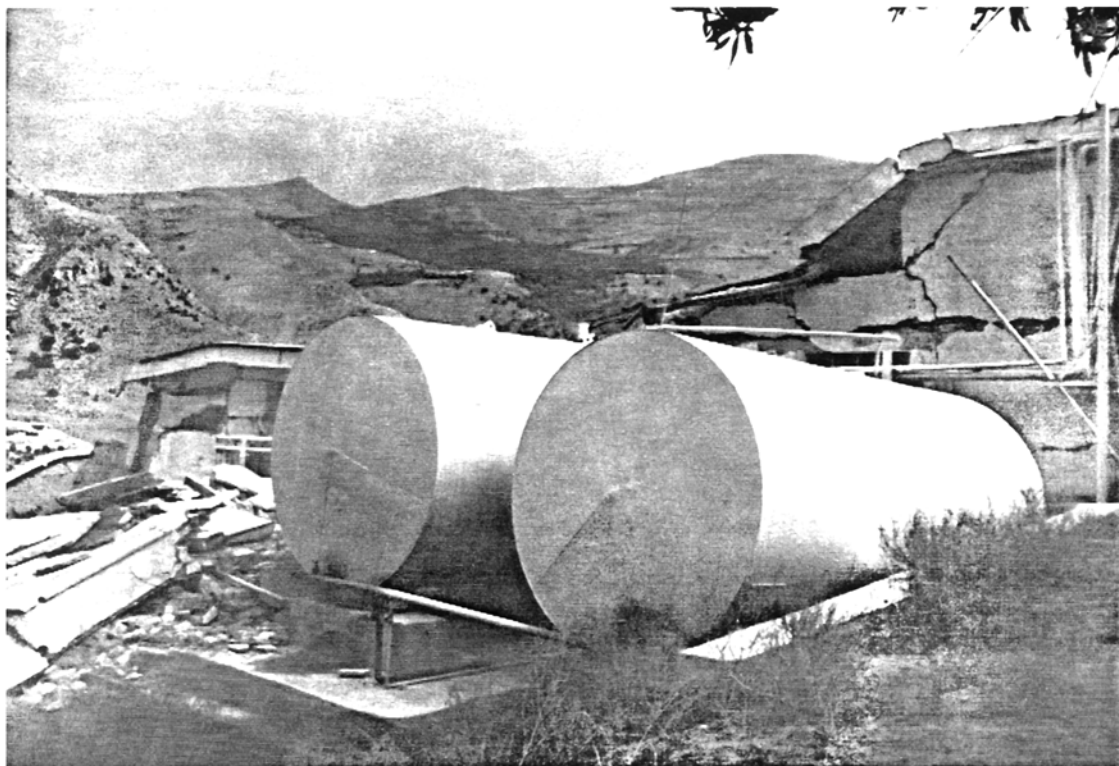
Picture 5.38 Vali-asr Hospital, Rudbar
Collapse of liquid storage tanks due to support failure
