**THE NORTHRIDGE, CALIFORNIA EARTHQUAKE
OF 17 JANUARY 1994**

A FIELD REPORT BY EEFIT

1. INTRODUCTION

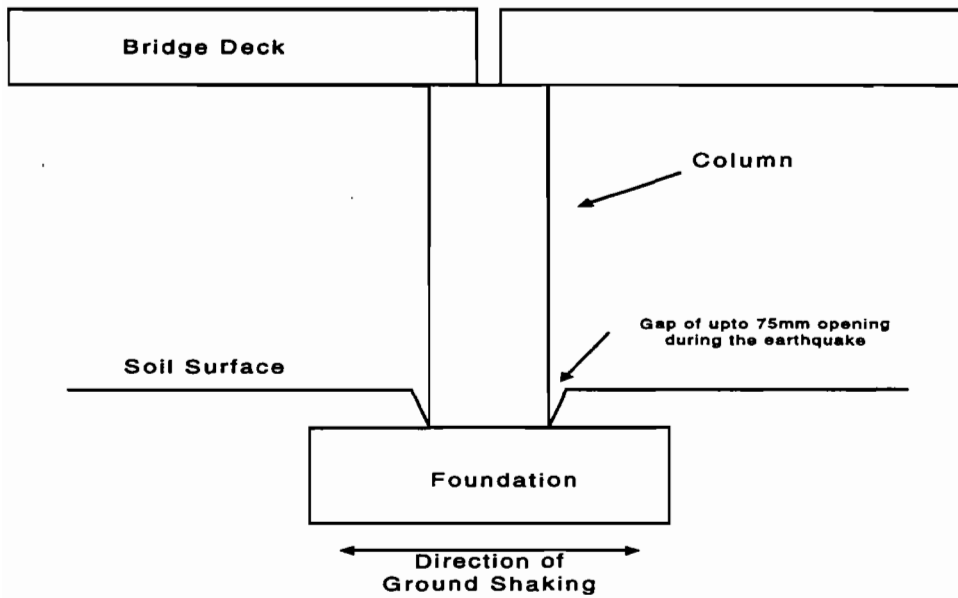
Figure 3.1: Schematic Diagram of Gaps Opening at the Base of the Column

Some of the failures which resulted from the earthquake can be understood more completely by considering the soil-structure interaction effects. One of the examples for this is the failure of columns supporting a bridge on State Highway 118. One half of the structure collapsed completely and the columns supporting the other half of the bridge suffered severe compression/shear failure with reinforcement popping out of concrete cover. The sag in the bridge deck was more than that accounted for by the failure of columns, indicating a foundation settlement (see Chapter 5). This failure may be understood by considering the deck-column-foundation interaction under large vertical and horizontal accelerations caused by the earthquake. Some of the columns supporting the Santa Monica Freeway have shown cracks up to 200mm deep in the soil adjacent to the columns (see Fig. 3.1). The dynamic behaviour of such a column-foundation system depends strongly on the stiffness of the soil surrounding the column and the foundation compliance (Lee, 1994). Also some of the bridge abutments have suffered rotation under the dynamic earth pressure caused by the earthquake.

The elevated outlet pipeline supported on columns on the downstream side of the Upper San Fernando Dam (Plate 3.5) is another example which deconstructed the interaction effects. During the present earthquake the pipeline-column-foundation system functioned as a single unit until the columns rotated

and the fixings securing the pipe to the column failed (Plate 3.6). Wide gaps opened in the soil adjacent to the base of the column.

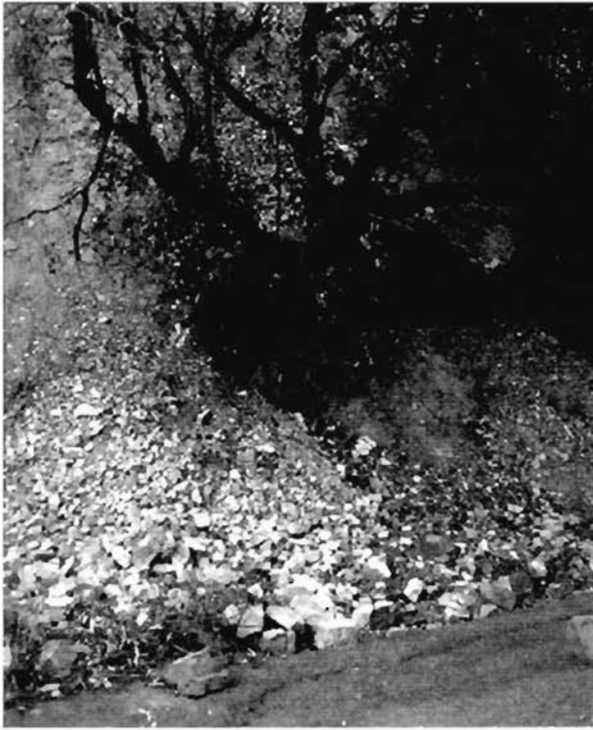
Several land slides were reported in the earthquake affected districts. The most spectacular of the land slides occurred on the Pacific Coast Highway north of Venice Beach. The extent of the land slide was about 400m in width and about 45m in height running in the N-S direction. A residential building at the lip of the slide failed during this earthquake with its roof coming down the slope (Plate 3.1). The foundation piles of several buildings in this location were exposed after the slide (Plate 3.2). On the northern side of the slope a horizontal layer of wetting was observed at about the mid height of the slide (Plate 3.3). This may be due to the breakage of a water main up the slope which resulted in the wetting of the slope plane and initiated the slope failure. Another major land slide was observed along the Canyon Boulevard in the Hollywood district. Less significant land slides comprising of small boulders and foliage were observed near the Upper Hollywood Dam site (Plate 3.4).

Plate 3.4: Land slide near the Hollywood Dam; the extent of the land slide was camouflaged by the foliage at the site

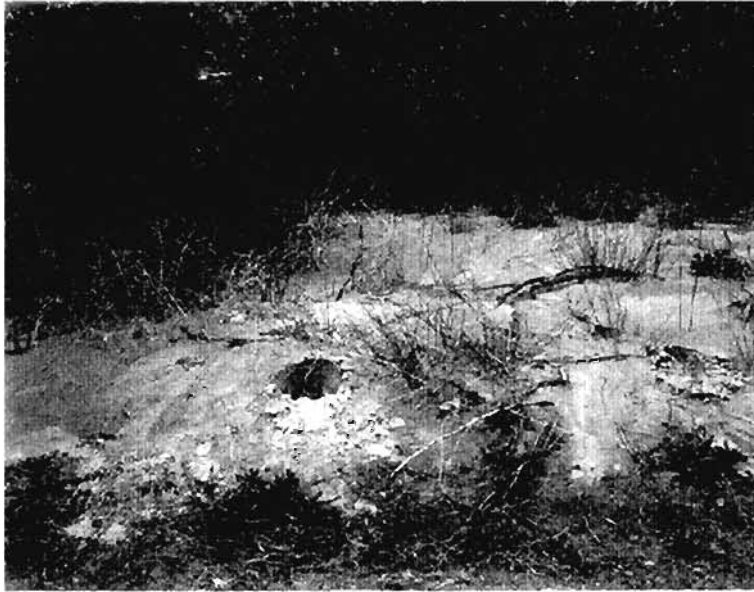
Severe sand boils were observed during the present earthquake on the upstream side of the Lower San Fernando Dam (Plate 3.7). The soil flow in the largest sand boil was measured to be 5 cubic metres in volume. The loose sandy soils in this region also liquefied in the 1971 earthquake (Seed et al, 1975). The shallow water table due to the presence of a small lake in the vicinity and predominantly sandy nature of the soil resulted in the generation of excess pore pressures during the earthquake causing these sand boils. Several sand boils were observed in the Redondo Beach area along the Pacific coast with soil flows occurring up to several hours after the earthquake. A major sand boil was observed in the Los Angeles Port area.

Plate 3.7: Large sand boil in the Los Angeles Dam complex; plate shows the extent of the sand boil

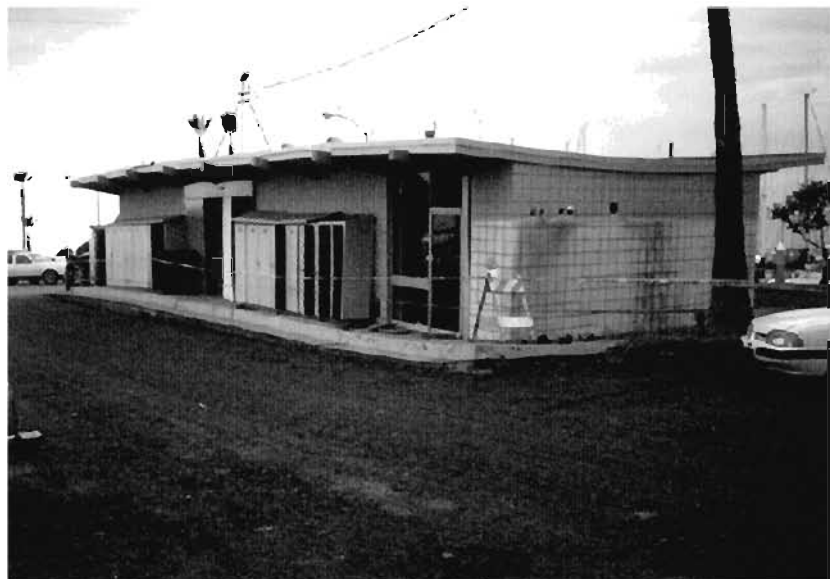
Plate 3.12: Structural damage due to subsidence following liquefaction; plate shows left hand side of building higher than right

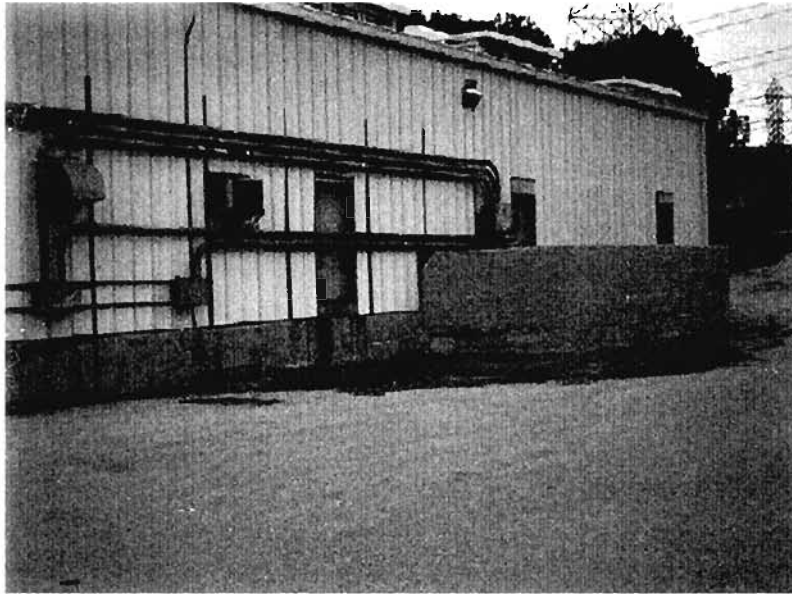
The pump house near the north dike of the Los Angeles reservoir suffered severe liquefaction failure. There was extensive cracking of the building due to ground subsidence which measured up to 350mm (Plate 3.13). A minor dam in this area failed during the earthquake. Also, the filter beds of Jensen water plant in the vicinity suffered some settlement and cracking.

Plate 3.13: Subsidence following liquefaction adjacent to a pump house in the Los Angeles Dam complex; a minor dam near this site failed following the earthquake

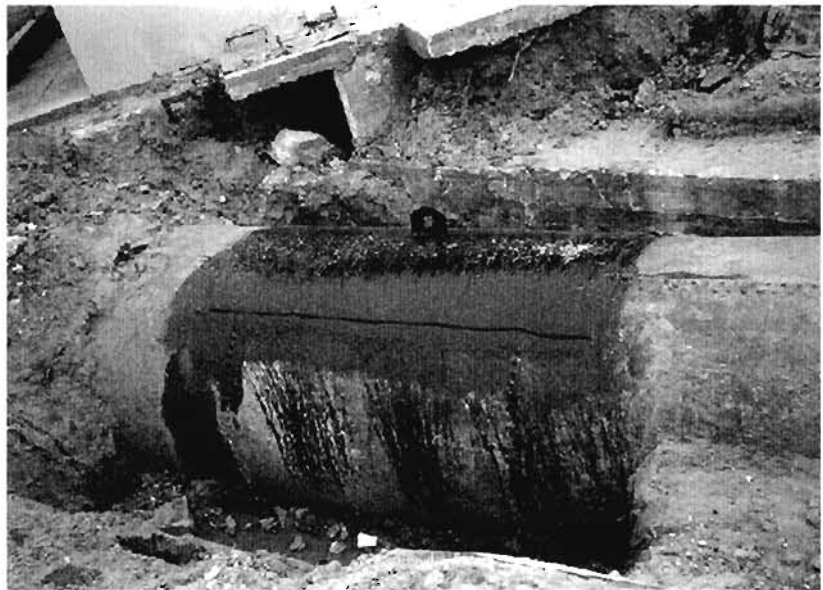
Large ground movements and extensive cracking resulted in severe damage to the pipelines. The most significant of these was the damage to the outlet pipe from the Los Angeles reservoir (Plate 3.14). The erosion resulting from the pipe breakage removed the traces of ground cracking but the cracks in the foundation of the pump house indicated the ground movement (Plate 3.15). The ground movement across Balboa Boulevard resulted in the upward buckling of the lifelines (Plate 3.16). This is further confirmed by the upward movement of up to 225mm of the pavement blocks (Plate 3.17).

Plate 3.14: Breakage of main outlet pipe of Los Angeles Dam; plate shows recent repairs to the pipe following the earthquake

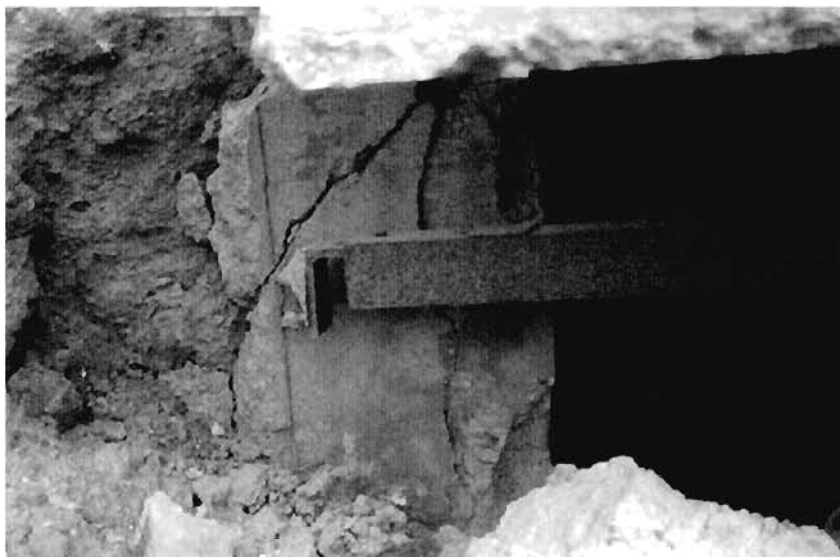
Plate 3.15: Ground movement causing failure of outlet pipe is confirmed by failure of foundation block of nearby pump house

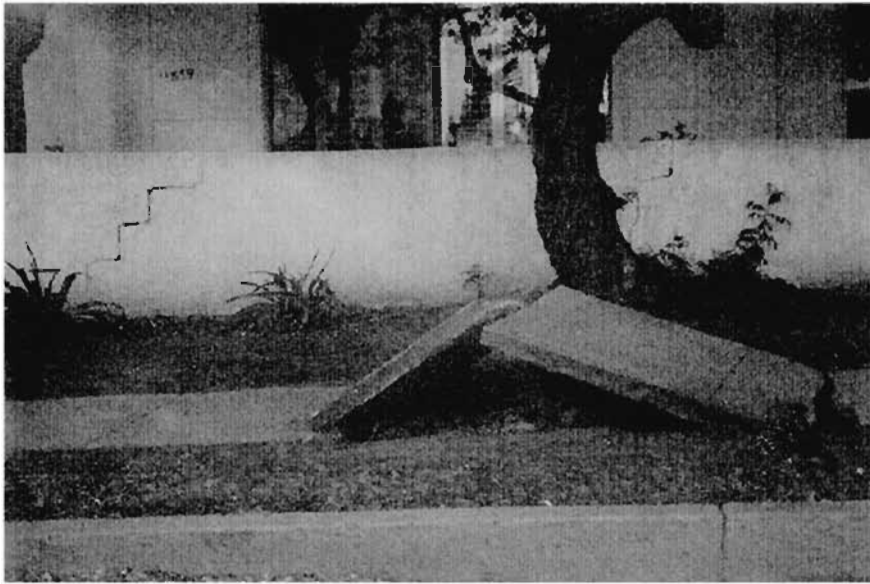
Plate 3.17: Dislodged pavement blocks due to ground movement

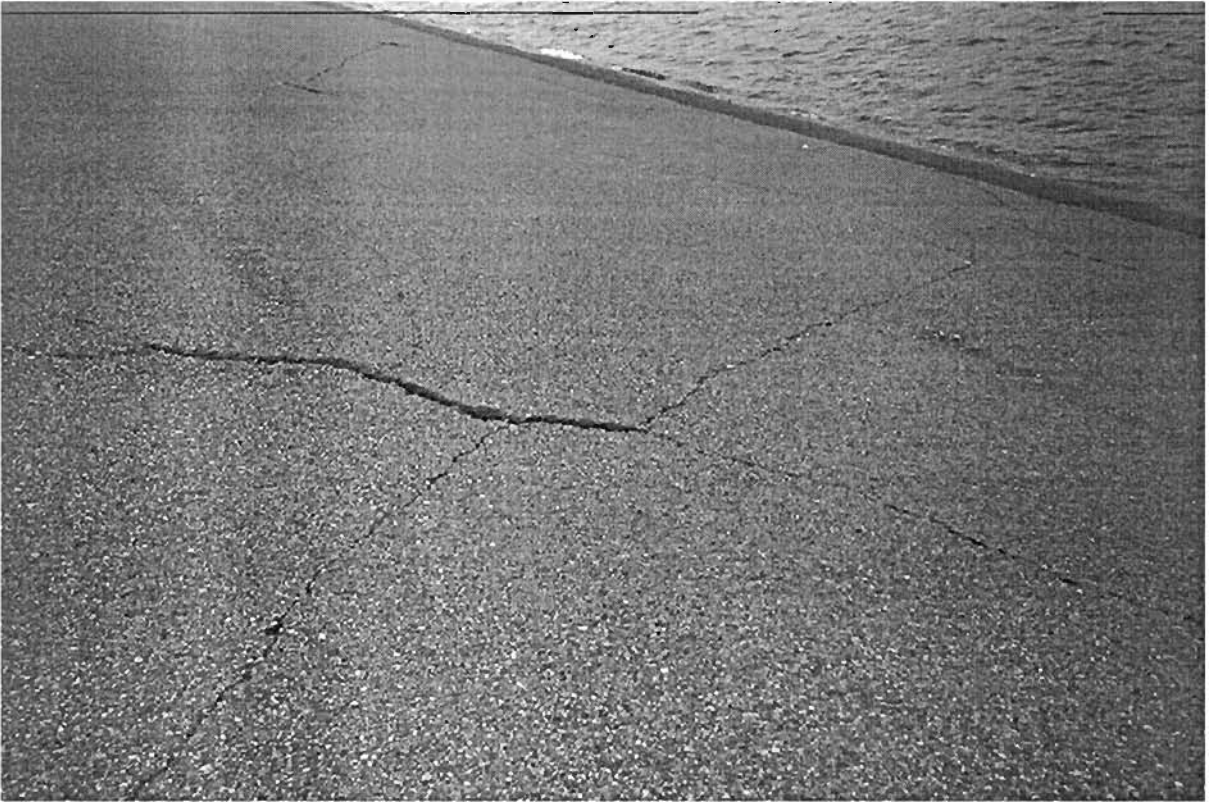
Plate 4.2: Los Angeles Dam - Diagonal Cracks in Asphalt Lining on Upstream Face

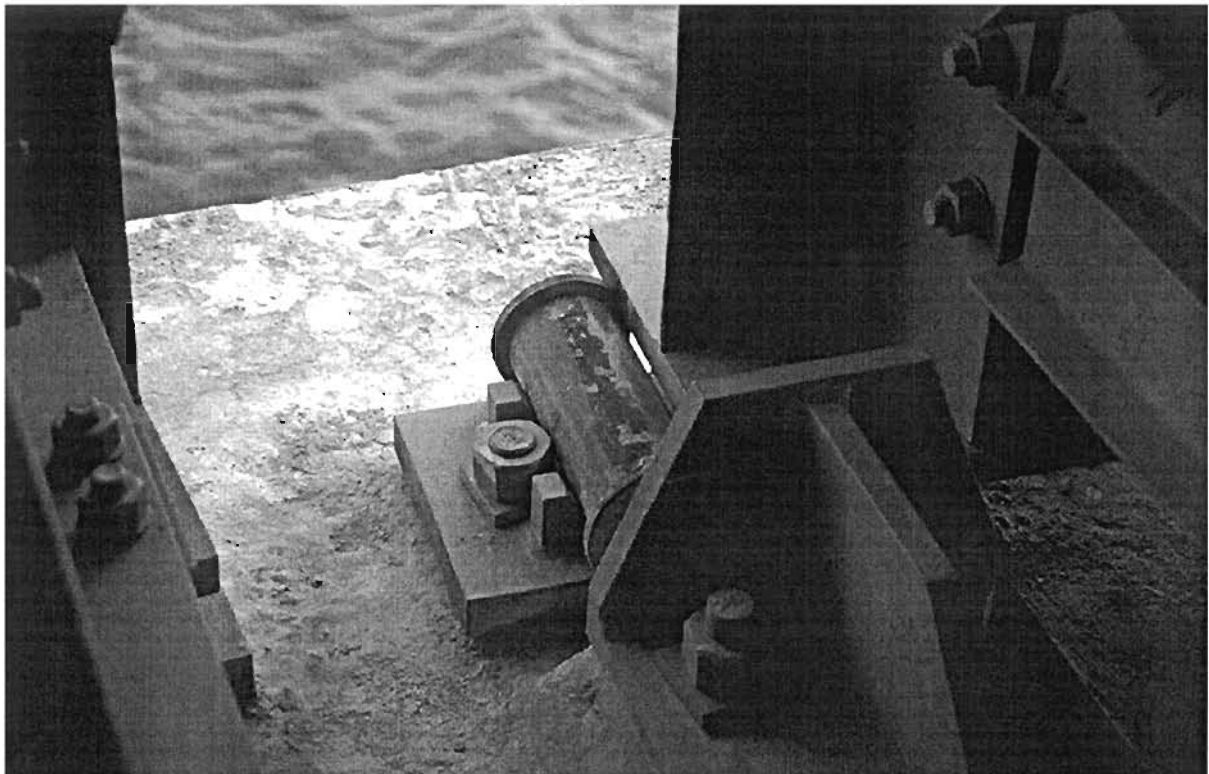
There were two instances of the localised failure of the bearings to intake tower bridges; one at the Los Angeles Reservoir and one at Castaic Lake. These cases indicate that the movement of the towers may have caused the failure in the bridges. Another less serious case of damage to a tower and bridge occurred at the Upper Hollywood reservoir. It is believed that major pipe work and electrical and mechanical plant generally performed well with the exception of a burst in the main outlet pipe from the Los Angeles Reservoir.

Plate 4.9: Castaic Lake - Failed roller bearing

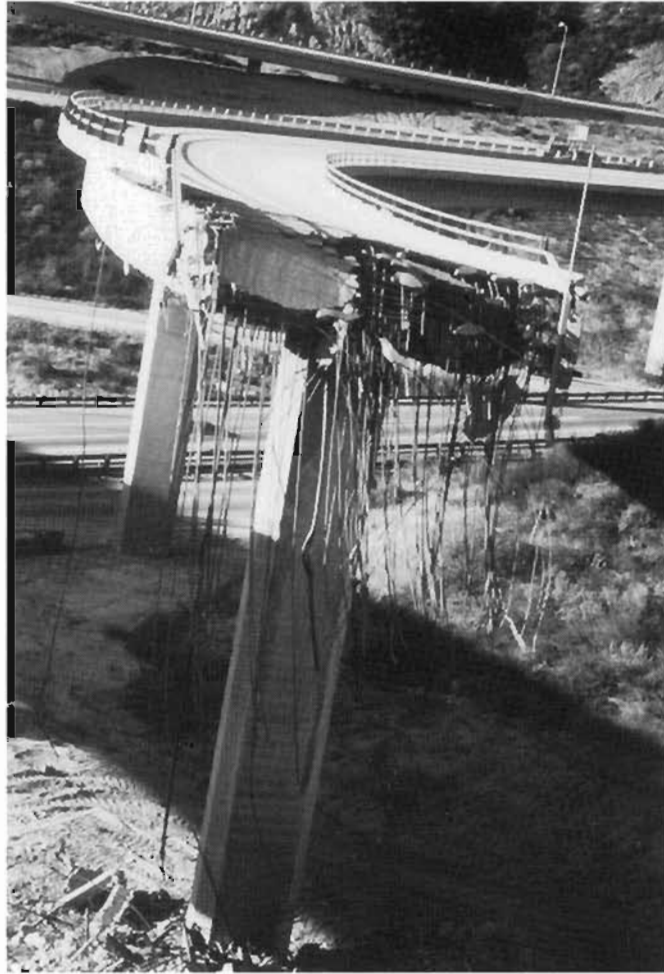
Plate 5.3: W14-N5 connector - bending failure of deck at Bent 3
(initiated by column shear failure elsewhere)

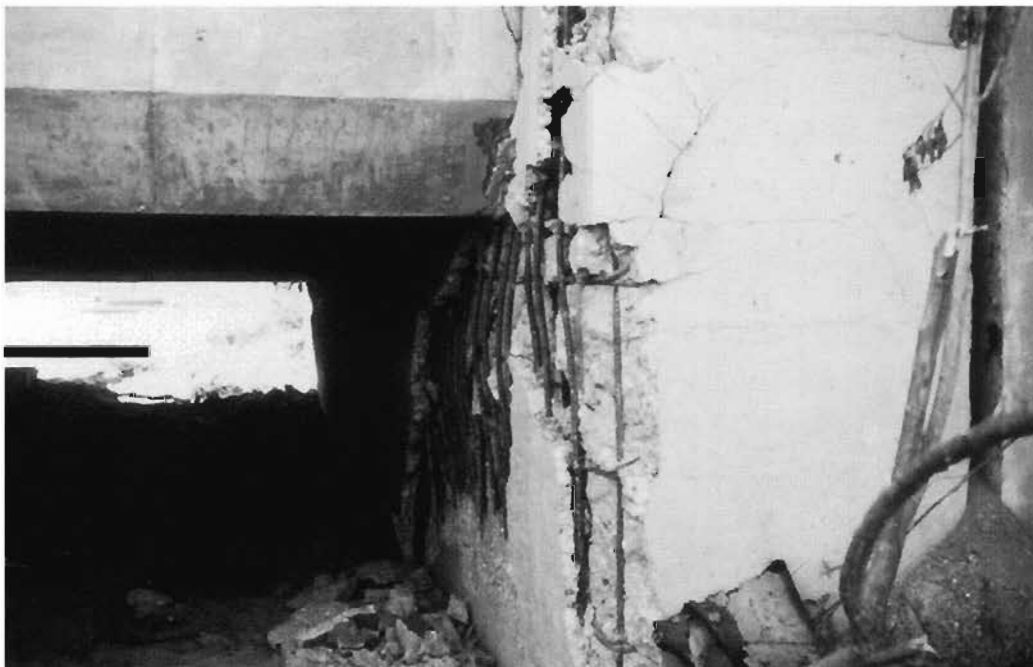
Plate 5.4: S5-E14 connector - damage to abutment wall

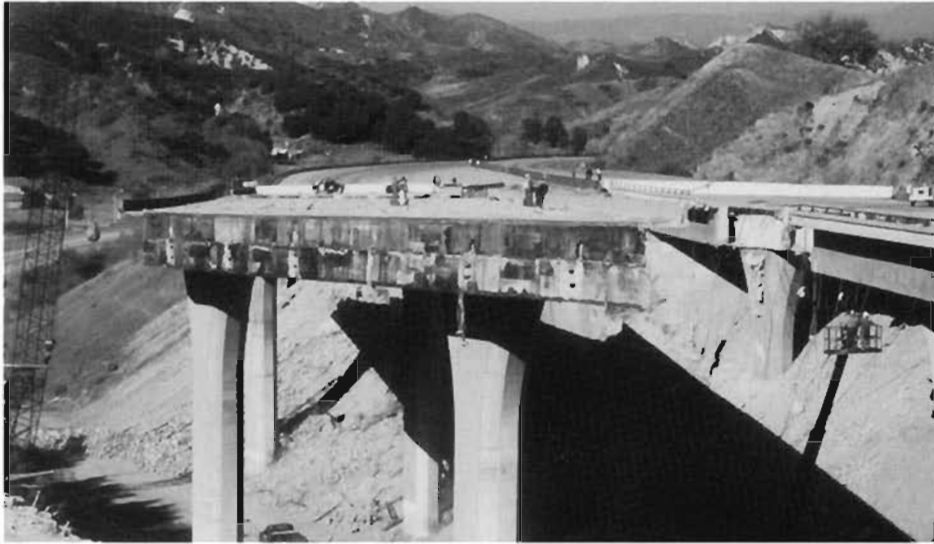
Plate 5.5: Gavin Canyon Bridge - view of intact central span after unseating of side spans

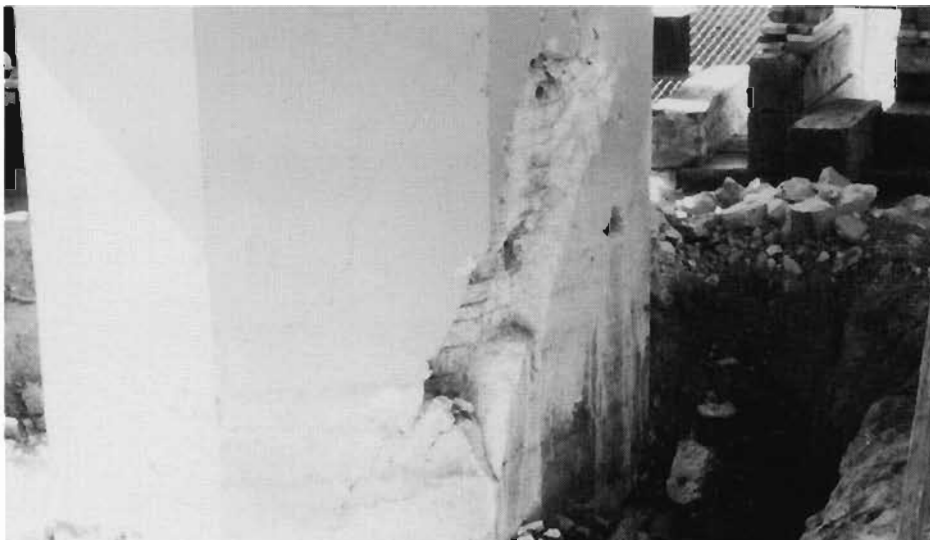
Plate 5.6: I405/H118 interchange - shear damage at base of column

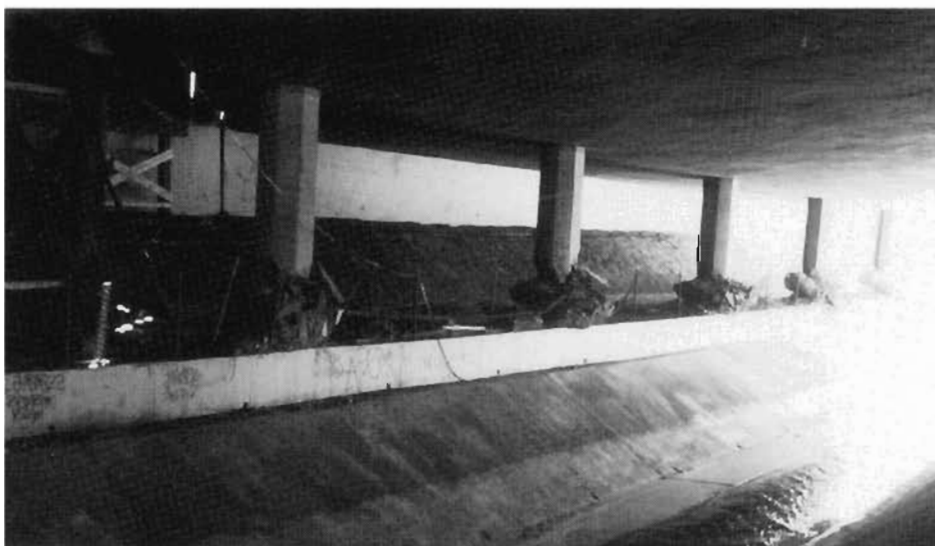
Plate 5.7: Column failures at Bull Creek Canyon bridge

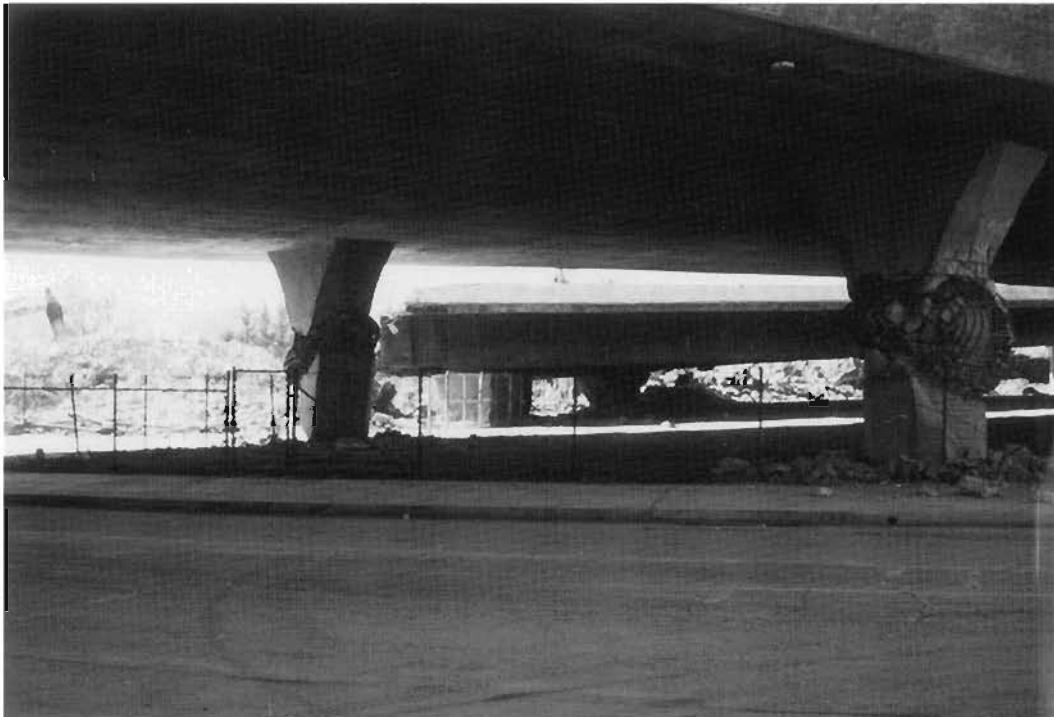
Plate 5.8: H118 at Mission and Gothic - column failures in Bent 3L

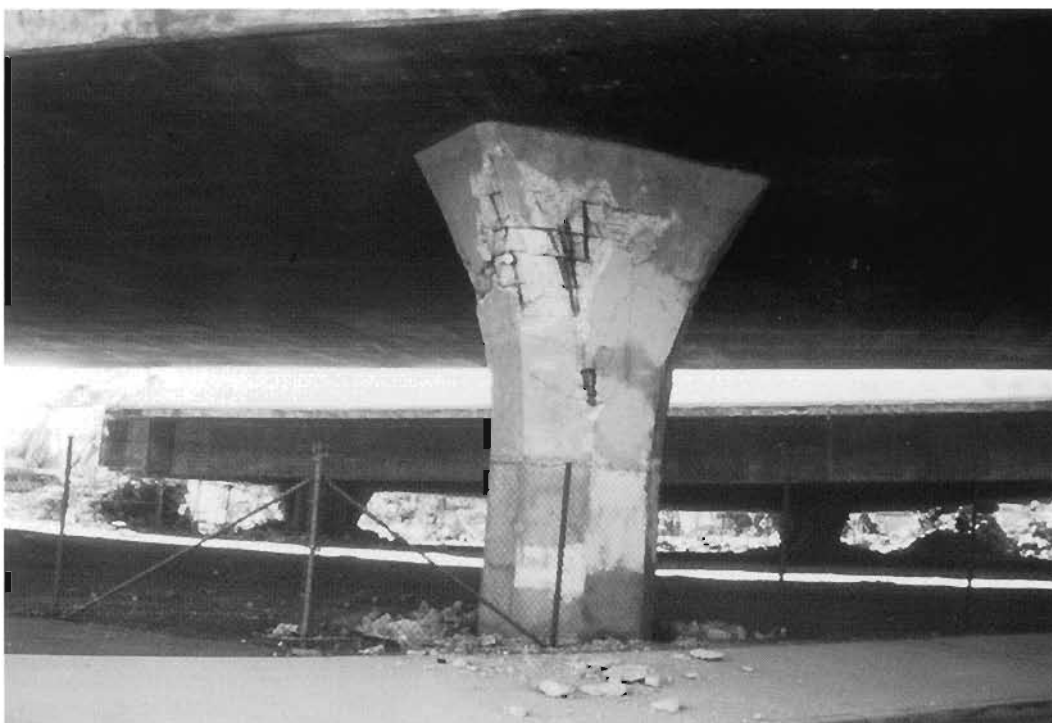
Plate 5.9: H118 at Mission and Gothic - column failures in Bent 2L

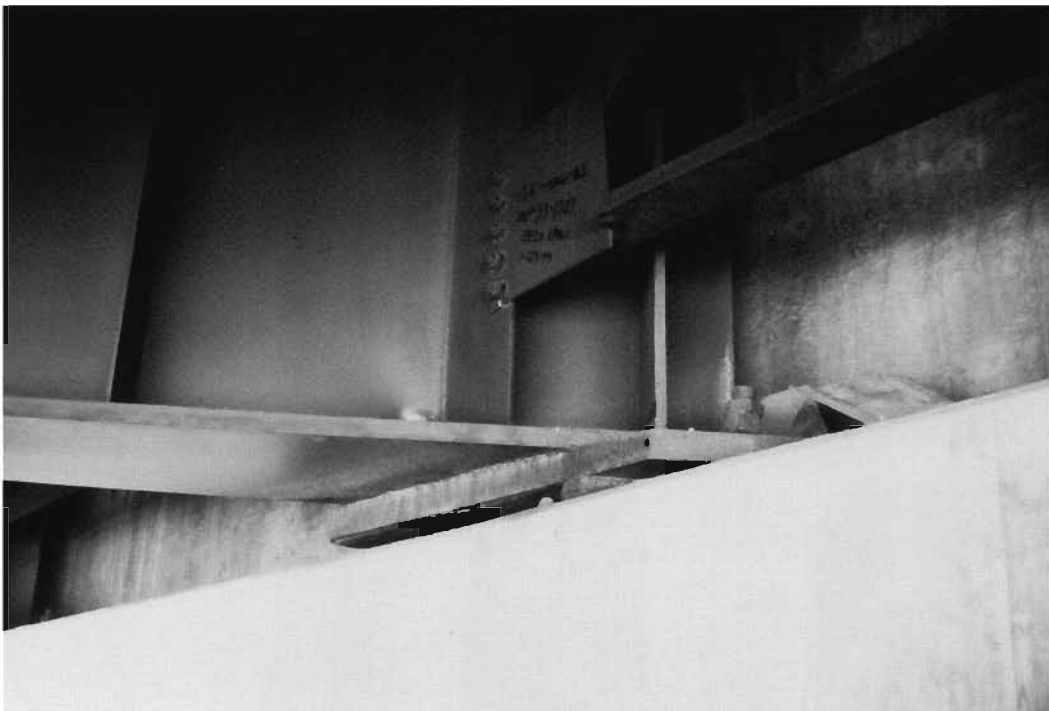
Plate 5.13: Peco Lyons Bridge - tension failure of cross-bracing

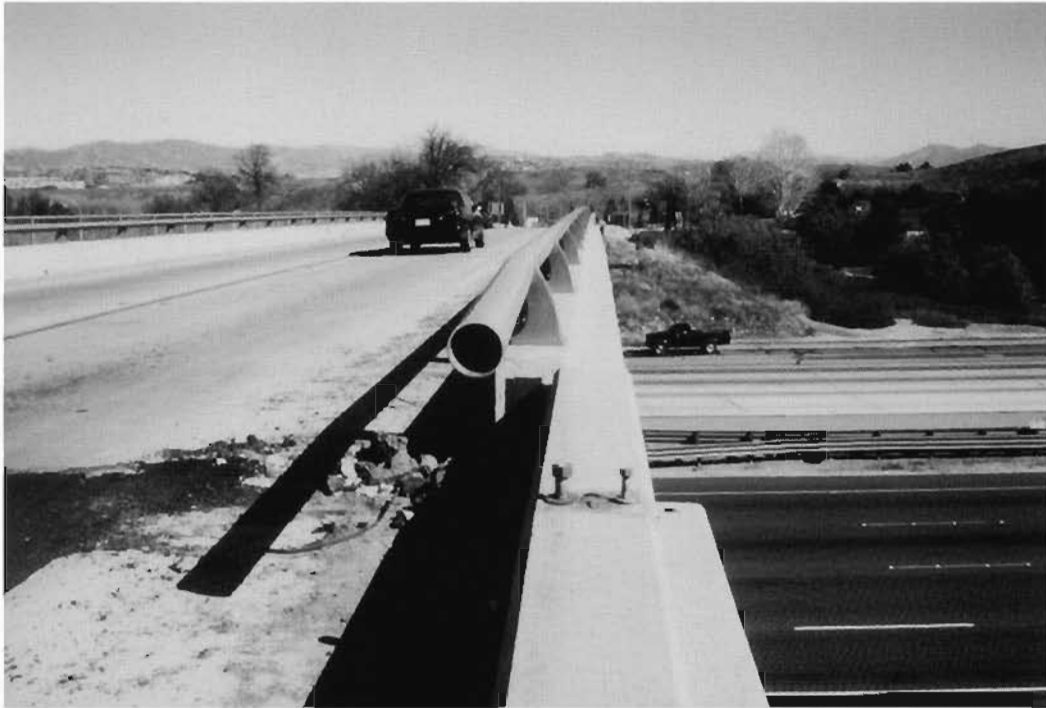
Plate 5.14: Lateral movement of composite bridge over Interstate 5

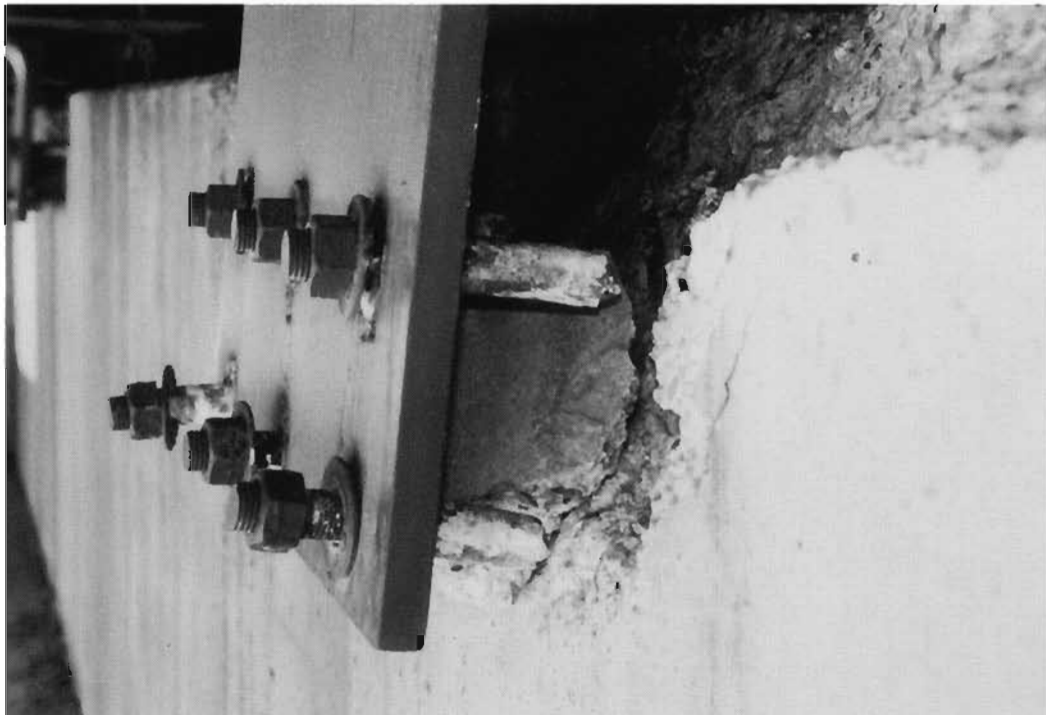
Plate 5.15: Peco Lyons Bridge - failure of retrofitted restrainer plates at abutment

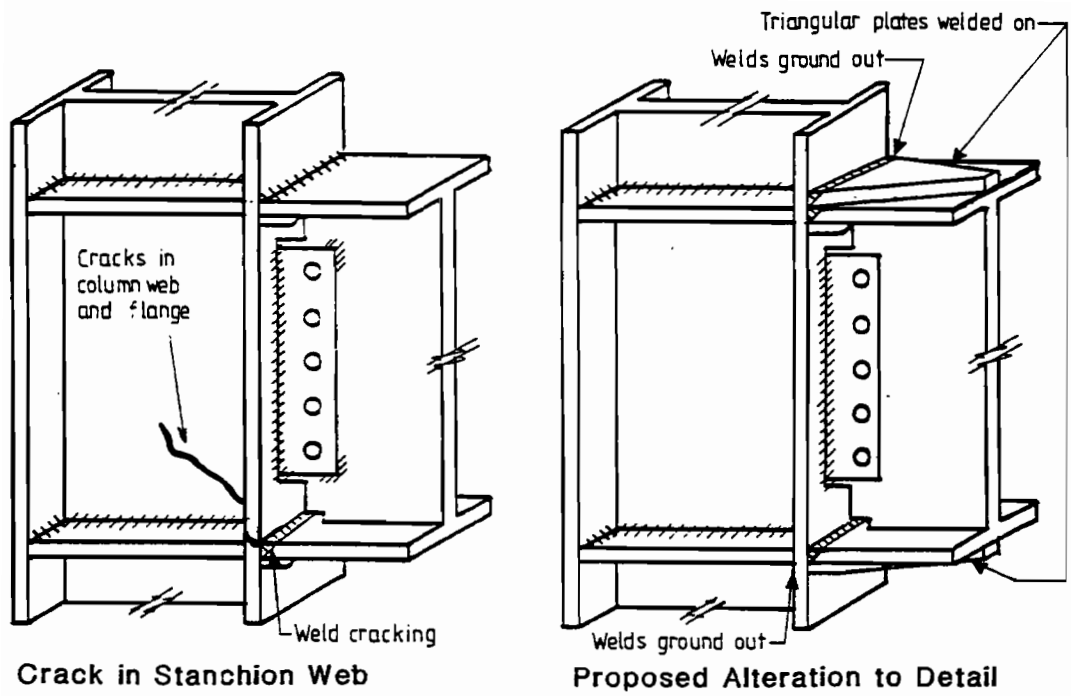
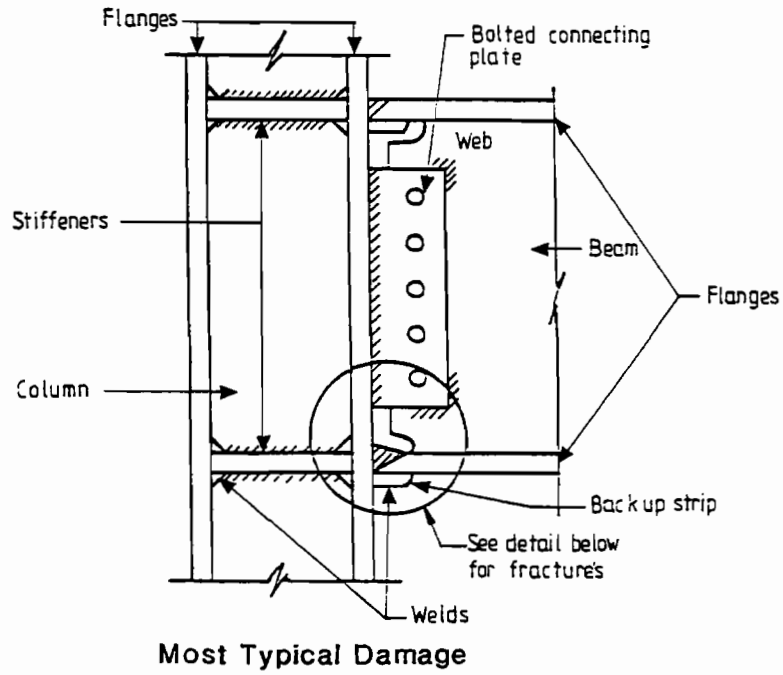
Damage at Lower Flange Connections

**Damage at Column Beam Connections
in Steel Moment-Resisting Frames**

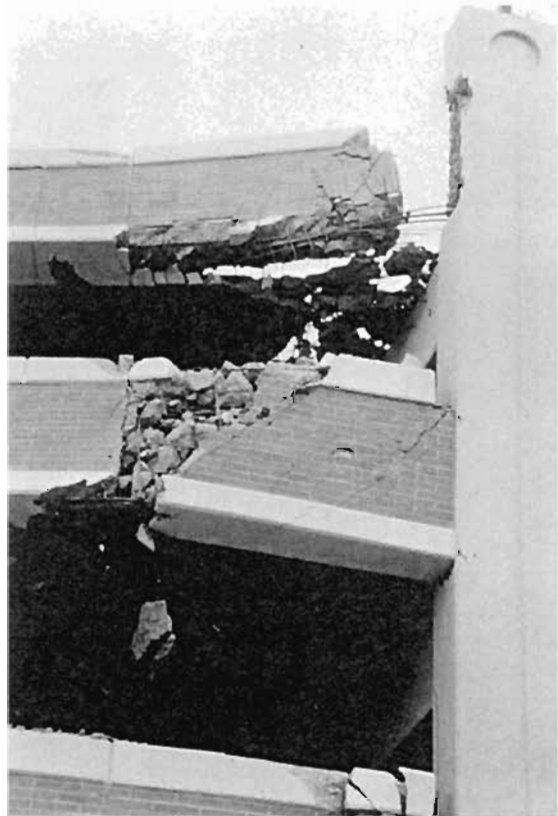
Plate 6.17: In-plane flexural failure of perimeter frame

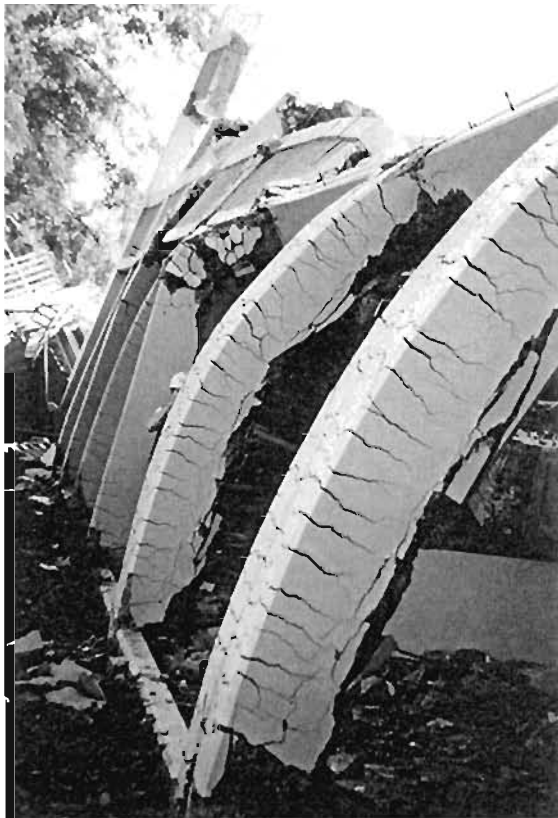
Plate 6.21: Closely spaced flexural cracks almost reaching compression face

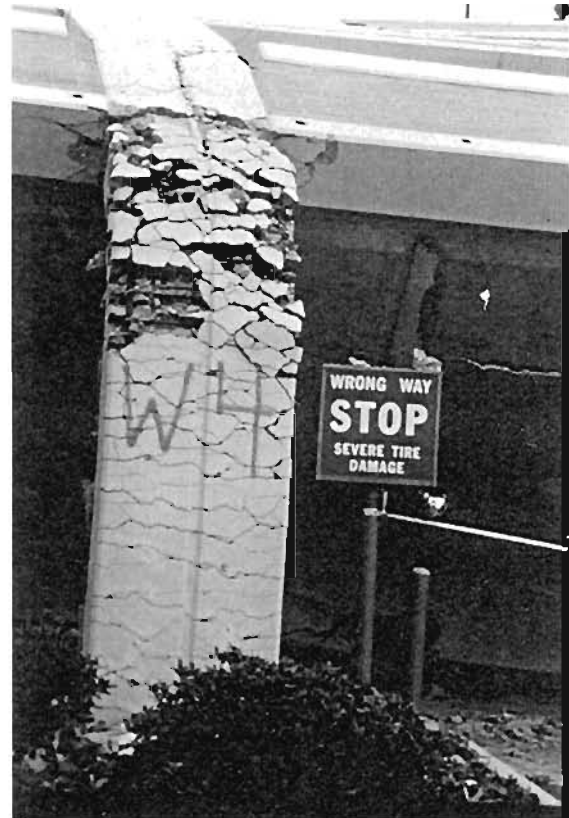
Plate 6.22: Spalling outside the well confined column cage

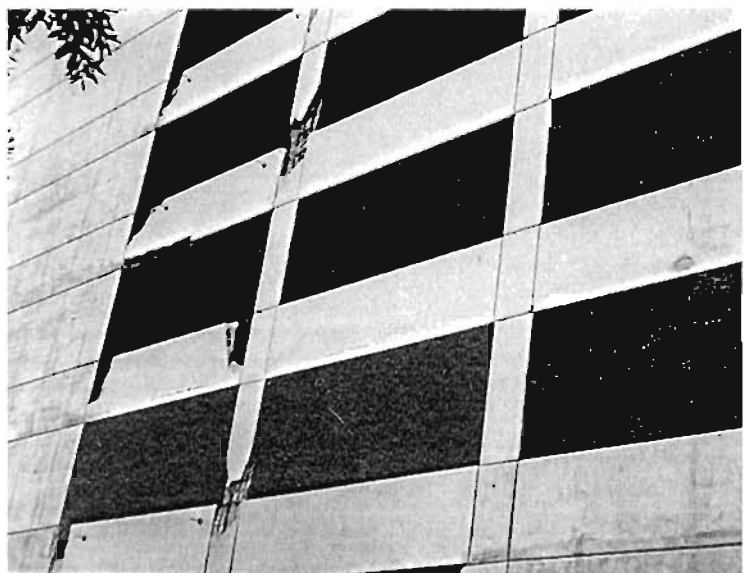
Plate 6.25: Crushing of parapet in bay next to shear wall

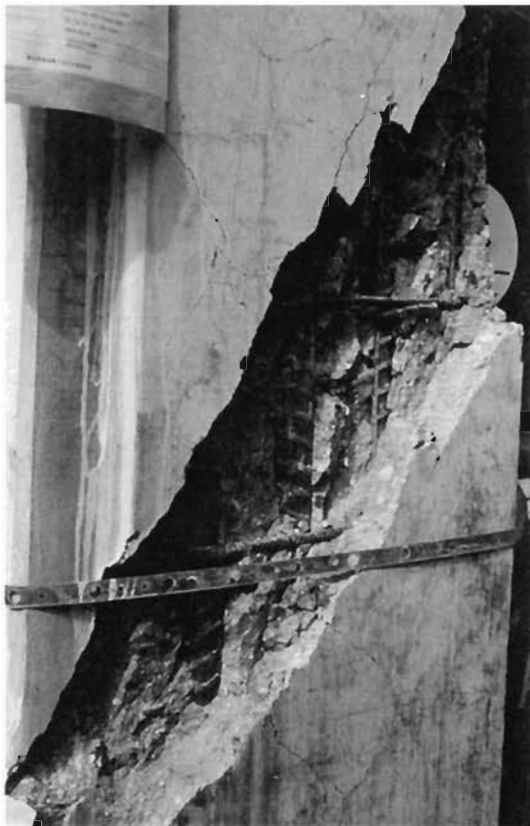
Plate 6.28: Shear cracking of column

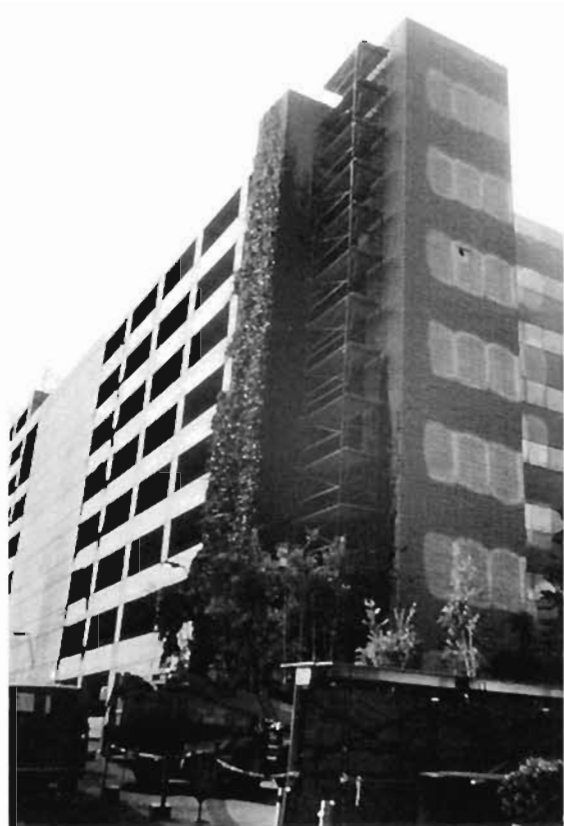
Plate 6.29: Separated stair well

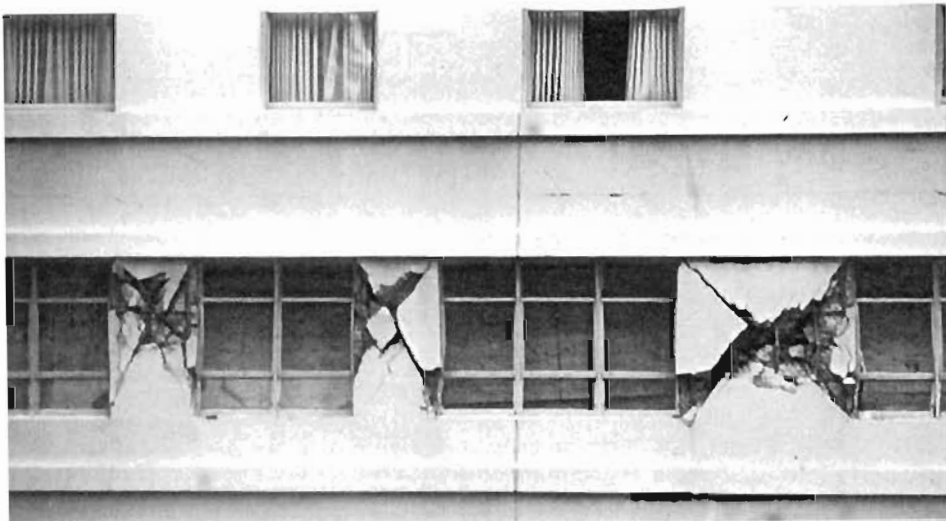
Plate 6.55: X-cracking in perforated shear wall

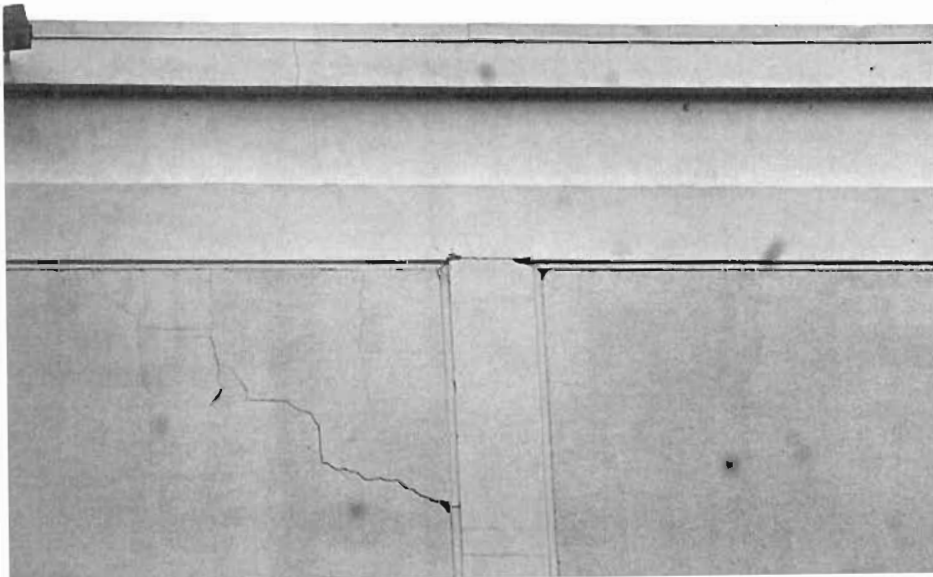
Plate 6.56: Infilled frame with infill and column cracked

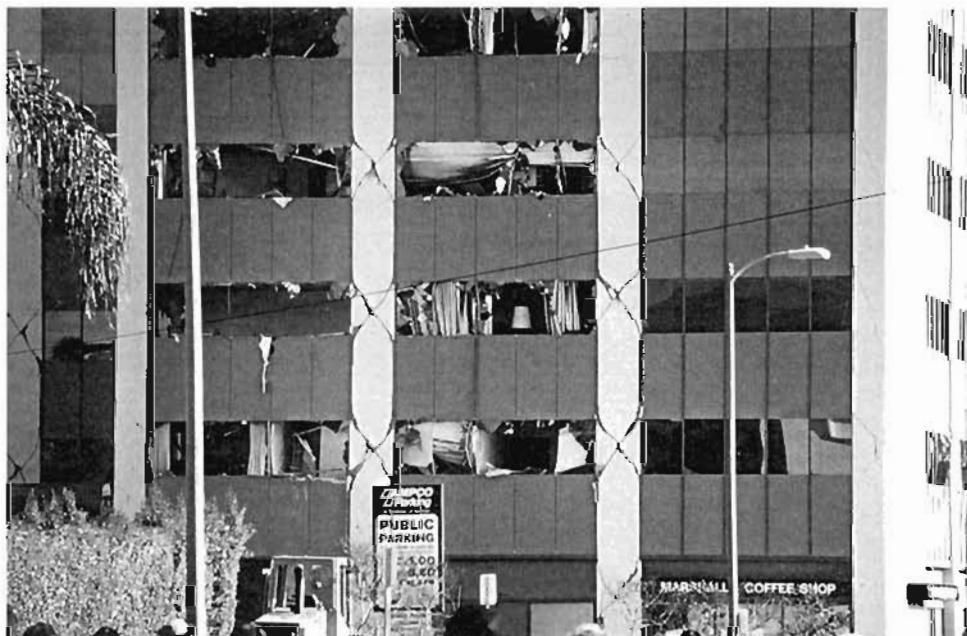
Plate 6.59: X-cracking in columns

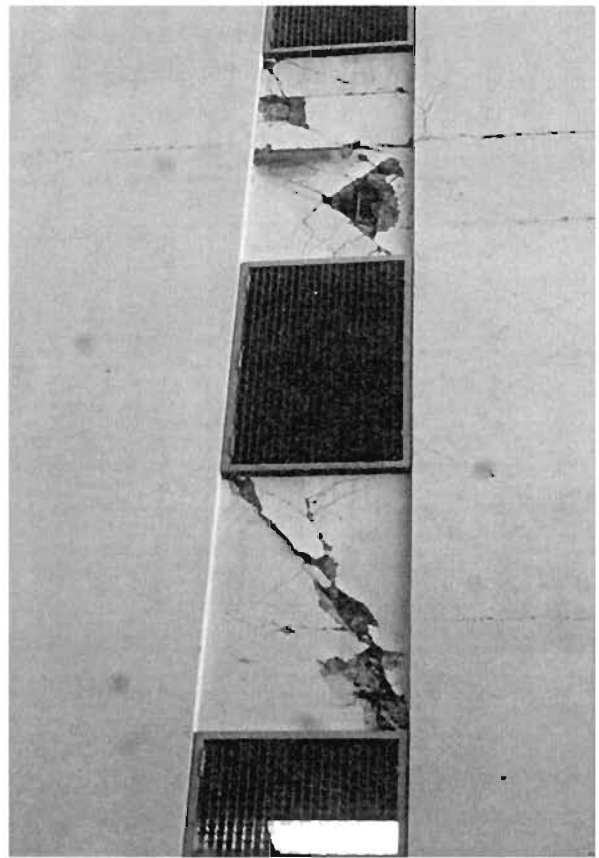
Plate 6.61: Diagonal cracking in connecting beam

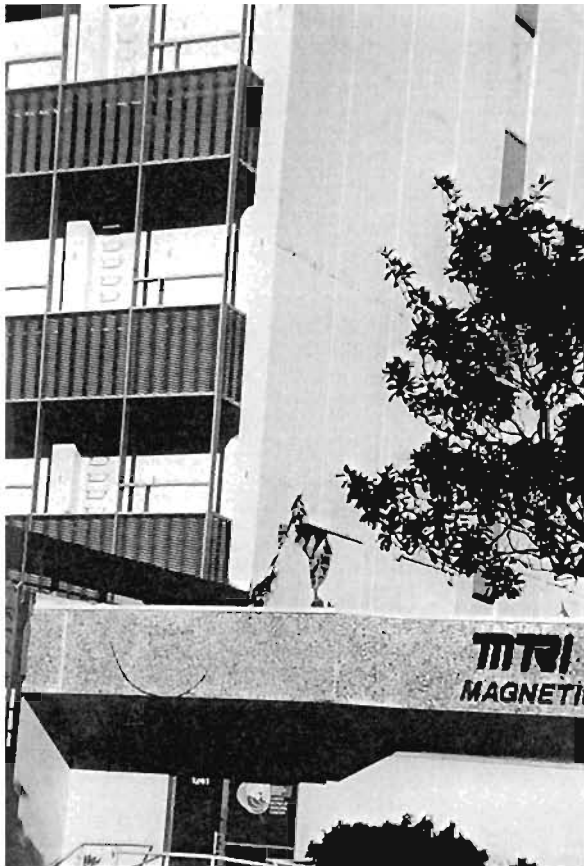
Plate 6.62: In-plane flexural crushing and surface spalling of side wall

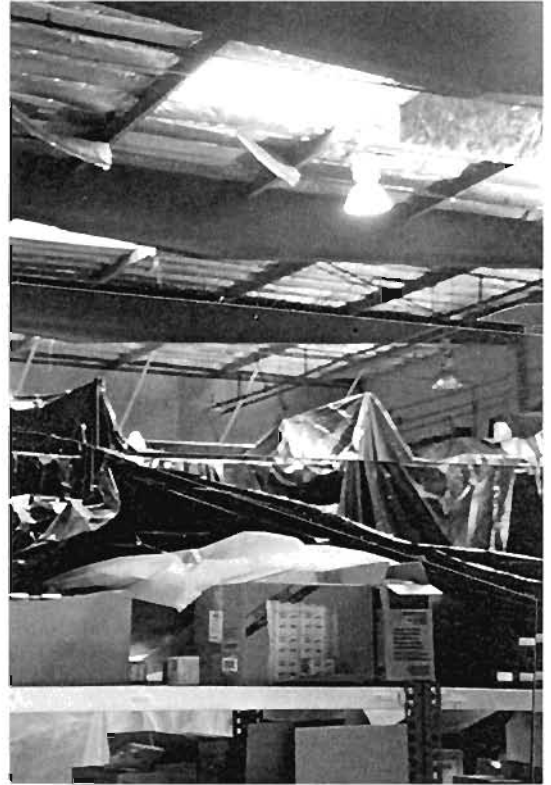
Plate 6.75: Interior and damage to plywood roof

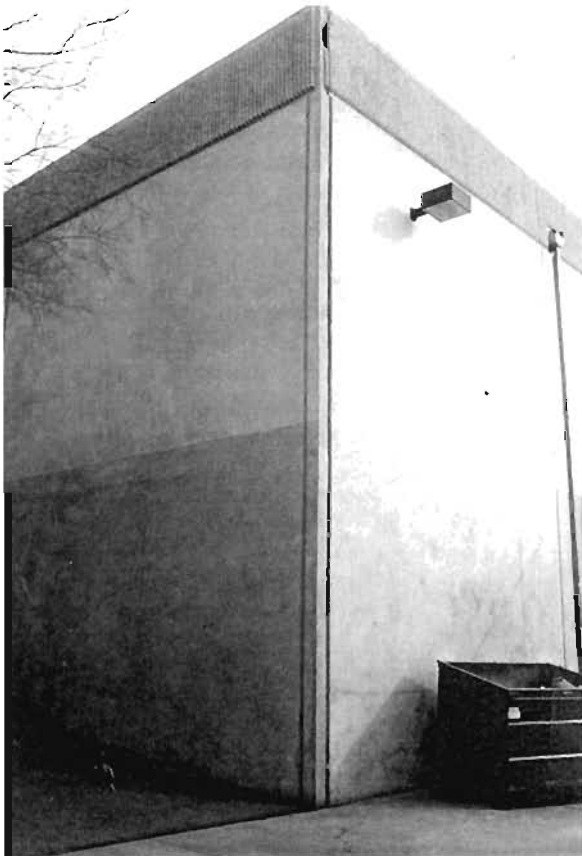
Plate 6.76: Panel separation and corner damage

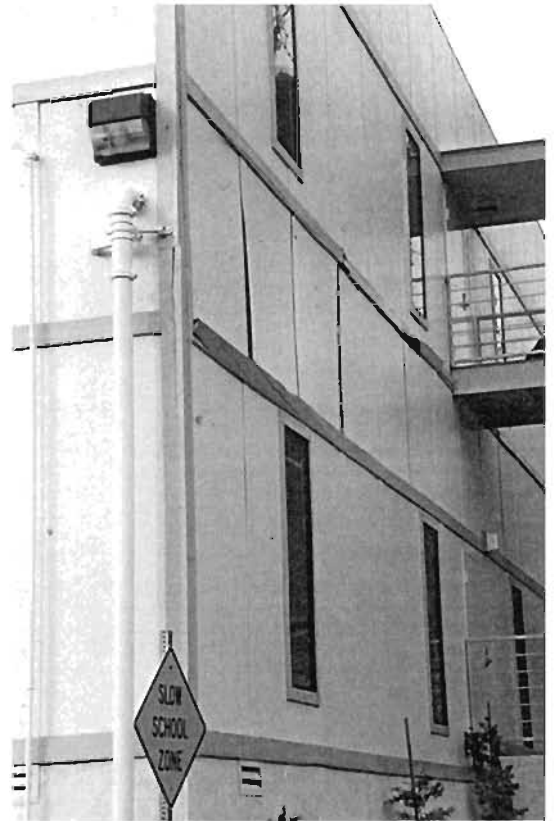
Plate 6.77: Damage to lightly clad older building

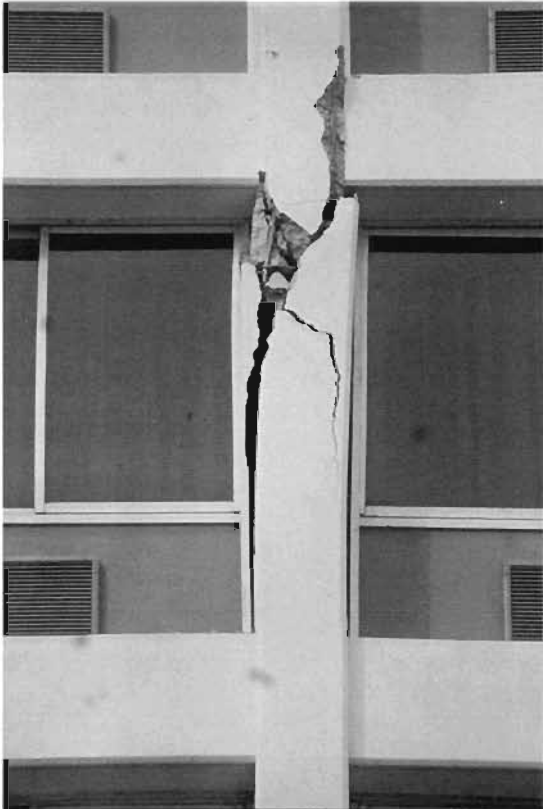
Plate 6.100: Close-up of X-cracking in columns
