**THE NORTHRIDGE, CALIFORNIA EARTHQUAKE
OF 17 JANUARY 1994**

A FIELD REPORT BY EEFIT

1. INTRODUCTION

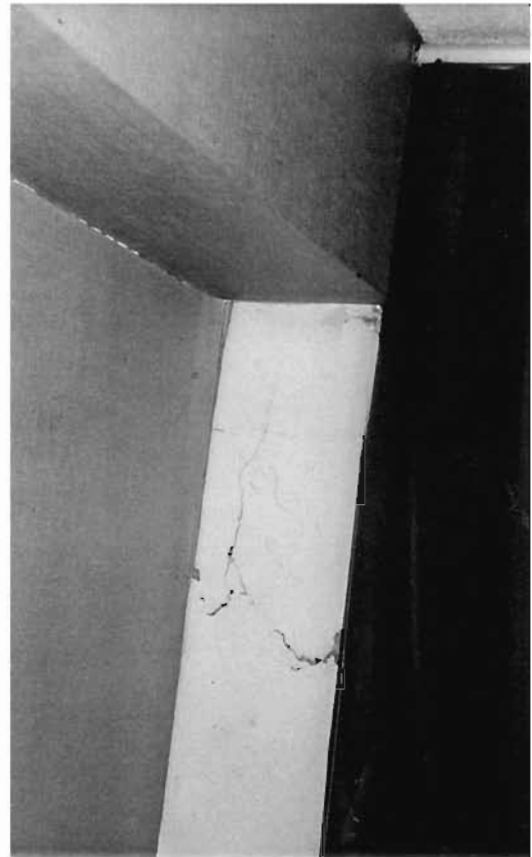
Plate 6.102: As plate 6.95 but by end wall

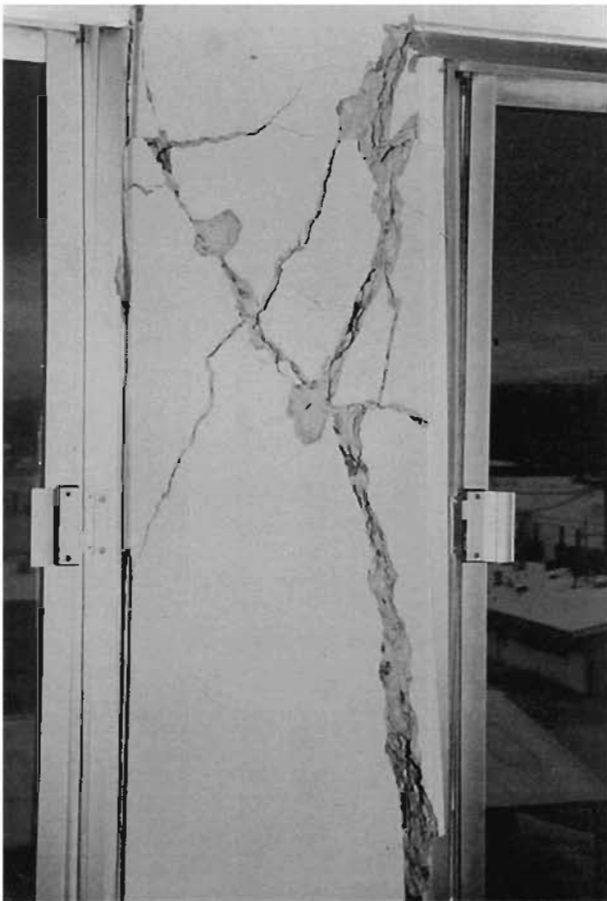
Plate 6.103: Internal view of X-cracking on 4th storey column

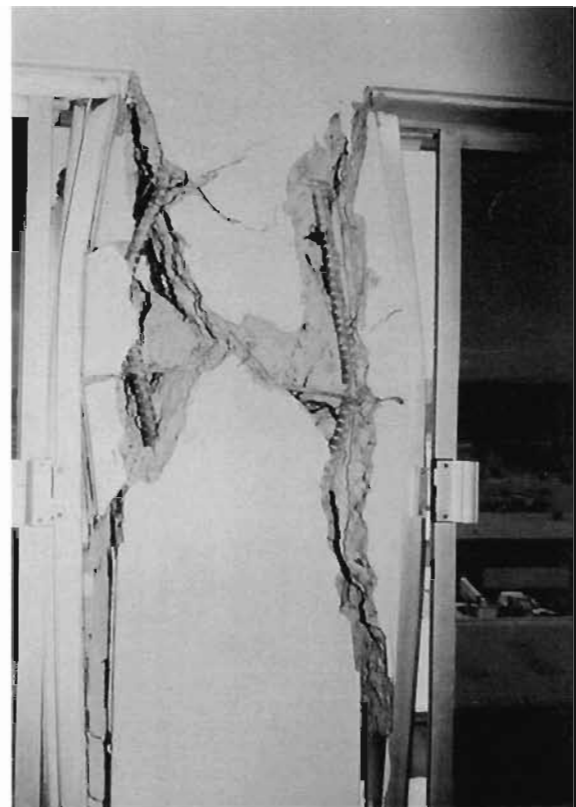
Plate 6.104: Internal view of X-cracking where tie failed

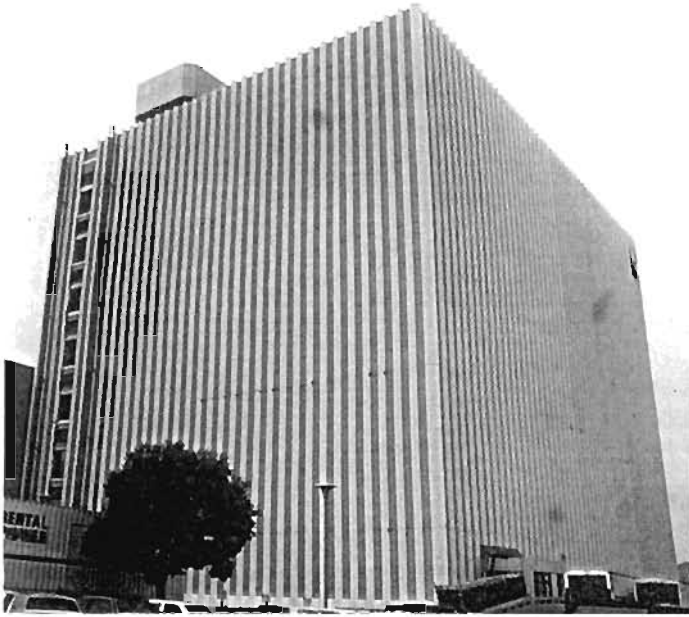
Plate 6.111: Extensive wall cracking in AT&T building

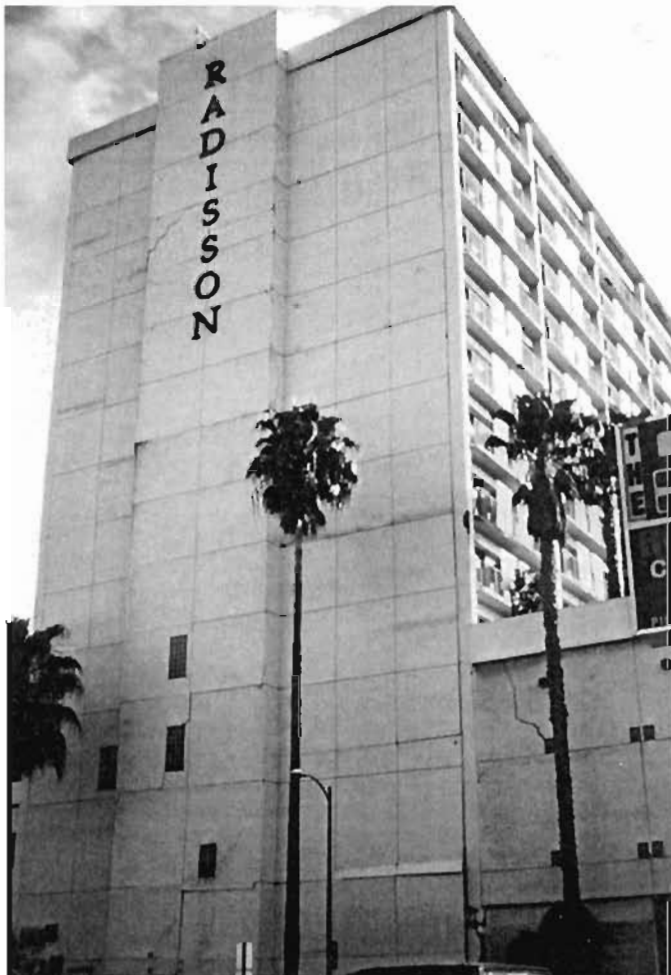
Plate 6.116: Cracked shear wall above low level roof

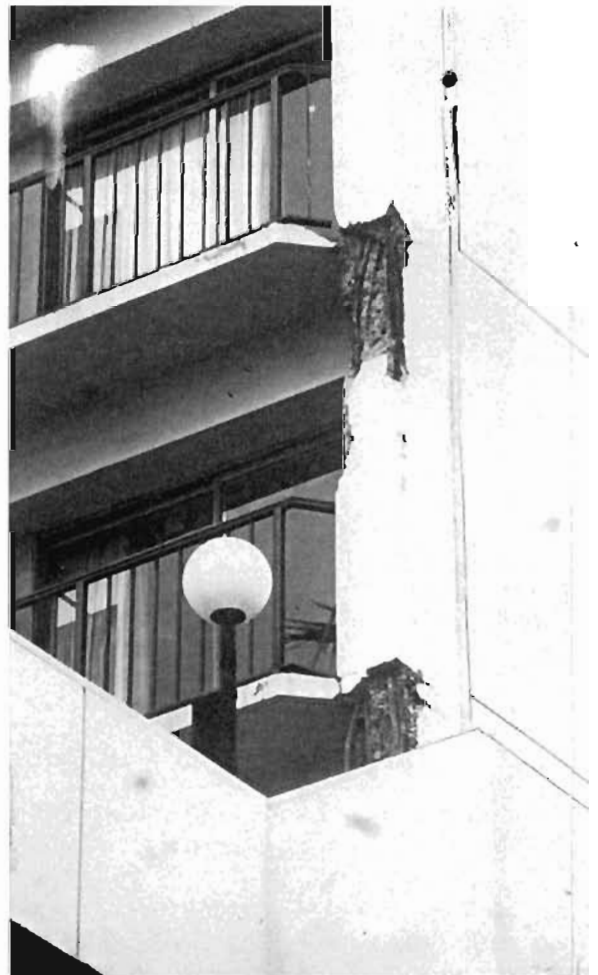
Plate 6.117: Buckled shear wall reinforcement above low level roof

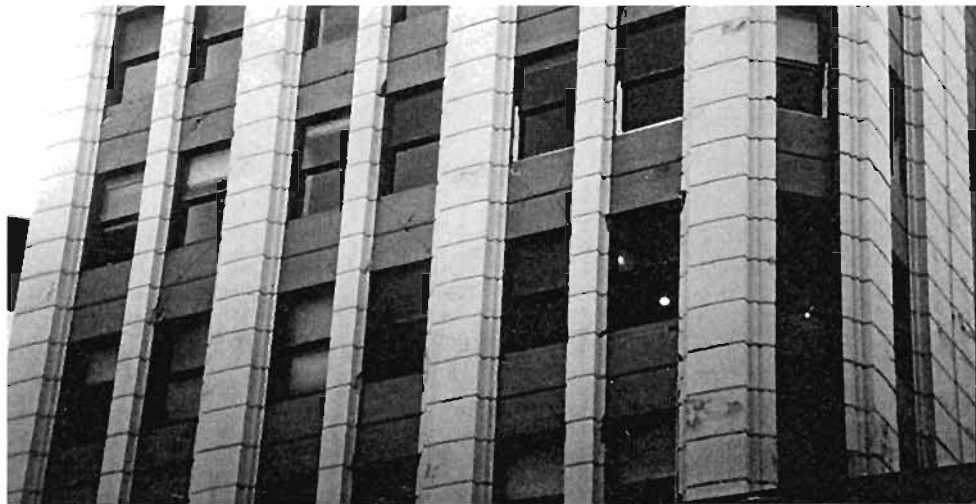
Plate 6.137: X-cracking in beams of 12 storey building in Santa Monica

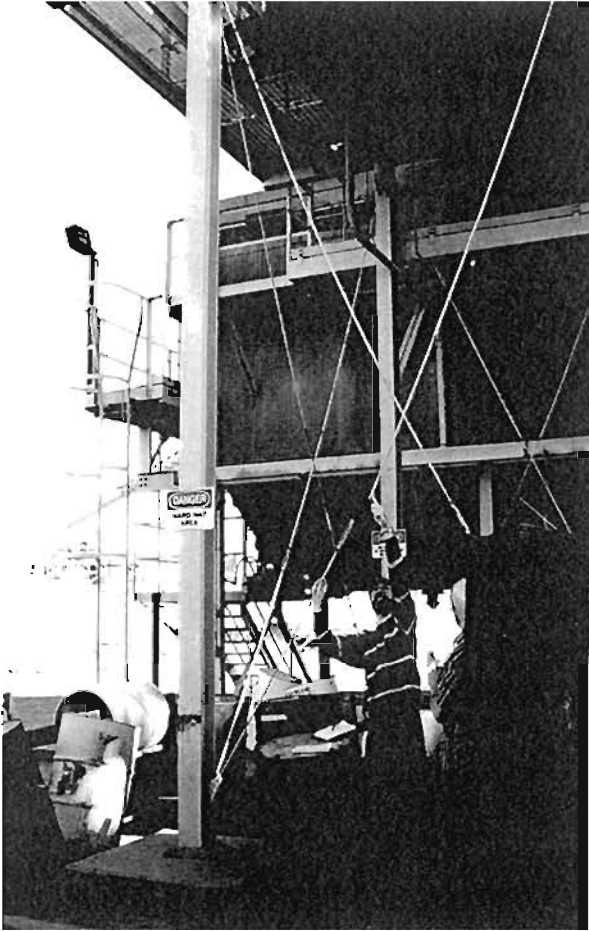
Plate 7-2 : Broken tie on light steel framed structure at aggregate handling facility, Sun Valley

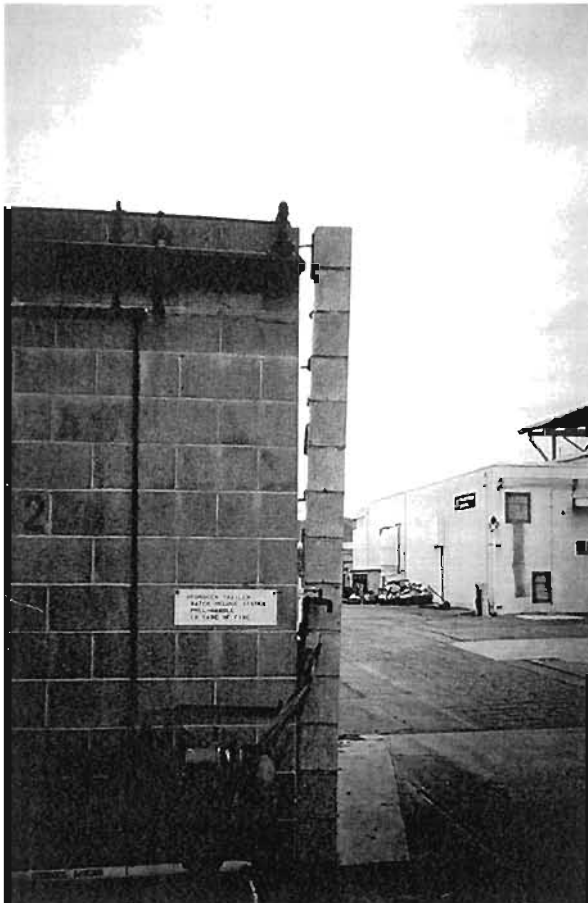
Plate 7-10 : Damage to blast wall due to inadequate continuity, Van Nuys

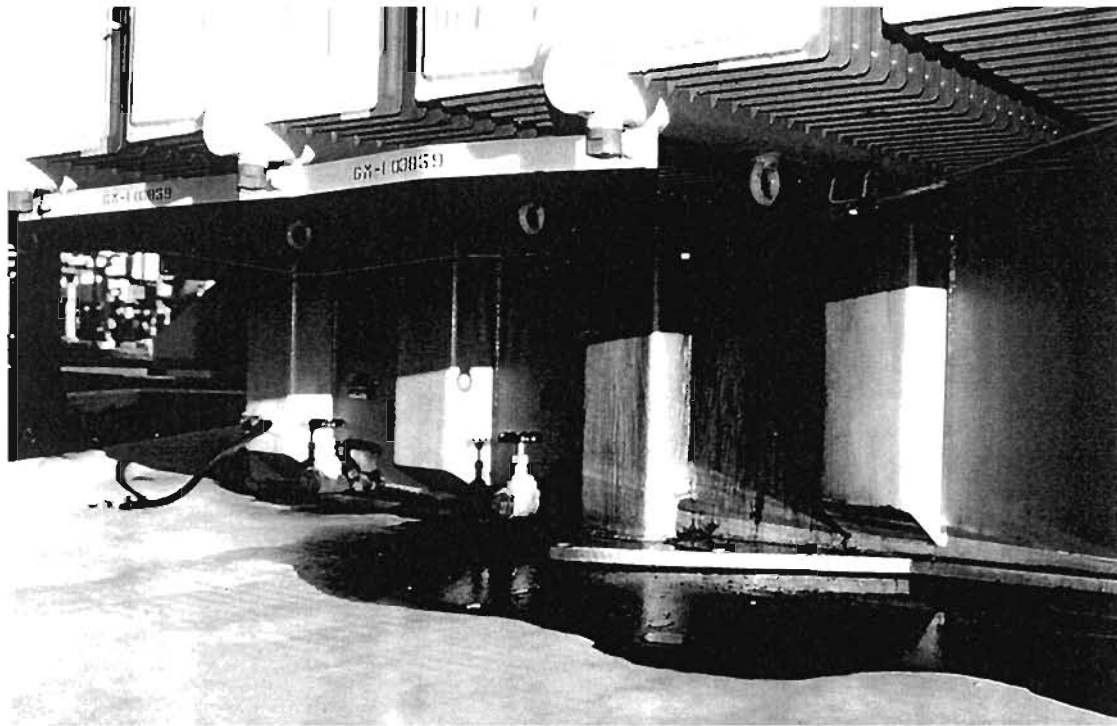
Plate 8-7 : Buckled brace and oil leakage at cooling fins of transformer, Sylmar converter station
