# **THE UMBRIA MARCHE EARTHQUAKES OF 26 SEPTEMBER 1997**

## **A FIELD REPORT BY EEFIT**

October 1998

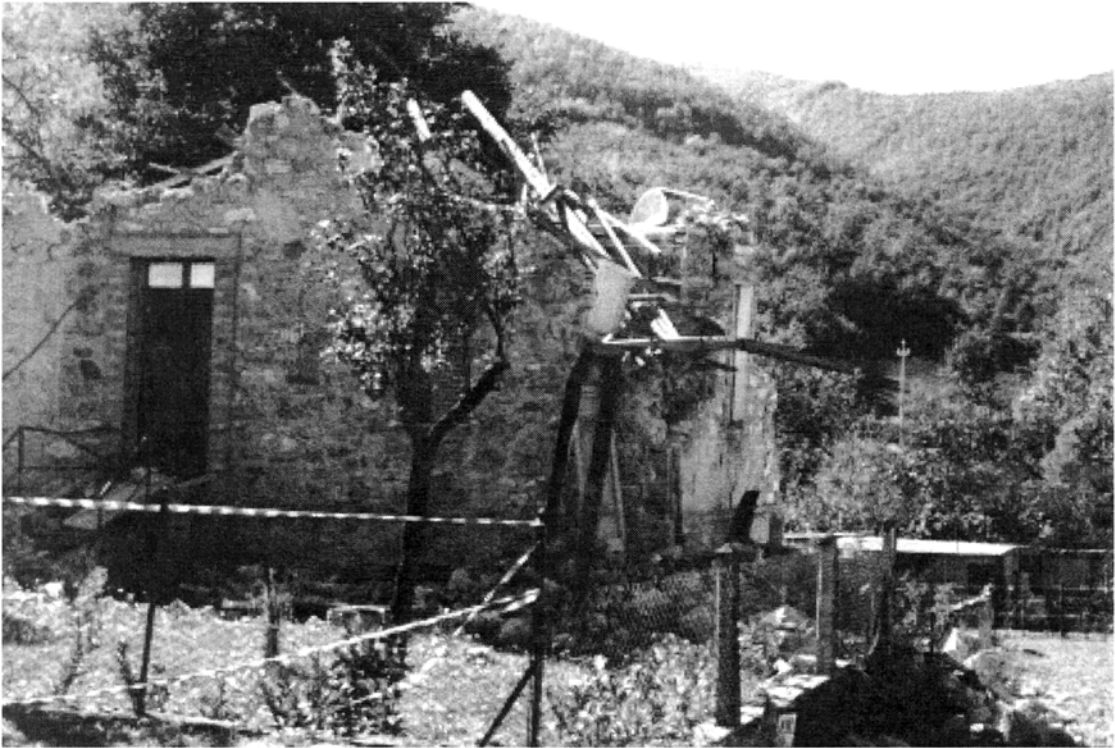
Plate 2.13: Partly collapsed unreinforced masonry building: Casenove

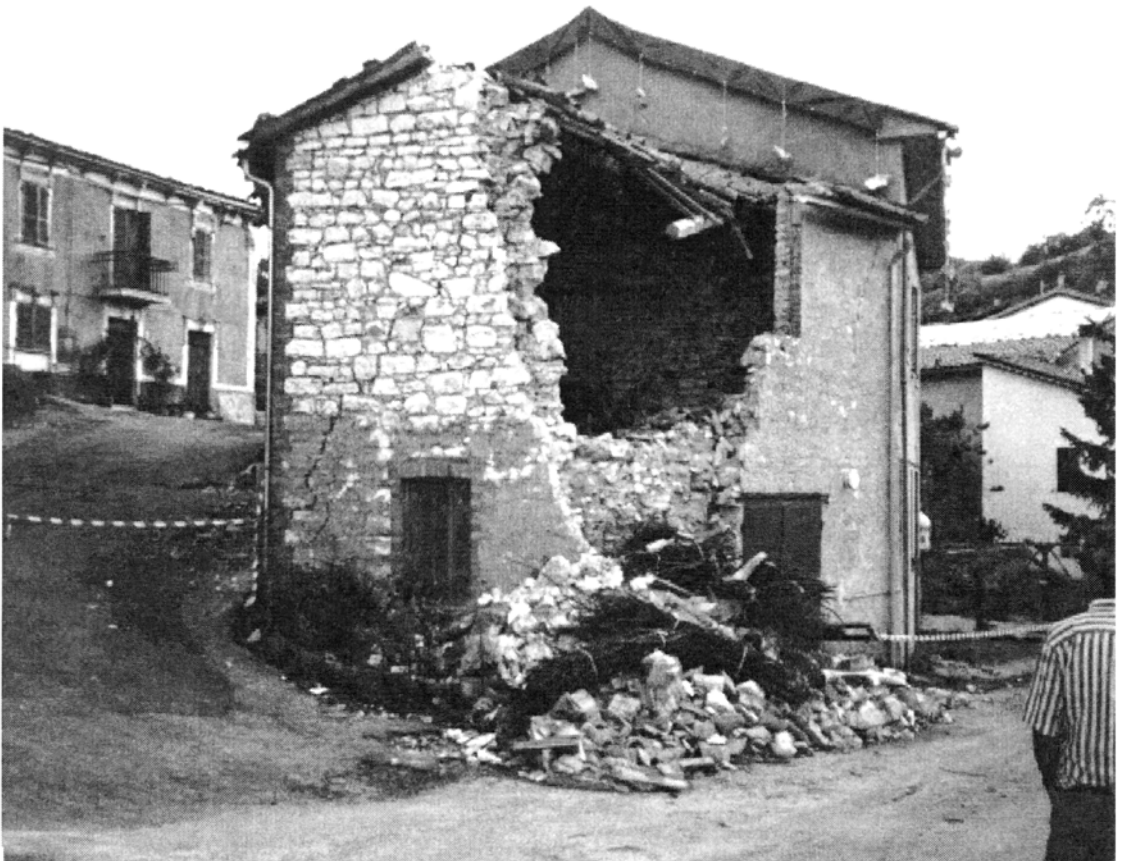
Plate 2.14: Partly collapsed unreinforced masonry building: Annifo

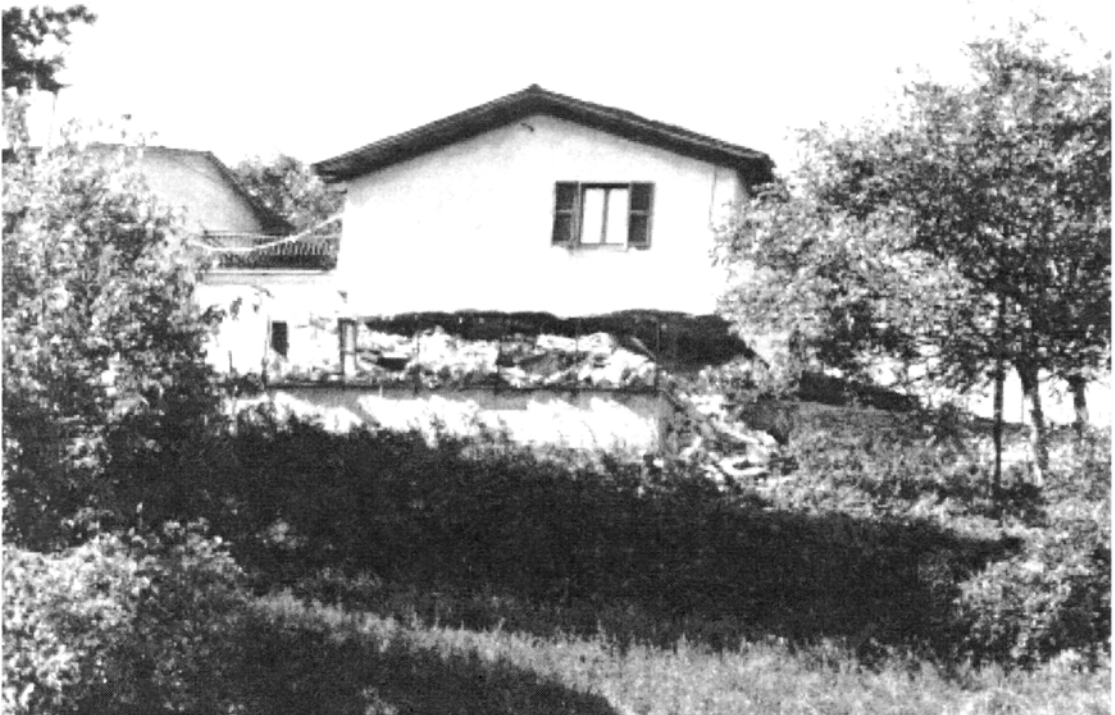
Plate 2.18: Failure of lower storey walls: Collecurti

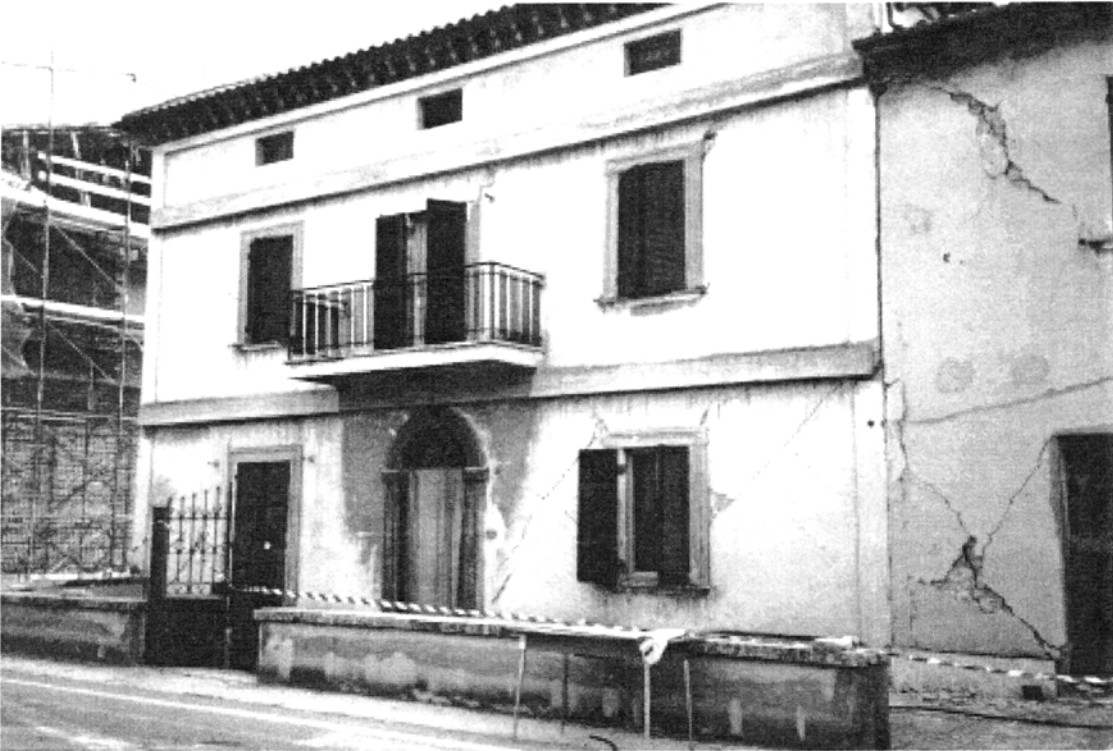
At Nocera Scalo, on the main north-south route 53 (via Flaminia), a more recent mix of building types was observed. Masonry buildings were mostly of burnt clay brick construction with reinforced concrete floor and roof slabs. Several buildings were of infilled reinforced concrete frame. Major shear failures of the masonry walls were observable in a number of buildings (Plates 2.19, 2.20).

Plate 2.20: Shear failure in lower and upper storey walls: Nocera Scalo

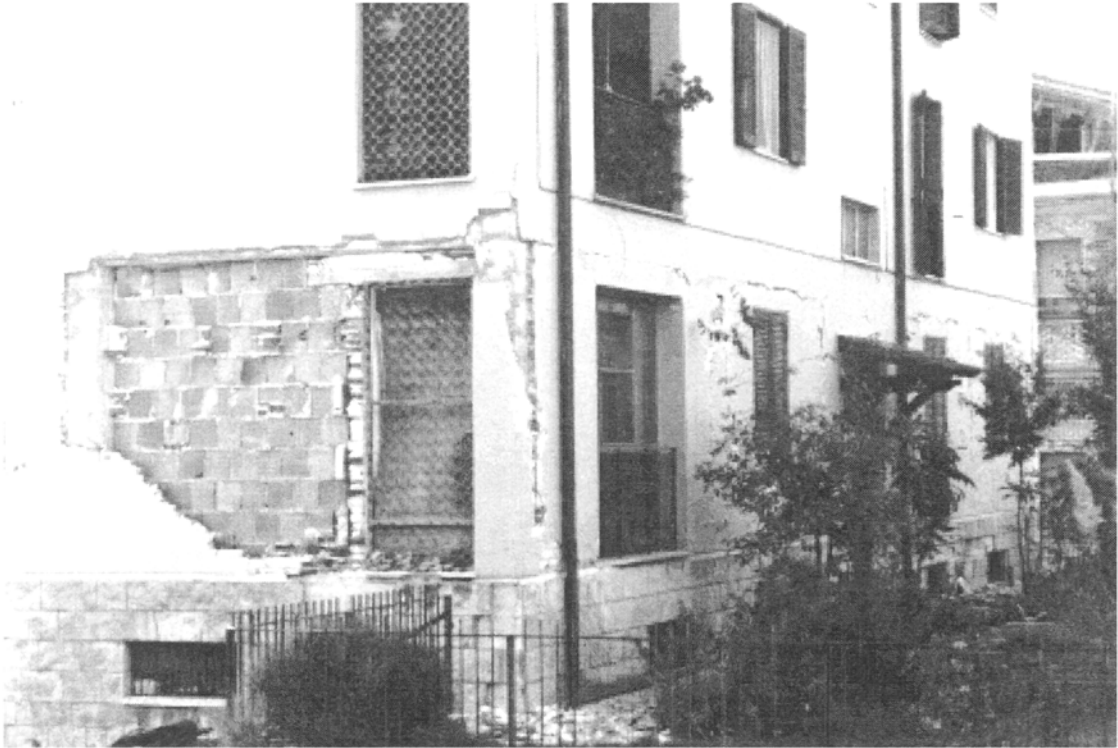
Plate 2.21: Failure of masonry infill in reinforced concrete frame building: Nocera Scalo

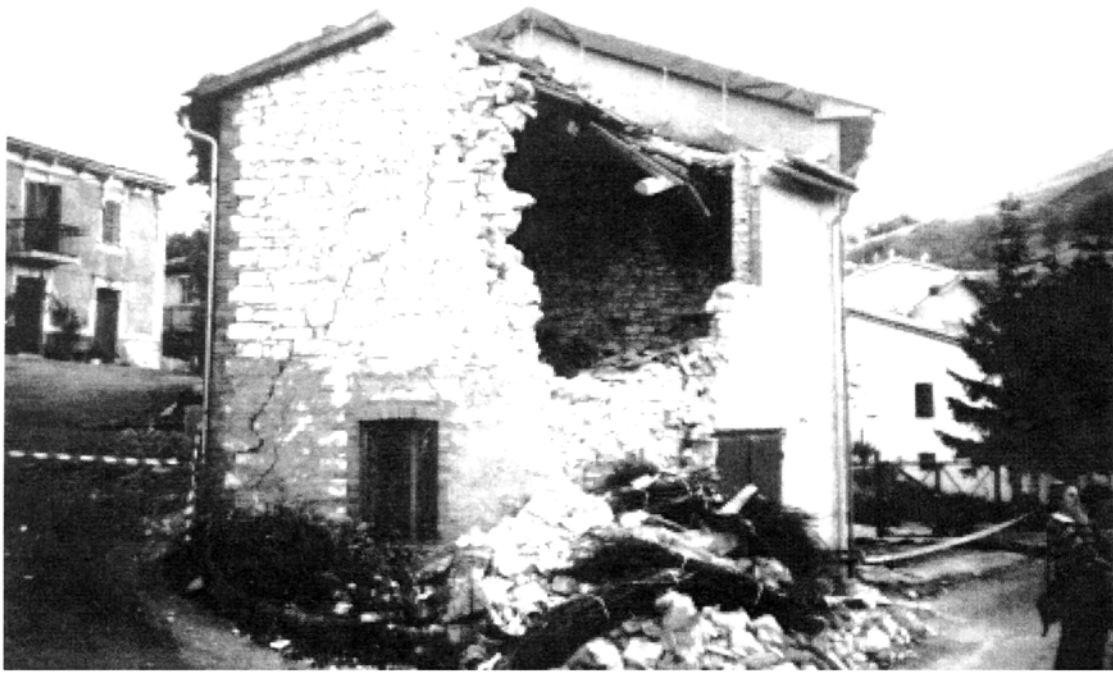
Plate 2.23: Rubble masonry building with corner damage: Annifo

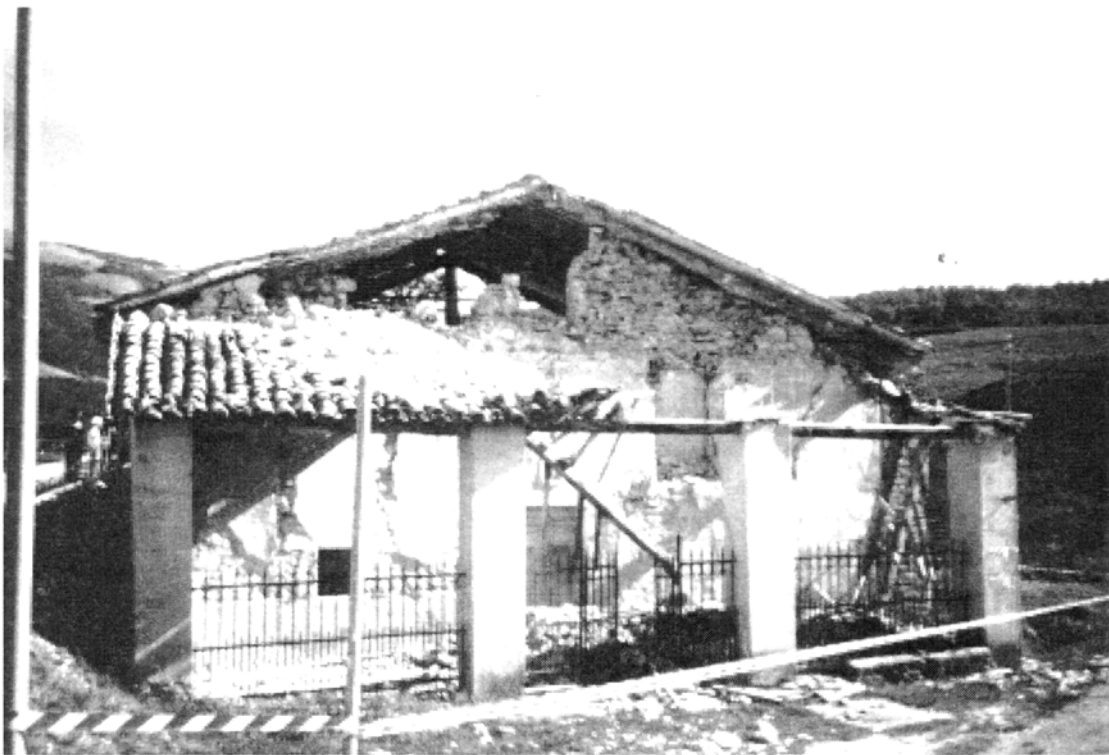
Plate 2.24: Masonry wall peeling: Cesi

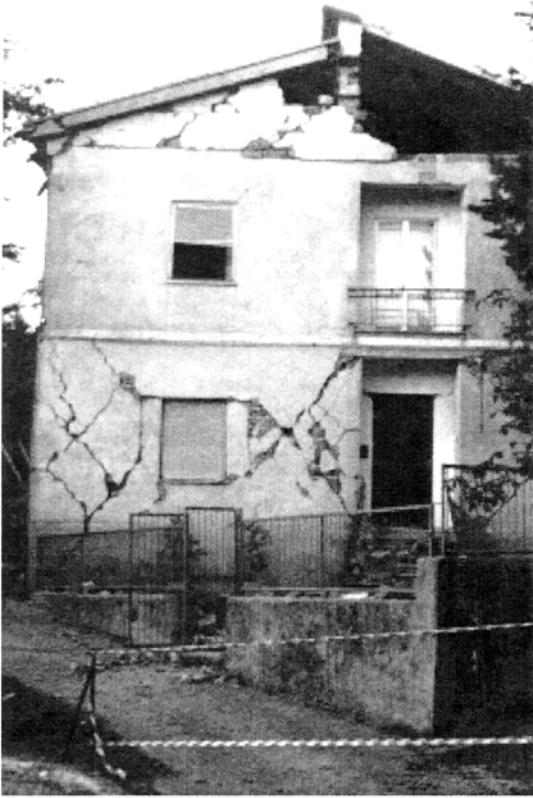
Plate 2.25: X-cracking in lower storey: Annifo

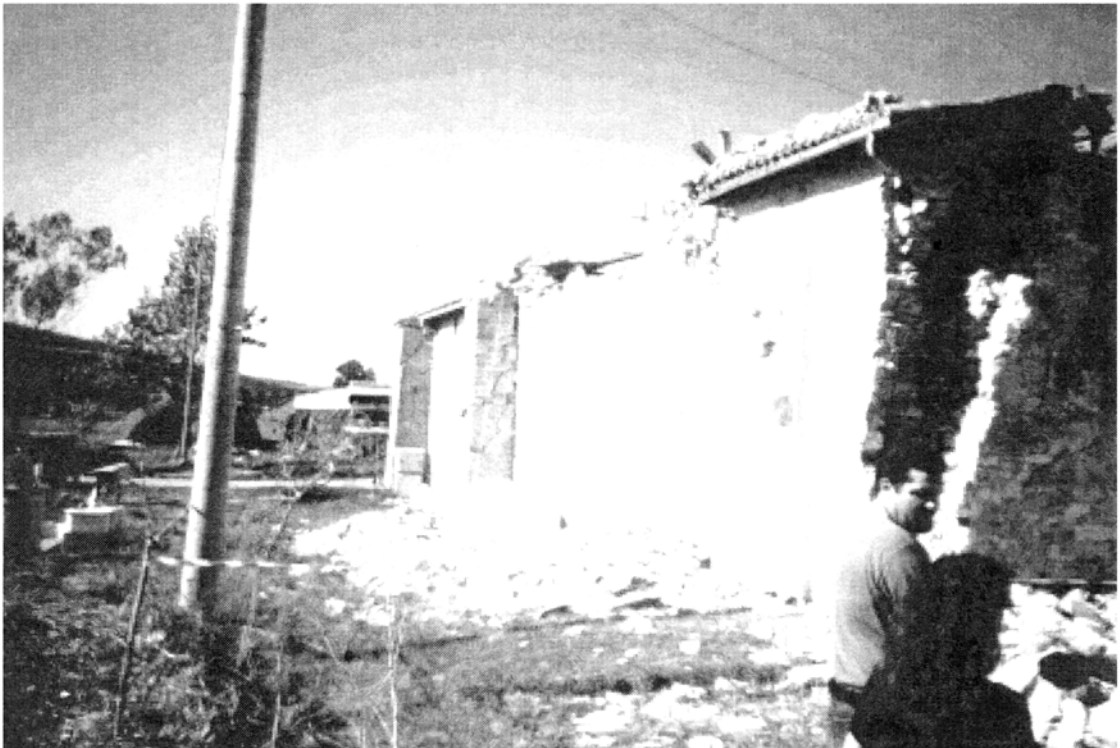
Plate 2.26: Shear cracking in buttress of church: Cesi

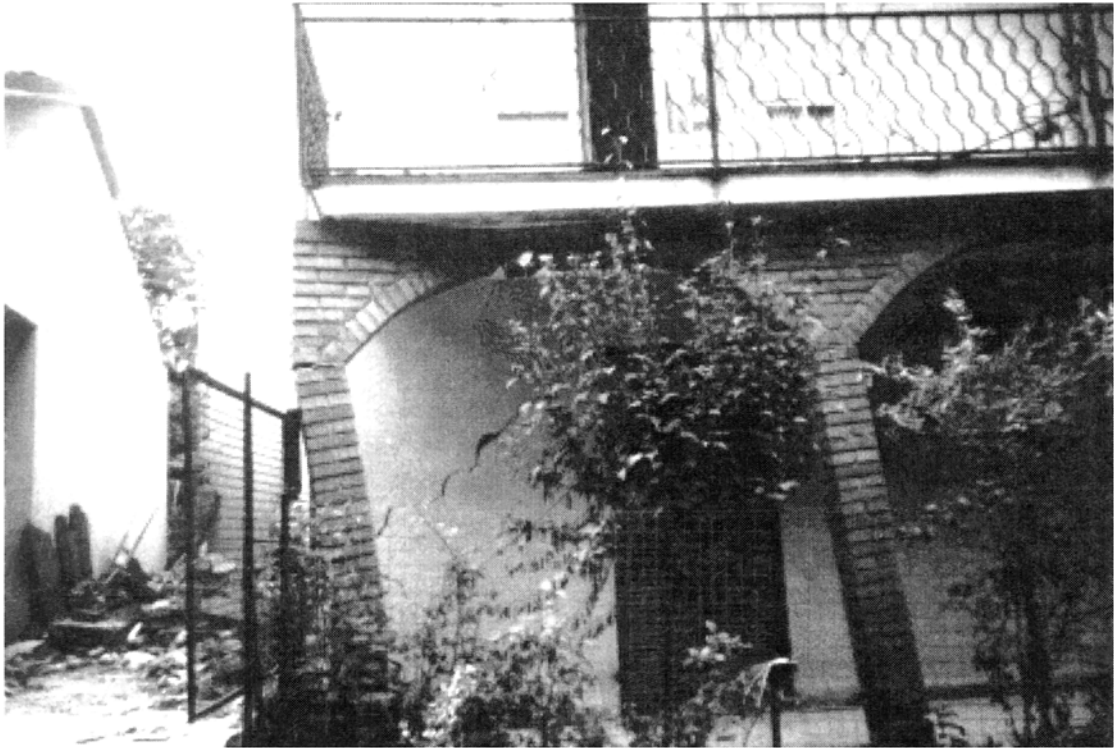
Plate 2.27: Column sideways failure mechanism: Isola

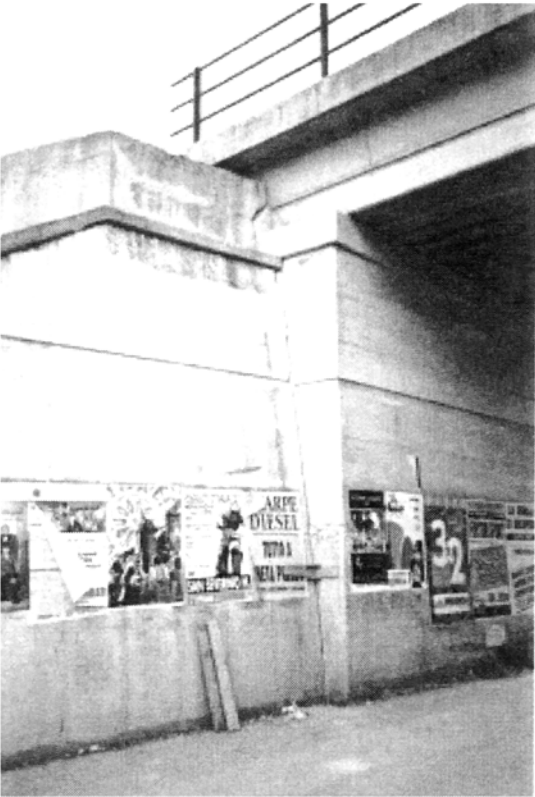
Plate 2.28: Embankment displacement: Isola

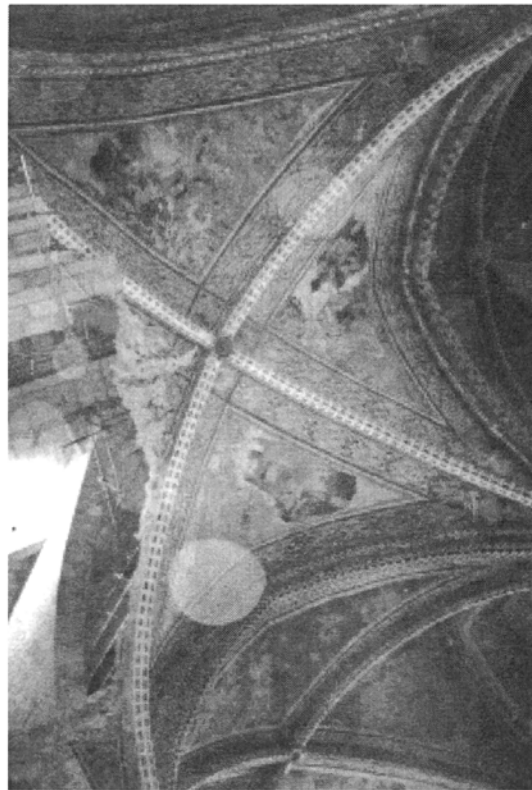
Plate 3.2: Damage to the vault above the crossing of San Francesco Upper Basilica

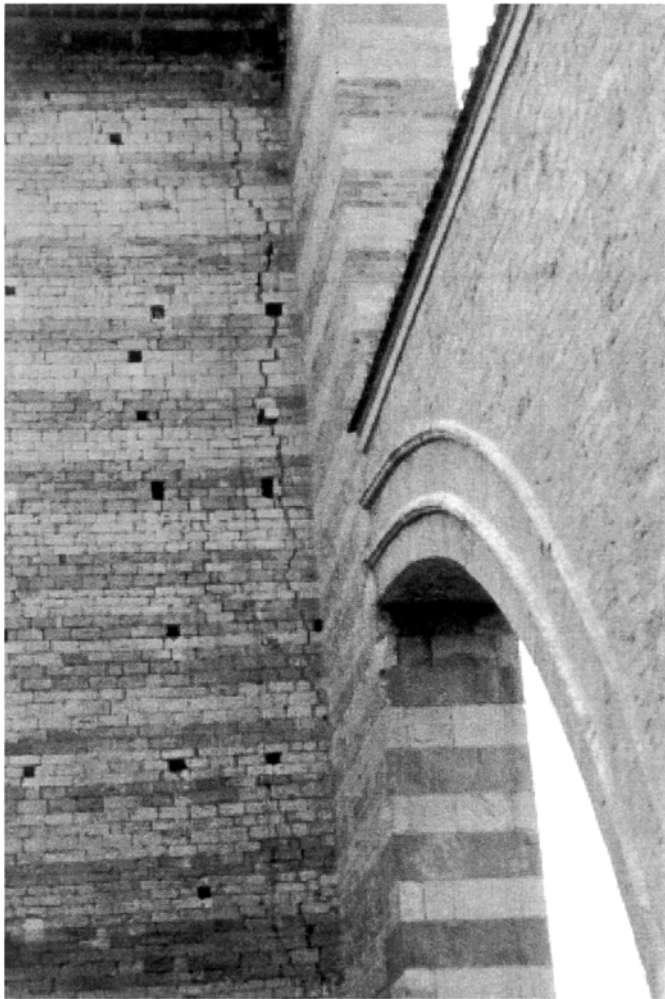
Plate 3.9: Santa Chiara Basilica: vertical cracks on the northern longitudinal wall

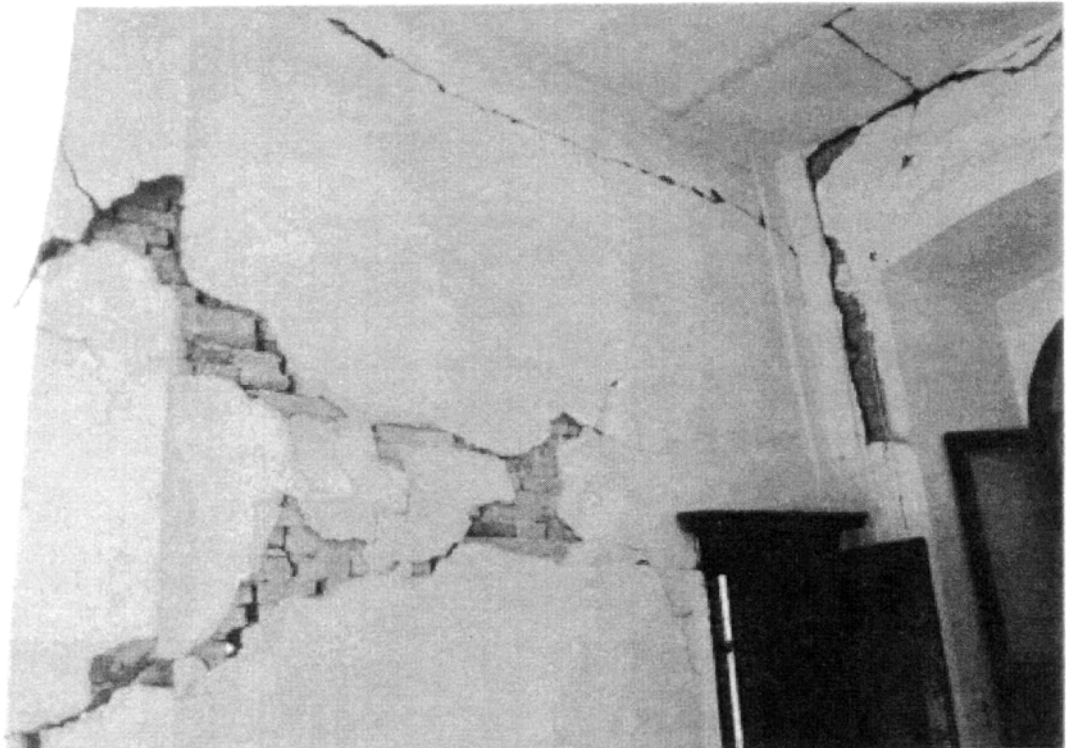
Plate 3.12: Santa Chiara Convent: an internal bearing wall with shear cracks and buckling collapse at the wall junction

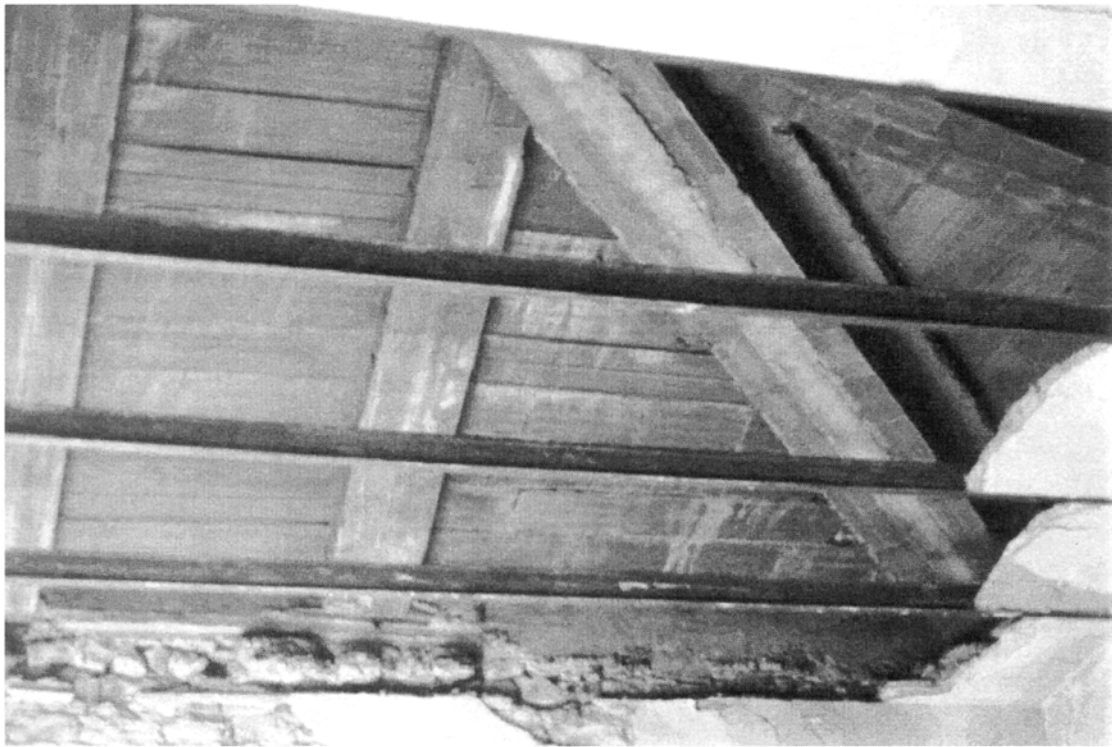
Plate 3.13: Santa Chiara Convent: collapse of the false ceiling and the roof structure at the southwestern corner

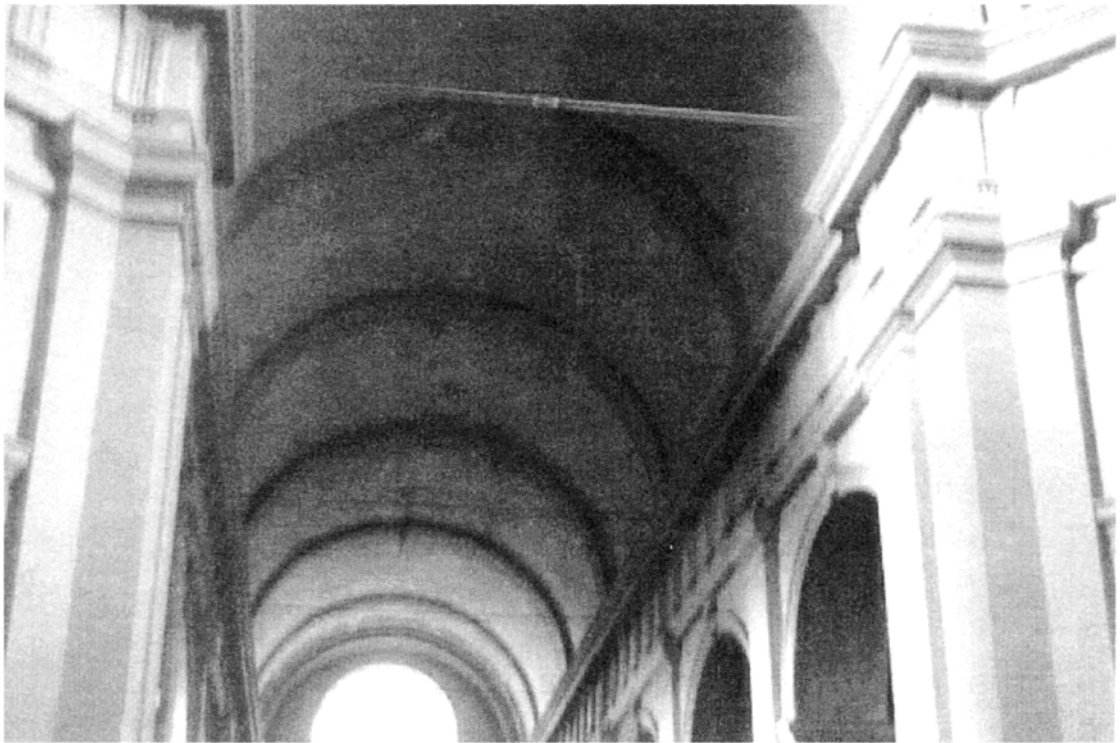
Plate 3.19: San Rufino Cathedral: longitudinal cracks along the intrados of the main nave barrel vault

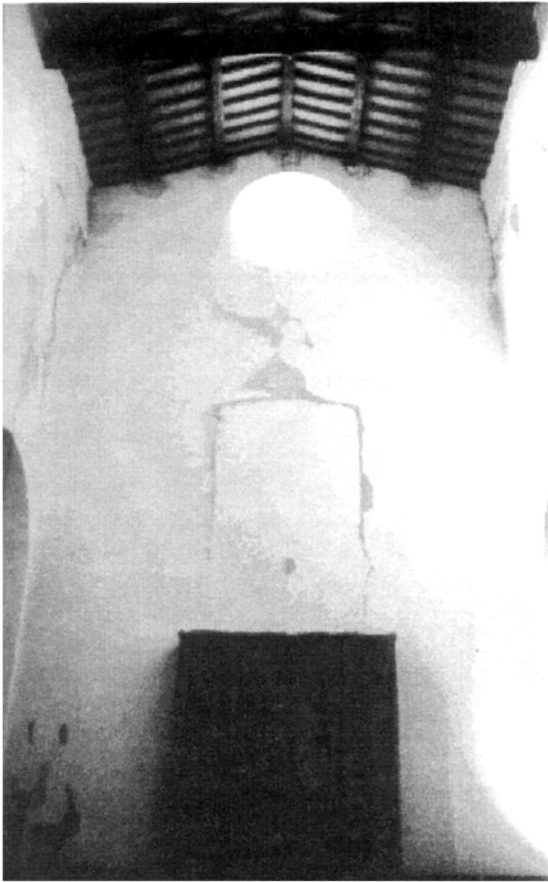
Plate 3.21: Santa Maria Maggiore: internal elevation of the façade; damage caused by oscillation of the façade out-of-plane

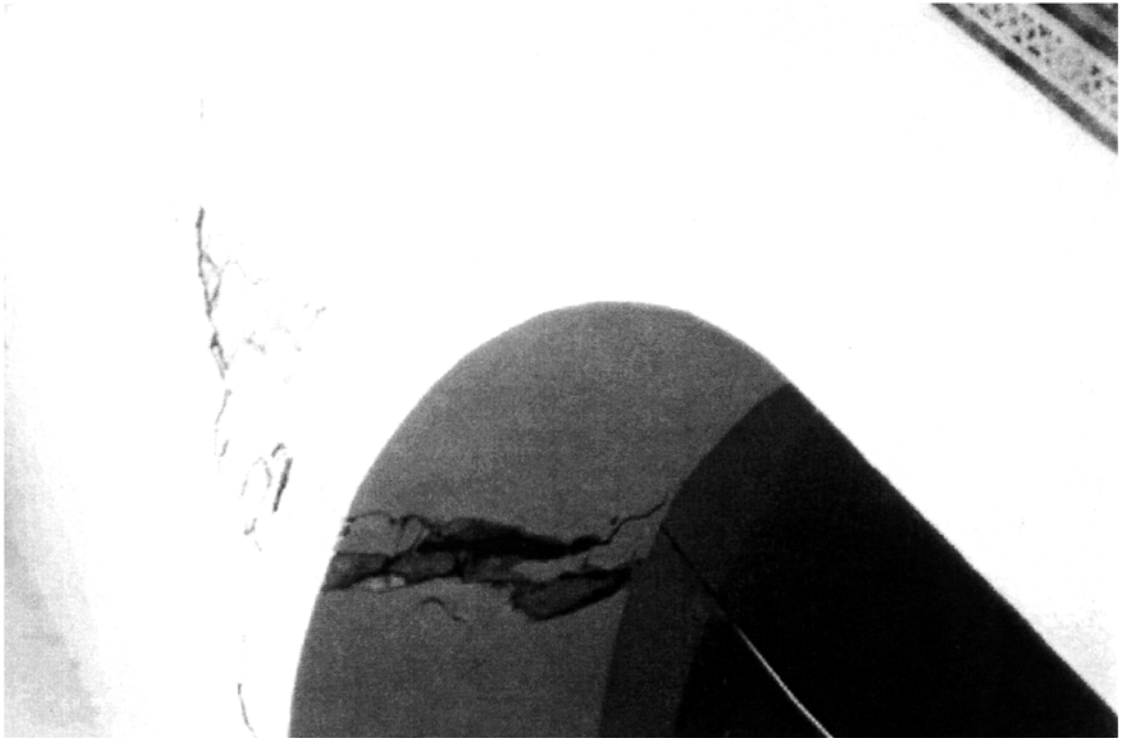
Plate 3.23: Santa Maria Maggiore: shear cracks over the archway between main nave and aisle

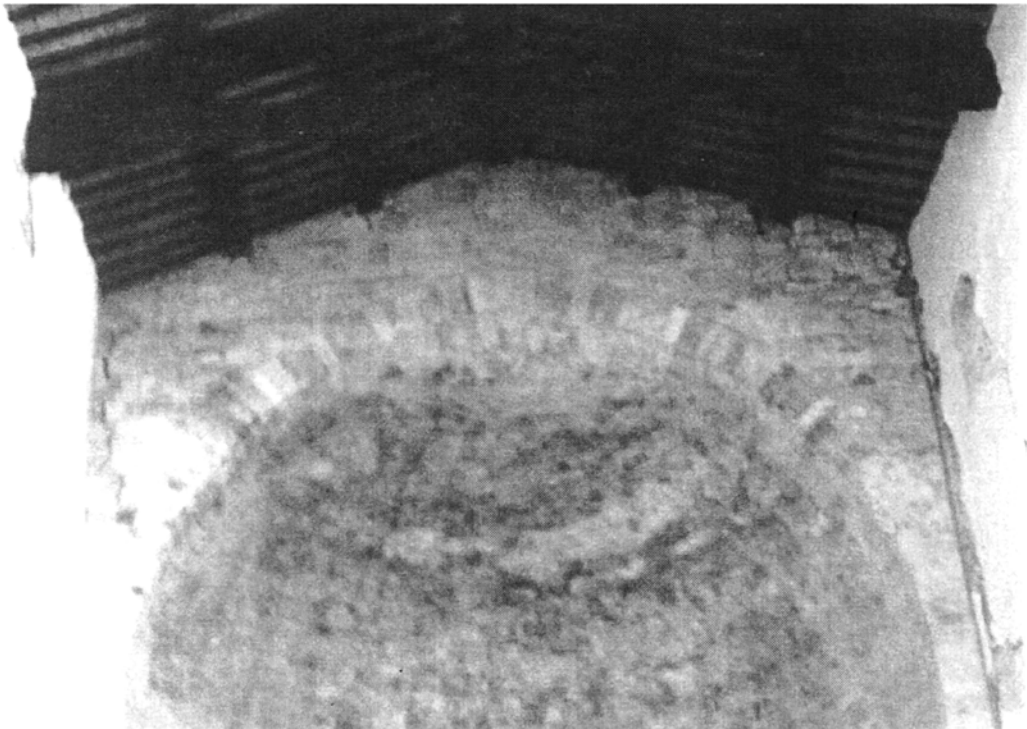
Plate 3.24: Santa Maria Maggiore: vertical crack at connection between apse and lateral walls

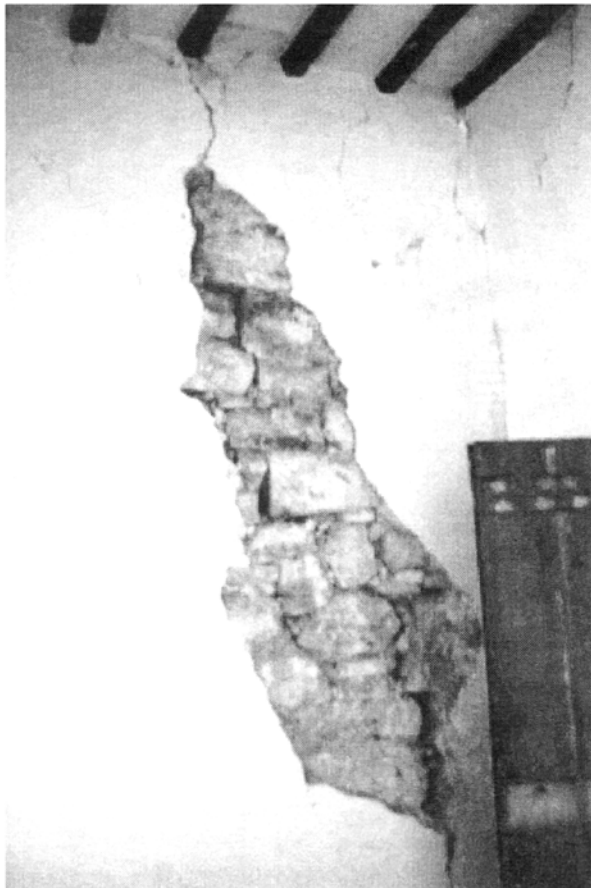
Plate 3.28: Frati Minori Convent: shear cracks in cross walls reveal rubble masonry with stone wedges and bricks.

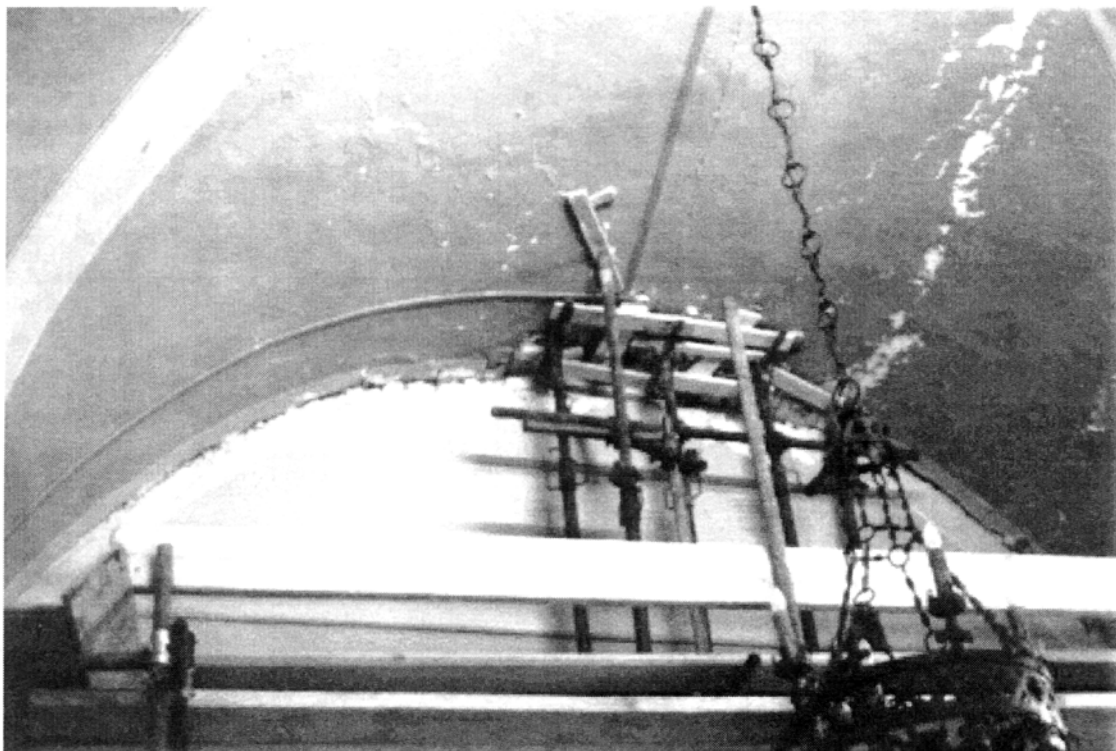
Plate 3.29: Frati Minori Convent: damage to the vault of the library and shoring

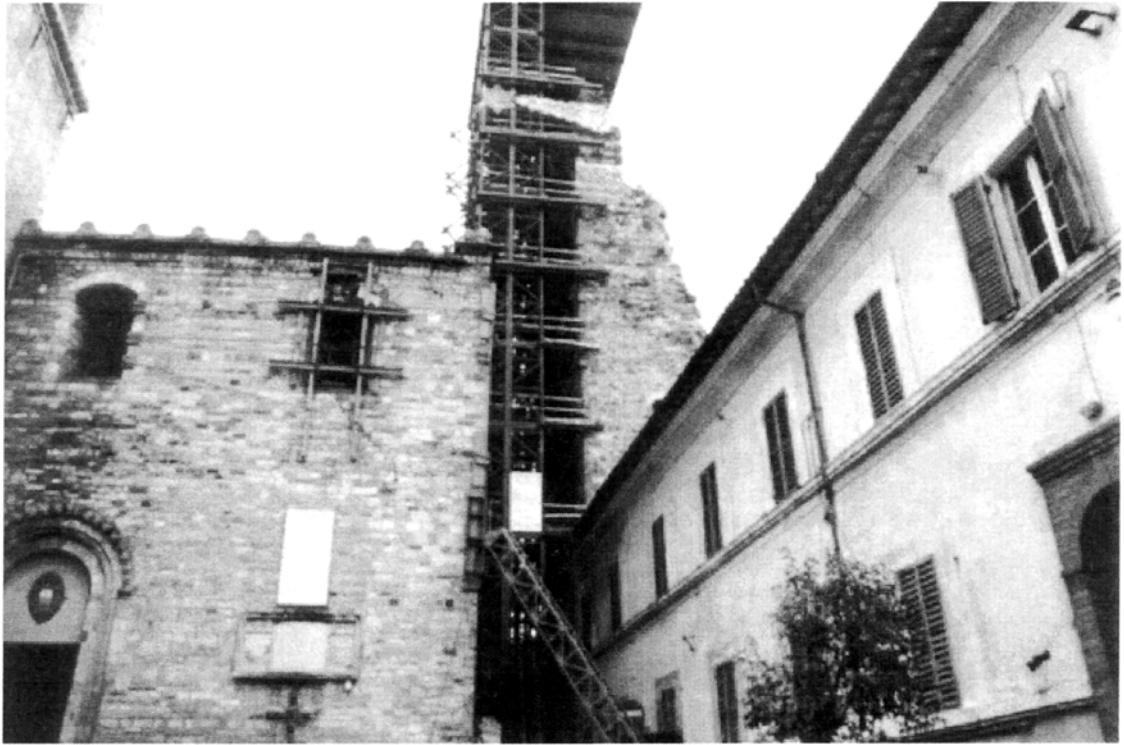
Plate 3.31: Nocera Umbra: shoring work after the collapse of the Civic Tower (right) and urgent repair measures to the Cathedral

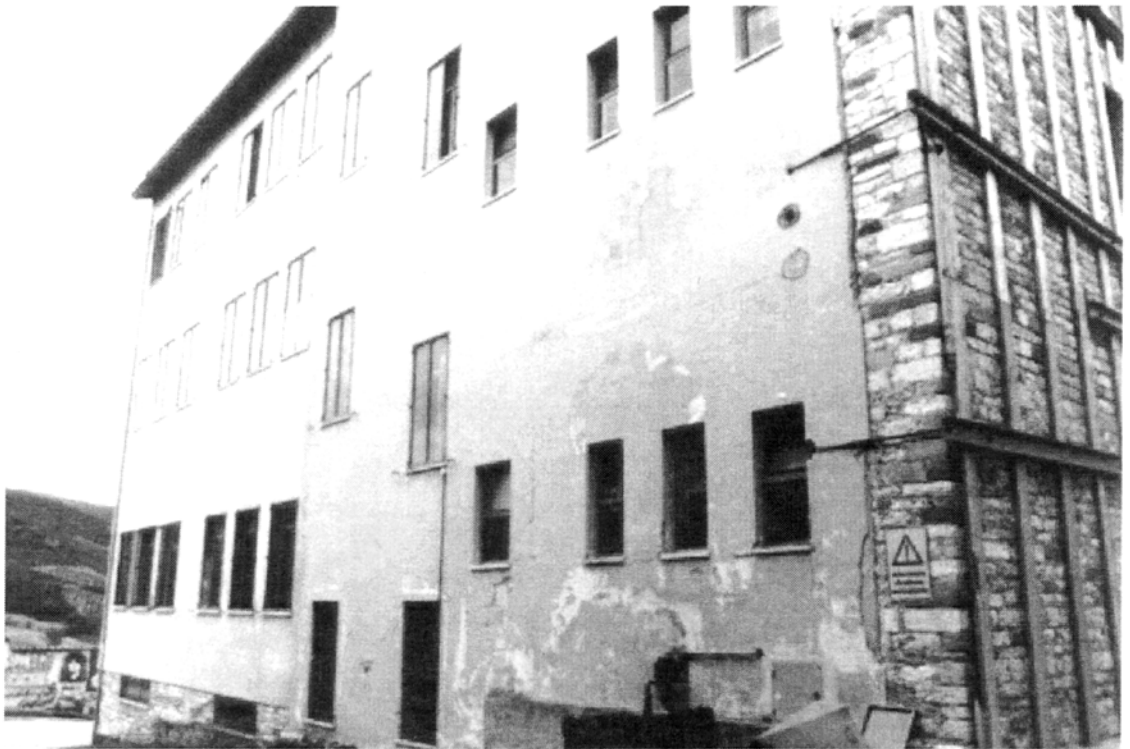
Plate 3.32: Comune, Nocera Umbra: detachment of perpendicular walls and shear cracks in infill panels within new reinforced concrete structure

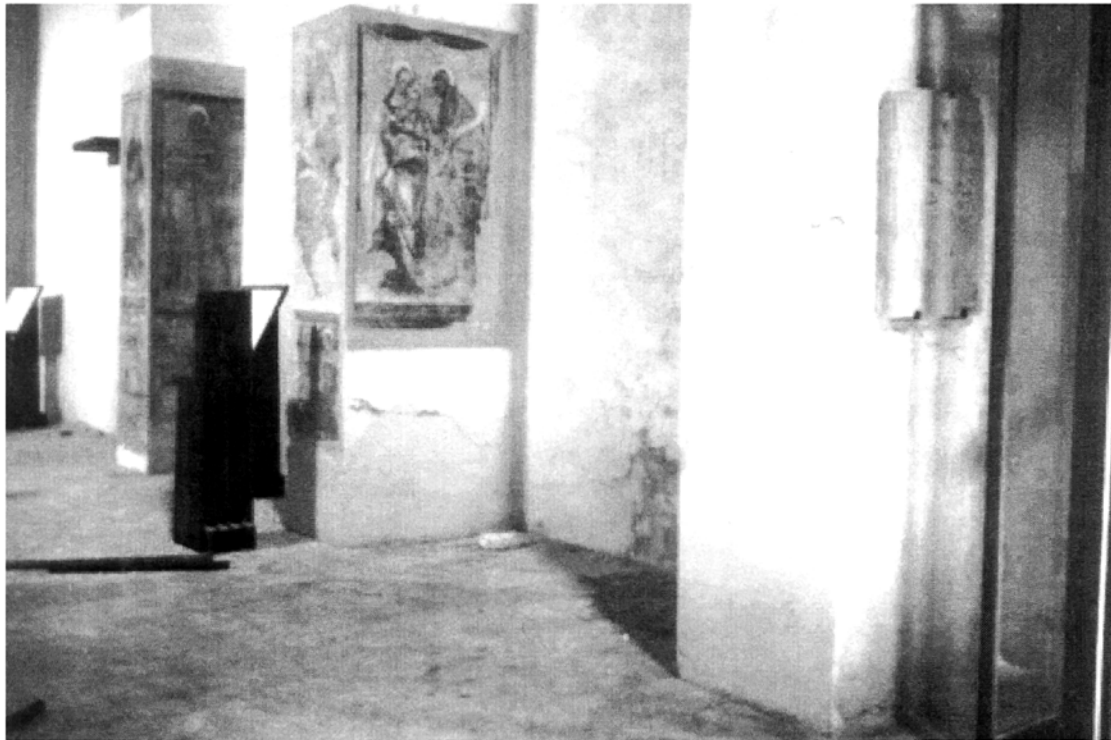
Plate 3.33: Pinacoteca, Nocera Umbra: horizontal cracks at the base of columns

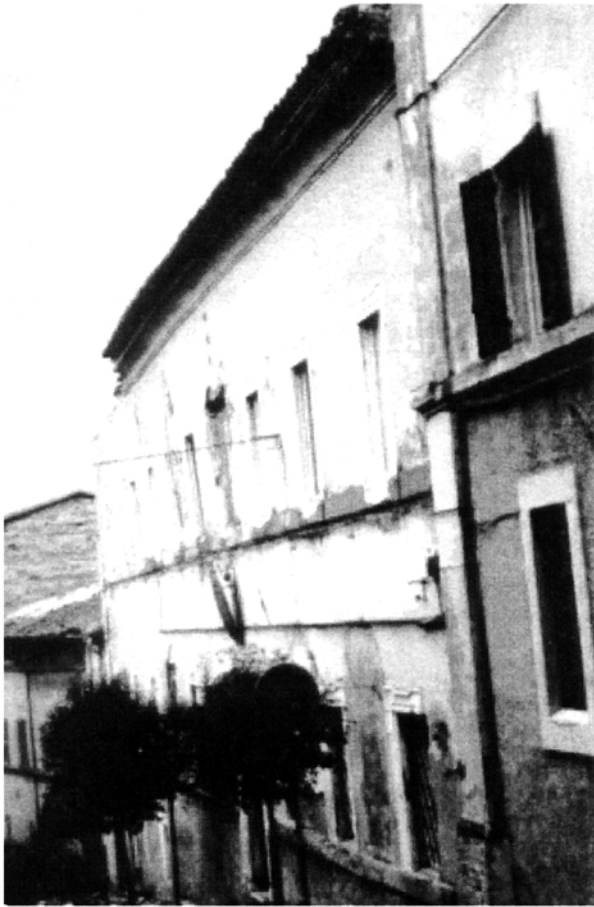
Plate 3.35: Nocera Umbra: out-of-plane overturning of the Civic Archive façade

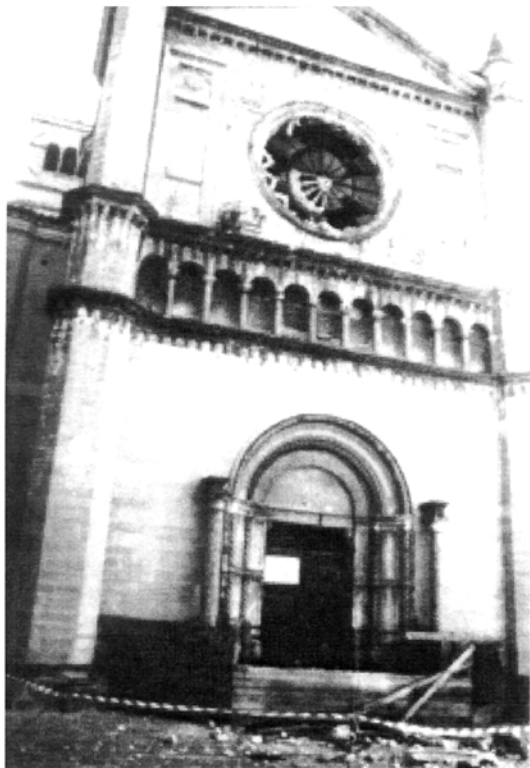
Plate 3.37: San Filippo Church, Nocera Umbra: damage to the upper part of the façade (overturning mechanism)

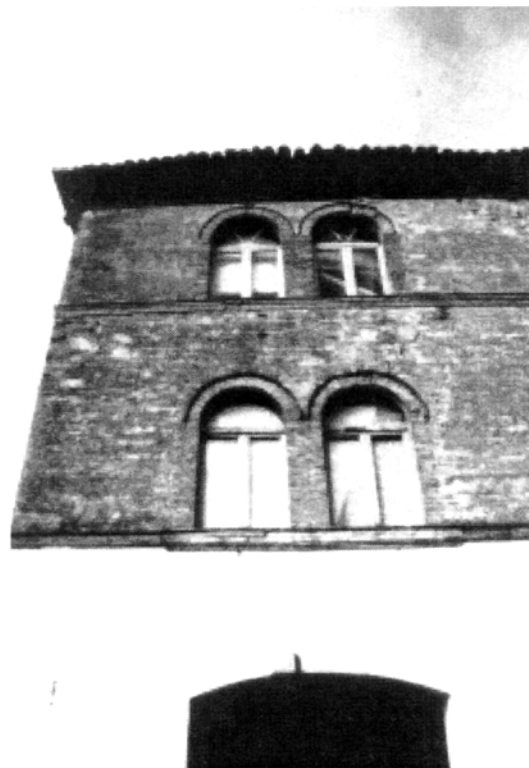
Plate 3.38: Nocera Umbra: central sub vertical cracks in building opposite San Filippo church, associated with ground movement
