THE KOCAELI, TURKEY EARTHQUAKE OF 17 AUGUST 1999

A FIELD REPORT BY EEFIT

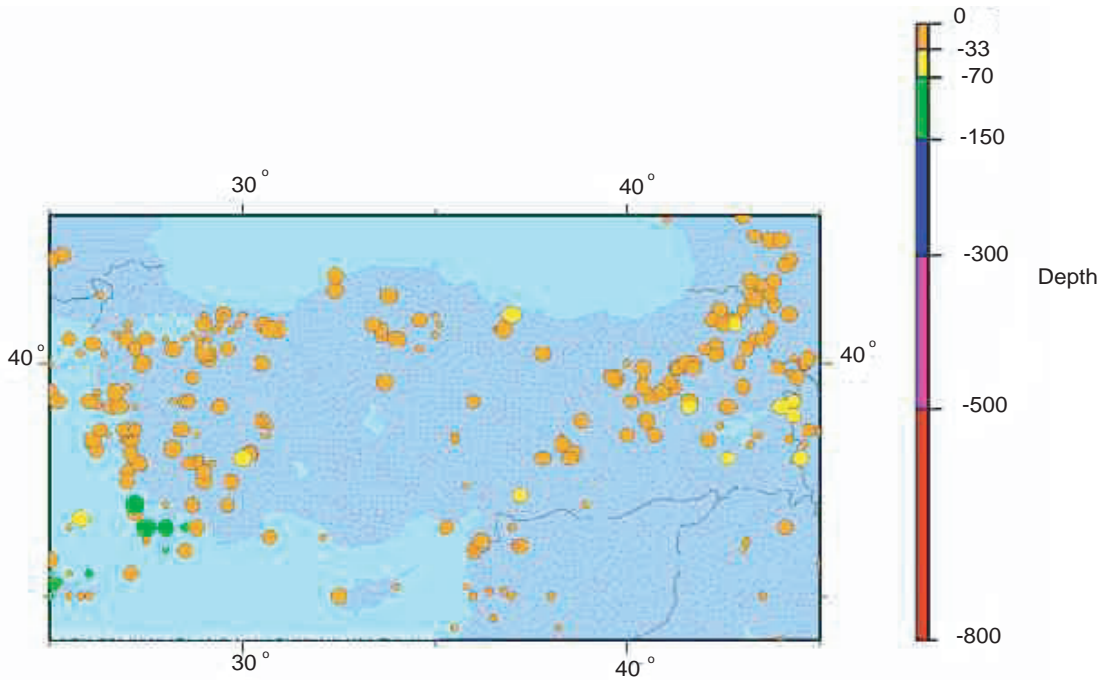
Figure 1.1: Distribution of damaging earthquake epicentres in the Anatolian peninsula (USGS)

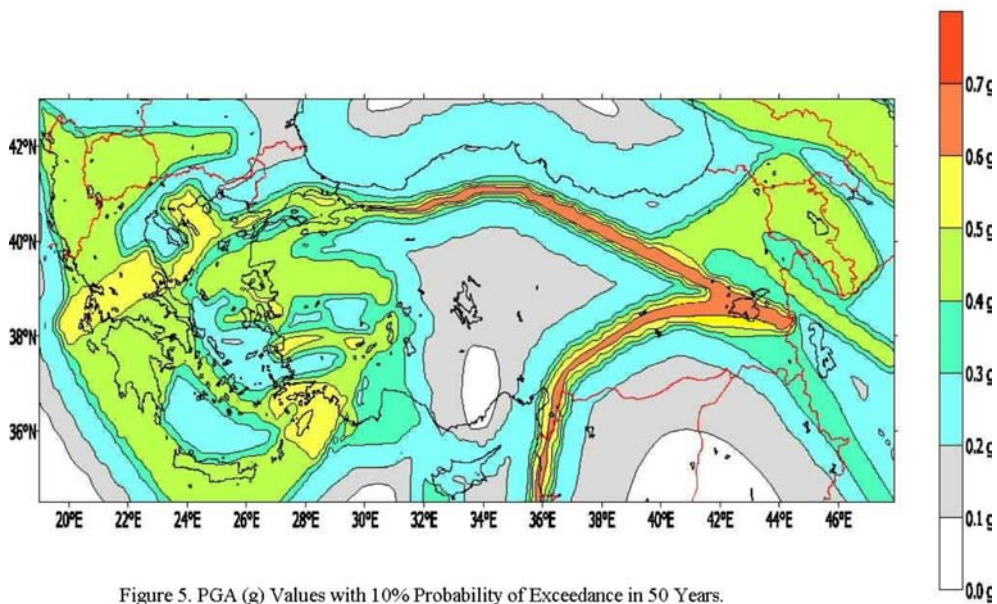
Figure 5. PGA (g) Values with 10% Probability of Exceedance in 50 Years.

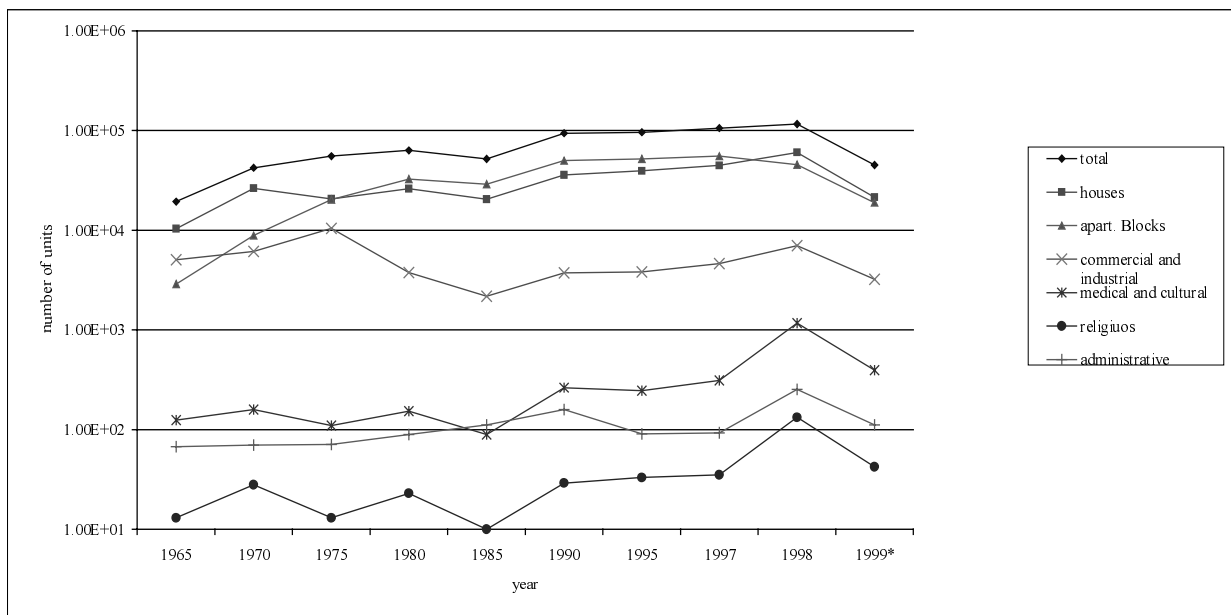
Figure 1.9: New construction classified by use in the period 1965-1998. Year 1999 data account for first quarter only.

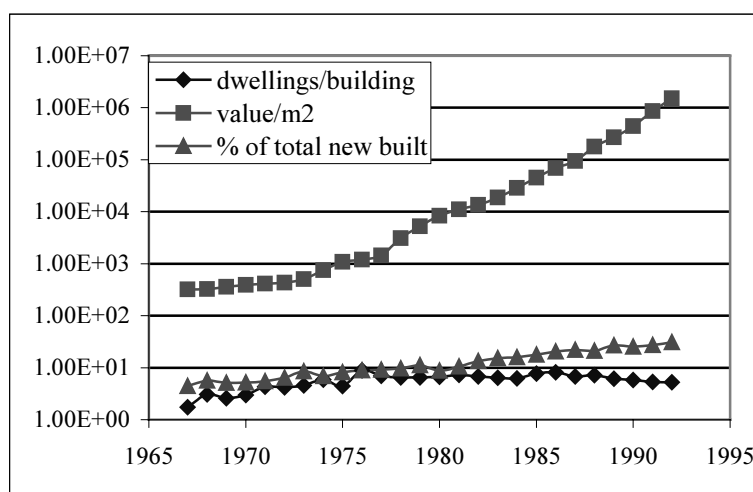
Figure 1.10: Statistics for co-operative financed residential buildings in Turkey.

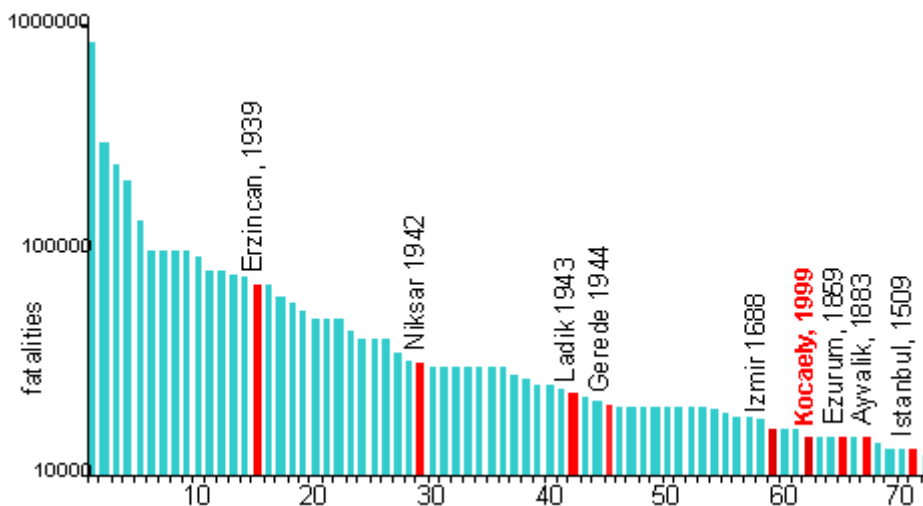
Figure 1.11: Ranking of destructive earthquakes world-wide by loss of life. Turkish earthquakes (labelled) account for 12% of all disasters in this figure, and though the loss of life in 1999 exceeded 17000, it ranks 62nd in the catalogue.

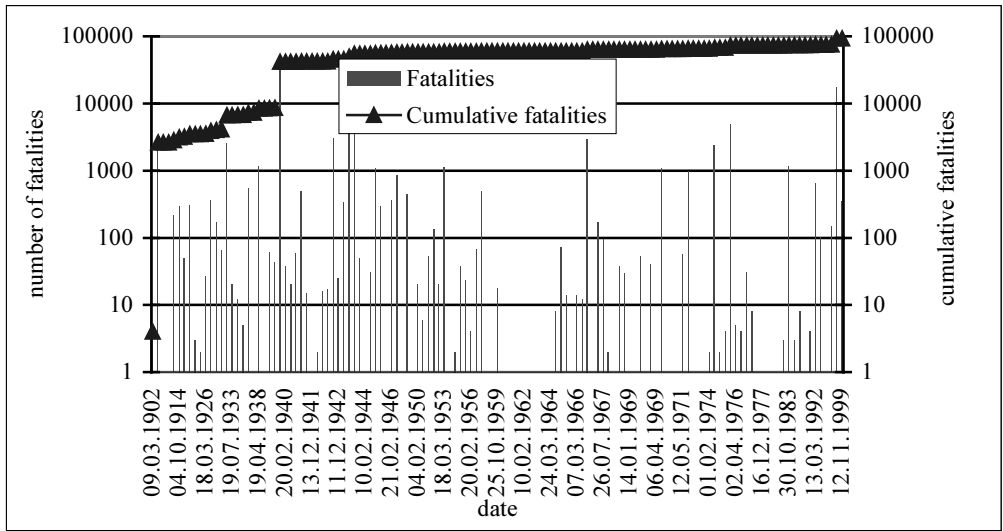
Figure 1.14: Number of fatalities by earthquake, and their cumulative contribution for the period 1900-1999. Note that the time scale is non-linear.

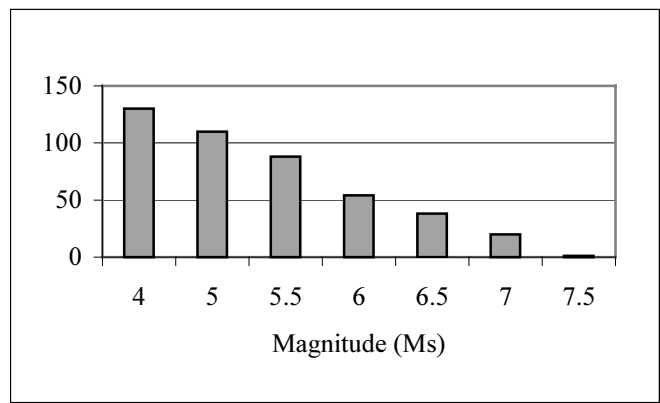
Figure 1.15: Cumulative number vs magnitude distribution of Turkish earthquakes, 1900-1999

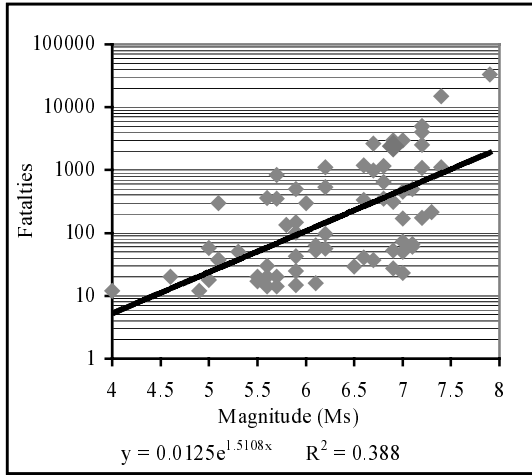
Figure 1.16: Distribution of fatalities as function of earthquake magnitude Ms

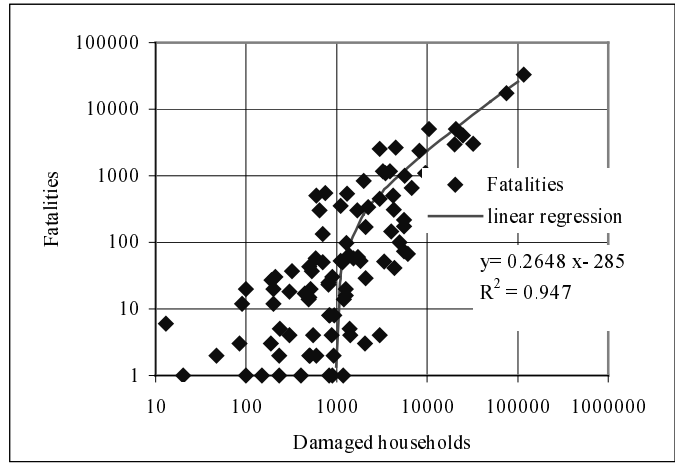
Figure 1.17: Correlation between damaged households and fatalities

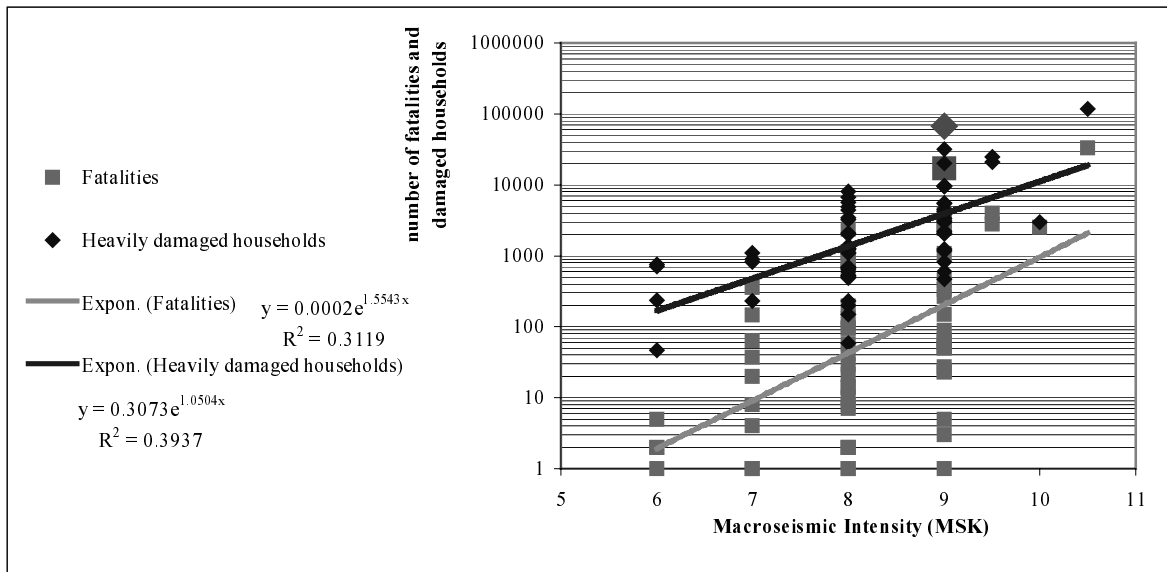
Figure 1.18: Distribution of damaged households and fatalities by intensity. Symbols representative of the Kocaeli earthquake are of greater dimension

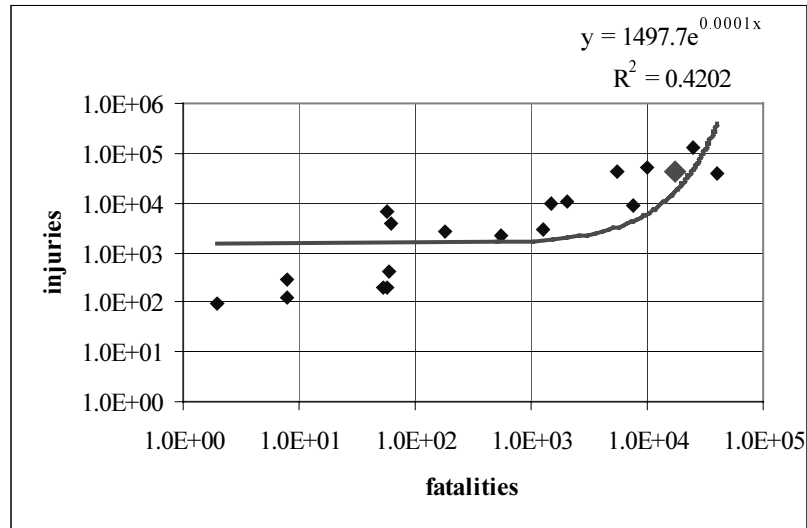
Figure1.19: Correlation between fatalities and injuries in 20 earthquakes worldwide from 1970 to date (Kocaeli event, larger symbol on diagram)

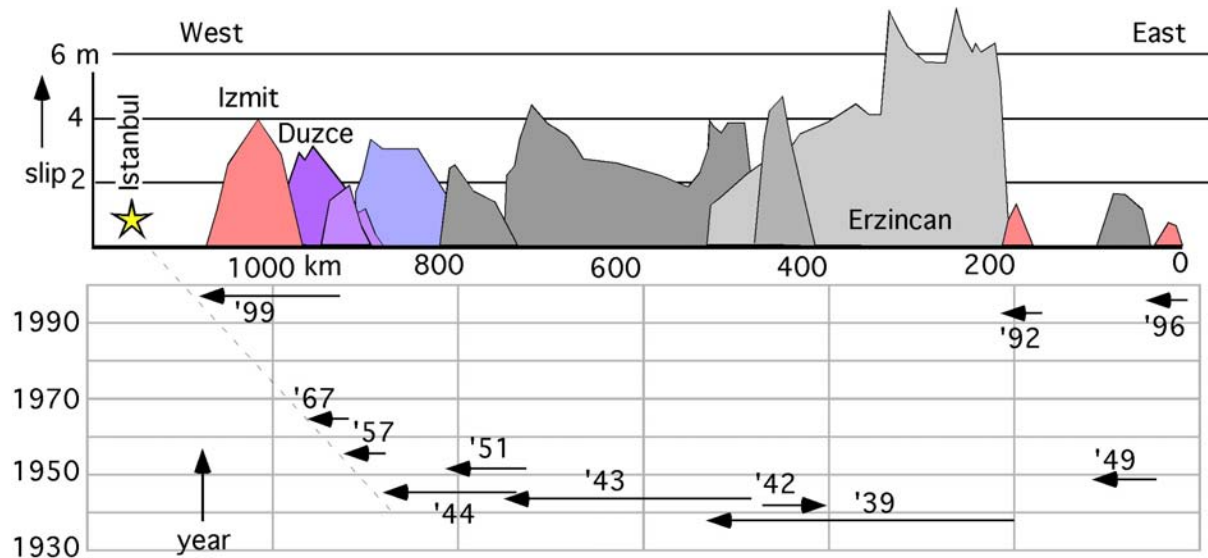
Figure 2.2: The most recent sequence of earthquakes started in 1939 and has propagated westward with occasional exceptions (figure after Stein et al. 1997). The central 640 km of the fault ruptured westward in the five years following 1939. Since 1944 there has been an approximately linear westwards propagation of the western tip of the rupture front of 200 km in 25 years (8 km/yr) which would suggest that the remaining segment of the fault near Istanbul (yellow star at km-1200) will be ready for rupture no later than 2025. Ruptures to the west are documented by Nalbant et al., 1998 and Hubert-Ferrari et al, 1999.

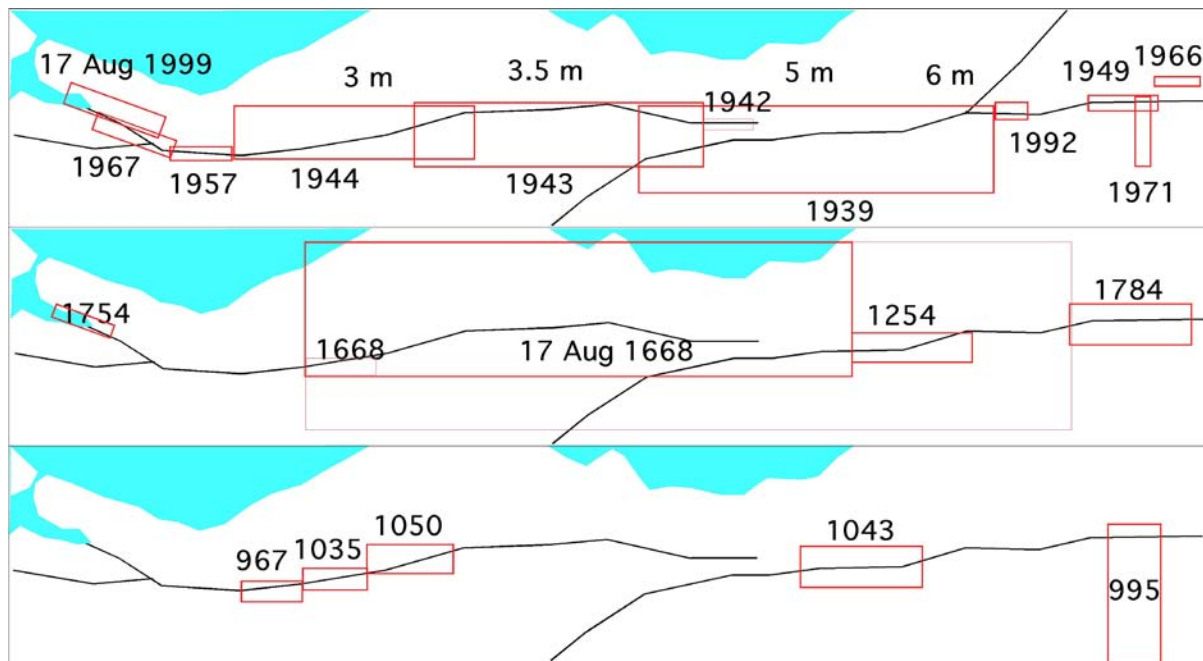
Figure 2.3: Historic ruptures (projection after Stein et al. 1977) with areas of boxes scaled to rupture length, The lower box shows the 967-1043 sequence, the middle box the 1668-1784 sequence. Geological and contemporary GPS measurements suggest that 22m of slip has accumulated on the fault since 937AD, yet if slip in pre-twentieth century events is assumed to be similar to that of the 1939-1999 sequence, only 12-15m is accounted for. Simple scaling laws applied to the August 17 1668 event suggest that it may have been associated with 7 to 9m of slip, thereby accounting for the apparent slip deficit on the fault since 967

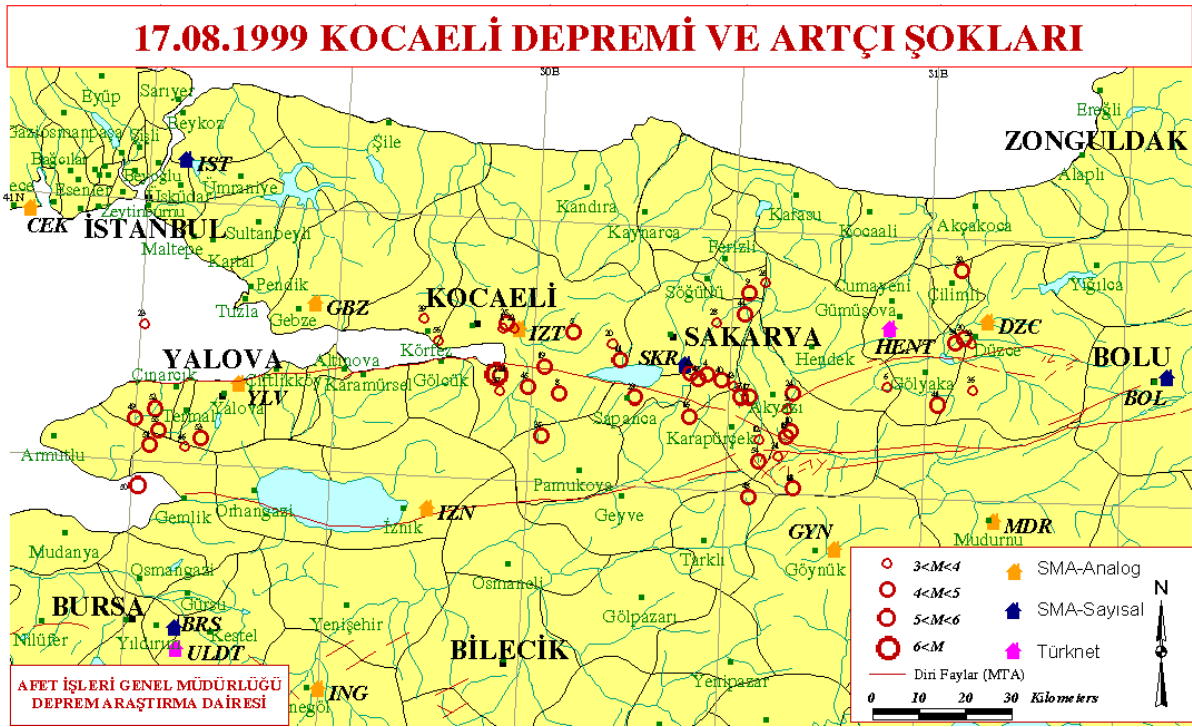
Figure 2.4 Locations of instruments of terrestrial and teleseismic networks and location of aftershocks

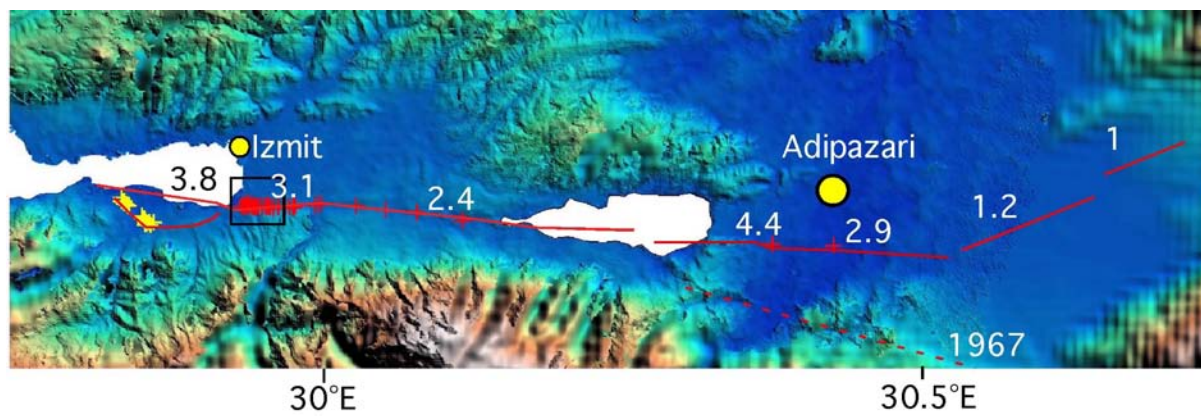
Figure 2.5: 100-km-long ERS1/2 composite SAR image in which gaps caused by steep slopes or heavy vegetation (resulting in incoherence) have been filled with ETOPO30 DTED (by Eric Fielding). Red crosses indicate EEFIT-measured fault offsets located using GPS and taped to 0.1 m accuracy. Yellow crosses indicate measurements across the western margin of a slump scarp that drowned the coast at the SE corner of Izmit Bay near Gölcük (Figure 2.7) The length of the fault inspected by the EEFIT team was 41 km. The total length of the rupture is approximately 100 km. The November 12 Düzce earthquake propagated 40 km eastward from the eastern edge of this map with maximum slip of ≈ 4 m. Black square shows location of Figure 2.6.

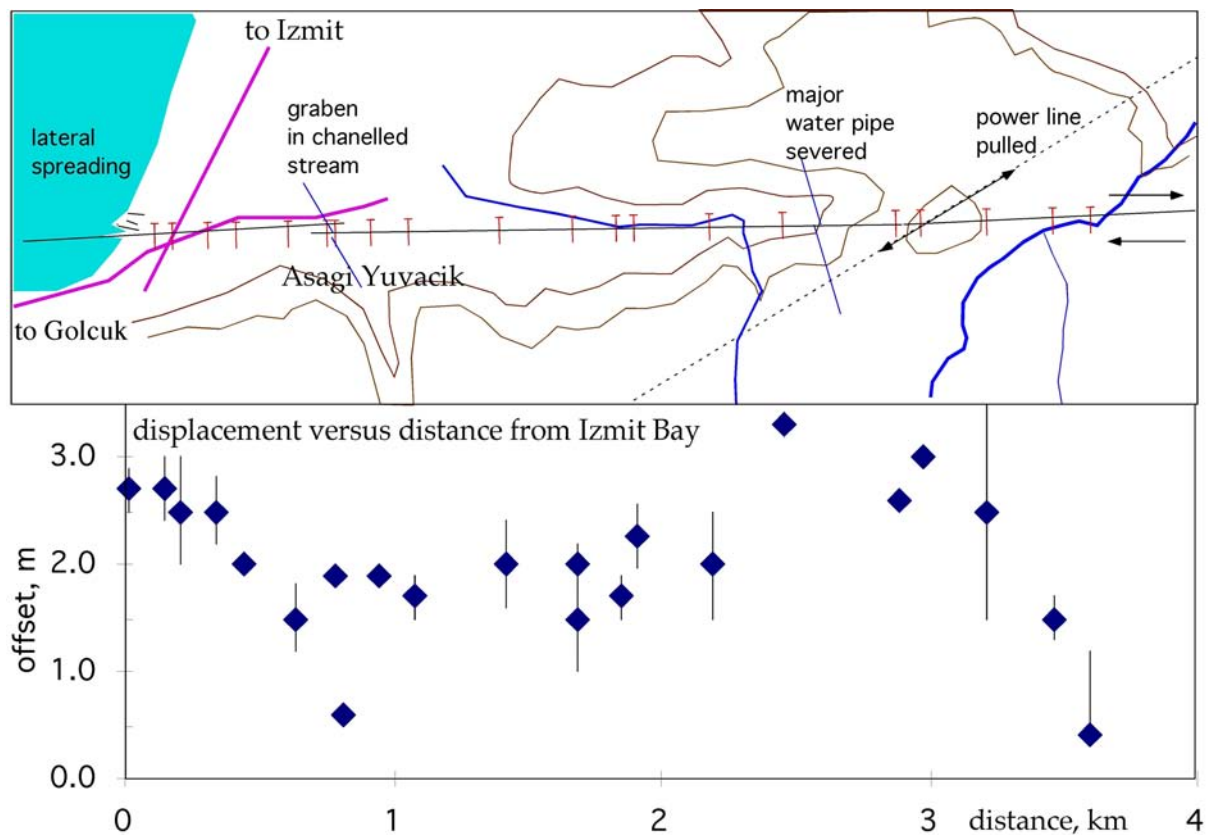
Figure 2.6: Map and slip distribution of rupture offsets for 4 km of the fault near Izmit.

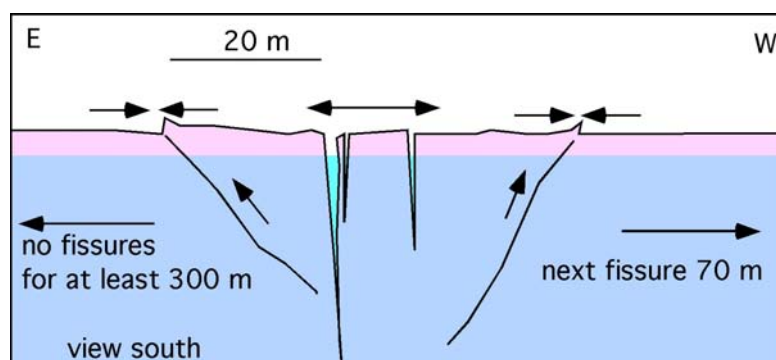
Figure 2.8: Inferred cross-section through fissure approximately 1 km north of Adapazari Railway Station. The fissure shows compression fractures near edges of the tension fissures suggestive of pounding of the tension gashes during strong ground shaking. The water table is within 1 m of the surface.

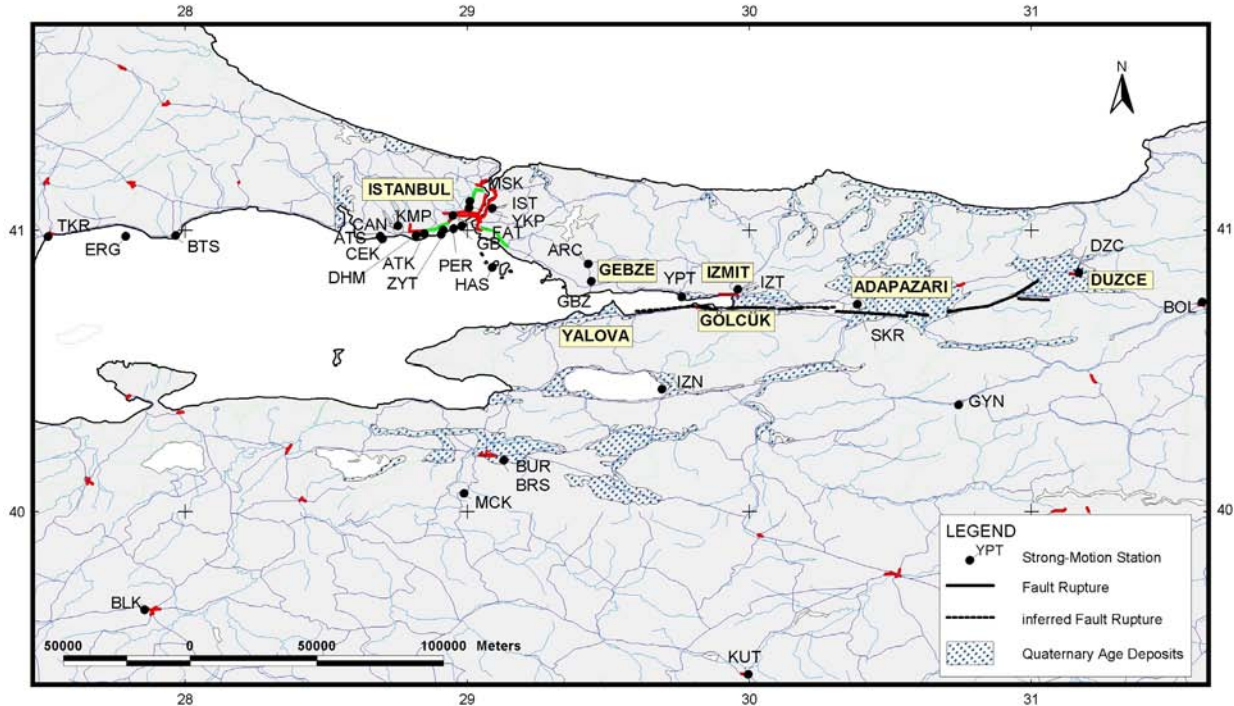
Figure 3.1: Location of the instrumentation and peak ground acceleration recorded. Indicative fault rupture line

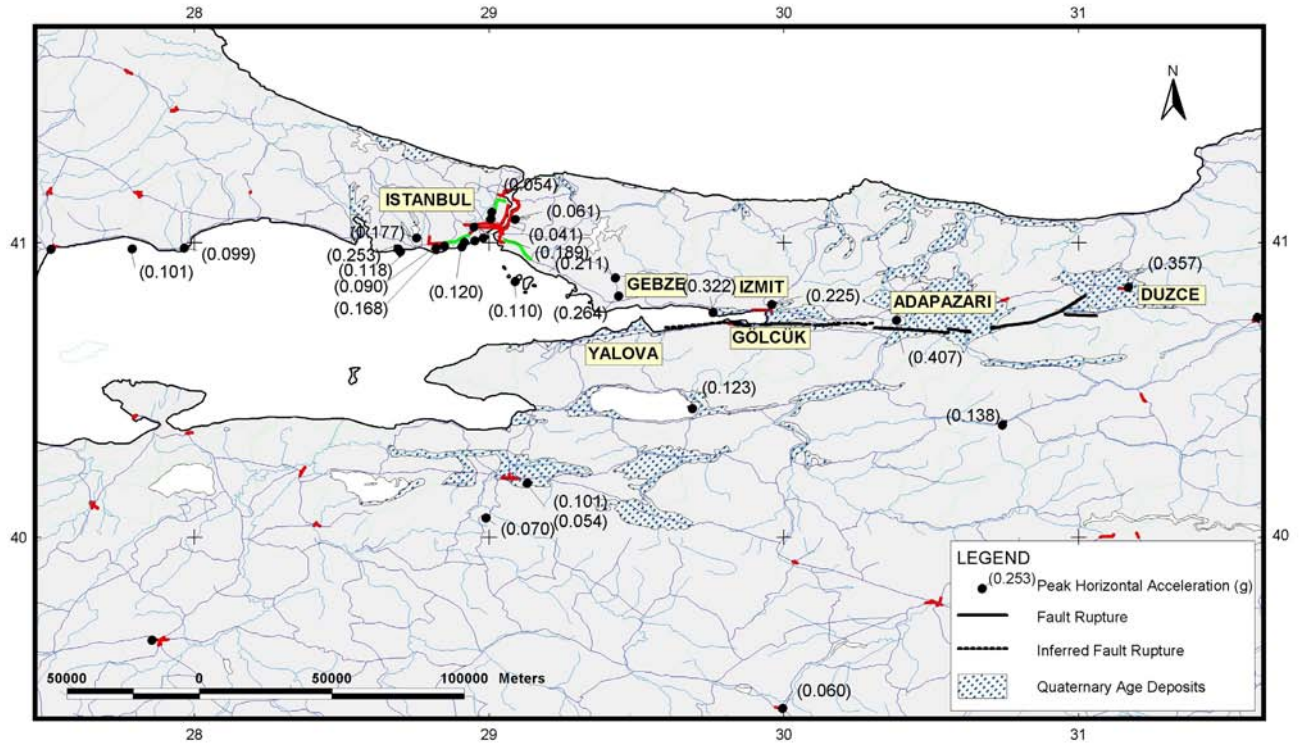
Figure 3.2: Distribution of peak horizontal acceleration in earthquake region. For station names refer to Figure 3.1. (Location of fault rupture from Lettis et al. 2000. Location of Quaternary Age Deposits from Emre et al. 1998.).

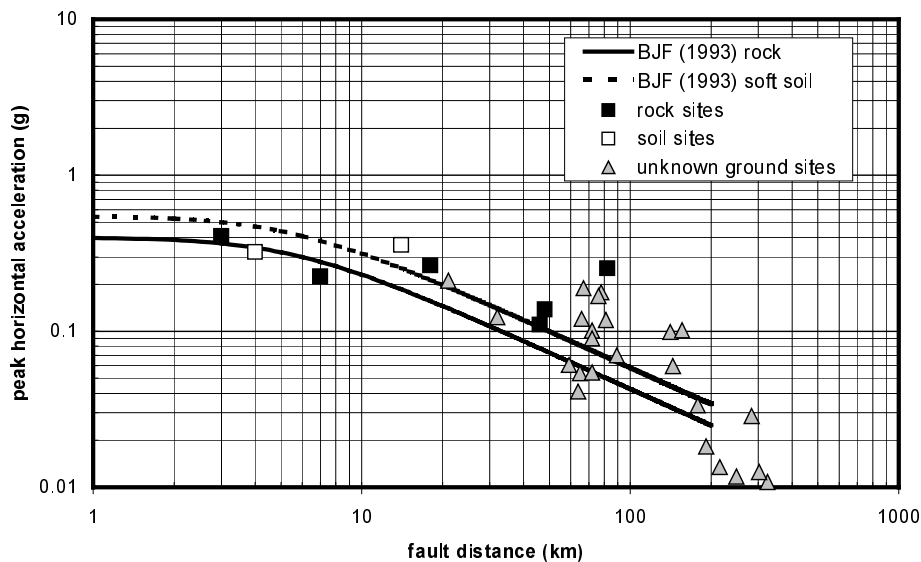
Figure 3.3: Plot of peak horizontal acceleration versus fault distance. Also shown are attenuation relationship curves of Boore et al. (1993) for rock (solid line) and soft soil (dashed line) for a magnitude $M_w = 7.4$.

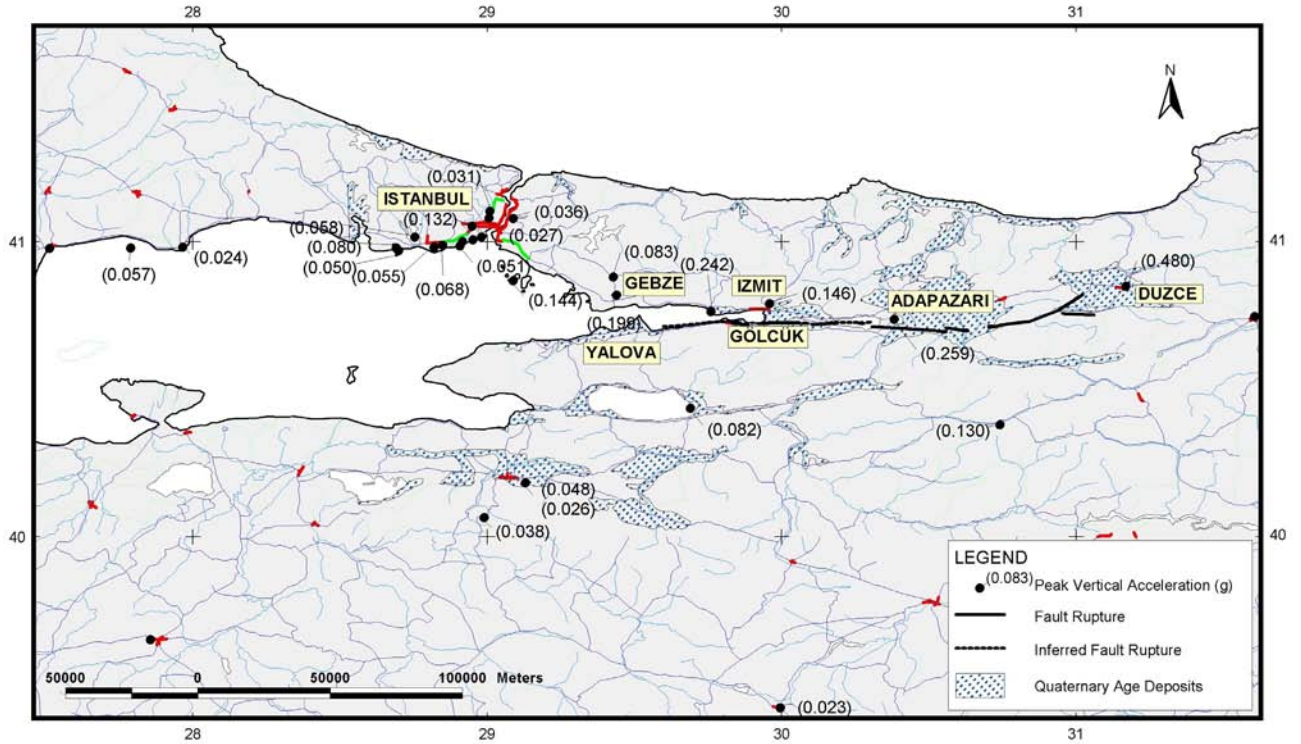
Figure 3.5: Distribution of peak vertical acceleration in earthquake region. For station names refer to Figure 3.1. (Location of fault rupture from Lettis et al. 2000. Location of Quaternary Age Deposits from Emre et al. 1998.).

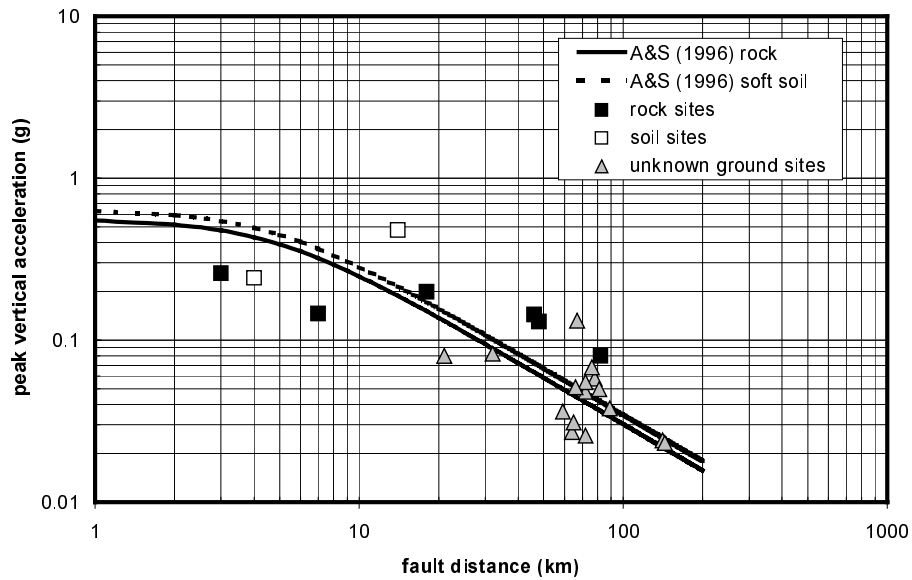
Figure 3.6: Plot of peak vertical acceleration versus fault distance. Also shown are attenuation relationship curves of Ambraseys and Simpson (1995) for rock and soft soil for a magnitude $M_S = 7.8$.

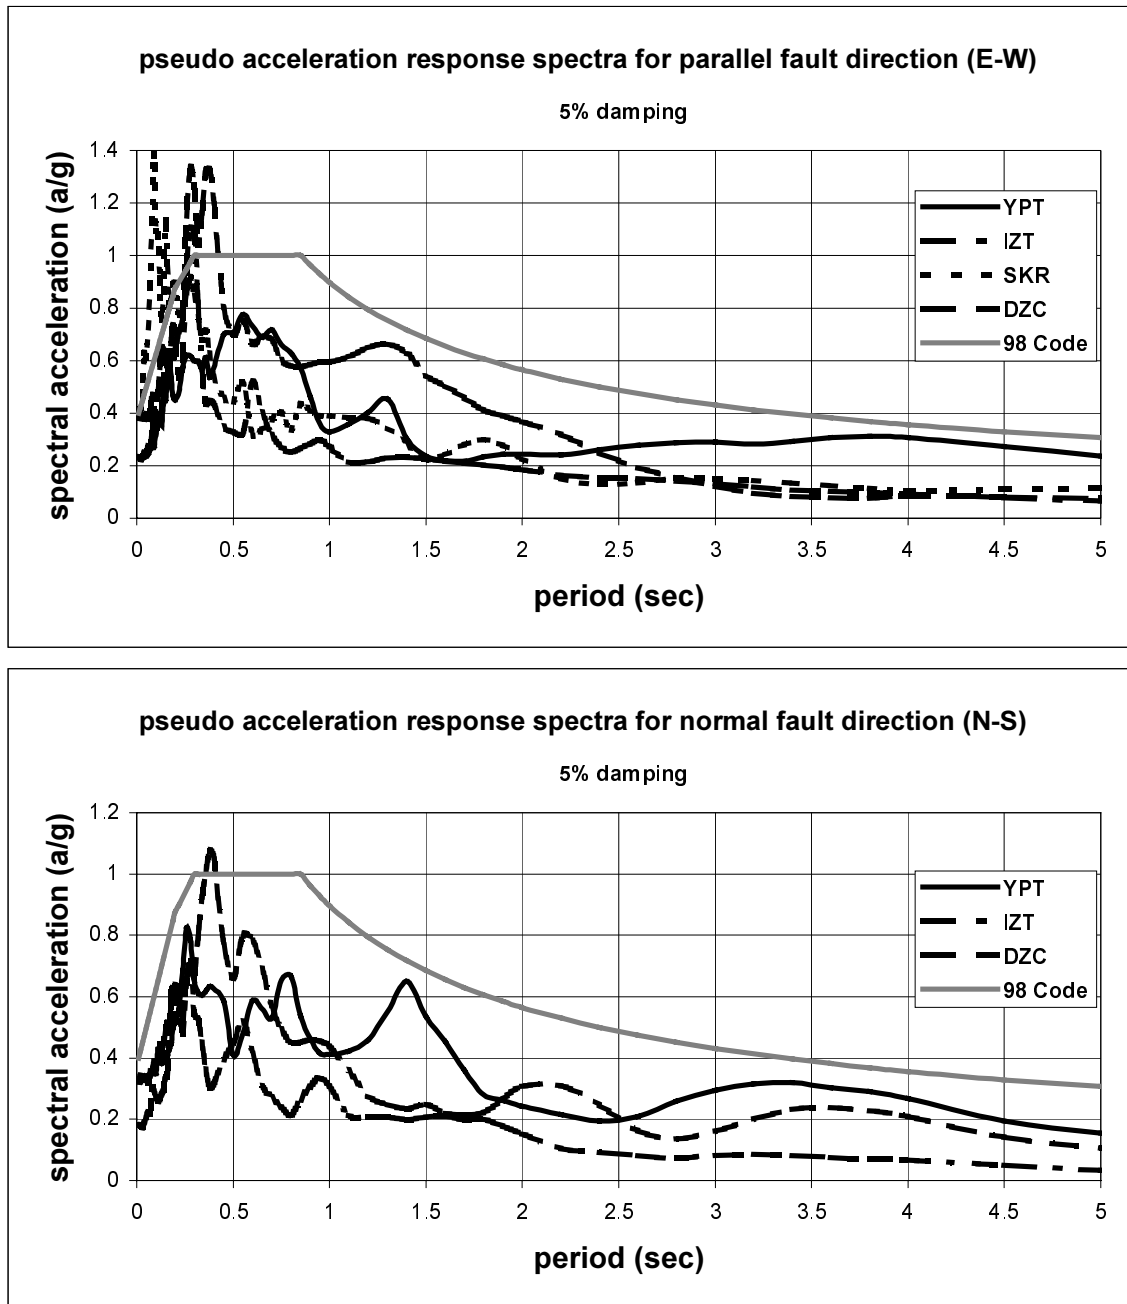
Figure 3.8: Pseudo-acceleration response spectra for the Yarimca Petkim (YPT), Izmit (IZT), Sakarya (SKR) and Duzce (DZC) horizontal acceleration components in the fault-parallel (E-W) and fault-normal (N-S) directions. Also shown is the Turkish Seismic Design Code (1998) design spectra for Sesismic Zone 1 and Local Site Class 4 (deep soft soil).

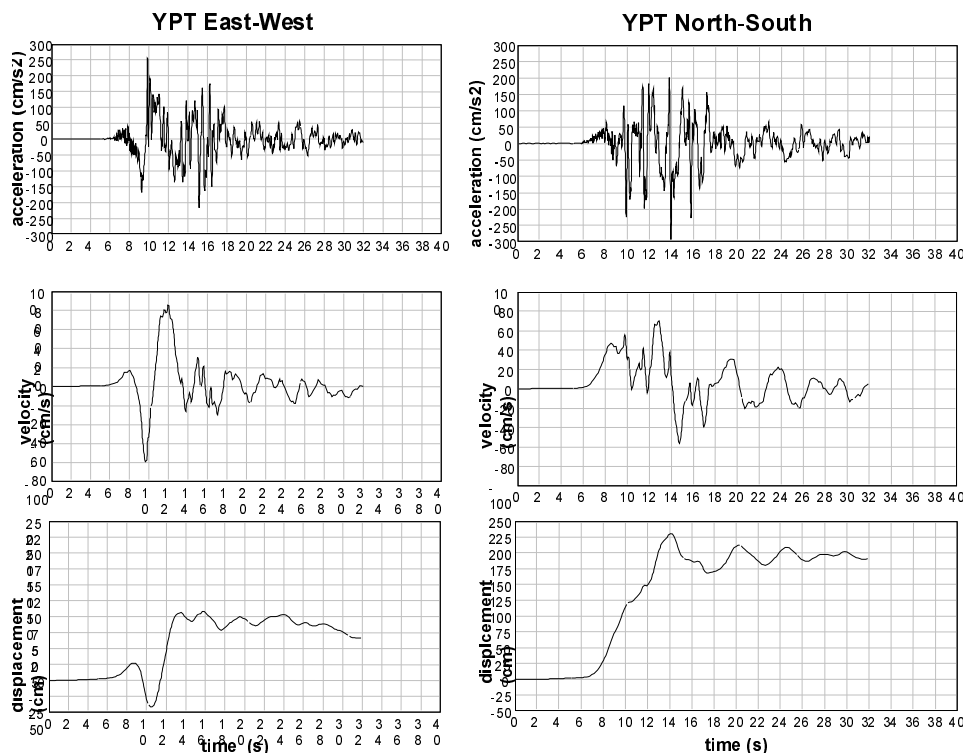
Figure 3.9a: Time histories of recorded acceleration (cm/s^2) and calculated velocity (cm/s) and displacement (cm) for the Yarimca Petkim Station (YPT) showing the pulse-like velocities and step-like displacements that are typical of near-field motions (from Safak *et al.* 1999).

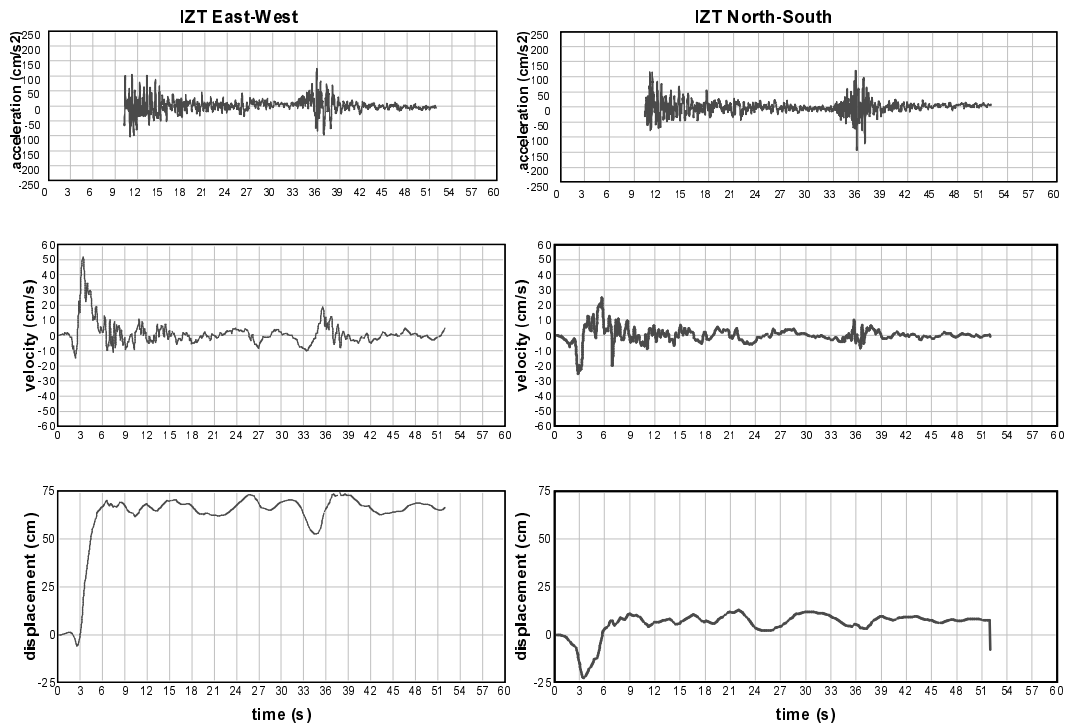
Figure 3.9b: Time histories of recorded acceleration (cm/s^2) and calculated velocity (cm/s) and displacement (cm) for the Izmit Station (IZT) showing the pulse-like velocities and step-like displacements that are typical of near-field motions (from Safak et al. 1999).

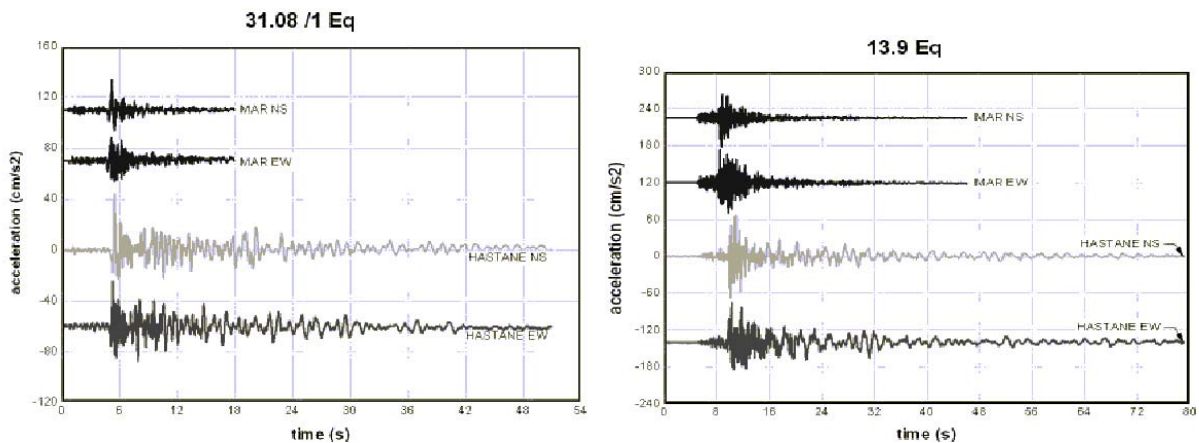
Figure 3.11: Horizontal acceleration time histories recorded at IMAR station (rock) and HASTANE station (soil) during the 31 August 1999 ($M_w = 5.2$) and 13 September 1999 ($M_w = 5.8$) aftershocks. Note the increase in amplitude and duration and shift in frequency content of the records recorded on soil (from Safak *et al.* 1999).

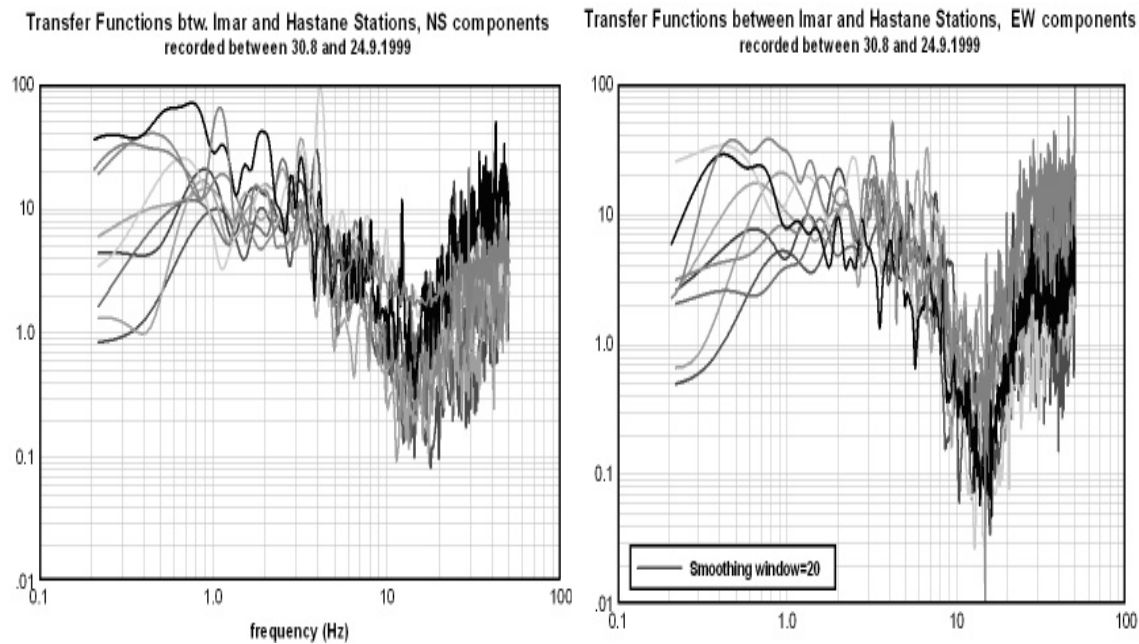
Figure 3.12: Soil-to-rock spectral ratio versus frequency (Hz) for horizontal motions from nine aftershocks recorded at the IMAR (rock) and HASTANE (soil) stations (from Safak et al. 1999).

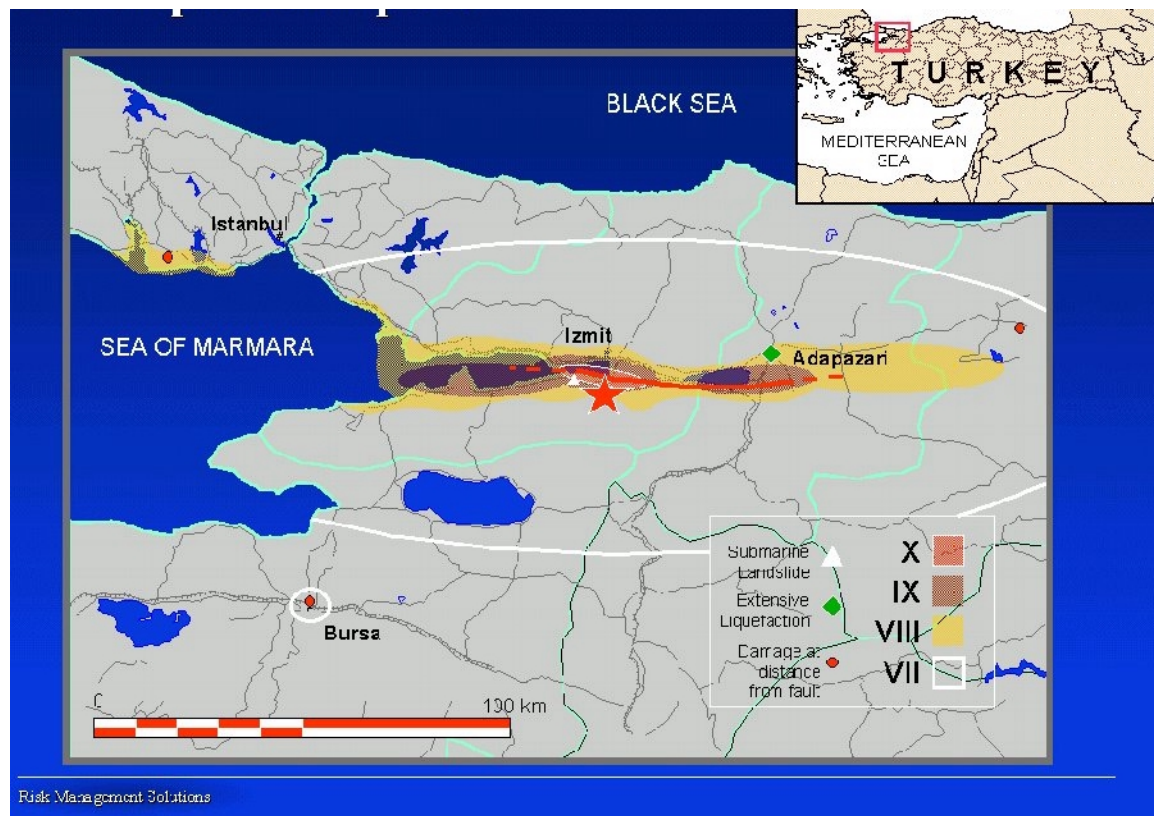
Figure 3.13: Macroseismic intensity map produced by RMS

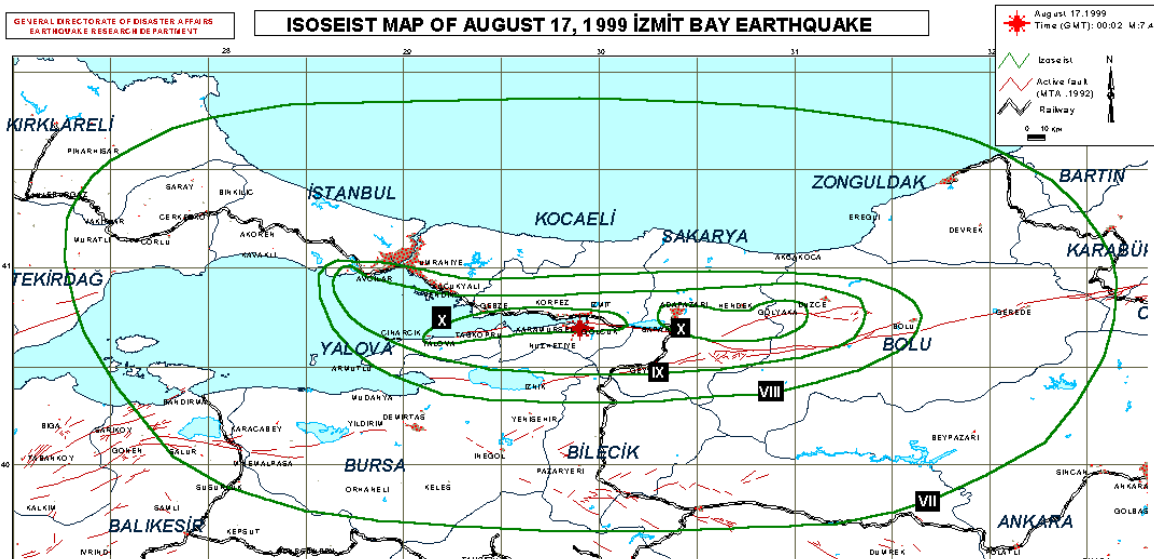
Figure 3.14: Macroseismic intensity map produced by ERD, General Directorate of Disaster Affairs

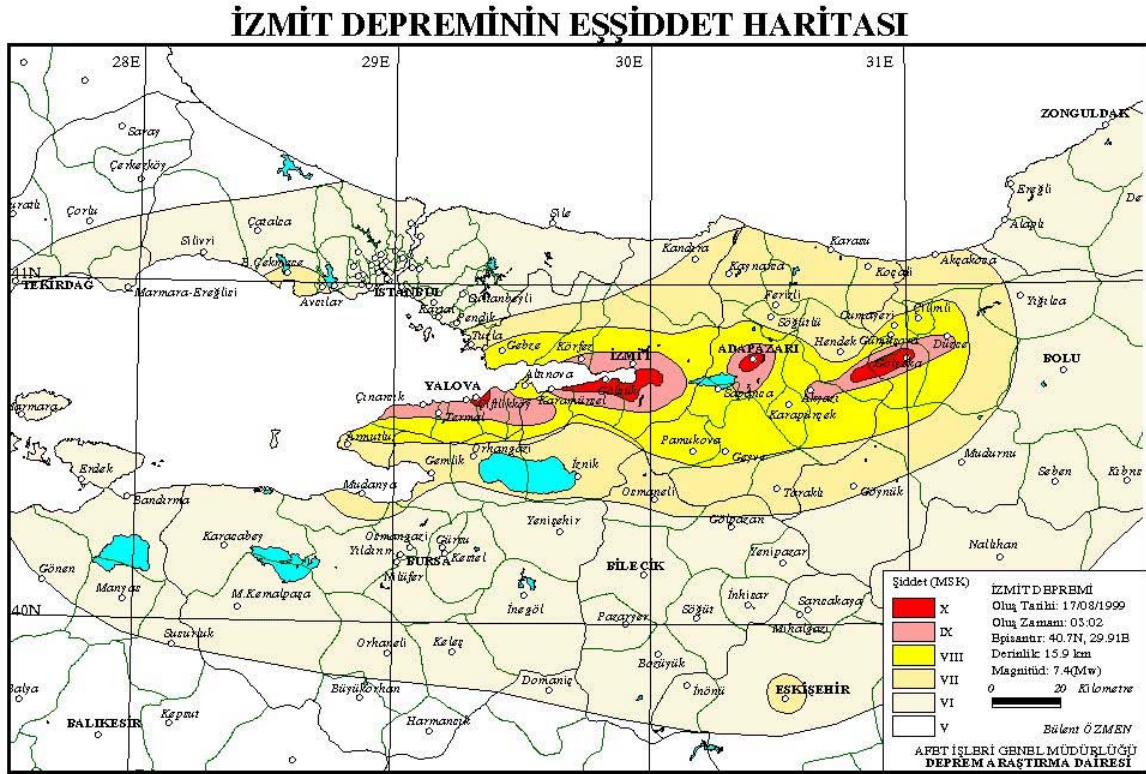
Şekil 3 : İzmit depreminin eşiddet haritası

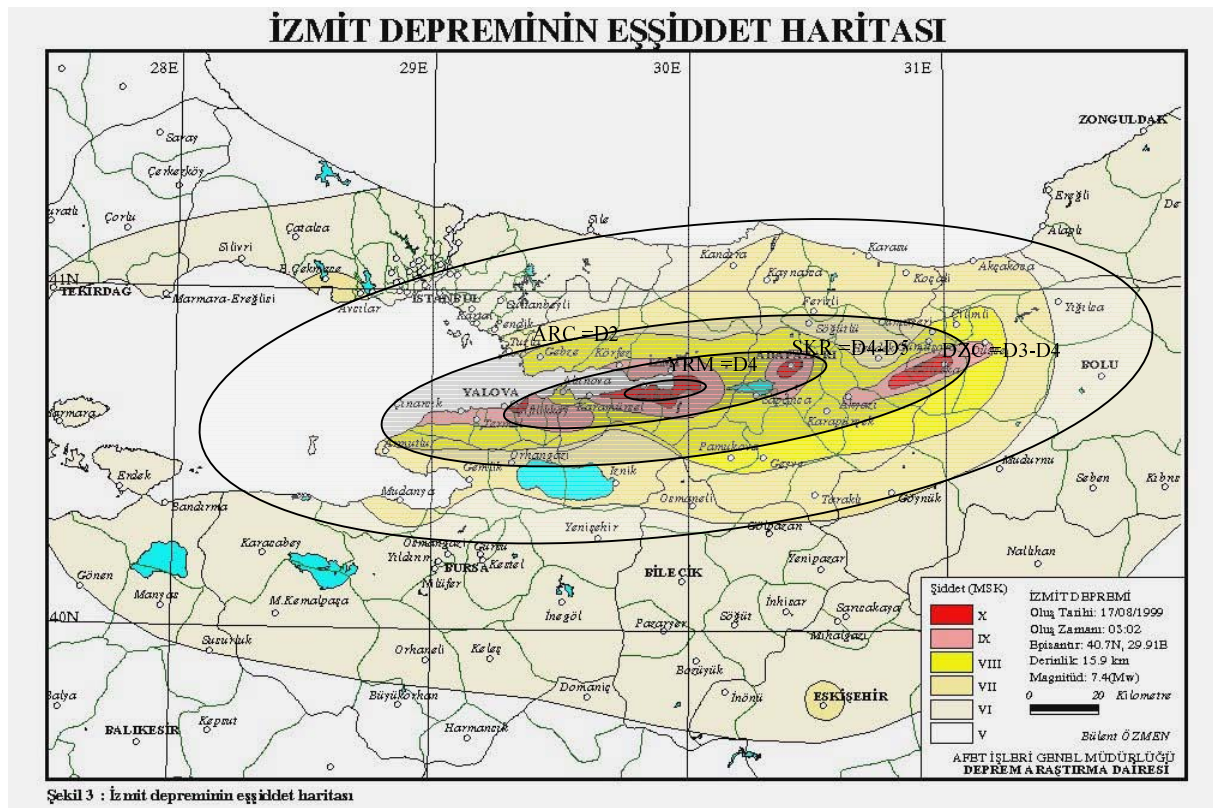
Figure 3.17 Comparison of calculated isoseismal and surveyed levels of damage according to MSK scale for degrees 10 to 7
