THE KOCAELI, TURKEY EARTHQUAKE OF 17 AUGUST 1999

A FIELD REPORT BY EEFIT

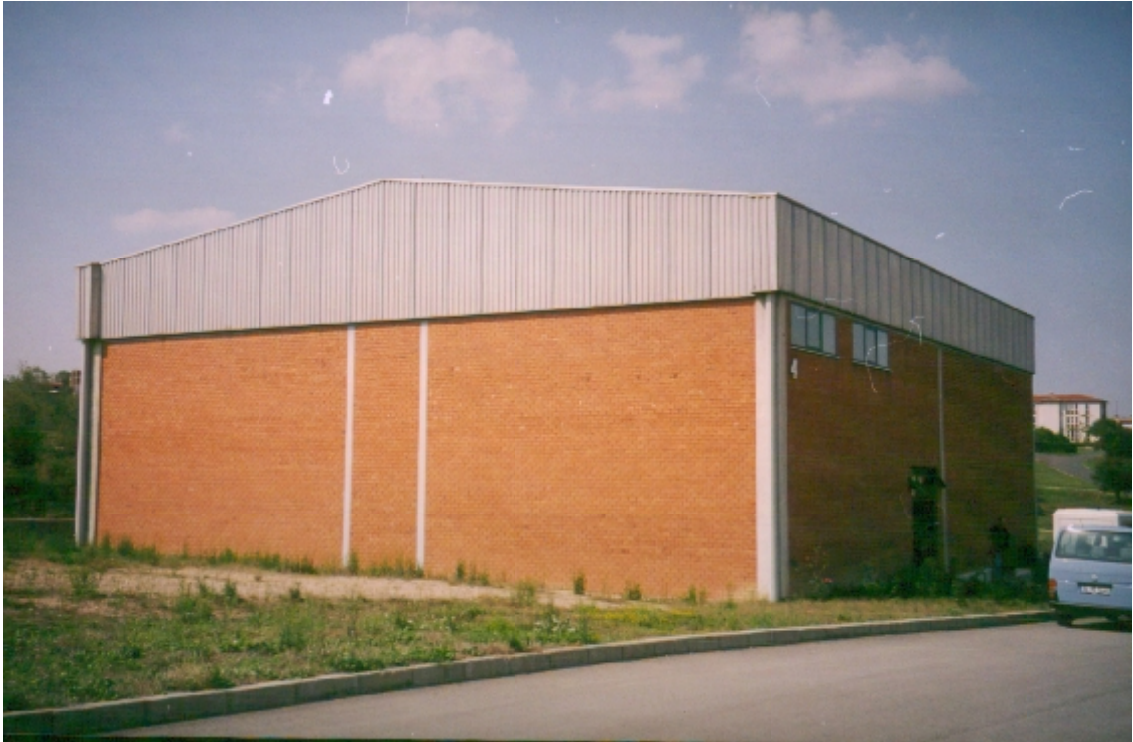
(9/9/99)	
Station Topography: Cut and fill slope benched on less than 5 degree slope. Structure within cut.	
Regional Geology: The Arcelik Facility is located in a shallow valley within a plateau composed of meta-sedimentary and metamorphic rocks (quartzite, limestone and schist) (Devonian Age?). Cut and fill platforms have been formed for the facility buildings.

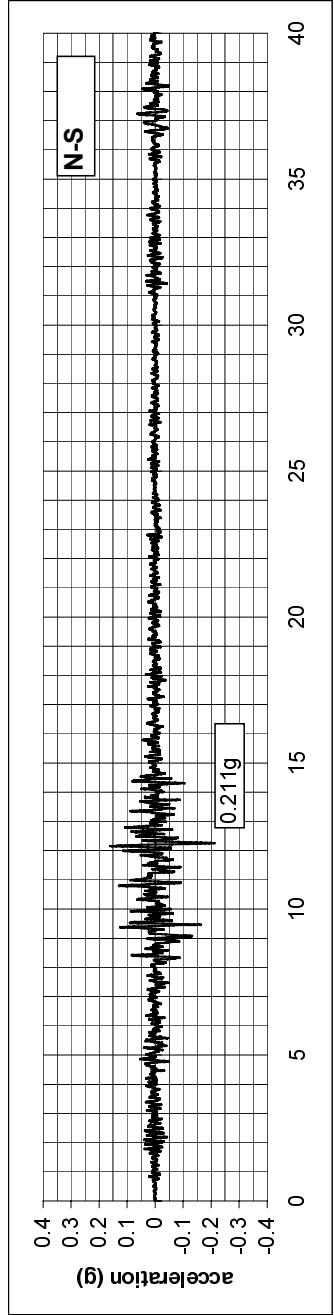
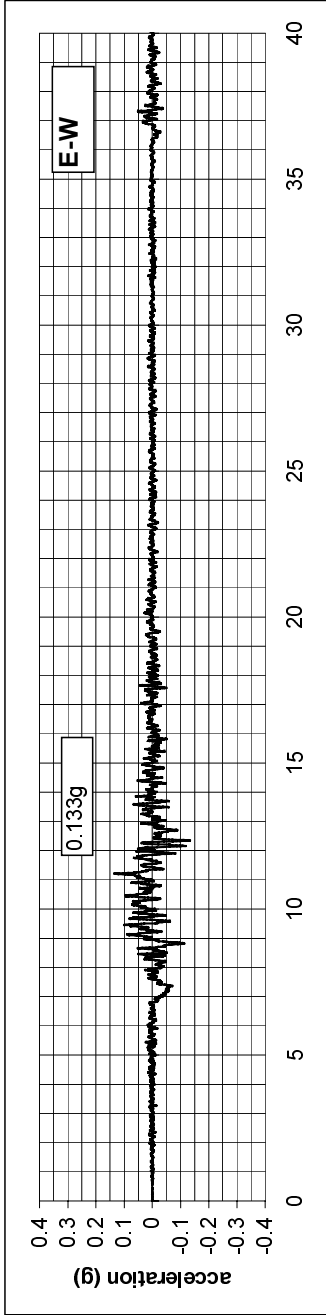
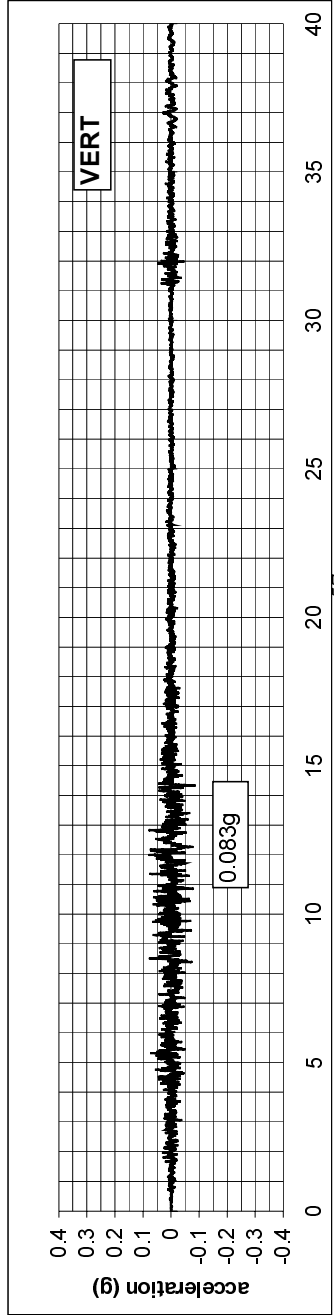
Event: Kocaeli, Turkey 17 August 1999
Station: Ambarlic Thermic Power plant
Code: ATS

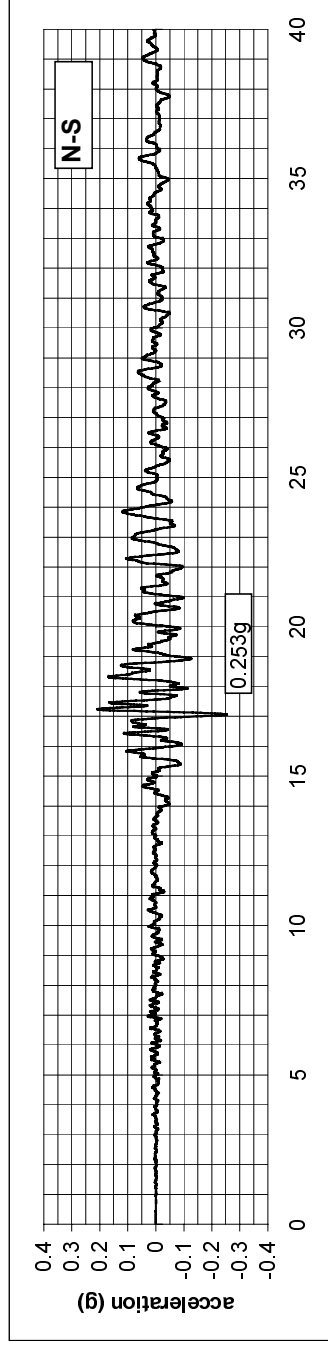
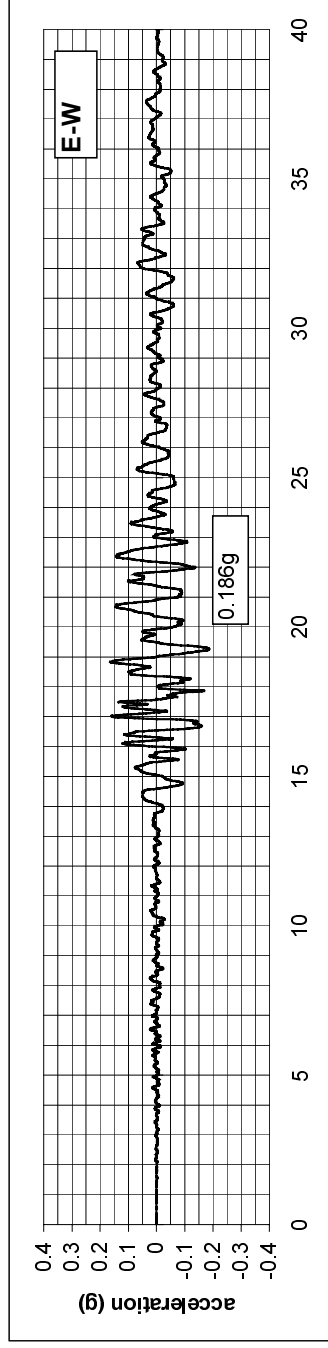
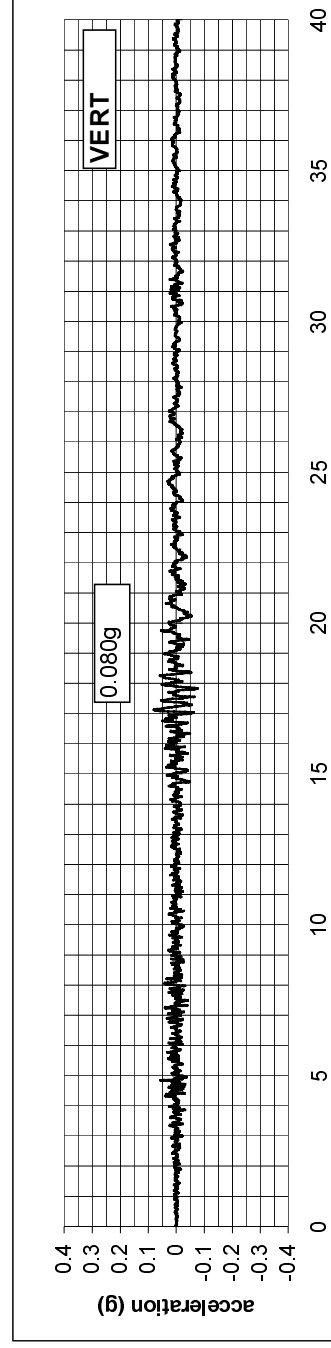
Event: Kocaeli, Turkey 17 August 1999
Station: Botas Gas Terminal?
Code: BTS (BOT)

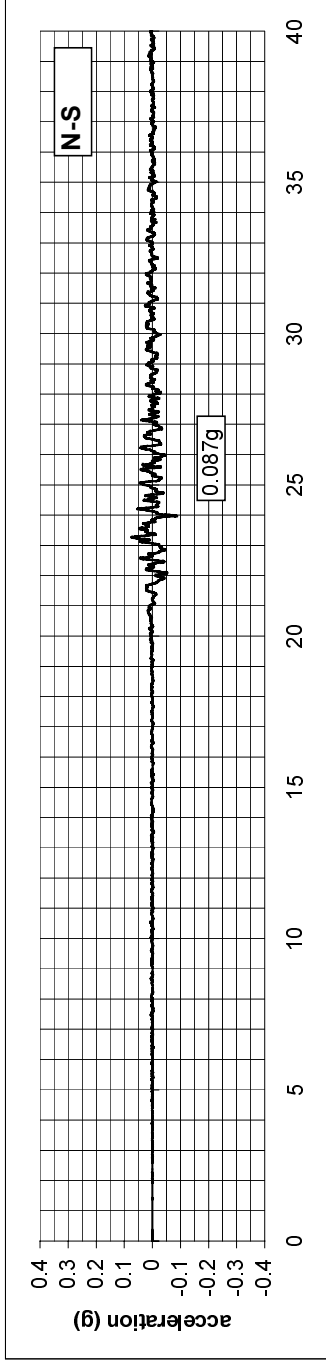
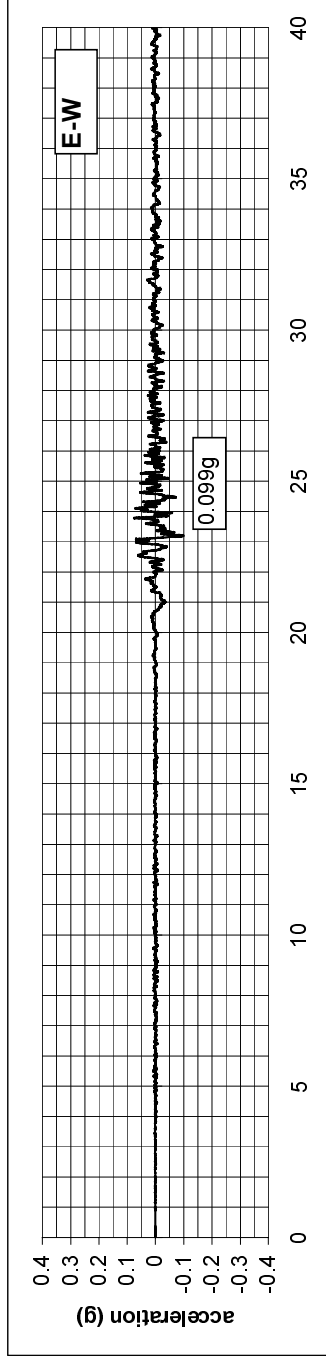
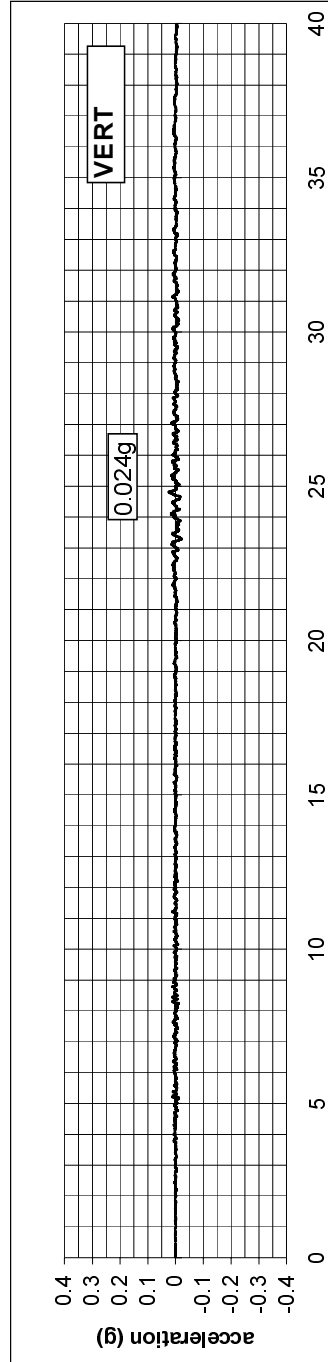
Event: Kocaeli, Turkey 17 August 1999
Station: Bursa Tofas Fabrikasi
Code: BUR

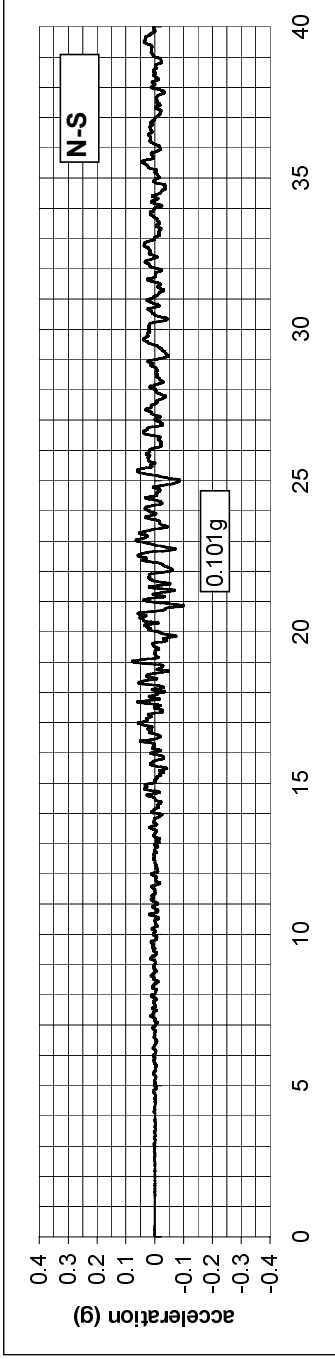
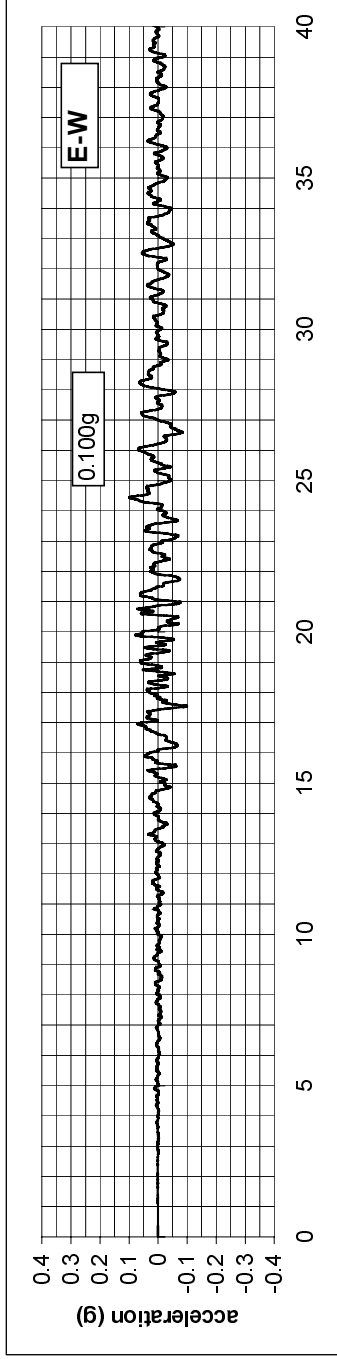
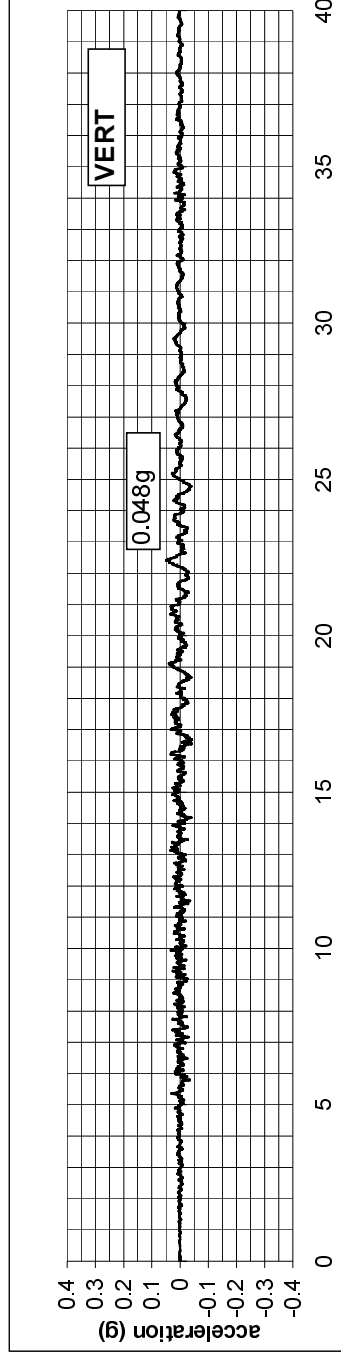
Event: Kocaeli, Turkey 17 August 1999
Station: Cekmece Nuclear Research Centre
Code: CEK

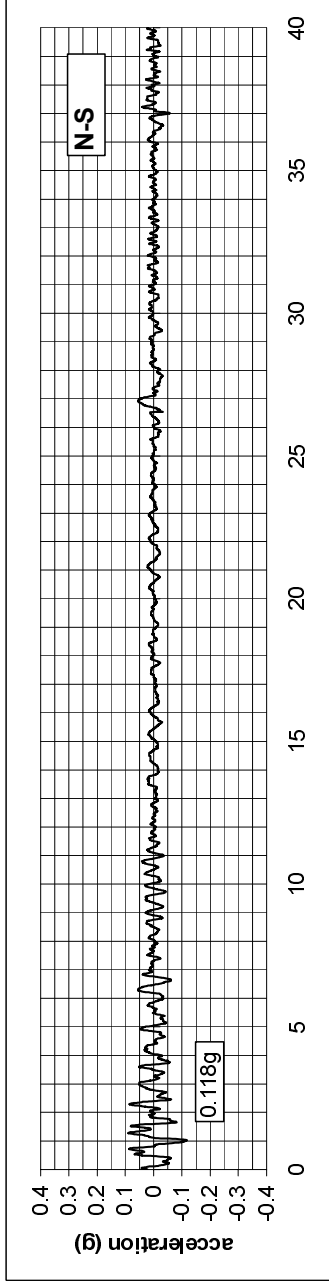
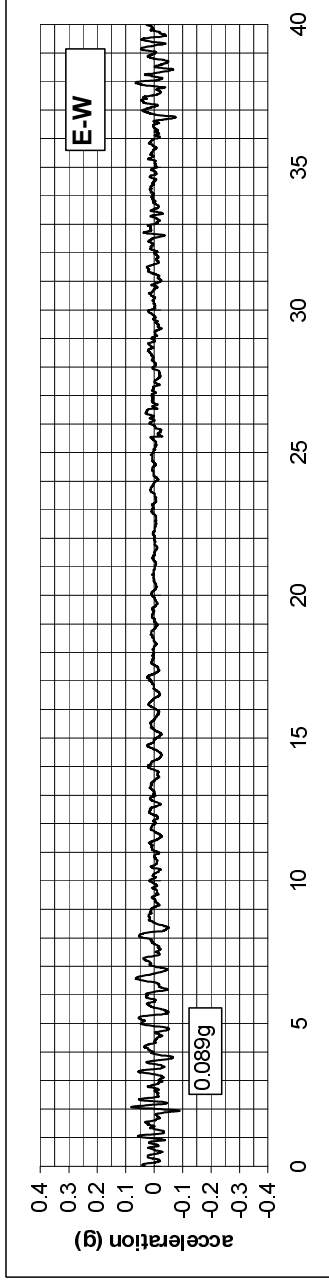
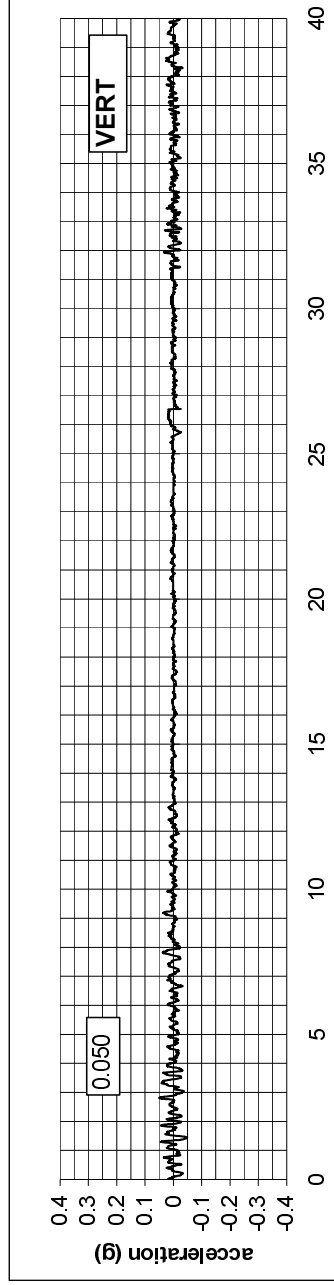
Event: Kocaeli, Turkey 17 August 1999
Station: Cekemece Nuclear Research Centre
Code: CNA

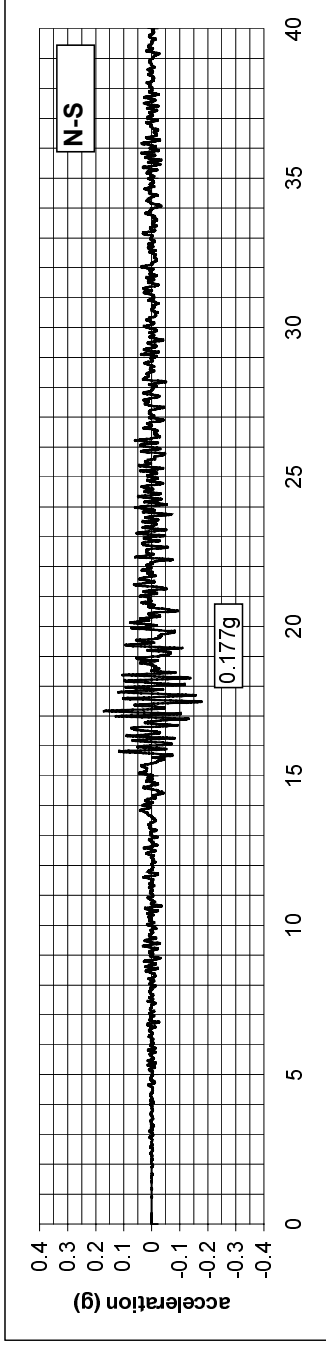
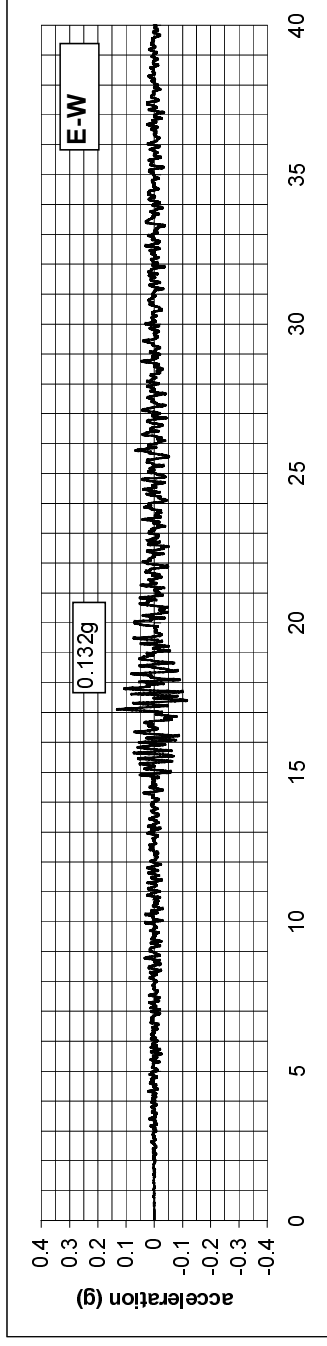
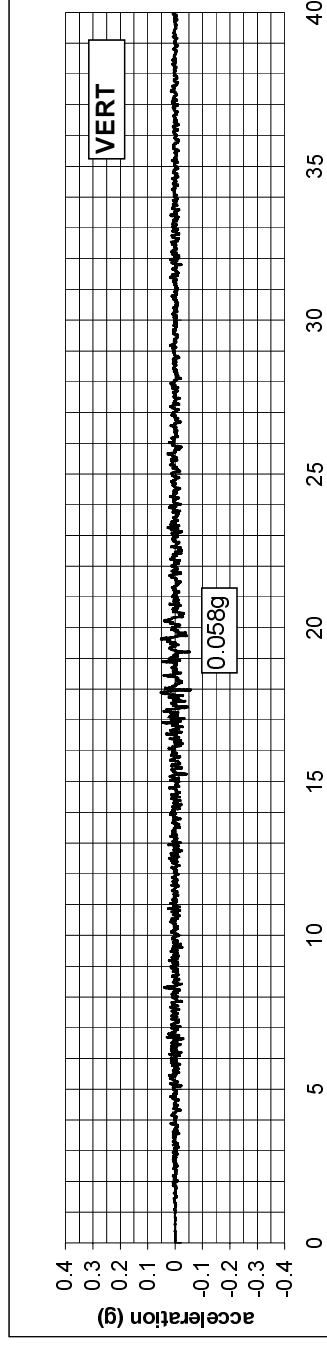
Event: Kocaeli, Turkey 17 August 1999
Station: Duzce Meterologi Istasyonu
Code: DZC

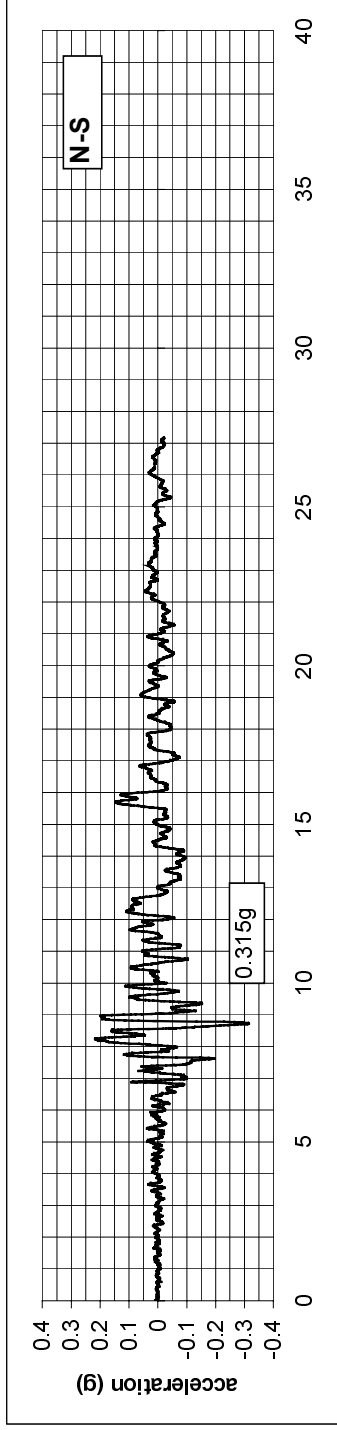
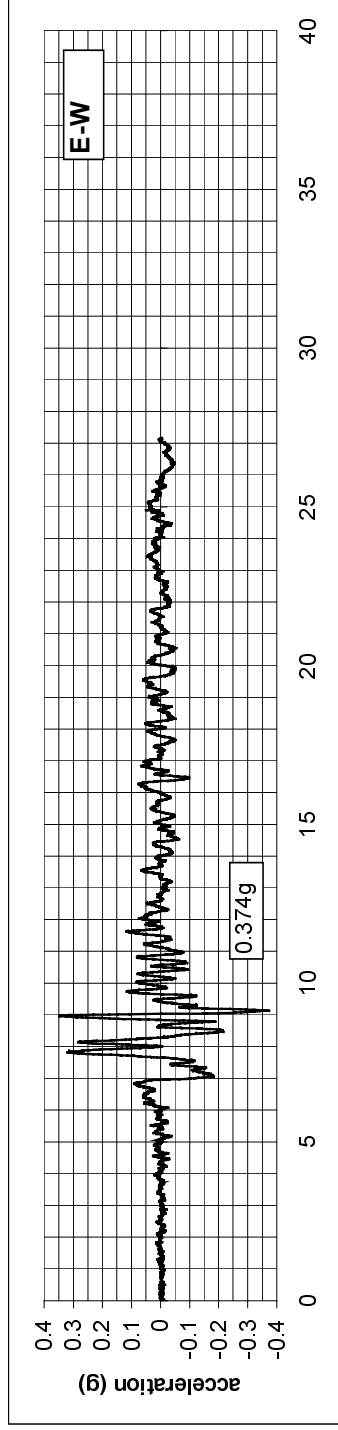
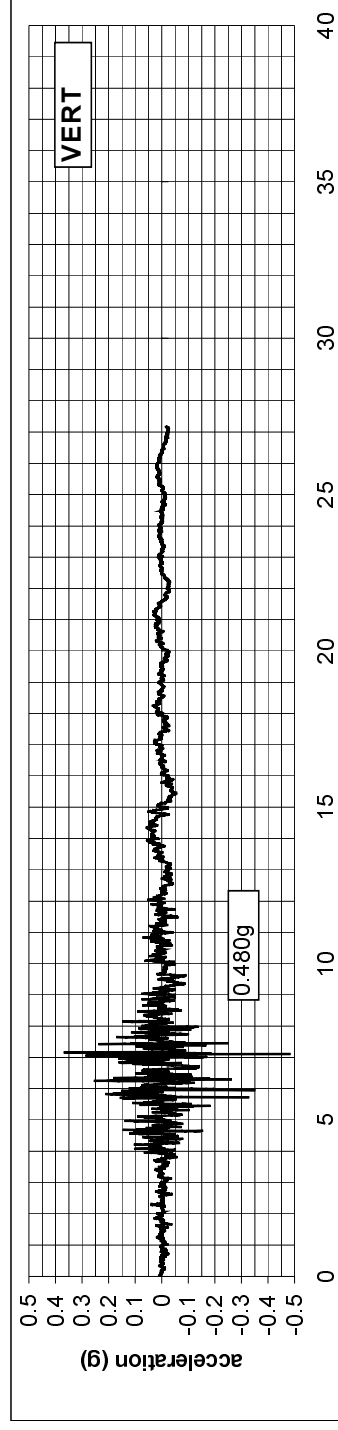
Event: Kocaeli, Turkey 17 August 1999
Station: Ereğli Kaymakamlık Binası
Code: ERG

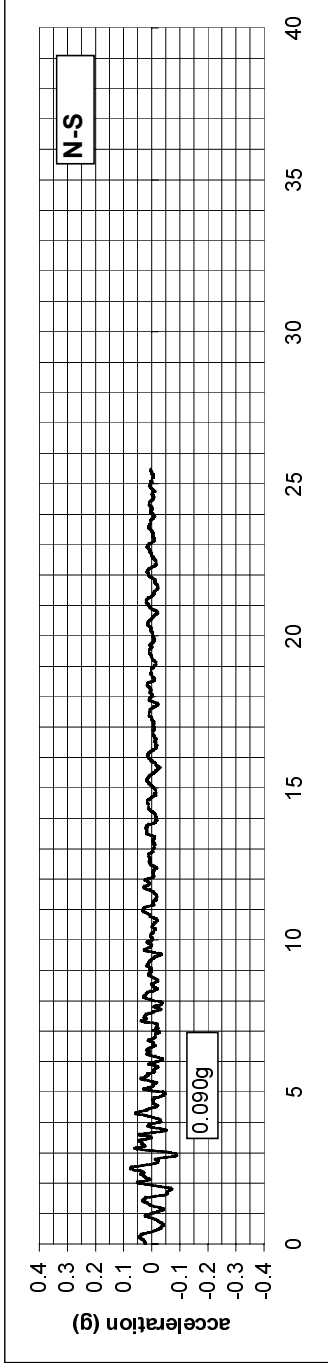
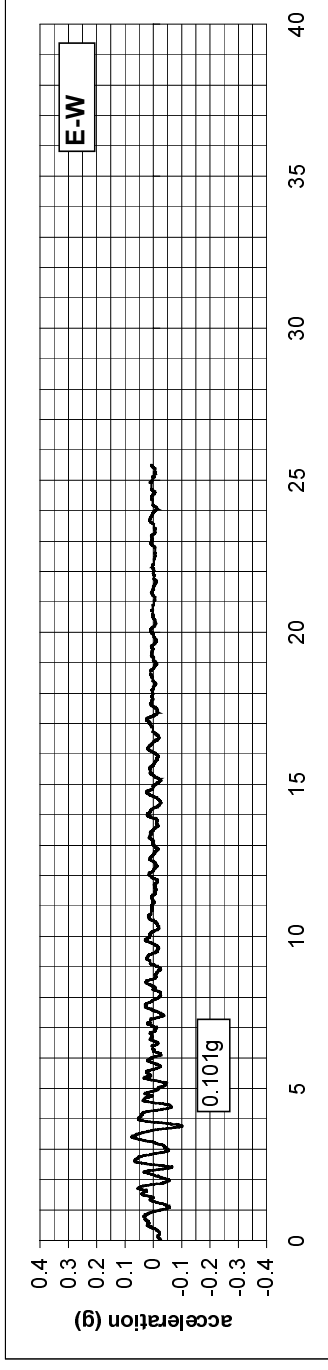
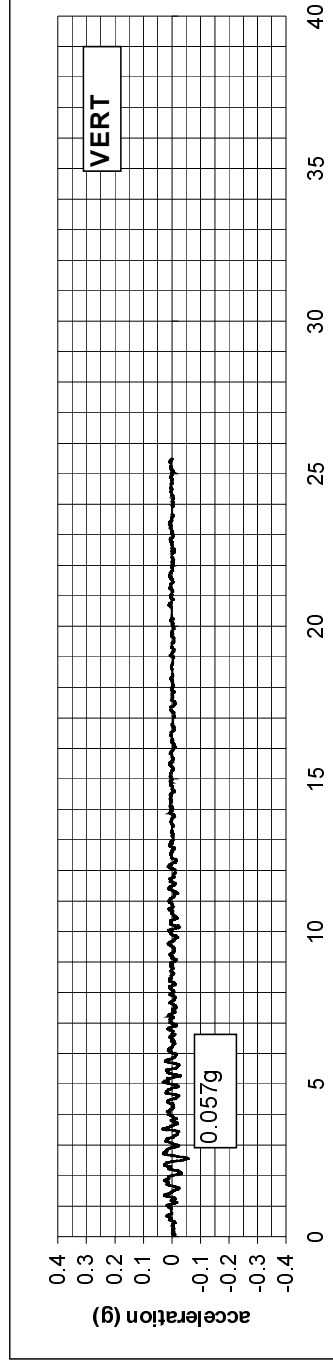
Event: Kocaeli, Turkey 17 August 1999
Station: Fatih Mosque Complex
Code: FAT

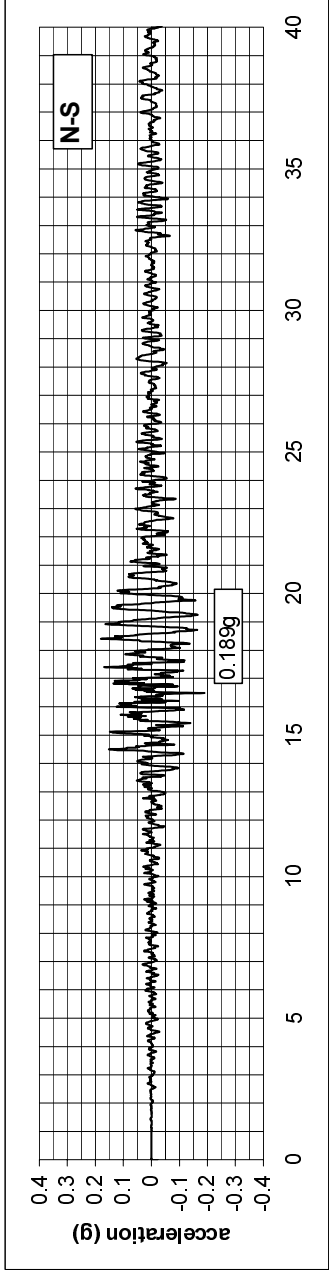
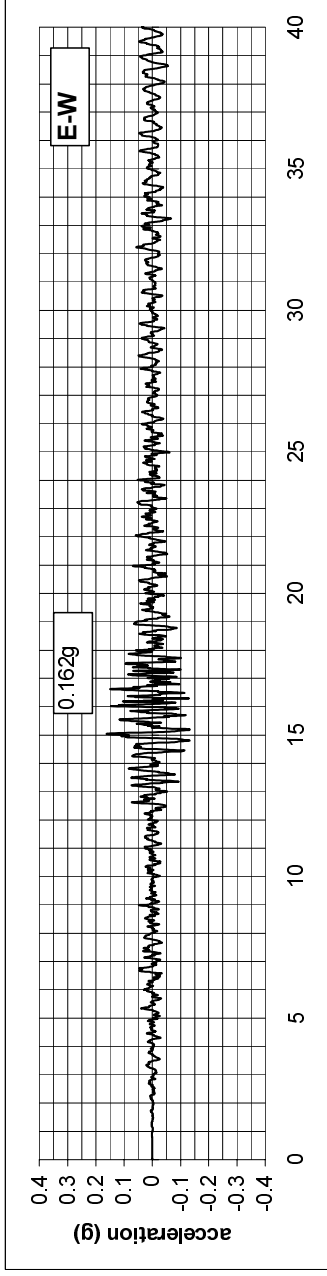
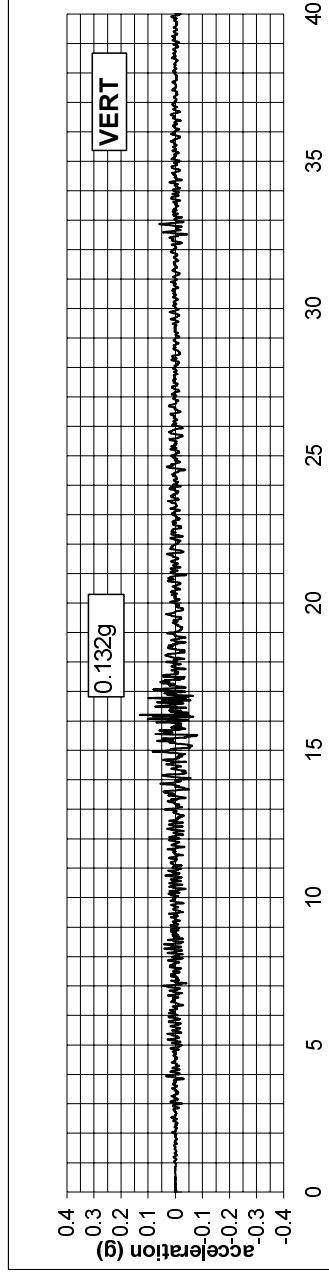
Event: Kocaeli, Turkey 17 August 1999
Station: Gebze Tubitak
Code: GBZ

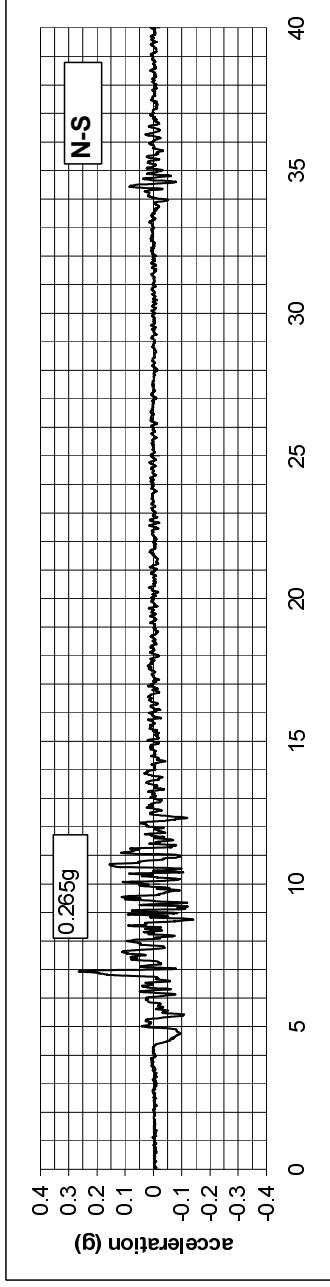
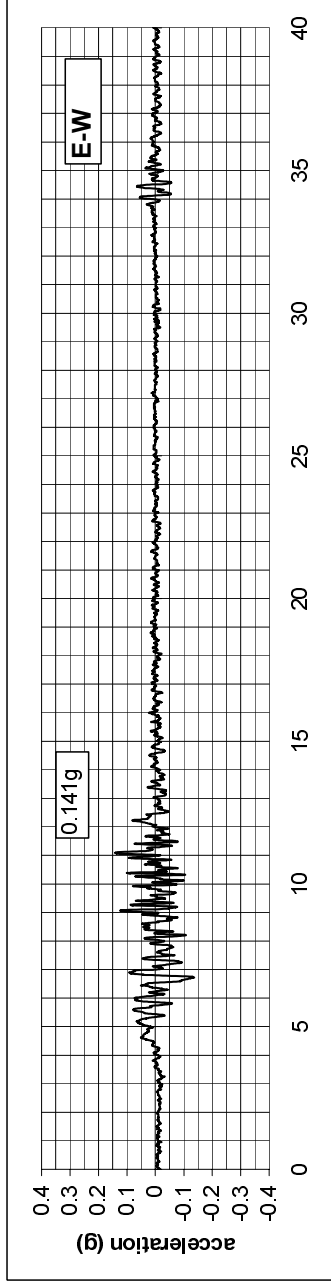
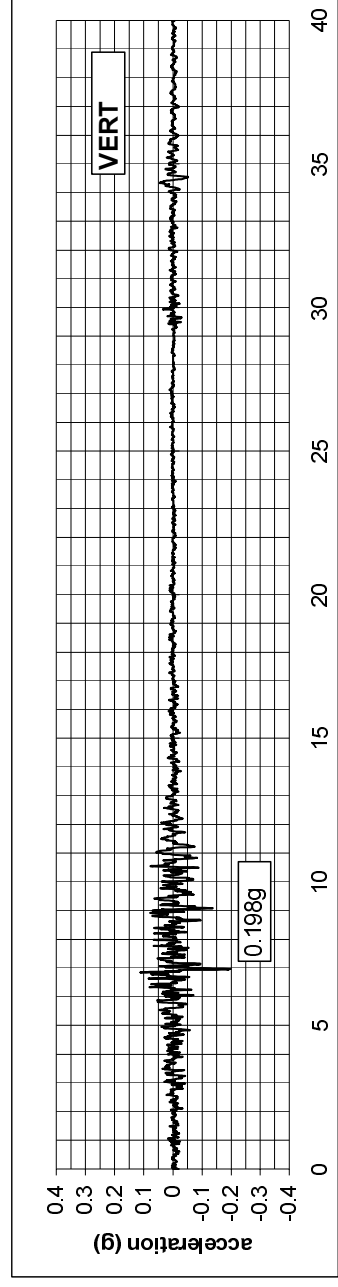
Event: Kocaeli, Turkey 17 August 1999
Station: Goynuk Devlet Hastanesi
Code: GYN

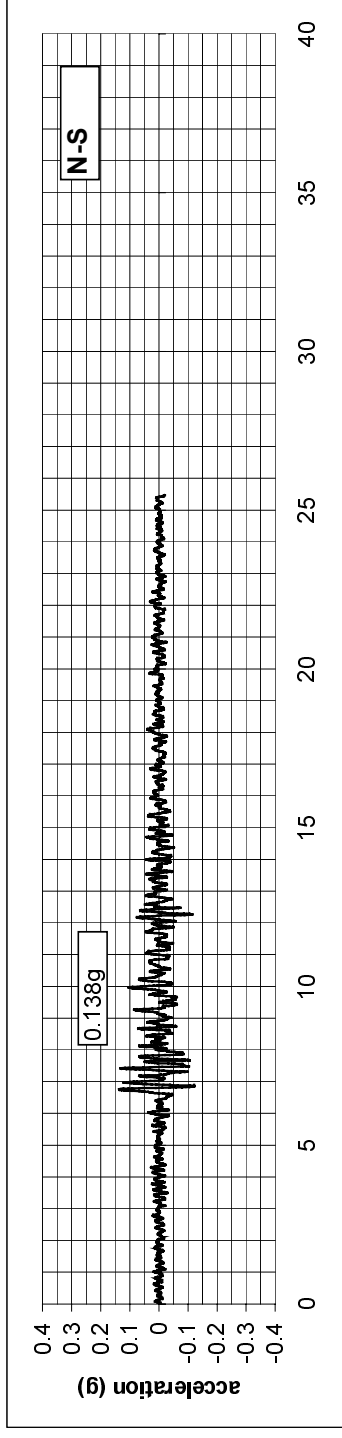
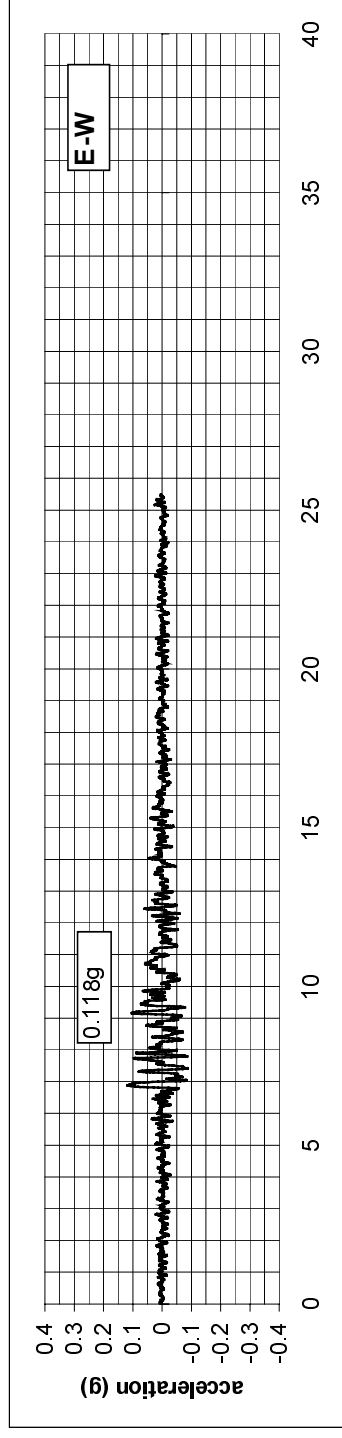
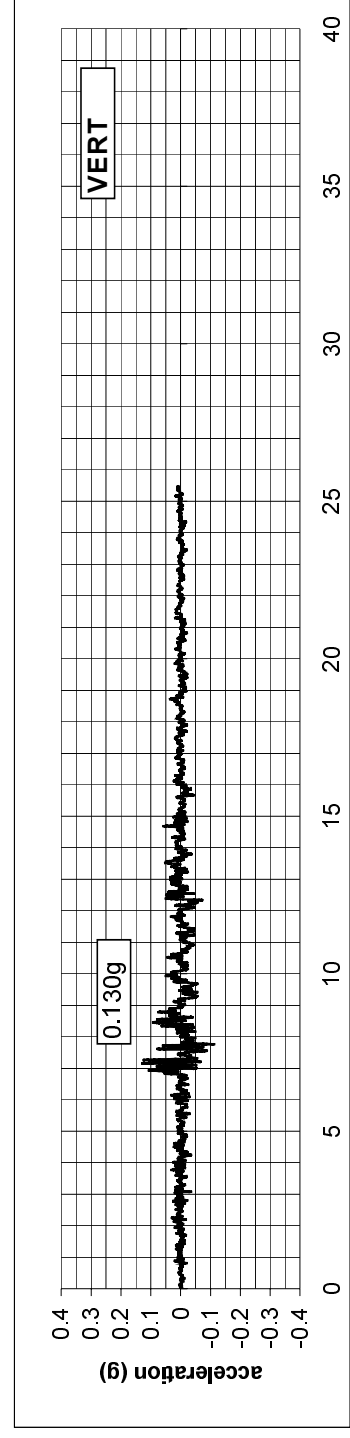
Event: Kocaeli, Turkey 17 August 1999
Station: Heybeliada Hospital
Code: HAS

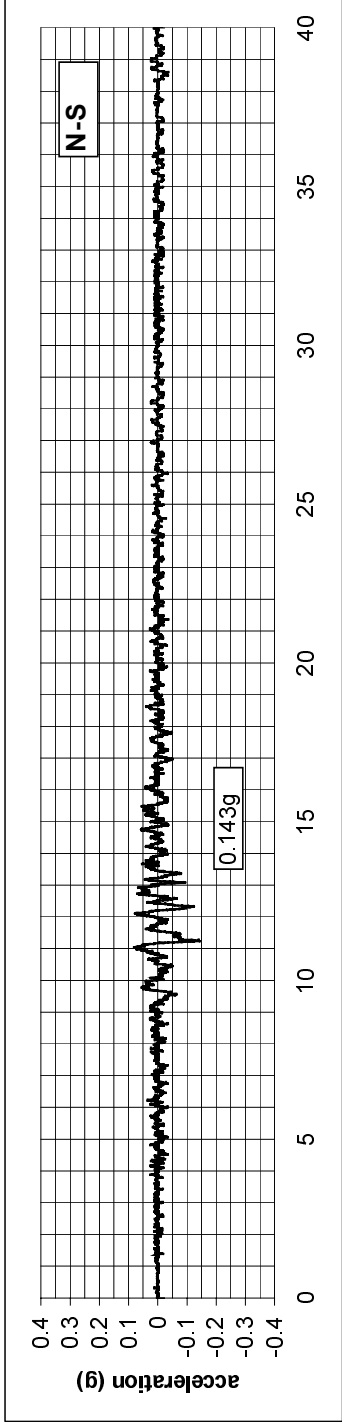
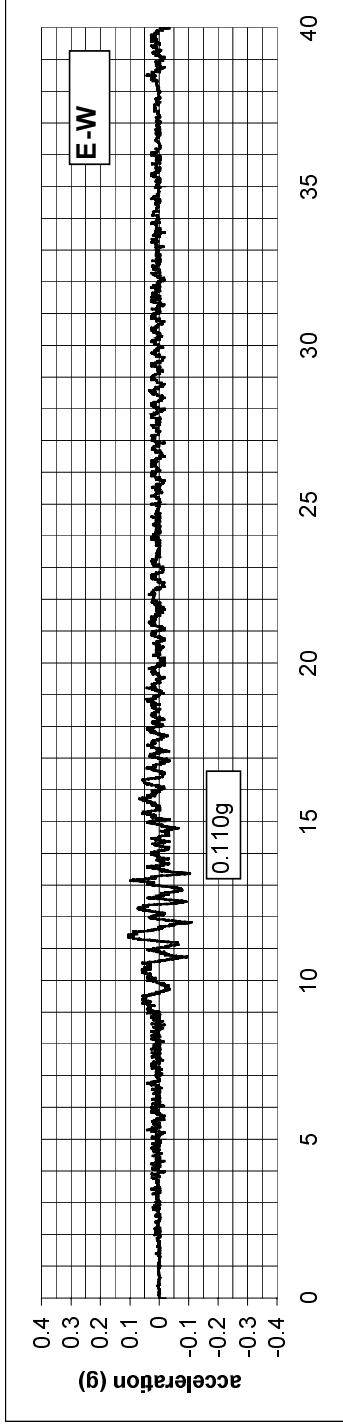
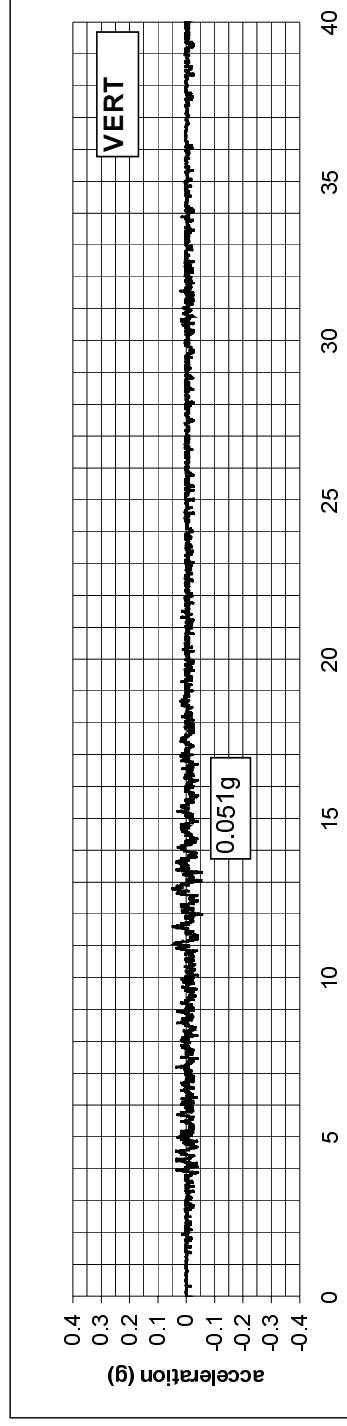
Event: Kocaeli, Turkey 17 August 1999
Station: Iznik Karayollari Sefligi
Code: IZN

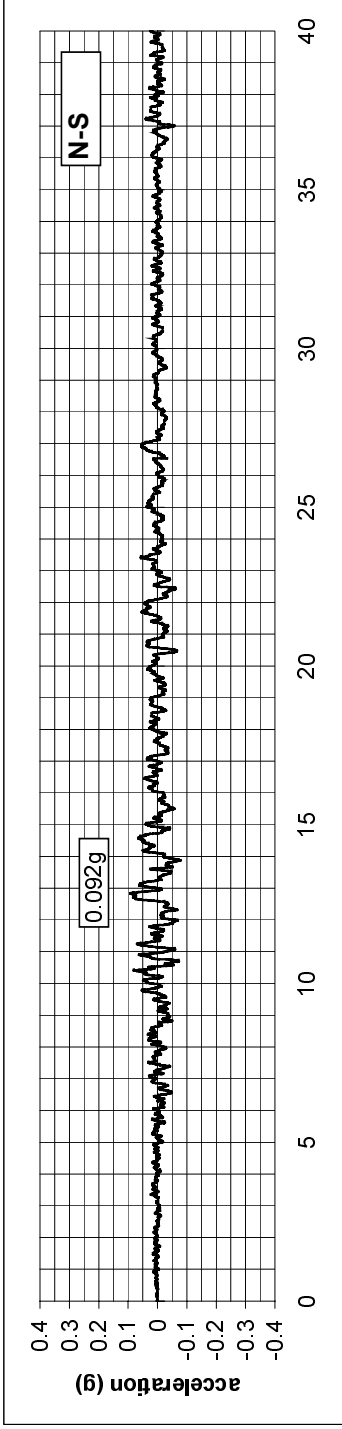
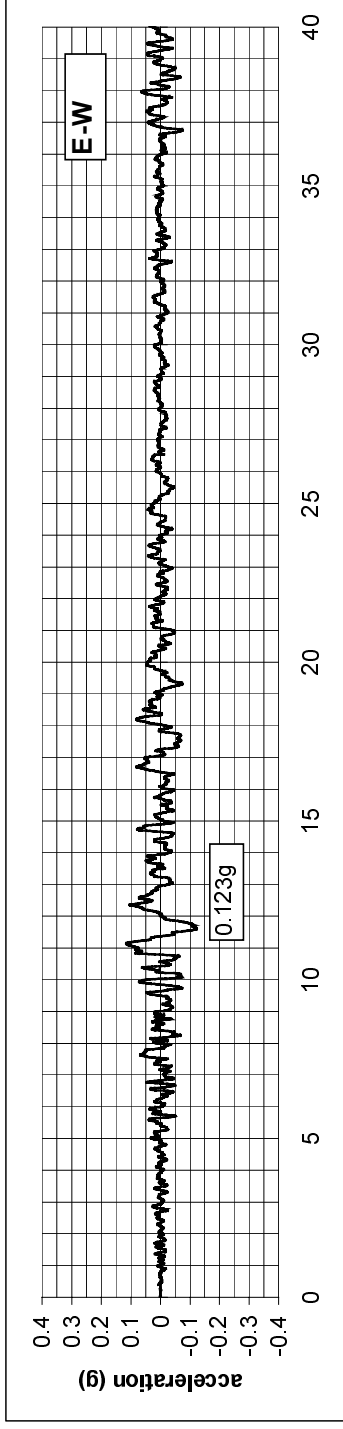
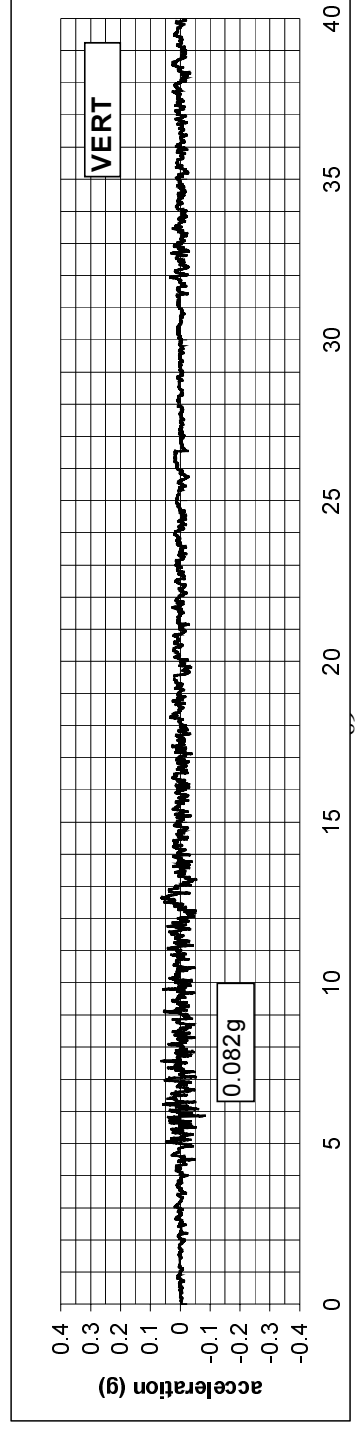
Event: Kocaeli, Turkey 17 August 1999
Station: Izmit Meteoroloji Istasyonu
Code: IZT

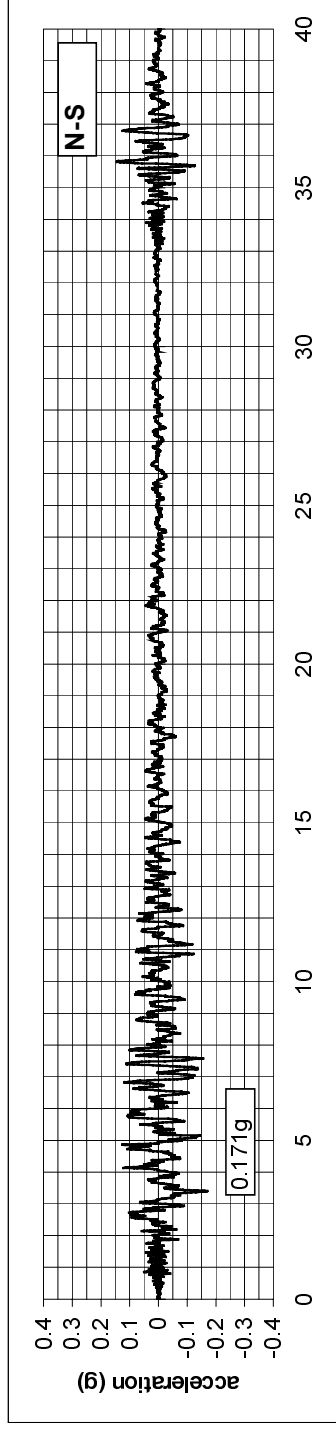
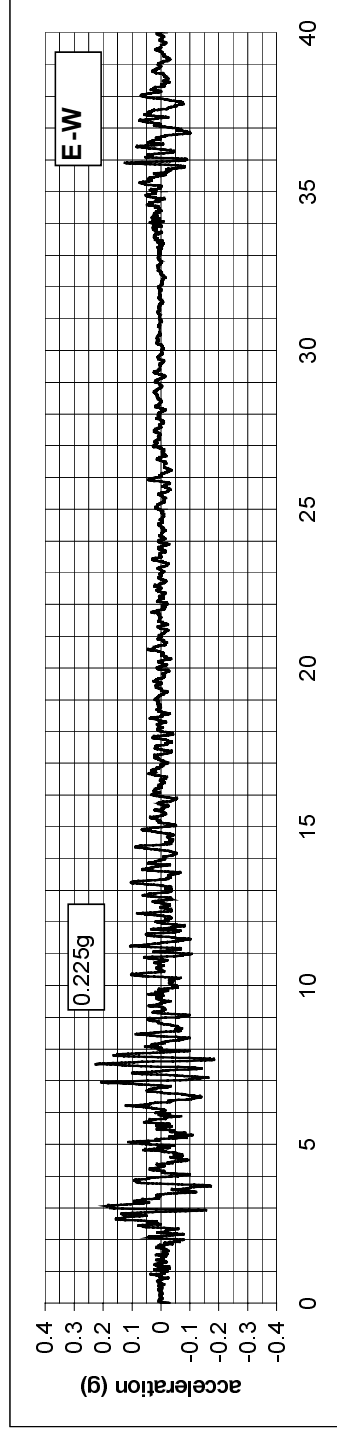
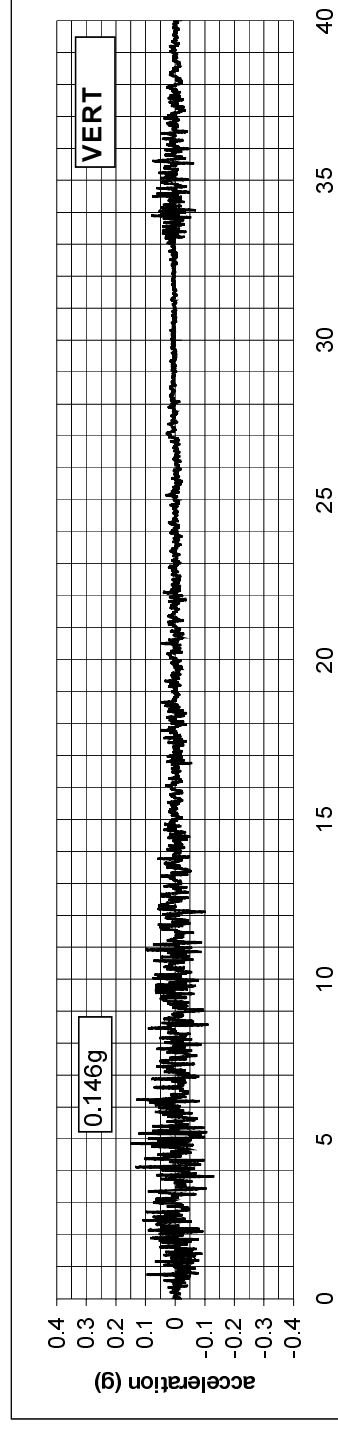
Event: Kocaeli, Turkey 17 August 1999
Station: Adapazari (Sakarya)
Code: SKR

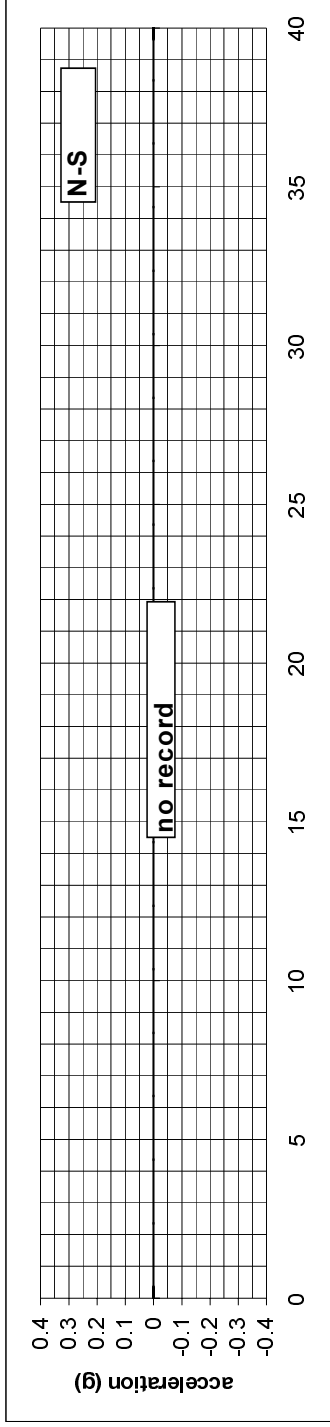
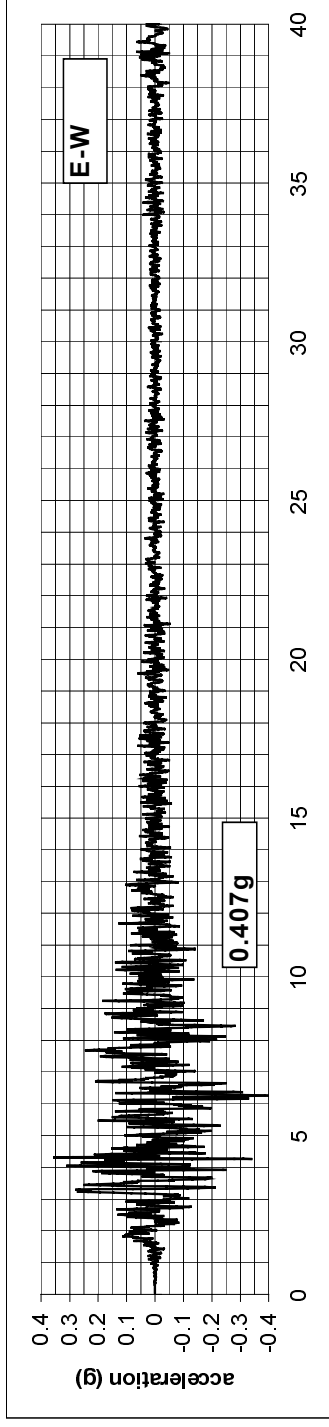
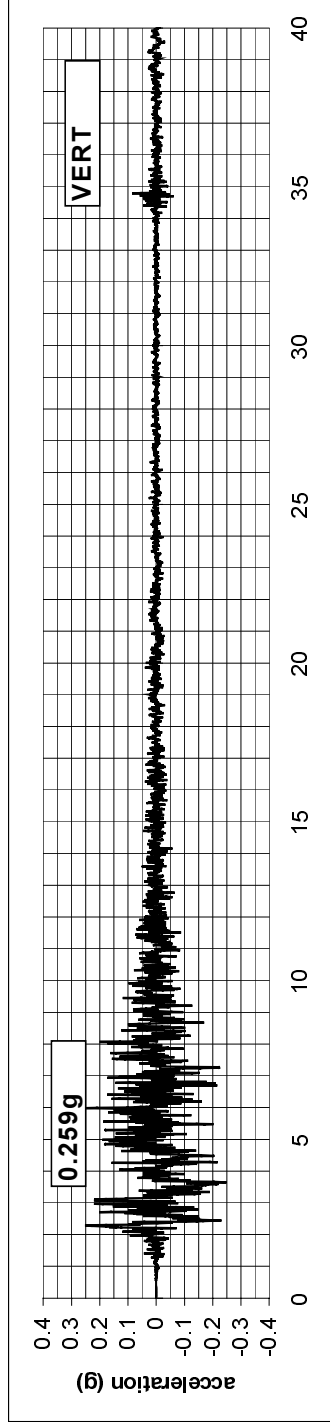
Event: Kocaeli, Turkey 17 August 1999
Station: Yarimca Petkim
Code: YPT

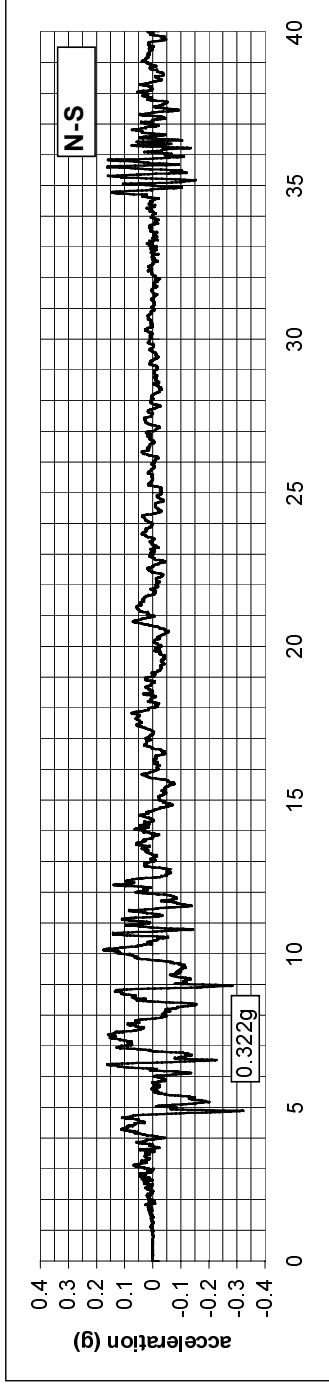
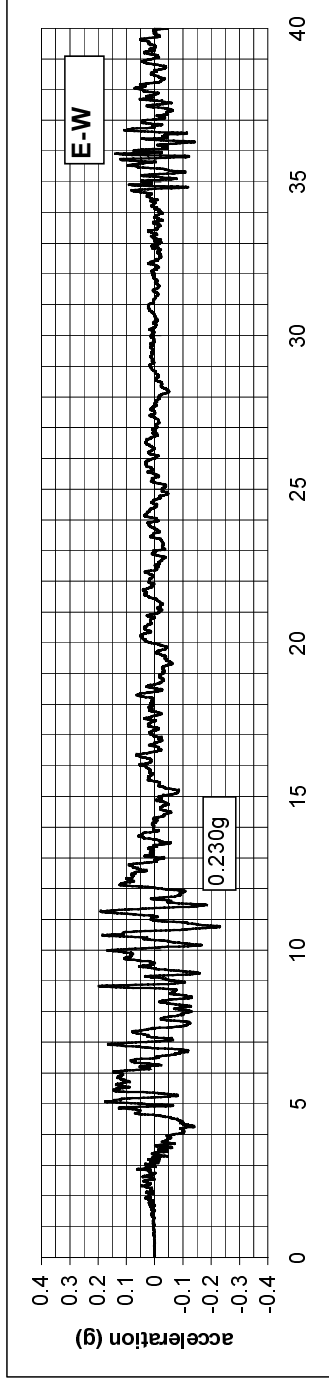
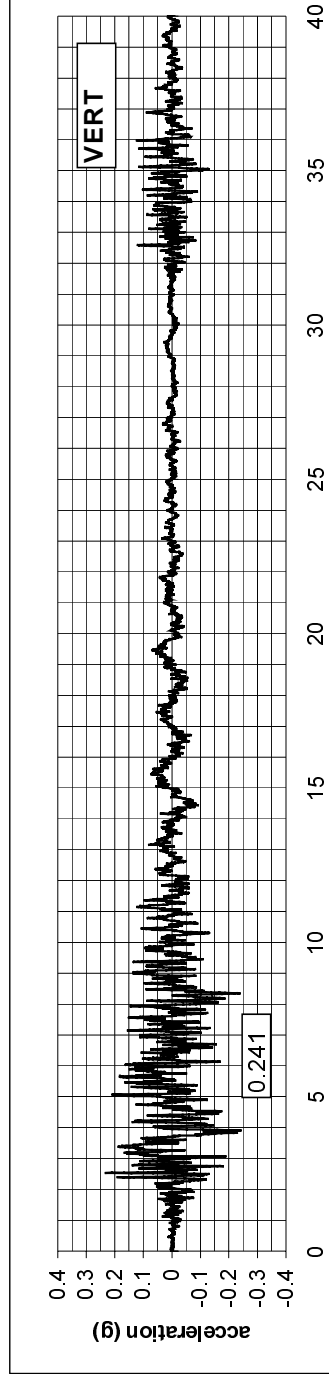
Ground Conditions: Soil
Distance: 4 km
