THE KOCAELI, TURKEY EARTHQUAKE OF 17 AUGUST 1999

A FIELD REPORT BY EEFIT

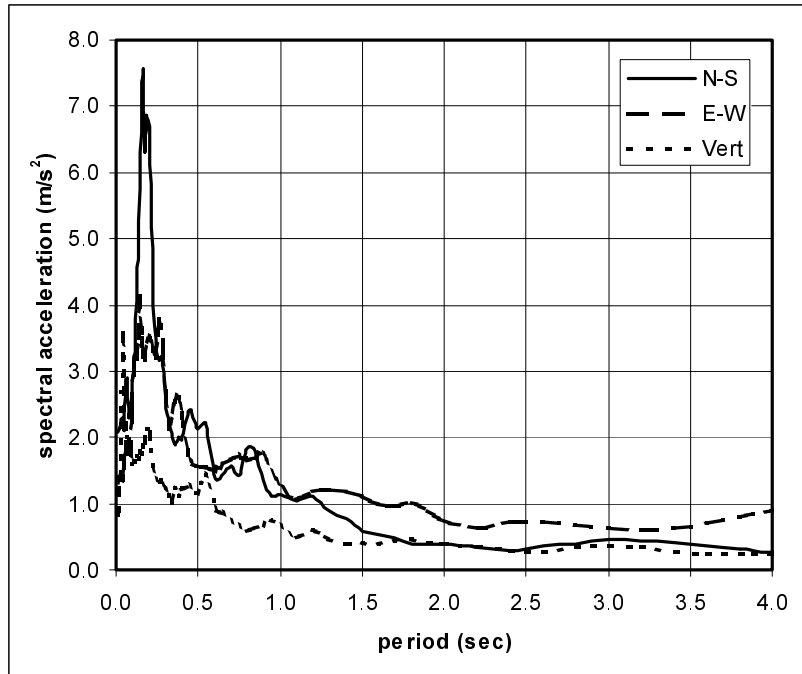
Event: Kocaeli, Turkey 17 August 1999
Station: Ambarlic Thermic Power Plant
Code: ATS

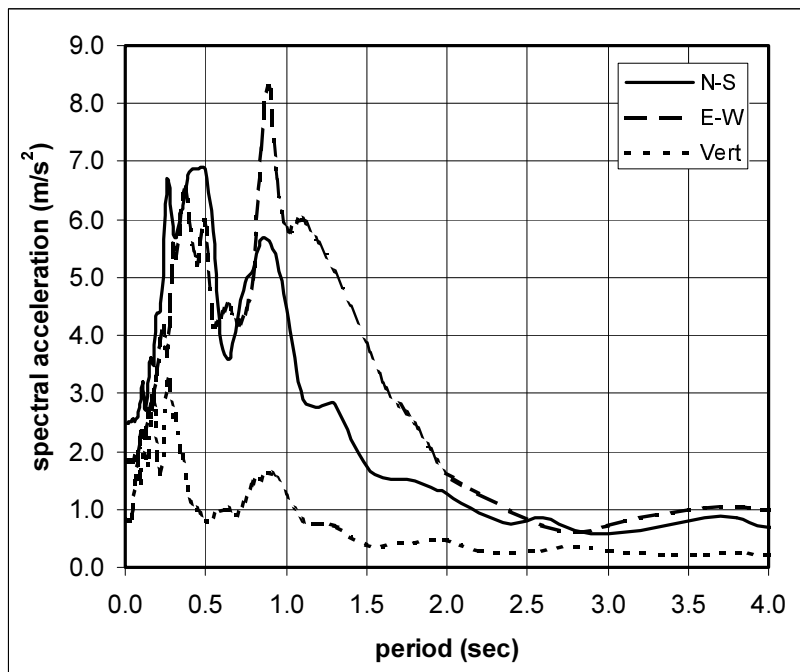
Event: Kocaeli, Turkey 17 August 1999
Station: Botas Gas Terminal?
Code: BTS

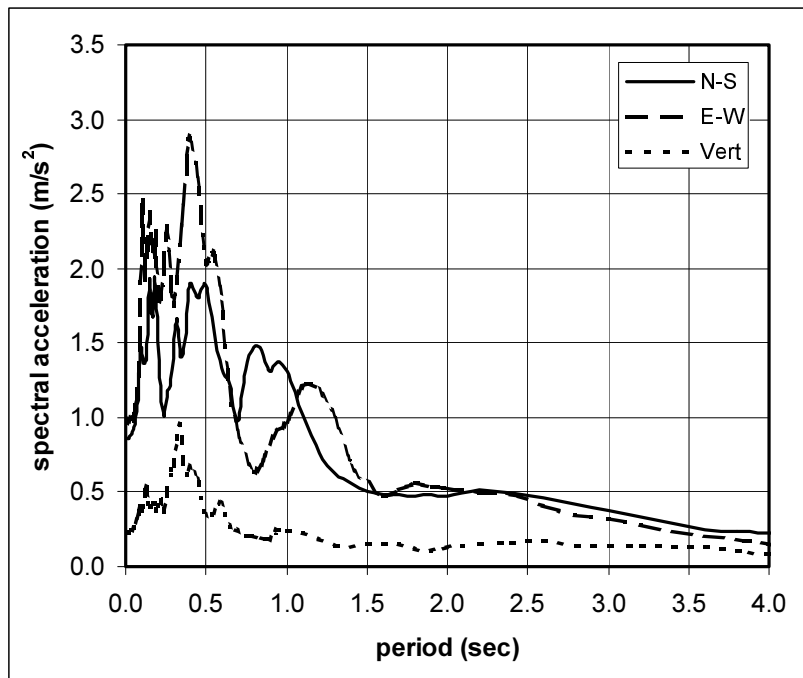
Event: Kocaeli, Turkey 17 August 1999
Station: Bursa Tofas Fabrikasi
Code: BUR

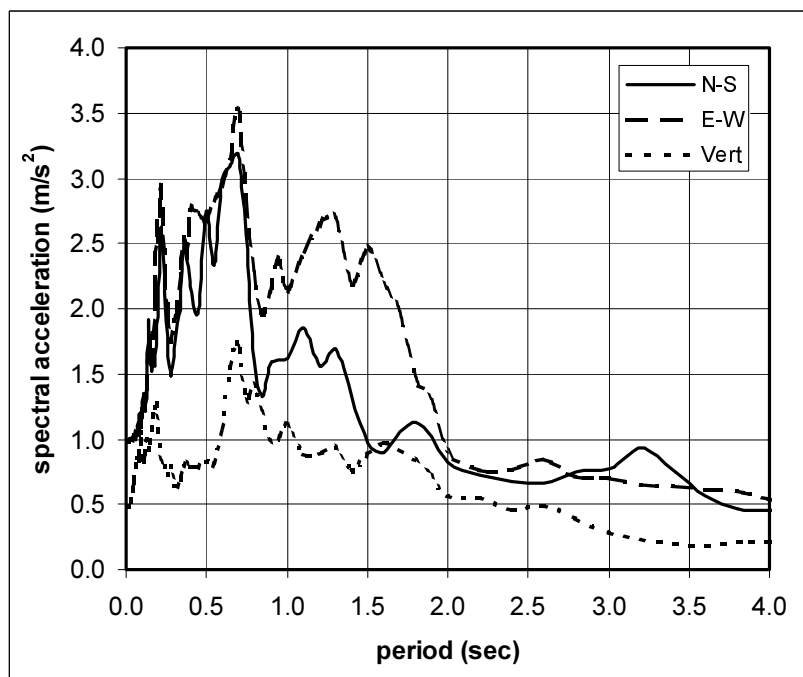
Event: Kocaeli, Turkey 17 August 1999
Station: CEKMECE Nuclear Research Centre
Code: CEK

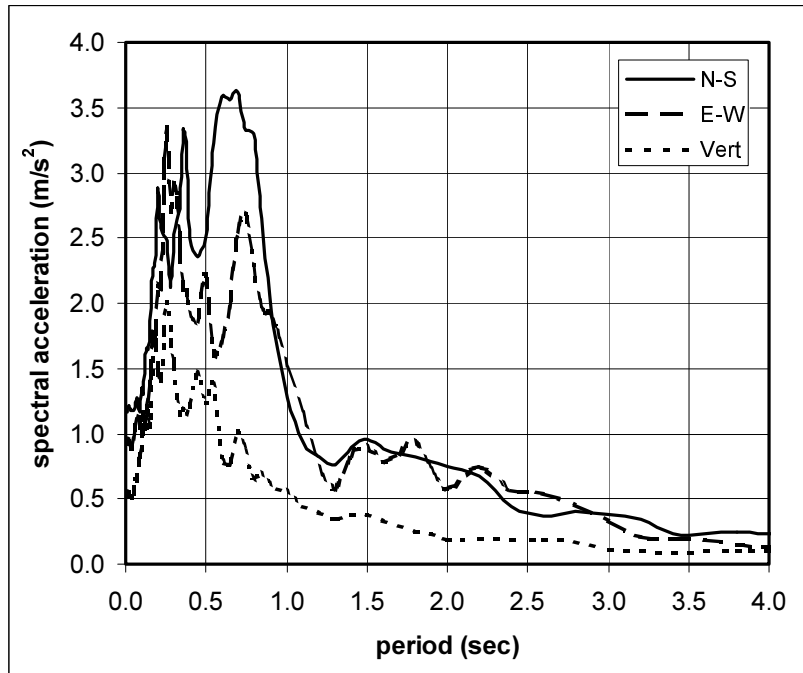
Event: Kocaeli, Turkey 17 August 1999
Station: CEKMECE Nuclear Research Centre
Code: CNA

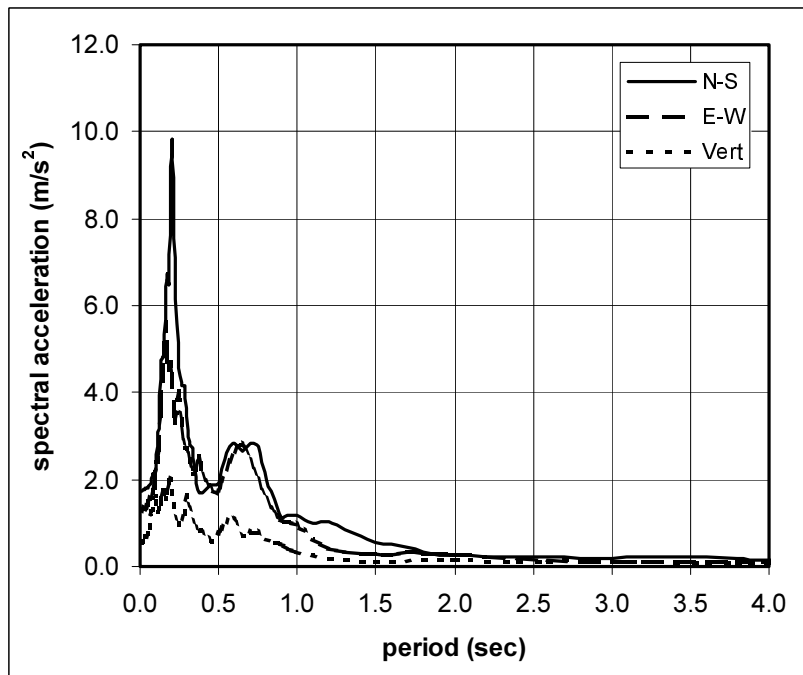
Event: Kocaeli, Turkey 17 August 1999
Station: Duzce Meteroloji Istasyonu
Code: DZC

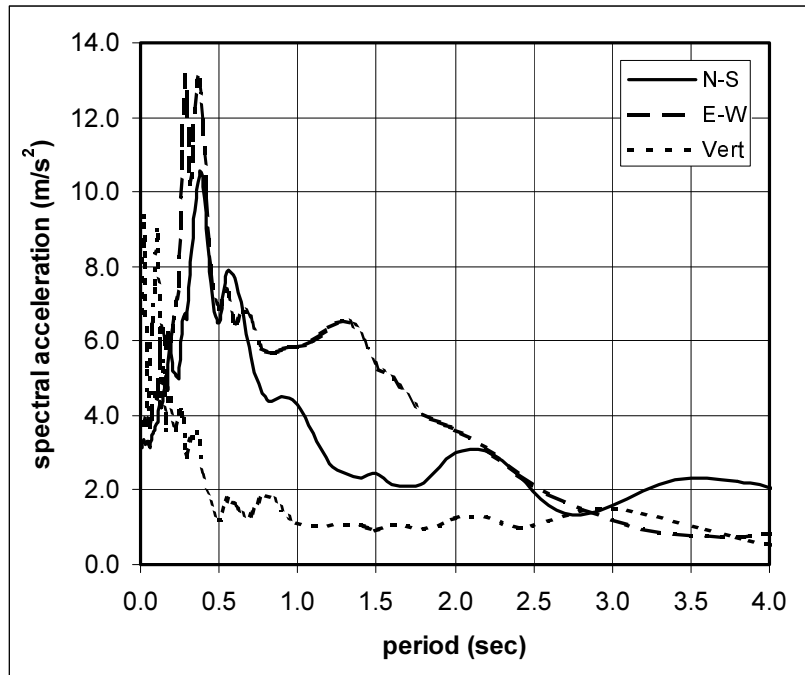
Event: Kocaeli, Turkey 17 August 1999
Station: Eregli Kaymakamlik Binasi
Code: ERG

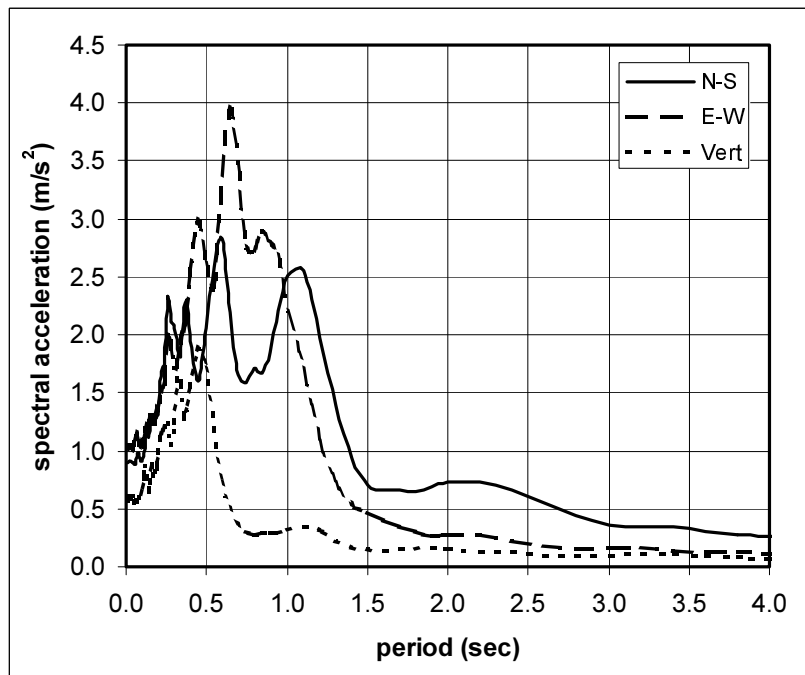
Event: Kocaeli, Turkey 17 August 1999
Station: Fatih Tomb
Code: FAT

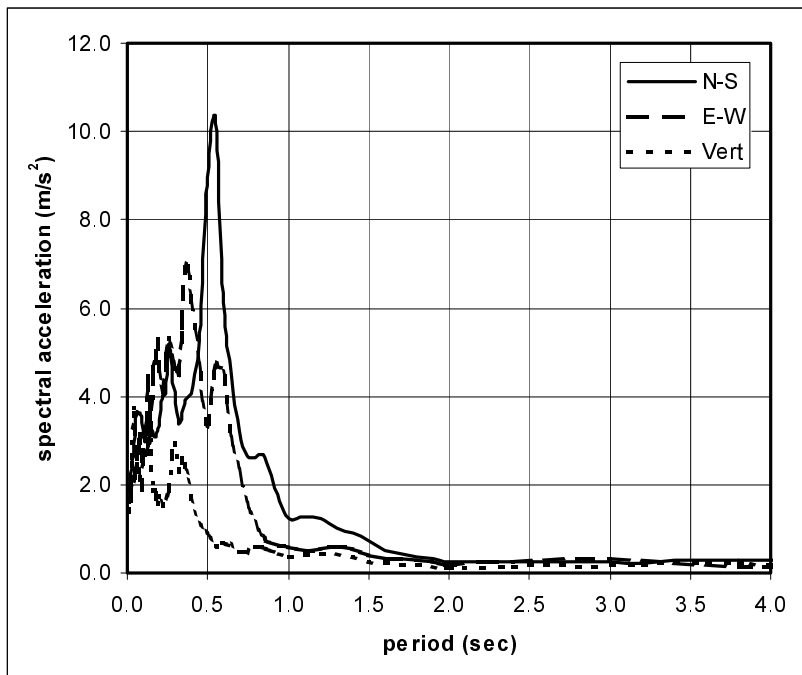
Event: Kocaeli, Turkey 17 August 1999
Station: Tubitak Marmara Arastirma Merkezi
Code: GBZ

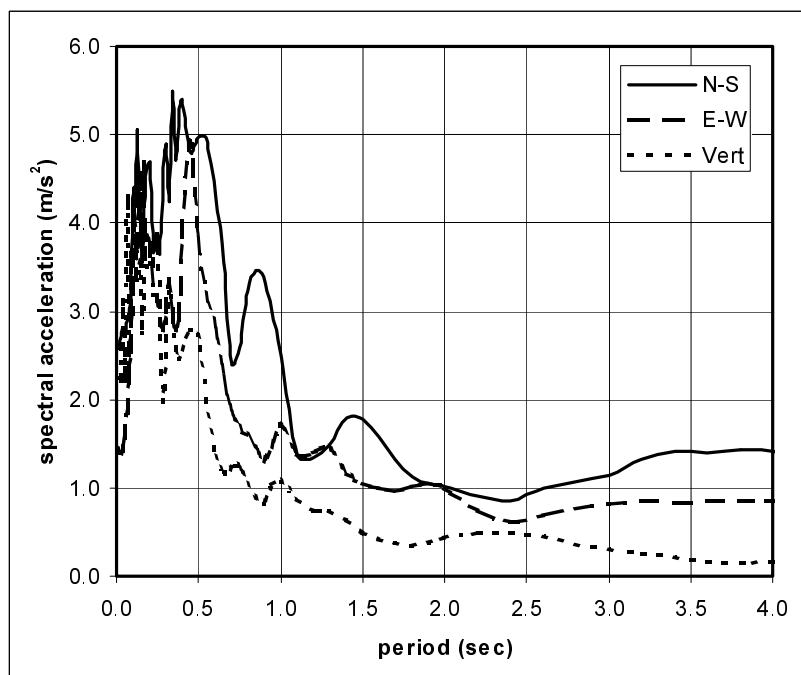
Event: Kocaeli, Turkey 17 August
Station: Goynuk Devlet Hastanesi
Code: GYN

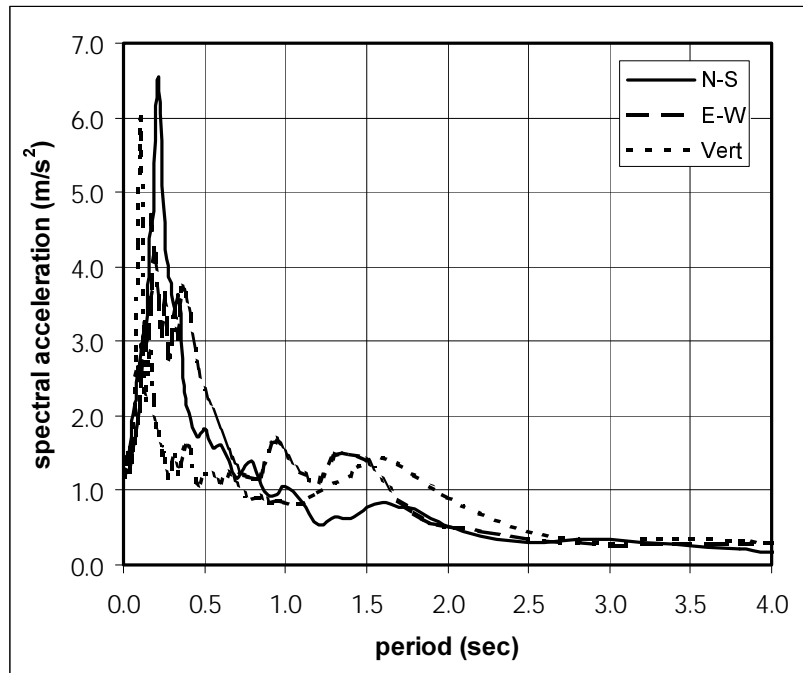
Event: Kocaeli, Turkey 17 August 1999
Station: Heybeliada Hospital
Code: HAS

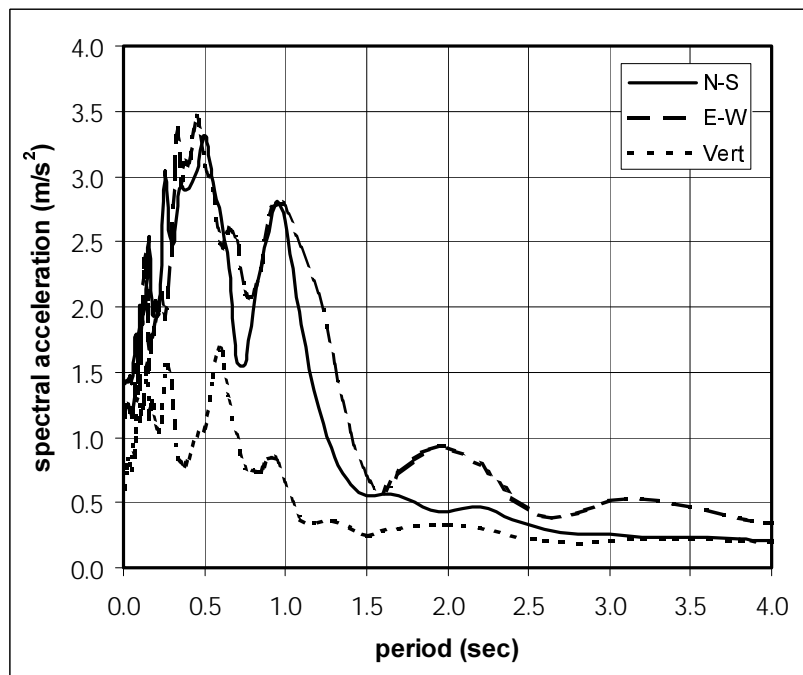
Event: Kocaeli, Turkey 17 August 1999
Station: Iznik Karayollari Sefligi
Code: IZN

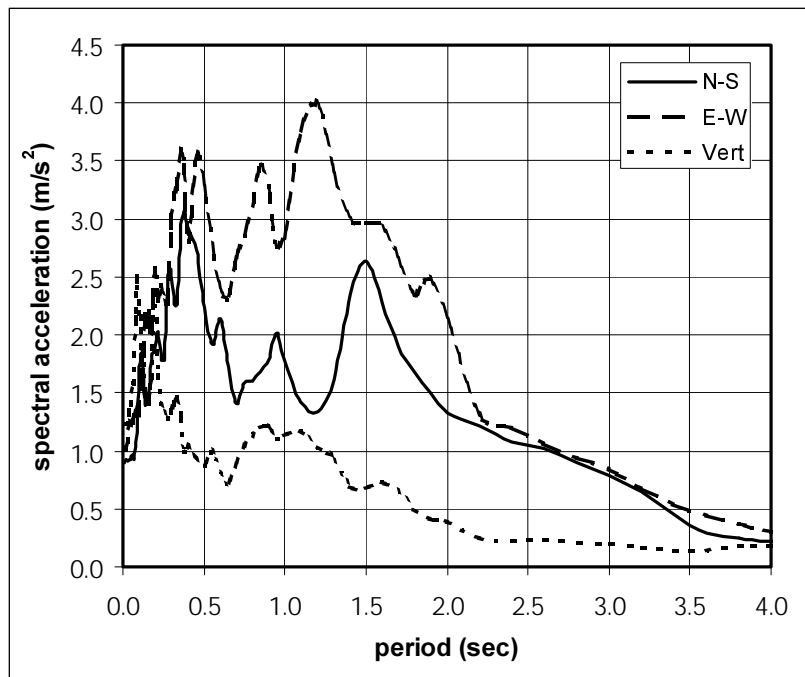
Event: Kocaeli, Turkey 17 August 1999
Station: Izmit Meteroloji Istasyonu
Code: IZT

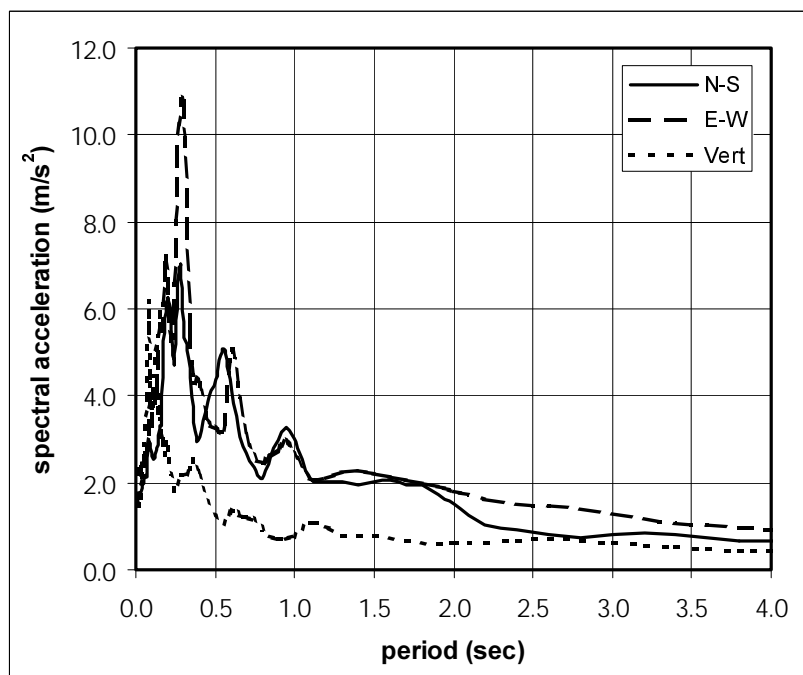
Event: Kocaeli, Turkey 17 August 1999
Station: Adapazari (Sakarya)
Code: SKR

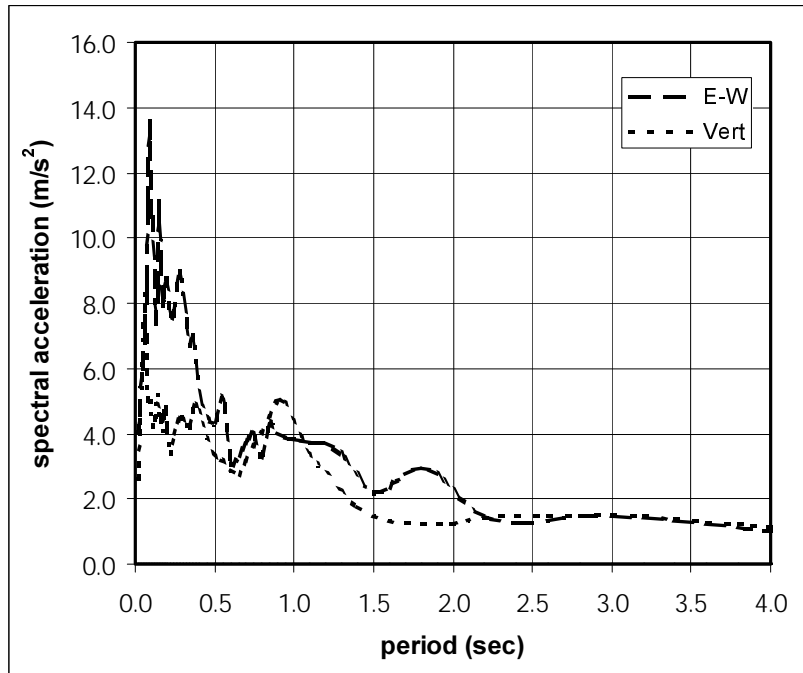
Event: Kocaeli, Turkey 17 August 1999
Station: Yarimca Petkim
Code: YPT

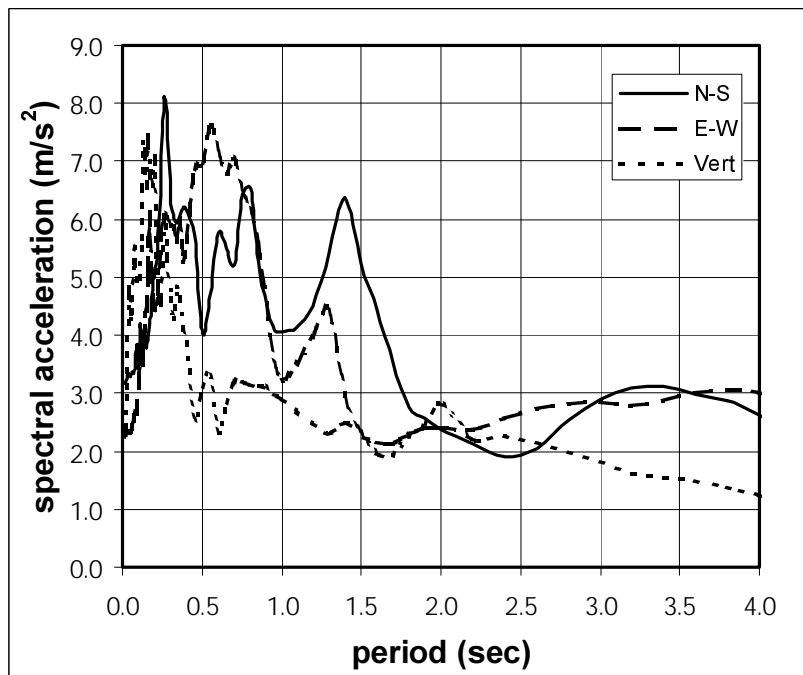
4 Geological and Geotechnical Aspects

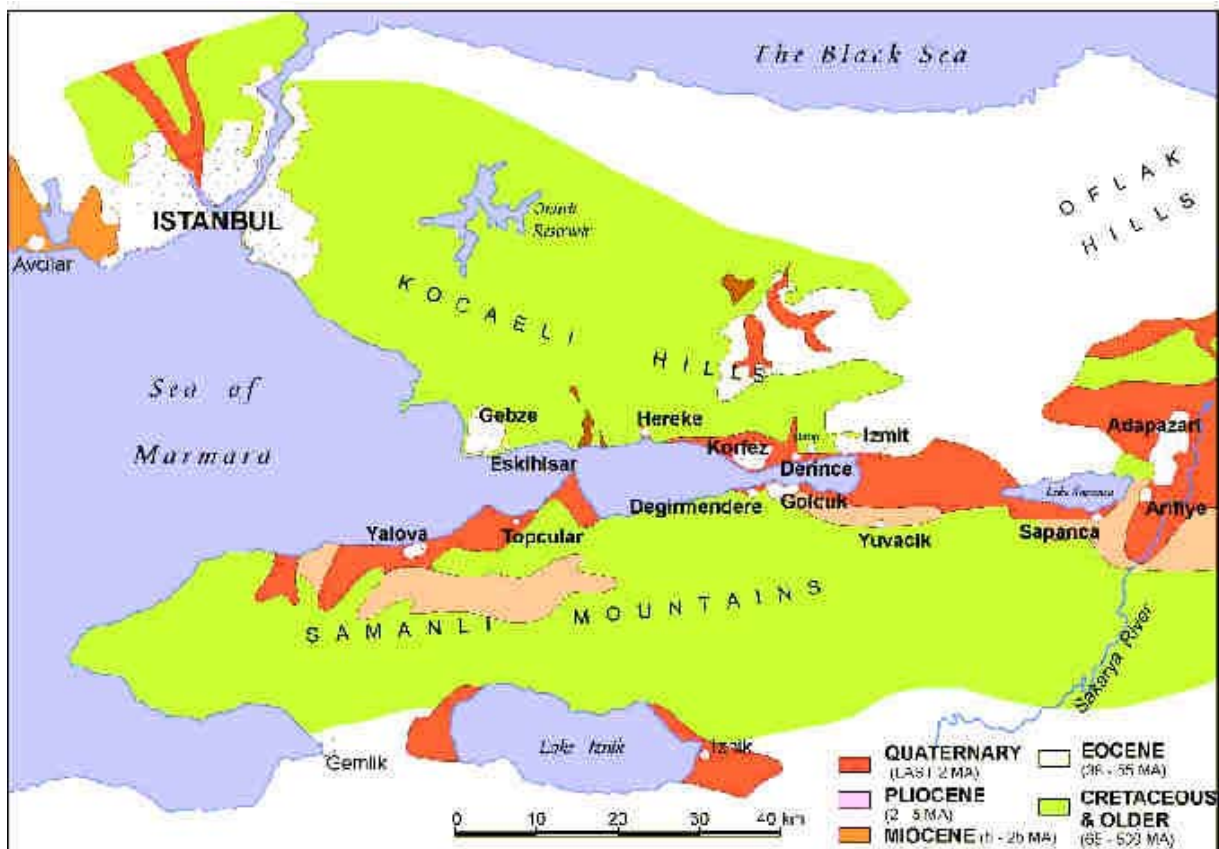
Figure 4.1: Simplified geological map of earthquake affected area

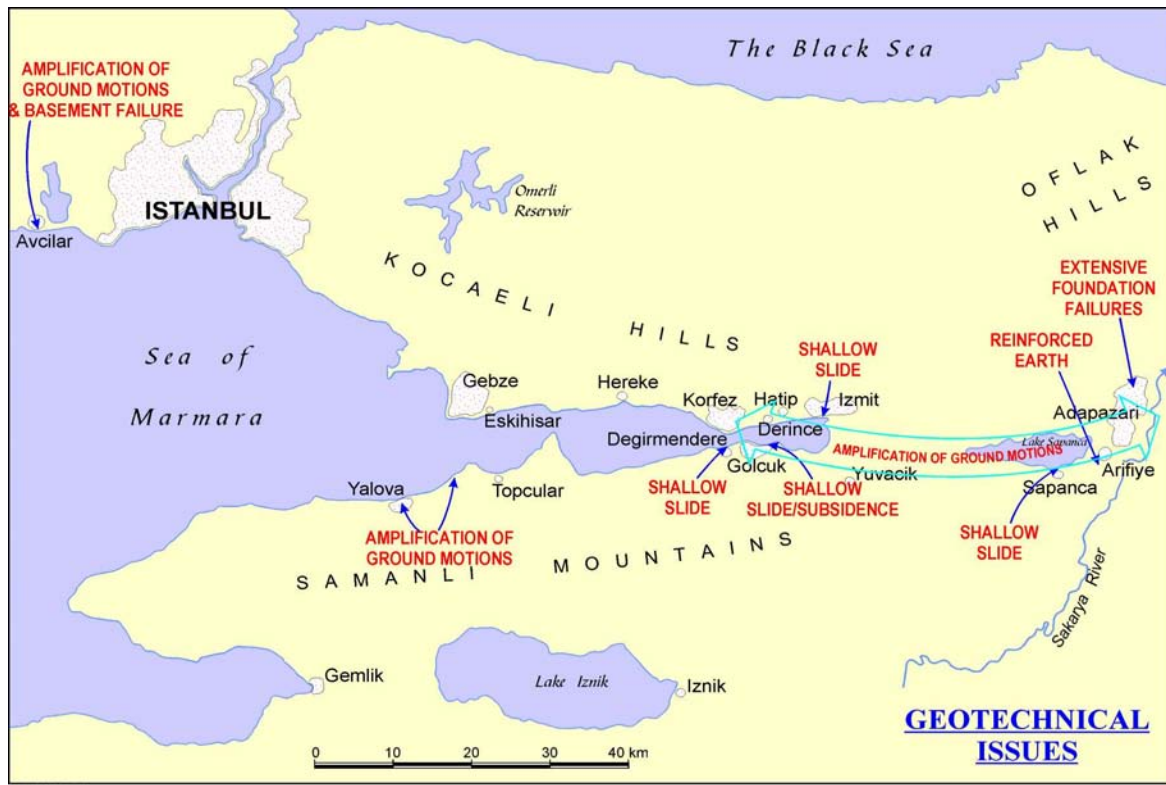
Figure 4.3: Location plan of earthquake affected area showing the location of geotechnical issues.

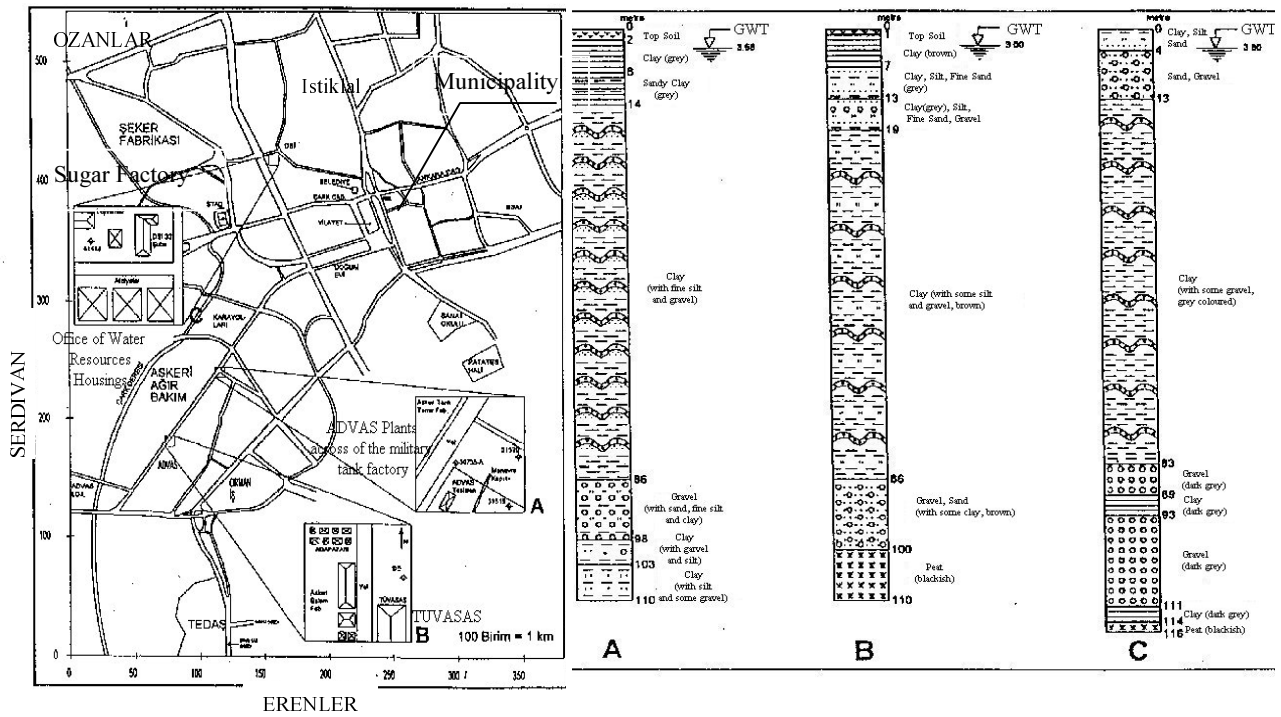
Fig. 4.4: Location plan for State Water Works Division boreholes in Adapazari City and summary of geological logs

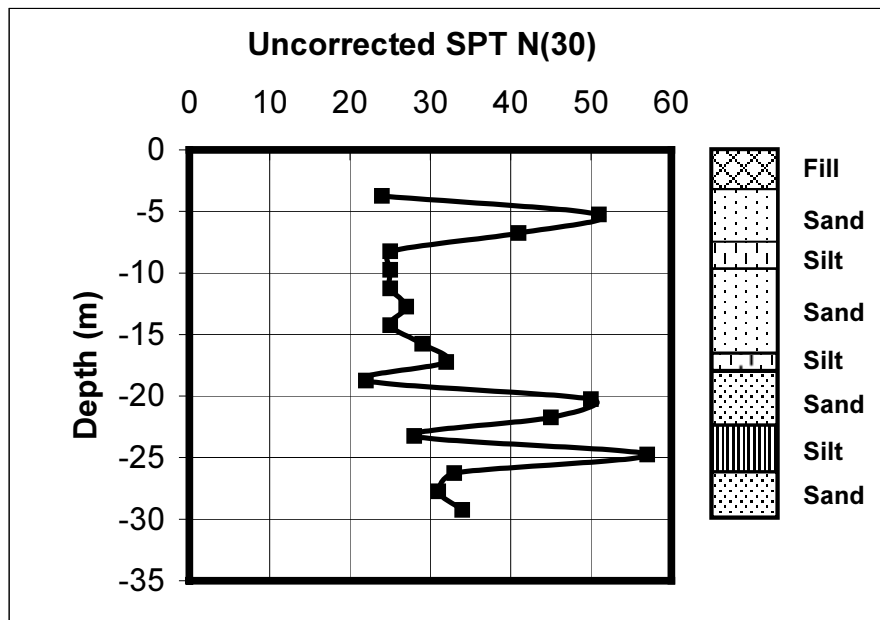
Figure 4.9: Summary geological log and uncorrected standard penetration test, N(30) profile for borehole in Gölcük area.

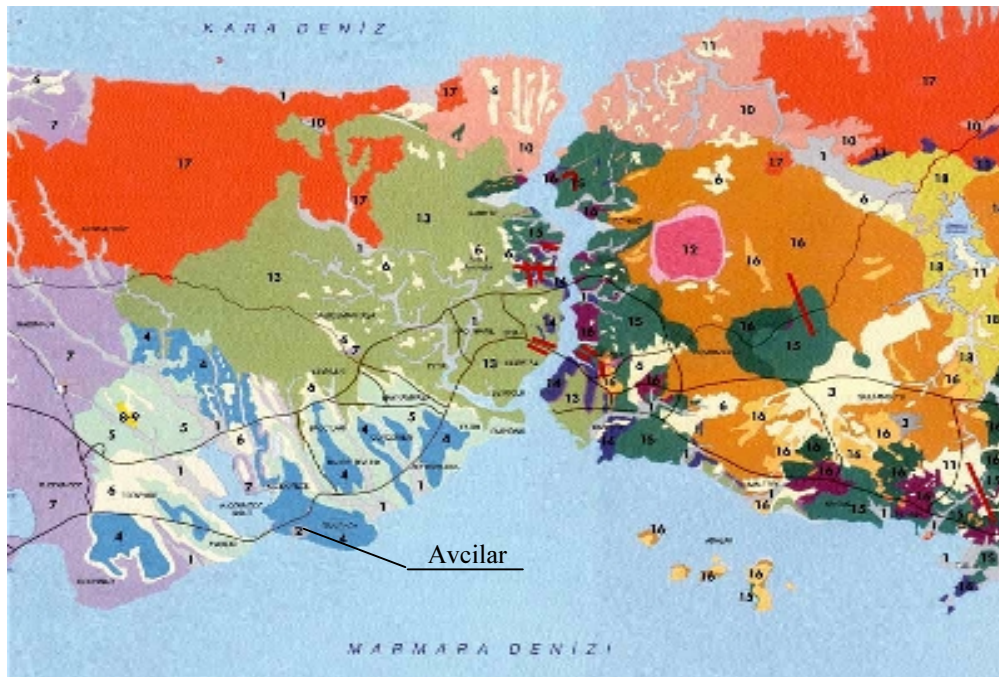
Figure 4.12: Engineering geological map of Istanbul City region. 1-3 stand for alluvial with low-loading capacities, 4 stands for alluvial deposit with good loading capacity with weak zones locally, 5 is for alluvial with low loading capacity with landslide probability with slopes. 6 is for high-loading capacity, 7 for low-loading capacity and 13 for rock (Municipality of Istanbul)

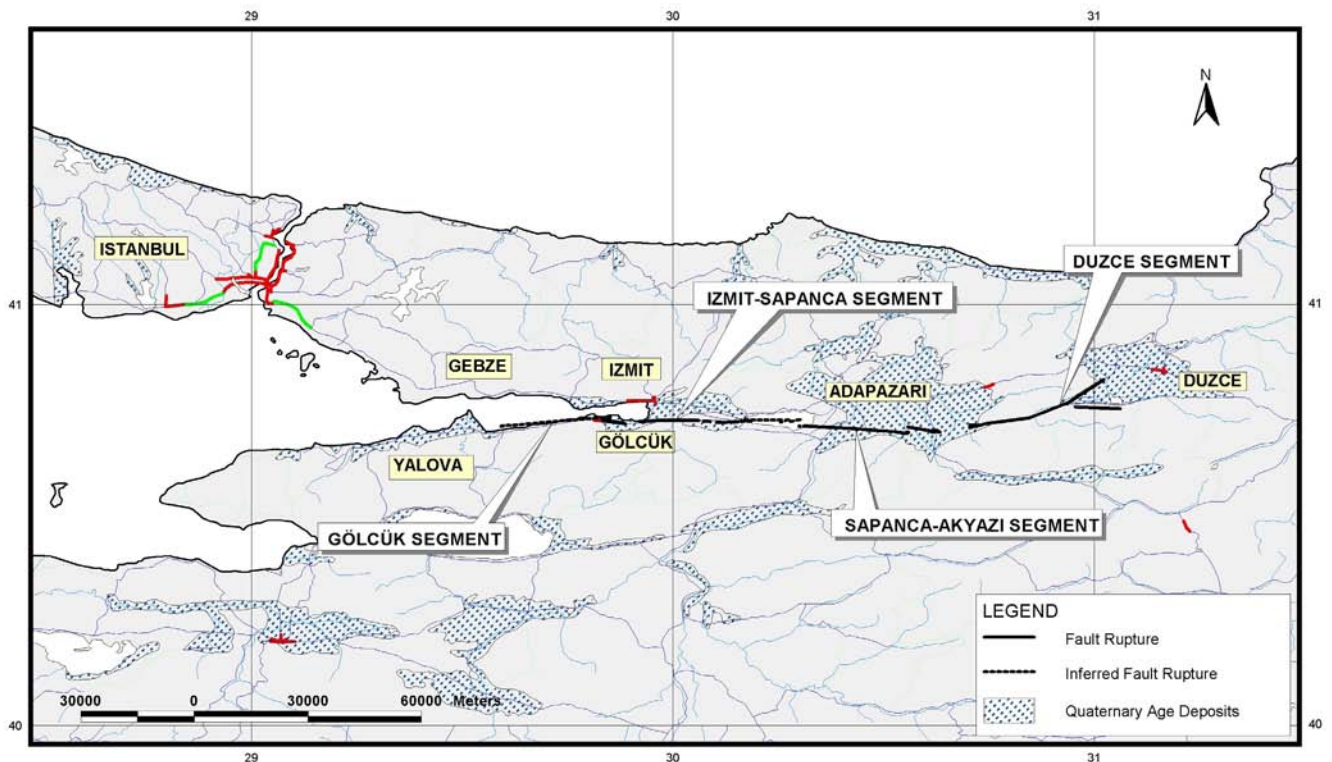
Figure 4.13: Map showing surface fault rupture during the Kocaeli earthquake. Location of fault rupture from Lettis et al. (2000). Location of Quaternary Age Deposits from Emre et al. (1998).

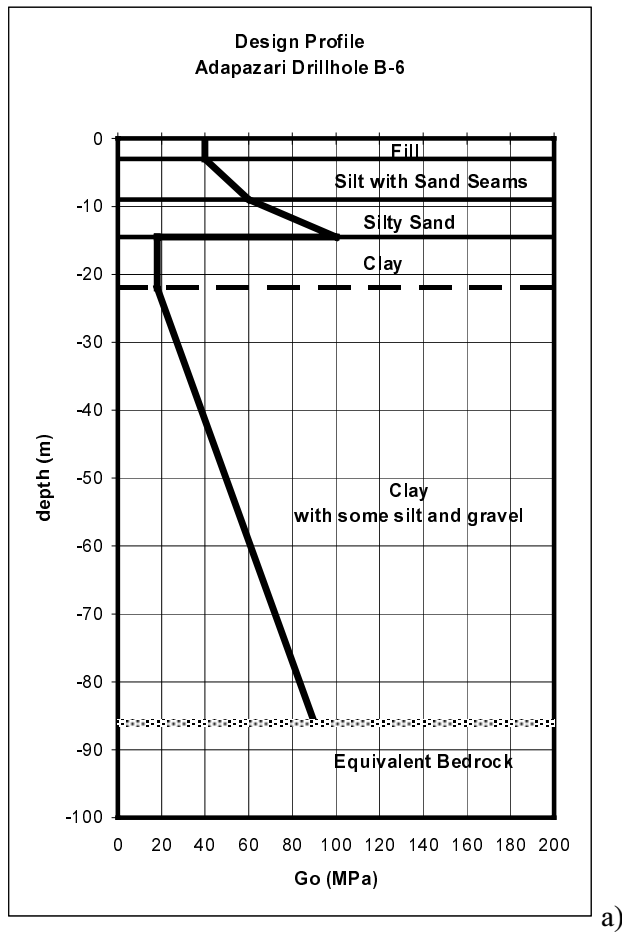
The local site effects within the Adapazari Basin have also been examined by Beyen *et al.* (2000) using data from an aftershock network established in the city after the mainshock. Their results indicate a site amplification factor of about 10 (i.e. a spectral ratio of 10) in the period range 0.25 to 1.0 seconds. The large amplifications reported by Beyen *et al.* are for weak motion and will not necessarily be representative of the amplification likely to occur during strong shaking. These results are discussed in more detail in Section 3.6.3.

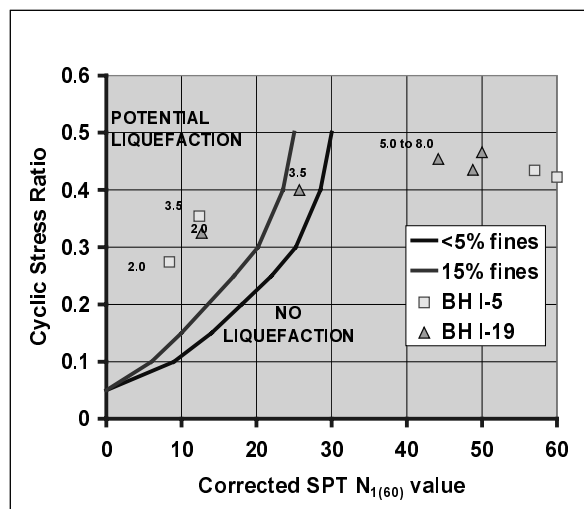
Figure 4.18: Liquefaction potential in Adapazari from SPT data. Depth below ground level (m) is shown beside each point. BH I-19 at 3.6 m is likely to be too silty to have liquefied.

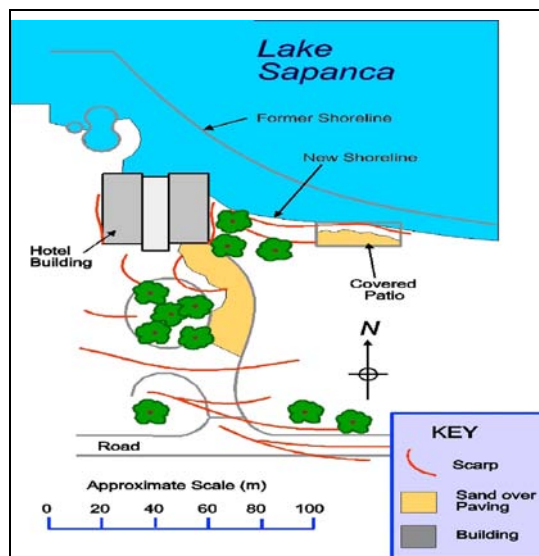
Figure 4.20: Sapanca Hotel layout plan

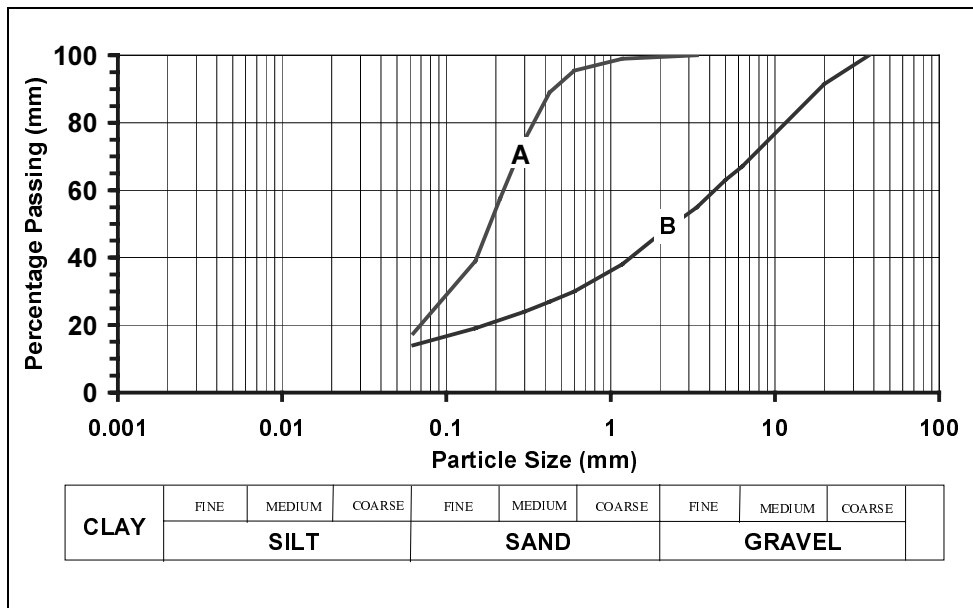
Figure 4.21: Grading Curves form Hotel Sapanca Site. (Courtesy Soil Mechanics Limited)

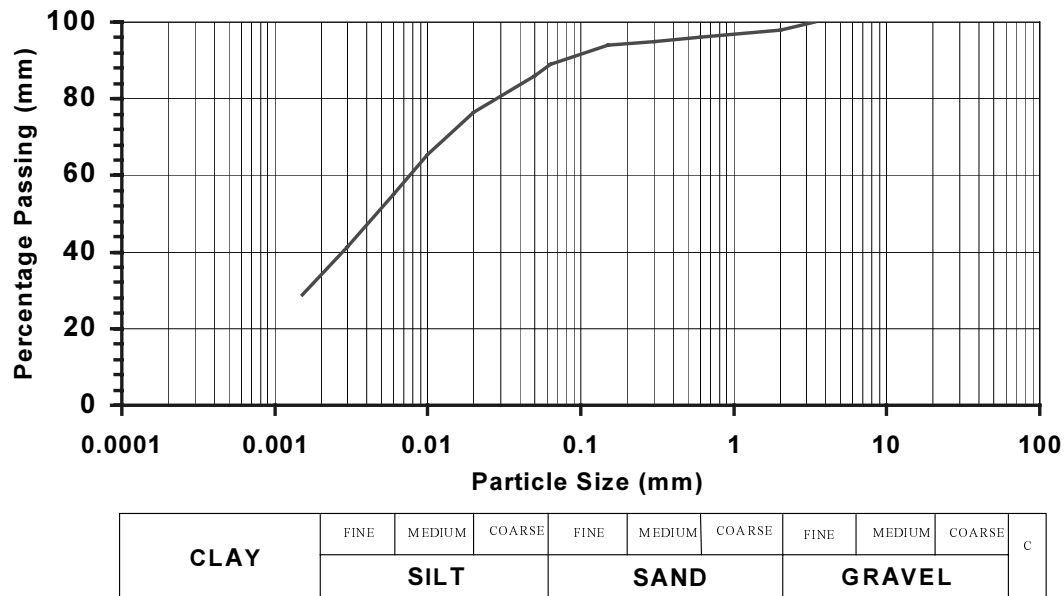
Figure 4.22: Particle size distribution for soil beneath tilted foundation slab at Adapazari

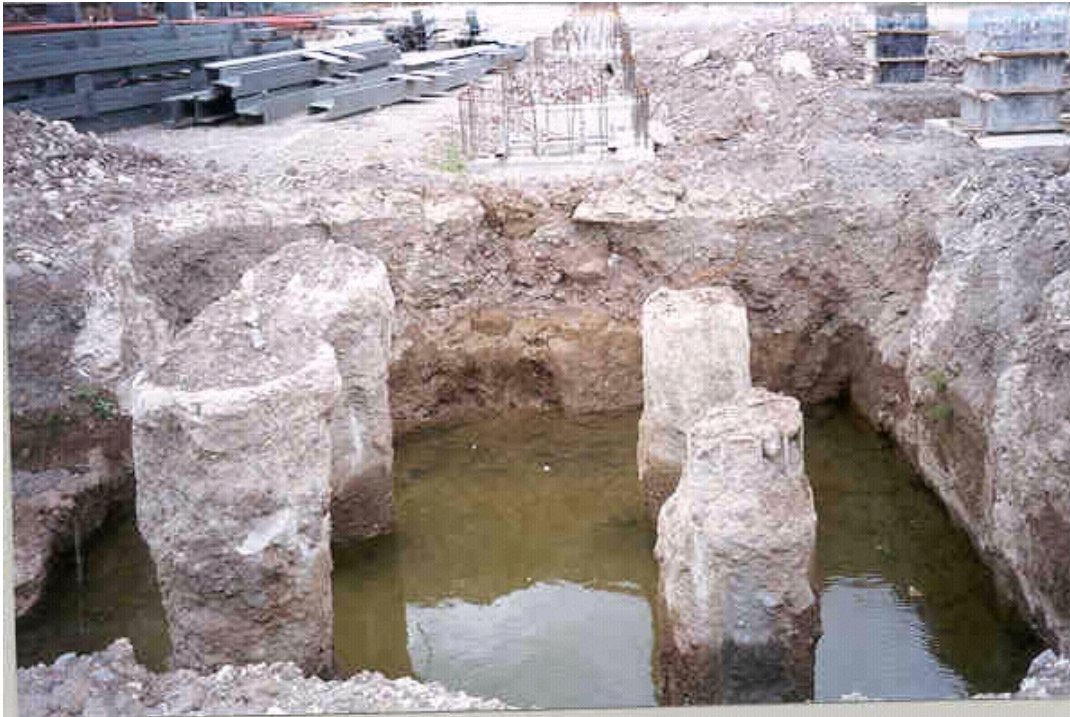
Plate 4.1 Ford Otosan, Gölcük Plant Press Shop under construction. View to west of pile cap excavation showing 1.2 m of reddish brown gravelly sand fill overlying loose alluvial sand. Evidence of jet grouting at site can also be seen. Foundations comprise four-pile groups with 600 to 700 mm diameter piles at 2000 mm centres. Main reinforcement is 10 number 16mm deformed steel bars and confining steel is 10 mm deformed steel. (photograph taken on 5 September 1999).

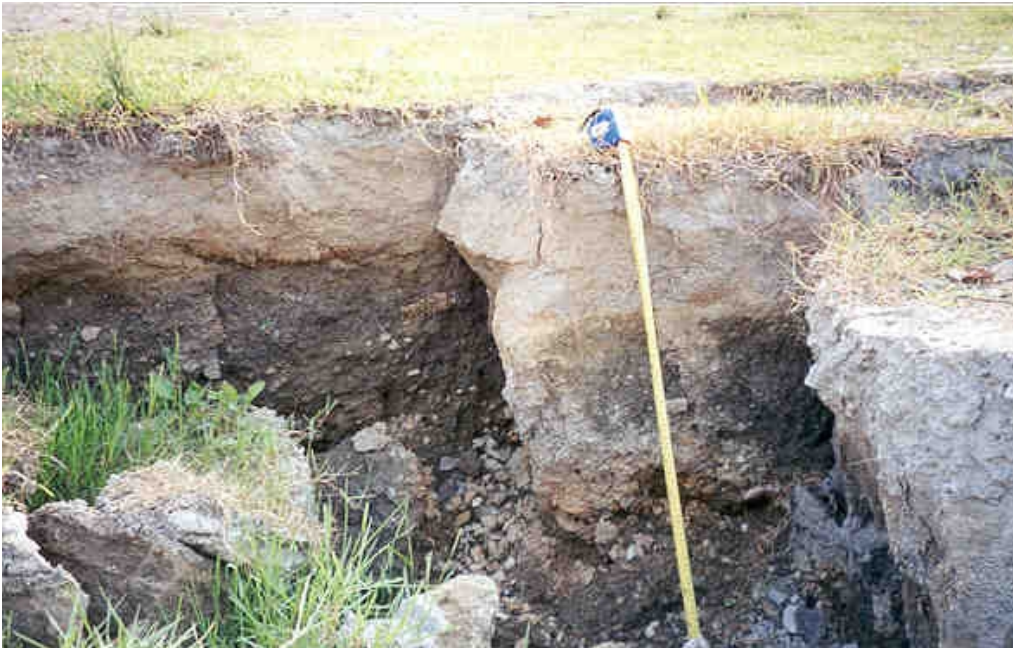
Plate 4.2 Near surface stratigraphy exposed in fault scarp in Gölcük near the Indoor Sports Hall showing a thin topsoil layer underlain by 0.5m of silty sand and 1m of sandy gravel (photograph taken 10 September 1999).

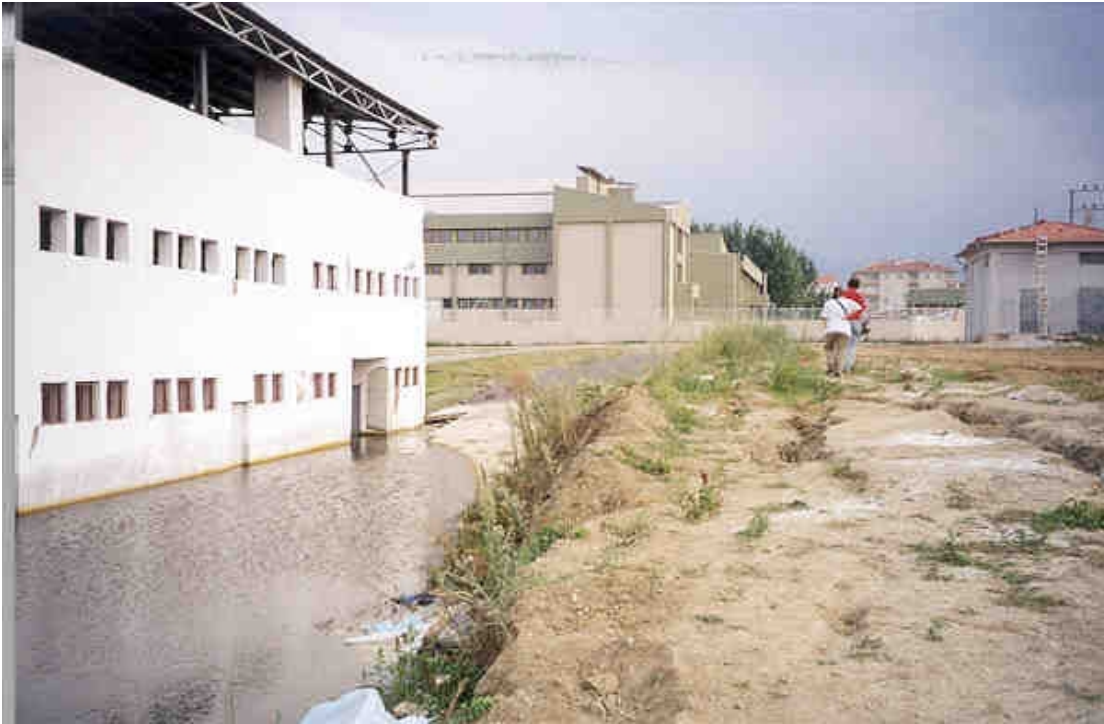
Plate 4.5 Normal fault scarp adjacent to Gölcük Football Stadium. Stadium is on down thrown side with approximately 2m of vertical offset. EEFIT members are standing on back scarp tension cracks. View is toward south-east along fault alignment (photograph taken on 10 September 1999).

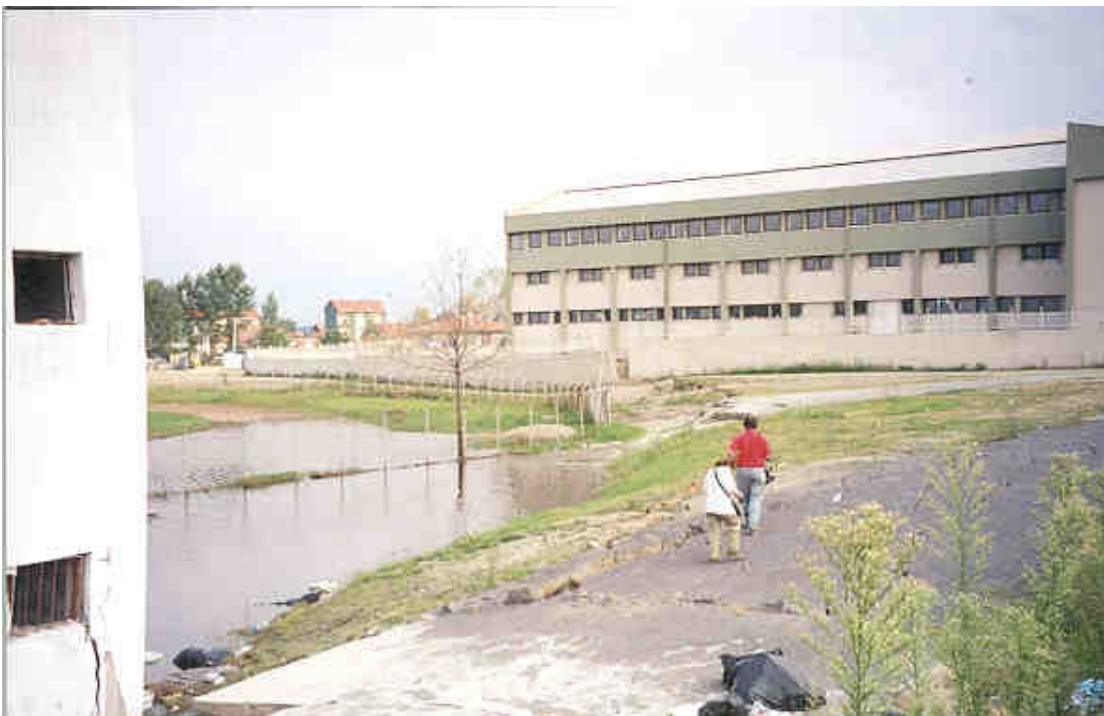
Plate 4.6 Normal fault scarp adjacent to Gölcük Football Stadium and passing beneath corner of Gölcük indoor sports hall. Sports hall wall has approximately 1.5m vertical and 1m lateral offset. View is toward south-east along fault alignment (photograph taken on 10 September 1999).

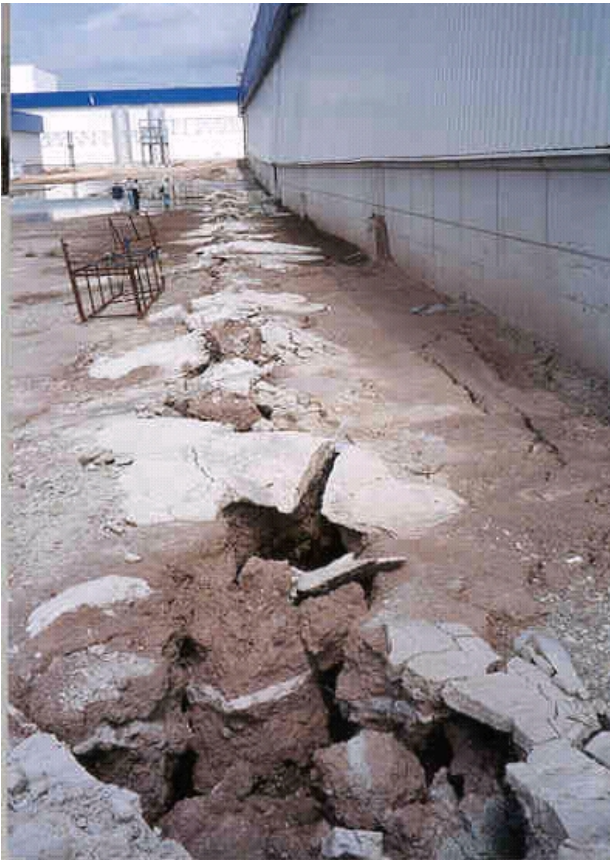
Plate 4.8 Ford Otosan, Gölcük Plant Body Shop west wall. View from southwest corner looking north. Fissure in ground has formed along alignment of cement grout columns, which were installed across the site as ground improvement to increase bearing capacity and resist liquefaction susceptibility. Note differential settlement distortion of wall (photograph taken 5 September 1999).

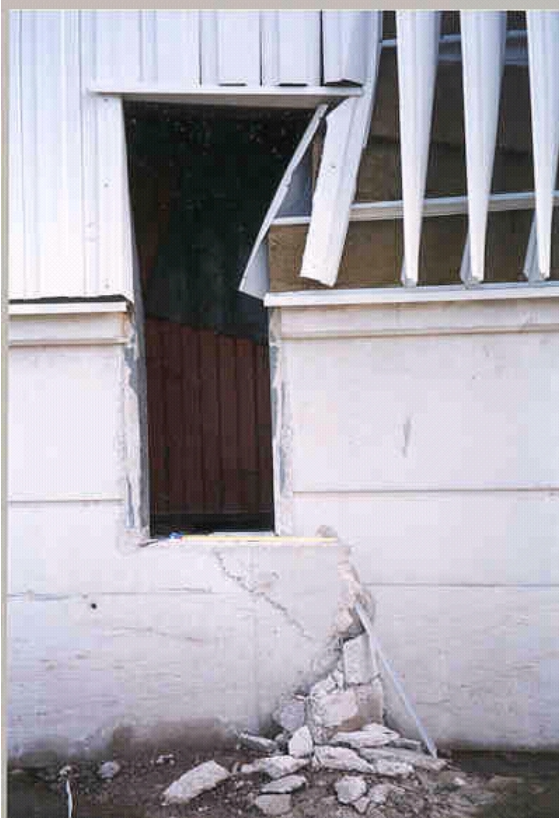
Plate 4.9 Ford Otosan, Gölcük Plant Body Shop west wall. Failure and closure of door in west wall illustrates compression in north-south direction of approximately 400mm (photograph taken on 5 September 1999).

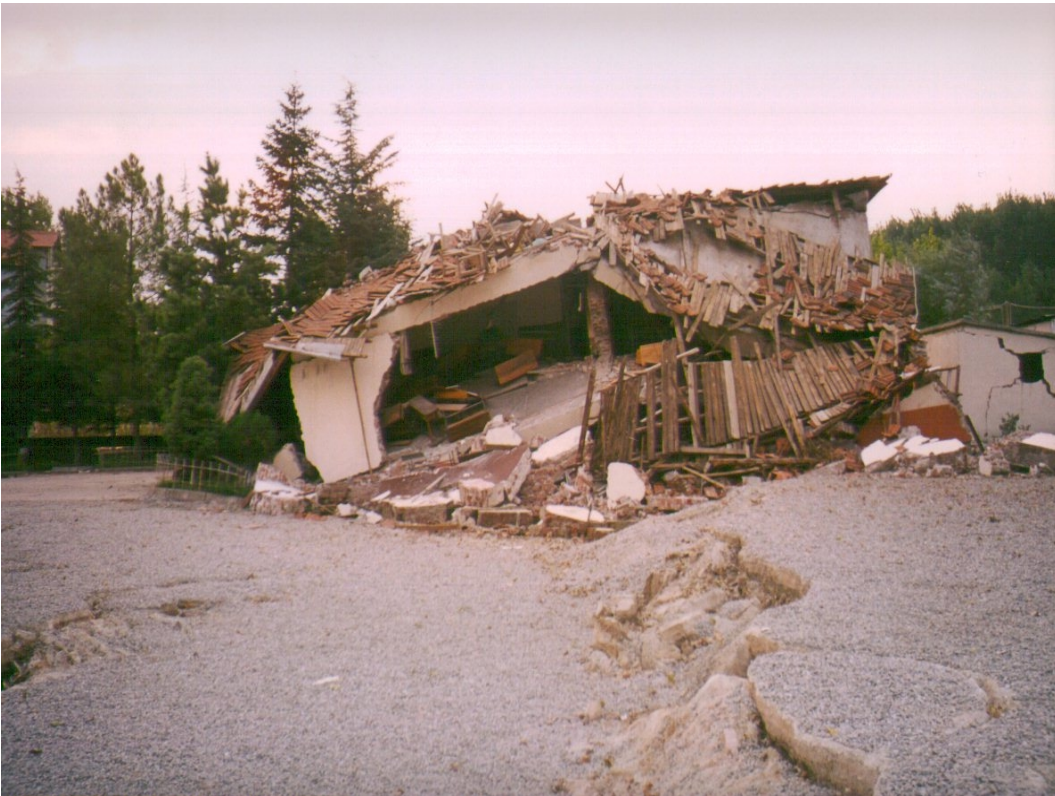
Plate 4.10 Fault rupture at Yuvacik bisected school building causing collapse. At this location the fault was divided into two ruptures oriented 285° with a central graben 5m to 8m wide. The main rupture had 1.5m right lateral offset and 0.7m vertical offset (photograph taken on 18 September 1999).
