THE KOCAELI, TURKEY EARTHQUAKE OF 17 AUGUST 1999

A FIELD REPORT BY EEFIT

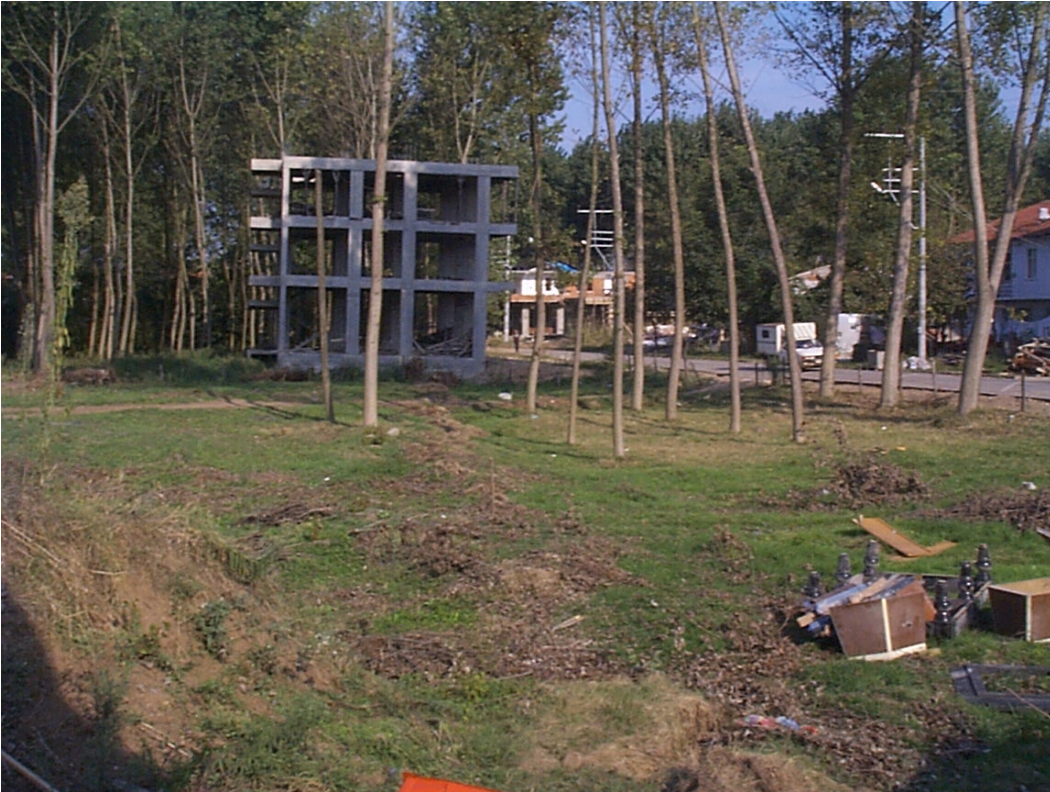
Plate 4.11 Fault rupture 'mole track' at Yuvacik passes beneath a three storey reinforced concrete frame building without causing collapse. At this location the fault was a single rupture oriented 285° with a 1.6m right lateral offset (photograph taken on 18 September 1999).

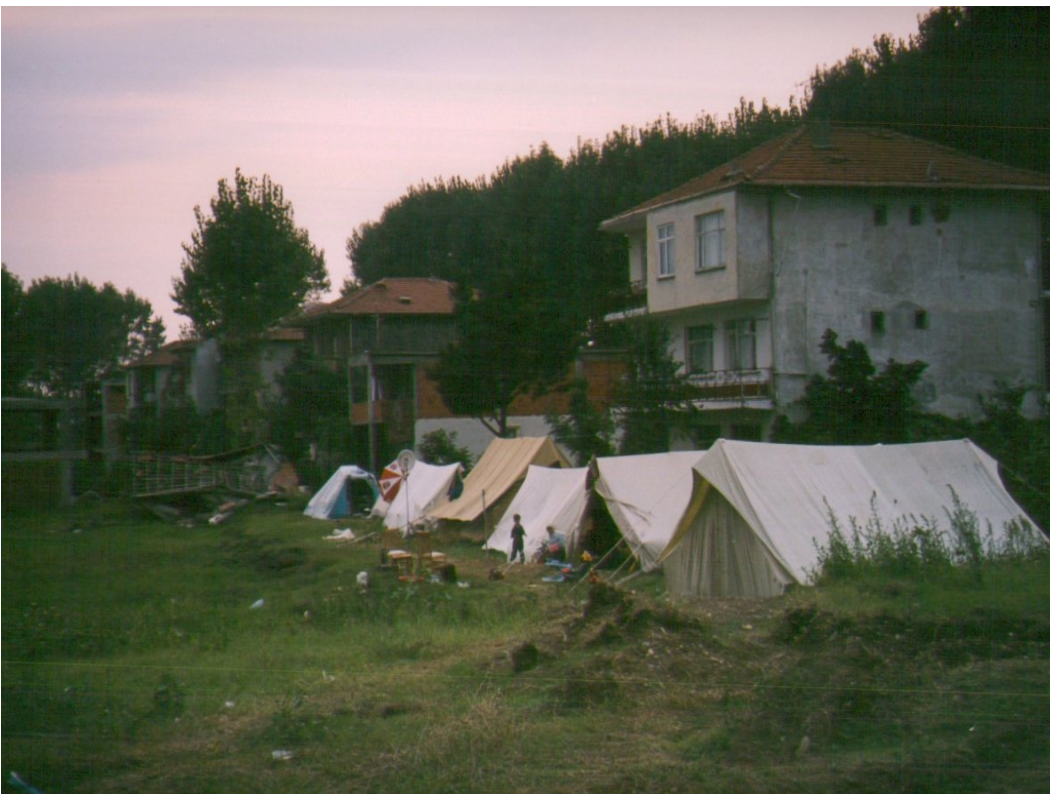
Plate 4.12 Fault rupture 'mole track' at Yuvacik passes in front of three-storey reinforced concrete frame buildings without causing collapse. At this location the fault formed two ruptures oriented 270° with a 1.6m right lateral offset on the main rupture and 0.9m right lateral offset on the secondary rupture (photograph taken on 18 September 1999).

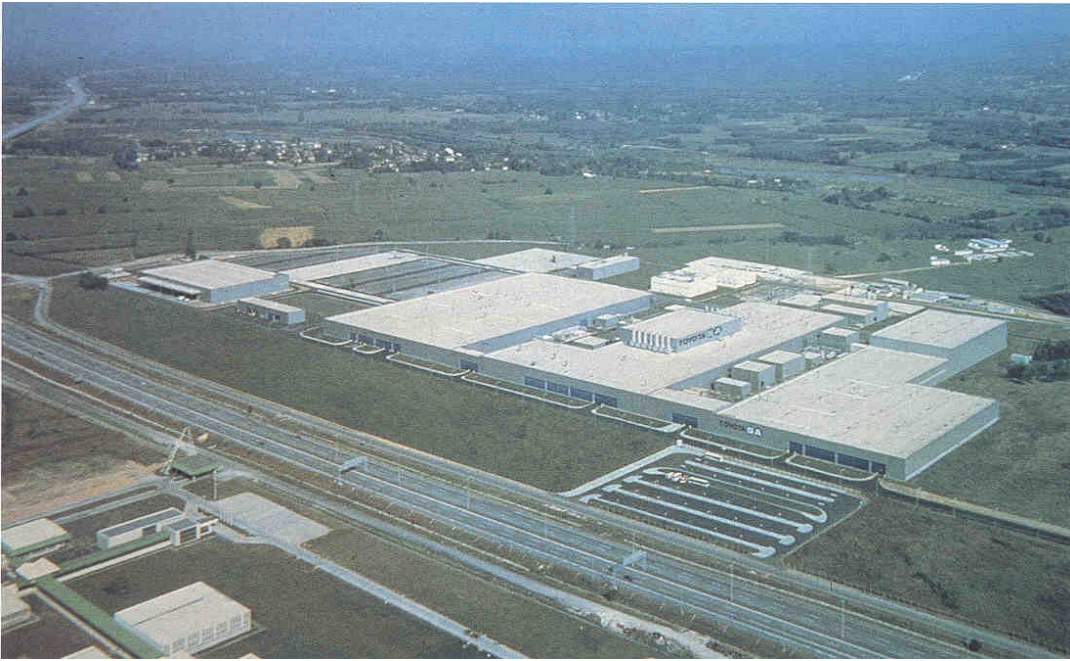
Plate 4.13 Oblique aerial view of Toyota Factory taken prior to earthquake. Highway is located on north side of factory and alignment is approximately east–west. The fault rupture passed to south of factory.

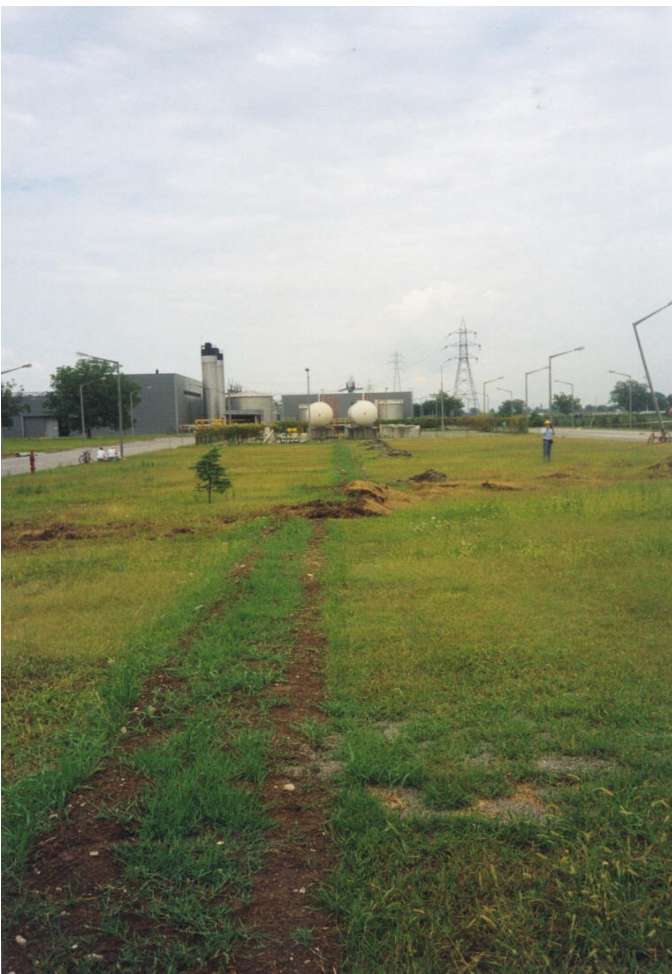
Plate 4.14 Fault rupture ‘mole track’ at entrance to Toyota Factory. Fault at this location formed broad 50m to 100m wide zone of deformation with series of sub-parallel ruptures (photograph taken on 8 September 1999).

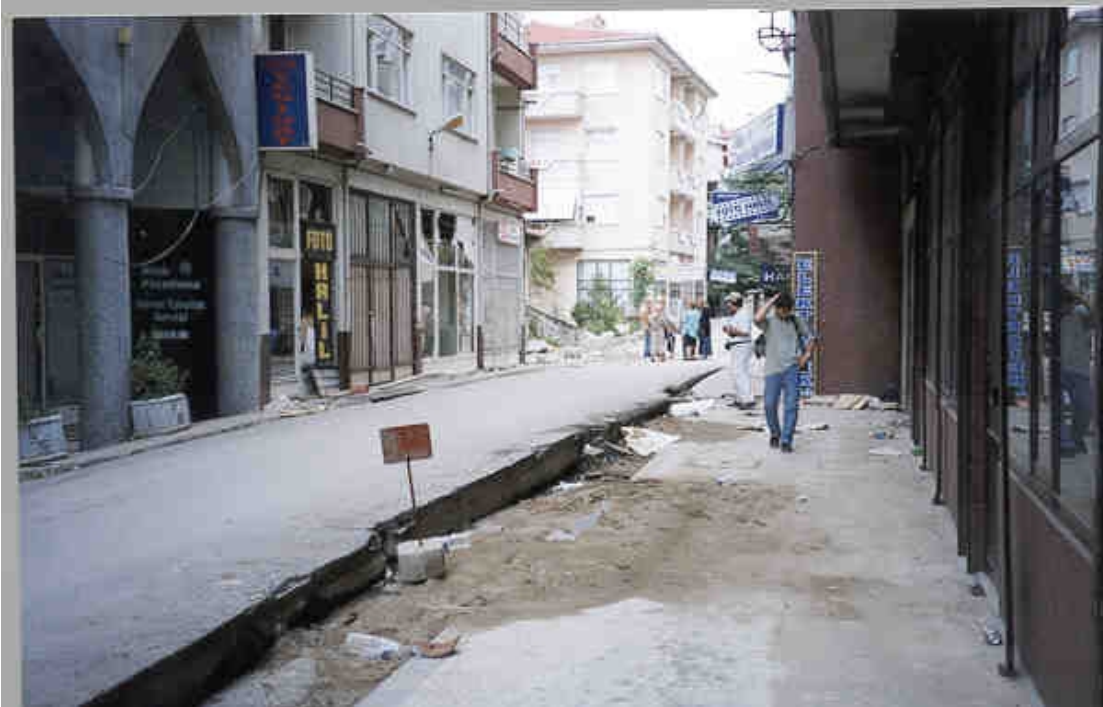
Plate 4.15 Sand venting and 300mm differential settlement of pavement in central Adapazari interpreted to be associated with liquefaction (photograph taken on 6 September 1999).

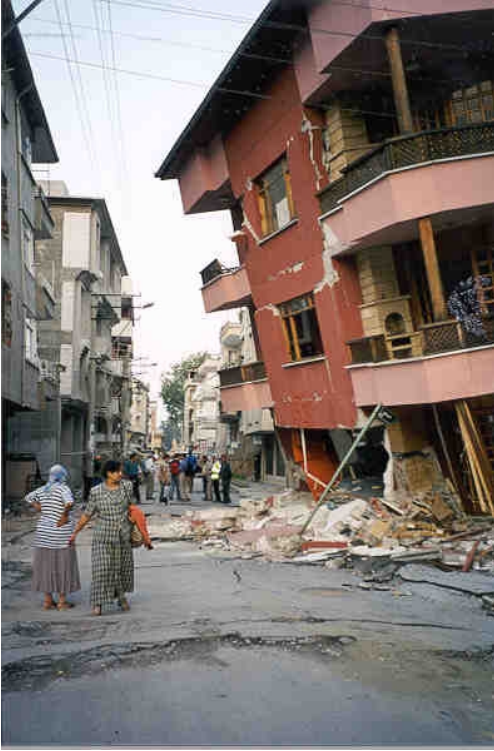
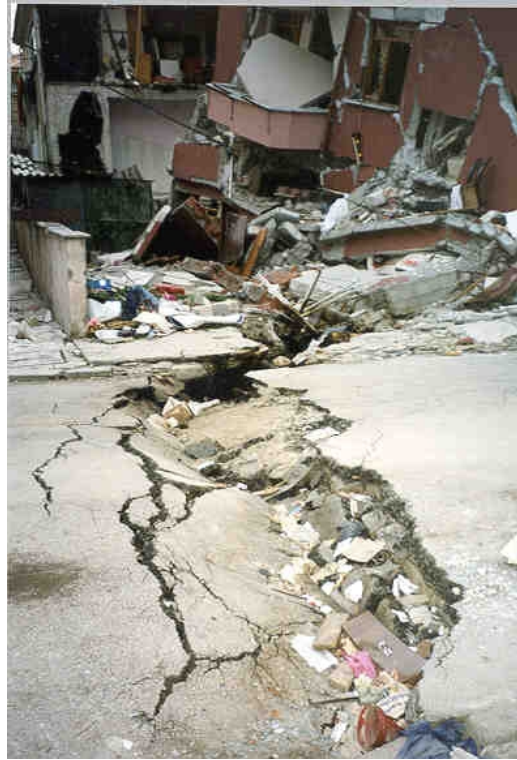
(a) (b)
Plate 4.17 Compression ridges and fractures (a) and tension fissures (b) in the road pavement on Tasler Sokak in central Adapazari (photograph taken 8 September 1999).

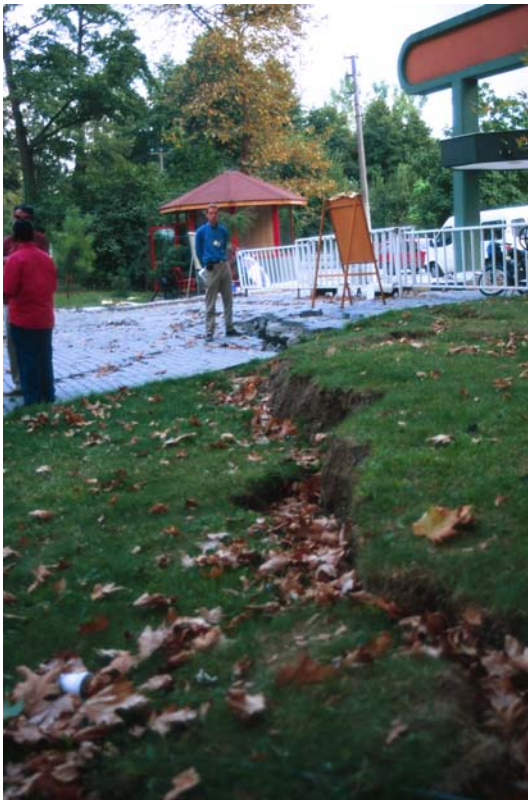
Plate 4.18: At the Hotel Sapanca site, liquefaction of fine sand at depth is interpreted to have resulted in lateral spreading of the shoreline into Lake Sapanca. The failure scarp extended over 100 m back from former shoreline.

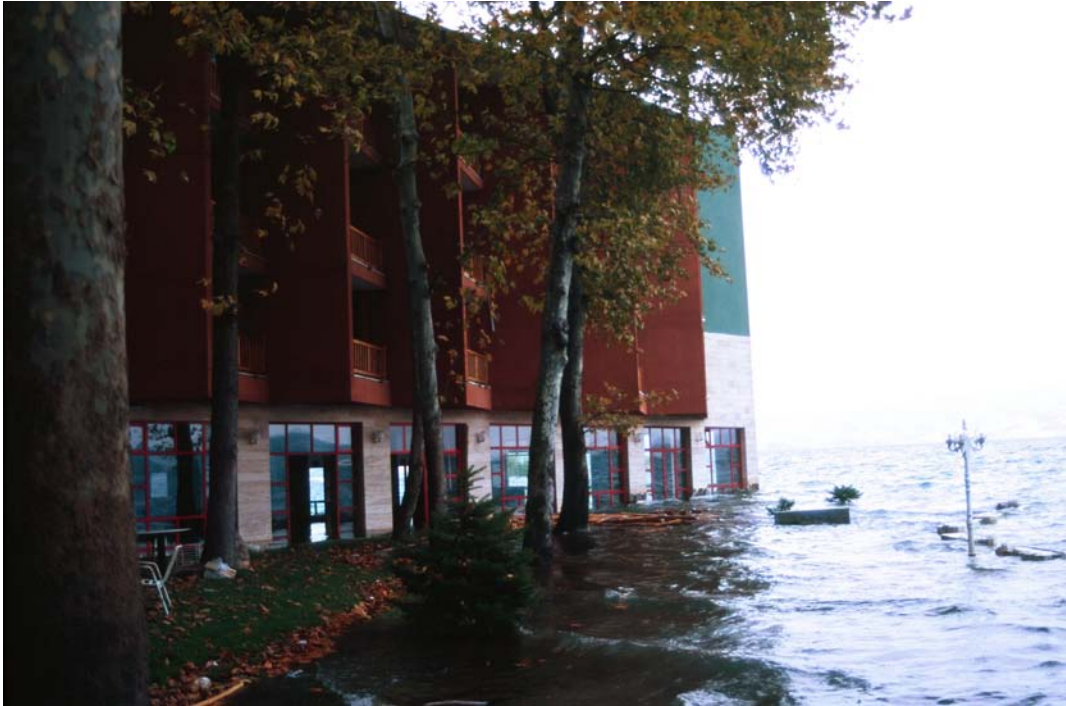
Plate 4.19: At the Hotel Sapanca site, the lateral spreading slide mass has moved toward the lake resulting in submergence of the lake front side of the hotel. The hotel is constructed on two independent raft foundations, however, only minor differential movement occurred between rafts.

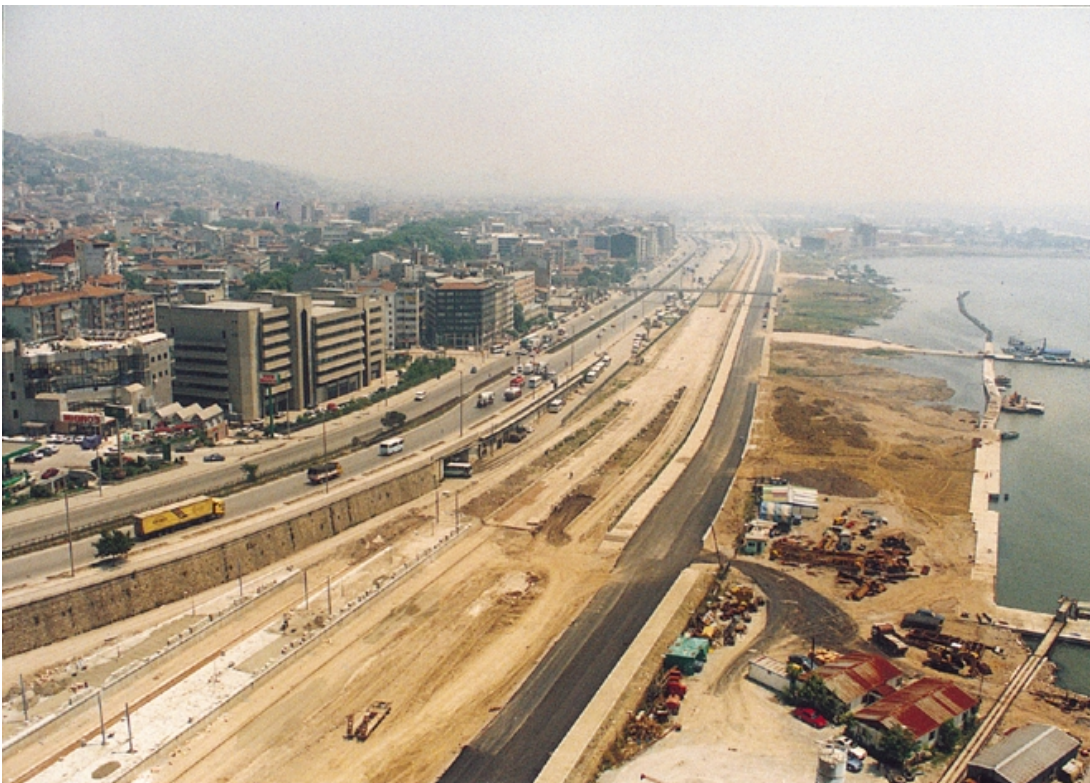
Plate 4.20: Oblique aerial view of Izmit waterfront under construction in June 1998.

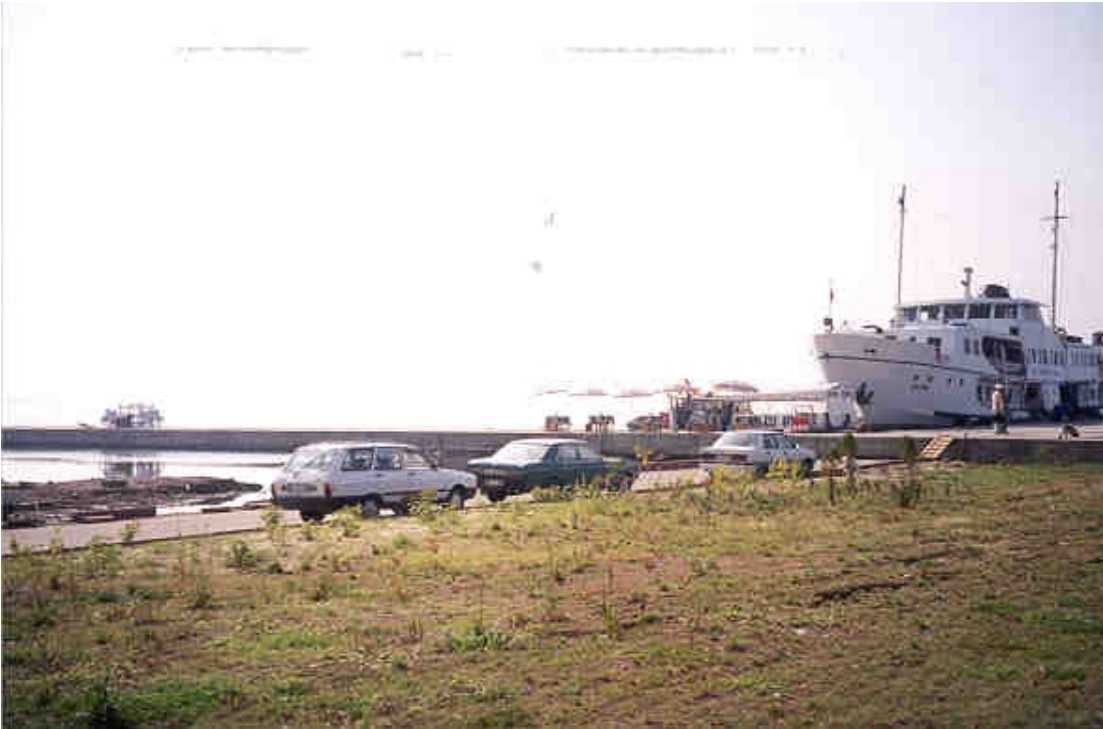
Plate 4.21 Ground settlement and low angle lateral spreading at Izmit Steamer Port. Note approximately 1m differential settlement between piled wharf structure and backfill. Also note tension cracks in foreground and slide toe uplift at centre left (photographs taken 11 September 1999).

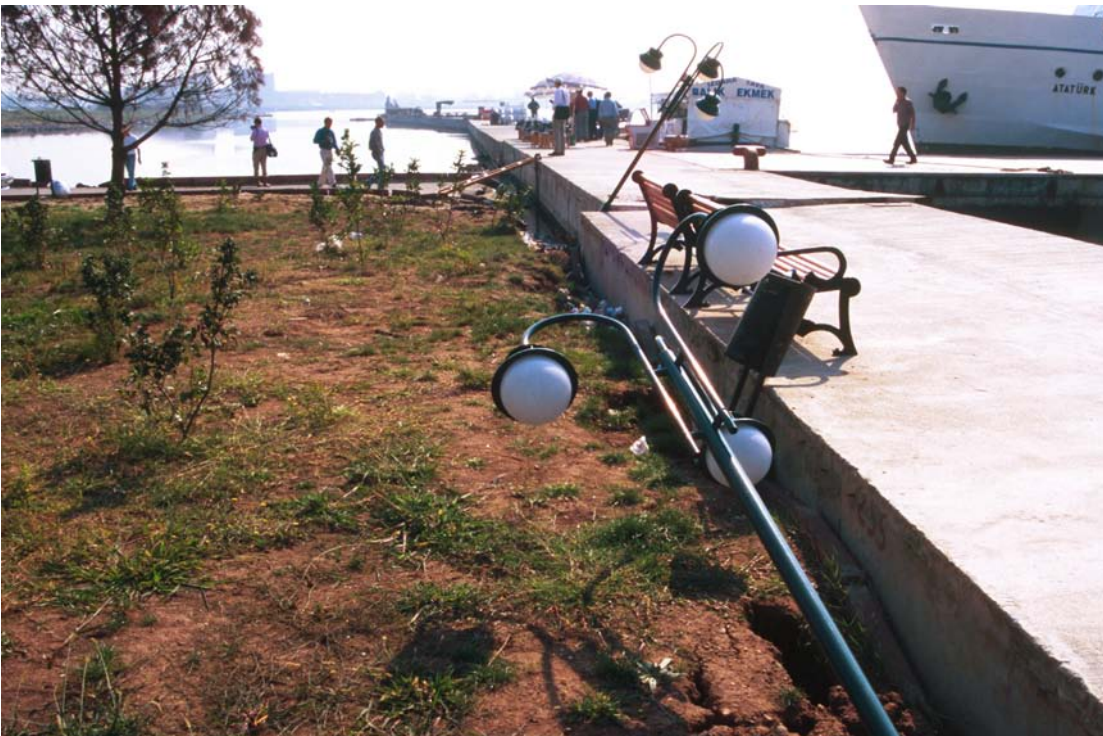
Plate 4.22 Displaced waterfront structure with settled made ground behind at Izmit Steamer Port.

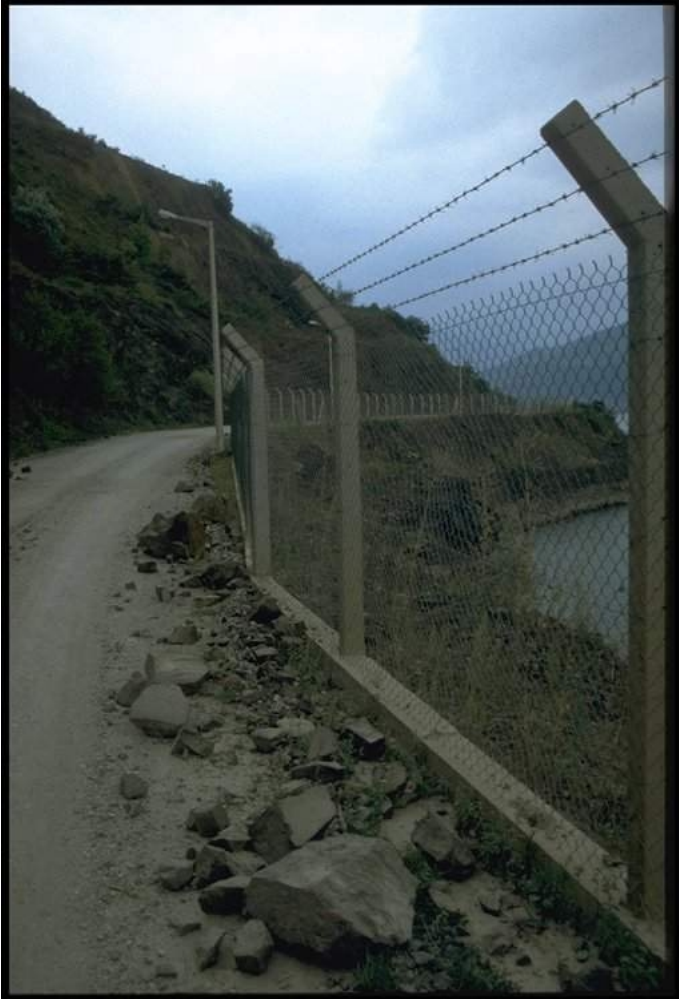
Plate 4.23 Minor rockfall debris observed on the road to Yuvacik Dam.

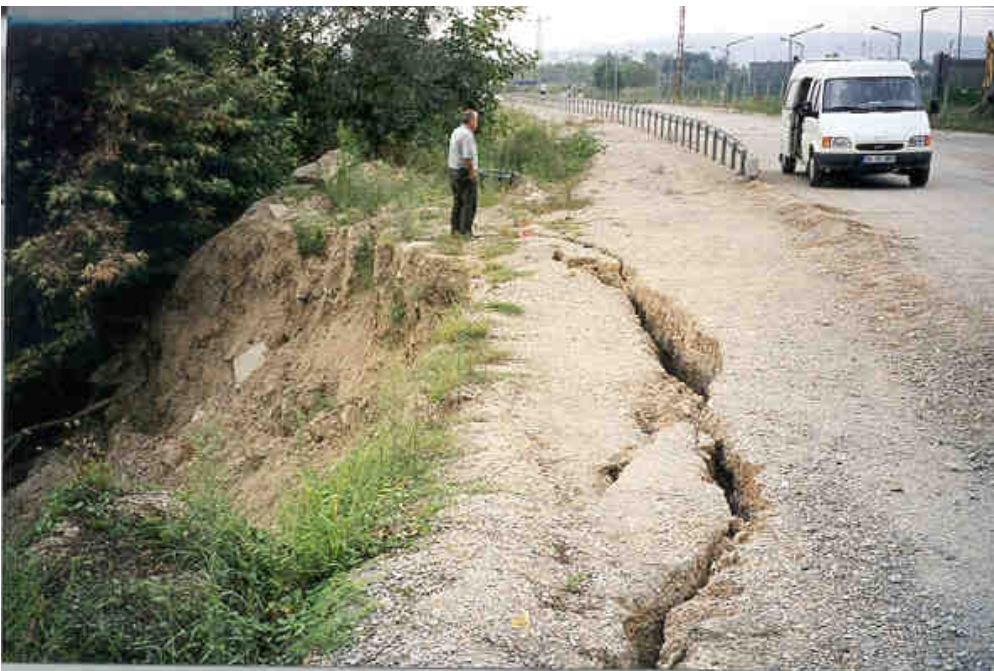
Plate 4.24 Soil slumping on banks of Sakarya River near Toyota Plant outside Adapazari (photograph taken on 8 September 1999).

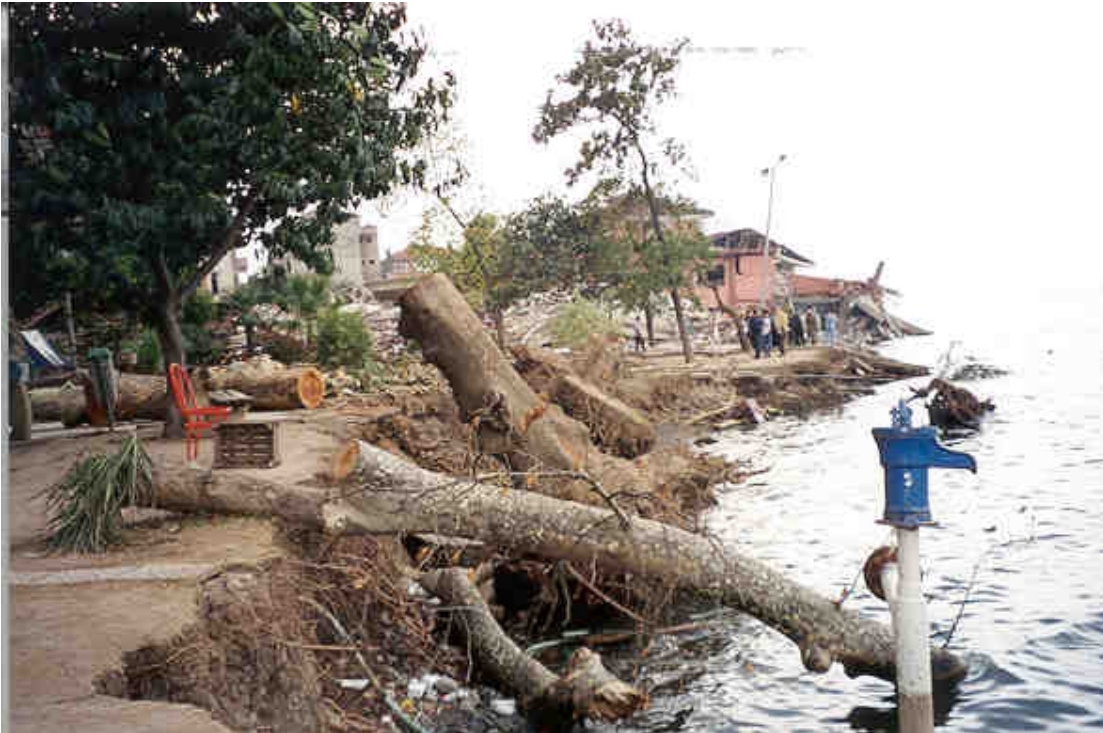
Plate 4.25 Back scarp of low angle slide or lateral spread at Degimendere. Approximately 20m of waterfront promenade is understood to have failed (photograph taken on 10 September 1999).

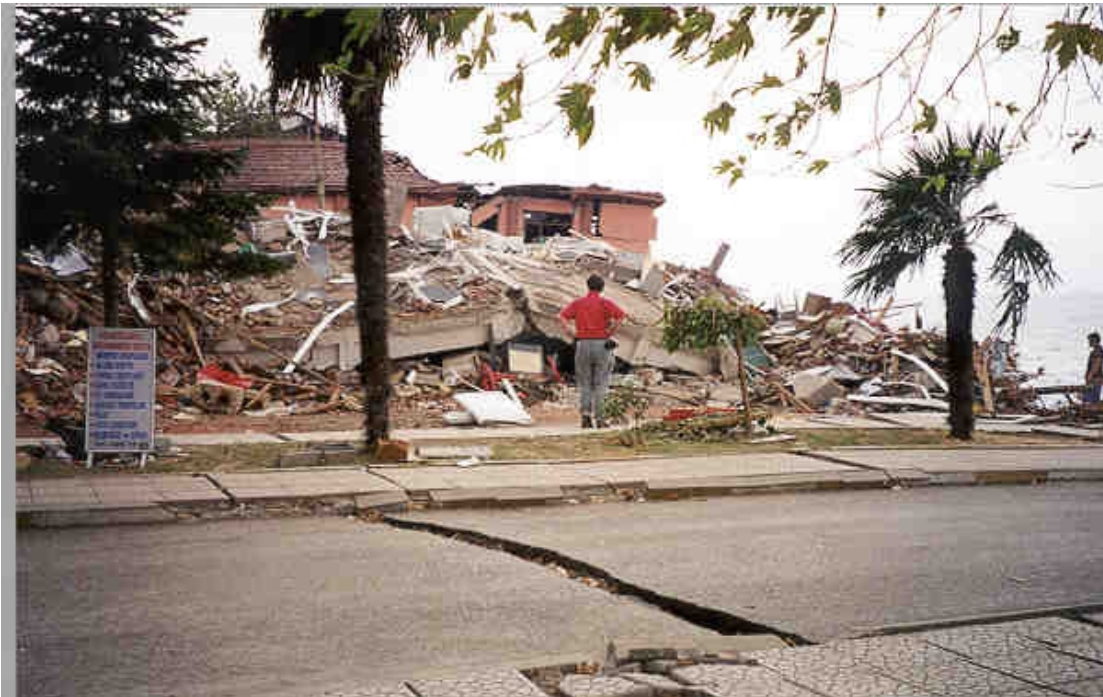
Plate 4.26 Tension crack behind back scarp of low angle slide or lateral spread at Degimendere (photograph taken on 10 September 1999).

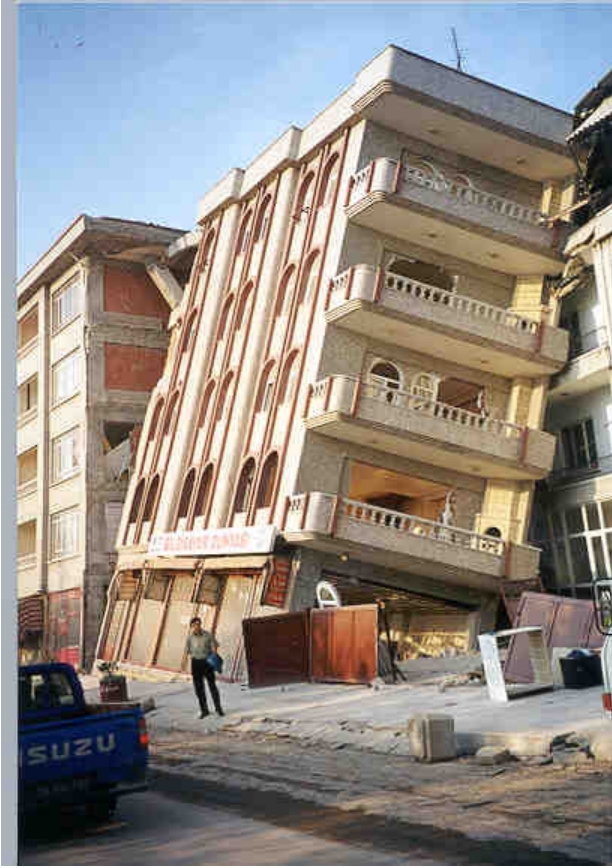
Plate 4.27 Bearing capacity failure of five storey building in Sedat Sokak in central Adapazari. Failure is interpreted to be due to liquefaction as building has settled into ground by 0.5m to 2m. Overturning has been arrested by neighbouring building (photograph taken 8 September 1999).

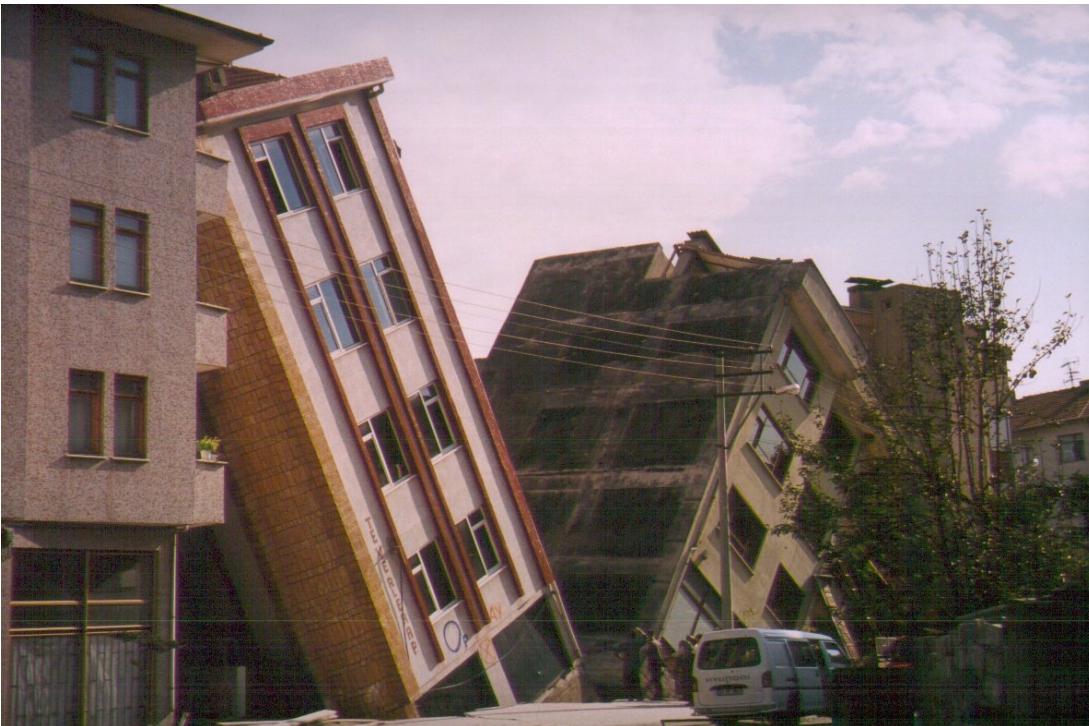
Plate 4.28 Bearing capacity failure and tilting of four and five storey buildings in Yenigun Mahallesi in central Adapazari (photograph taken on 6 September 1999).

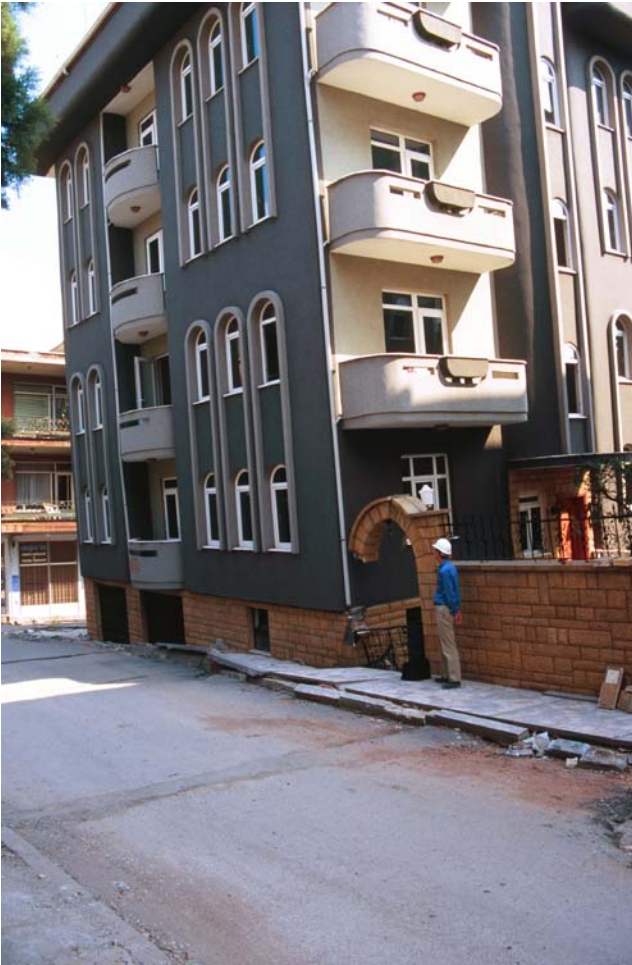
Plate 4.29 Tilting building. Note separation of 1 m between arch and its springing on corner of structure.

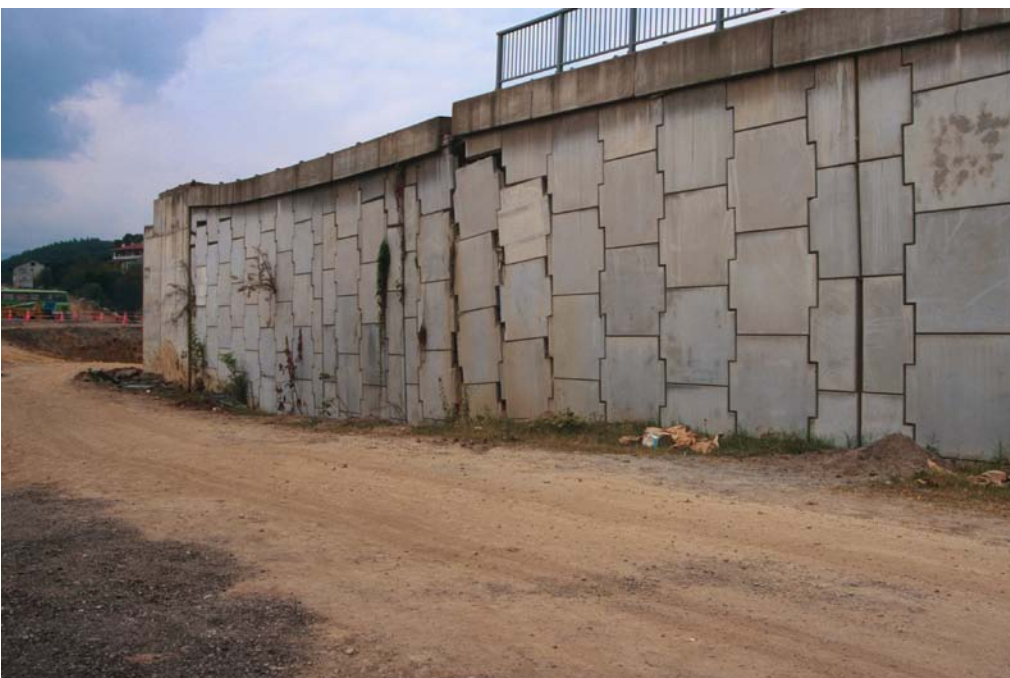
Plate 4.30 Reinforced earth wall for E80 highway approach ramp at Arifiye. View toward the southwest. Culvert crosses the ramp beneath the nearer end of the damaged coping units. Vertical movement joints in the panels run up from the edges of the culvert.

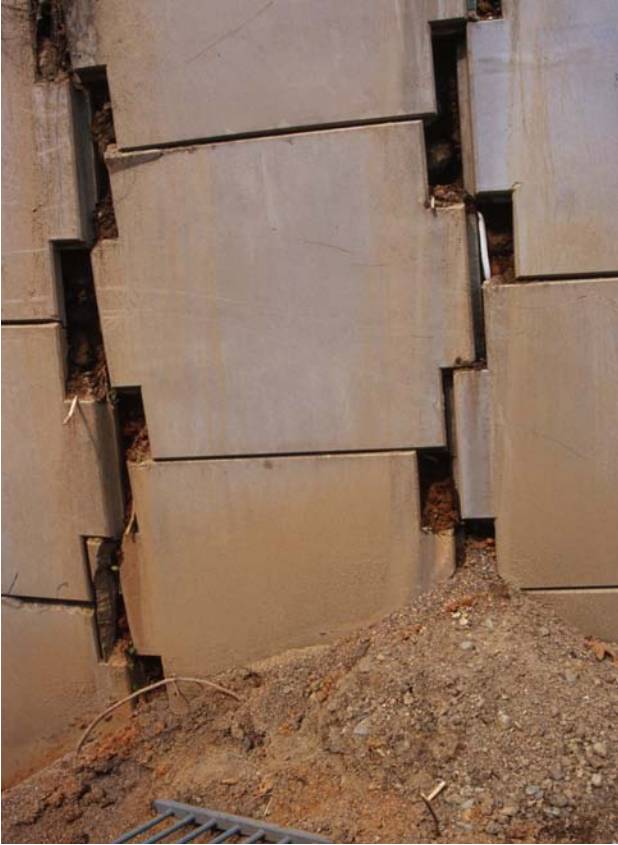
Plate 4.31 Reinforced earth wall for E80 highway approach ramp at Arifiye. Damage to wall panels on the eastern side of the ramp. The ramp on the left side has settled with respect to that on the right. Opening of panel joints has been exacerbated by the horizontal distortion of the ramp about a 'hinge point' on the opposite side of the ramp.

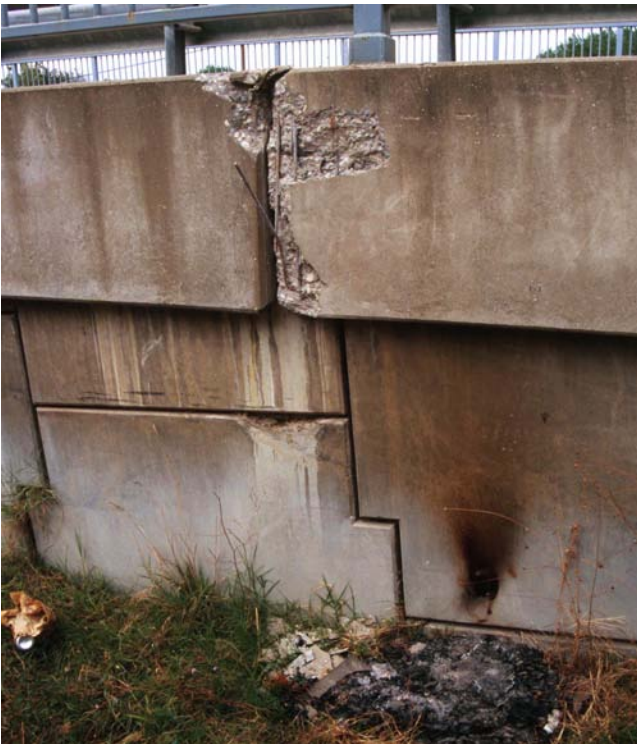
Plate 4.32 Reinforced earth wall for E80 highway approach ramp at Arifiye. Pounding damage to cope units.

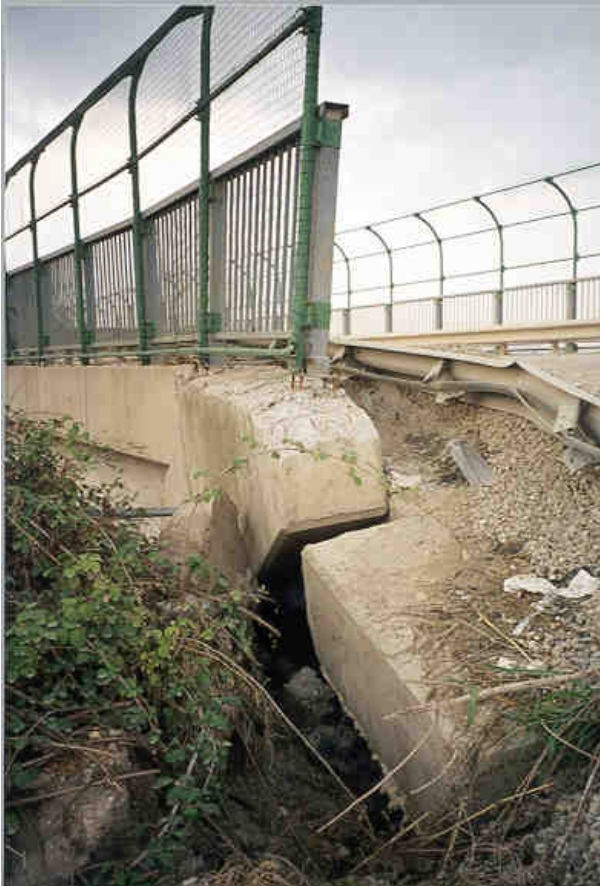
Plate 4.33 Differential settlement of approach embankment and damage to bridge abutment on access road to Toyota Factory outside Adapazari (photograph taken on 8 September 1999).

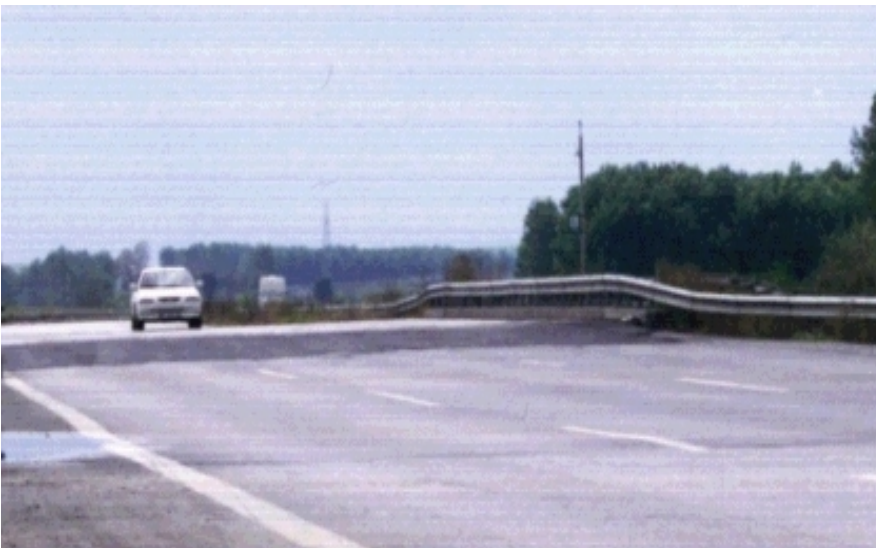
Plate 4.34 Differential settlement of earth embankment on-ramp and off-ramp to highway bridges formed bump-on and bump-off structures .

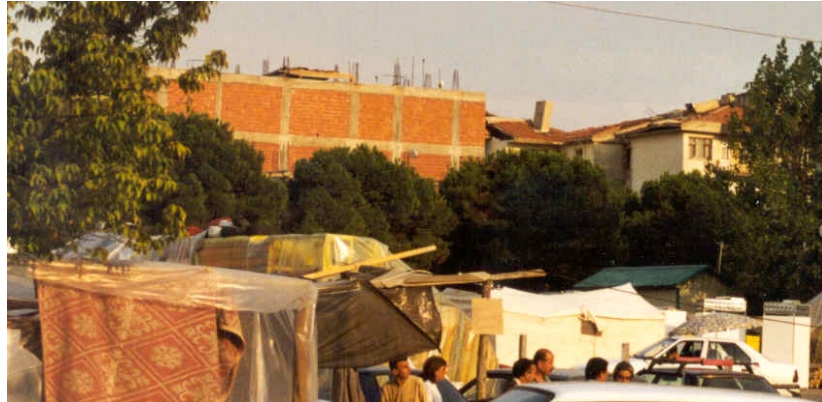
Figure 5.2: Typical r.c. frame building with protruding “waiting” bars

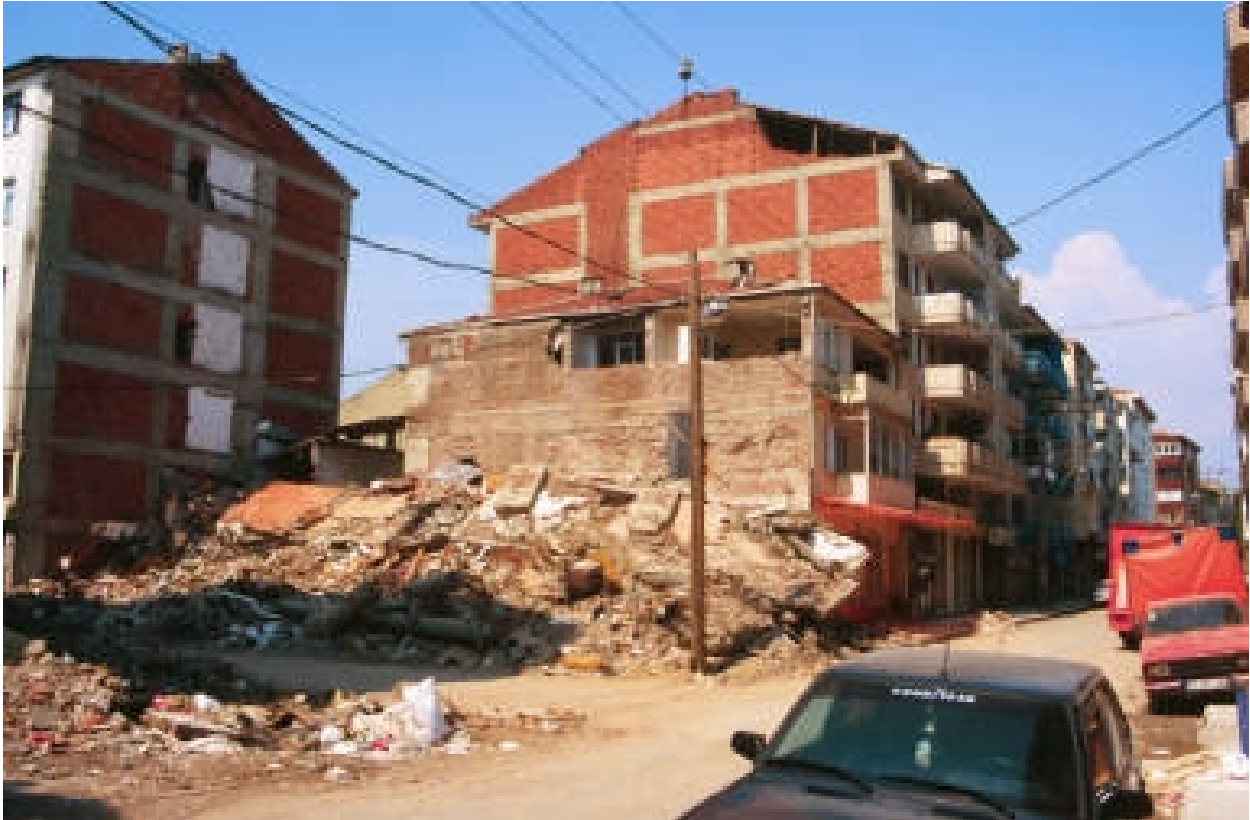
Figure 5.3: Typical medium-high density urban block in Yalova. Notice the failure of the corner building

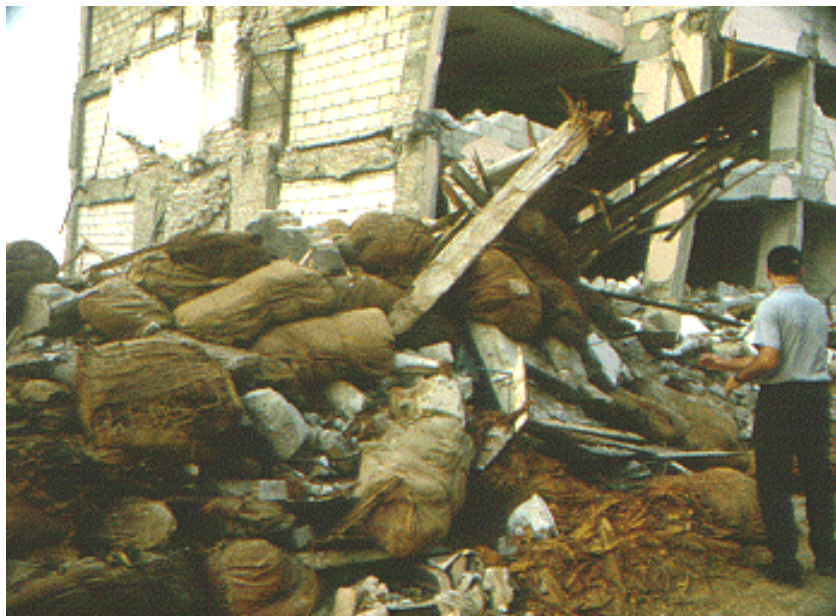
Figure 5.4: Aerated concrete block (Ytong) infill panels

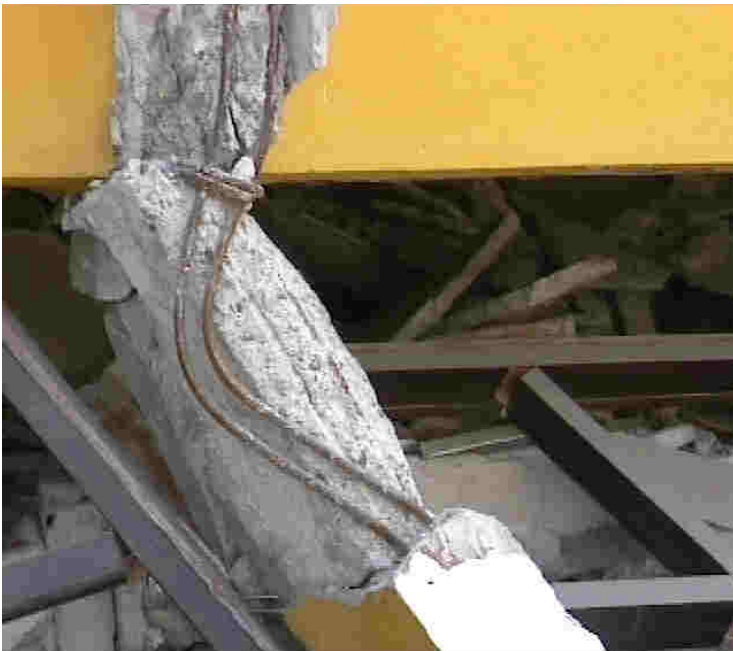
Figure 5.5a: Slender column, lack of bonding and absence of stirrups

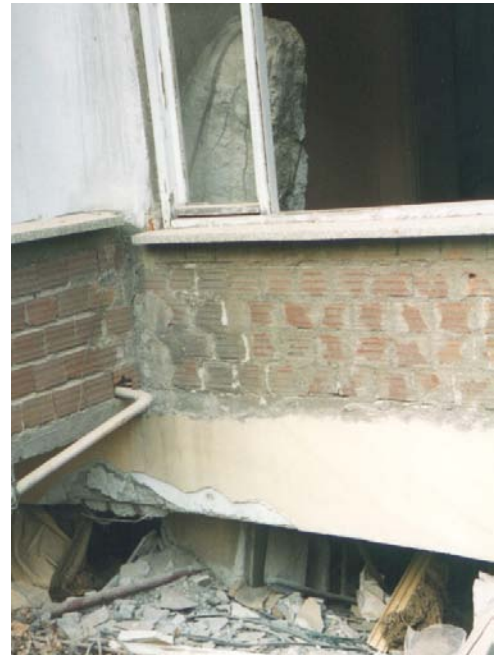
Figure 5.5b: behaviour of smooth mild steel reinforcement

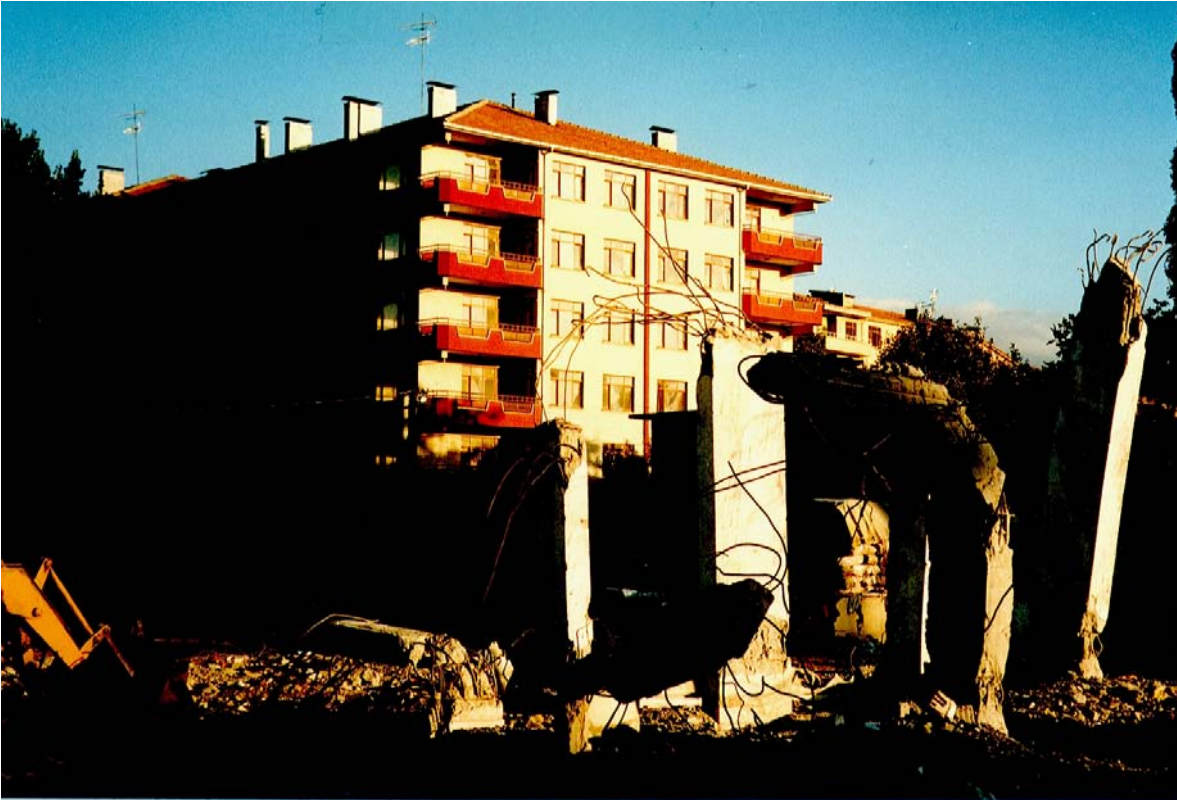
Figure 5.6: The collapsed building in Gölçük from which the sample was taken.

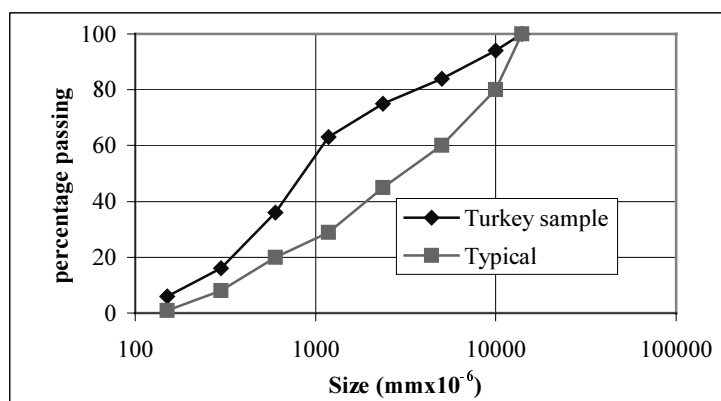
Figure 5.7: Grading of concrete sample

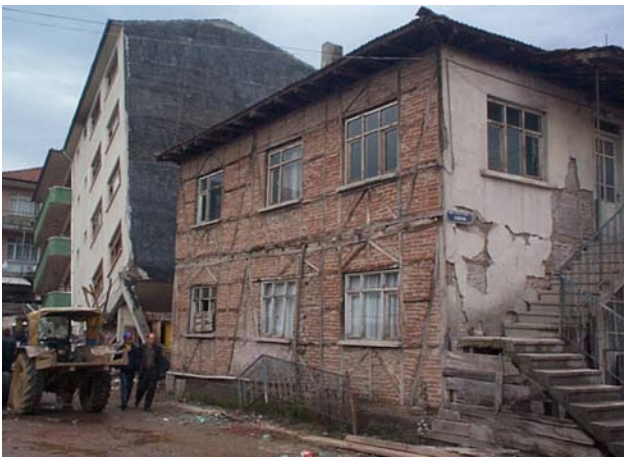
Figure 5.8: Himis timber house standing next to failed r.c. building

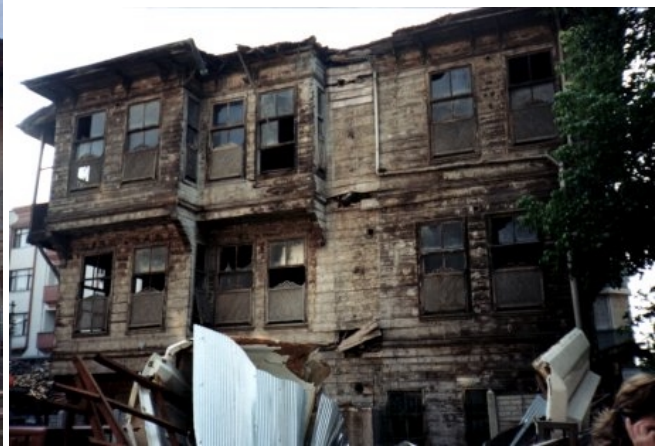
Figure 5.9: Bagdadi timber house (photo B. Teymur)

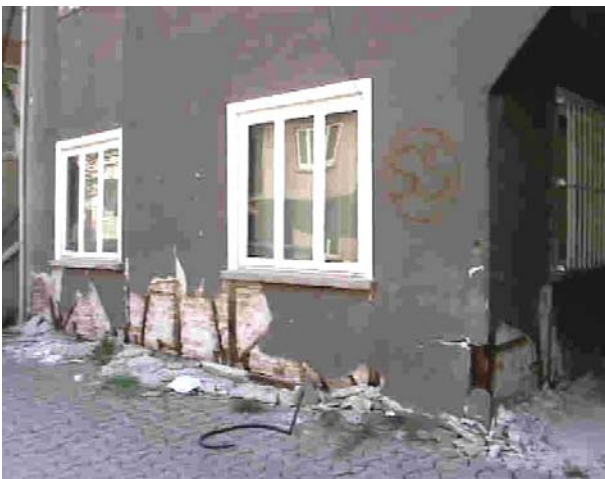
Figure 5.10: Damage to Himis house caused by soil failure

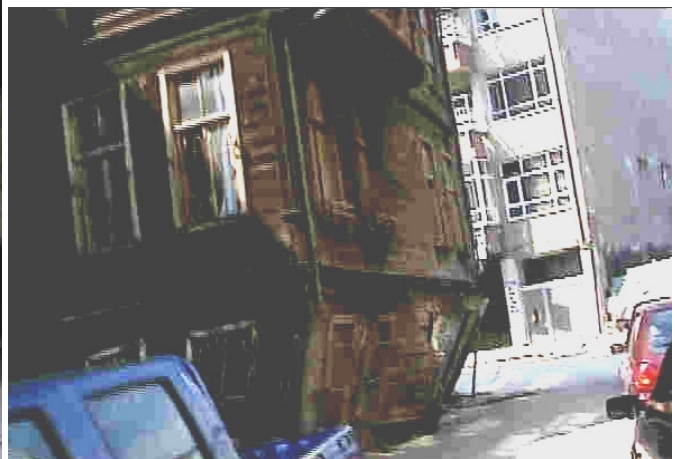
Figure 5.11: Hinge column failure of Bagdadi house in Adapazari

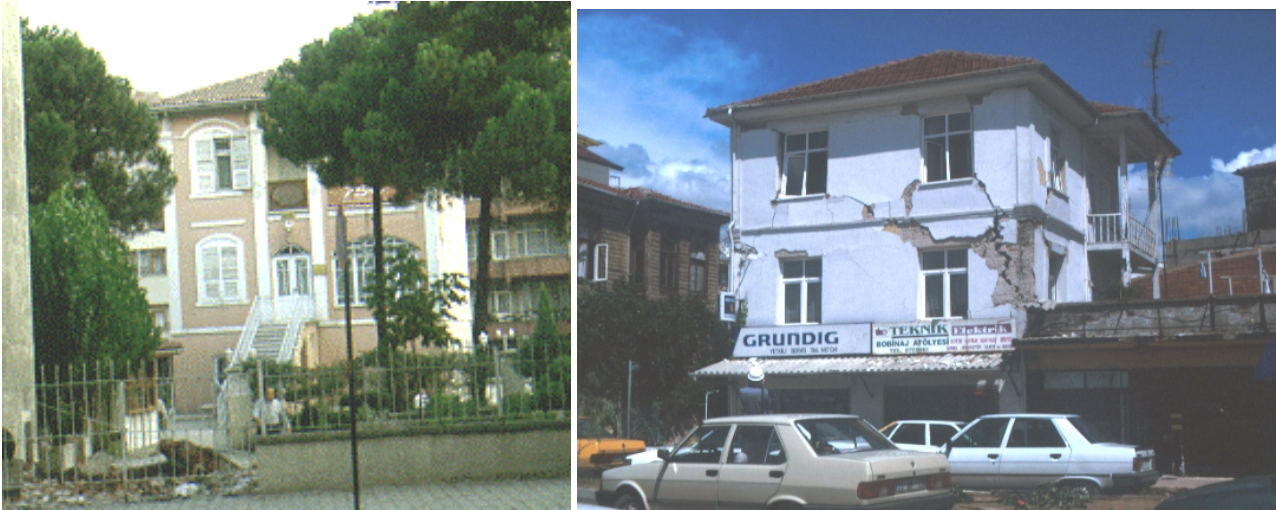
Figure 5.12: Adapazari. XIX century restored 3 storey masonry building survived undamaged in an area of numerous collapses, while another similar building suffered damage level D3, with diagonal cracks around the openings.
