THE KOCAELI, TURKEY EARTHQUAKE OF 17 AUGUST 1999

A FIELD REPORT BY EEFIT

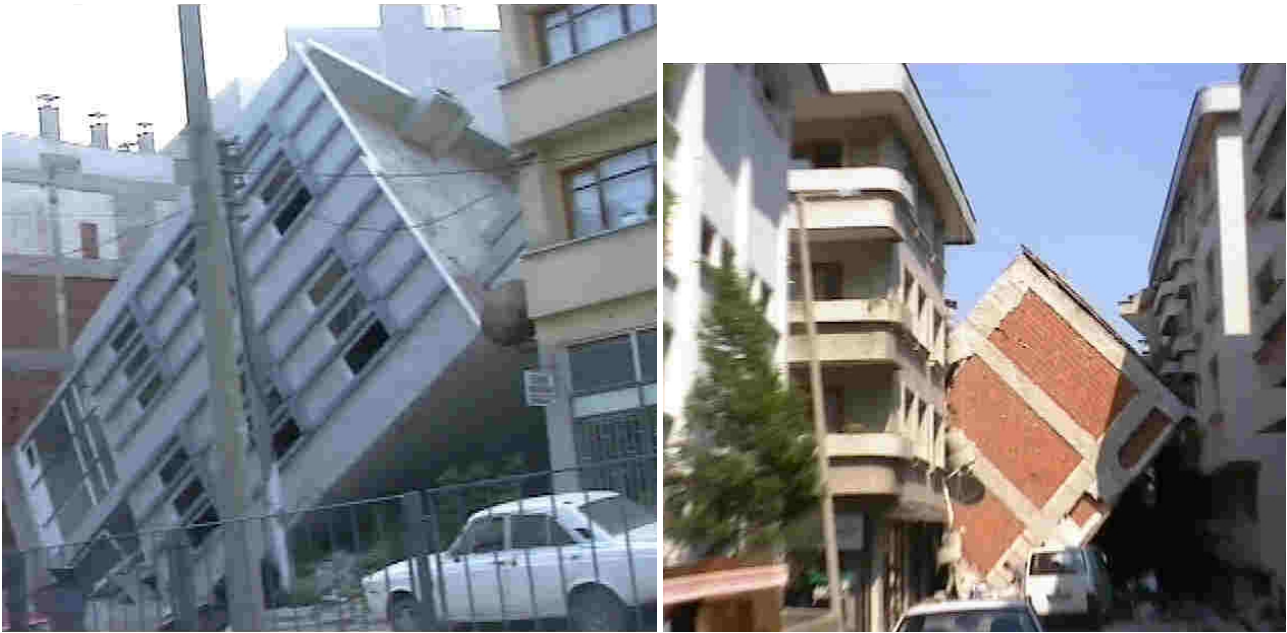
Figure 5.32 Two overturned building in Tigcilar, the worst district of Adapazari affected by liquefaction

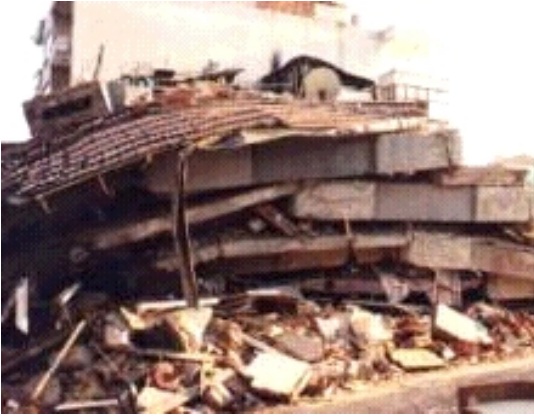
Figure 5.14a: Pancake collapse.

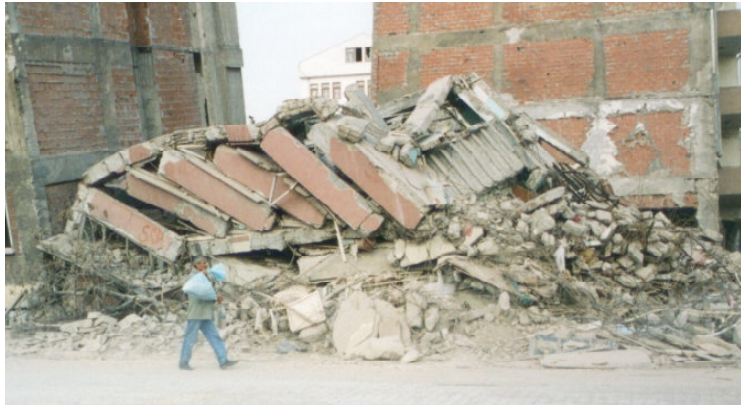
Figure 5.14b: Slender building with column oriented in the direction orthogonal to failure plane. Lack of reinforcement continuity

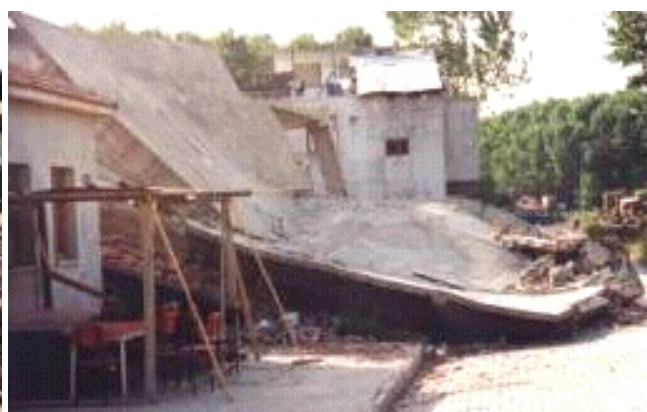
Figure 5.16b: slab damage to the same building of Figure 5.16a

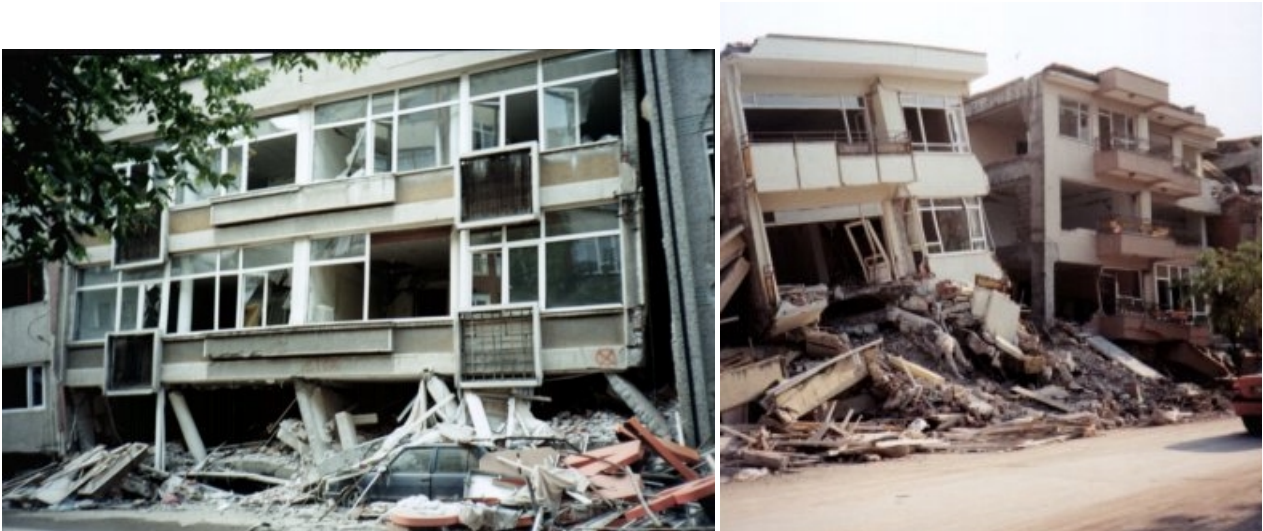
Figure 5.17: Buildings in Cark Cad., Adapazari for which the lower 2 storeys columns had collapsed.

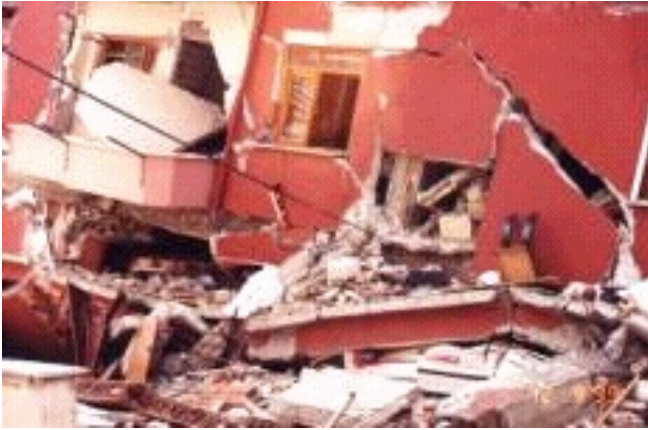
Figure 5.19 a: Lower storey collapse of a 4 storey building and failure of infill panels

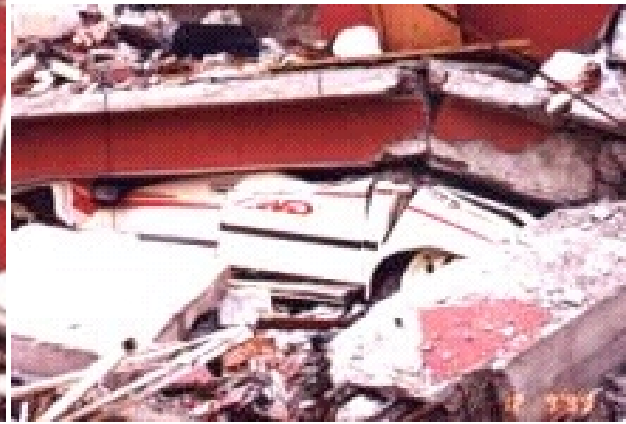
Figure 5.19 b: bottom right detail of fig 5.19a), showing failure of the beam

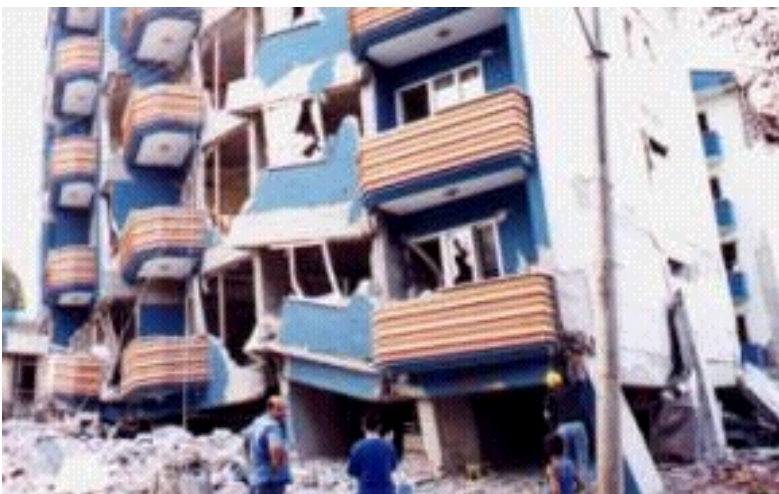
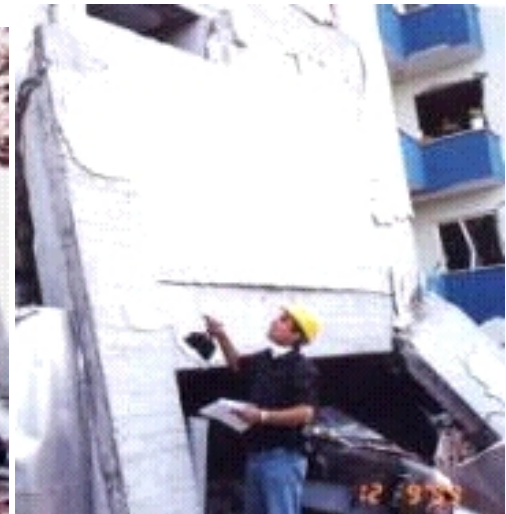
Figure 5.20 a, b: General view and detail of failed building in Milli Egemenlik Cad., in Adapazari

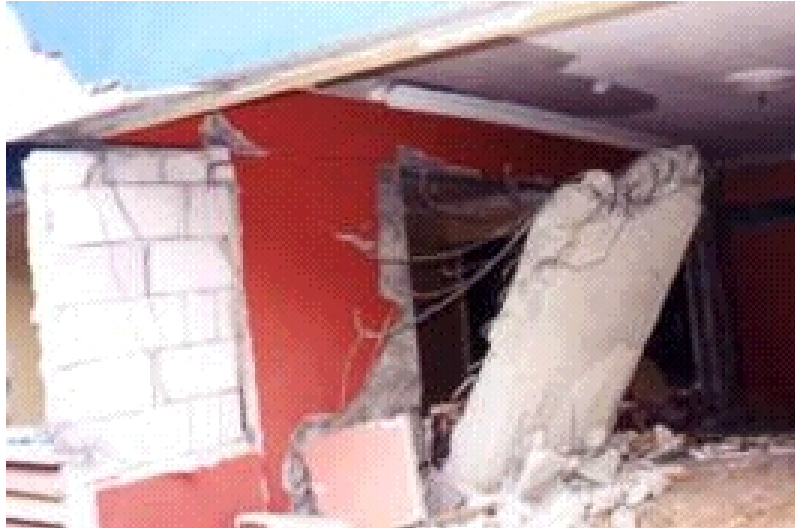
Figure 5.20c: The gravity loads are now carried by the surviving infill panels

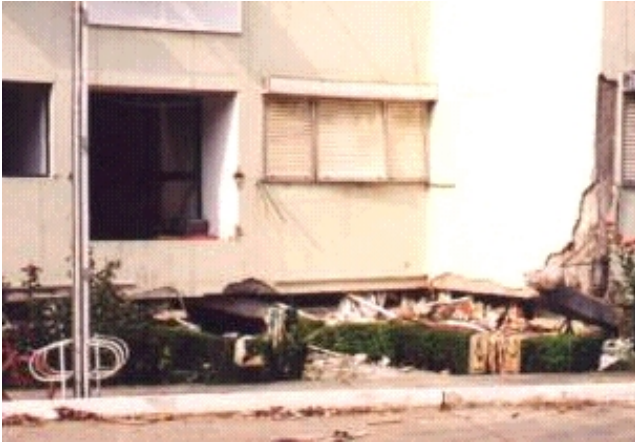
The upper layer of good materials is quite capable of carrying the loads imposed from a five story block of flats, with correct design of the foundations. Indeed, for this type of speculative development it is likely that site investigation had been limited to trial pits and the presence of the soft clay layer was not appreciated. This layer would have almost certainly caused considerable amplification of the earthquake motion, and as a result the loads would have been increased, leading to collapse of the highly stressed lower floor columns.

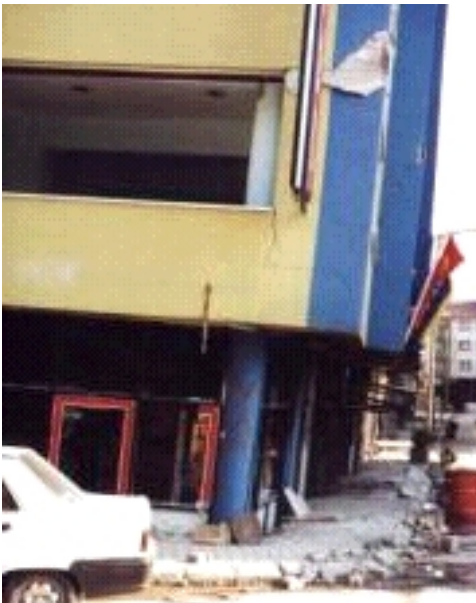
Figure 5.23a: 7 storey hotel building with raft foundation

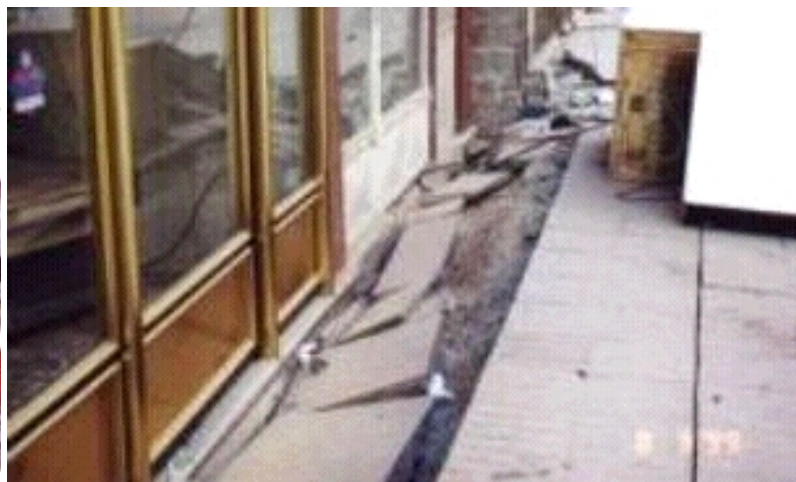
Figure 5.23b: Soil failure. The building is undamaged

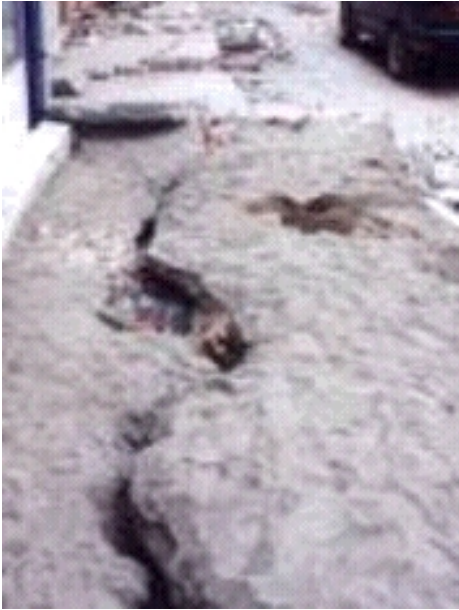
Sand was apparent over a considerable extent of the pavement in this road. This is illustrated in Figures 5.24a and b. This may be indicative of liquefaction, or it may be sand that had been used as a bedding material below the paving. The following photographs (Figures 5.25a) and b)) show typical damage at Degirmendere, on the south shore of the Marmara sea, where the subsided area extended about 250m along shores and about 70 m inland, photographed from the opposite shore.

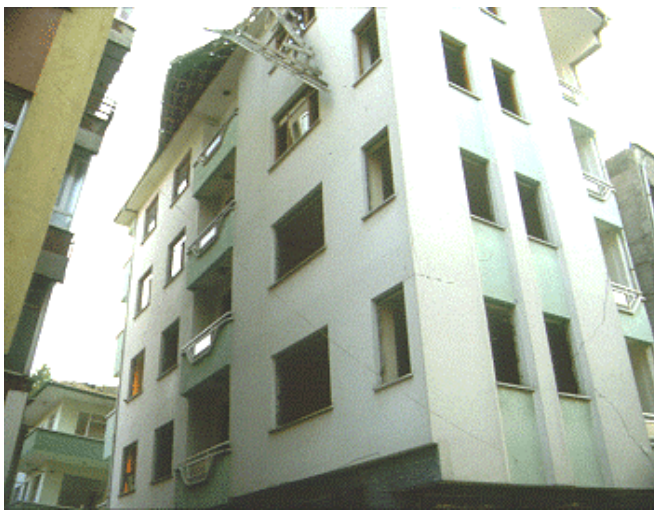
Figure 5.27a: Roof failure in a light damaged building in Adapazari

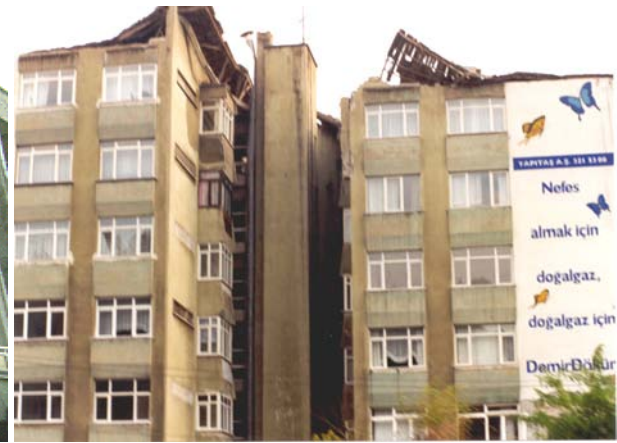
Figure 5.27b: Roof failure in a 8- storey building in Izmit

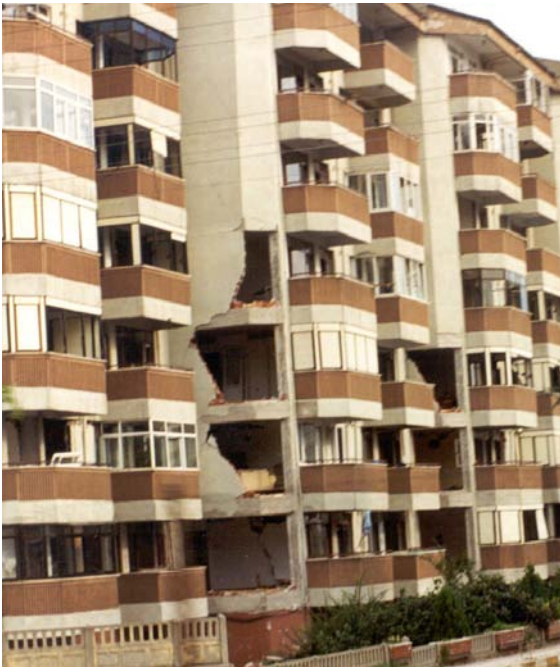
Figure 5.28a: Composite diagonal and out of plane failure of infill

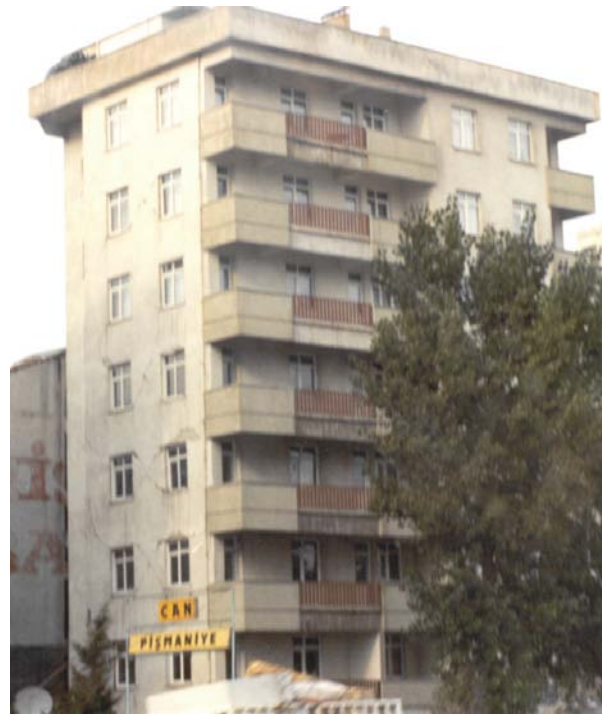
Figure 5.28b: X cracks in the lateral wall between opening

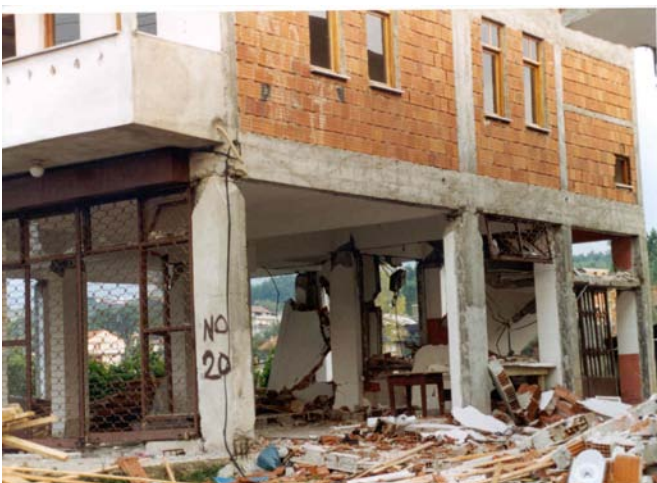
Figure 5.29: Hinges forming at bottom and top of columns.

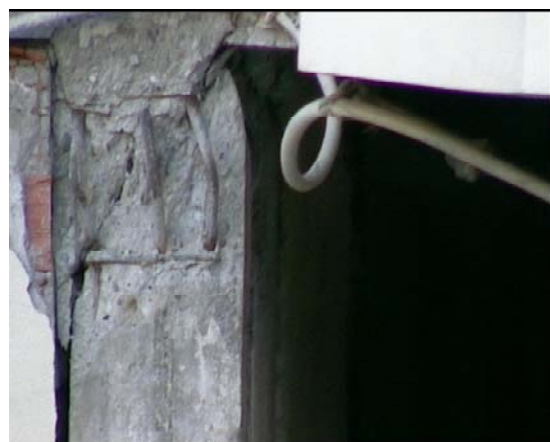
Figure 5.30: Shear failure in column

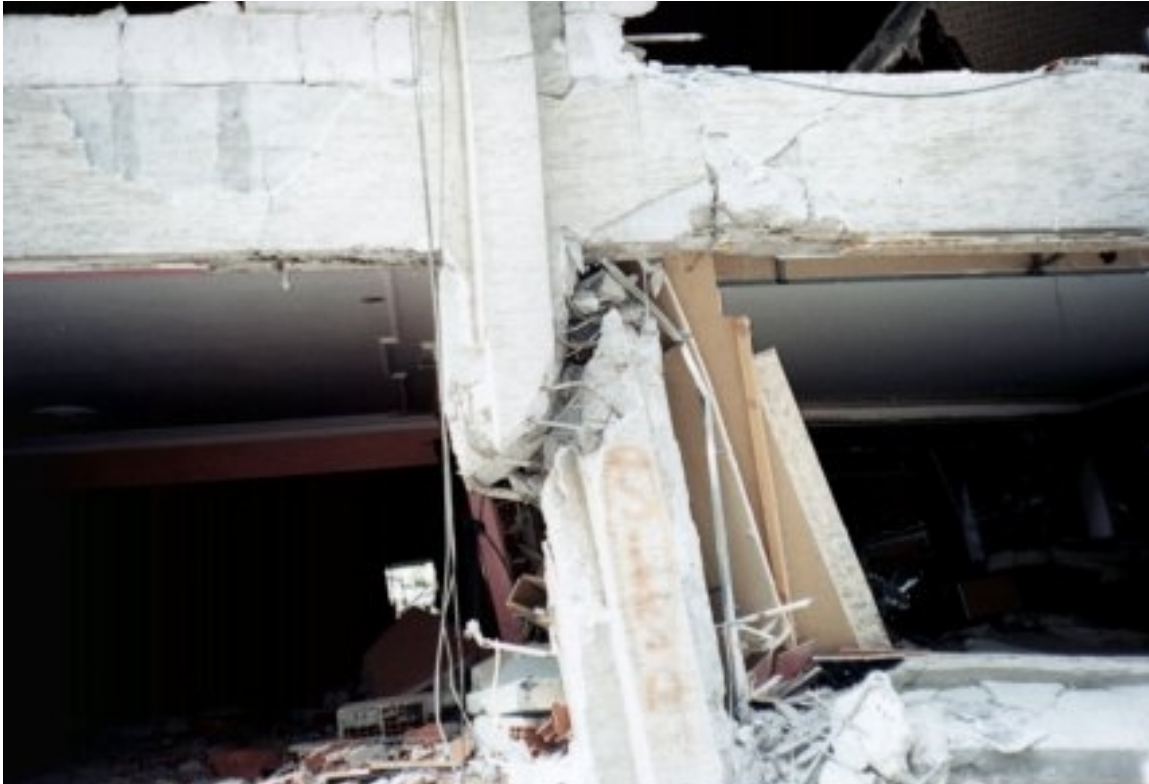
Figure 5.31: Shear failure of ground floor column

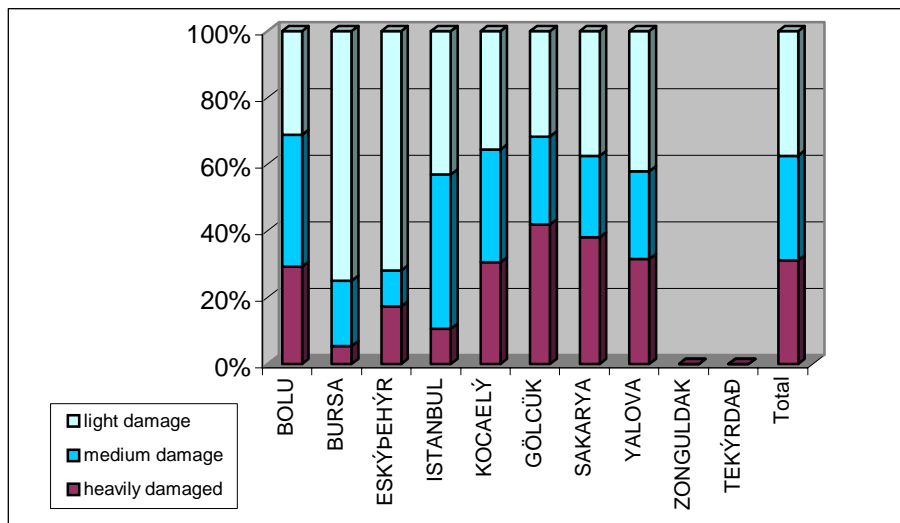
Figure 5.32: Official distribution of damage by municipality at 30-06-2000.

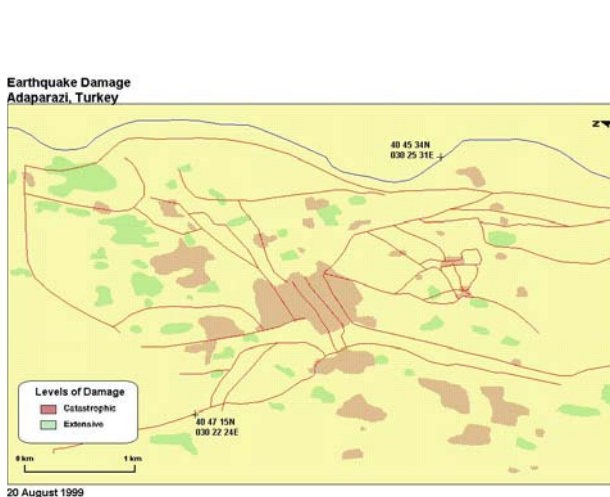
Figure 5.33a: Damage survey of Adapazari based on aerial photography (North is left)

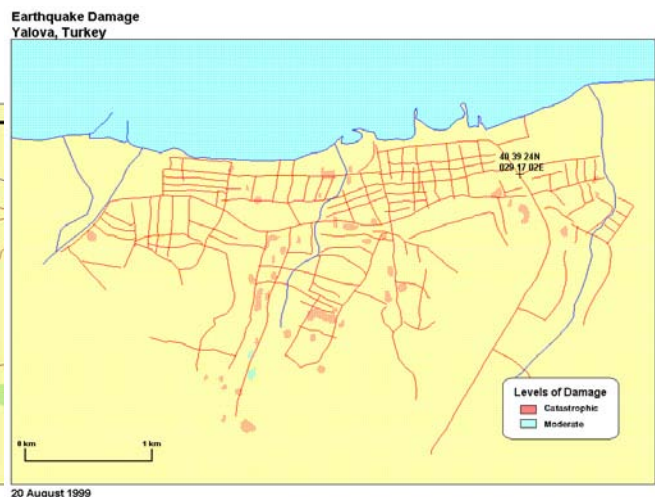
Figure 5.33b: Damage survey of Yalova based on aerial photography (Bogazici University 20-08-99)

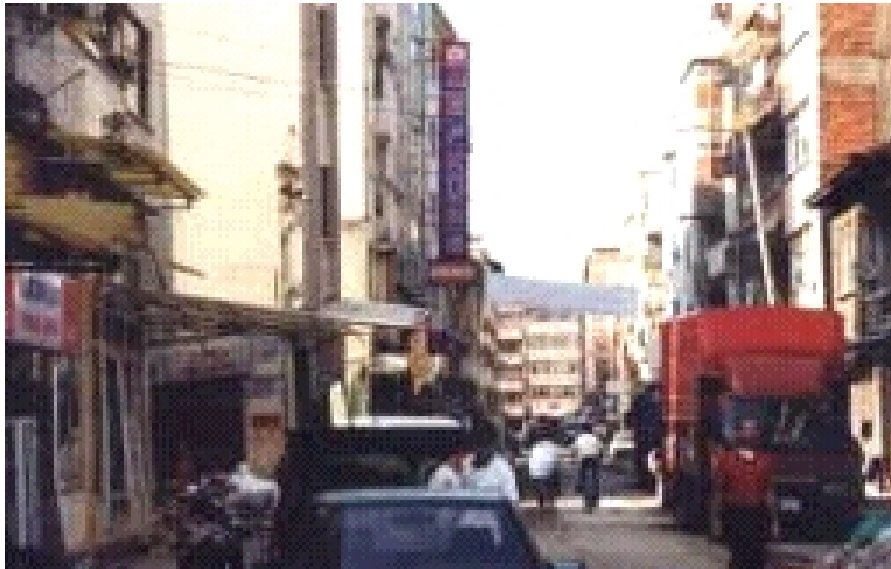
Figure 5.34a: Nato Cad. south showing relatively little damage

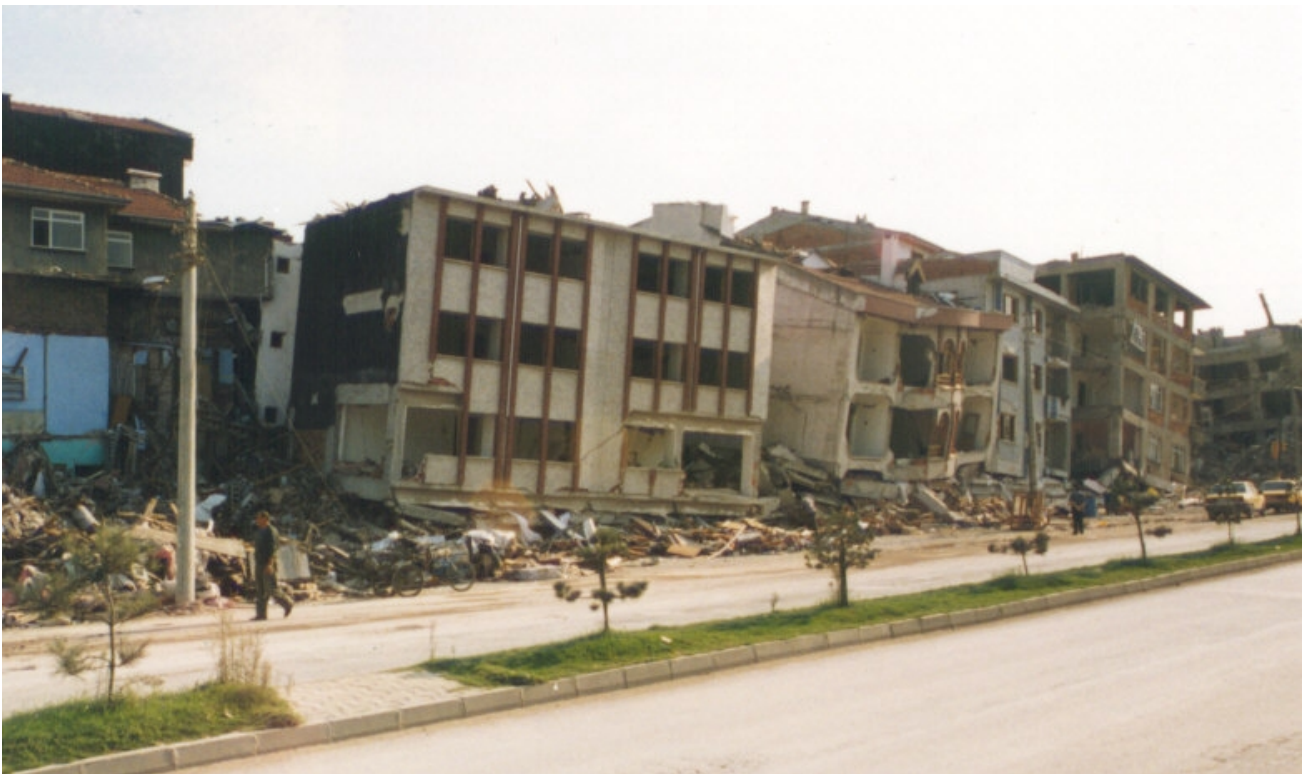
Figure 5.34b: Nato Cad. north showing numerous soft storey collapses

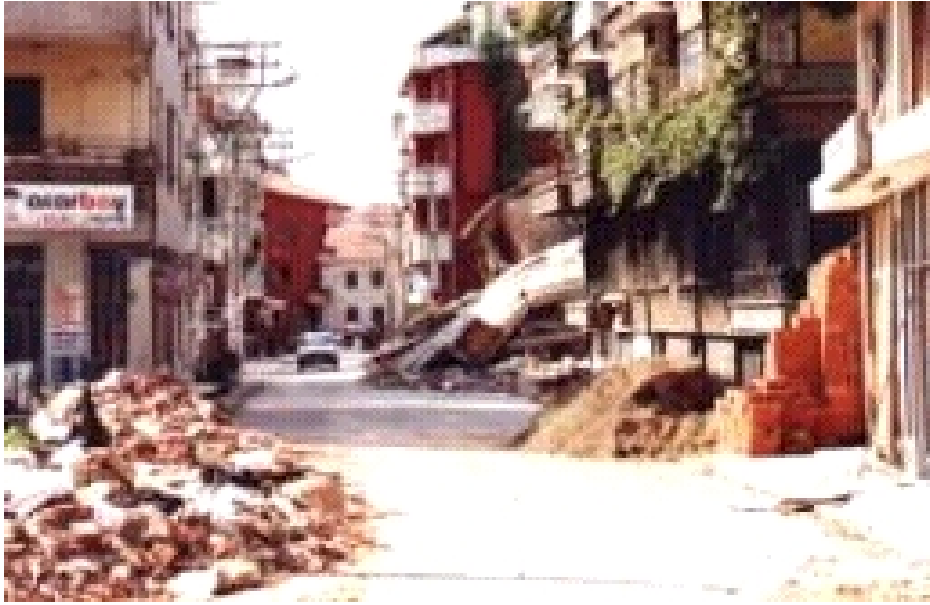
Figure 5.35: Bahcivan Sokak, showing some damage, but the majority of buildings surviving

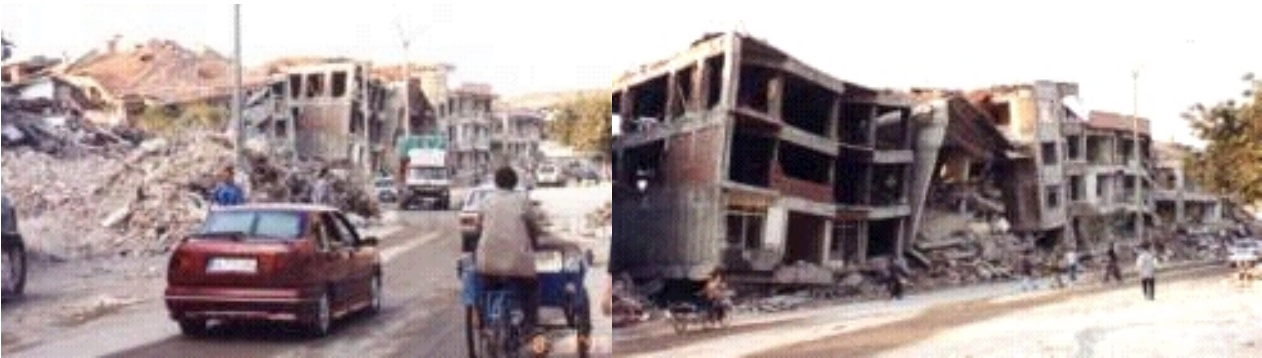
Figure 5.36a, b: Izmit Caddesi, where few buildings survived. Most of the damaged buildings were 5 stories with shops.

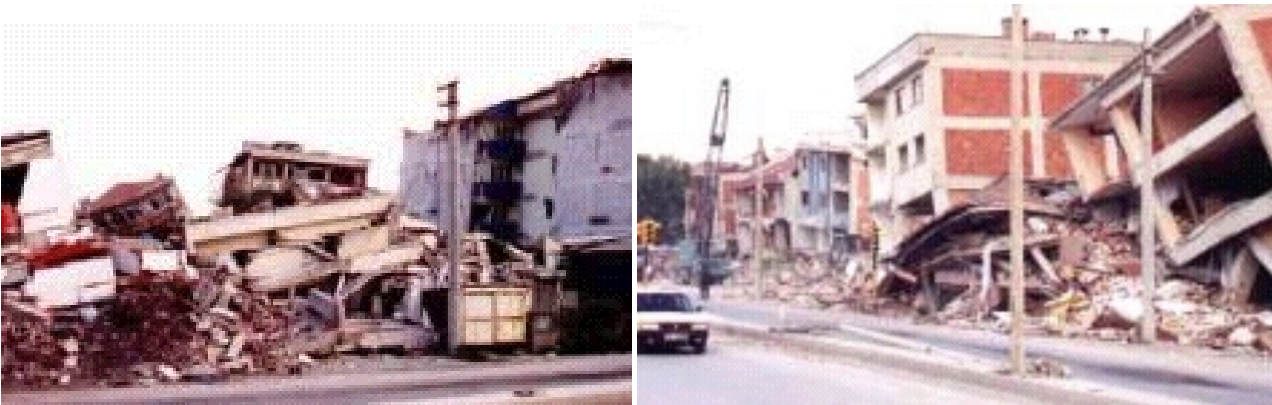
Figure 5.37a, b: Milli Egemenlik Cad. Damage was localised along the northern end of the road

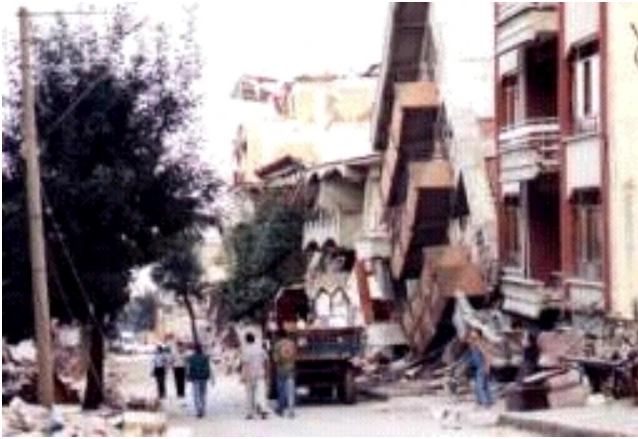
Figure 5.38a: Fabrika Cad. westward of the tobacco factory

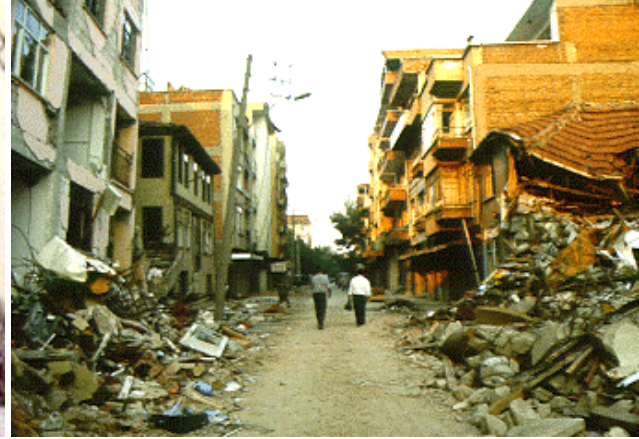
Figure 5.38b: Fabrika Cad. eastward of the factory

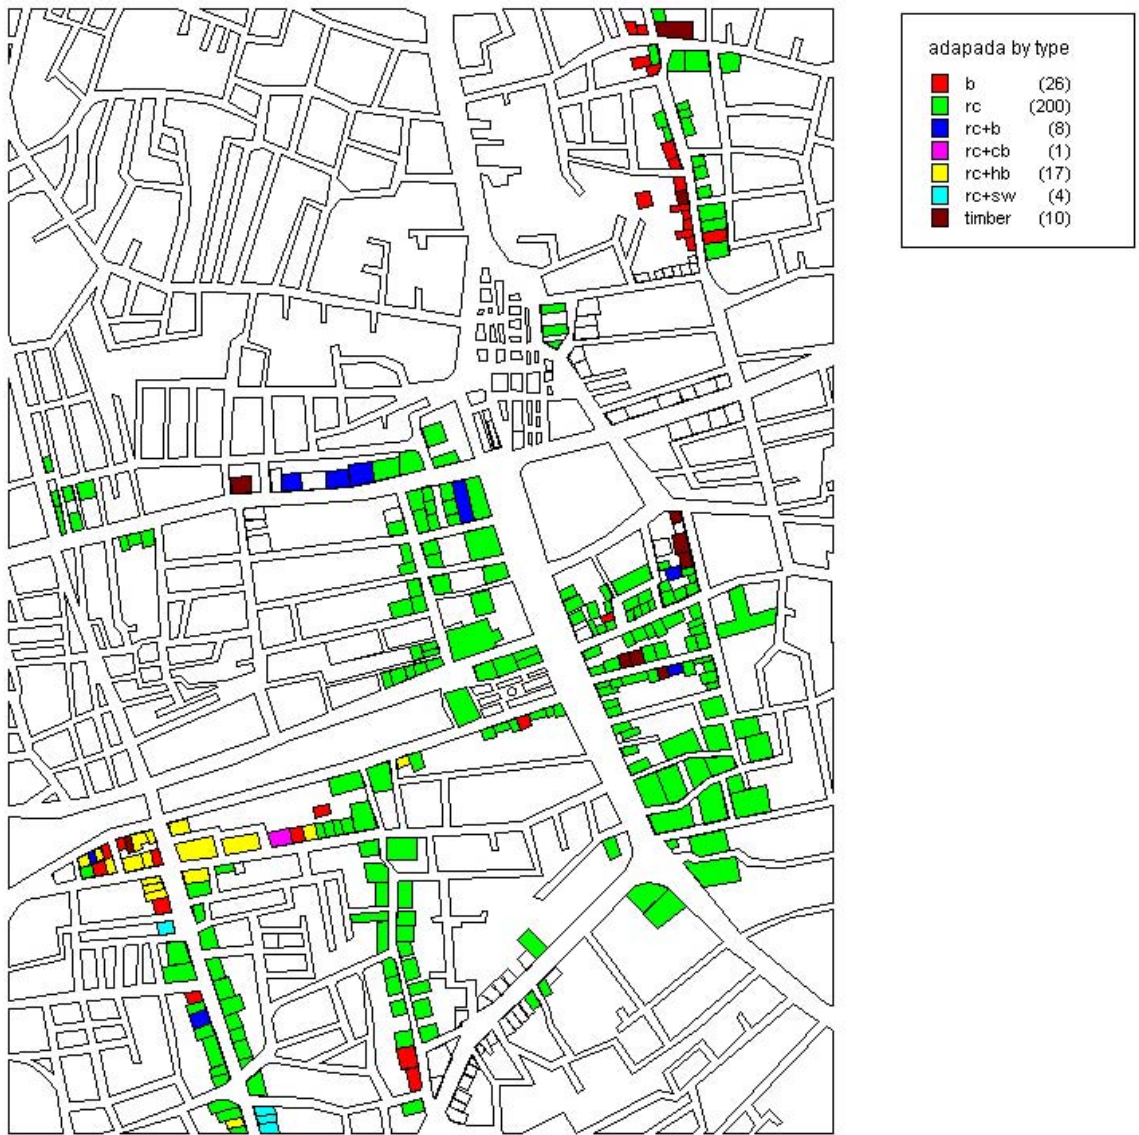
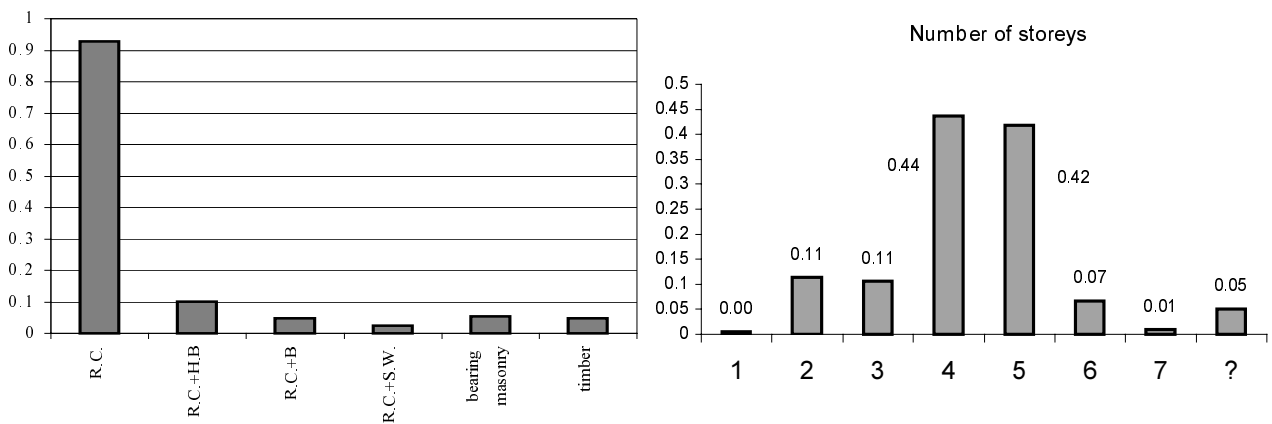
Figure 5. 39: Distribution of types of buildings and number of storeys in Adapazari centre.

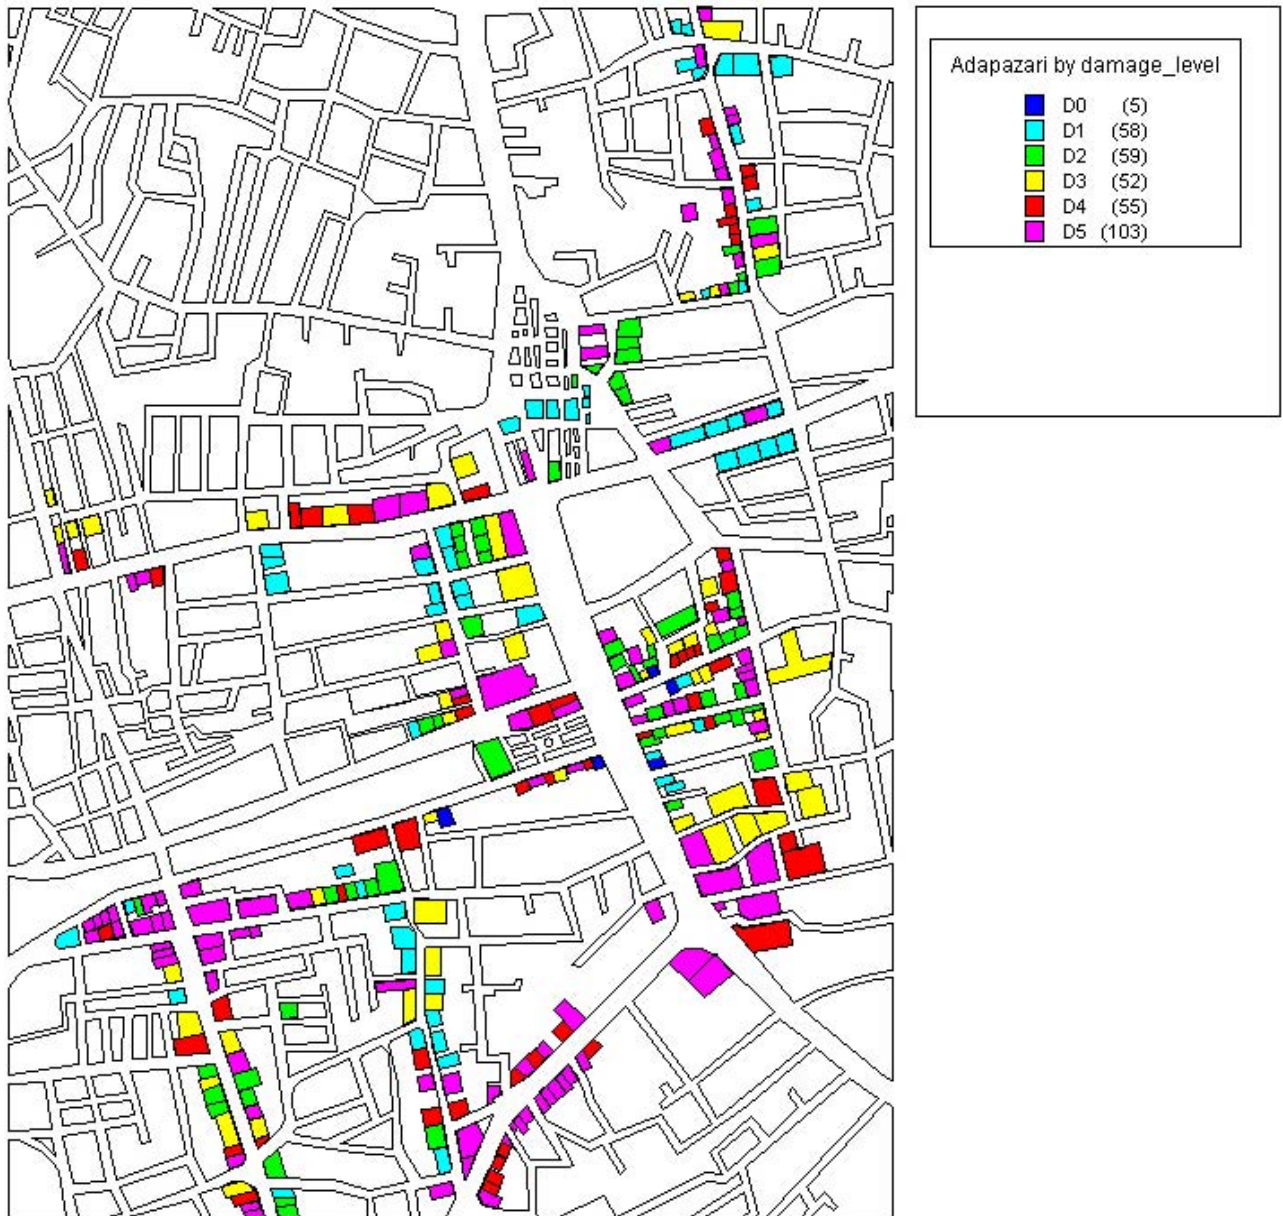
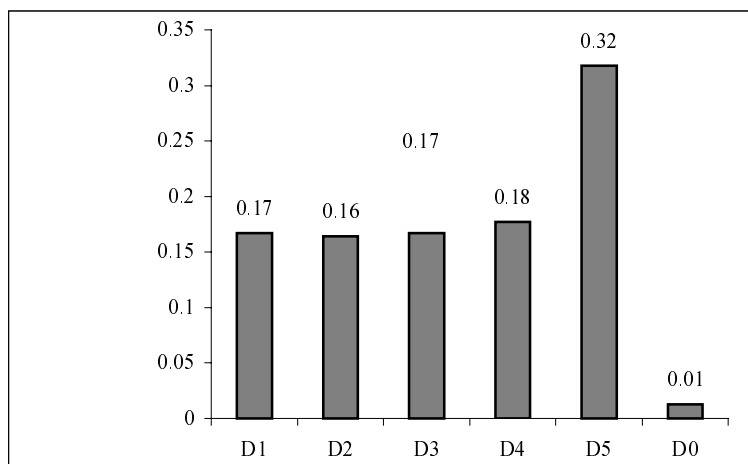
Figure 5.40: EMS 98 damage level distribution and mapping

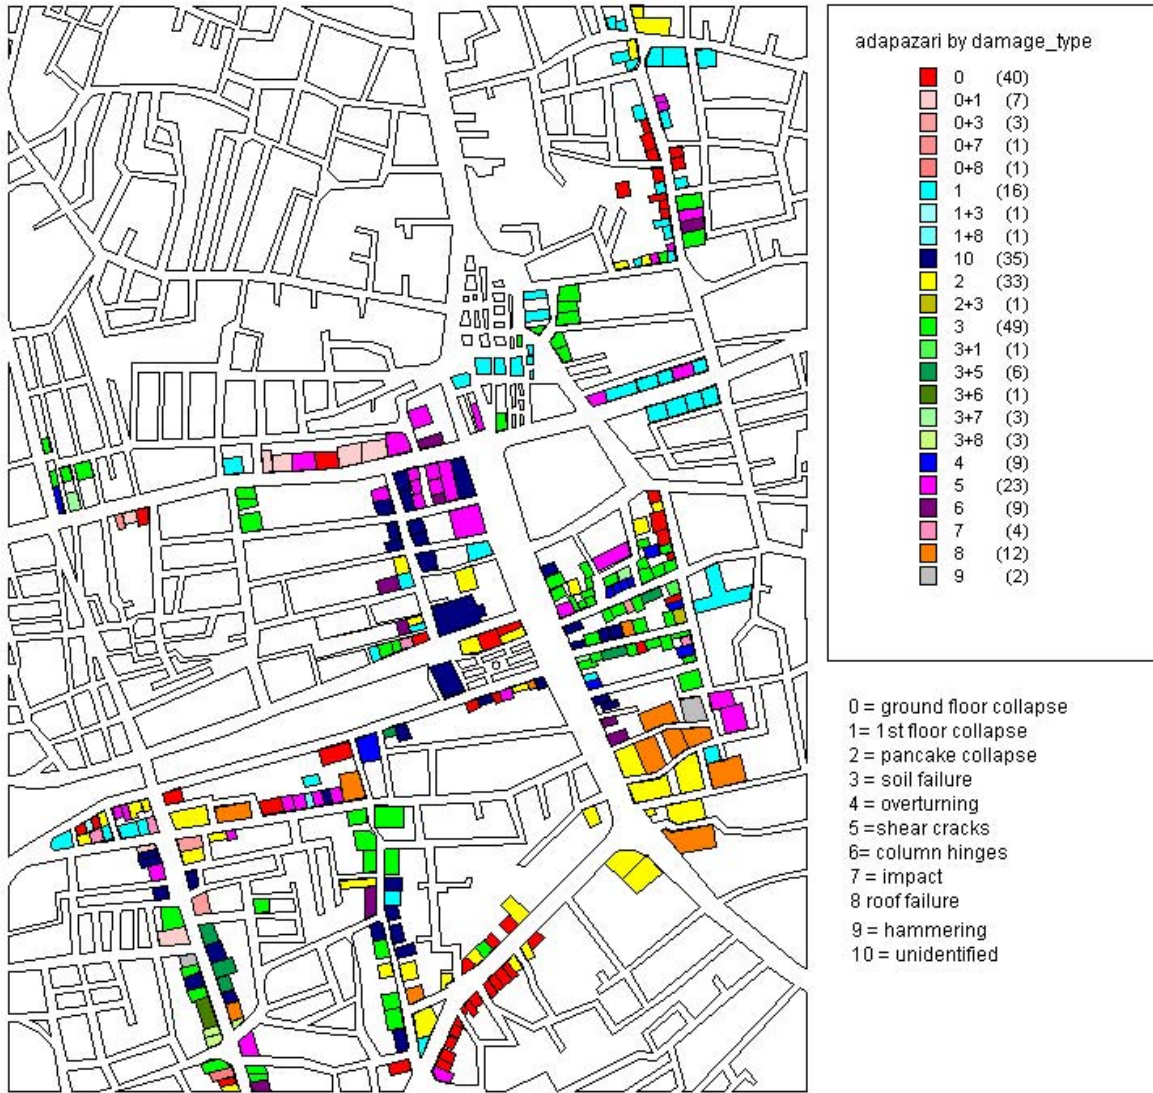
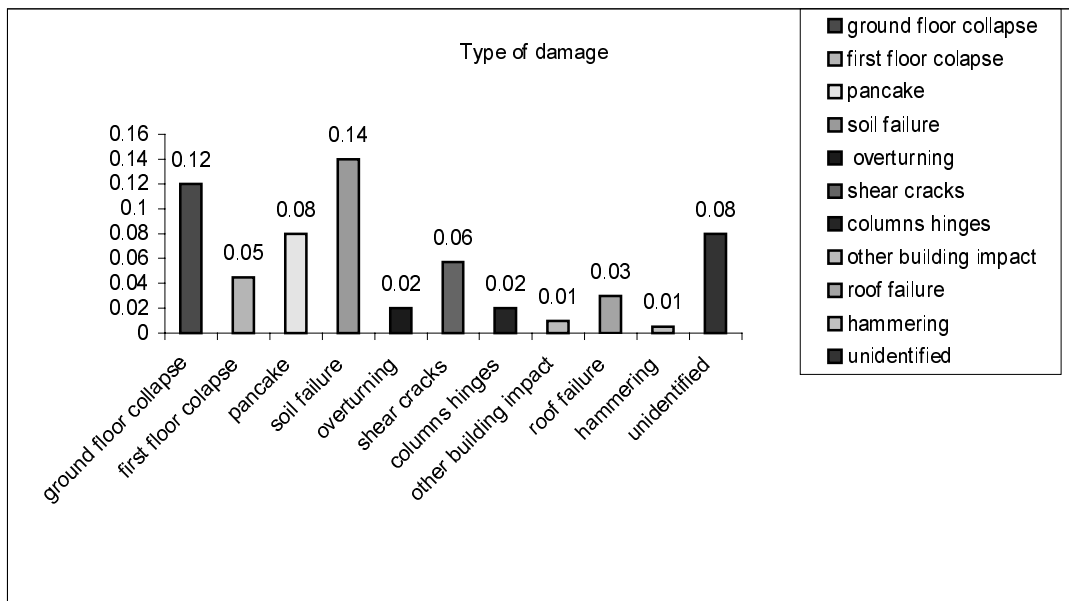
Figure 5.41: Distribution of damage by type

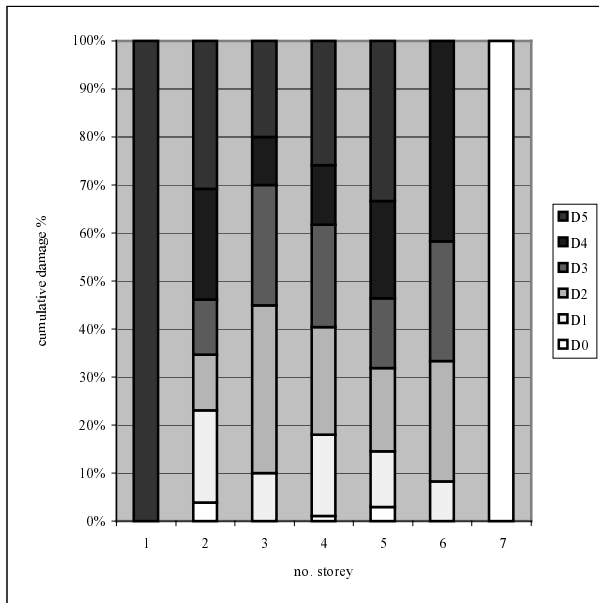
Figure 5.42: Distribution of damage level by number of storeys.

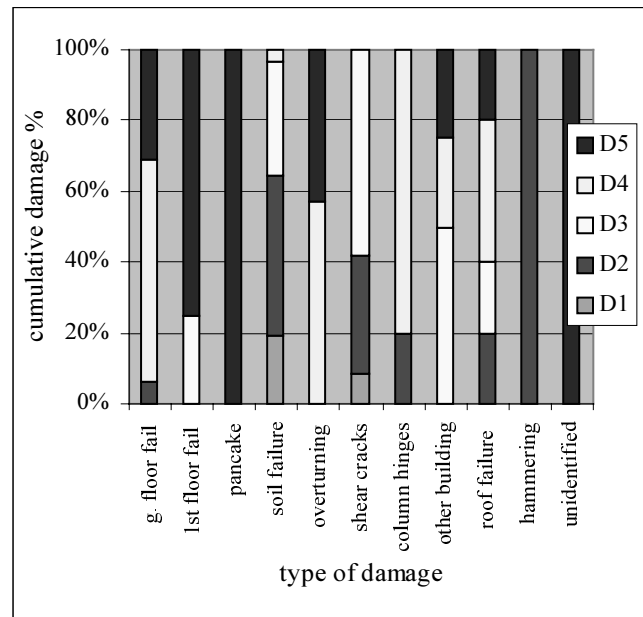
Figure 5.43: Distribution of damage level by damage types

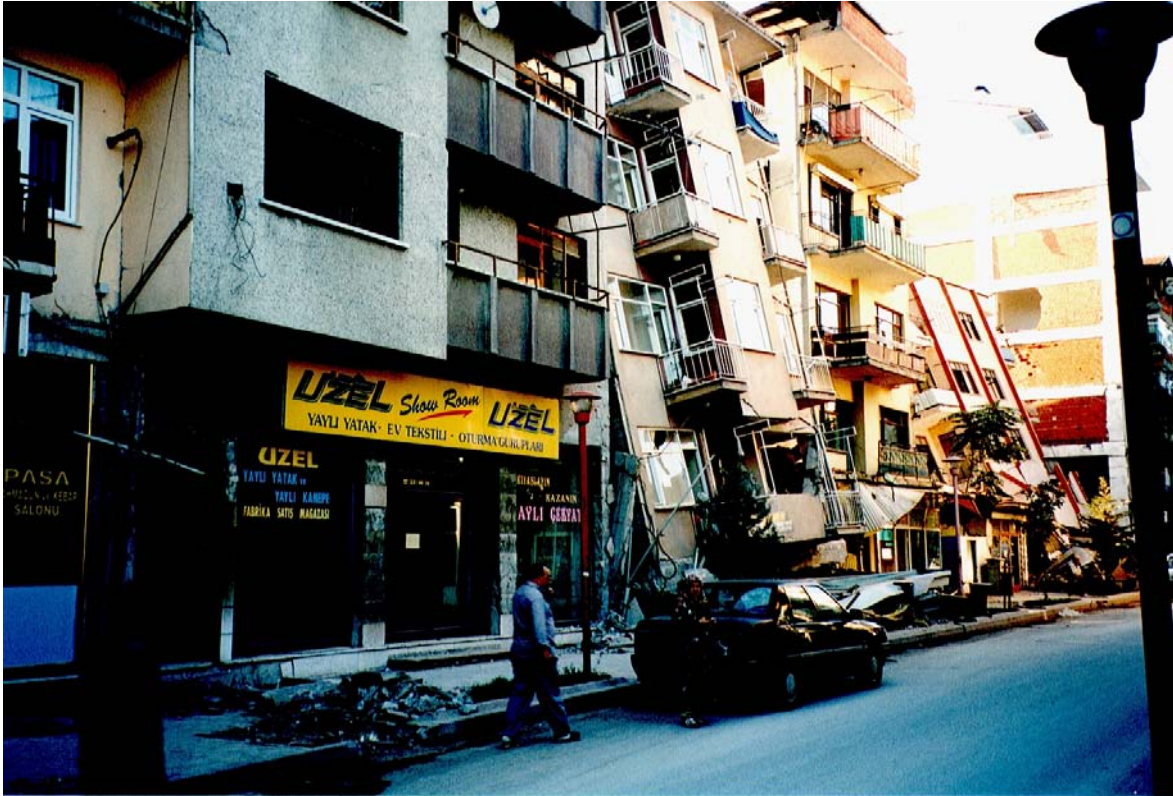
Figure 5.44: Mehmet Alipasa Sokak, part of the survey area

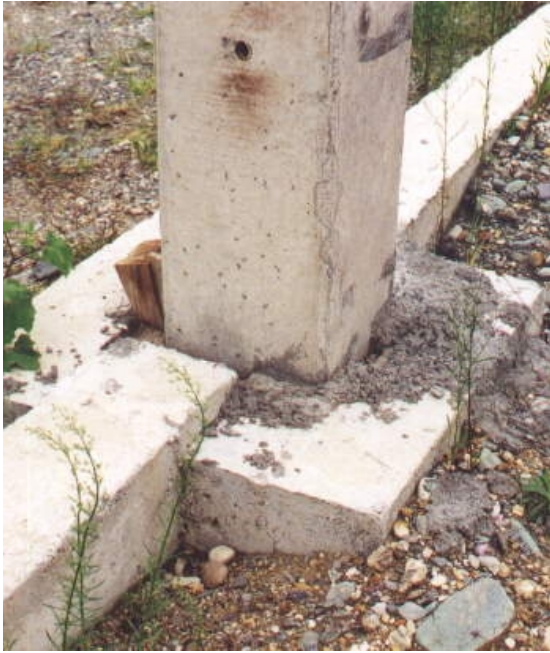
Construction details of the precast concrete frames are fairly standard throughout. The foundations are universally large pads containing sockets into which the precast column is concreted to provide a moment connection (Figure 6.1). The column heads are either then corbelled to take the rafter ends, or there is a half joint at about 1/3 span in the rafter. The connections are either single or twin bolts sleeved through holes in the rafters, hence the columns act as vertical cantilevers with the rafter/column connections as pins. In multiple bay portals, the rafters are frequently continuous over internal columns, resting directly on the column heads and held by two bolts projecting from the column through the rafter.

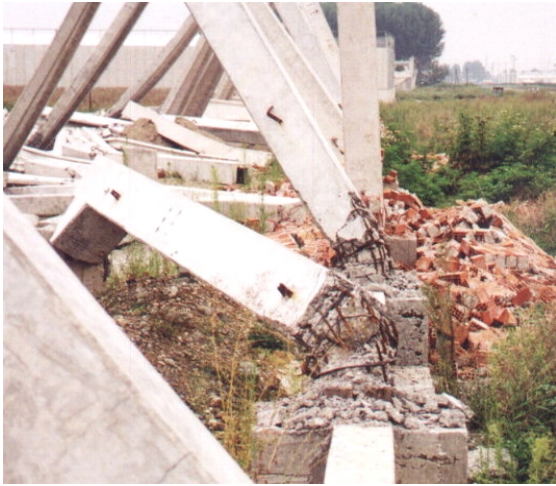
Figure 6.4a: Typical failure of main columns

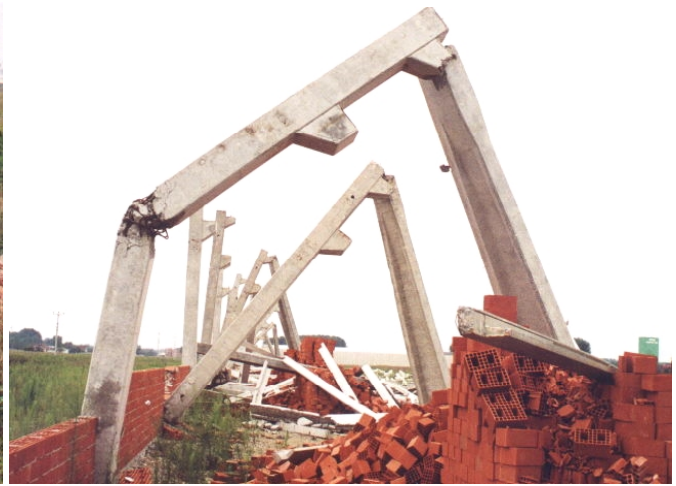
Figure 6.4b: Failure of main columns with part built external cladding

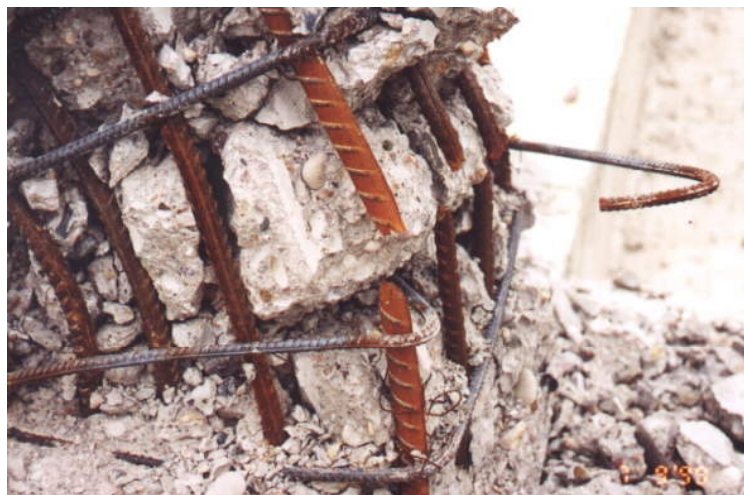
Figure 6.4c: Detail of failed connection at base of columns. Note the ruptured longitudinal bars

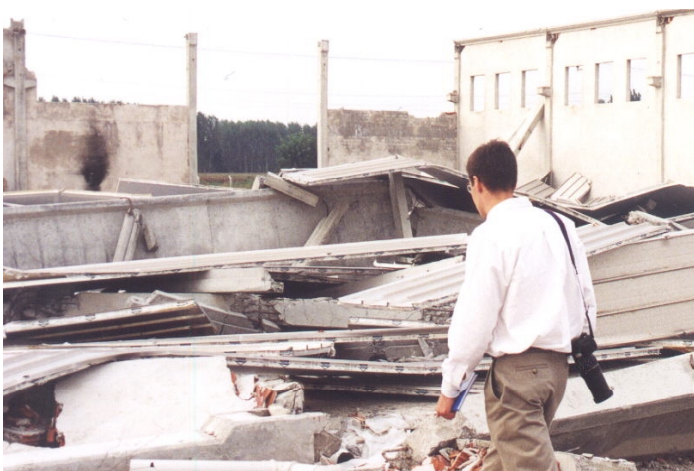
Figure 6.5a: Failure of rafters: note about 1.5m depth at apex giving a very heavy roof

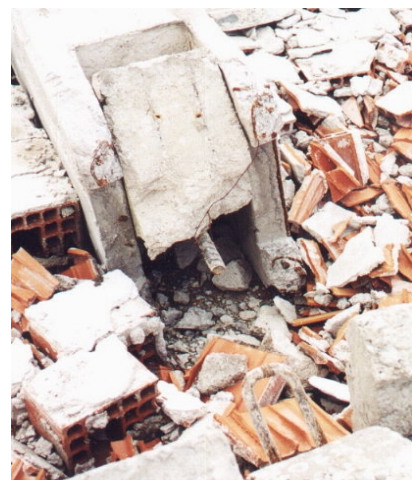
Figure 6.5b: Detail of connection
