THE KOCAELI, TURKEY EARTHQUAKE OF 17 AUGUST 1999

A FIELD REPORT BY EEFIT

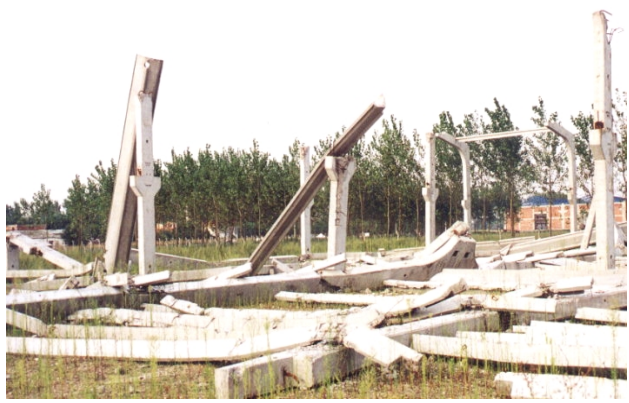
Figure 6.6b: Typical failure pattern

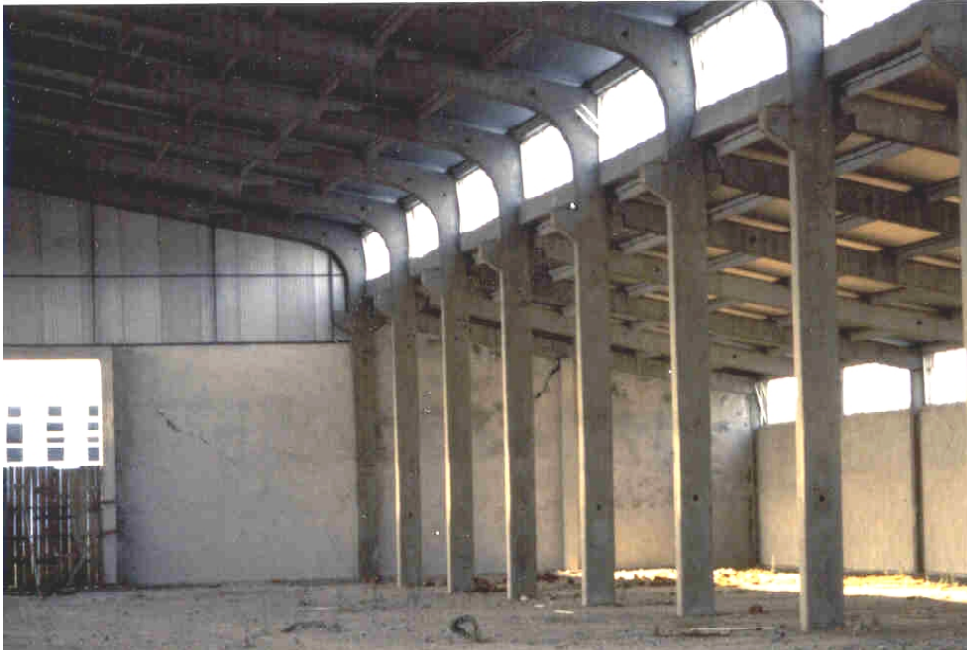
Where the structures have been completed the unreinforced masonry infill panels provide transverse restraint and lateral bracing to the column, although sometimes failing out of plane due to a lack of connection to the columns. Major damage still resulted from relative movement between the columns and rafters or failure of the gable wall (Figure 6.11) which is often poorly connected at roof level. Only in one building was roof bracing observed and this was significantly undersized for the seismic loads which occurred.

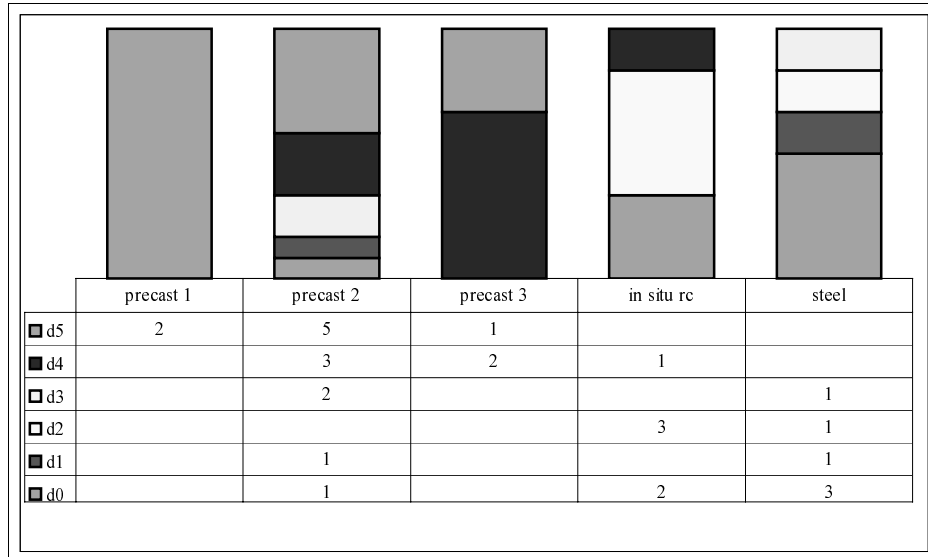
Figure 6.12: Histogram of damage by structural type of the industrial estate in Adapazari

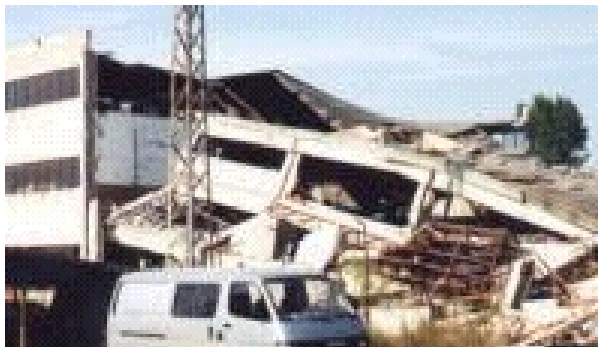
Figure 6.13a Failure of in-situ concrete and steel roof trussed factory near Yuvacik

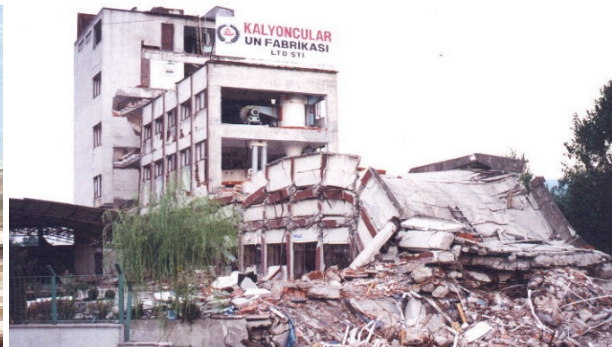
Figure 6.13b: Failure of RC factory south Marmara Sea area

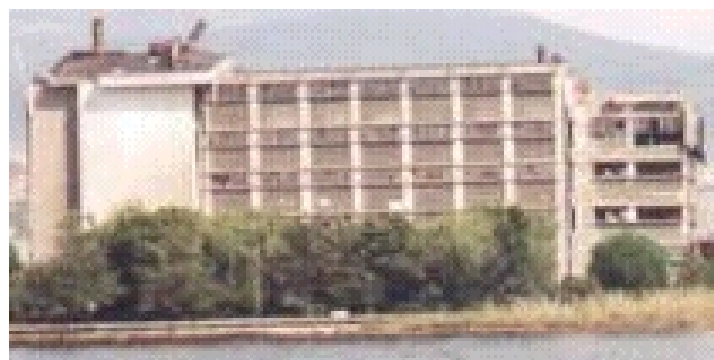
Figure 6.13c: Failure of steel frame on top of RC concrete framed building near Izmit

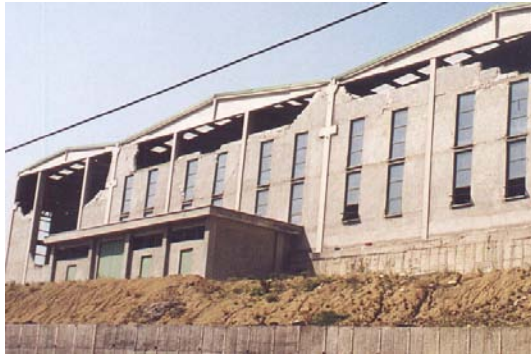
Figure 6.14a: Failure of cladding – factory near Korfez

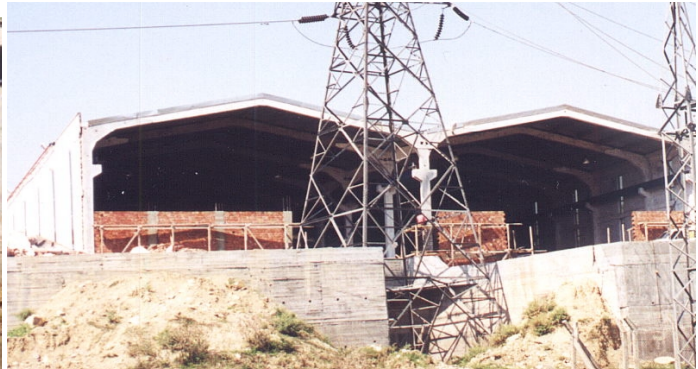
Figure 6.14.b: Failure of cladding – factory near Korfez. The EOT crane in this building needed to be replaced post earthquake.

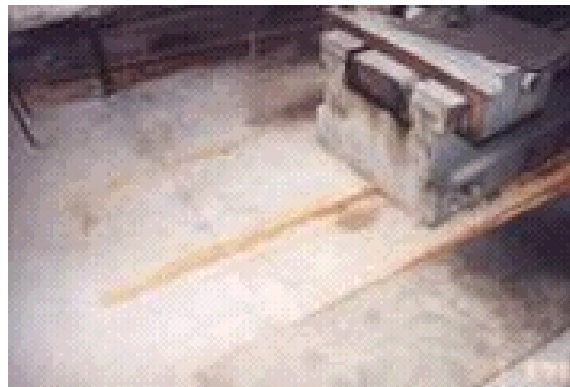
Figure 6.14c: Movement of plant inside factory near Adapazari. This 10t press moved approx 1m in the earthquake. As shown by rust marks

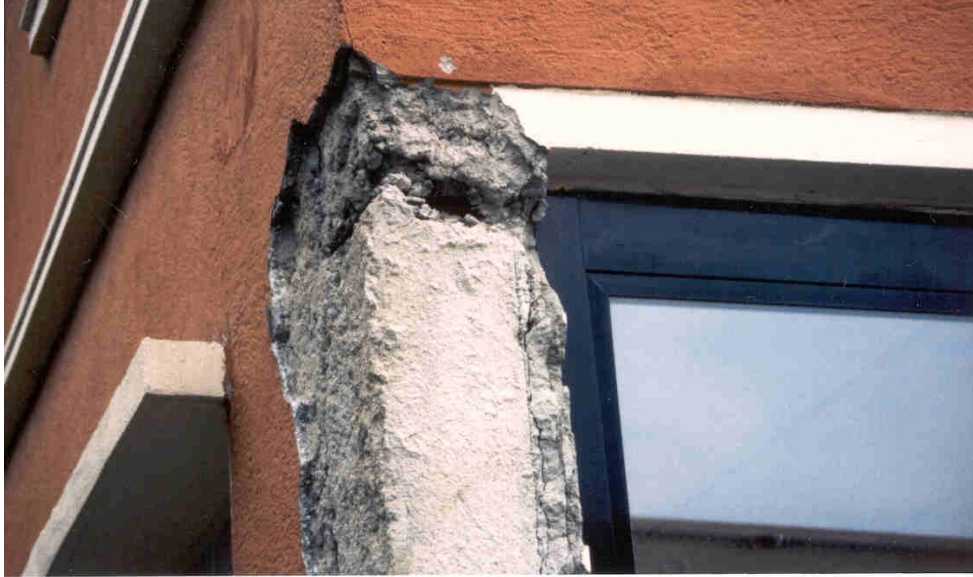
The plant comprises large oil storage tanks, pipe work, process plant, a warehouse for storage of the product and two administration blocks. The buildings are generally concrete framed, with the exception of a steel framed warehouse, and the plant was not seismically designed. Water and electricity both failed during the earthquake, but the grid electrical supplies were restored within a few hours. The plant has no back up electrical supply of its own.

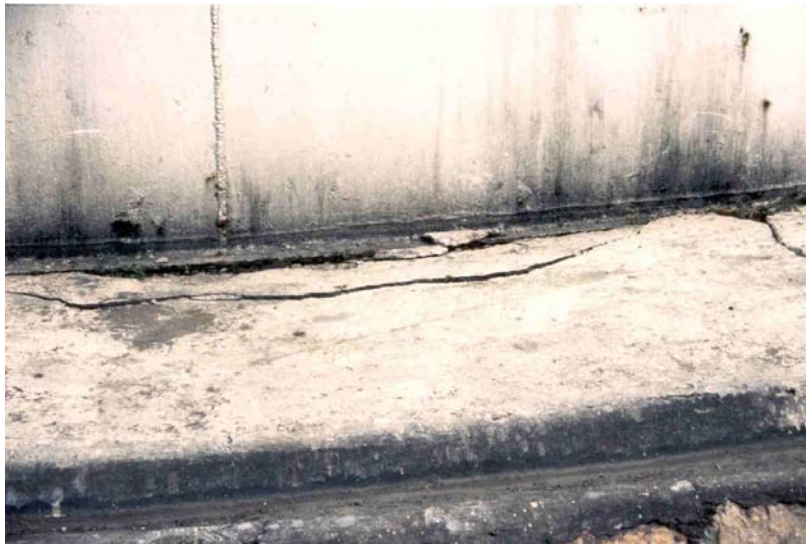
The oil storage tanks are 10m diameter by 15m high and were full to within 0.5m of the top at the time of the earthquake. Settlement of around 30mm was noted at each tank (Figure 6.19) but the draw off pipework remained intact and no leaks occurred. There was no “elephant’s foot” buckling of the tanks.

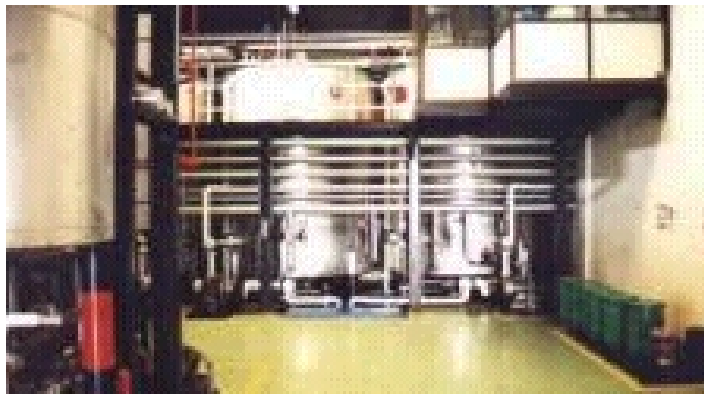
Fig 6.20a: Main processing area. Steel frame, and process plant undamaged

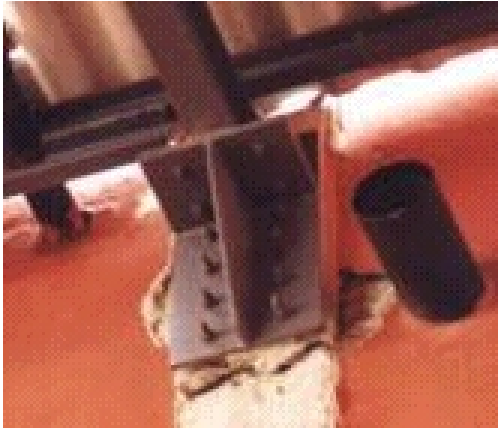
Fig 6.20c: Near failure of connection for canopy roof connecting two buildings

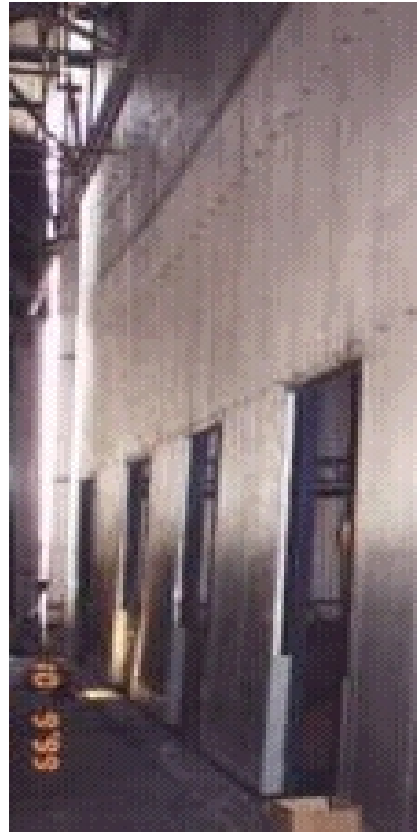
Fig 6.21a: Tilt of warehouse when compared to adjacent loading bay

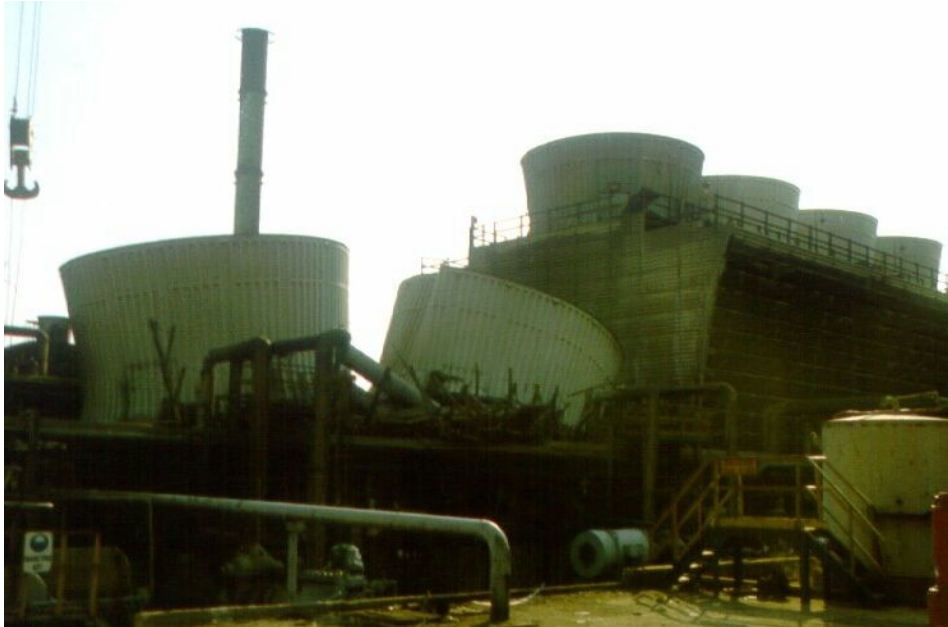
Figure 6.22: Collapsed Wooden Cooling Towers at Petkim

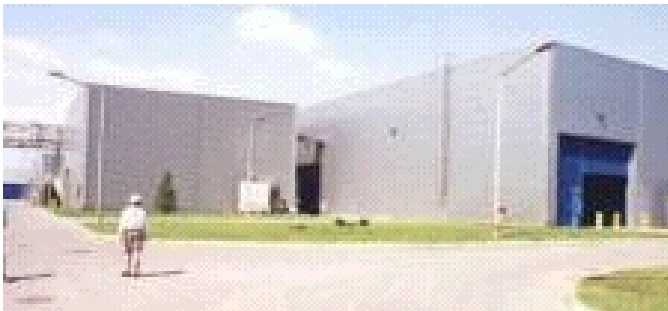
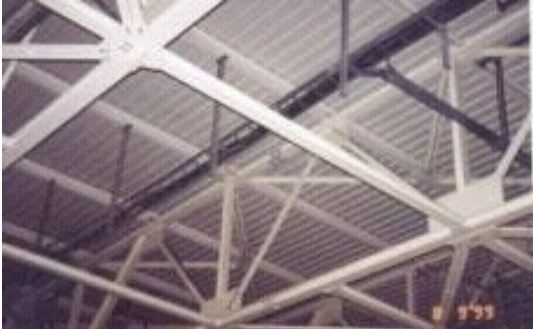
Figure 6.23a: General view of the main assembly shop

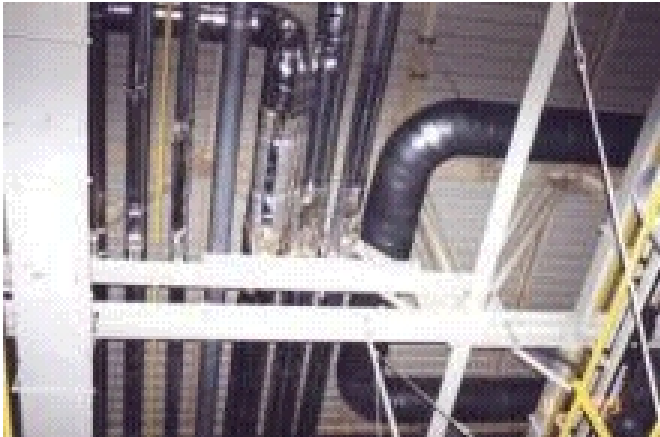
Figure 6.24: Services run in the roof

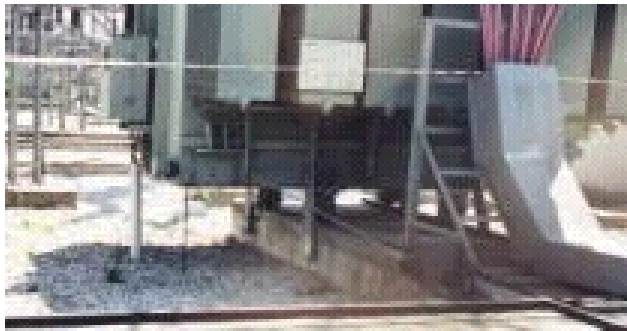
rails but remained operational (Figure 6.25a and b); the 60 tonne back up unit came off the rails and was removed for inspection although subsequently reported to be still functional.

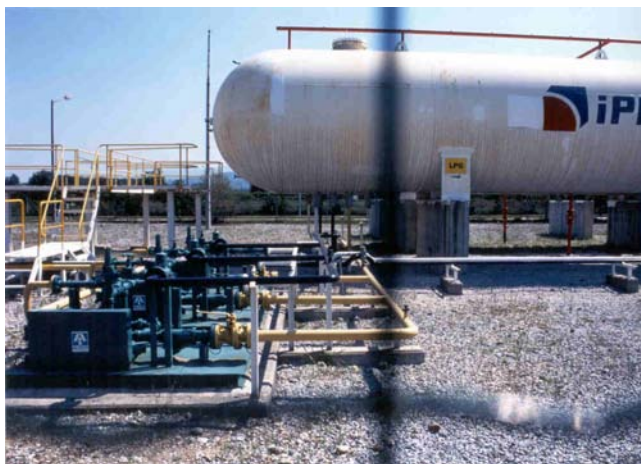
The gas supply system has an automatic shut off which activated, but the main tanks were undamaged (Figure 6.26). The water distribution system in the site ruptured in many places (Figure 6.27) and was being replaced by plastic pipe at the time of the visit. Within the plant, the only reported damage was cracking at a few valves and elbows.

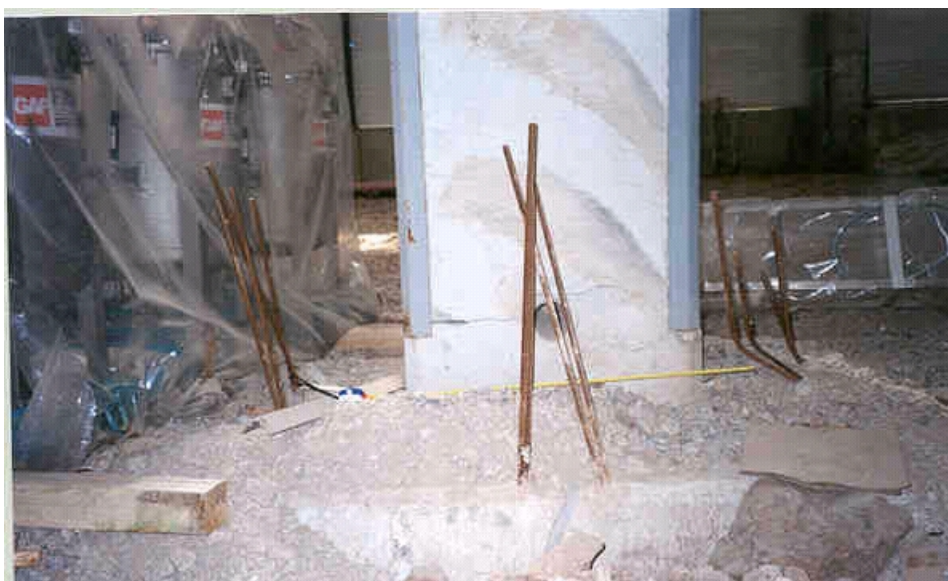
Figure 6.30a: Column Damage in Bodyshop

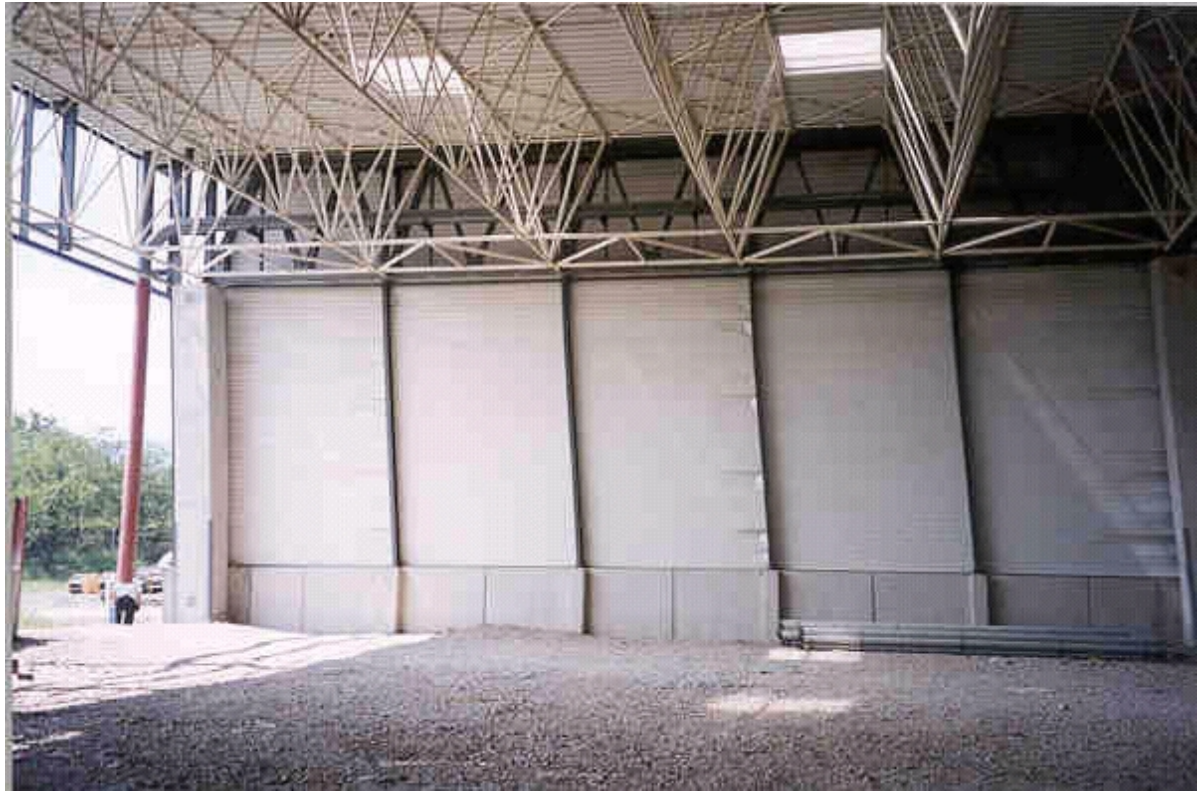
Figure 6.30b: Bodyshop west wall showing distortion of columns. Roof has kept its shape and pipe work from roof clearly shows horizontal displacement.

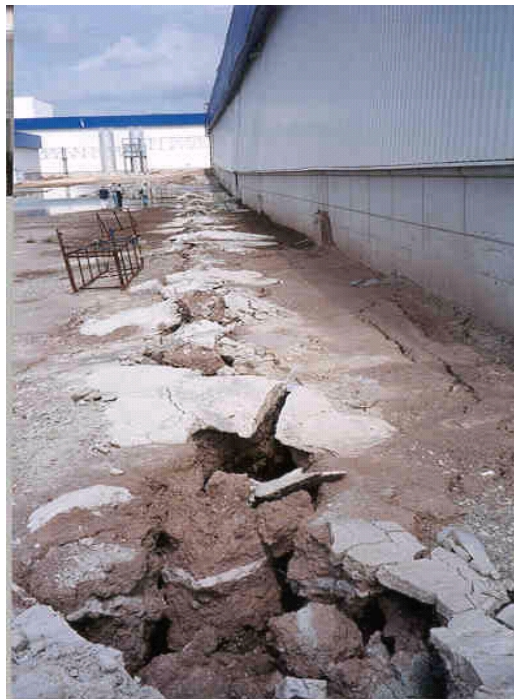
Figure 6.30c: Fissure in ground formed along alignment of cement grout columns.

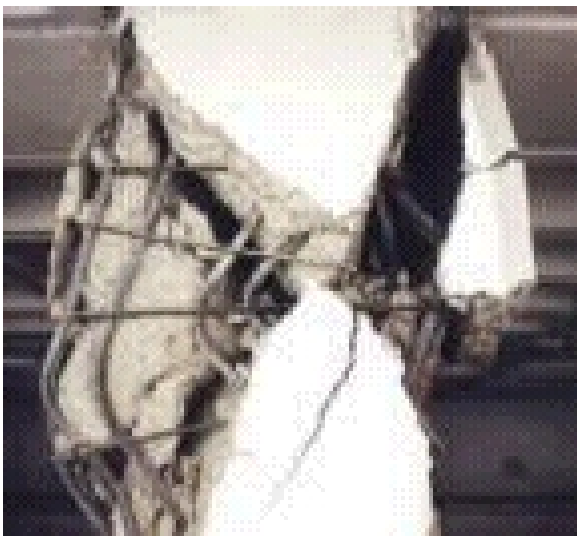
minor axis. It was also apparent that the building had undergone significant torsions, as the damage became progressively worse nearer the outside. Near the ramps the columns were less heavily damaged

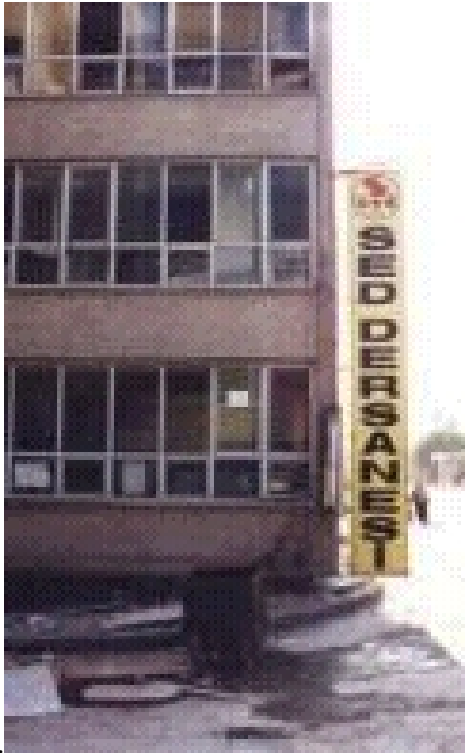
This five storey office building had suffered failure of the ground floor in a “classic “ soft storey failure. The lowest columns had failed, causing the building to topple sideways, but there appeared to be relatively little damage to the upper floors (see Figures 6.33 a to b).

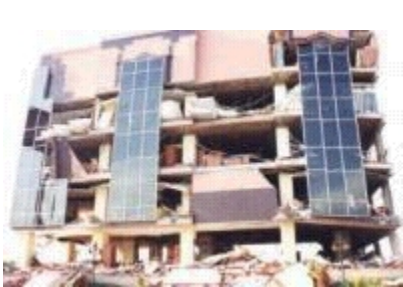
There were two stores on the south coast of the Marmara Sea, between Yuvacik and Golcuk, which although still standing had been badly affected by the earthquake. Figs 6.34a to d illustrate the first, which was a furniture store. Of particular note is that although the reinforced concrete frame is largely intact, the floor level for one of the end bays had dropped by about half a metre. It was also apparent that what failures there had been occurred in the beams, rather than in the columns.

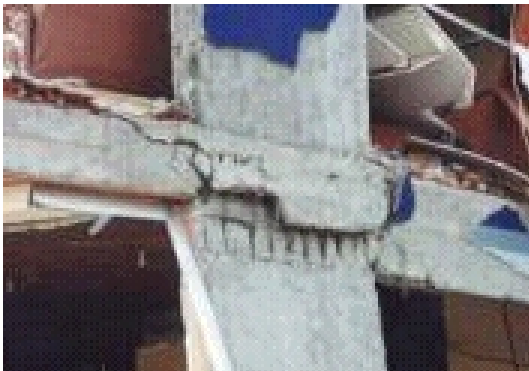
There was extensive damage to the external cladding, exposing the structure. On a subsequent visit to this store, the owner had hired access equipment and was removing the stock, so limiting the economic damage. However future trading from the building would be impossible, with demolition the only option.

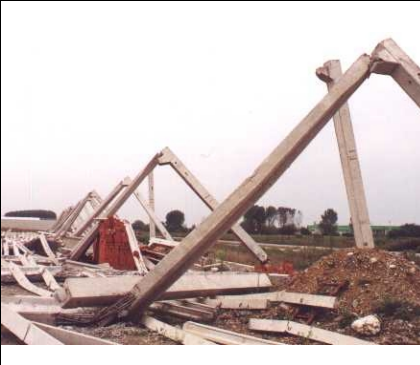
2 bay cold formed steel tied portal	30m	55m	Steel wall and roof panels + masonry dado wall	Ok	
3 bay pre-cast concrete portal frame type 2	54m	60m	Part built. No cladding	Collapsed

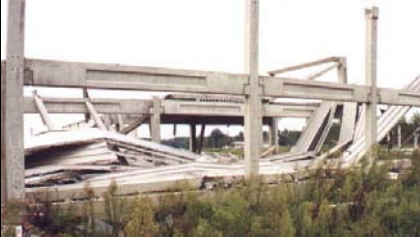
3 bay pre-cast concrete portal frame type 2	42m	54m	No cladding	Collapsed - failed by twisting of central columns. Outer frame still standing

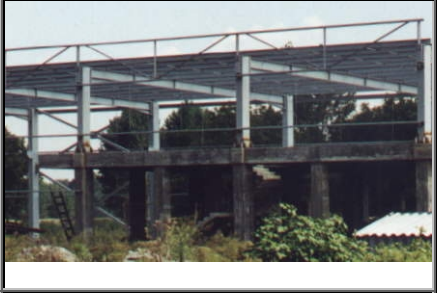
2 bay in situ concrete frame for walls. Steel truss roof	72m	24m	Masonry infill for walls. No cladding on roof.	Slight buckle on bracing

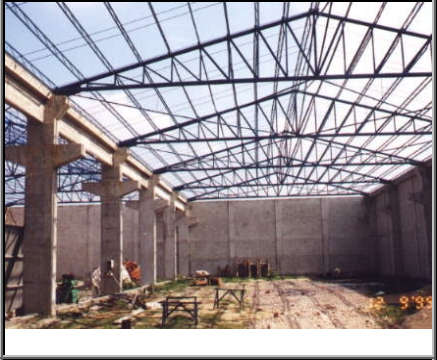
2 bay steel portal frame, with longitudinal tension only "X" bracing (very light)	72m	60m	Masonry infill walls. Light weight cladding on roof	Bracing failed in one bay. Bracing considerably stretched in others.

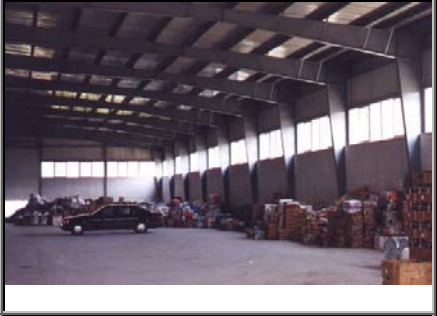
3 bay portal frame. Outer bays in-situ concrete to first floor. Columns above and roof in cold formed steel.	78m	30m	Masonry walls, with asbestos cement type roof	Minor damage to masonry walls

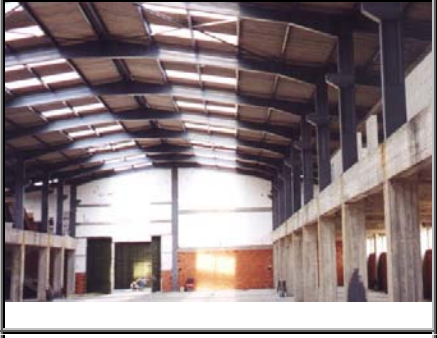
3 bay pre-cast concrete portal frame type 2. In use	60m	54m	Masonry walls half height with glazing above. No roof - removed.	Collapsed roof. Walls standing

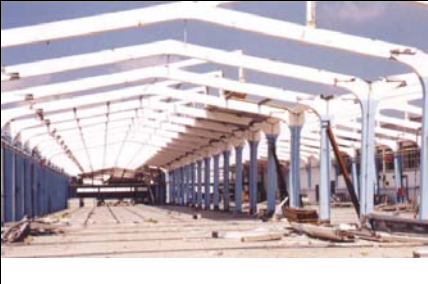
Two storeys office annexe to above, in-situ concrete	30m	30m	Masonry walls. Roof unknown	Ok	
3 bay pre-cast concrete portal frame type 1	72m	72m	PC panels for roof. No walls	Collapsed. Very badly broken.	
2 bay pre-cast concrete portal frame type 2. In use as textile factory	66m	36m	Masonry walls with lightweight cladding for roof	Roof collapsed. Walls OK	
2 bay pre-cast concrete portal frame type 2	36m	48m	No cladding	Collapsed	
2 bay steel frame. No purlins or bracing.	180m	36m	No cladding	Ok	
2 bay steel portal frame with bracing	48m	36m	No cladding	Ok	
2 bay pre-cast concrete portal frame type 3. In use	36m	36m	Masonry walls with lightweight cladding for roof	Roof collapsed. Walls standing

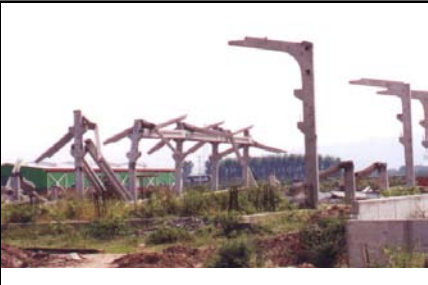
2 bay steel portal with in situ concrete service building	60m	36m	Masonry walls with lightweight cladding for roof	Ok	
2 bay pre-cast concrete portal frame type 2	66m	36m	Masonry walls with lightweight cladding for roof	Roof OK. Still standing but very badly damaged	
2 bay pre-cast concrete portal frame type 2	48m	36m	Masonry walls with lightweight cladding for roof	Collapsed

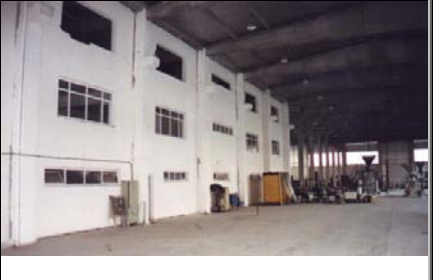
Single bay portal frame type 2 (modified) with lean to bays on either side of portal frame. Office block in last two bays	32m	84m	Masonry walls with lightweight cladding for roof	Bay between service building and main building collapsed. Minor cracks to remainder of frame. Halving joint failure in service building.

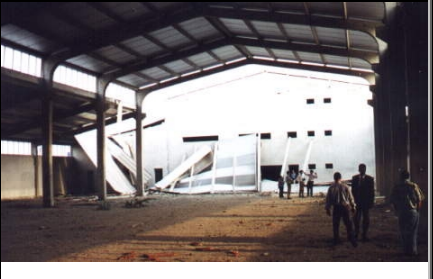
3 bay pre cast concrete portal frame type unknown. Service building at one end. Building in use	54m	84m	Masonry walls. Roof no longer present	Roof collapsed. Walls still standing

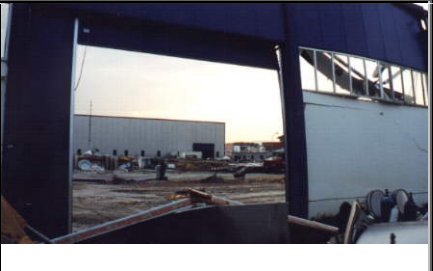
Note: Condition 'OK' indicates no visible damage, although it was not possible to carry out a detailed internal inspection in all cases.

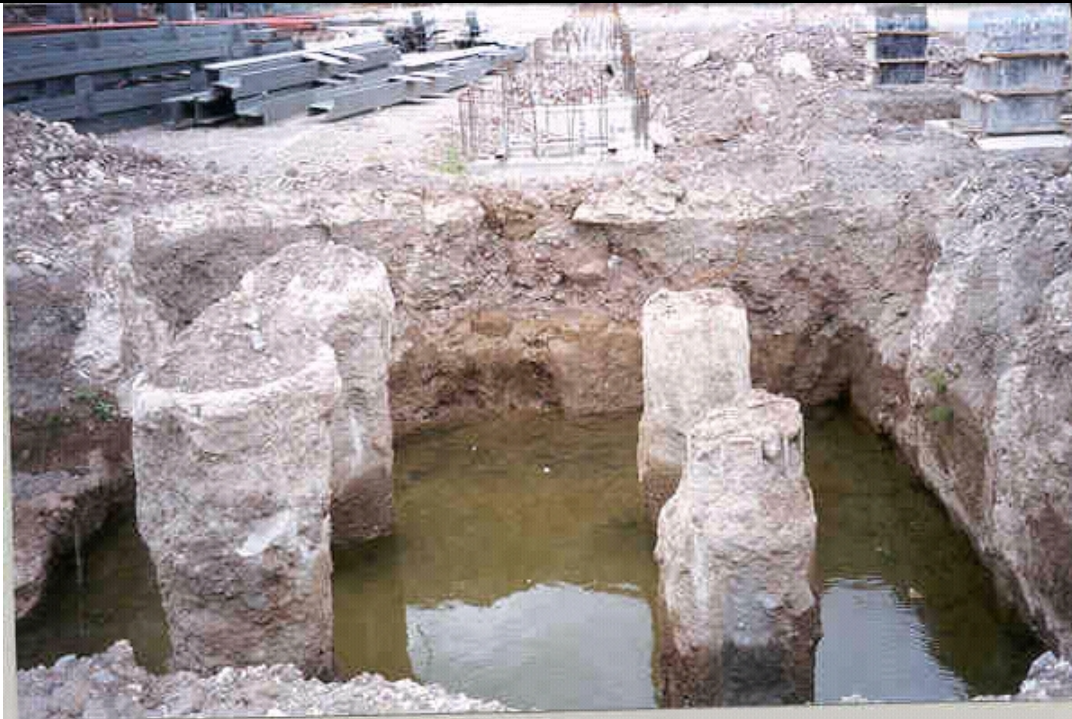
Plate 6.1: Ford Otosan Plant, Golcuk. Press Shop under construction. View to west of pile cap excavation showing 4 pile group of 600 to 700 mm diameter piles at 2000 mm centres. Main reinforcement is 10 number 16mm deformed steel bars. Confining steel is 10 mm deformed steel with unknown pitch (5 September 1999).

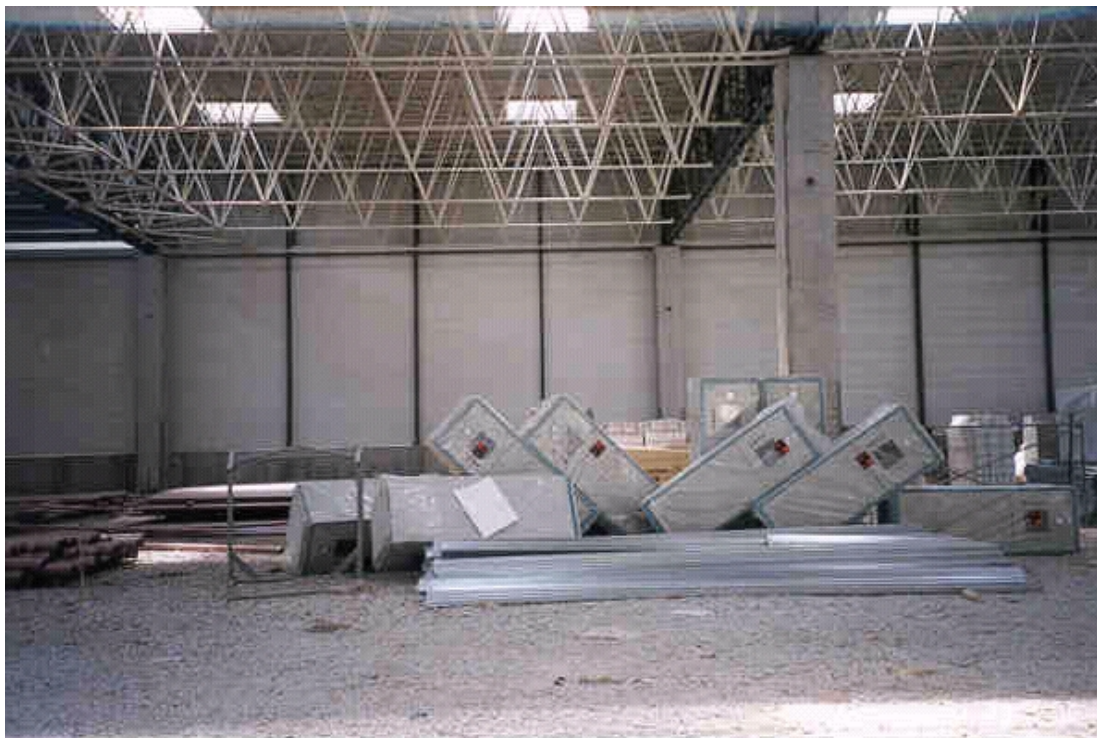
Plate 6.2: Ford Otosan Plant, Golcuk. Body Shop. Overturned electronic equipment. The plant was not operational at the time of the earthquake. Ground beams and floor slab were not complete in this area. Equipment was standing on aggregate layer. Note that columns and roof appear to be in good condition for most buildings (5 September 1999).

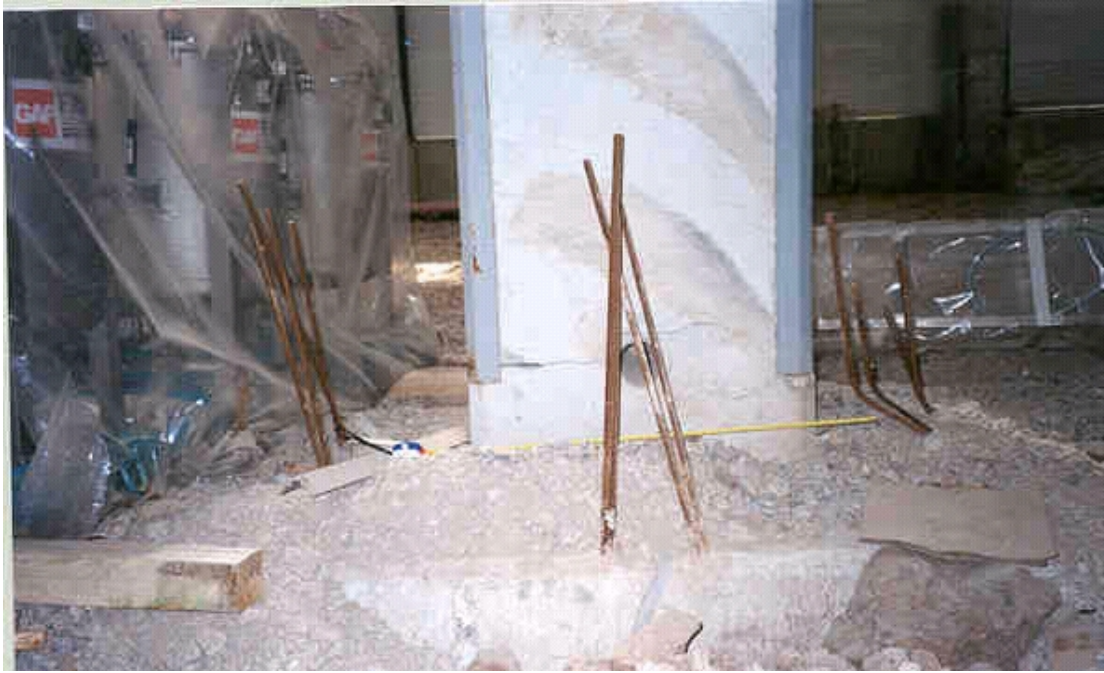
Plate 6.3: Ford Otosan Plant, Golcuk. Body Shop. On closer inspection a large number of columns were damaged at the base (5 September 1999).

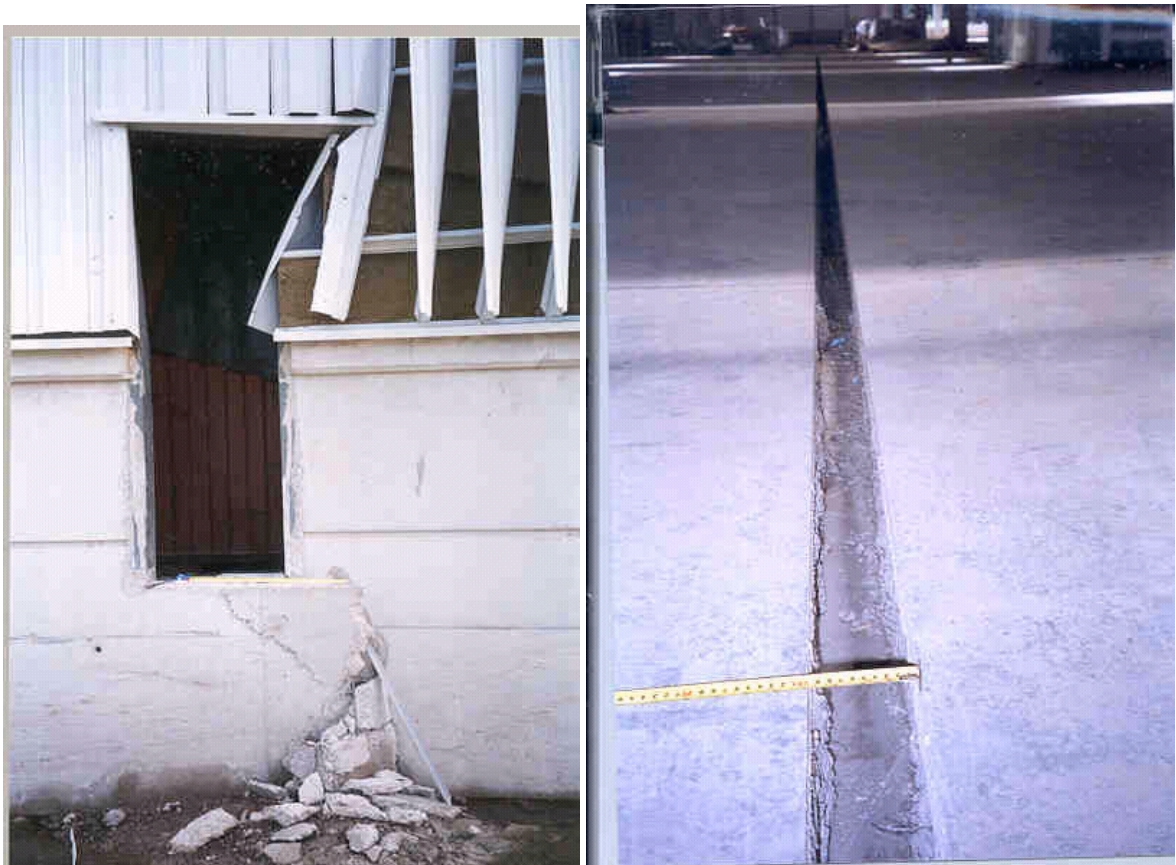
Plate 6.4: Ford Otosan Plant, Golcuk. Body Shop. Separation of construction joints in floor slab of building. Sliding occurred along plastic sheeting layer beneath concrete without tearing sheeting (5 September 1999).

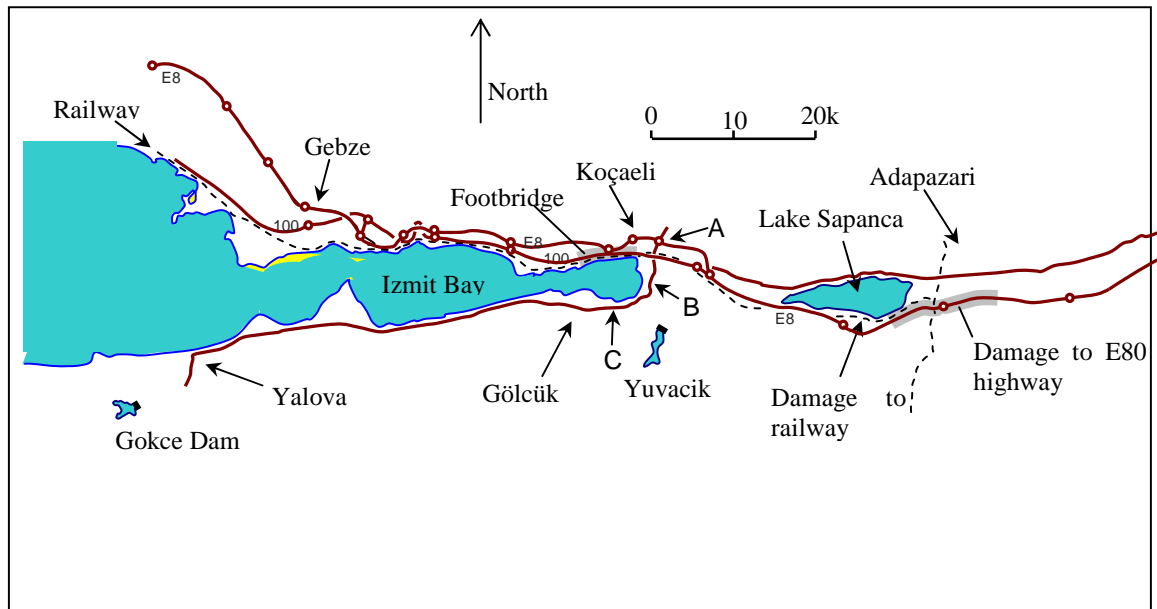
Figure 7.1: Layout of Transport Links and Civil Engineering Structures in Earthquake Area

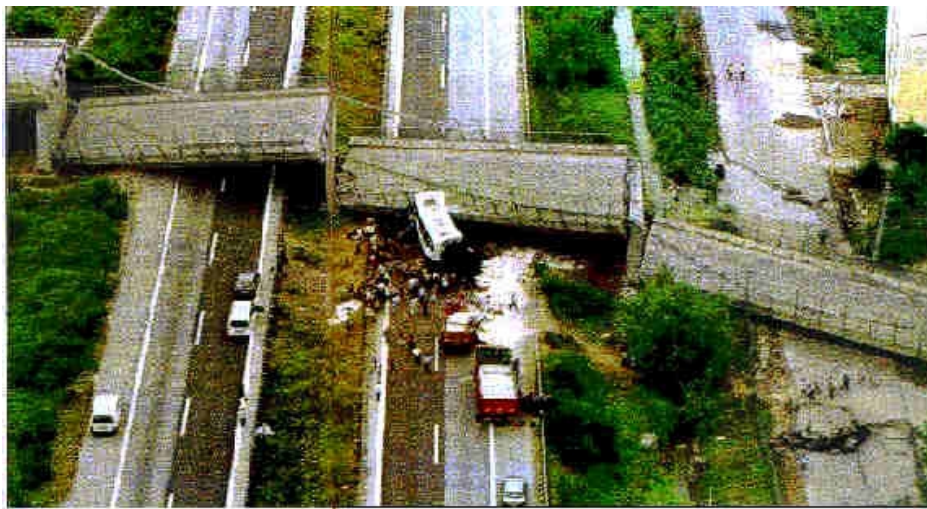
Figure 7.2: Collapse of Highway Bridge From News Footage

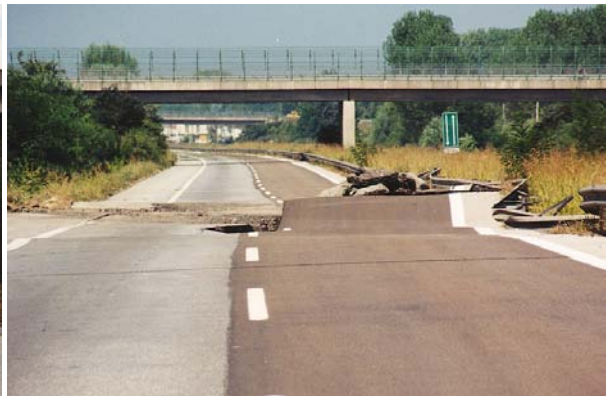
Figure 7.4: Fault rupture crossing the E80 highway (photo H.Aydin)

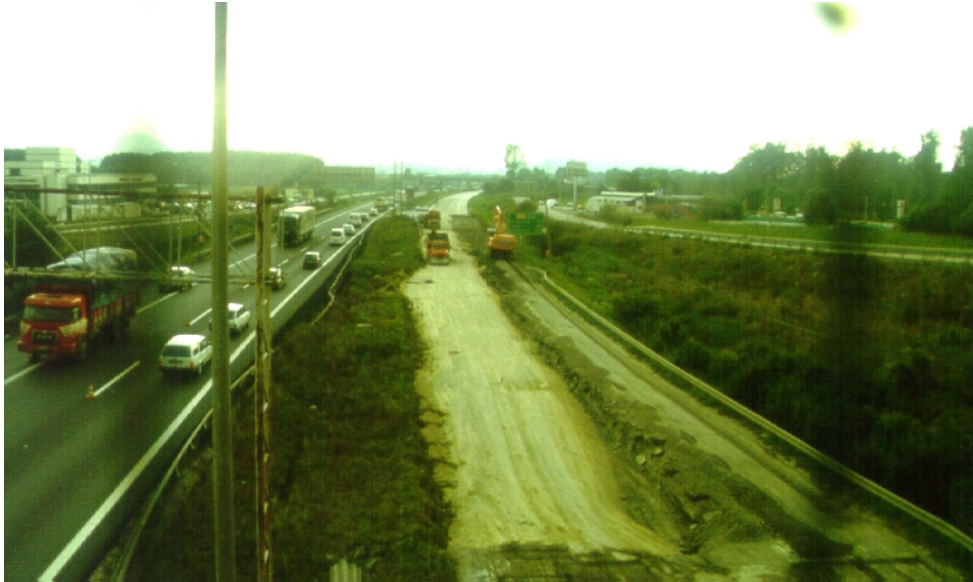
Figure 7.5: Road repair resulting from fault rupture

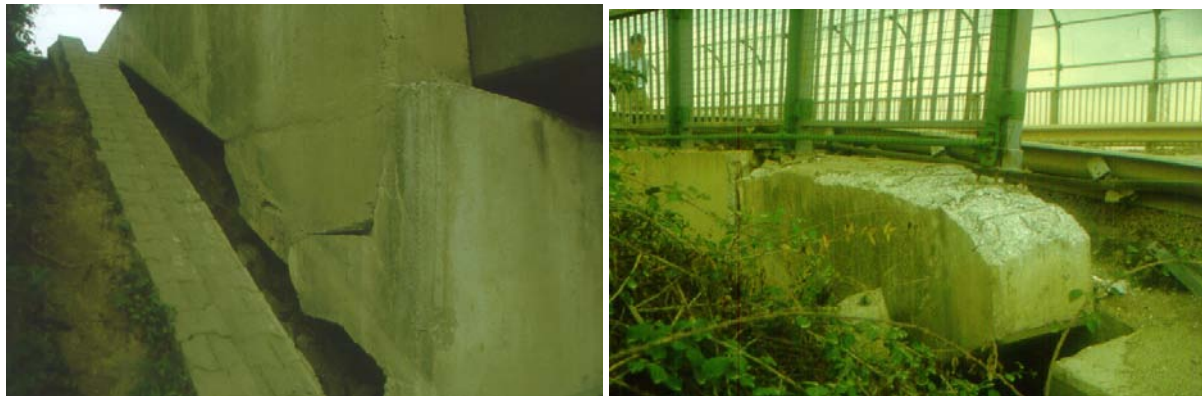
Figures 7.6, 7.7: Movement of overpass abutment and of road bridge abutment close to fault rupture

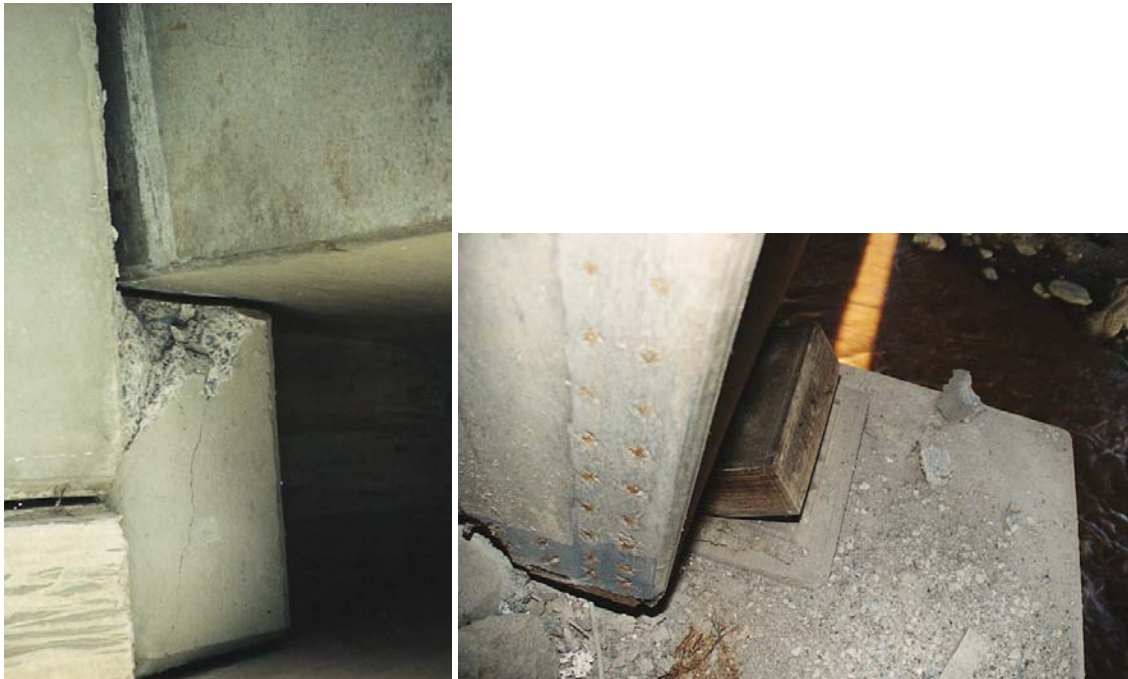
Figures 7.8, 7.9: Spalling and damage to bearing pad at seat of bridge deck (photo: N.Apaydin, H.Aydin)

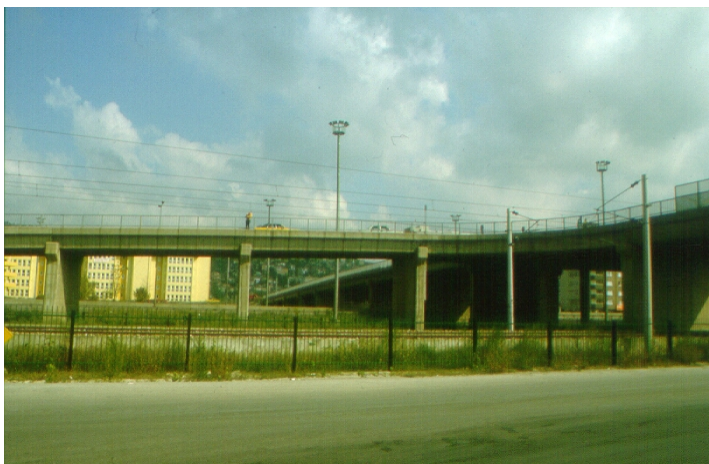
Figure 7.10: General view of viaduct in Izmit

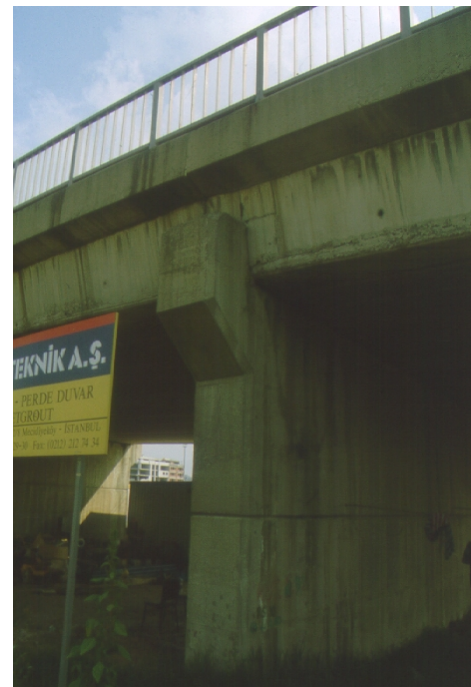
Figure 7. 11: Column detail

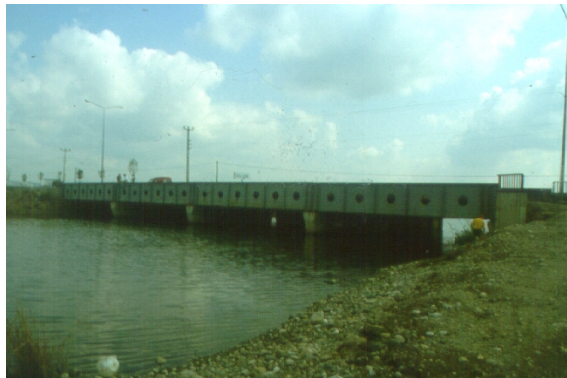
Figure 7.12 River Crossing South of Izmit

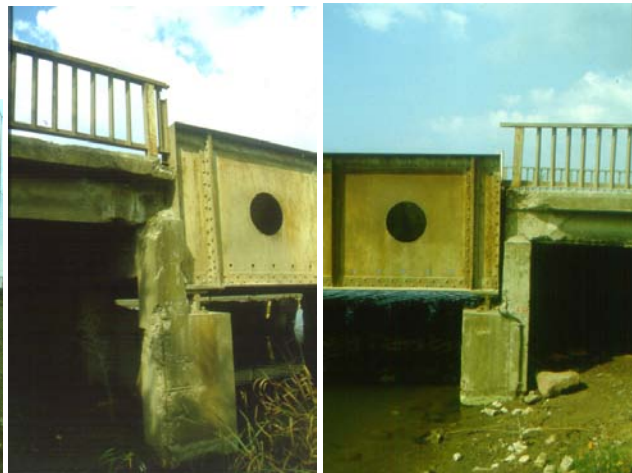
Figure 7.13 Pounding Damage to Supports

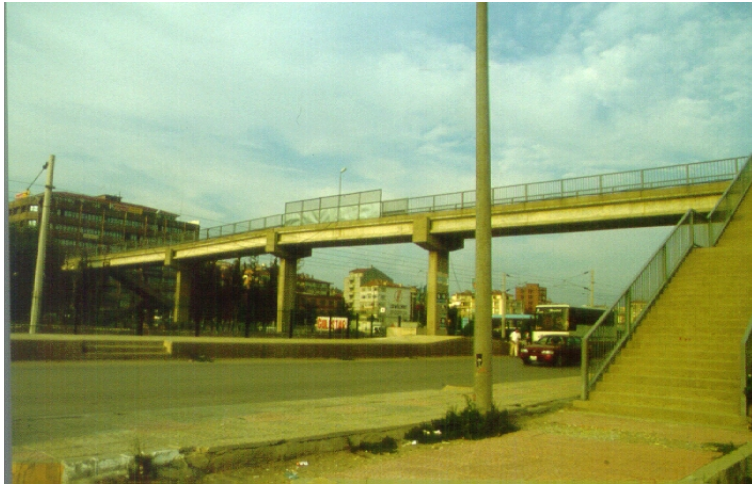
Figure 7.14: Footbridge in Izmit

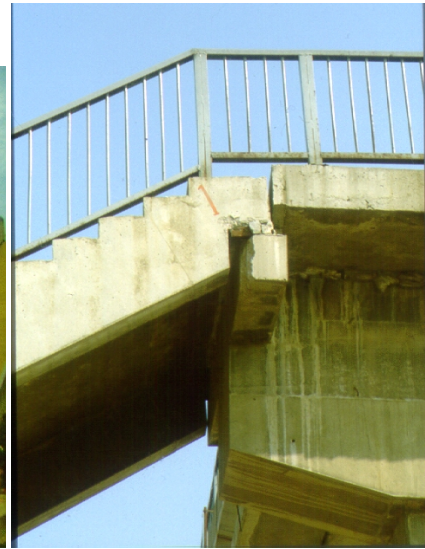
Figure 7.15: Detail of damage to the access staircase

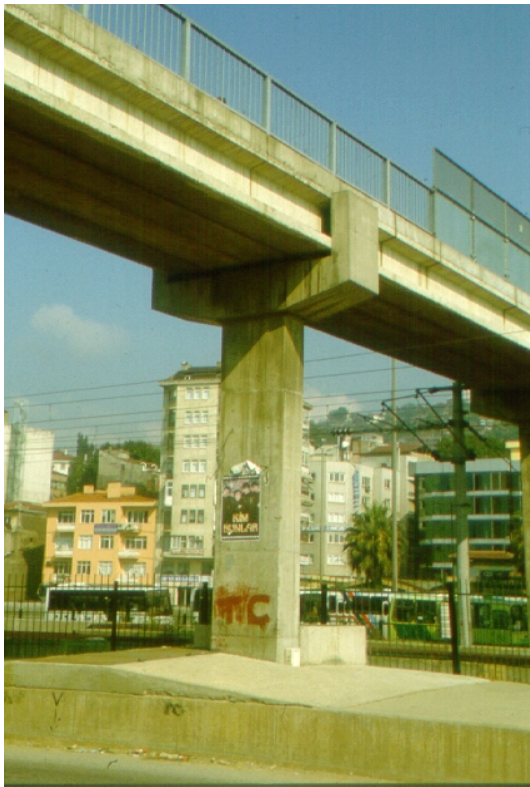
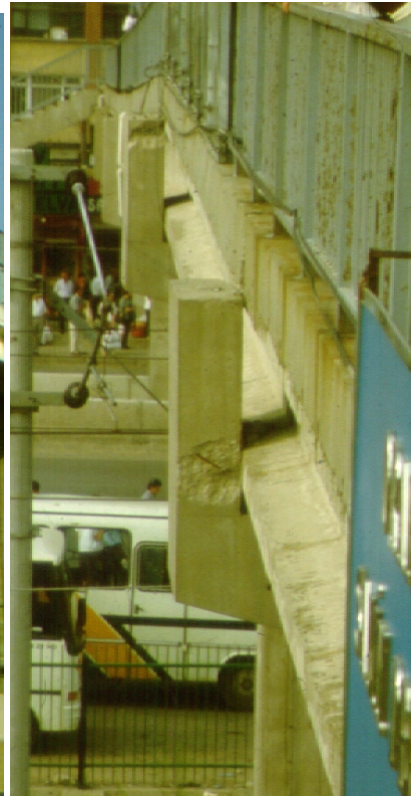
Figure 7.16: Typical Footbridge Column Head Detail

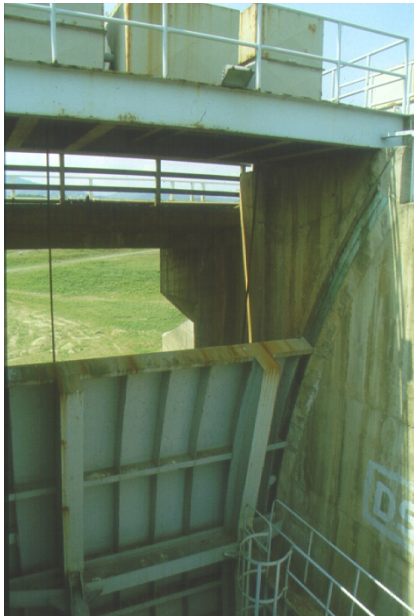
Figure 7.17: Gokce Dam: Radial Gate Structure

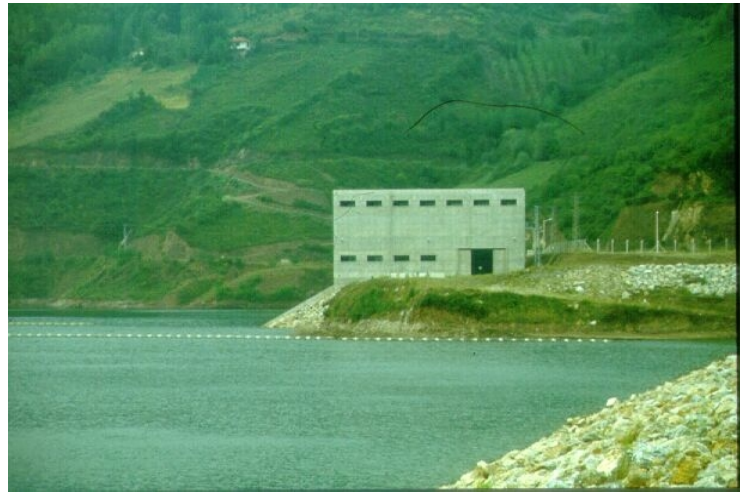
Figure 7.18: Gokce Dam: Intake Structure

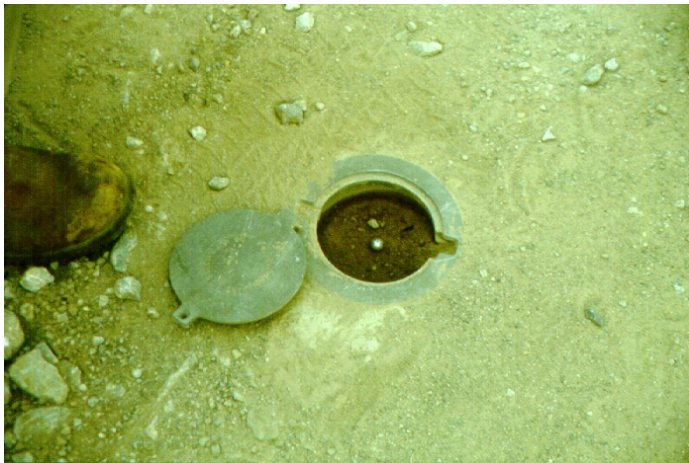
Figure 7.20 Survey Point on Yuvacik Dam Crest
