THE KOCAELI, TURKEY EARTHQUAKE OF 17 AUGUST 1999

A FIELD REPORT BY EEFIT

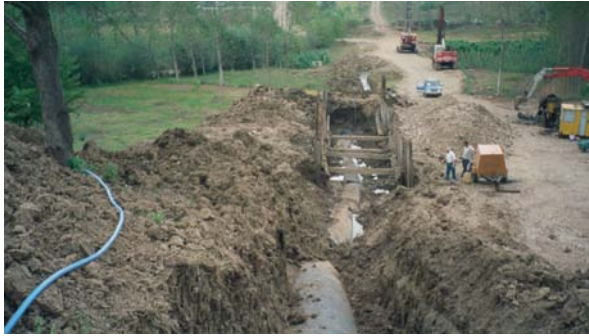
Figure 7.22: Damaged run of pipeline in a region of high ground disturbance

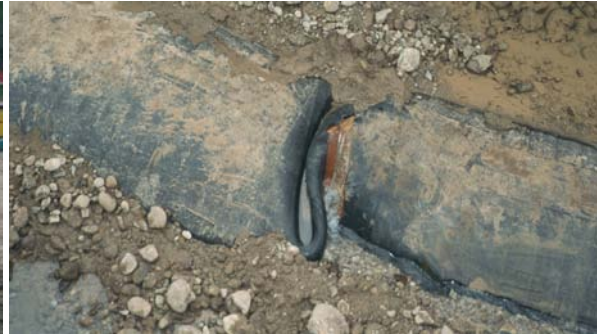
Figure 7.23: Local distortion of pipe due to displacement imposed by ground movement

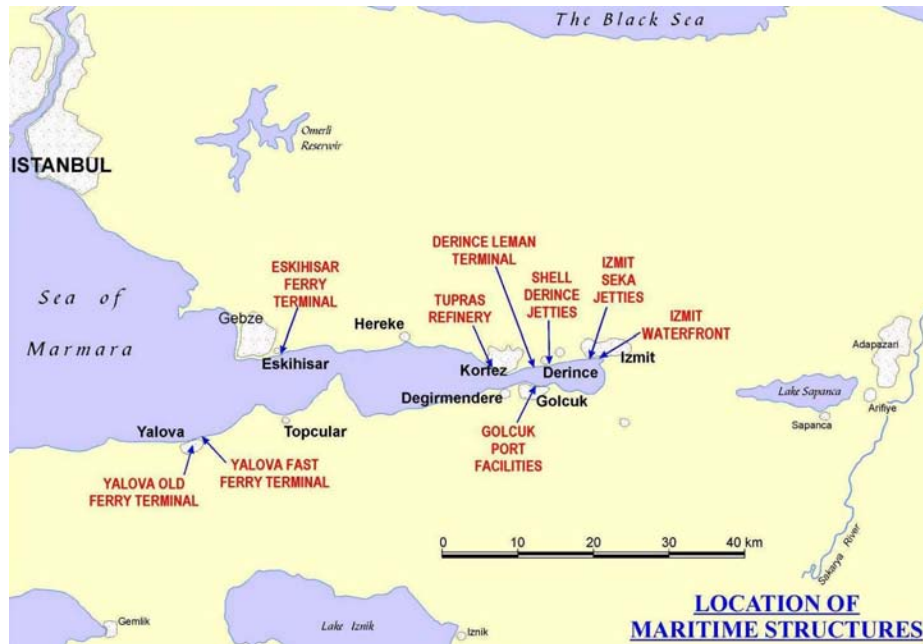
Figure 7.24: Location of maritime structures

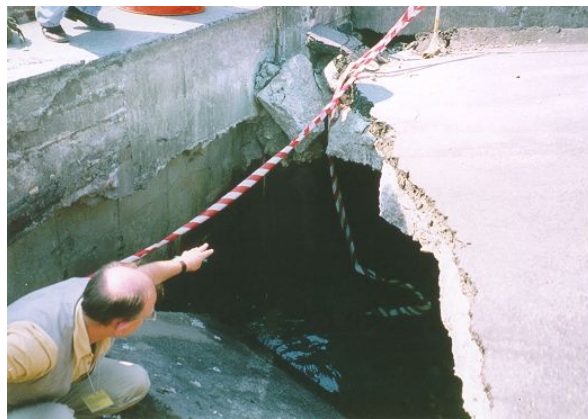
inspection revealed that the collapse had occurred at the junction between the gravity wall and sheet pile wall. Damage to the top of the gravity wall indicated that during the seismic event, the sheet pile structure had pounded against the gravity structure. This movement resulted in a permanent gap of 200 mm between the two structures. This allowed water to penetrate the wall and wash out the fill behind, leaving no support for the overlying deck slab (Figure 7.26). The fill underneath adjacent deck slabs had undergone relatively minor settlement of 50 mm. No significant seaward movement of the sheet pile wall was apparent, suggesting that the performance of any anchors present was adequate.

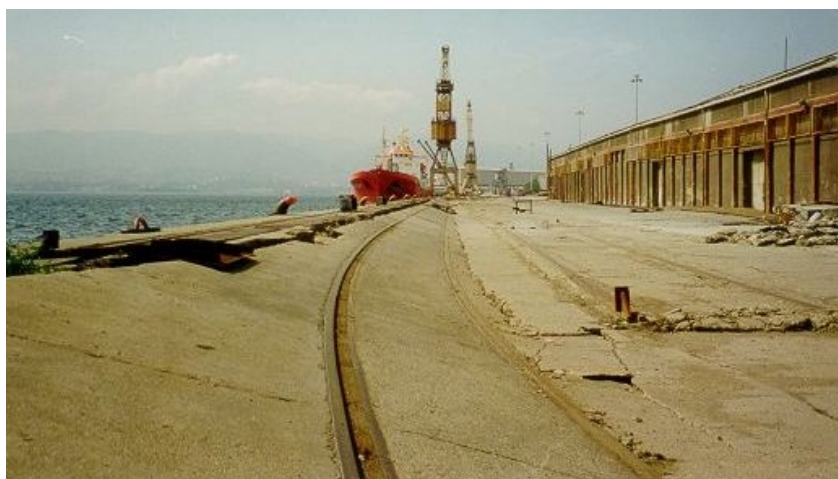
The Derince Leman industrial facility to the west of Izmit has a number of container berths. The oldest quay, a sheet pile wall with concrete deck, suffered the most damage. The wall had moved outwards allowing the fill behind the wall to settle approximately 1 metre (Figure 7.27.) A steel framed warehouse 20 metres back from the wall had remained structurally intact despite considerable settlement (Figure 7.27). The only damage inflicted on the building was due to a rail mounted cargo crane that serviced the quay tipping over and striking the corner of the warehouse. The adjacent quay was in the final stages of construction and its form of construction appeared to be a tubular piled wall. This quay also suffered settlements and cracking of the deck, but on a scale small enough for the quay to be serviceable when construction is completed.

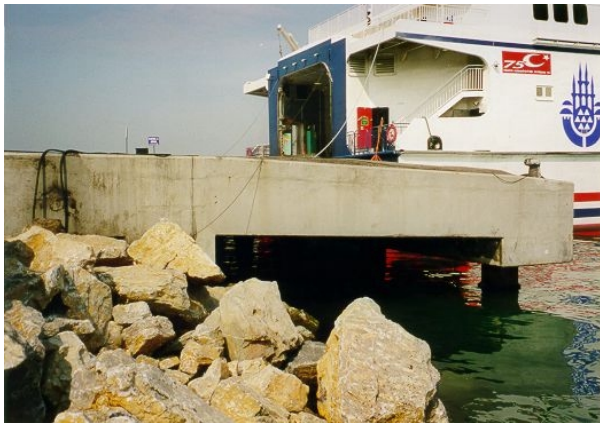
Quay structures consisting of a reinforced concrete deck supported on vertical steel piles performed significantly better in the earthquake than other types of construction. The fast ferry terminal at Yalova, constructed in 1997, was one of the few waterfront structures in the area to suffer minimal damage. The 1.5 metre thick concrete deck of the ferry berth is supported by steel tubular piles and sits above a rock revetment. (Figure 7.28) The stability of the revetment - and in particular its liquefaction resistance - are critical to the adequate performance of this type of quay.

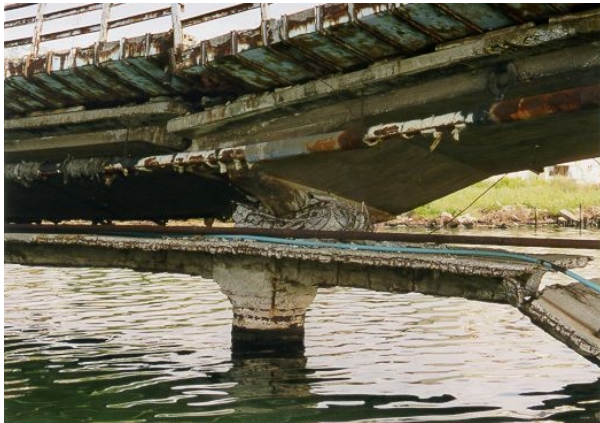
Considerable damage was caused to four reinforced concrete jetties along the North coast of the gulf to the West of Izmit. A jetty that had served as a cargo berth for the Seka paper factory in Izmit failed by crushing of the concrete pile heads at the landward end (Figure 7.30.) This failure allowed the deck to rotate severely (Figure 7.31) The seaward end of the jetty, which is supported by two rows of piles (rather than the single row at the landward end), survived despite the severe loss of concrete at the pile heads.

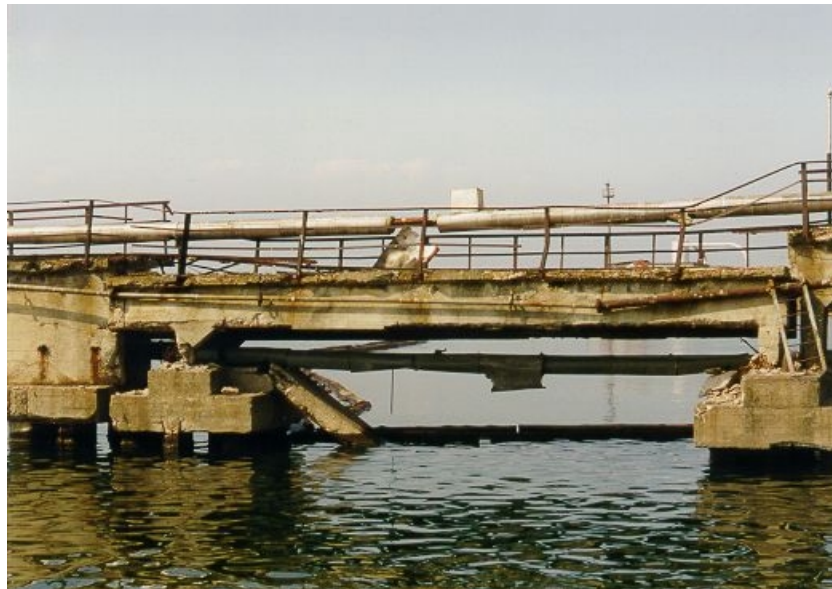
A concrete jetty 50 metres to the west of the cargo jetty had suffered the collapse of two of its spans. The deck was supported on slender concrete columns which were supported by concrete pile caps. The failures occurred in the columns, allowing the deck to drop 500 mm (Figure 7.32.). Approximately 4 kilometres further west at the Shell refinery in Korfez, two reinforced concrete jetties had suffered total collapse. Failure had again occurred at the pile heads. The east jetty had completely sunk leaving only a sheared pile head as evidence of its existence (Figure 7.33.) The western jetty was only partially visible. The remaining parts of the jetties showed signs of pounding along the jetty axis prior to failure. It appears that the failures may have involved shallow angle sub marine landslides.

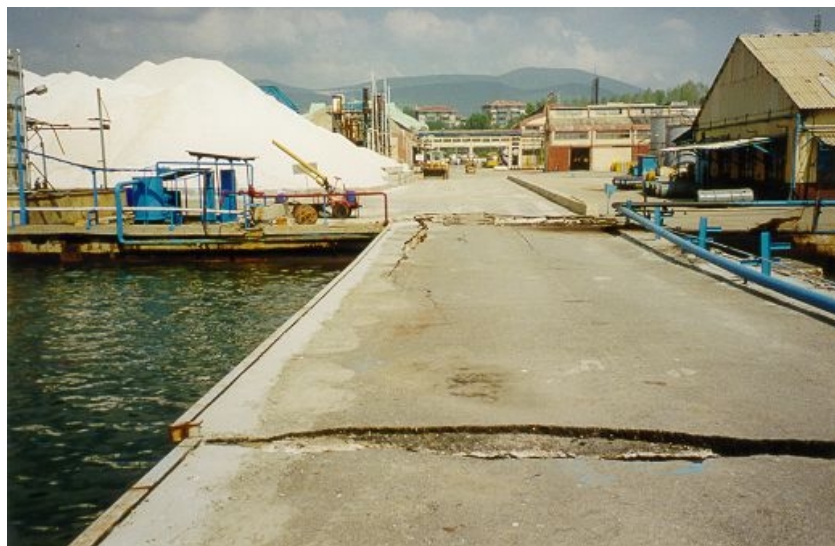
In general, jetties with a concrete deck supported by steel piles fared better during the earthquake than the concrete piled equivalent. At Gölçük naval base, a steel pile/concrete deck jetty suffered an unusual failure, possibly attributable to the presence of the fault directly beneath the structure. The jetty, approximately 80 metres long, was constructed in two separate sections. The seaward section had moved 3 metres northwards and 3 metres eastwards, with no change in vertical level (Figure 7.34.) The eastward component of the movement is consistent with the direction of the tectonic plate movement. An identical jetty situated 100 metres to the west showed no signs of damage or movement.

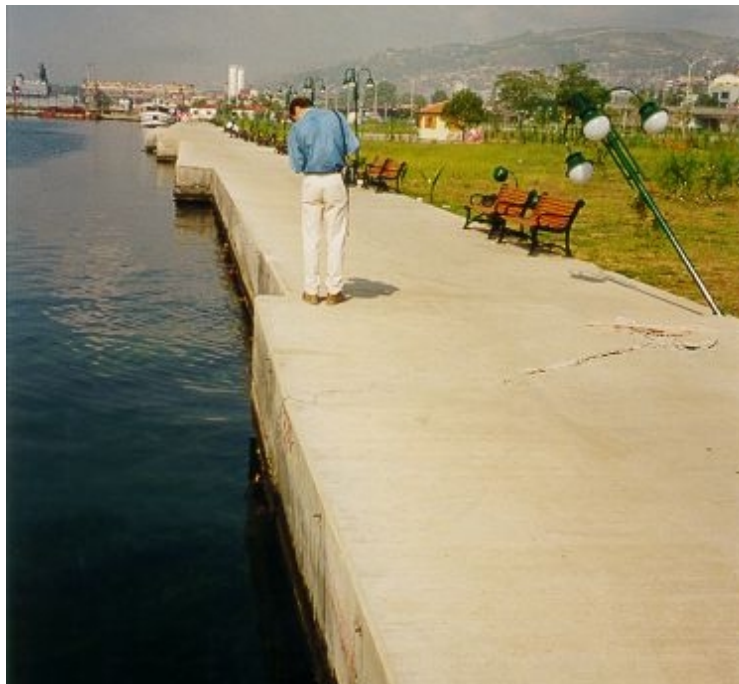
In Izmit, a steel piled jetty suffered no damage despite the 300 mm seaward movement of an adjacent promenade (Figure 7.35) and a drop in the ground level behind the jetty of 1.5 metres. On the north coast of the gulf to the west of Izmit, four steel piled concrete jetties were observed at various industrial facilities; all four structures appeared to be undamaged. The mooring jetty at the Yalova fast ferry port was also undamaged (Figure 7.36.)
