The value of multiple earthquake missions: the EEFIT L'Aquila Earthquake experience

Keywords L'Aquila Earthquake · Field survey · Strong ground motion · Building damage · Return mission

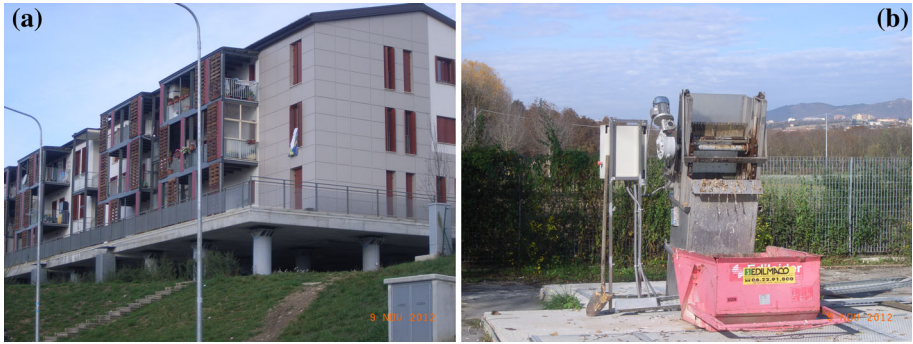
Fig. 8 Photograph of a C.A.S.E. building in the Bazzano site (a), and the inadequate sewage filtering site alongside the Aterno river (b)

The state of maintenance of the C.A.S.E. buildings remains adequate, but it is not clear how long this situation will prevail. Coppito 3 has landscaping problems, in that the state of maintenance of the public open space is very poor. When they were interviewed, residents complained about difficulties and delays in getting repairs done.

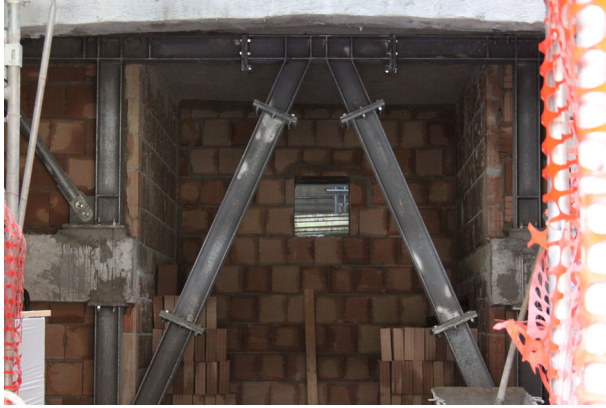
In a very few cases steel frames were observed to have been applied or base-isolation introduced. For example, a new steel frame was observed to be applied to the concrete frame of a five storey block of apartments in L’Aquila (see Fig. 12). Three identical apartment buildings in Pettino were demolished and replaced with new structures incorporating seismic isolation at basement level (Fig. 13a). The five storey reinforced concrete frames incorporate garage space on the ground floor, are infilled with clay bricks and are approximately 28 m × 14 m on plan. A grid of 6 × 4 concrete columns in the new basement support 24 ‘FIP Industriale’ base isolators (Fig. 13b). The base isolators support a 400 mm thick RC slab and are in turn supported by 1.5 m high concrete columns that are a cruciform shape on plan and sit on a 600 mm thick raft foundation. It was noted on site that the cruciform section provides good biaxial stiffness while maintaining room for inspection and replacement of bearings if necessary. The basement retaining walls had been detailed to accommodate lateral displacement using a ‘dog-leg’ gutter detail, with also a vertical gap of approximately 15 cm at the slab edge.

Fig. 12 Condominio Vico Picenze, L’Aquila. Retrofitted steelwork observed from the site boundary

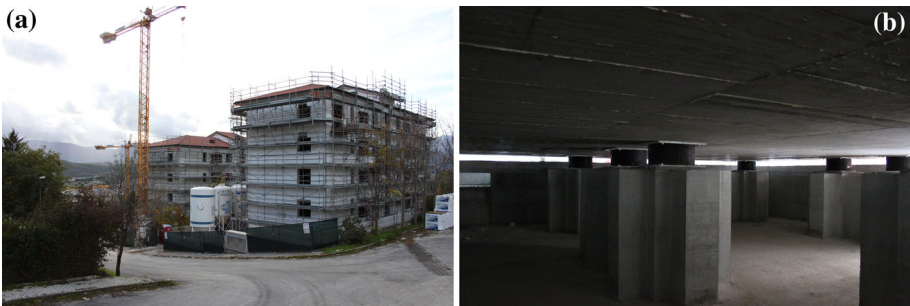
Fig. 13 Via Francia, Pettino. **a** Photo of the base-isolated buildings and **b** view of the base isolators in the basement
