# CROSS Safety Report

## Unusual steelwork connection discovered during fit-out works

This month's report discusses an unusual steelwork connection found during an inspection of an existing structure.

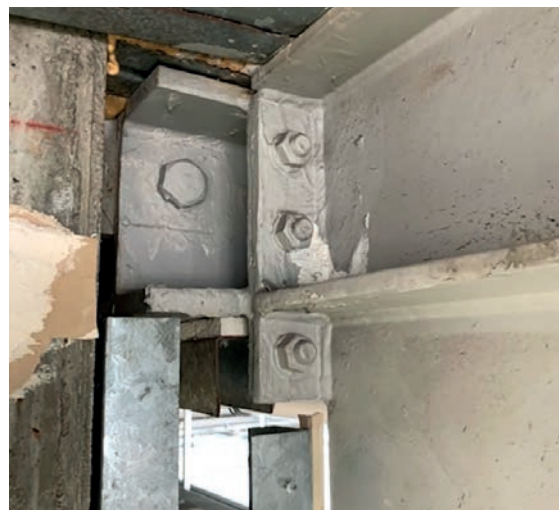
When involved with a fit-out in a high specification building, a reporter found an unusual steelwork connection during the inspection of the existing structure. The structural form was steel frame supporting composite concrete decks, with reinforced concrete (RC) core walls. When exposing the end of a main 9m long floor beam to check its connection into the RC stair core, the reporter found that an approximately 600mm deep floor beam (plate girder compositely designed with floor slab) was supported off a 203UC trimming

beam. This, in turn, was supported off a single M30 bolt, and small fin plate into the RC core (see **Figure 1 and 2**).

The reporter believes the connection might be okay under the original design loading, which they assessed to be around 240kN of shear (ULS), as a single M30 bolt could potentially carry 215kN in single shear. Therefore, depending upon original loadings and design, it is not impossible for the design reaction to be within the

However, the detail is not shown on the as-built drawings and there are many other checks to consider such as the plate bending and weld capacity. Also, the reporter holds concerns about single bolt fixings in primary structural elements, even if the calculations stack up.

**FIGURE 1:** Single M30 bolt supporting beams to fin plate

The reporter adds that in the example described in this report, the connection detail was observed on two floors that they were working on and a more robust remediation detail was implemented on site.
