THE QUINDÍO, COLOMBIA EARTHQUAKE OF 25 JANUARY 1999

A FIELD REPORT BY EEFIT

August 2000

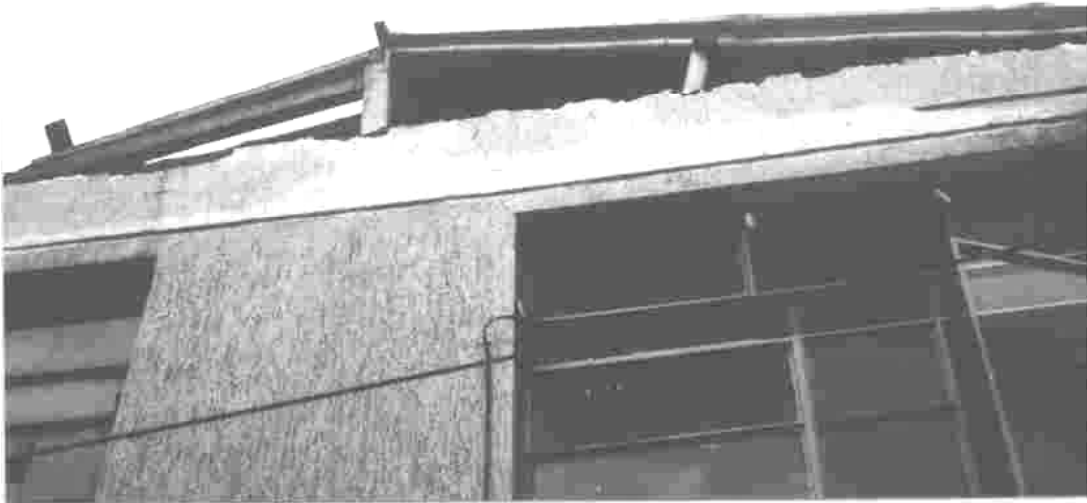
Figure 4.13: Collapse of free-standing masonry wall

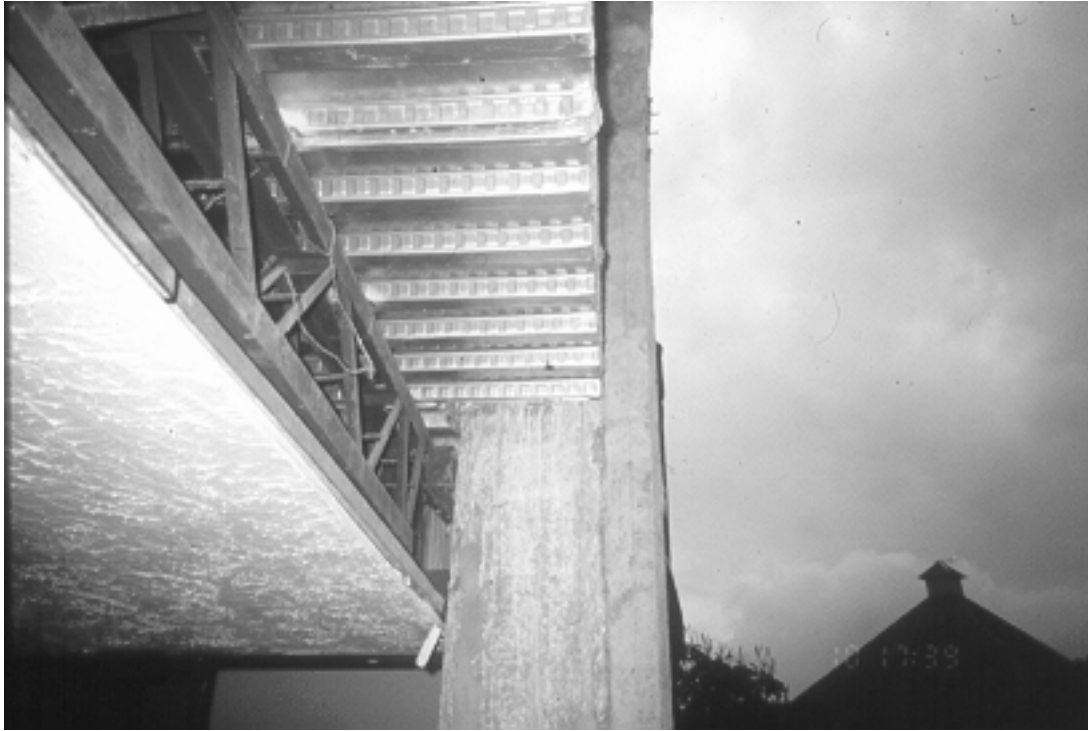
Figure 4.17: New steel truss floor beam with metal decking and RC slab over

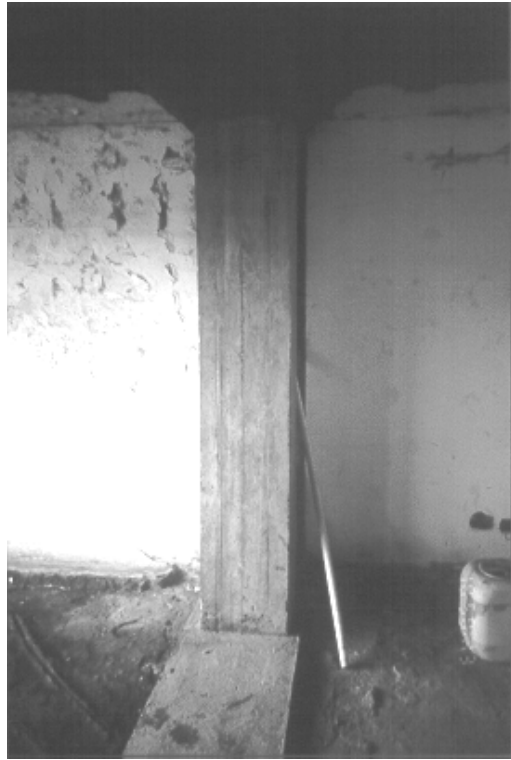
Figure 4.27: Retrofitted beam and column, with beam only providing additional restraint to column in one direction

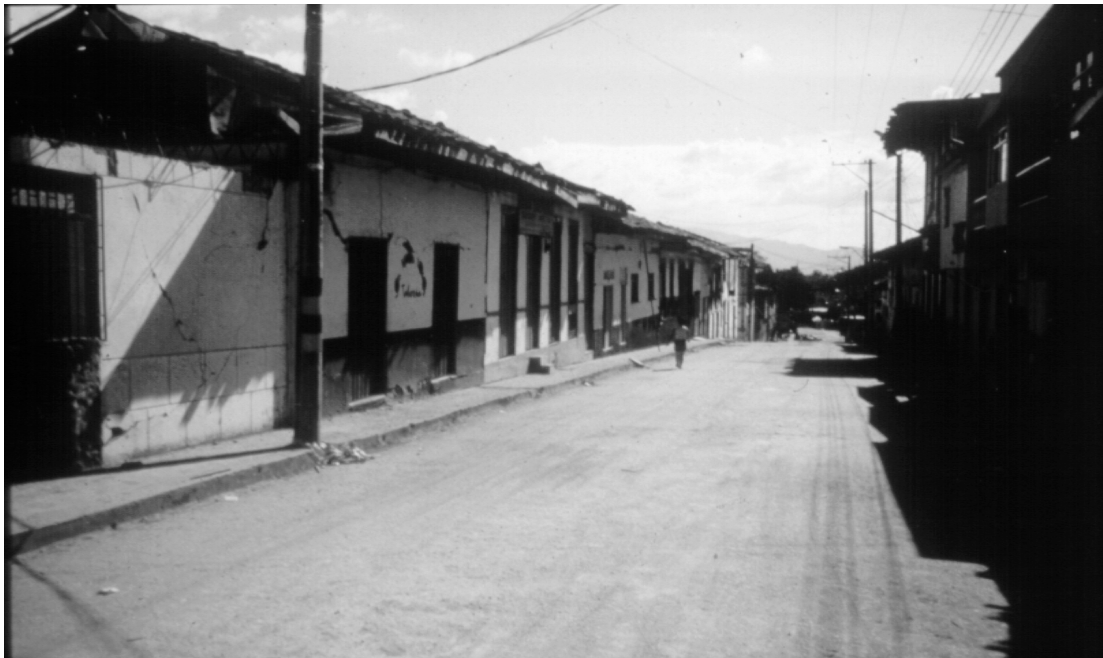
Figure 5.2: Terrace of relatively undamaged bahareque buildings in Barcelona

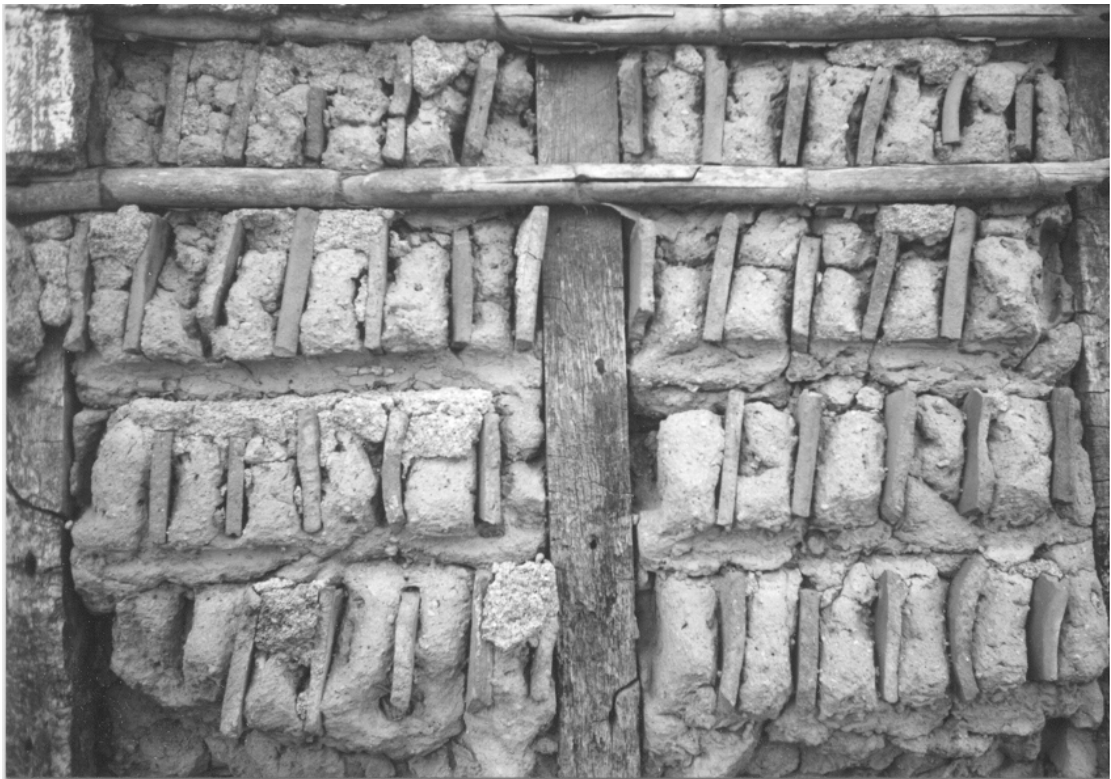
Figure 5.4: Wall construction of a bahareque building, showing tiles embedded in mud infill

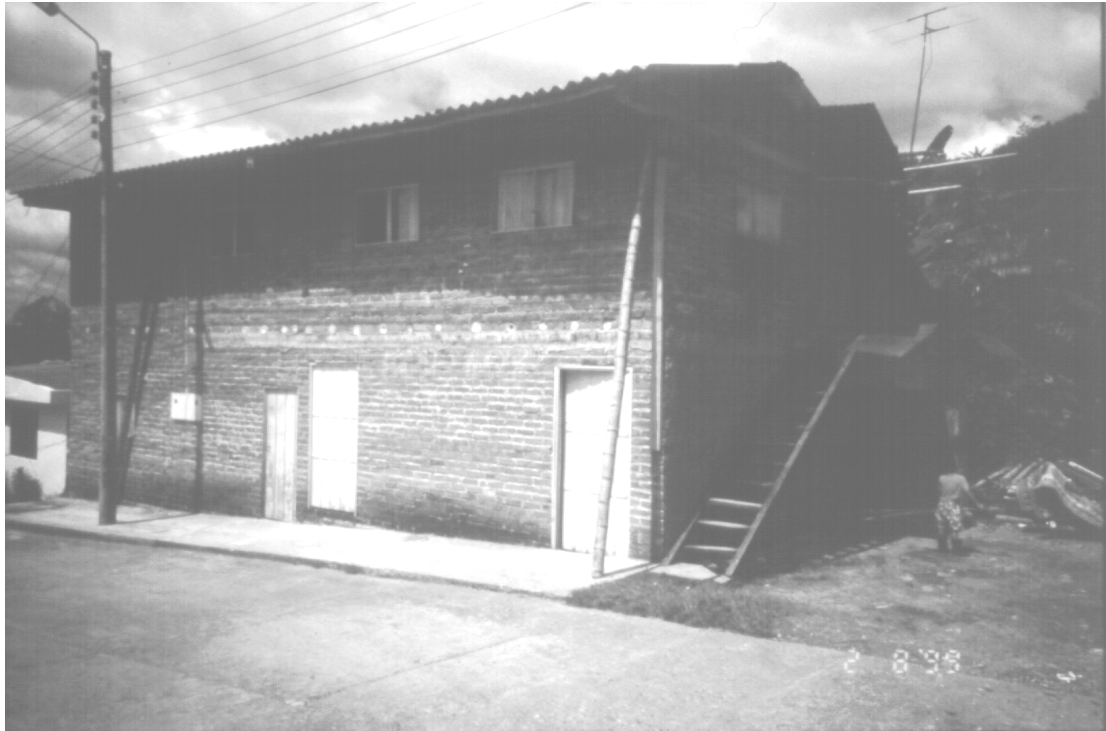
Figure 5.5: Masonry building with ring beams at first floor and roof level. Note bamboo sections above ring beam forming the main structural floor members.

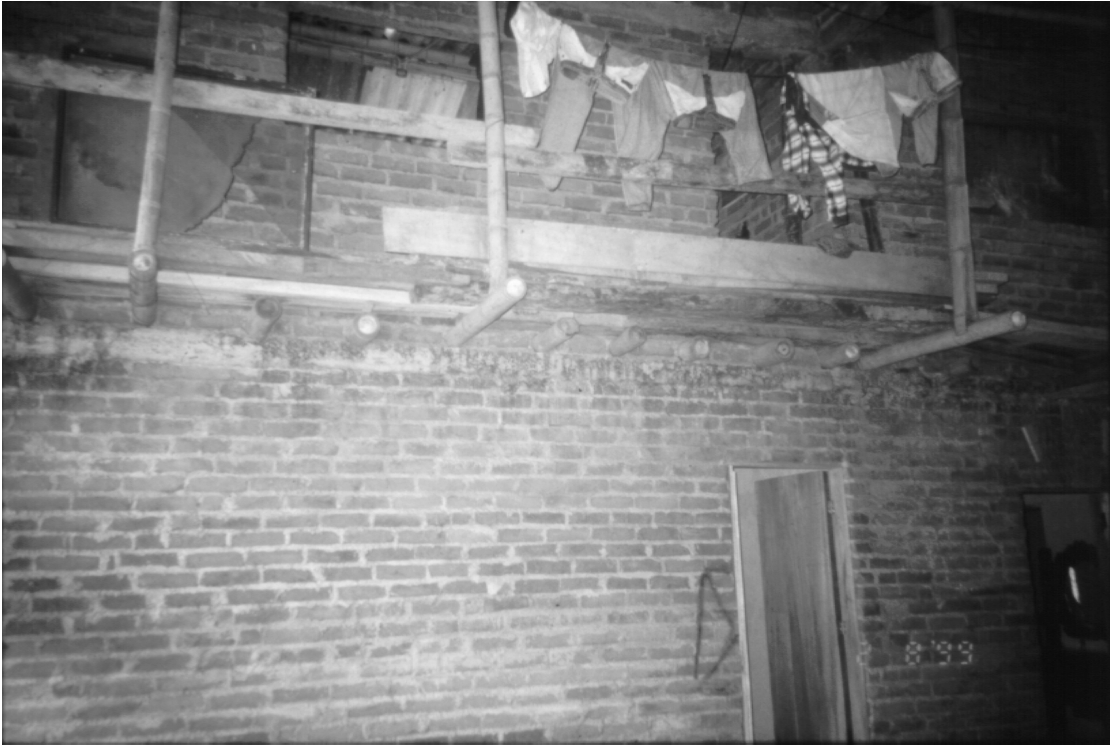
Figure 5.7: Internal wall of house shown in Figure 5.5

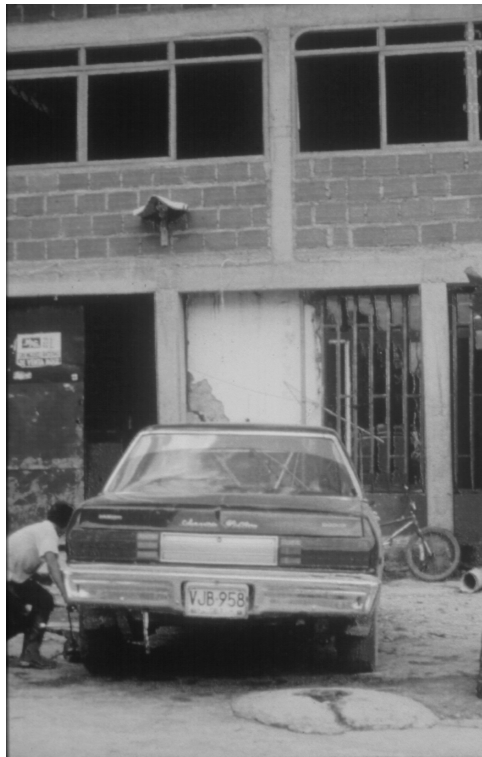
Figure 5.12: Non-coincident beam and column arrangement. Column transfers load to the centre of the beam.

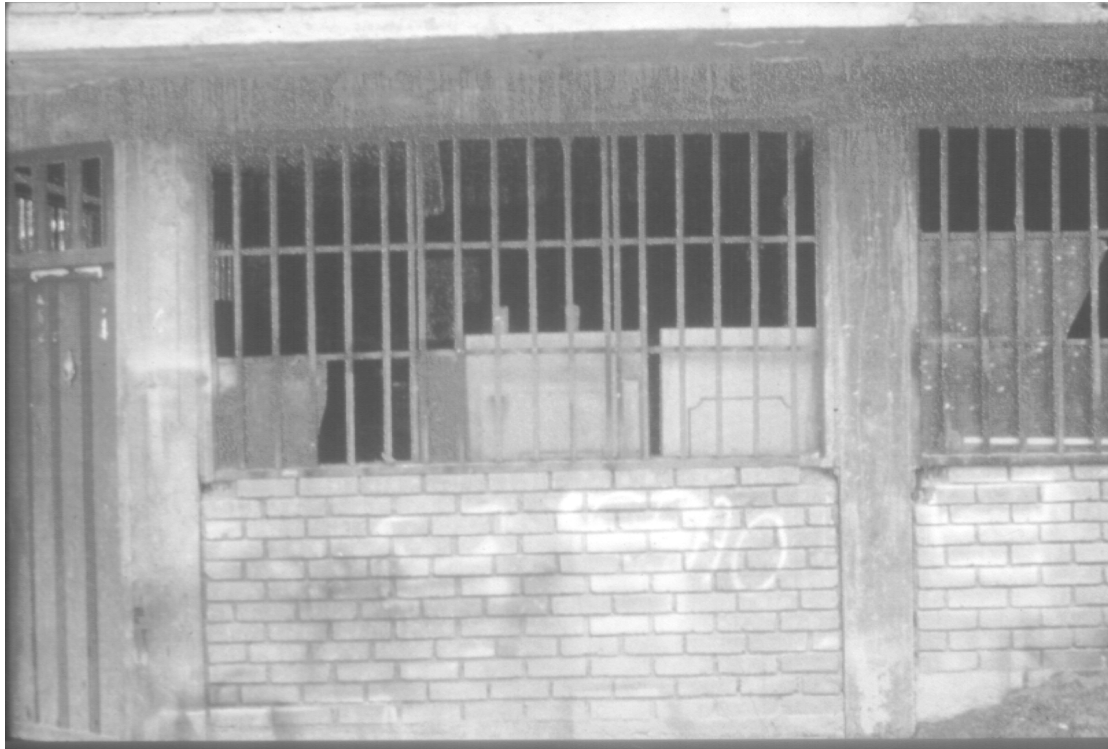
Figure 5.13: Masonry wall built between columns to half storey height to form window

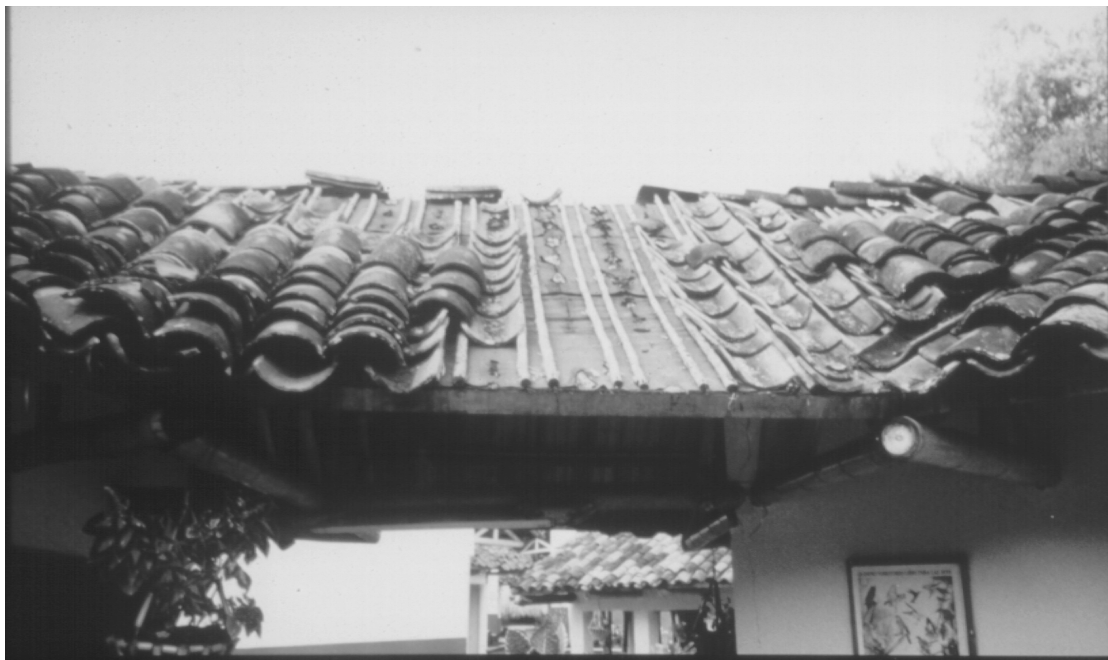
Figure 5.18: Displaced tiles from the roof of a house at the bamboo centre

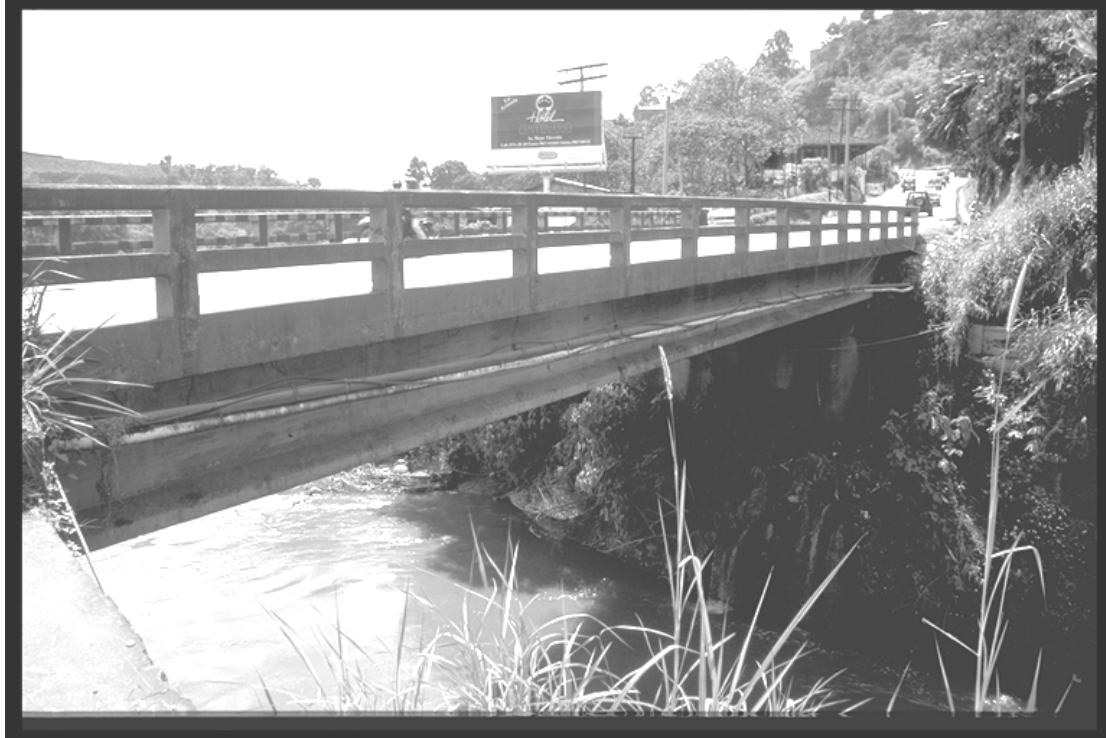
The majority of the road bridges were of reinforced concrete of a very similar design. Many were single span of approximately 20m at right angles to the river, for example as over the River Quindío on the road between Armenia and Calarcá (Figure 7.1). Others were of multiple simply supported spans of a similar design, for example the two-span bridge in Pijao (Figure 7.2). There were three similar bridges on the main road between Pereira and Armenia, and several more in the area. The largest bridge of this type is the four-span bridge over the River Quindío to the south of Armenia near Barcelona, carrying the main east-west through route across the region (Figure 7.3). This bridge is slightly curved on plan (Figure 7.4), but it is otherwise very similar.

Figure 7.1: Single span concrete bridge over River Quindío on Armenia-Calarcá road

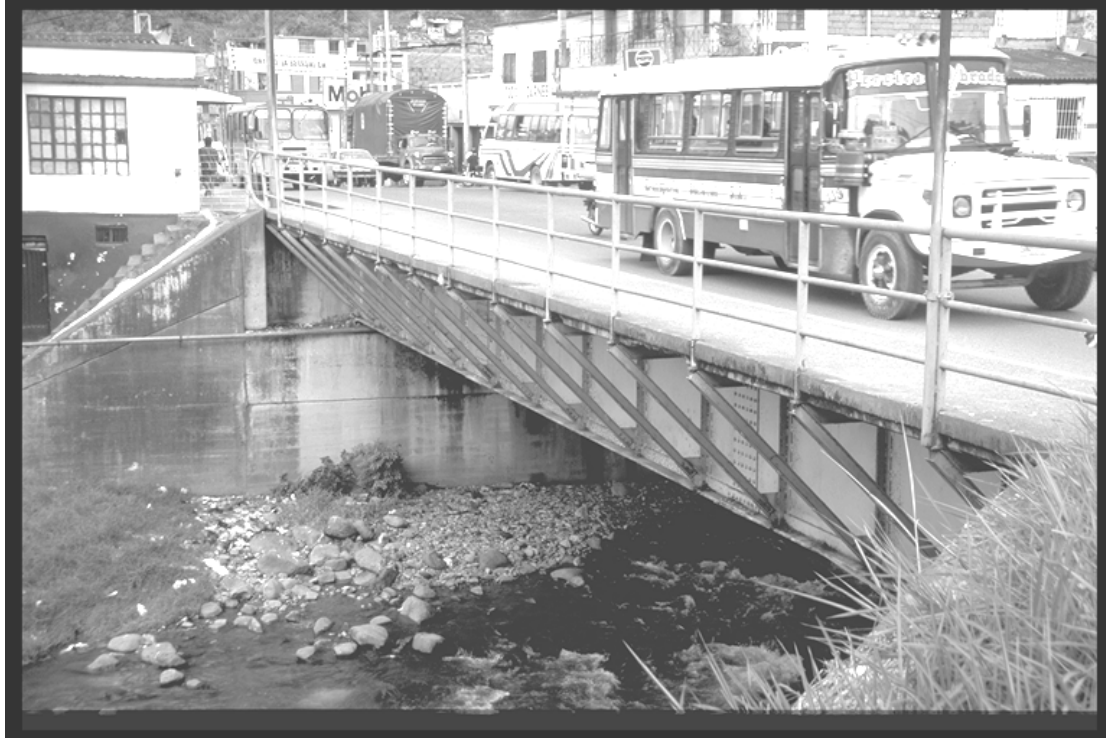
Although, as stated, the majority of the bridges over rivers were of concrete, there was a small number of single span steel plate girder bridges, for example in Pereira (Figure 7.5), close to the cable stayed bridge mentioned below.

Figure 7.5: Single span steel plate girder bridge close to cable-stayed bridge in Pereira

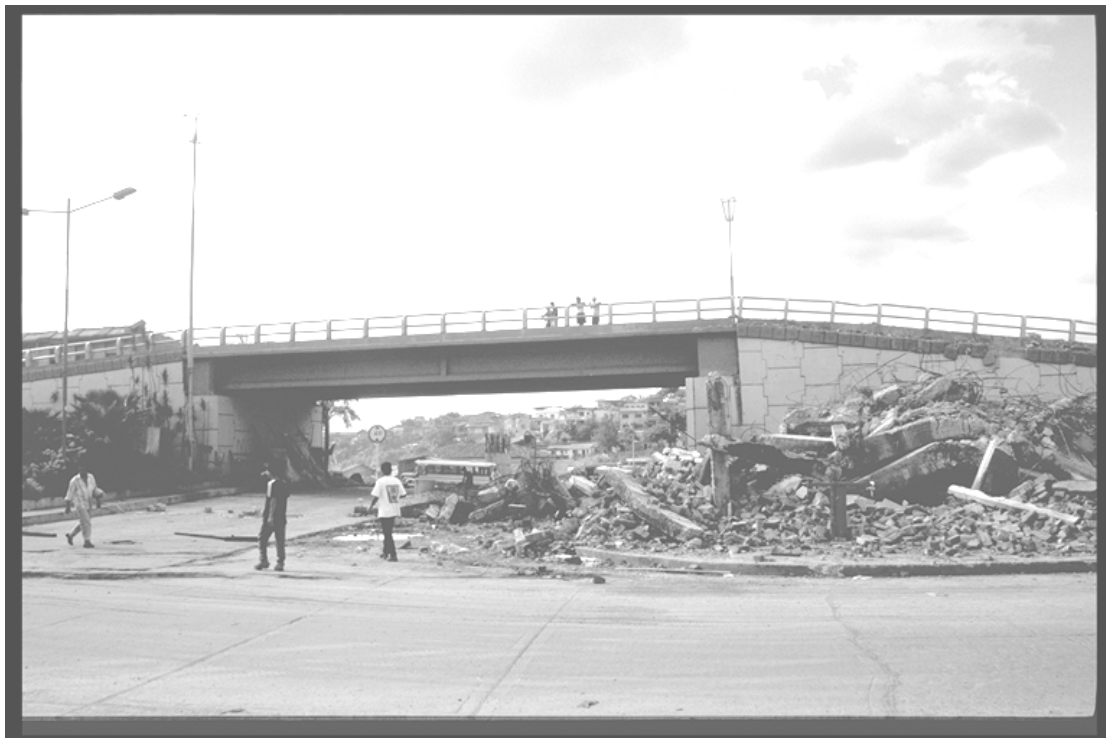
There are few road bridges in the area other than those over rivers, although in Pereira there were a few overpasses at major road junctions. One similar bridge had recently been constructed, but was not yet open to traffic, in the south-west of Armenia (Figure 7.6). This was of a similar size to the single span river bridges and was also of concrete, but it was of higher quality construction. Precast shaped beams were used and there were bearings at the abutments (Figure 7.7). There was no observable damage of the bridge, although in this case it was in an area with substantial damage to buildings, as seen the foreground of Figure 7.6. The similar bridges in Pereira also were undamaged, but there was little damage to buildings adjacent to them either.

Figure 7.6: Concrete overpass recently constructed in Armenia

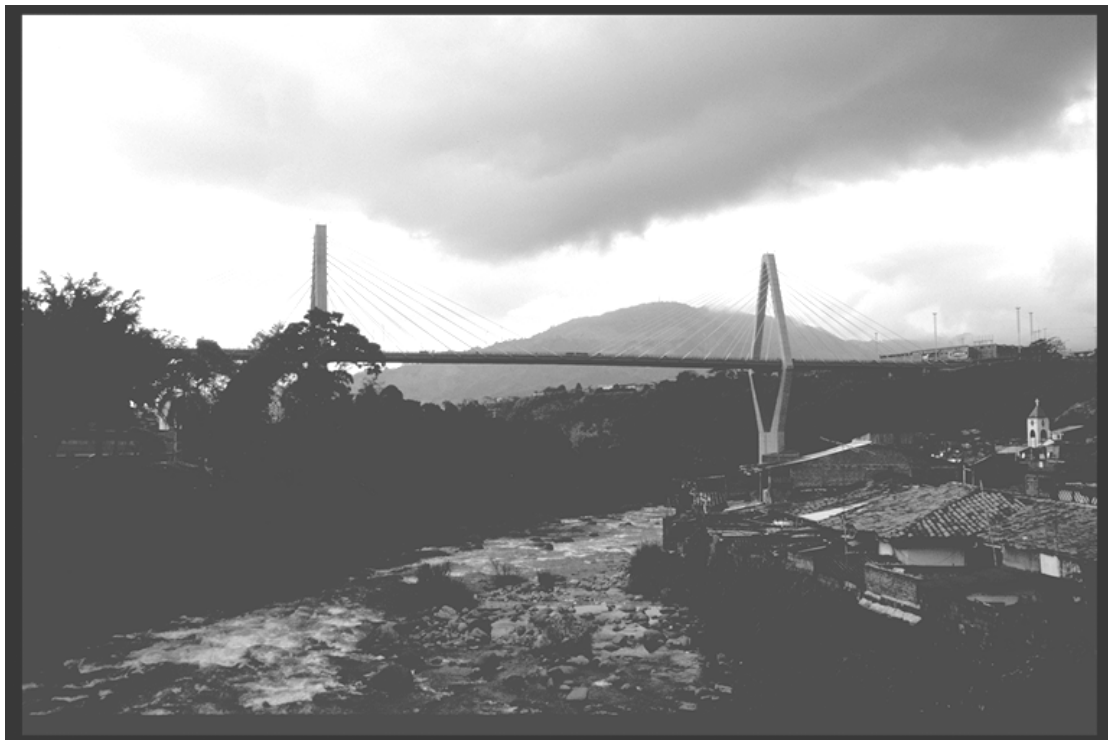
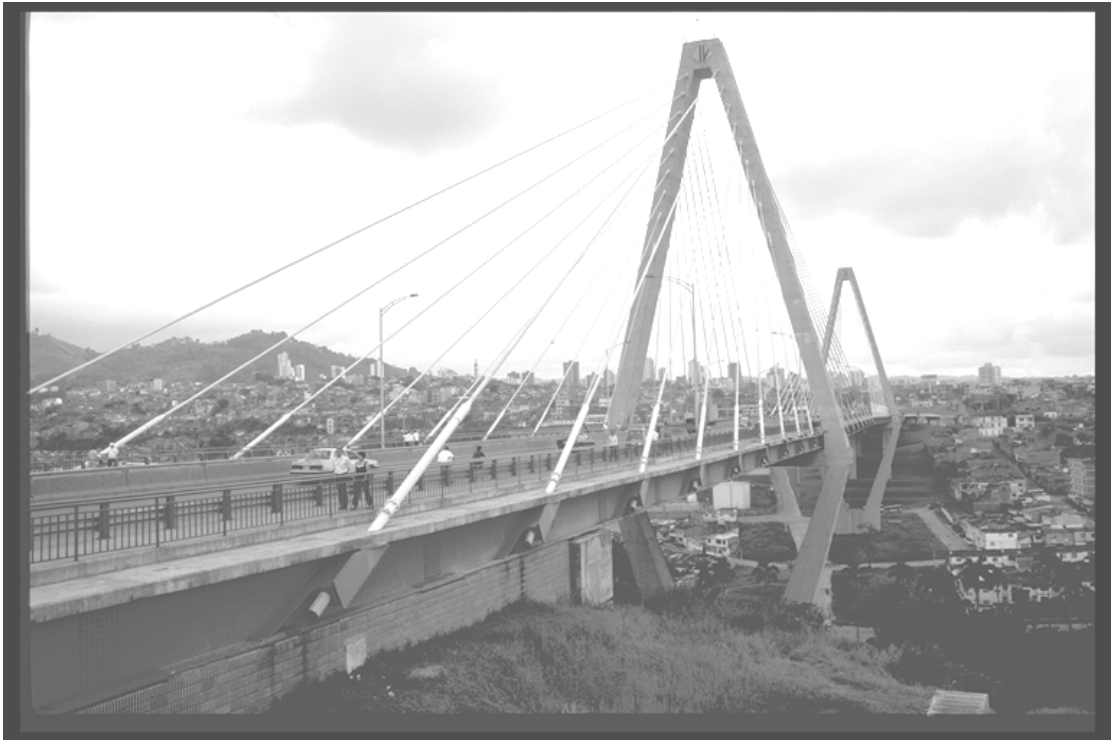
The largest bridge in the affected area is the cable-stayed bridge crossing the valley of the Otun River to the north-east of the centre of Pereira, towards the industrialised town of Dosquebradas (Figure 7.10 & Figure 7.11). It carries a dual carriageway and has a main span of 210m, with a concrete deck supported on steel plate girders. The bridge did not suffer any damage in the earthquake, nor did the approach viaduct on variable height piers on the south-west side of the bridge (Figure 7.12). The bridge was under construction during the earthquake in Pereira in 1995, at which time the pylons and part of the deck had been erected, but again no damage was caused then.

Figure 7.10: Cable-stayed bridge in Pereira

Figure 7.11: View of Pereira cable-stayed bridge from north

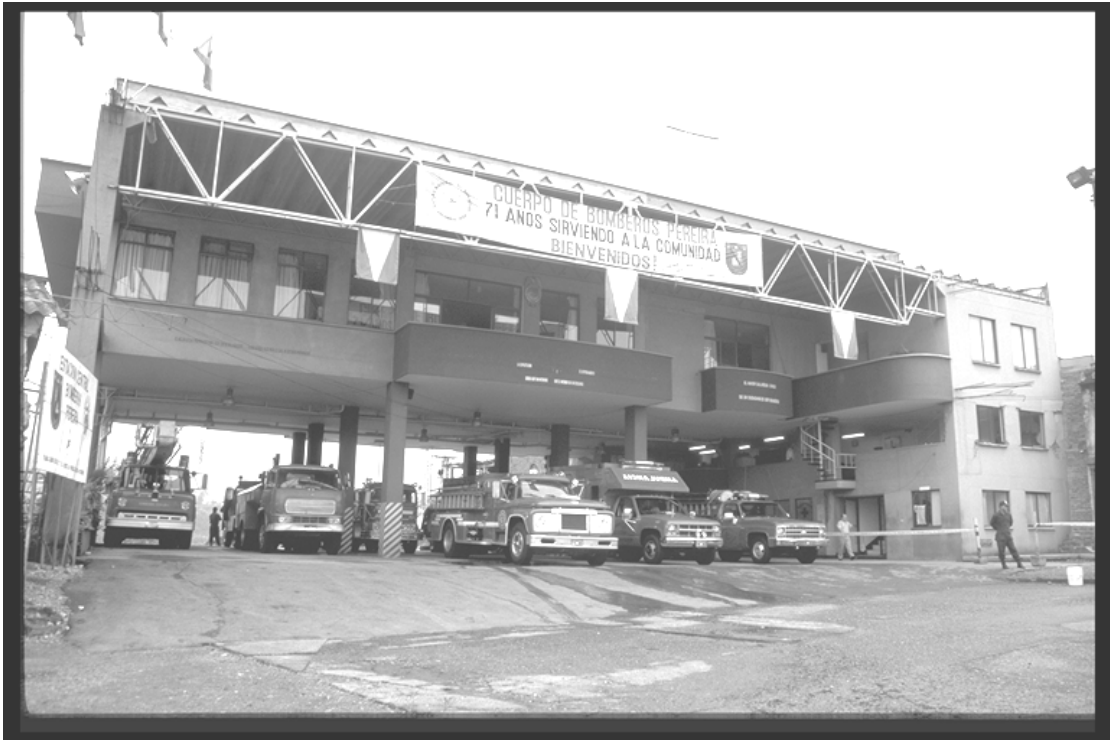
The Pereira fire station, a three-four storey reinforced concrete structure with a steel front canopy, remained in good condition except for some minor masonry cracking (Figure 7.23). However, the open plan ground floor may have made it vulnerable had the earthquake excitation been greater at this location. It acted as well co-ordinated centre for disaster management for the city.

Figure 7.23: The fire station in Pereira, which suffered very little damage
