2007 August 15 Magnitude 7.9 Earthquake near the Coast of Central Peru

Earthquake Field Investigation Team (EEFIT) Field Mission, 5-12 SEPTEMBER 2007 / Final Report

Fabio TAUCER, Joint Research Centre (Editor and Team Leader)
Dr John ALARCON, Arup
Emily SO, University of Cambridge

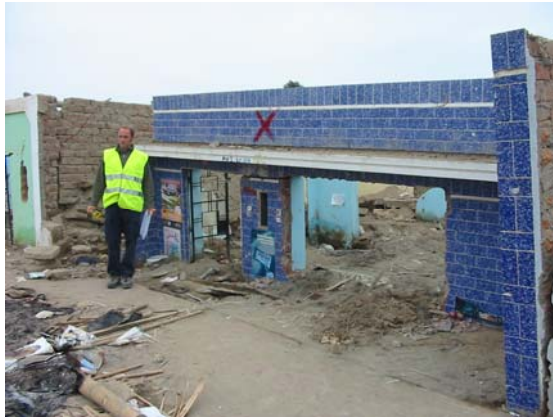
The foundation details of these houses could not be inspected during the visit, but are expected to be similar to those observed in the neighbouring town of Chincha Alta (see Section 3.3). Since each house affected by liquefaction settled relatively uniformly, it may be concluded that these foundations correspond to shallow continuous footings. The large settlements observed suggest the occurrence of large cyclic stress ratios in the sand layer.

Figure 3.3 Large settlements reached values of approximately 1.0 metre

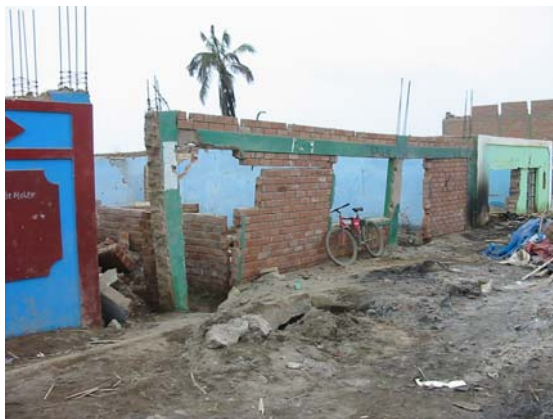
Figure 3.5 Large settlements reached values of approximately 1.0 metre

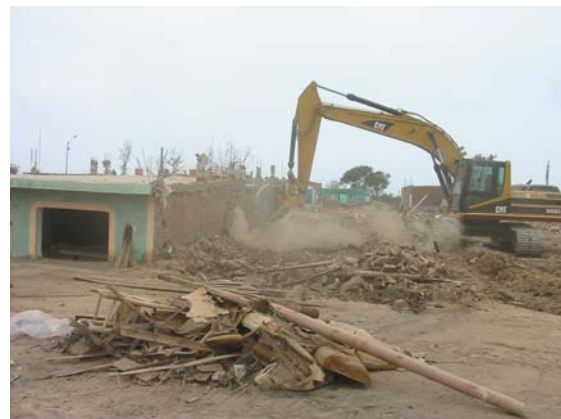
Figure 3.6 Liquefaction affected houses being demolished by the government

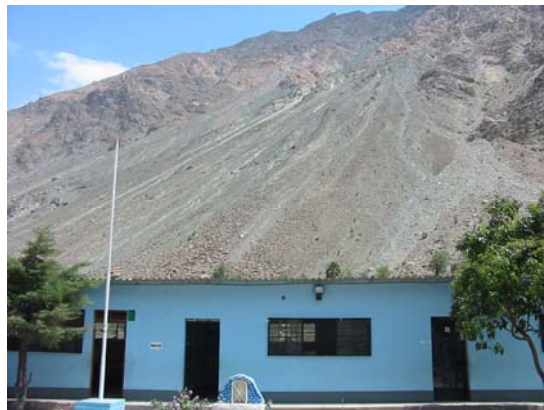
On the last day of the mission, the EEFIT team travelled eastwards to the mountains in order to identify the boundary between areas of significant and minor damage. During this journey into the mountains the most common process of instability observed were debris flows and rock falls, such as those shown in Figure 3.11 and Figure 3.12. The rock fall given in Figure 3.11 hit the abutment of a pedestrian bridge, leading to the collapse of the structure (see Section 6.2). No evidence of deep landslides was observed during the field visit.

Figure 3.12 Debris and rock flow on the slope of mountains; most of the landslides shown in the photo were already there before the earthquake

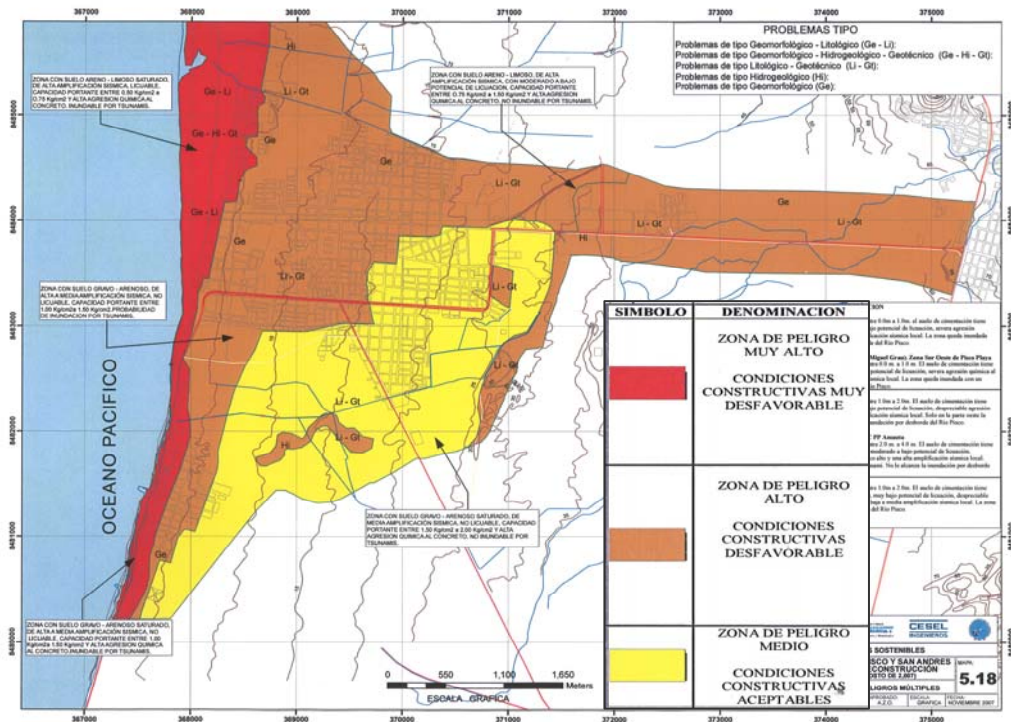
Site effects may be evident in the level of damage observed in the city of Pisco and the town of San Andrés. Besides political limits, the boundaries between these two agglomerations are indistinguishable and thus, from the spatial point of view, can be considered as one city. Damage in Pisco, especially in the central part of the city, showed a greater degree of damage than in San Andrés. This may be due to various reasons, such as age of constructions (being older in central Pisco), structural typology and quality of construction (being better in San Andrés), and more unfavourable site conditions in central Pisco, as shown by the hazard zonation map elaborated by the Peruvian National Civil Defence (INDECI) (Figure 3.15). Characteristics of the delimited zones are:

- Very high hazard (Zone a – red colour): soils with undrained strength capacities between 0.5 to 0.75 kg/cm² (about 50-75 kPa)
- High hazard (Zone b – orange colour): soils with undrained strength capacities between 0.5 and 1.5 kg/cm² (about 50-150 kPa)
- Intermediate hazard (Zone c – yellow colour): soils with undrained strength capacities between 1.5 and 2.0 kg/cm² (about 150-200 kPa).

Figure 3.15 Hazard zoning map of the city of Pisco (source: INDECI); the map summarises hazard evaluation from earthquakes, tsunamis and floods

It is important to note that the INDECI zonation map of Pisco summarises a broad group of hazards, including seismic hazard, tsunamis and floods caused by both heavy rains and river overflow. A more helpful way to identify and address each problem appropriately would be to plot and make available to the community and governmental institutions maps for each one of these natural events. Similar maps exist for Chincha (Figure 3.16) and Cañetes (not included in this report).

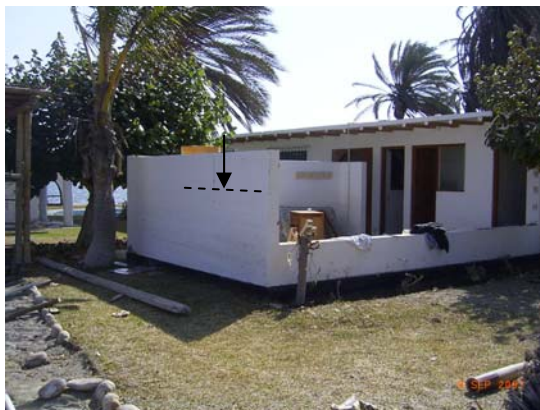
Figure 4.1 Tsunami water height in holiday villas at Paracas

Along the road next to the holiday villas of Paracas, there was very little visible structural damage, with only one wooden access-gate smashed due to water ingress and some damaged light structures for keeping boats; water marks were measured at 1.4 m with respect to the ground (approximately 2.5 m with respect to sea level), as shown in Figure 4.1 and Figure 4.2.

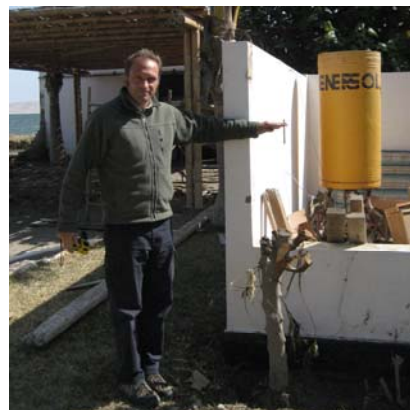
Figure 4.2 Tsunami water height in holiday villas at Paracas

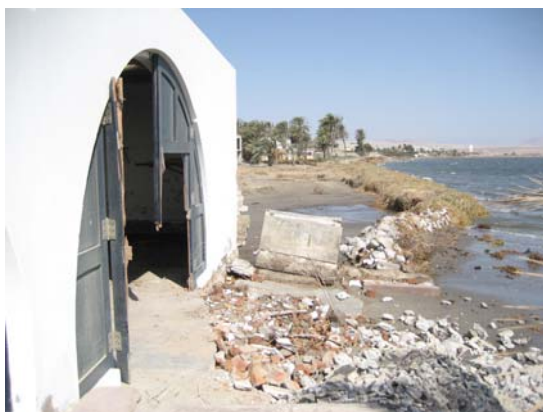
Figure 4.3 Tsunami damage at shore in front of holiday villas in Paracas

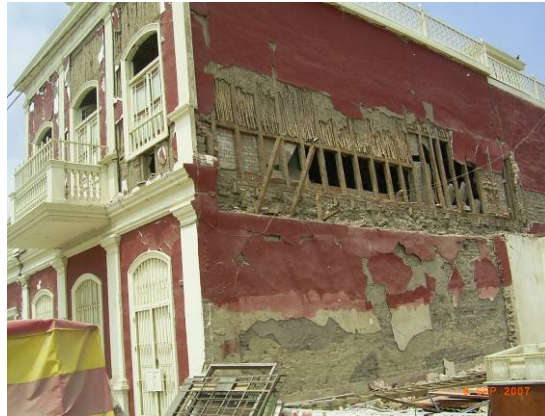
Figure 5.2 Pisco historic waterfront: adobe building with *quincha* exposed at second storey

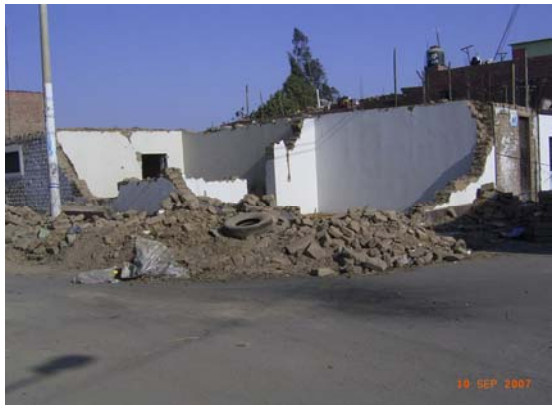
Figure 5.3 Collapsed adobe house in Ica

According to information received from INDECI, in the most affected areas (Pisco, Chincha Alta and Ica) approximately 80% of adobe houses collapsed (Figure 5.3 and Figure 5.4)³, an outcome that was more than predictable in view of the lessons learned from previous disasters in Peru and worldwide (Eje Cafetero, Colombia, 1999; Bam, Iran, 2003; El Salvador, 2001), as well as from the research

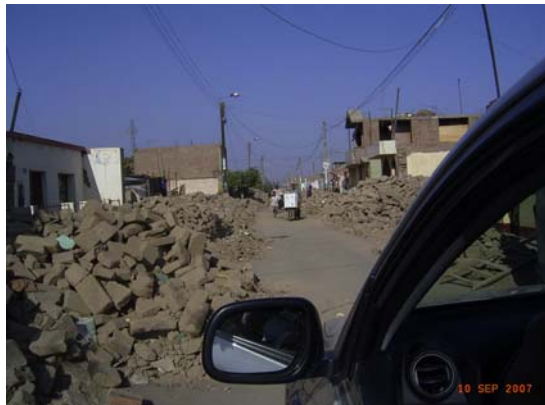
Figure 5.4 Debris of collapsed adobe houses in Ica

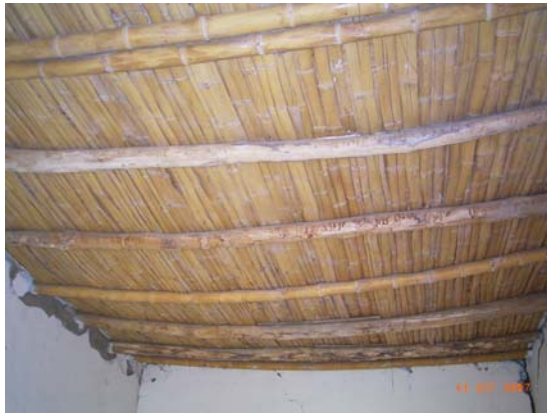
Figure 5.6 Flexible roof offers restraint in only one direction

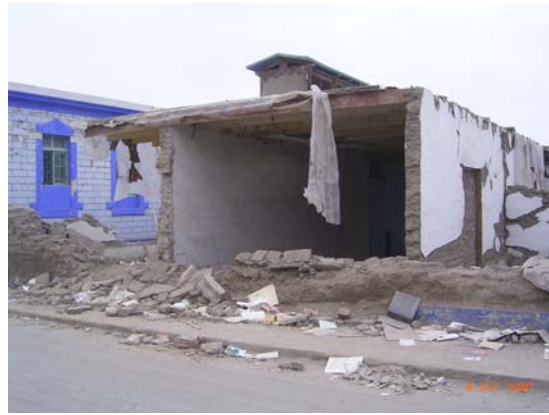
Figure 5.7 Walls not restrained by the roof collapsed out-of-plane

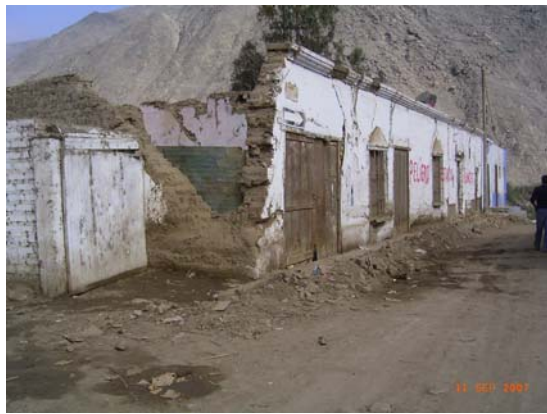
Figure 5.8 Sturdier walls up the Cañete river valley in Zúñiga close to collapse

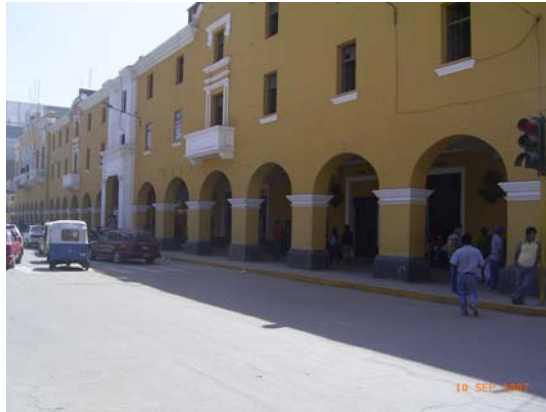
At the Plaza Mayor in Ica, a large institutional building of masonry construction with a series of arches at the front was reported with no damage along one of the sides of the square (Figure 5.14), whereas at the opposite side of the square, the same type of building (probably of newer construction, as evidenced by the larger, square windows) had failed at the corner (Figure 5.15), probably due to pounding from an adjacent, taller RC building, confirming the brittle mode of failure of these structures.

Figure 5.14 Masonry structure in Plaza de Armas, Ica, showing no damage

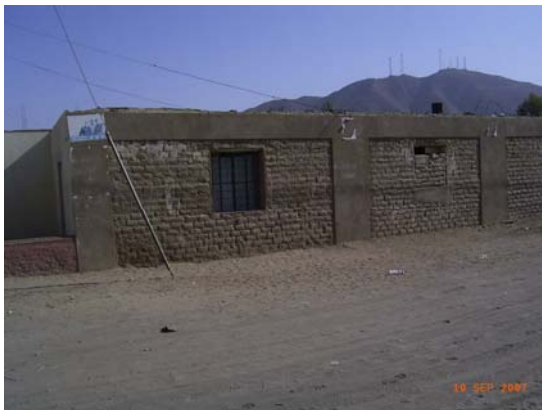
Figure 5.17 Adobe house in Guadalupe upgraded with steel net reinforcement plastered to the exterior and interior surface and showing good performance

Nearby Ica, in the town of Guadalupe, an adobe house was upgraded by the *Universidad Pontificia Católica del Perú* (PUCP) by means of strips of steel net tied and plastered to the exterior and interior surfaces of the adobe walls (Figure 5.17) (San Bartolome et. al, 2004); the house exhibited good performance after the earthquake, with the only portion of the wall not upgraded (due to insufficient funds) collapsing out-of-plane (Figure 5.18). The technique used in retrofitting this house was developed at PUCP; Figure 5.19 and Figure 5.20 show ongoing research where a polymer mesh (similar to the type used for stabilising soil) is used in place of a steel net, with the purpose of achieving a more ductile design (Blondet et al., 2006). It is interesting to note that most dwellers of adjacent streets to the upgraded house knew about “the house that resisted the earthquake”.

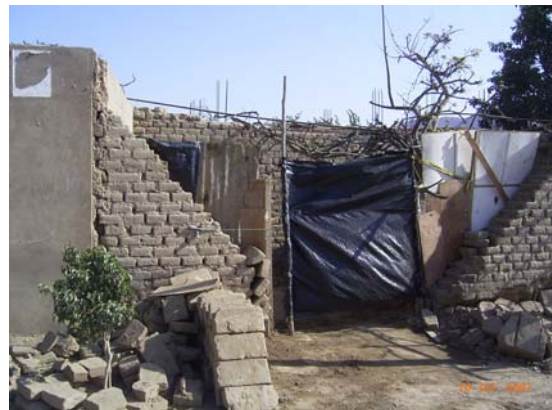
Figure 5.18 Collapsed right corner of the adobe house shown in Figure 5.17 (not upgraded due to insufficient funds)

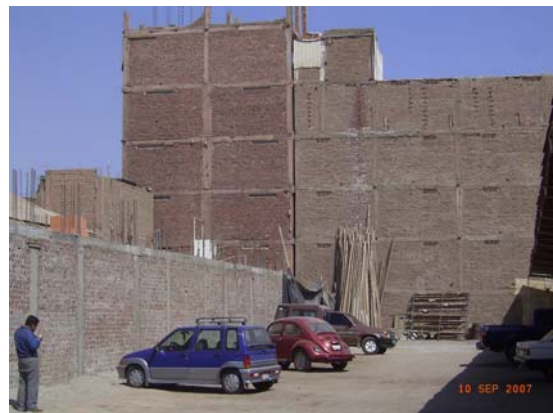
Figure 5.25 Six-storey RC confined masonry building in Ica, showing no signs of damage

The good performance of RC confined brick masonry houses, which may reach a height of up to six storeys (Figure 5.25), may be explained by the inherent large capacity of the structure to resist lateral loads. However, these structures, when reaching their ultimate capacity after failure of the clay brick masonry walls, may form soft storey mechanisms if not properly detailed and designed. It is possible that this type of failure may have developed in many buildings had the ground motions been higher in the affected areas, especially for structures with low construction quality. Therefore, it is recommended that the complete load displacement path of these structures up to failure is carefully examined, assessing the level of energy dissipation that they can provide and the associated type of failure mechanism.

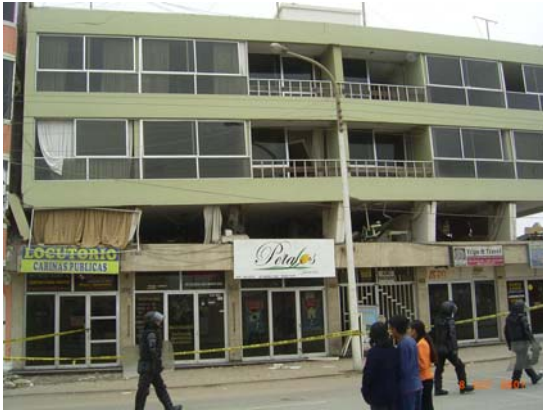
In Figure 5.29 a four-storey RC infilled structure that collapsed after developing a soft storey mechanism is shown, possibly due to the reduction of flexural capacity in the column from the first to the second storey, or to deficient detailing of the beam-column connection as shown in Figure 5.30.

Figure 5.29 Four-storey RC infilled frame in Pisco showing soft storey collapse at 2nd floor

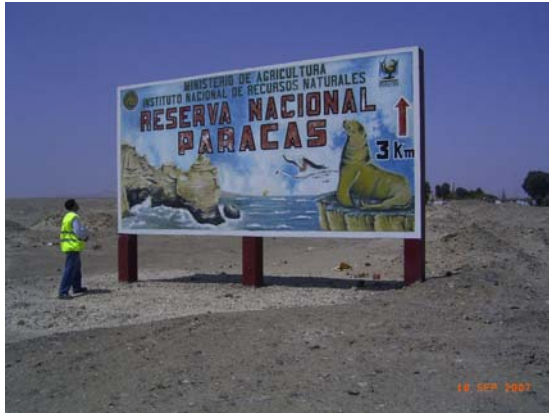
During the field visit, the EEFIT team found several RC billboard structures infilled with clay bricks: one near the Paracas National Reserve (Figure 5.33), which suffered practically no damage, and one at Pozo Santo, approximately 25 km southeast of Pisco, which collapsed (Figure 5.34) and is used in the present report to perform back calculations to determine the ground accelerations sustained at the site. It is worth mentioning that the adjacent structures located at Pozo Santo suffered heavy damage, including a church (Figure 5.40) and several one-storey adobe structures.

Figure 5.33 RC infilled frame billboard near the Paracas National Reserve

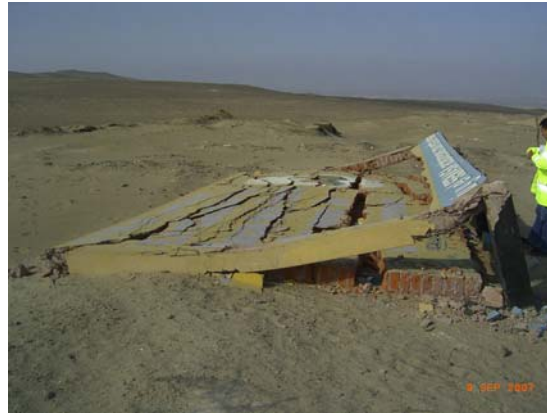
Figure 5.34 RC infilled frame billboard that collapsed at Pozo Santo

The collapse mode of the billboard shows that failure took place at the boundary between the top of the free standing columns and the longitudinal deep beam, suggesting that the damage of the structure started in the longitudinal direction (in-plane) followed by overturning of the structure in the transverse direction (out-of-plane)⁴. From the geometry, materials and collapse mode of the structure, it is possible to infer the spectral accelerations that occurred at the site. This is done by computing the base

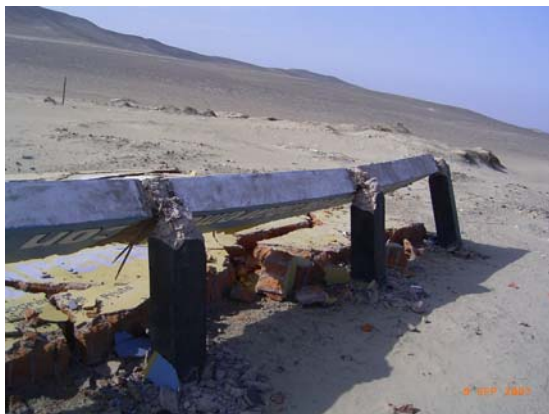
The geometry of the billboard at Pozo Santo was measured on site: a 250 mm thick, 7 m in length and 4.7 m in height rectangular section of clay bricks bounded by 250 mm deep RC elements along the perimeter, supported by four 250x250 mm cross section 1.05 m free standing RC columns (Figure 5.35); in the longitudinal direction the columns were linked by a stiff 500 mm deep RC beam.

Figure 5.35 Overall view of the collapsed billboard at Pozo Santo, showing four 250x250 mm 1.05 m RC columns

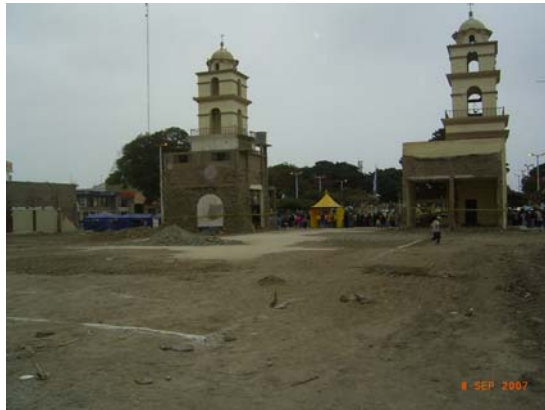
Figure 5.38 Location of the collapsed church in Pisco after demolition and debris removal

The church of San Clement of the Compañía de Jesus, in front of the Plaza de Armas in Pisco, collapsed during a mourning service at the time of the earthquake event, causing the single largest death toll of any structure during the earthquake (Figure 5.38).

The deficient performance of these structures calls for an extensive effort of earthquake performance assessment and upgrading, where required, of those churches that did not collapse or where only lightly damaged during the earthquake event.

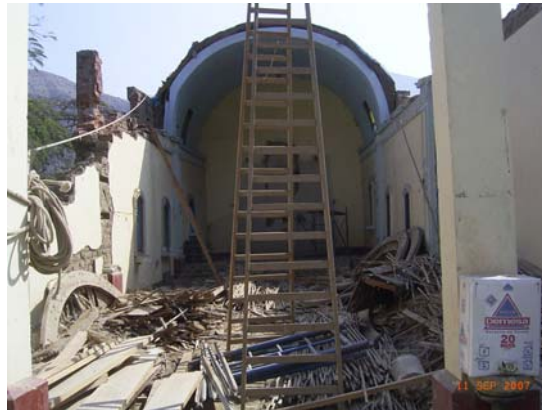
Figure 5.39 Typical collapse of a *quincha* vaulted roof of a church in Zúñiga

The large majority of churches surveyed during the field mission sustained considerable damage after failure of the roof (Figure 5.39 and Figure 5.40), longitudinal walls (Figure 1.1) and tower bells (Figure

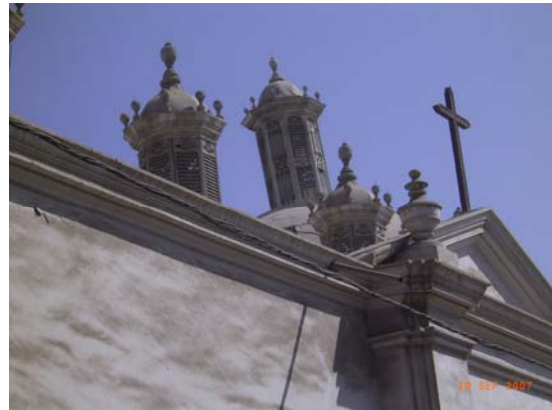
Figure 5.41 Tilted bell towers of a church next to Plaza de Armas in Ica

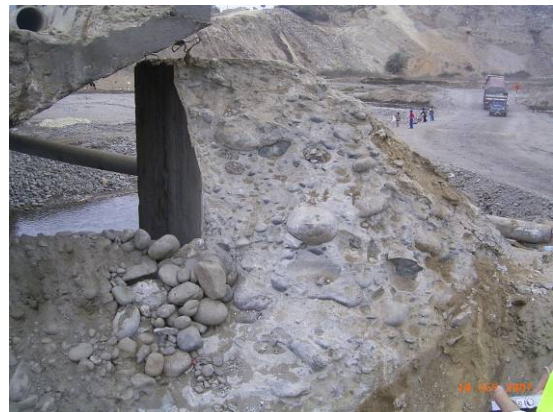
Figure 6.7 Huamaní Bridge: large size round aggregate used in the concrete of abutments

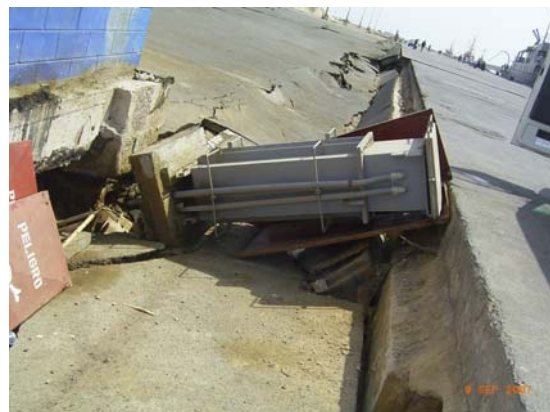
Figure 7.6 Port of San Martín: toppled electric transformer

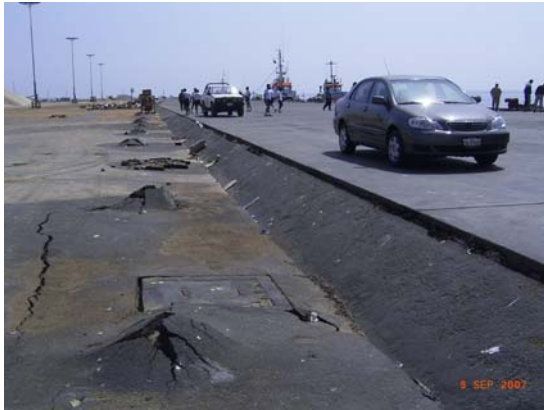
Figure 7.7 Port of San Martín: pile caps punching through the paved access (looking north)

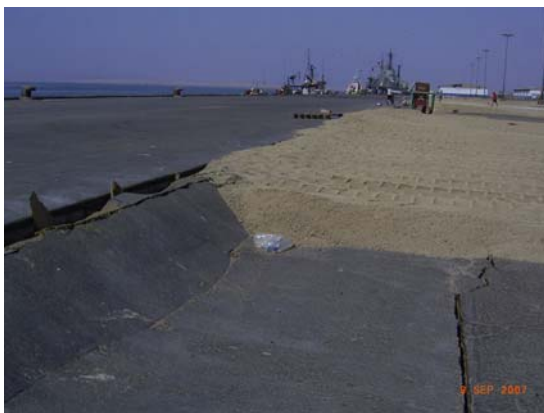
Figure 7.9 Port of San Martín: temporary access to the dock at the north end.

The dock structure, an 18 m wide reinforced concrete 0.55 m thick slab supported on 600 mm diameter circular steel piles spaced at 4 m (Figure 7.8), did not suffer major damage, however, due to failure of the access structures it could not be used immediately after the earthquake. The use of the port as an emergency centre for receiving assistance became possible only when a temporary access for trucks was constructed by levelling with sand and gravel the settlement that had occurred between the access and the dock (Figure 7.9). However, major repairs will be needed to restore full operation of the port.

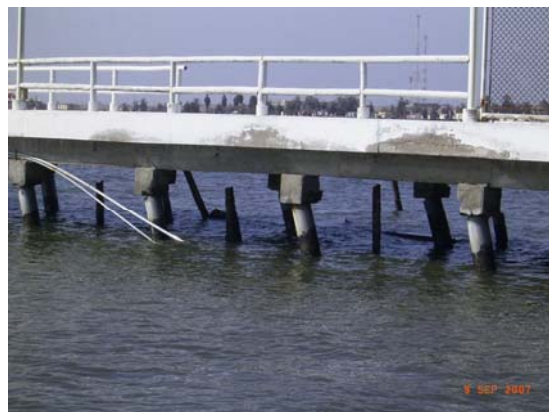
Other minor dock structures were surveyed in the area of Paracas, one at the waterfront which showed settlement of the dock (Figure 7.11), and a jetty at a Yacht Club south of Paracas that had sustained damage after longitudinal hinging of the steel piles at the connection with the pile cap in the longitudinal direction (Figure 7.12). The damage to these structures may compromise the development of the tourist activity of the area, as many boats depart from Paracas to visit the nearby National Reserve.

Figure 7.12 Jetty structure at Yacht Club in Paracas: top hinging of steel piles

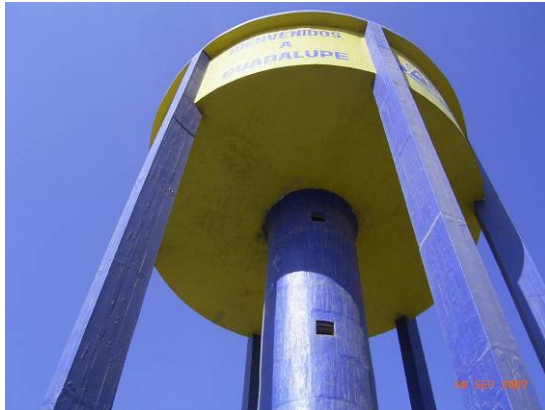
In Guadalupe, the team passed near to a concrete water tower which seemed to have suffered little damage, but upon further inspection it revealed systematic cracking. The water tower, built in the 1980's, is a 20 m high concrete structure supported by a central hollow cylindrical reinforced concrete member (3-4 m diameter) and 6 slender 35x25 cm RC columns on the perimeter (Figure 8.1). Damage was observed at the central support: at the base, a crack running all the way around the perimeter (possibly coinciding with non-staggered splicing of the reinforcement) (Figure 8.2), while at the top, cracking was observed just below the tank structure, probably due to punching or excessive shear. Although the slender columns shared only a small portion of the lateral load (most of the seismic lateral forces were taken by the stiffer, central cylindrical element), signs of uplifting were observed at their base. The tank was reported to be empty at the time of the earthquake and was declared unusable after it leaked when filling the tank again.

Figure 8.1 Water tank near Guadalupe.

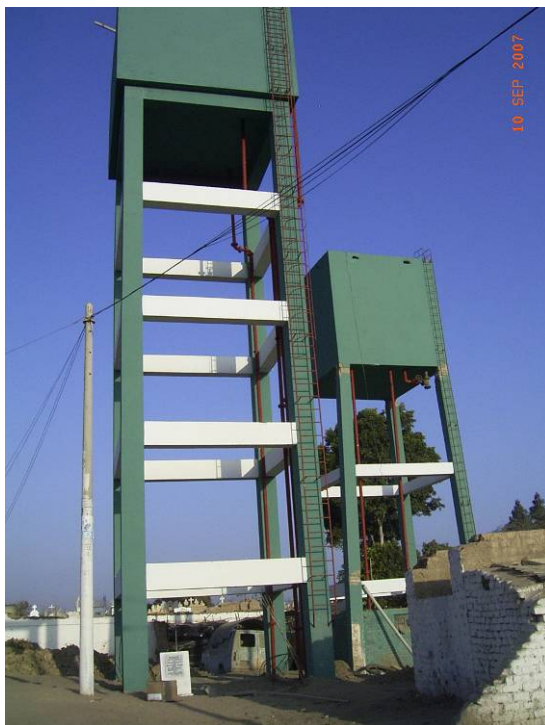
In San Juan, a small town 10-15 km away from Guadalupe, one out of two water towers close to the main square was severely damaged (Figure 8.3). Upon closer inspection it was found that the two tanks were built at different periods of time, the undamaged, higher tank being of newer construction. The older tank showed cracks at the level of an infill wall built at the base (Figure 8.4) and at the connection with the main body of the tank. After closer inspection, it was found that there were no stirrups and splicing was made at the joints. The fact that the newer tank did not suffer damage is a very good demonstration that good earthquake performance can be achieved by following current design standards.

Figure 8.3 Water towers in San Juan (older tank in the background).

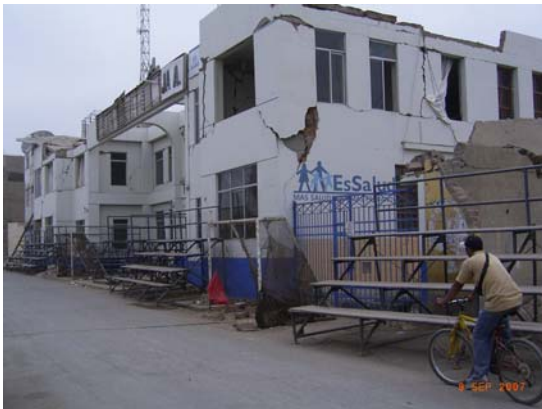
According to preliminary assessments of the Peruvian Government (6 September 2007), 14 hospitals were destroyed, and 103 were affected in the area (OCHA SR14, 2007). Figure 10.1 shows a public structure for the supply of health related services that suffered severe damage; the structure was of RC construction in combination with brick masonry. The large damage sustained may have been caused by an irregular geometry in plan and to the presence of large window openings at the second storey; the building was being evacuated at the time of the survey; however, it was not clear whether the structure would have been demolished or repaired.

Figure 10.1 Public health structure being evacuated in Pisco

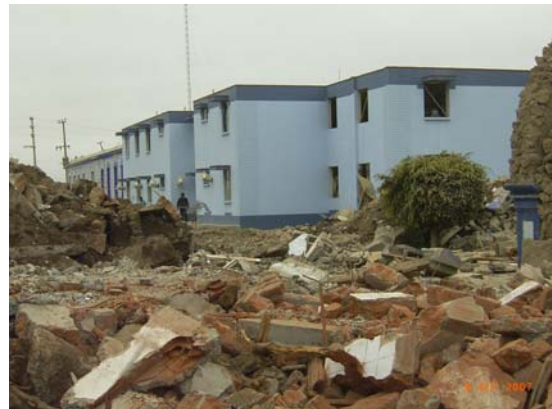
Figure 10.2 shows a new hospital built prior to the earthquake that exhibited adequate performance, next to the remains of an older part of the hospital which was severely damaged and demolished after the earthquake.

Figure 10.2 New hospital, built prior to the earthquake, next to a previously existing one that was severely damaged and demolished in Pisco

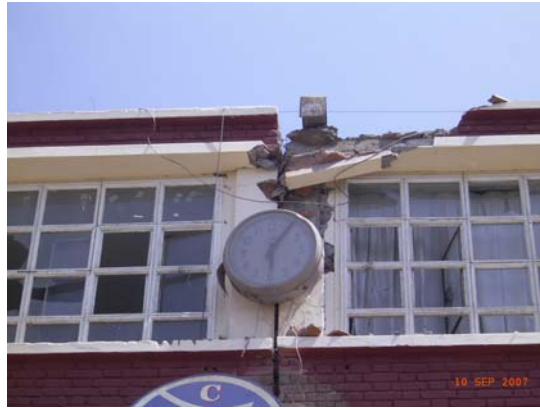
- Inappropriate design of expansion joints, leading to damage after pounding at the roof level between independent units (Figure 10.10).

Figure 10.10 *Gran Unidad Escolar San Luis Gonzaga*: damage due to pounding at ceiling level

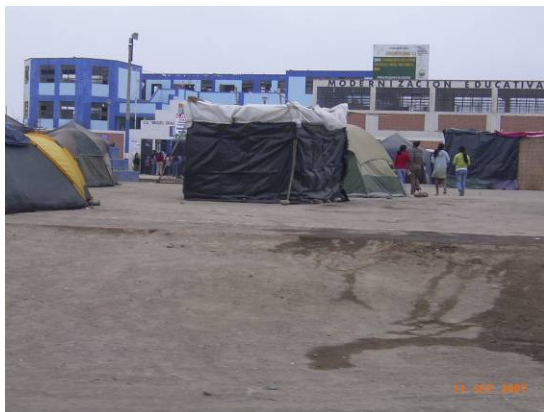
In Pisco, the team visited two temporary relief camps based at the sites of the *Viejo Club Atlético* (Figure 11.1) and at a local park (Figure 11.2). The tents were supplied by INDECI and each of these facilities housed nearly 50 families. The shelter camps were working at overcapacity, while the adjacent building structures were unusable and hazardous, as these were severely damaged by the earthquake. In addition, many of the relief camps visited by the team were set up next to the premises of public institutions, such as hospitals, schools, sport facilities, impairing their use and resumption of activities (Figure 11.3).²

Figure 11.3 Relief camp in premises adjacent to a school

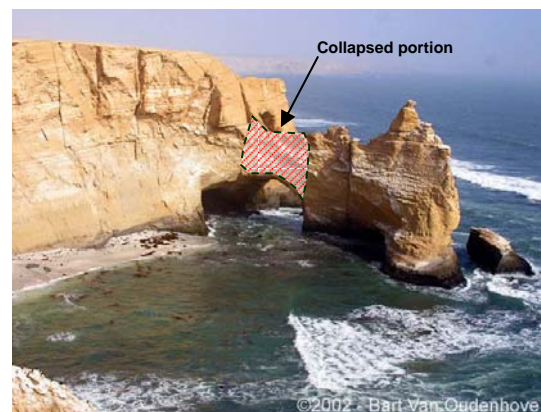
Figure 12.10 La Catedral natural rock formation in Paracas National Reserve (from www.tierra-inca.com)

A natural rock formation, known as the “Catedral”, a major tourist attraction in Peru located in the Paracas National Reserve, had collapsed into the sea during the earthquake (Figure 12.10).

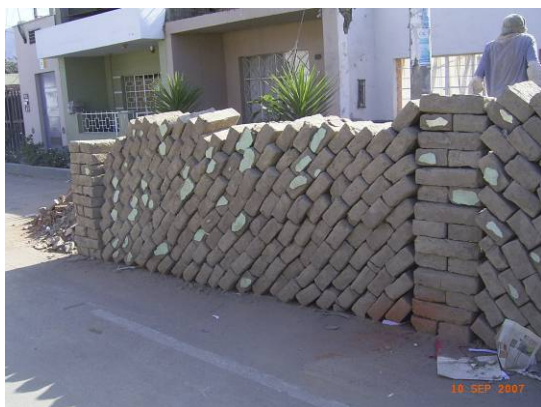
As mentioned in Sections 11 and 12, emergency relief had not been very effective in rural areas, especially in the mountains, where families that had lost their homes were starting reconstruction using adobe bricks (Figure 13.1) from the previous existing houses that collapsed.

Figure 13.1 Adobe bricks ready for use in reconstruction in Chincha Alta

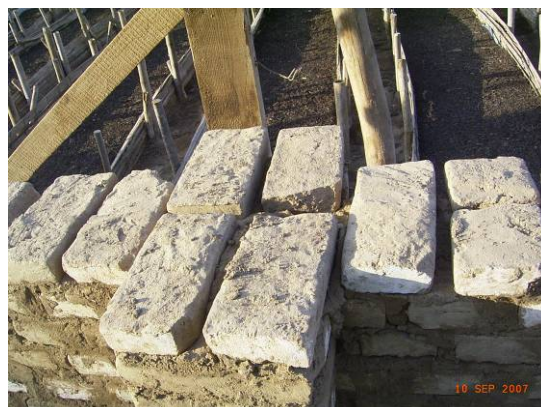
Most of the reconstruction was taking place using either traditional techniques of adobe construction (Figure 13.2), in the case of the more poor families, or non-engineered techniques for the construction of reinforced concrete confined masonry houses, in the case of families with higher economic means (Figure 13.3 and Figure 13.4).

Figure 13.2 Reconstruction of an adobe wall using traditional techniques in El Carmen

The reconstruction of adobe houses was mostly observed in rural areas, while that of non-engineered RC frame and RC confined masonry houses was typically observed in urban centres, resulting in both cases in highly vulnerable constructions to earthquake hazard, thus re-establishing the same high risk present before the earthquake event.

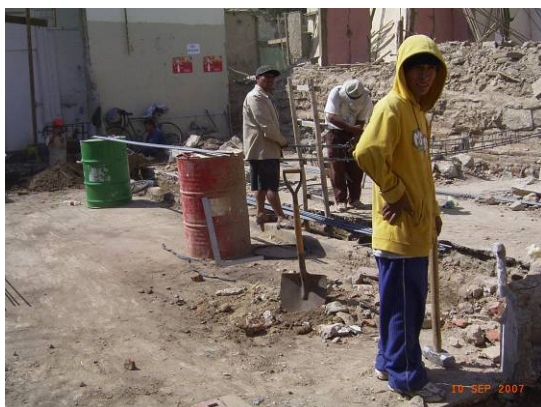
Figure 13.3 Reconstruction taking place in Chincha Alta

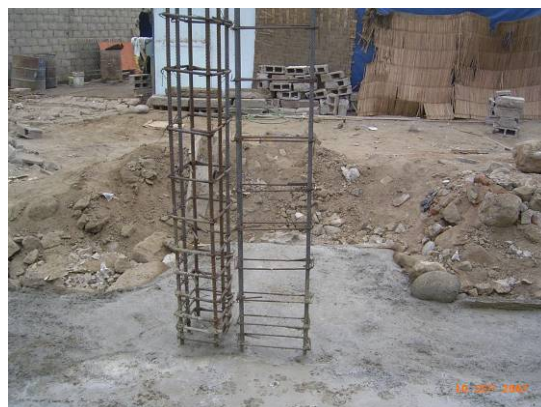
Figure 13.4 Reconstruction using RC in Chincha Alta without adequate technical assistance
