**THE M_w 6.4 ALBANIA
EARTHQUAKE ON
THE 26TH NOVEMBER 2019**
A FIELD REPORT BY EEFIT
OCTOBER 2020

Anton Andonov, Mott MacDonald

October 2020

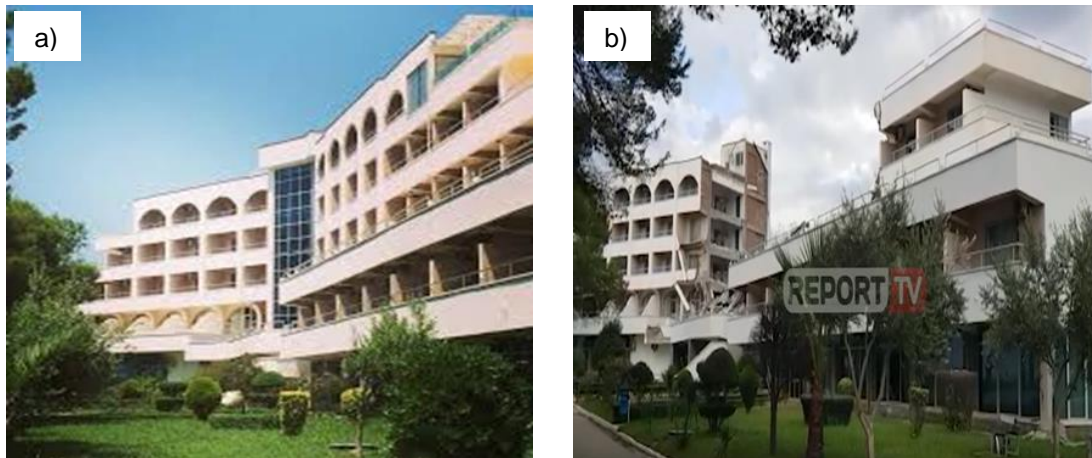
- Figure 5.14. Five-storey RC building in Durrës, a hotel dedicated to the employees of the Internal Ministry, in Durrës that caused 1 fatality. a) & b) the hotel before and after the earthquake [5.17], [5.22].

Figure 5.14: Five-storey RC building in Durrës, a hotel dedicated to the employees of the Internal Ministry, in Durrës that caused 1 fatality

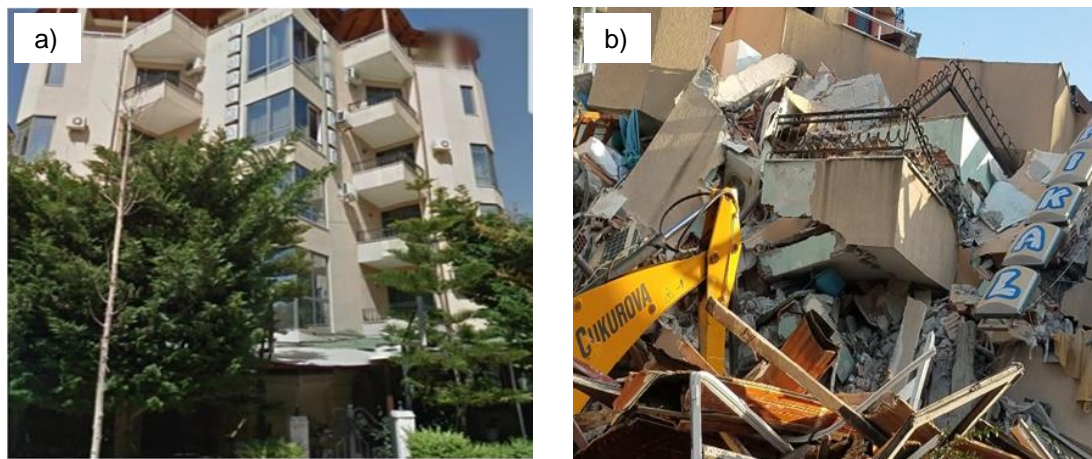
- Figure 5.15. Six-storey hotel in Durrës, that caused 2 fatalities, at least the first five stories are RC, that caused 2 victims. a) and b) the hotel before and after the earthquake [5.11]. The hotel was built without permission from the authorities, according to [5.9] and [5.14].

Figure 5.15: Six-storey hotel in Durrës, that caused 2 fatalities, at least the first five stories are RC, that caused 2 casualties

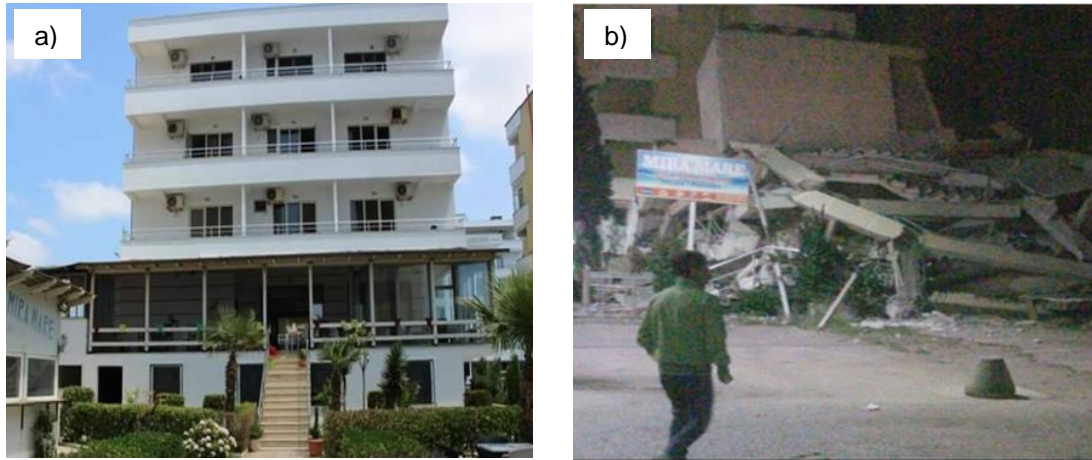
- Figure 5.16: Five-storey RC hotel in Durrës that caused 2 fatalities. Five-storey RC hotel in Durrës that caused 2 fatalities. a) and b) the hotel before the earthquake [5.18], [5.19]. First the hotel was built with 2 stories, later three more stories were added without permission from the authorities [5.9].

Figure 5.16: Five-storey RC hotel in Durrës that caused 2 fatalities

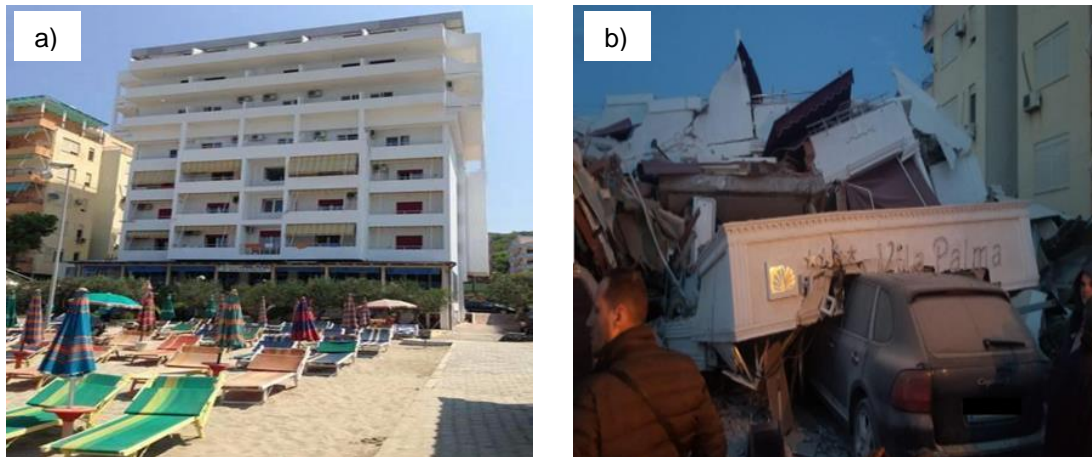
- Figure 5.17. Eight-storey RC hotel in Durrës that caused 1 fatality. a) and b) the hotel before and after the earthquake [5.10], [5.7]. First the building had three stories, later on upon permission from the authorities three more stories were added [5.9]. Last two stories were built without permission from the authorities [5.25].

Figure 5.17: Eight-storey RC hotel in Durrës that caused 1 fatality

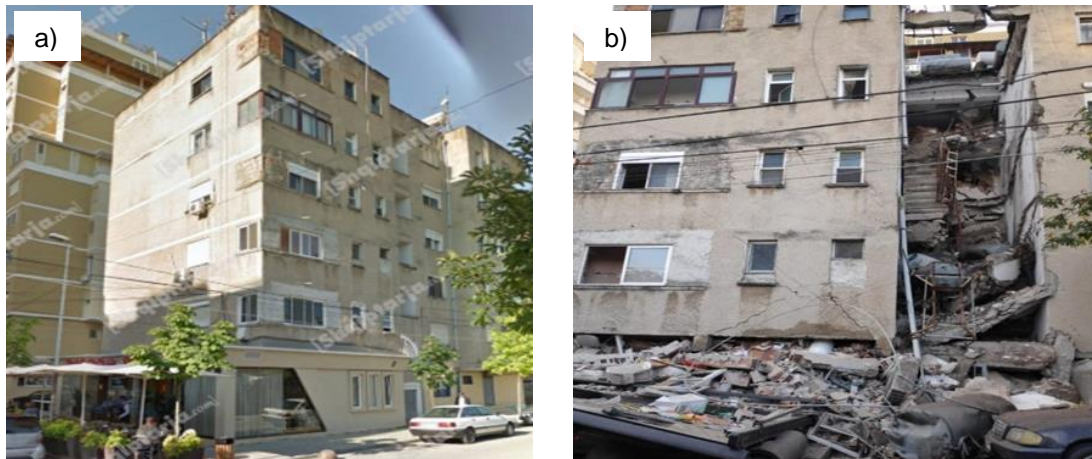
- Figure 5.18. Six-storey RC building that caused 2 fatalities. [5.9][5.13] a) and b) the building before and after the earthquake [5.13], [5.26].
- Figure 5.19. Two five-storey calcium-silicate masonry buildings in Kodër-Thumanë that caused 24 fatalities [5.12], [5.21]. a) It is reported that in the building 16 people died under the debris and one was wounded and died in a car accident while was being transported to a hospital. b) It is reported that in this building 8 people died under the debris [5.24], [5.23]. The buildings were constructed pre 1990 with voluntary work [5.9], and likely with improper knowledge of construction and inferior material quality.

Figure 5.18: Six-storey RC building that caused 2 fatalities

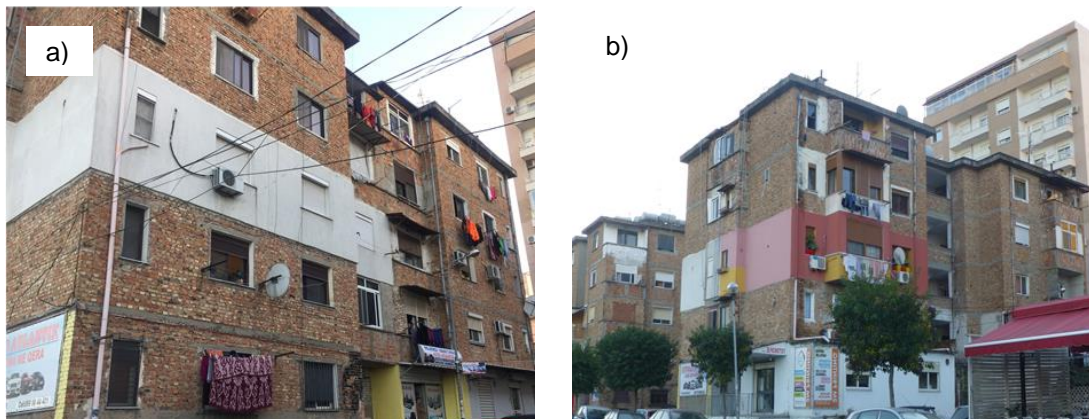
Buildings in fired clay bricks and cement mortar with concrete slabs show a good seismic performance, as illustrated in Figure 7.4, pictures taken in the city centre of Durrës, one of the worst affected cities by the earthquake due to failures and severe damage observed on RC buildings. The good connections observed among bearing walls and the presence of RC slabs working as a diaphragm under seismic loads underline the effectiveness of the design templates for URM buildings standardised by the Albanian governmental authorities in the Communist period. The major deficiencies observed for these buildings are related to irregularities in elevations due to unauthorised interventions (e.g., additional floors, closure and creation of new openings, use of different masonry for reparation) of Figure 7.5, carried out by local residents. These interventions together with the lack of maintenance observed for this typology, by degrading mechanical properties of the constructional material and changing load paths, may become the cause of possible damage and collapse, if an earthquake of high intensity hits these areas in the future.

Figure 7.4: Typical 5-storey URM buildings in Durrës

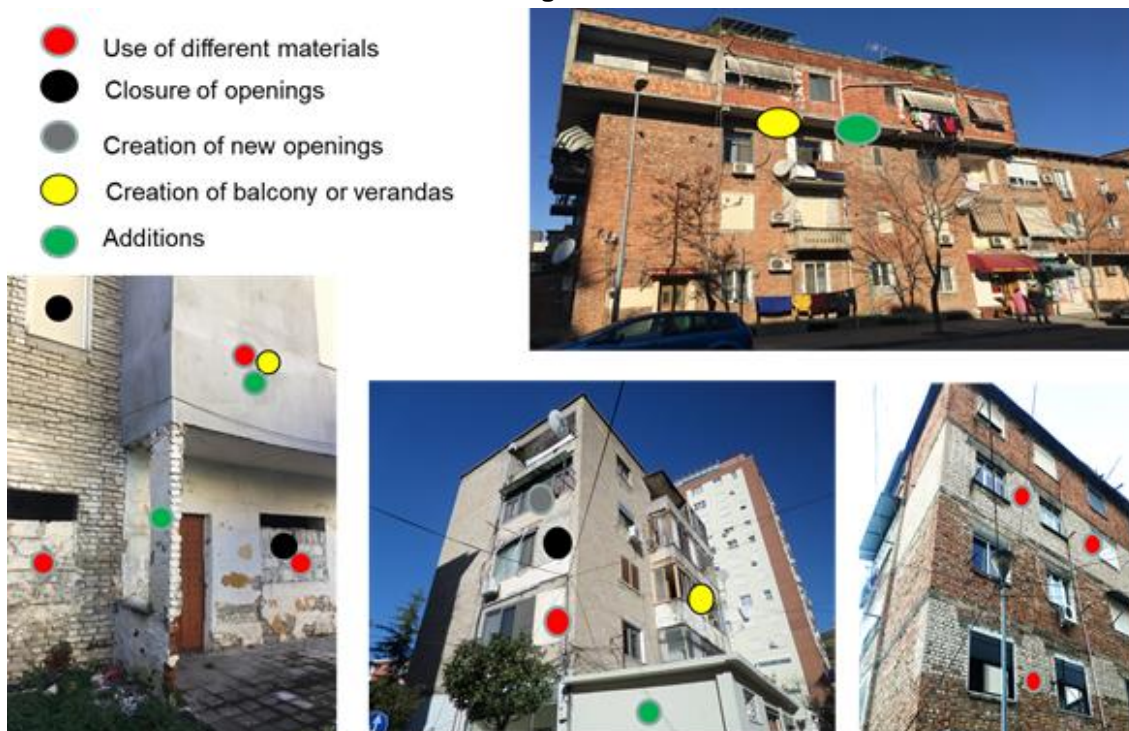
Figure 7.5: Irregularities in elevations due to unauthorised interventions on URM buildings in Durrës

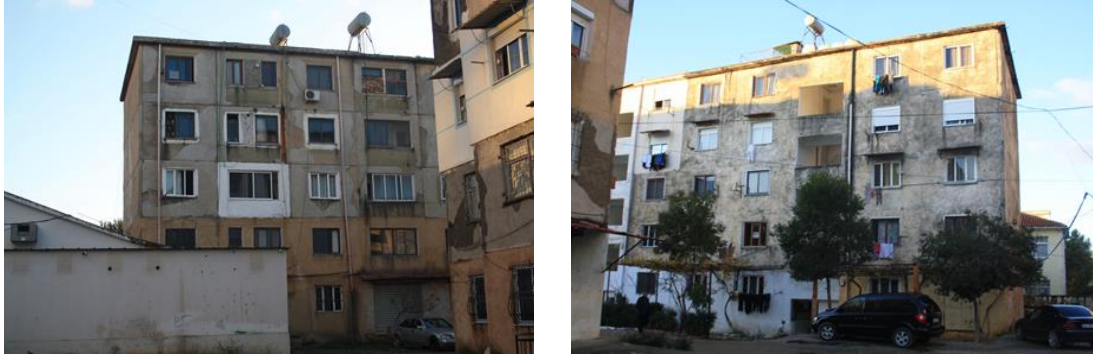
The team visited two neighbourhoods with large-panel buildings, in Laç on 14th December and in Durrës on 15th December. All buildings seemed to have poor maintenance and many signs of deterioration were visible on the facades, see Figure 7.13 and Figure 7.15. However, there were no external signs of earthquake-induced damage in any of the buildings. An inspection from inside showed minor cracking in the interface between the panels in the first two floors – vertical cracks in the contact zone between two wall panels, see Figure 7.14, and horizontal cracks in the contact zone between slab and wall panels, Figure 7.16. These are typical crack patterns in large-panel buildings in the onset of structural damage when the damage is mainly in the form of cracking of

Figure 7.13: Neighbourhood with LPBs in Laç (Module 1, two sections)

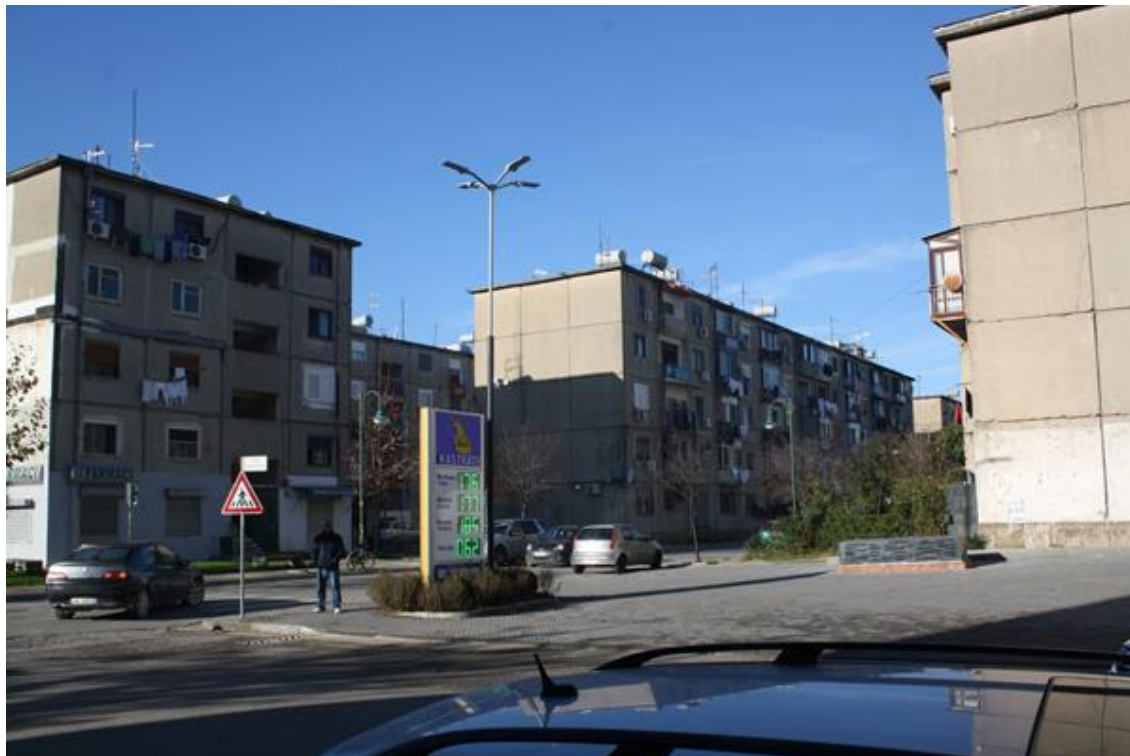
Figure 7.15: Neighbourhood with LPBs in Durrës (Module 2 with one, two & three sections)

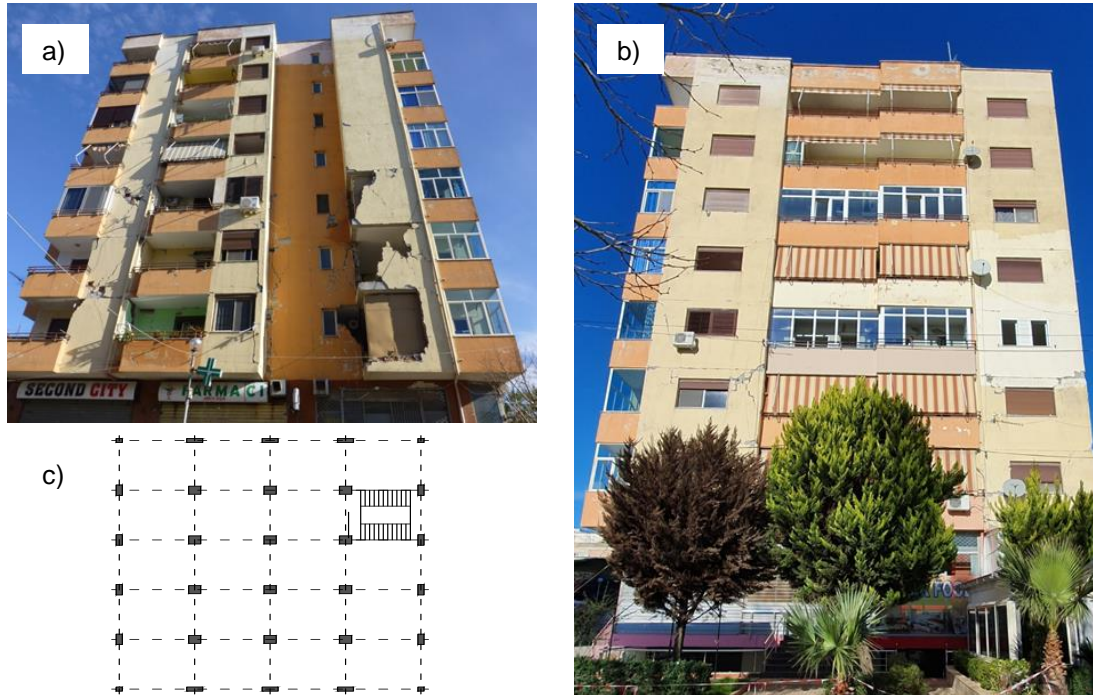
The first case study investigated is a typical 2000s multi-storey RC building located in Durrës just across Niko Dovana Stadium. Many buildings with similar characteristics showed the same damage pattern described here. The structure is characterised by nine storeys with a constant inter-storey height approximately equal to 3.20 m and by 5x4 bays with a constant span of ≈ 5 m. The structure is regular in plan and elevation and is illustrated in Figure 7.19a and b. Figure 7.19 shows the deduced indicative plan view. It is worth mentioning that, in this structure, no core wall is included and that the horizontal forces are resisted by the frames only. Based on the several observed buildings of this typology, this has been identified as a common situation where the

Figure 7.19: Typical 2000s multi-storey RC building compliant with KTP-N.2-89: a) east façade; b) south façade; c) indicative plan view

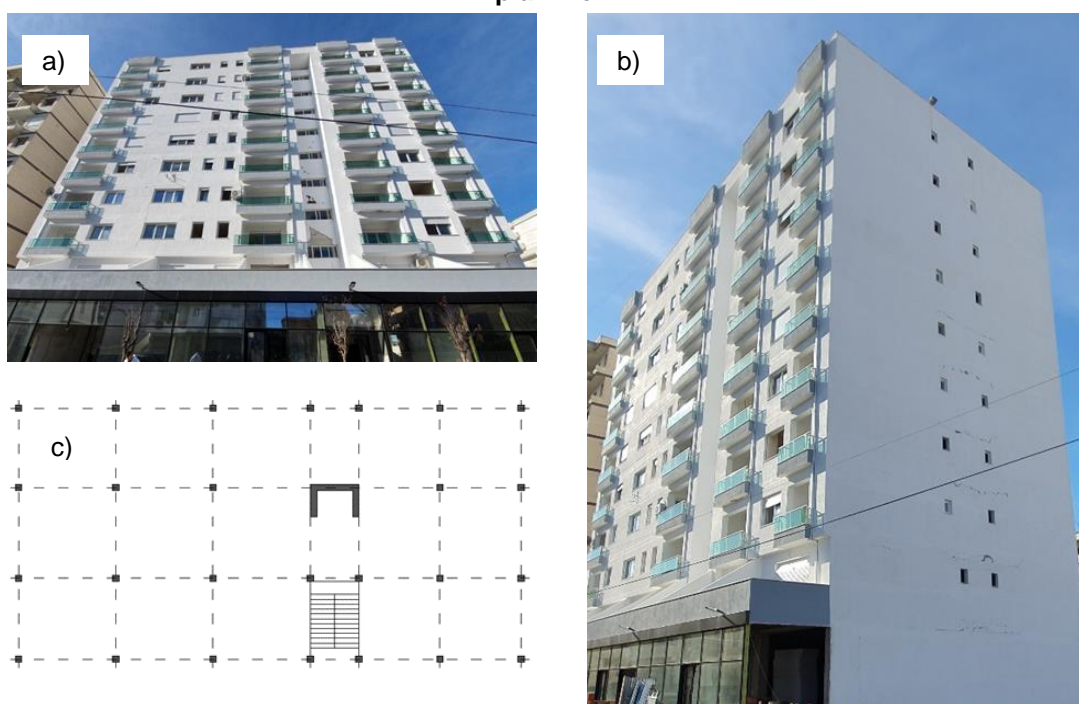
In this building, damage was mostly concentrated in the staircase and in the interior infill panels. The damage of the stairs, exterior and interior, can be observed in Figure 7.25a and b respectively. This is likely related to the large displacements generated by the presence of the core wall, that induced torsional effects. Due to their higher stiffness, the staircase was not able to accommodate these displacements and experienced large shear cracks in the landings, in the external beams (including the adjacent non-structural walls). Extensive damage was observed in the first five stories of the structure.

Figure 7.24: Typical post-2010 multi-storey RC building compliant with KTP-N.2-89 with integrated aspects of Eurocode 8: a) north-east facade; b) south-east side; c) indicative plan view

The observed damage in these recent post-2010 multi-storey RC buildings, despite less extensive, is very similar to the one described for the 1990s structures. The damage pattern highlights a significant need for additional design requirements to be included within the KTP-N.2-89 such as the inclusion of Damage Limit States checks and the need to avoid unconfined infills. However, it is worth mentioning that the Damage Limit States requirements of the Eurocode 8 have demonstrated to be ineffective in a number of occasions *e.g.*, [7.22][7.23], and that more strict limits should be used to ensure the design expected behaviour of the infills.

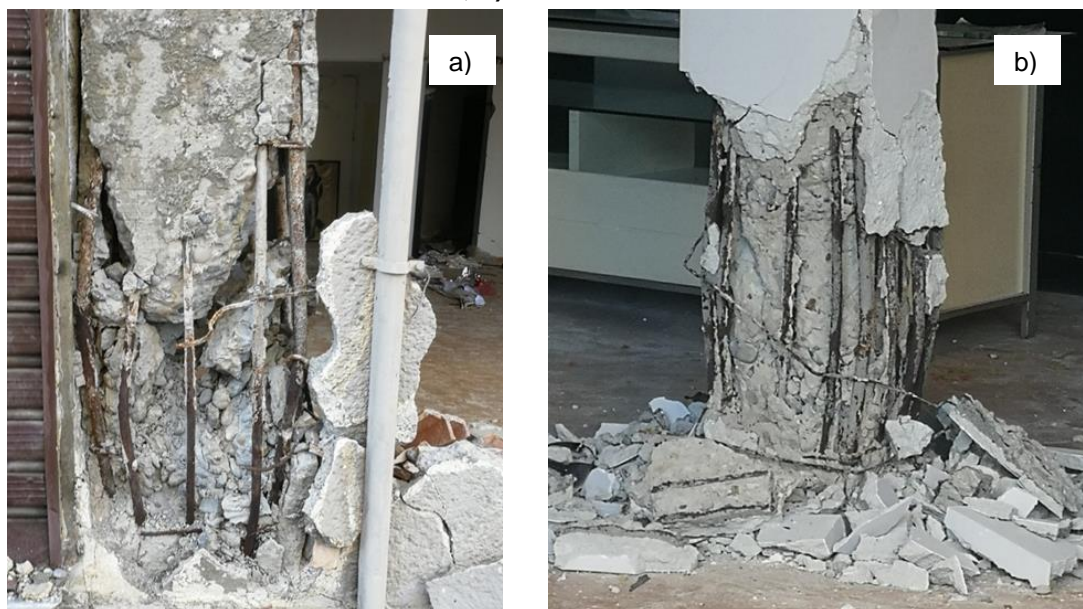
Figure 7.29 shows the shear and axial load failure of one external (a) and one internal (b) columns of a RC multi-storey building in Durrës. Although the year of construction is unknown, it is evident that the quality of both the materials and the structural details is very poor for this case study. Figure 7.29 shows the presence of weak concrete (possibly with low percentages of cement), smooth aggregates, plain round longitudinal bars, particularly small stirrups missing the 135° hook and showing a particularly large spacing.

Based on this information, it is fair to say that likely this building was designed and/or constructed without abiding the code and with a clear lack of quality control on the construction materials.

Figure 7.29: Case with structural damage showing shear and axial failure in a) external column; b) internal column

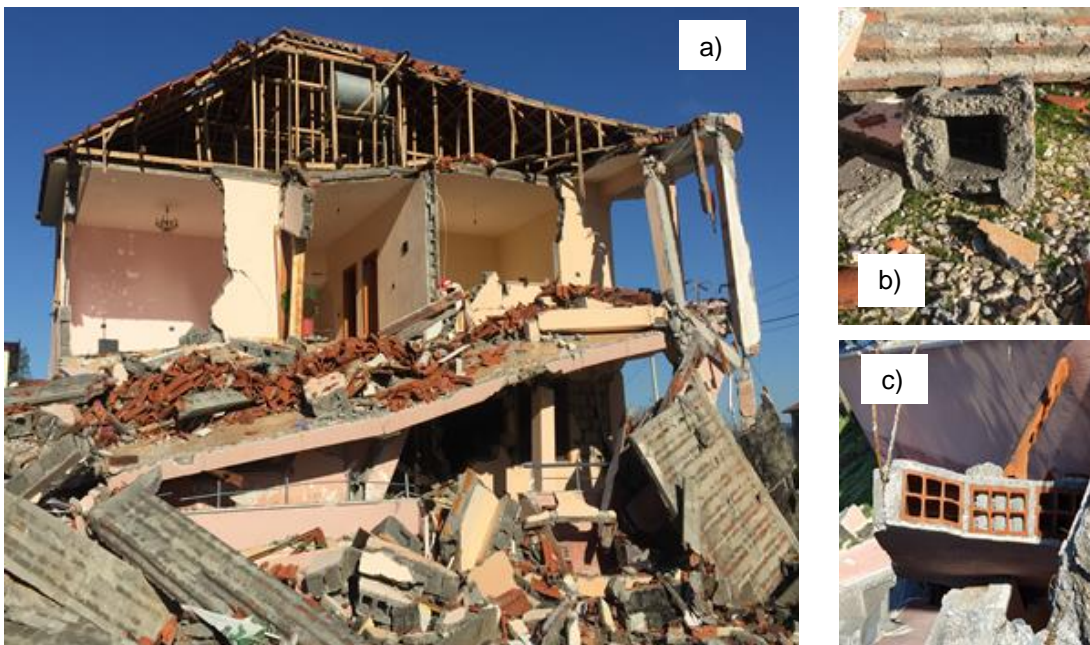
which was already damaged by the earthquake in September, completely collapsed in November due to the torsion failure of the portico supported by columns, poorly reinforced as highlighted by the joint connection of Figure 7.31c and d.

Similar failures and cracks were also observed in other single-family houses of the same typology with floor plans which differ in sizes. Local engineers confirmed that the 1st and the 2nd levels of these inspected houses were also built at different time, using different materials and structural floors for the 1st and 2nd level. Figure 7.32 shows the failure of a single-family house with a plan geometry smaller than the ones in Figure 7.30. The observed damage confirms that the failure is triggered by torsion of the portico, as highlighted by the horizontal cracks on the top columns of the 1st level and overturning of the side façade.

Figure 7.31: Collapsed single family rural house in Bubq: a) severely damaged side façade b) internal view of the failed portico, c) and d) details of the poor reinforced columns of the portico at the joint connections.

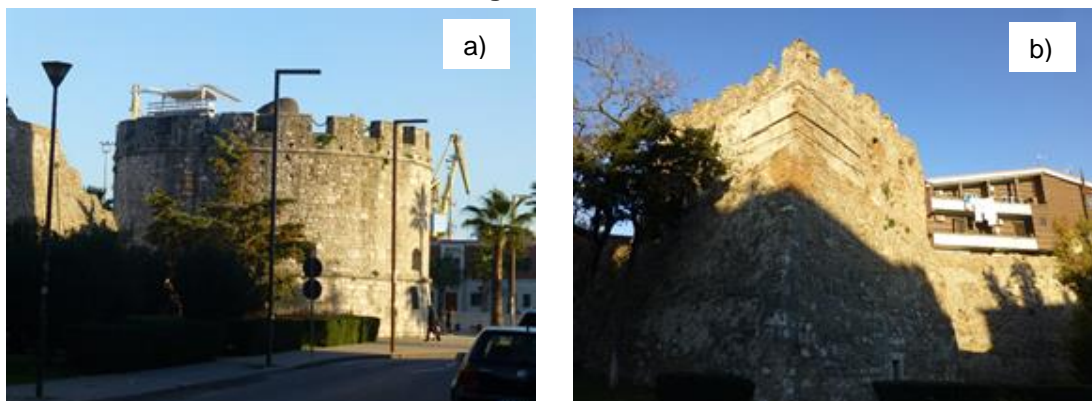
Under the Republic of Venice, the castle was reinforced with several guard towers and the walls were reinforced during the Ottoman Empire. The walls present different typologies of stone and brick masonry. Signs of the alteration and repair of the walls and towers are visible, as shown in Figure 7.34, such as local reconstruction of the masonry and repair of the corners with visible metallic elements on the exterior side.

Figure 7.34: Visible repairs of the walls and towers of Durrës (a) Venetian tower and (b) gate tower

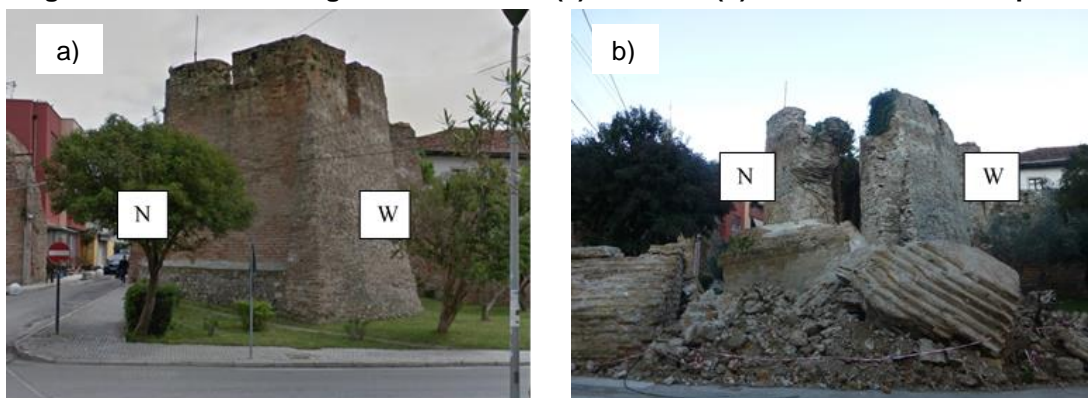
The damage caused by the November earthquake is concentrated in the tower gate located at the intersection between Anastas Durrsaku street and Xhamia street. A view of the tower before and after the earthquake is provided in Figure 7.35. The tower has a squared shape, offset towards the road with respect to the fortification walls. Based on observation shown in Figure 7.35a it is possible to identify different masonry types, possibly associated to several alterations over time. The north façade (N) shows a stone masonry base course supporting brick masonry walls. Towards the top, the wall changes from brick to stone masonry. On the contrary, the west façade (W) appears to be made of quite uniform stone masonry until the merlon, which shows a different type of stone masonry. Local repair of stones with bricks is also visible on the wall. The stone masonry at the merlons appears to be in poor condition, with visible decay and loss of mortar. The different types of masonry connect at the corner where the two walls rely on a poor interlocking, if any. Although it was not possible to access to the interior of the tower, from the hole left by the collapsed masonry it was possible to observe an extensive presence of vegetation growing on the interior side of the walls. The presence of vegetation is sign of both lack of roofing and lack of maintenance, which could be triggers for developing weak points leading to the observed damage.

The collapsed material is quite varied (Figure 7.35b), and the masonry appears to have failed in blocks, with only a small amount of material resulting disintegrated. This type of failure is not very common in masonry and can be explained by the presence of very thick mortar joints, generally thicker and stronger than the units, as can be observed in Figure 29. It is unknown whether the brick masonry is part of the original wall or it is a more recent alteration. However, this type of construction with thick mortar joints is quite common in the Byzantine brick masonries, in construction located in seismic areas and/or on subsidizing soils [7.11]. In the studies conducted by Baronio *et al.* [7.12] on similar masonry, this material was observed to behave more as a conglomerate or concrete rather than mortar, since the size of its aggregates reaches values closer to a modern concrete rather than a traditional mortar for joints [7.12].

Figure 7.35: View of the gate tower before (a) and after (b) the November earthquake

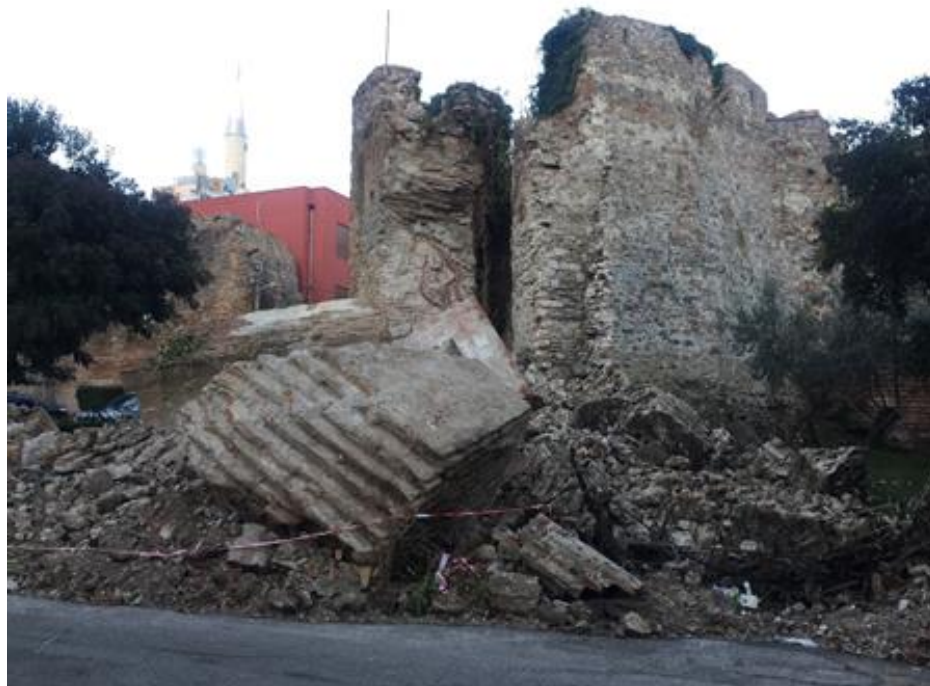
The type of failure experienced by the tower consisted in the collapse of the corner, which resulted in the obstruction of the pavement and part of the road due to the out-of-plane collapse of the masonry walls. From Figure 7.36 it is possible to observe a significant presence of roots on the failure plane of the north wall, whereas the failure plane on the west wall is extremely vertical and regular suggesting the absence of interlock between the different masonries. Also, it appears that the external layer of the masonry was added at a later stage, with absence of transversal connectors to the existing masonry. This way of thickening the existing masonry walls of defensive architecture was practiced during the Ottoman period [7.10].

Figure 7.36: View of the surfaces of rupture of the gate tower

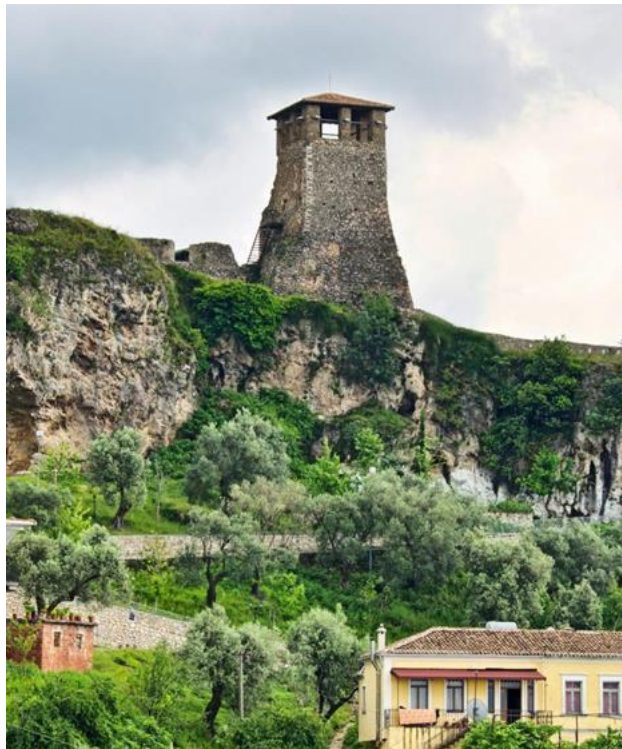
The concerns related to the geological stability of the rocky hill led to a series of interventions of consolidation of some critical areas. Some anchors are visible in Figure 7.39 on the hill's side near the clock tower. The November earthquake caused the formation of some new cracking in the ground around the tower, which was pointed out during the survey by the local contacts.

Figure 7.39: View of the anchors present on the hill's side near the clock tower

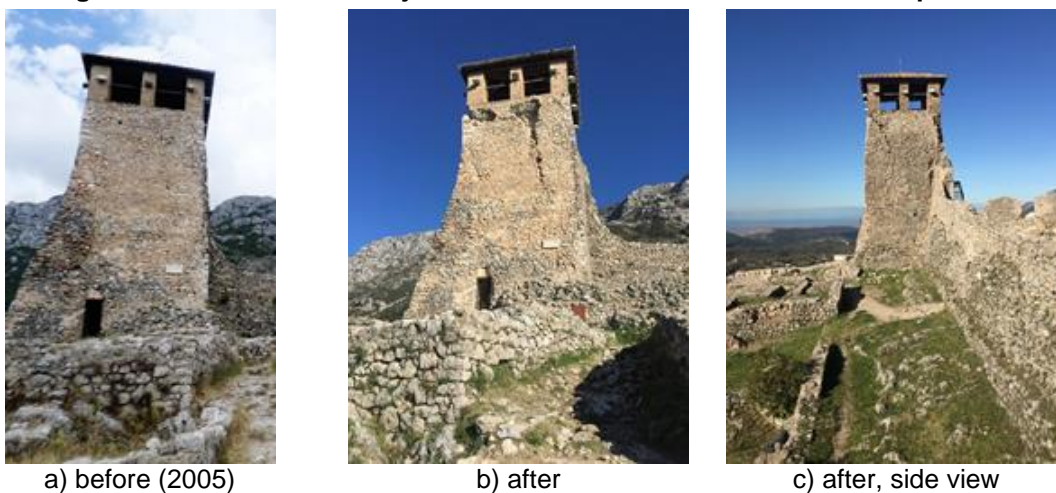
Views of the tower before and after the earthquake is provided in Figure 7.40. The type of failure observed is a global mechanism consisting of long vertical cracks on the walls and a significant displacement out of plane of part of the masonry walls towards the corners. No damage is observed on the belfry, at the top of the tower, which proofs the high rigidity of the new system introduced with the 1970s intervention. Such high rigidity is usually not compatible with that of historic masonry, being often the source of additional damages in earthquakes.

Figure 7.40: View of the Krujë clock tower before and after the earthquake

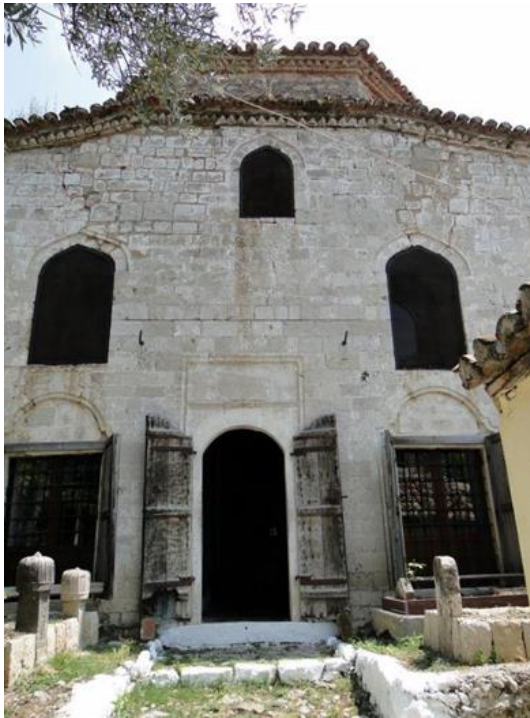
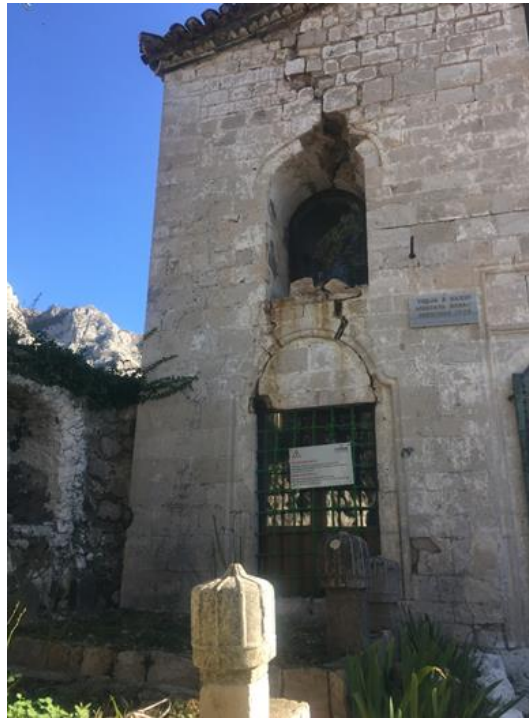
When comparing the “before” and “after” figures of the exterior of the Tekke of Dollma (Figure 7.42), it is possible to observe that cracking was present on the masonry walls at the same locations before the November earthquake. The original causes of the cracking could be connected to the ground instability observed in the area, as well as previous earthquakes [7.13]. Therefore, the November earthquake appears to have caused a progression of the existing damage, significantly increasing the size of the pre-existing crack pattern.

Figure 7.42: View of the Tekke of Dollma a) before and b) after the November earthquake

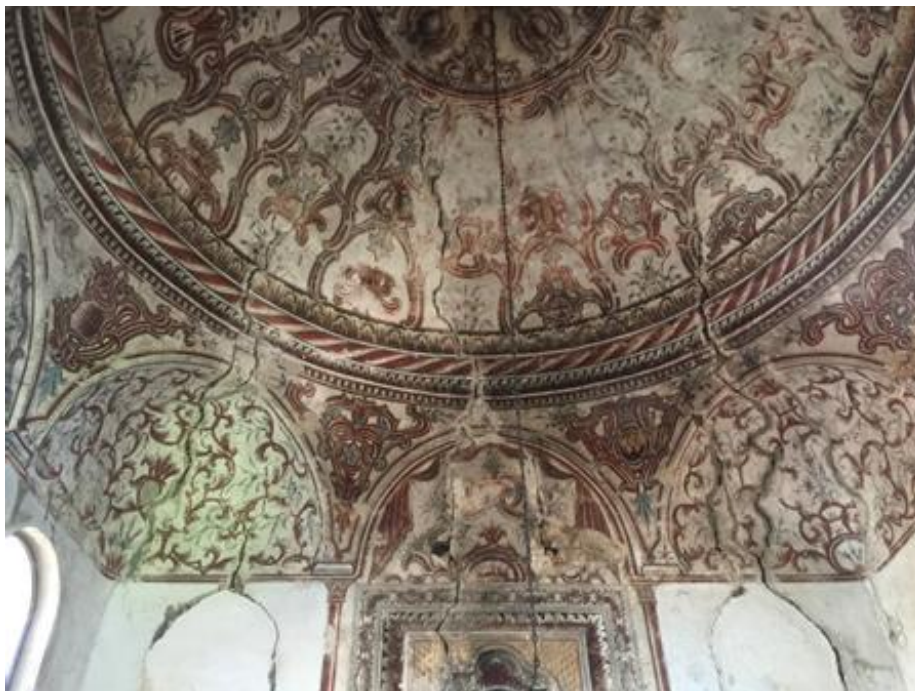
The building square shape turns into hexagonal in the upper part to envelope the central dome (Figure 7.41). The dome is sitting on squinches which are in turn resting on the stone masonry walls. The structure shows in-plane cracking of the masonry walls, with cracks developing diagonally from the bottom part of the corners through the openings (Figure 7.42b). The failure of the corners is likely to be the cause of the cracking observed on the dome, visible from Figure 7.43. From a glimpse of the inside, the dome presents a meridian crack pattern, with no cracking shown at the crown and regular cracking like “slices” in the lower part, as shown in the schematic illustration proposed by Jacques Heyman [7.17], shown in Figure 7.44. This type of failure is generally caused by movement in the dome’s support causing an increase of the dome’s span.

Figure 7.43: View of the cracking of Tekke of Dollma dome

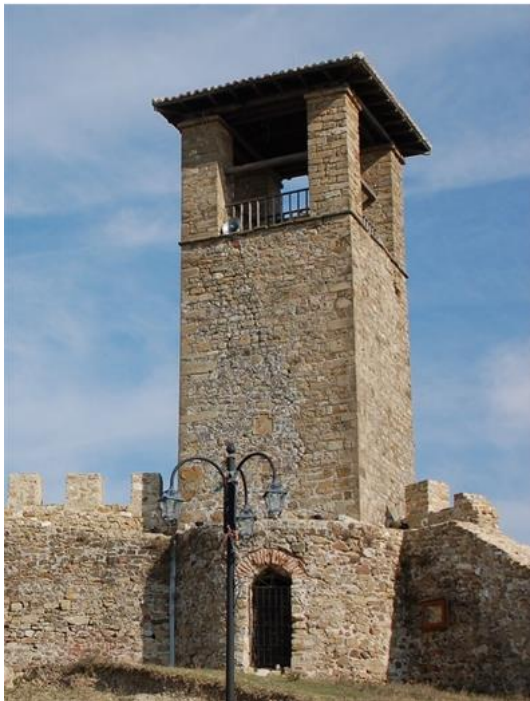
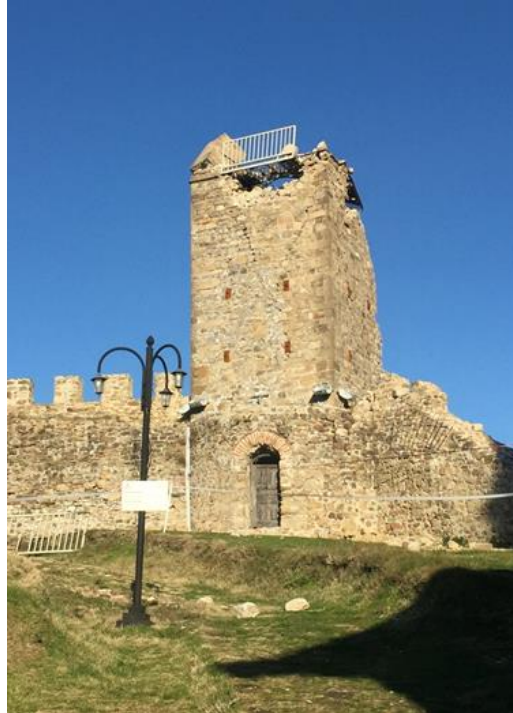
A view of the tower before and after the earthquake is provided in Figure 7.48. From Figure 7.48b it is possible to observe that the clock tower completely lost the roof and the columns framing the top floor. Figure 7.49 shows the opposite east side of the tower, where the damage is more extended and includes the loss of the masonry of the upper third of the tower, below the top floor.

Figure 7.48: View of the Prezë clock tower: a) before and b) after the 2019 earthquake

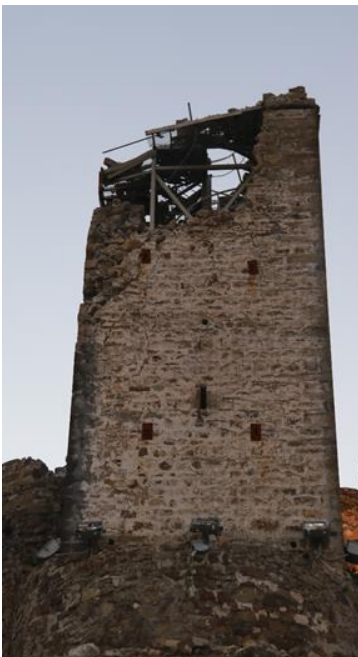
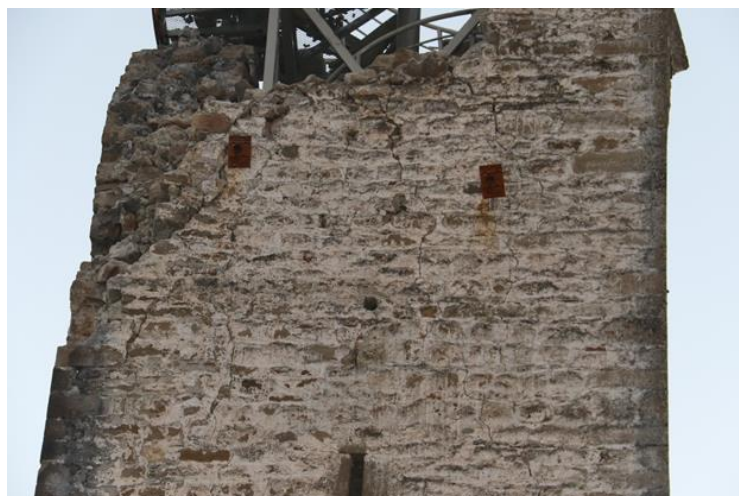
Where the masonry was reinforced with anchors, the walls resisted the out of plane forces by activating the parallel wall and/or perhaps the internal steel structure and engaging the shear capacity of the transverse walls. In this part, the masonry shows vertical cracking between ties, some of which could have been present since before the November earthquake.

Figure 7.49: Damage observed on the south side of the Prezë clock tower: a) overview and b) closeup

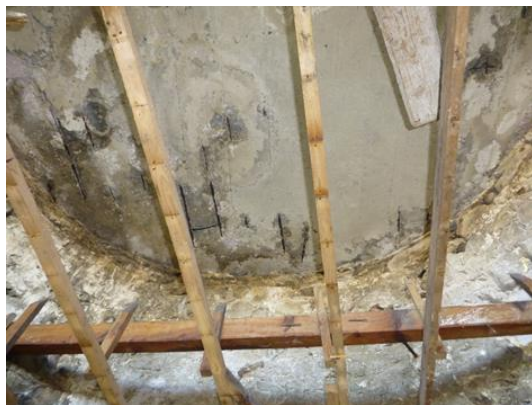
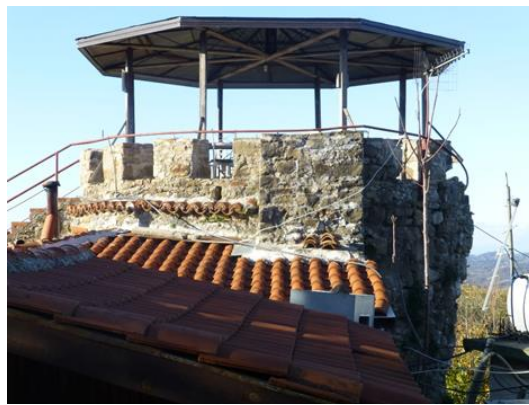
The damage caused by the November earthquake also occurred to the North tower (Figure 7.45). The tower has a circular shape and is made of stone masonry walls. Visible alteration to the original configuration of the tower observed during the visit are the introduction of a RC floor to create a terrace on the roof of the tower (Figure 7.50a) and the construction of a building on the side of the fortification walls and adjacent to one of the sides of the tower (Figure 7.50b). The damage occurred on the outer side of the tower, facing the cliff. This side is the most vulnerable due to the lack of confinement provided by adjacent structures. In this part, the masonry collapsed out of plane, whereas the stiff slab remained undamaged (Figure 7.51). The presence of the new heavy RC floor activated a larger seismic mass and therefore resulted in a higher demand for overturning capacity on the wall.

Figure 7.50: View of the Prezë north tower and alteration to the original configuration: a) new reinforced concrete slab, b) new construction adjacent to the side of the tower

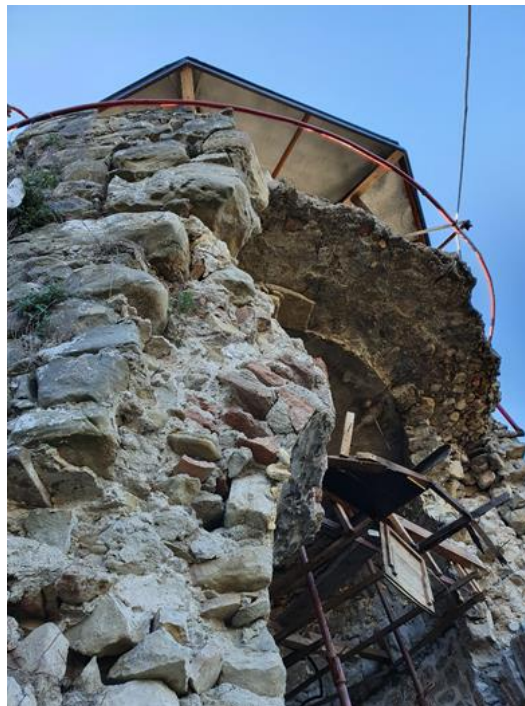
Figure 7.51: View of the damage to the Prezë clock tower

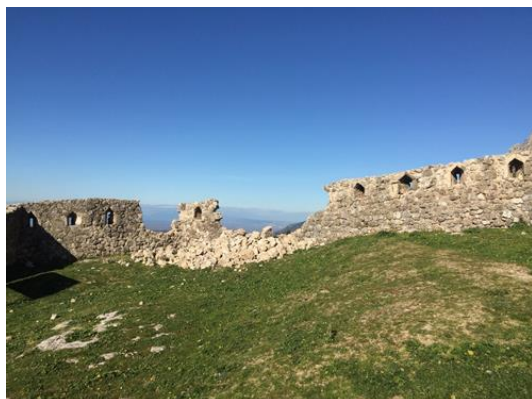
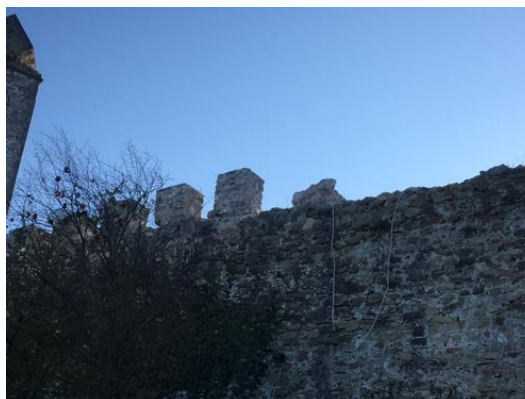
Finally, the fortified walls of the castles suffered some damage due to the November earthquake. The same type of damage was observed in both the castles of Krujë and Prezë. The damage was localised and consisted in the out-of-plane failure of the masonry merlons, sometimes affecting groups of them as shown in Figure 7.52a. The vulnerability of the merlons to earthquake, especially due to out-of-plane mechanisms, is a common type of vulnerability characterising ancient fortified architectures. This type of mechanism was observed occurring in previous earthquakes even at low values of peak ground accelerations starting from about 0.05g [7.19].

Figure 7.52: Collapsed sections of the fortified walls: (a) Krujë castle, (b) Prezë castle
