**THE M_w 9.0 TŌHOKU
EARTHQUAKE AND TSUNAMI OF
11TH MARCH 2011
A FIELD REPORT BY EEFIT**

A FIELD REPORT BY EEFIT

Mr. Antonios Pomonis, *CAR Limited, Global Earthquake Model* (Team Leader)

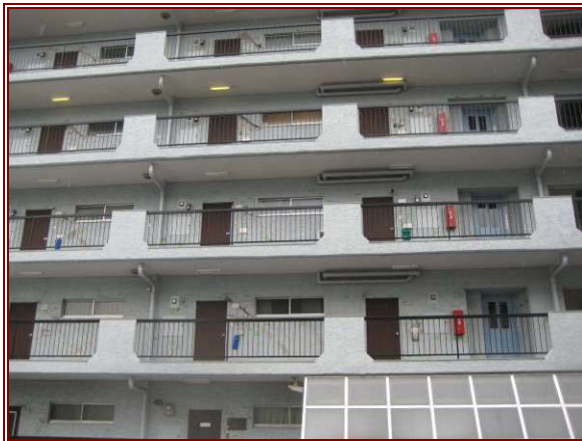
(a) Yamato apartment

The residential apartment building in Yamato was a 12-storey RC building that suffered significant damage to walls and columns (Figure 4.5a and Figure 4.5b). The building is about 2200 m south of the MYG013 station. It was constructed in 1975, prior to 1981 when major improvements in seismic provisions were incorporated (Nakashima and Chusilp, 2003). Many shear cracks on non-structural walls were observed at various storey levels. Obvious defects of this RC building include the use of smooth reinforcement bars, insufficient hook length, and 90° hook angles. It is noted that in nearby areas, ground settlement was observed (about 10-20 cm settlement; see section 8.1).

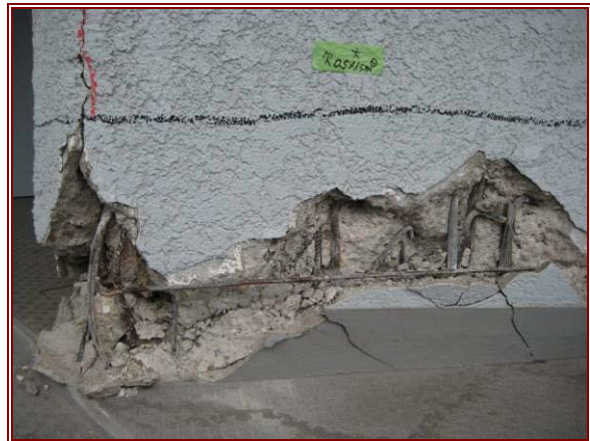
(b) Column-floor joint failure

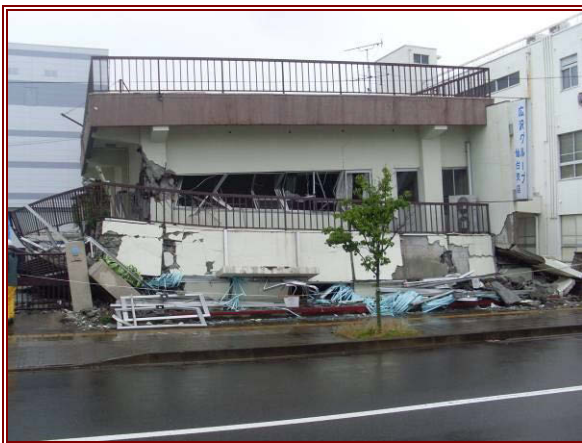
The second case study is a 2-storey RC office building in Oroshi (Figure 4.5c and Figure 4.5d), which was constructed in 1969. This building is about 1500 m south of the MYG013 station. It completely collapsed due to a soft storey mechanism (Figure 4.5c), and at the 1st storey level, shear failures of columns and fracture of lateral reinforcement stirrups were observed (Figure 4.5d).

(c) Oroshi office building

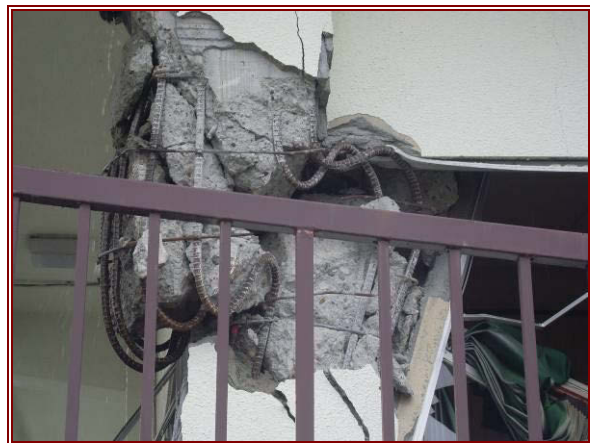
(d) Shear failure of column (1st storey level)

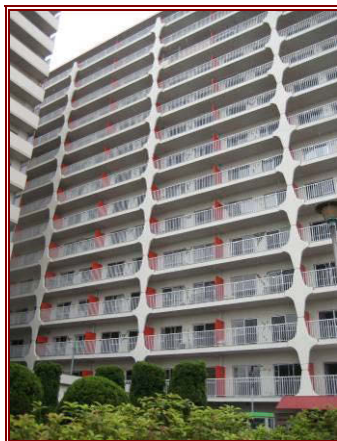
(e) Takasago apartment

The third case study is a 14-storey residential apartment building (Figure 4.5e-f), which is about 3000 m east of the MYG013 station. This building consists of two structures, which are connected by expansion joints, and forms an L-shape in plan as a whole. It was constructed in 1975, and suffered from damage during the 1978 Miyagi-Oki earthquake (cracks on non-structural walls in the lower part of the building); repairs were done by replacing damaged RC walls with new ones of increased thickness (NILIM and BRI, 2011). During the Tōhoku earthquake, many shear cracks occurred in non-structural-walls (Figure 4.5e) and several major cracks occurred in columns and beams. Furthermore, one of the two structures was tilted by about 2 degrees due to ground settlement (Figure 4.5f and Figure 4.5g). This building will be demolished; the decision was reached by the consensus of the residents/owners.

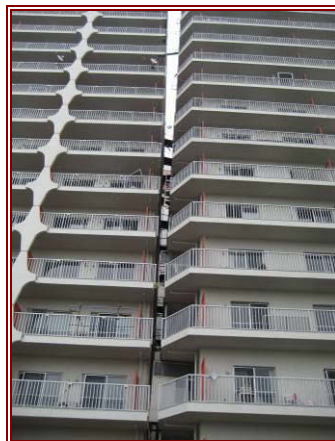
(f) Gap between two buildings

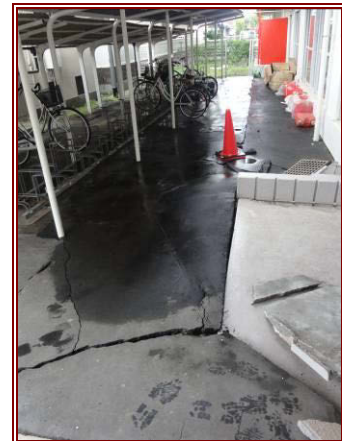
(g) Ground settlement

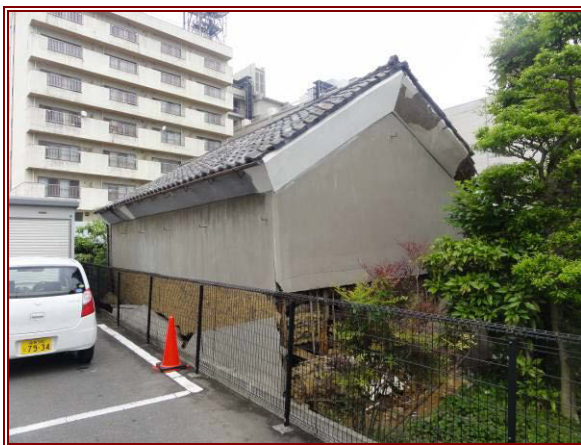
No major structural damage was observed during the on-foot survey around the Shirakawa City Office and the Shin-Shirakawa train station close to the FKS016 station (note: a few buildings that suffered from severe damage were observed while driving through the city). Collapsed walls of a traditional warehouse were observed (Figure 4.8a), and several houses had sustained roof damage. Generally speaking, damage in downtown Shirakawa was minor.

(a) Damage to traditional warehouse

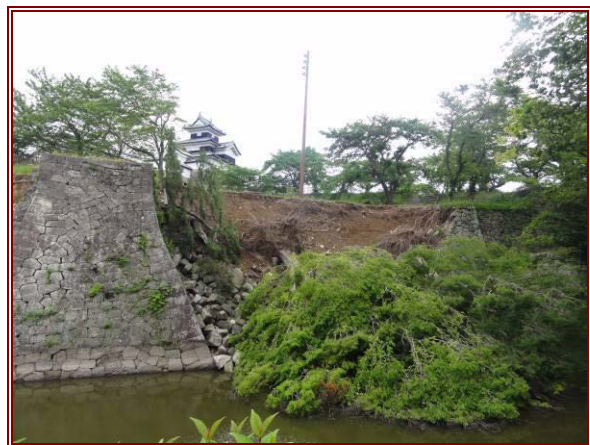
At the Komine Castle, stone walls had collapsed due to a combination of ground shaking and landslide (Figure 4.8b). This is related to large ground accelerations observed in Shirakawa. In total, the collapse occurred at eight locations (North and South sides of the Castle, noting that ground shaking in the North-South direction was greater than that in the East-West direction; see Figure 4.7a and Figure 4.7c).

(b) Collapse of stone wall

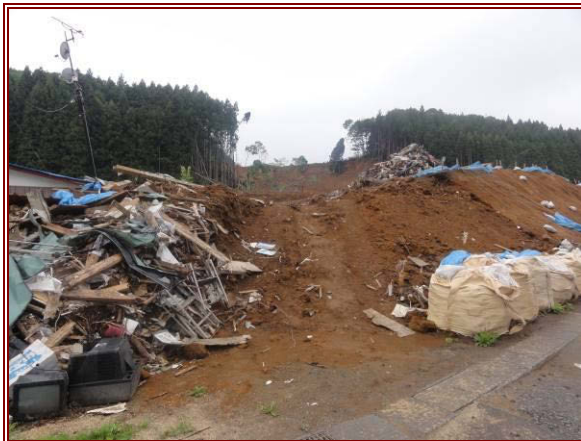
At Hanokidaira, there was a landslide (Figure 4.8c) which killed ten people and destroyed several houses at the foot of the slope (Figure 4.8d). Landslides at the Komine Castle and Hanokidaira are discussed further in section 8.2

(c) Hanokidaira landslide

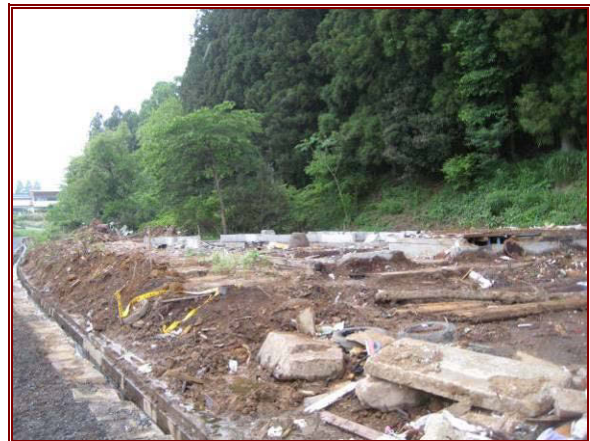
(d) Foundations of destroyed houses

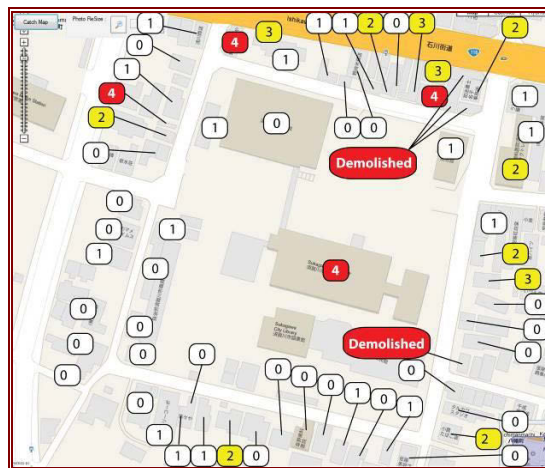
Figure 4.11 Summary of the damage survey conducted in the surrounding of the Sukagawa City Office ($37^{\circ} 17' 12''$ N, $140^{\circ} 22' 22''$ E). The number indicated in the figure corresponds to the assigned EMS-98 grade.

Out of 63 surveyed buildings (Figure 4.11), 4 buildings were demolished, 4 buildings were severely damaged (grade 4), 11 buildings were partially damaged (grade 2 or 3), and 17 buildings were with minor damage (grade 1). In general, the survey results are in agreement with the damage statistics shown in Table 4.5. Three photographs for two damaged buildings with grade 4 are shown in Figure 4.12d to Figure 4.12f. For the damaged liquor store, a 3-storey RC building, (Figure 4.12e and Figure 4.12f), many cracks on non-structural walls and falling of concrete covers were observed.

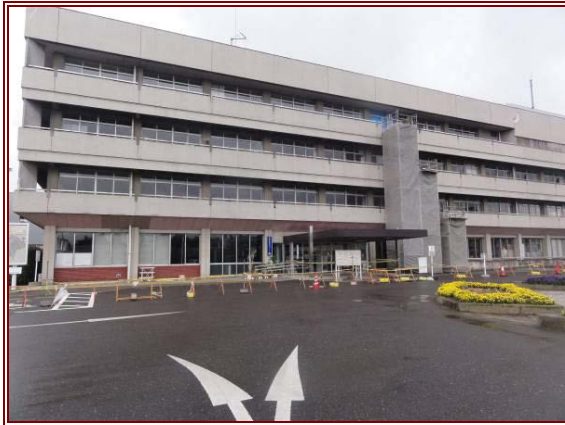
(a) Sukagawa City Office

The City Office, a 4-storey RC building constructed in 1970 (Figure 4.12a), was severely damaged due to ground shaking. No seismic upgrading was conducted. Many large diagonal cracks on non-structural walls and shear failures of structural walls/columns were observed (Figure 4.12b and Figure 4.12c). The locations of shear failure in columns correspond to a change in the amount of reinforcement (NILIM and BRI, 2011): more reinforcement was placed at joints but less reinforcement was placed in the middle of the columns. Shear failures of columns due to the change of steel reinforcement were also observed in the 1995 Kobe earthquake. Because of the severe damage, the building was not occupied at the time of the survey; all departments of the City Office were operating from at the gymnasium beside the City Office, which had no apparent damage.

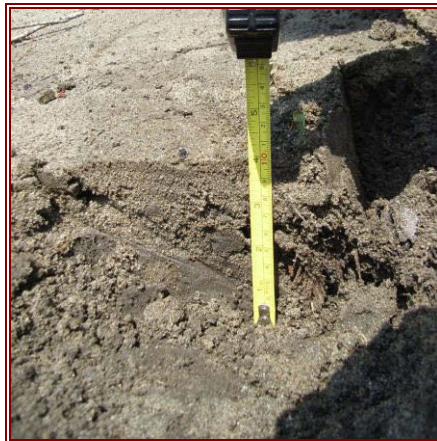
Figure 5.8 shows a sample of sediment deposited during the tsunami on the Sendai Plains. The upper 100 mm is the tsunami sediment consisting of layers of sands and muds. The sands are normally graded with an approximate grain size near the base of 1 mm. Below 100 mm are muds from rice fields, as this is a cultivated area.

Figure 5.8 Sediment deposited by the 11th March 2011 tsunami approximately 1 km from the coast at Arahama Beach in the Sendai Plains (38° 14' 14.55" N, 140° 59' 02.25").

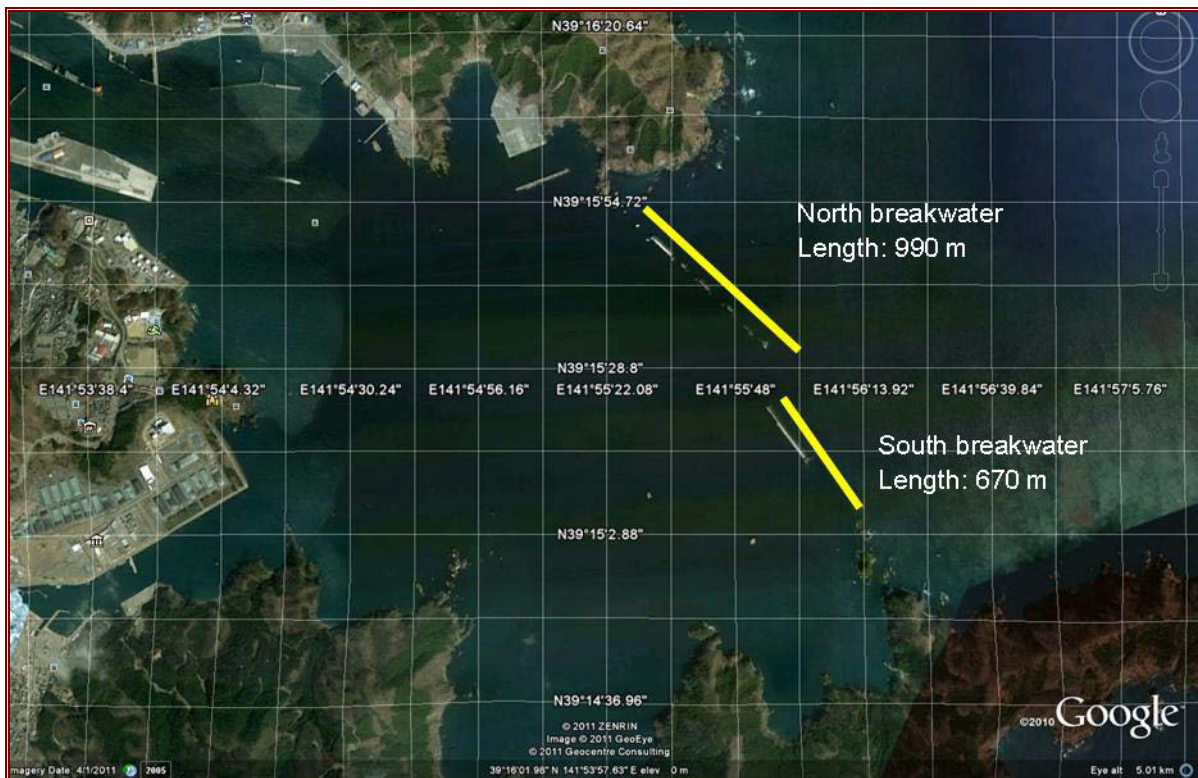
Figure 6.2 Location of the Kamaishi Bay breakwaters. The positions of breakwaters are indicated by yellow lines, which have been offset slightly to the east in order to show the post-tsunami state of the structures.

The breakwater was designed to protect against tsunami waves typical of the 1896 Meiji-Sanriku tsunami (i.e. 5 m to 6 m), and also for protection against storm waves. The tsunami of 11th March, being of a much greater magnitude, overturned the north section of the breakwater and though the south section survived mostly intact it was left inclined.

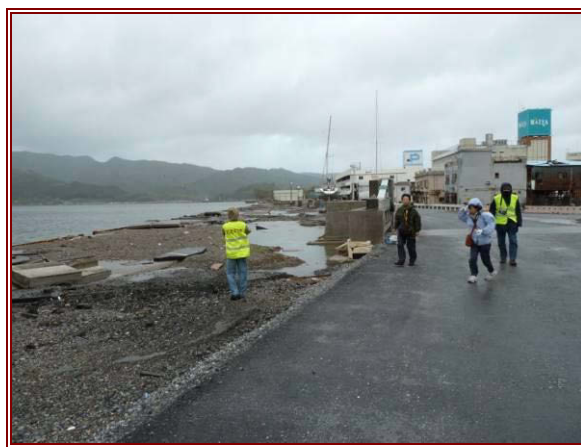
The port of Ōfunato, Iwate Prefecture was very badly damaged by the 1960 Chilean tsunami and as a result tsunami breakwaters were built at the entrance to the bay (Murata et al., 2010). Unfortunately the entire combined 540 m length of breakwaters has collapsed (PIANC, 2011). The breakwater caissons were observed to have shifted before the peak of the tsunami (PARI, 2011b) and were left scattered in the bay after the event. Furthermore, 1 m deep settlement of the quay walls occurred (PIANC, 2011). The low freeboard on the quay walls can be seen in Figure 6.3.

Figure 6.3 Quayside at Ōfunato City, showing limited freeboard of the quay walls

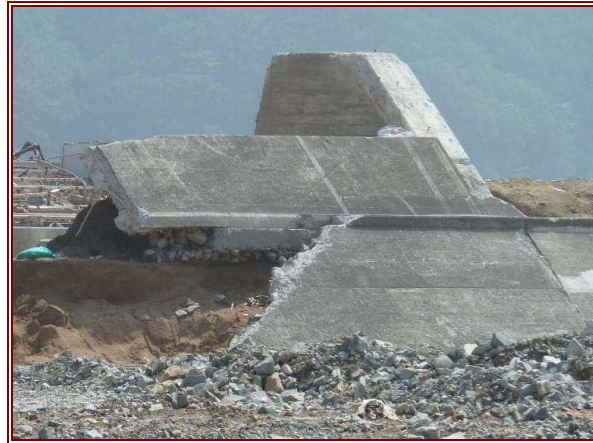
Figure 6.4 Unreinforced concrete interlocking blocks and sand infill of the sea wall at Tarō.

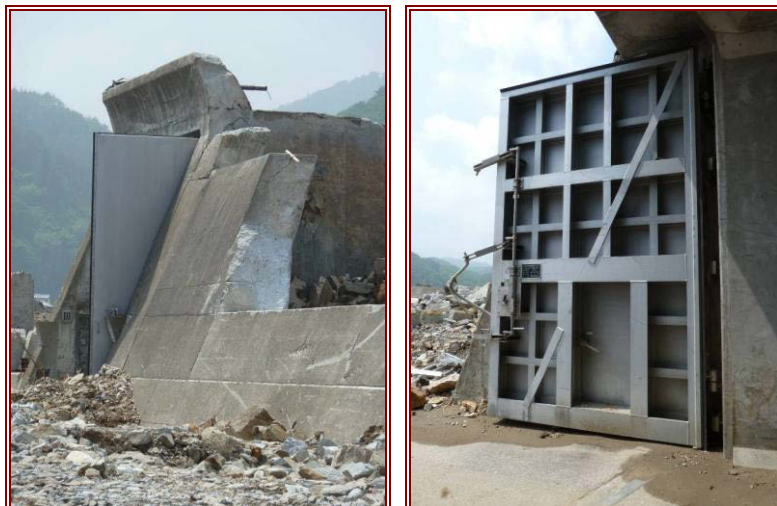
There exists a second layer of tsunami defence in this town, built when development started outside of the Great Wall. There were two periods of construction: from 1962 to 1967 a 582 m length of wall and from 1972 to 1978 a 501 m long section. A remote-controlled gate was also built during this second period (Smits, 2011). The concrete sections were apparently without reinforcement or interlocking blocks and had sand infill (Figure 6.4). As a result, despite their enormous size (approx. 10 m height) they were almost all toppled from their positions. The only part of the newer wall left standing were some buttress supports (Figure 6.5) and the sections around the gates (Figure 6.6 and Figure 6.7).

Figure 6.5 (left) Remaining buttress supports around a tsunami gate in the sea wall at Tarō.

Figure 6.6 (right) Tsunami gate that remained intact in the seawall at Tarō.

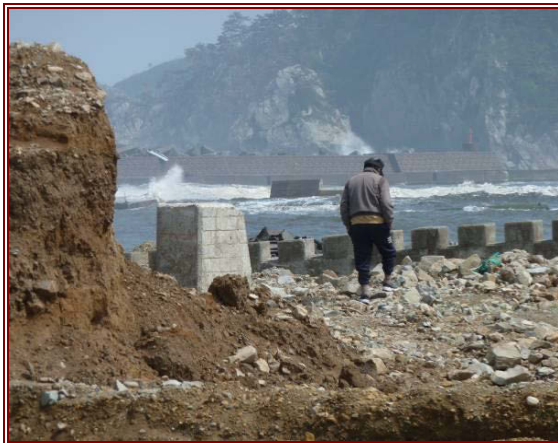
Figure 6.7 (left) A surviving gate structure and buttresses in Tarō. The seawall has been destroyed either side of this gate.

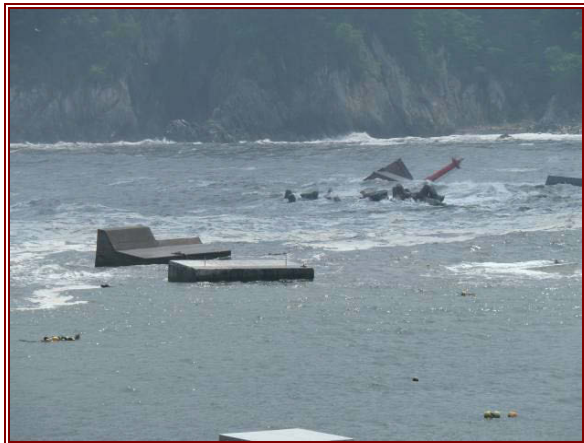
Outside the Great Wall there was utter devastation (Figure 6.8). The waves in fact overtopped the Great Wall but the extra defence provided some reduction in overtopping and certainly reduced the level of damage. Substantial resources were being devoted to the clear-up operation when we visited, which may be indicative of the strong links the village has with local government.

Figure 6.8 (right) Devastation seaward of the „Great Wall“ in Tarō.

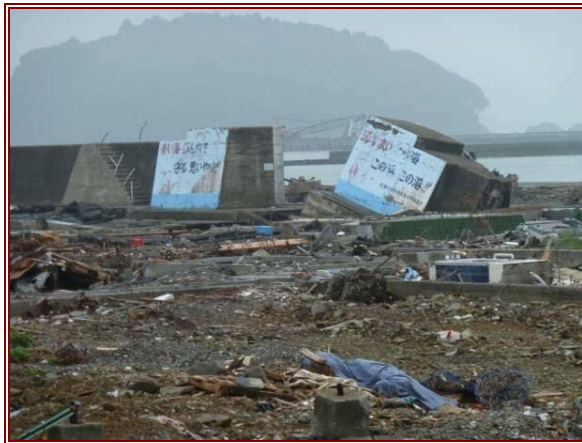
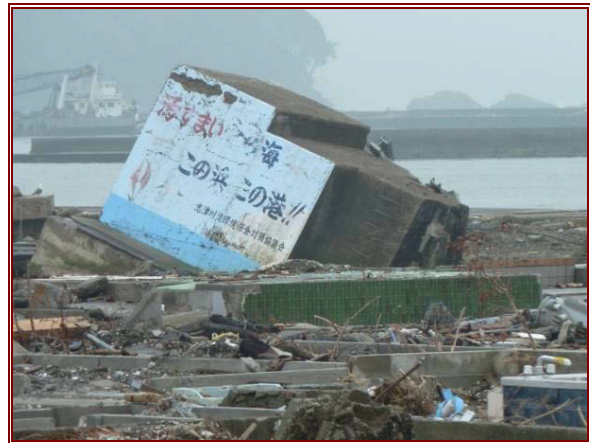
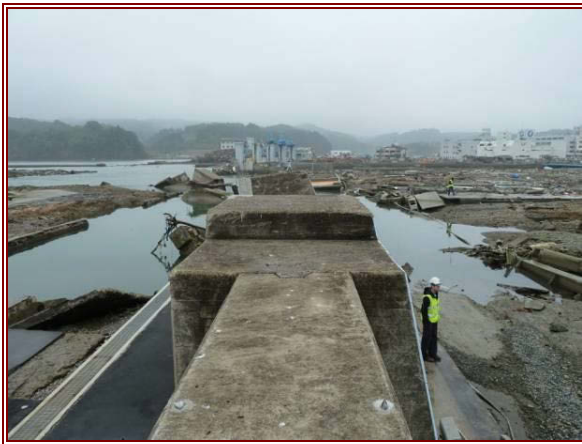
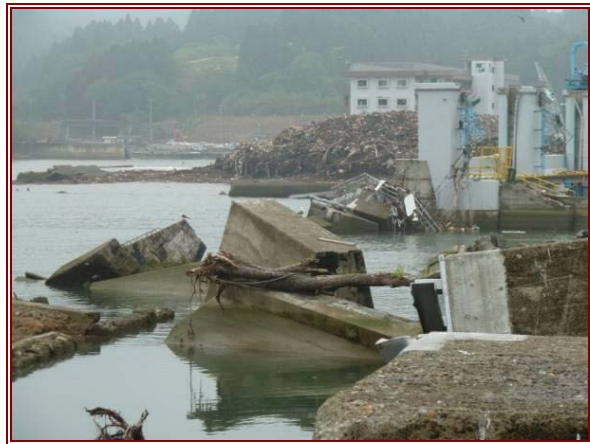
The coastal structures of Minamisanriku, Miyagi Prefecture suffered extensive damage. The main defences for the town appear to have consisted of a wall and a tsunami gate across each of the three rivers; north to south, these are the Niida River, Hachiman River and Mizushiri River. The collapsed wall is shown in Figure 6.11a to Figure 6.11d. Again, there was evidence of inadequate interlocking of adjacent blocks, relying instead on self-weight for stability. This may have been effective had the tsunami been of a similar size to the 1960 tsunami, but not for this latest event.

Figure 6.11 Failure of the Minamisanriku seawall (a) failure of end section (b) end block close-up (c) view along crest of wall (d) submerged blocks.

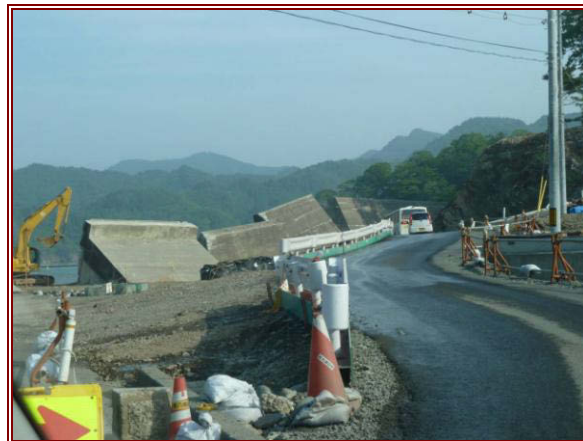
Close to the centre of this town, whole sections of a large concrete wall were displaced as shown in Figure 6.12. This photograph was taken from a vehicle and it was not possible to get a closer look at the concrete units.

Figure 6.12 Toppled concrete blocks from the seawall in Ryoishi.

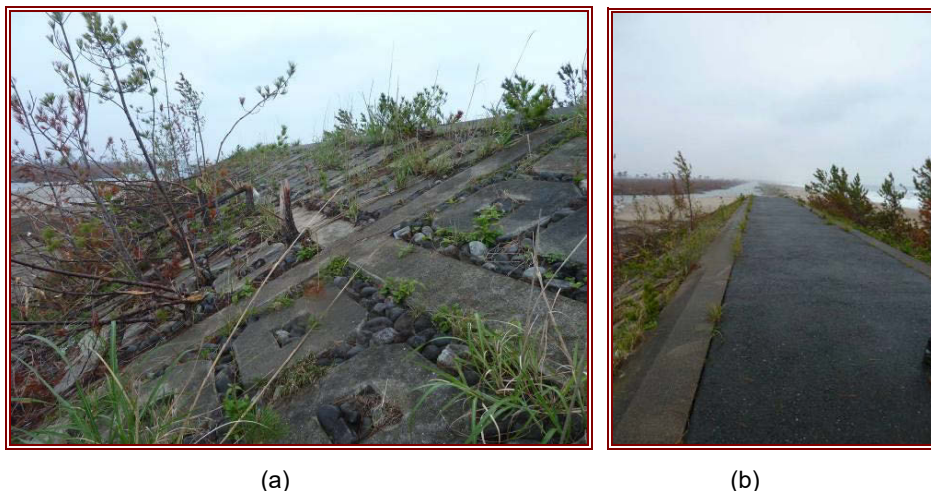
The shoreline of Yamamoto-cho, Miyagi Prefecture comprised a gentle sloped beach, some large periodically placed groynes and a concrete block revetment behind which were pine trees. Both sides of the revetment comprised a concrete lattice, block infill and a sand core with a concrete pathway on top (Figure 6.13).

Figure 6.13 Concrete block revetment at Yamamoto-cho: (a) leeward side showing vegetation and blocks (b) view along the crest.

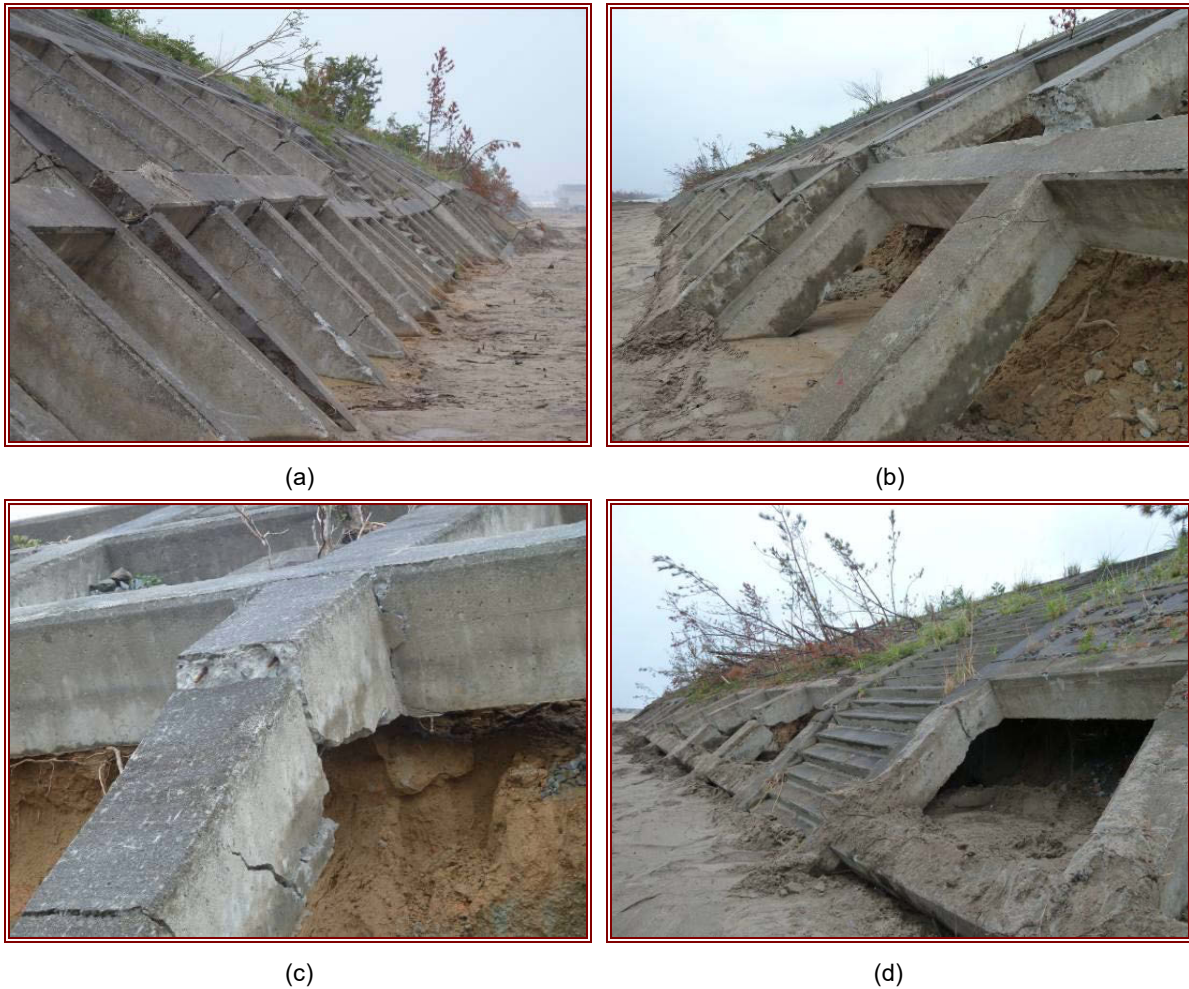
At several locations along the wall there were breaks in the lattice and most of the concrete blocks had „popped out“. It was surmised that a pressure wave may have passed through the sand infill leading to the blocks being ejected. Breaks in the lattice are shown in Figure 6.14. Reinforcement bars were evident in the lattice: four per connecting member. There was significant wash-out of the sand core as can be seen in Figure 6.14d. This image also shows how the original leeward side might have looked with stone infilling the concrete blocks and vegetation growing in the cracks. The scouring on the leeside is one of the main causes of embankment failures (Kazama, 2011). Just a few metres north the seawall had failed catastrophically, as shown in Figure 6.15.

Figure 6.14 Inland side of concrete block revetment at Yamamoto-cho. (a) to (c): Breaks in the lattice revetment. (d): Sand in-fill wash-out.

Vegetation was also evidently part of the structure of the revetment (see Figure 6.14 and Figure 6.18), with small trees growing in the cracks, but it is likely that a roughness layer of this magnitude would be completely ineffective at reducing energy, and is more likely planted for aesthetics and to bind the infill material of the defence.

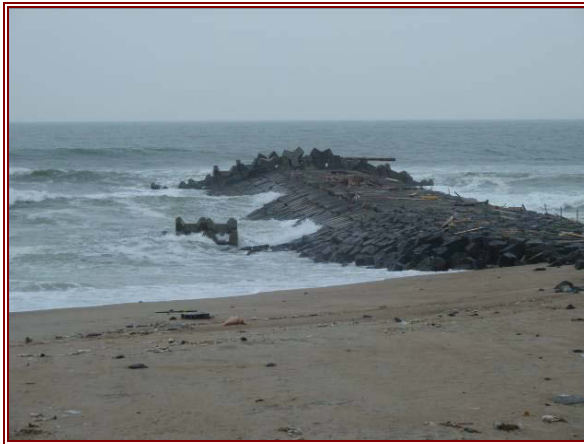
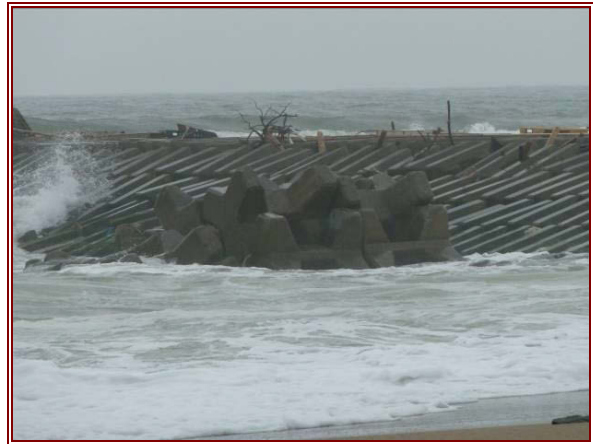
A gently-sloping beach and a groyne are located seaward of the revetment. These are shown in Figure 6.16. The groyne appeared largely intact and was constructed of slim concrete armour units aligned with the slope and with protective concrete armour units.

Figure 6.16 Groyne structure at Yamamoto-cho, (a) with beach in foreground (b) close-up of armour units.

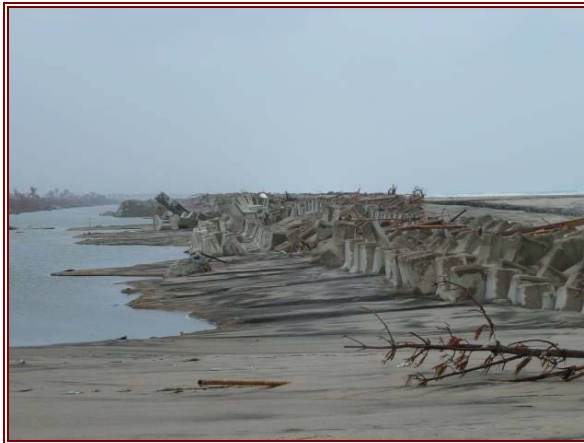
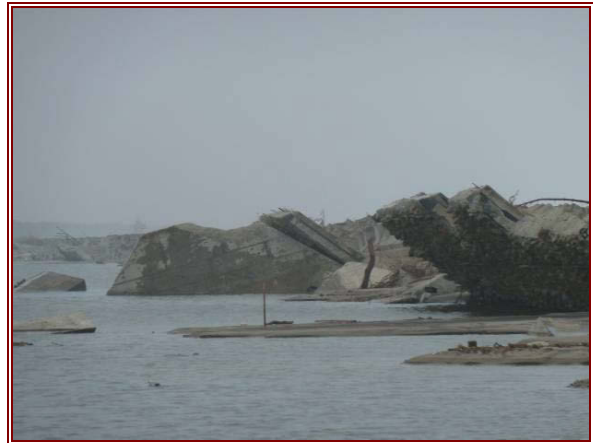
Further north along the beach, where the seawall had disappeared there were extensive „debris fields“ comprising large blocks of seawall and wave dissipating units (Figure 6.17). The photographs show pine forest to the left and sea to the right; the water in the left of both shots lies in land that is lower than the beach level. The effect of the tsunami on the morphology of this beach is not known.

Figure 6.17 Coastal structure debris on beach at Yamamoto-cho (sea to the right of both shots) (a) along the length of the beach (b) close-up showing concrete sections.

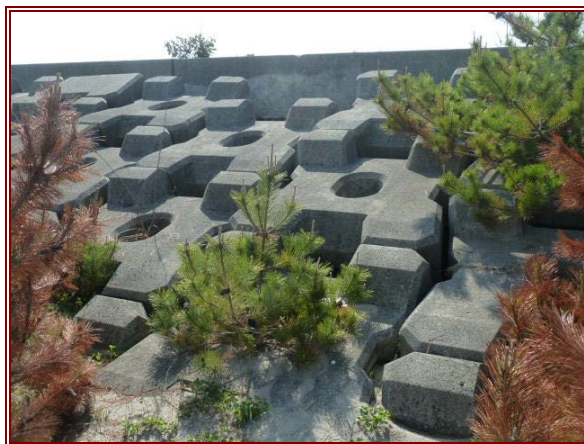
Slightly further north up the coast was Arahama beach which had defences similar to those on the Yamamoto shoreline though the concrete blocks were of a different form (Figure 6.18). The revetment had again failed in places; the concrete blocks were thrown larger distances from the wall – up to 100

Figure 6.18 (left) Seaward side of concrete block revetment at Arahama Beach.

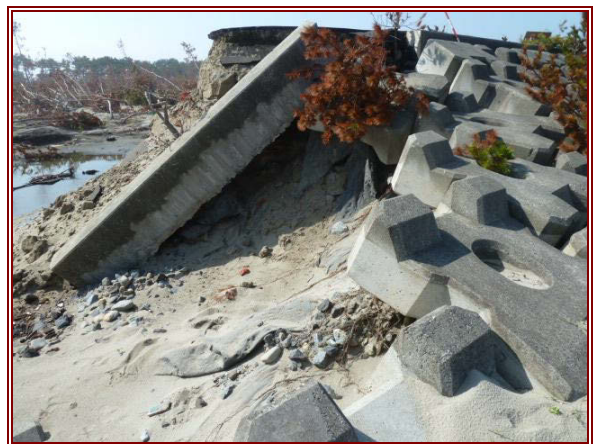
m into the coastal forest. The failure mechanism also looked very similar, with the sand infill being washed out (Figure 6.19).

Figure 6.19 (right) Collapse of revetment at Arahama Beach due to sand fill being washed out.

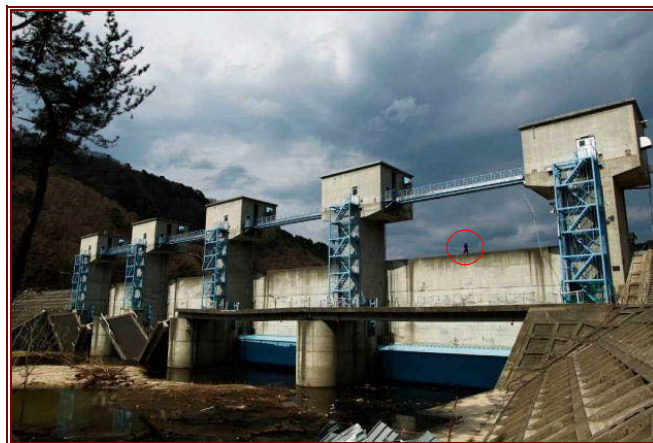
When the earthquake struck on 11th March the four main gates were closed remotely, though the smaller side gates needed to be closed by hand as they had jammed. The run-up level of the tsunami was measured at 20 m on the floodgate towers. The town suffered a little damage, though compared with the devastation around similar coves, it was fairly insignificant. Unfortunately, the exposed port on which many livelihoods depend was badly affected.

Figure 6.21 Tsunami sluice gates at Fudai. Notice the man walking along the top of the wall for scale (Komo News, 2011).

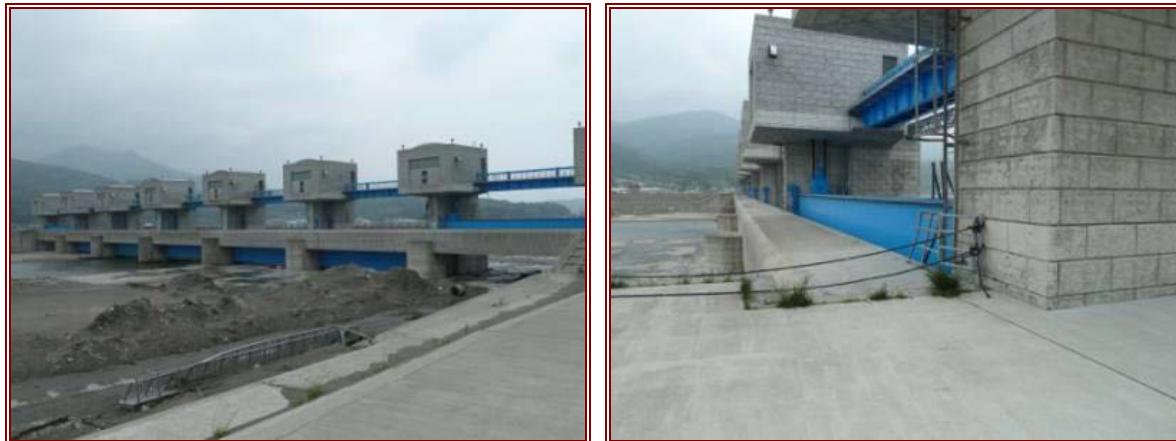
At the southern end of Miyako Bay there were completely undamaged gates on the Tsugaruishi River as shown in Figure 6.22.

Figure 6.22 Tsunami gates on the Tsugaruishi River in Miyako Bay.

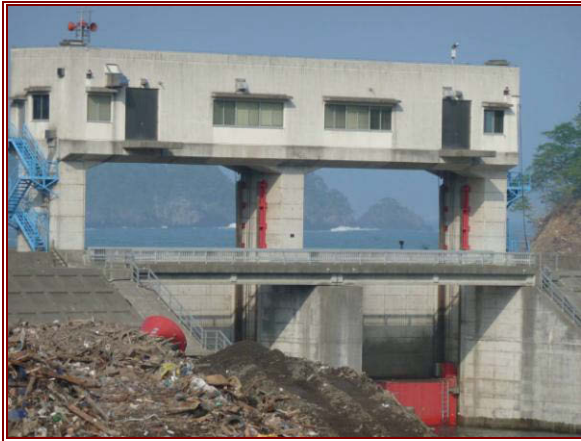
Undamaged tsunami gates were observed in the southern part of Ryoishi Bay (Figure 6.23).

Figure 6.23 (left) Tsunami gates to the south of Ryoishi.

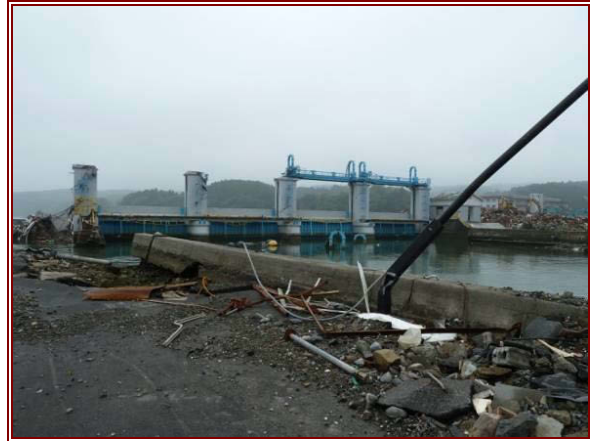
This location has been previously mentioned for its damaged seawall (see Figure 6.11), but its two tsunami gates also suffered damage as can be seen in Figure 6.24 and Figure 6.25.

Figure 6.24 (right) Damaged tsunami gates at the mouth of the Hachiman River, Minamisanriku.

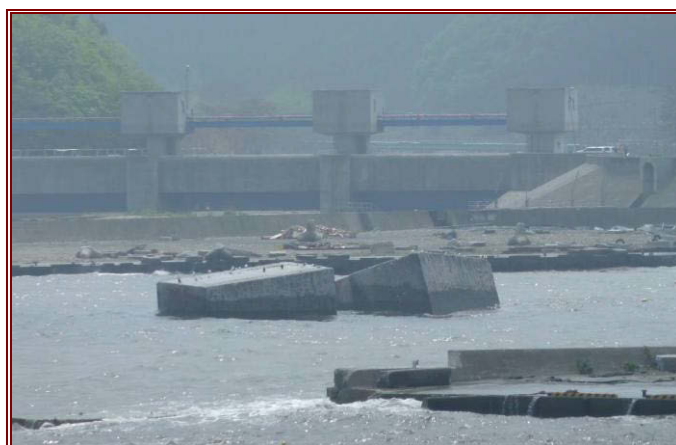
In addition to Tarō's famous seawalls (see Figure 6.4 to Figure 6.8) are tsunami sluice gates, shown in Figure 6.26. These appeared undamaged from the location where this photograph was taken.

Figure 6.26 Tsunami sluice gate and collapsed wharf at Tarō.

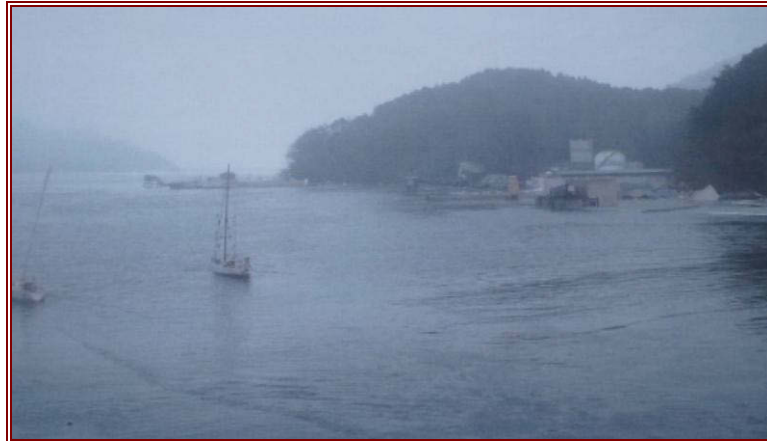
There was extensive damage in this bay, but there were no obvious coastal defences in the harbour and only a low harbour wall at the mouth of the bay. Figure 6.29 shows the bay viewed from the raised hospital car park during the tsunami inundation. The EEFIT survey photograph (Figure 6.30) is taken from a slightly different location on 2nd June 2011 (behind the red-brick building) but it is striking how much of the buildings in centre frame of the lower picture were engulfed in the wave as shown by the top picture. The inundation depth of more than 18 m was measured in Onagawa (PARI, 2011a).

Figure 6.29 Onagawa Bay during the tsunami. Photograph courtesy of Koji Shudo (Eastern Miyagi Prefecture Civil Engineering office) and Akihito Morikawa (Miyagi Prefecture Civil Engineering office).

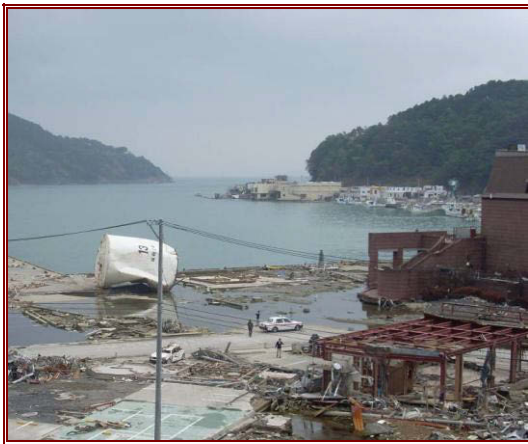
Figure 6.30 (left) Onagawa bay on 2nd June 2011. Photograph taken from hospital car park on raised 16 m platform.

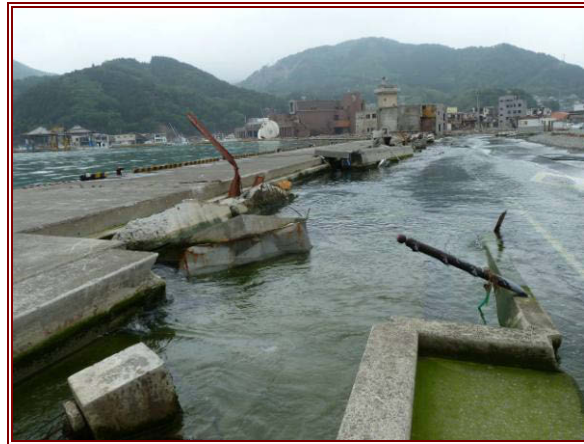
The coastal area around Onagawa also suffered from approximately 1.2 m of subsidence. As a result of this the shoreline is now subject to flooding at high tide. Figure 6.31 shows the incoming tide engulfing the quay road.

Figure 6.31 (right) Inundation of the quay in Onagawa at high tide, as a result of 1.2 m co-seismic subsidence.

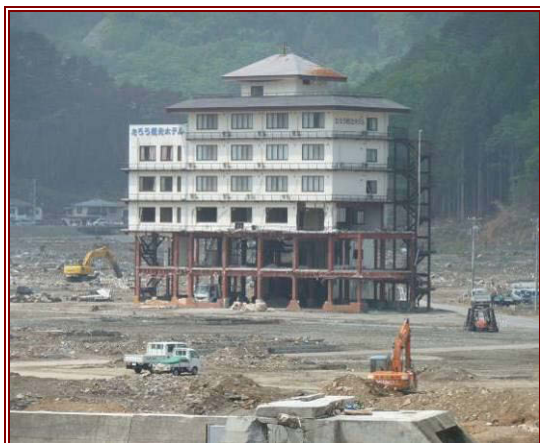
In the north-east quadrant, (between the very large defence completed in 1940 and the more modern wall completed 1978) there was almost total destruction of buildings by the tsunami and only two buildings remained standing at the time of our survey. A 7-storey steel-frame hotel building (Figure 7.2) remained standing with significant cladding damage to the lowest 2 storeys, and visible damage up to the 4th floor; from analysis of aerial photography this appears to have been the only building in this quadrant prior to the tsunami that was more than 3-storey in height. In the north-west quadrant behind the wall constructed in 1940, most timber structures had been washed off their foundations but many remained intact, while many steel frame and RC structures also survived with damage to lower-storey cladding. Figure 7.1 shows significant amounts of debris had been washed into this area and trapped behind the defence.

Figure 7.2 (right) Steel-frame hotel in Tarō Town showing heavy damage to the third floor and minor damage at the 4th floor.

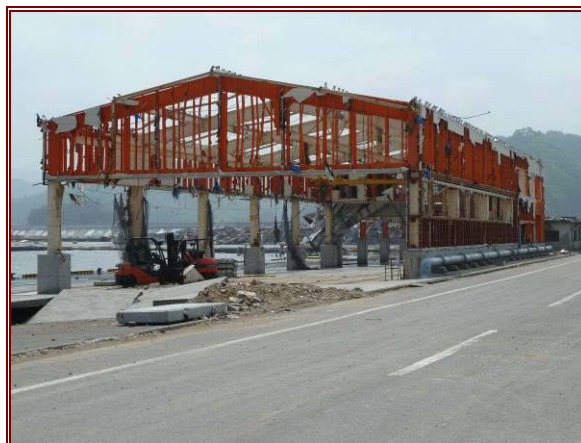
In front of the tsunami defences along the quay, two further buildings survived the 12 m deep tsunami flow: an RC frame building with significant tsunami damage to its lower 4 floors and a steel frame building (Figure 7.2 and Figure 7.3) whose structure appeared to be intact despite removal of non-structural components.

Figure 7.3 (right) Steel frame building on the quayside (in front of tsunami defences). The structure remains standing despite heavy damage and removal of non-structural elements.

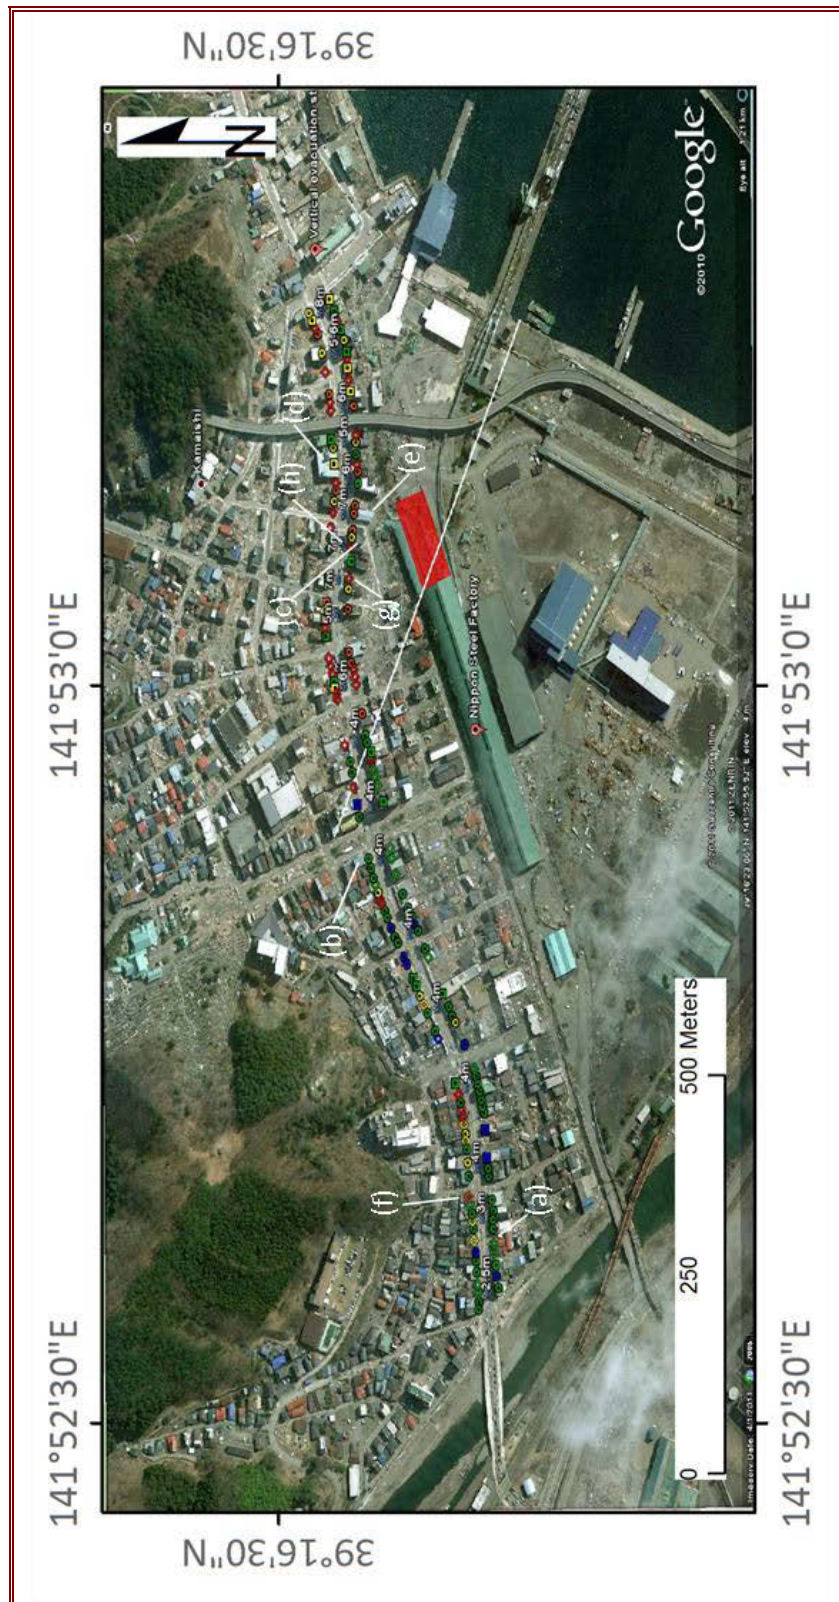
The survey indicates a general reduction in damage towards the western end of the survey with distance from the port and variable degrees of sheltering. At the eastern end of the survey most timber buildings suffered complete collapse and several had been washed away or cleared away, while steel frame buildings suffered damage level D1 to D3, and RC buildings D1 to D2.

Figure 7.5 Damage survey in Kamaishi City. Construction type indicated by shape – Diamonds: timber frame construction; Squares: RC; Circles: steel frame. Damage level indicated by colour – Blue: D0, Green: D1, Yellow: D2, Orange: D3, Red: D4. Inundation depths and the collapsed section of Nippon Steel Factory building (red polygon) are also shown. Locations of the example buildings listed in Figure 7.6 are marked.

There appears to be a boundary (indicated with a white line on Figure 7.5) where heavy damage ceases to occur – this is roughly in line with the end of a large trussed steel portal frame construction forming a long narrow shape on plan. Inundation depth also decreases abruptly around this area, from depths of 5-6 m to 4 m. The eastern-most end of this building suffered partial collapse in the tsunami (red shaded area on Figure 7.5). The lack of major horizontal members across the failed joint (Figure 7.8) suggests that the collapsed section of the building was structurally isolated from the remaining structure. The collapsed section of the building was also likely the same portal frame construction, though the failed columns had already been removed at the time of this survey. Failure of the portal frame columns may have been caused by impact from the large machinery originally contained within the building (Figure 7.9).

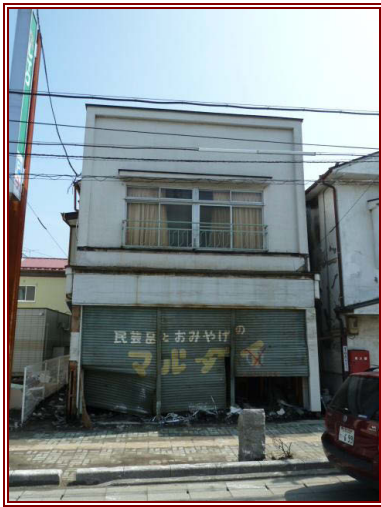
(a) Timber frame structure, damage D1, 3 m inundation.

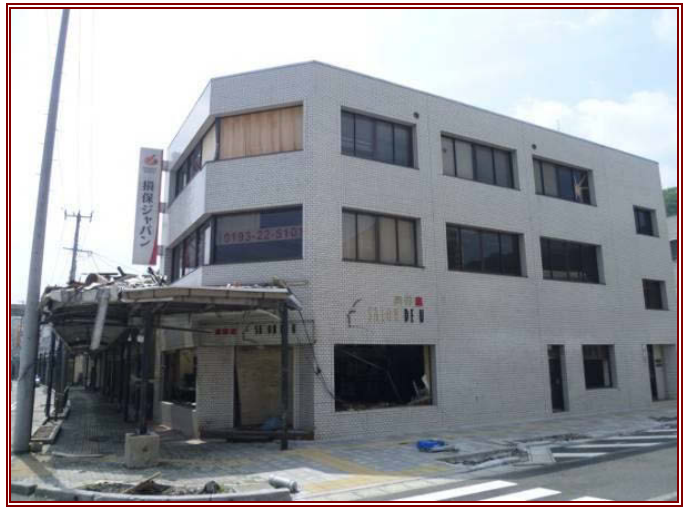
(b) Steel frame, D1, 4 m inundation.

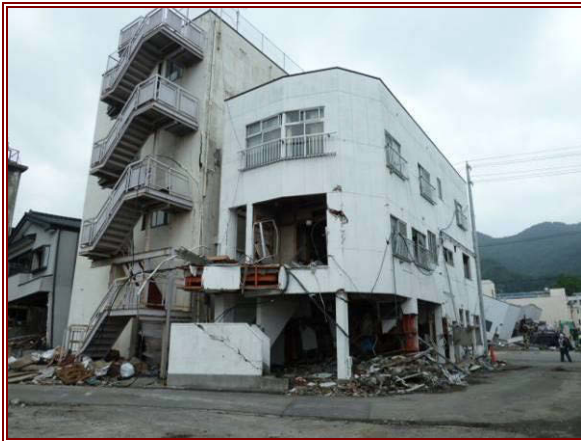
(c) Steel frame, D2, 7 m inundation.

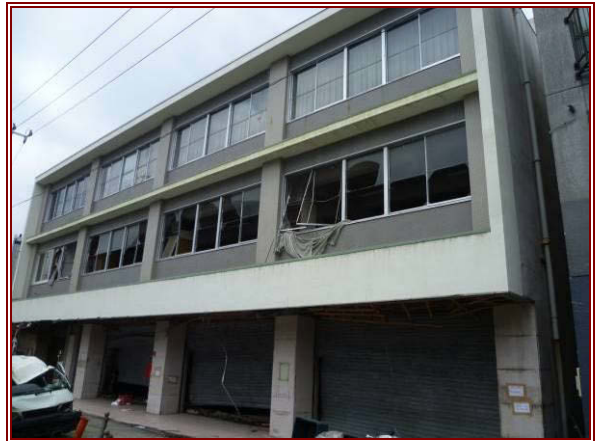
(d) RC shear wall, D2, 5 m inundation.

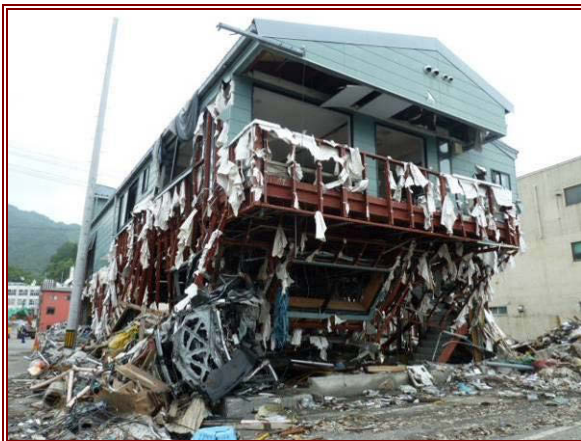
(e) Steel frame, D3, 6 m inundation.

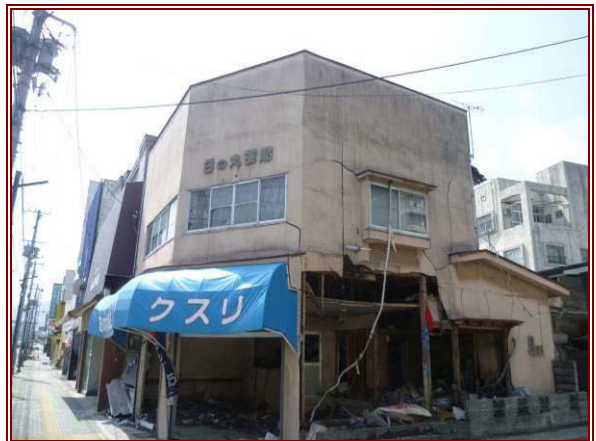
(f) Timber frame, D3, 3 m inundation.

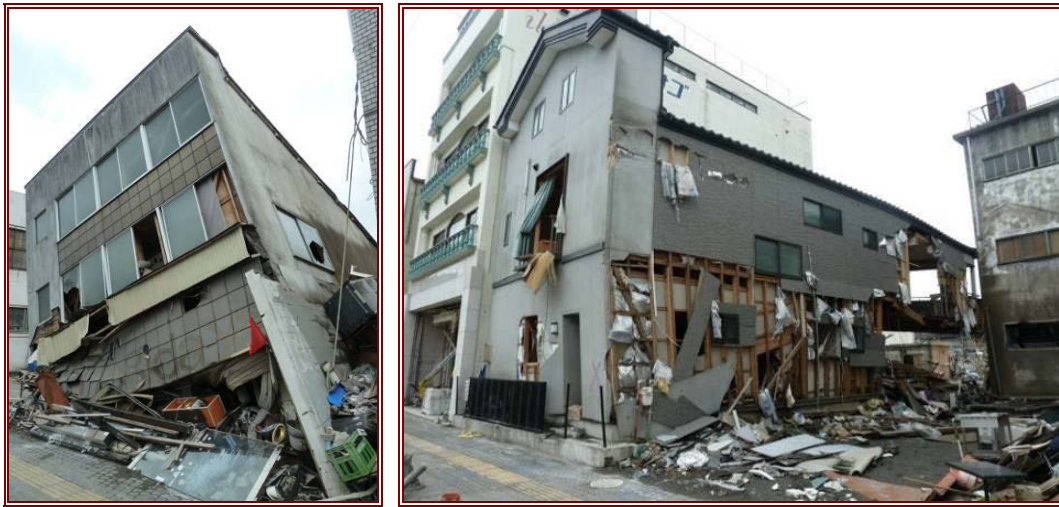
(g) Timber frame, D4, 7 m inundation.

(h) Timber frame, D4, 7 m inundation.

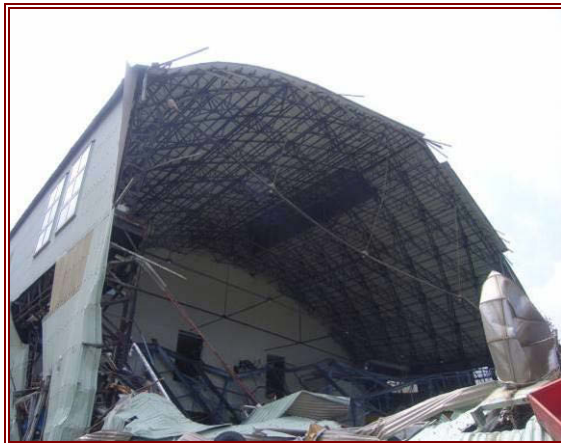
Figure 7.8 (left) Large trussed portal frame structure of the Nippon Steel Factory, at the eastern end of remaining structure.

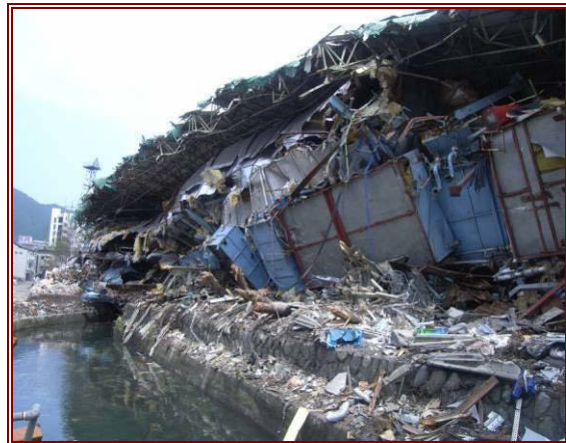
Figure 7.9 (right) Collapsed eastern section of Nippon Steel Factory building.

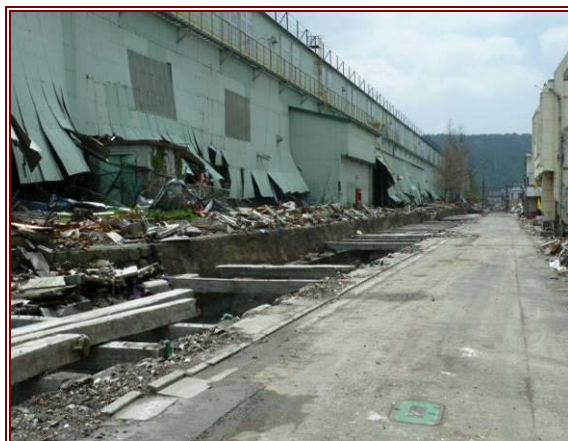
The decrease in inundation depth and damage close to this theoretical boundary suggests sheltering from the factory building, and although tsunami flow did cause failure of the light steel panel walls (Figure 7.10), the structure undoubtedly reduced flow velocities immediately to the northwest. It is suggested that sheltering observed along the survey route occurred due to a combination of the surviving factory building, the closely-spaced configuration of groups of surviving buildings and distance from the port.

Figure 7.10 (left) Water and some debris were able to pass through the structure limiting the amount of shelter this building was able to provide to the buildings behind.
