**THE M_w 9.0 TŌHOKU
EARTHQUAKE AND TSUNAMI OF
11TH MARCH 2011
A FIELD REPORT BY EEFIT**

A FIELD REPORT BY EEFIT

Mr. Antonios Pomonis, *CAR Limited, Global Earthquake Model* (Team Leader)

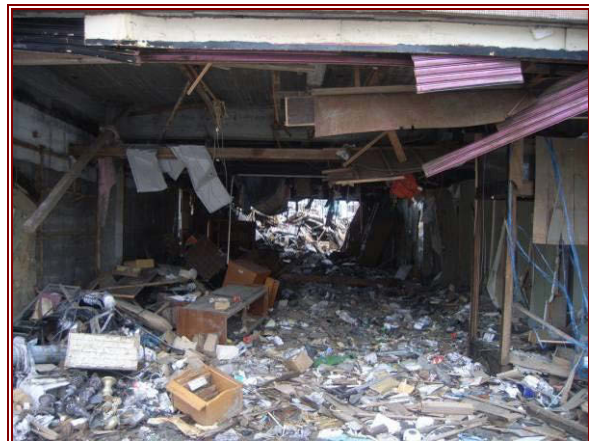
Figure 7.11 (right) RC frame building with heavy non-structural damage. Structural frame remains undamaged.

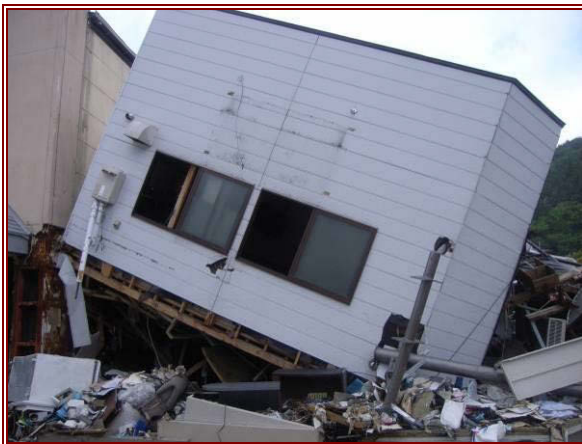
Moving further inland we observed several timber buildings that had experienced soft storey collapses, including some where the upper floors were resting against adjacent steel or RC buildings (Figure 7.12 and Figure 7.13). Short period component ground motions recorded at K-NET station IWT007, 1.5 km west of Kamaishi port, were sufficiently large and of long duration to cause deformation in these structures: 1g to 2g at 0.1 s to 0.5 s for both N-S and E-W components. This indicates that this failure could be due to earthquake ground shaking, although this cannot be confirmed: observations of purely seismic damage elsewhere in Tōhoku generally showed flexible timber framed buildings to have performed well. This suggests that whereas the steel and RC buildings were able to withstand hydrostatic and hydrodynamic forces of the tsunami (and to some extent the associated debris impact) the flexible timber framed buildings could not. Flexible timber framed buildings have less capacity than RC and steel frame buildings to resist the first-order stresses induced by lateral hydrostatic and impact forces.

Figure 7.12 (left) Soft story collapse of timber structure. Upper floor intact because of central steel strengthening beam supporting the second storey.

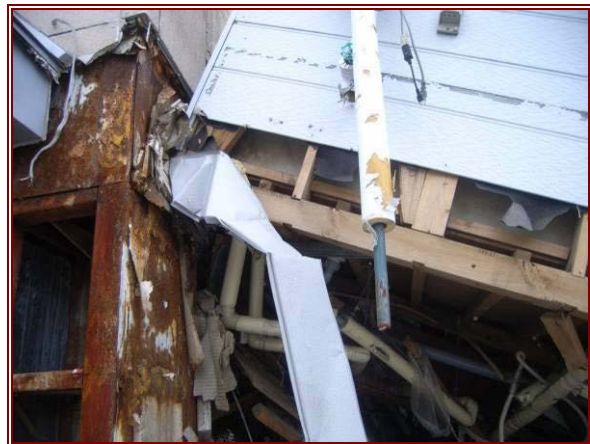
Figure 7.13 (right) Supported from complete collapse because wedged up against adjacent steel frame building.

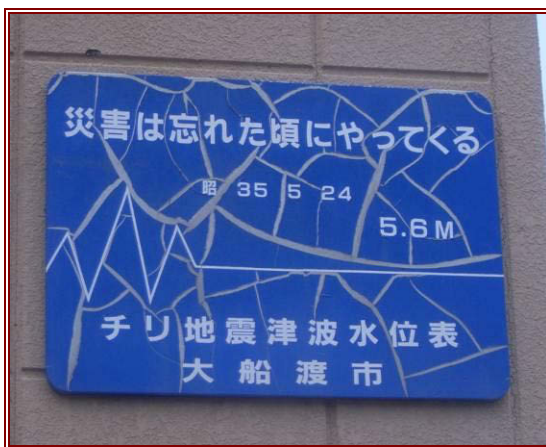
Figure 7.14 (left) Tsunami preparations were based on the 1960 Chilean tsunami which reached a inundation depth of 5.6 m in Ōfunato (sign is located at 39° 3'55.1" N, 141° 43'17.4" E).

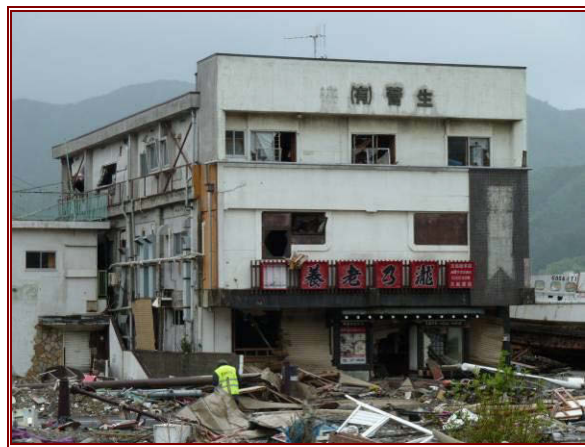
Figure 7.15 (right) Three-story residential RC buildings such as this one were thought to be safe due to expected tsunami inundation depths based on the distal Chile tsunami.

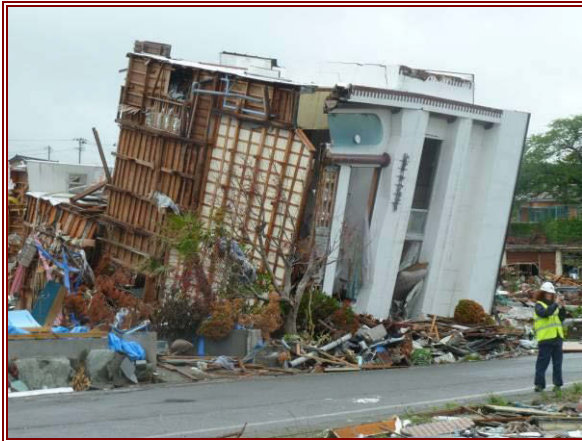
Figure 7.16 (left) An overturned timber building in Ōfunato.

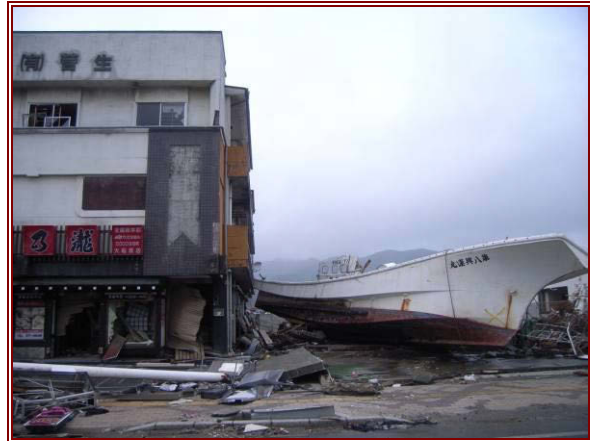
Figure 7.17 (right) Large debris from the port was found in the town (e.g. boat shown).

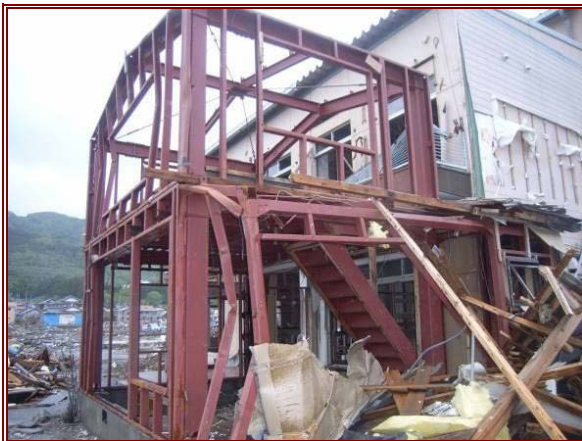
The commercial centre of Ōfunato City took the full brunt of the tsunami flow due to its location on the edge of the harbour. Several steel frame and RC buildings remained structurally intact but with heavy damage to non-structural elements such as the removal of cladding (Figure 7.18). This is consistent with observations from Kamaishi and Kesenuma, where inundation depths were also at or below 8 m. Evidence of damage caused during the period or periods when tsunami waters flowed back to the sea (subsequently referred to as „return flow“) is seen at an old traditional timber frame warehouse building in the commercial centre that leans seawards (Figure 7.19).

Figure 7.18 (left) Cladding had been washed away (or subsequently removed) and steel frame appears to have suffered impact damage but the structural steel frame seemed intact.

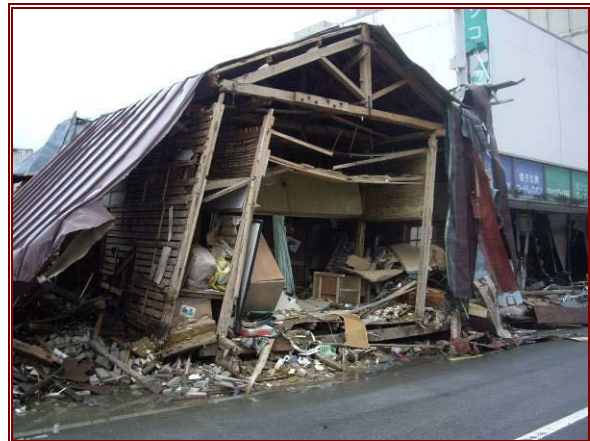
Figure 7.19 (right) A traditional timber frame warehouse in the commercial centre that was damaged during the tsunami return flow (leaning seawards).

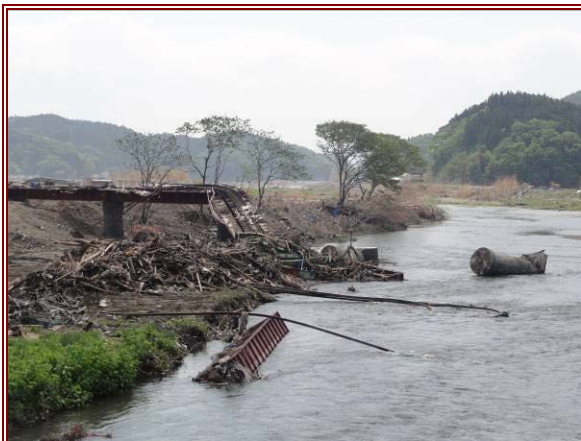
Figure 7.22 (left) The destroyed railway bridge just south of the Mattate Road Bridge in Rikuzentakata at a distance of approximately 2.5 km from the sea shore (May 31st 2011).

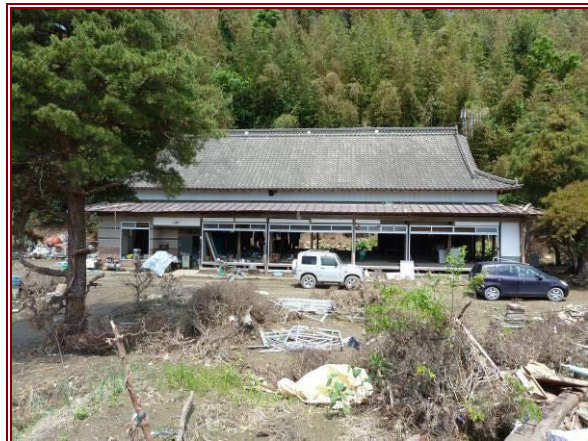
Figure 7.23 (right) A traditional single-storey timber frame house approximately 200 m west of the Mattate Road Bridge that was flooded up to its ceiling (4.2 metres above ground) situated approximately 2.75 km from the sea shore (May 31st 2011).

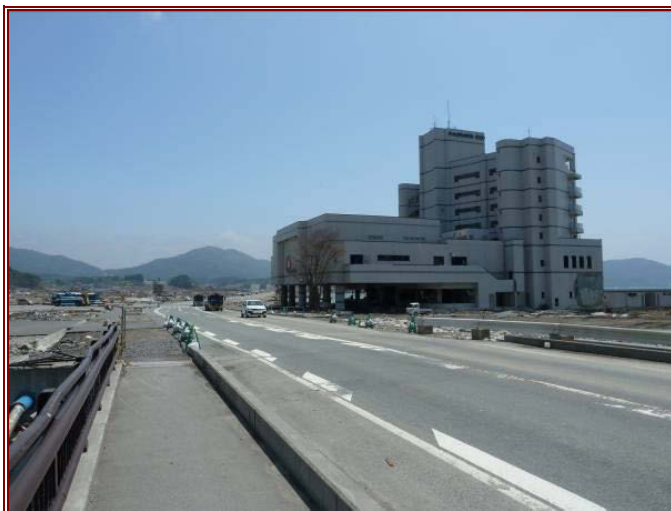
We continued south until reaching the sea front where we inspected the Capital Hotel (Figure 7.24). This is a 7-storey structure over 25 m tall with its first two levels reaching approximately 8 m high. Inundation depth flooded the third level, thus reaching around 10 m. It was too dangerous to enter this building and take accurate measurements but external non-structural damage is shown in Figure 7.25.

Figure 7.24 (left) The Capital Hotel at the seafront of Rikuzentakata (May 31st 2011).

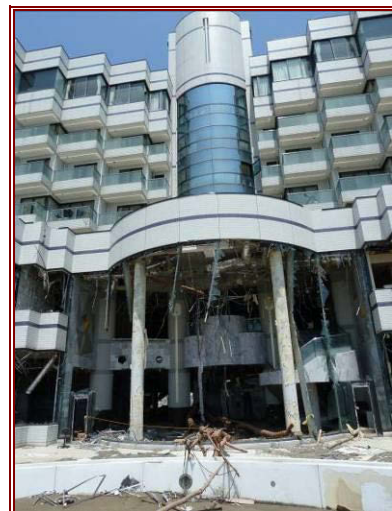
Figure 7.25 (right) Capital Hotel's sea front side, showing tsunami damage up to the third level (May 31st 2011).

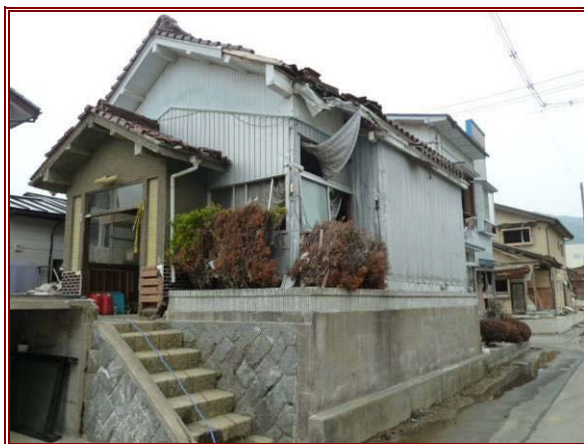
Figure 7.28 (left) Raised concrete foundation; structure built 2 m from ground level, 660 m inland and 100 m from Shikaori River. Inundation depth was approximately 6 m in the area around this building.

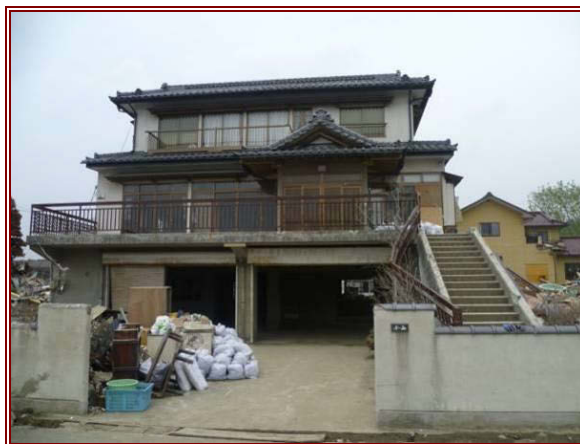
Figure 7.29 (right) RC frame providing garage space below the dwelling, which is 3 m from ground level, 780 m inland and 60 m from the Shikaori River. Inundation depth was approximately 6 m in this area.

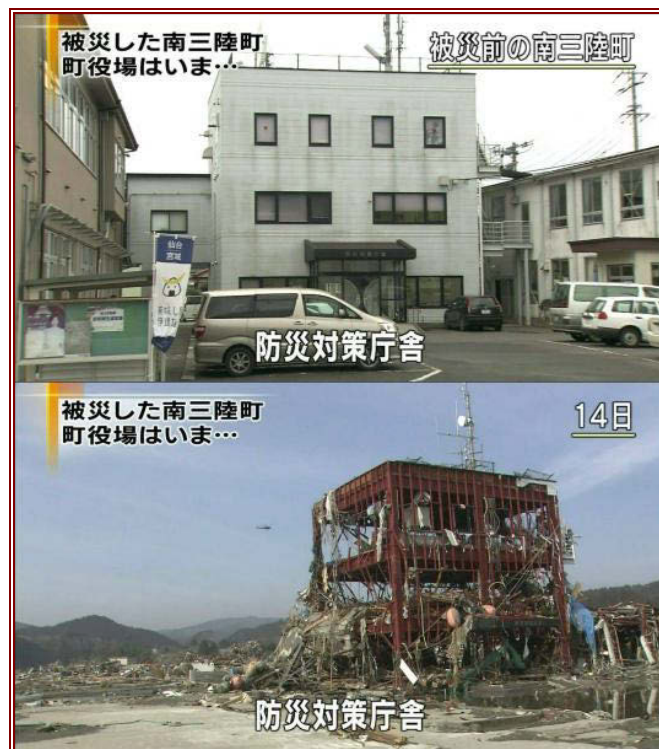
Figure 7.30 Crisis Management Department of Minamisanriku Town, which shows the building before and after the tsunami (Anon., 2011b).

The 3-storey steel frame Crisis Management Department building (Figure 7.30), 470 m from the harbour front, remains standing with heavy damage after inundation to a height of 10 m. Tsunami warnings were transmitted by an employee from this building via the city's loudspeakers until the last moment before the building was inundated. Thirty of the 130 staff in this building climbed up to the roof of the 3-storey building (c. 9 m high) and 20 of those died. Ten evacuees survived by clinging on to the antenna at the roof top during several minutes of flow at this height.

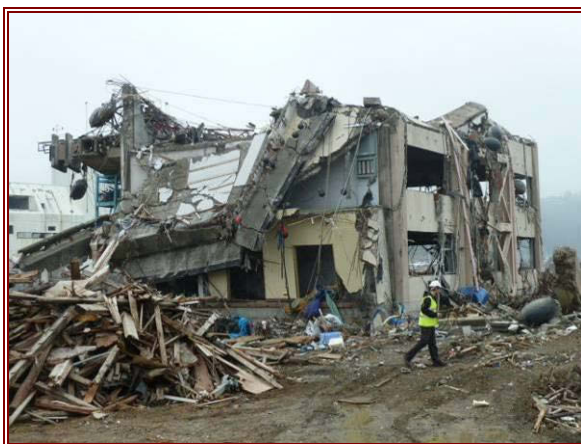
Figure 7.31 (left) Collapse of third storey of a RC building in Shiomi-cho, 100 m from the sea (38° 40' 29.10" N, 141° 26' 44.96" E).

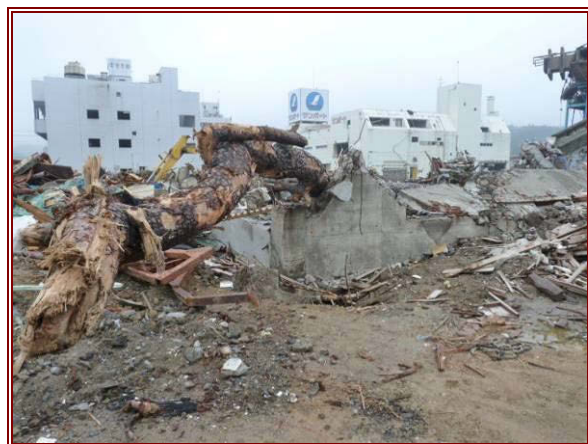
Figure 7.32 (right) Evidence of debris strike at the site of a former gymnasium building in Shiomi-cho, 100 m from the sea. Significant scour and collapse of RC walls was observed.

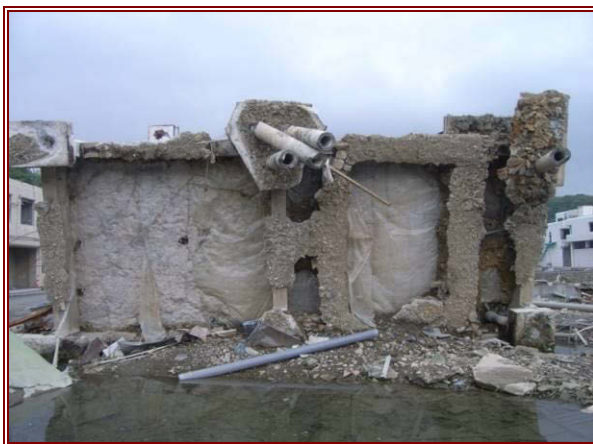
This 2-storey RC shear wall structure with piled foundations was a police office that was overturned landward during tsunami inflow. The structure has 1 pile at each corner, and 3 closely spaced piles at each of the central pile caps. Refer to Figure 7.35 for the final location of this structure.

The rebar in each pile does not continue very far down the pile and they appear quite lightly reinforced at the top, suggesting they were designed only for shear, rather than also for tension. The failure looks to be due to overturning motion: the uppermost (originally seaward) piles remain connected to the pile cap and are relatively straight, suggesting that they have been pulled out of the ground and then failed in tension (Figure 7.36). In contrast, the bottom (originally landward) piles are sheared off closer to the foundation and are all bent downwards; this suggests the lateral forces imparted by tsunami flow were concentrated on the landward piles, which became the pivot point in the overturning motion. Overturning in this case may have been initiated by debris strike to the top of the structure (Figure 7.37).

Figure 7.36 (left) Foundations of building A showing some piles remain connected to the pile cap.

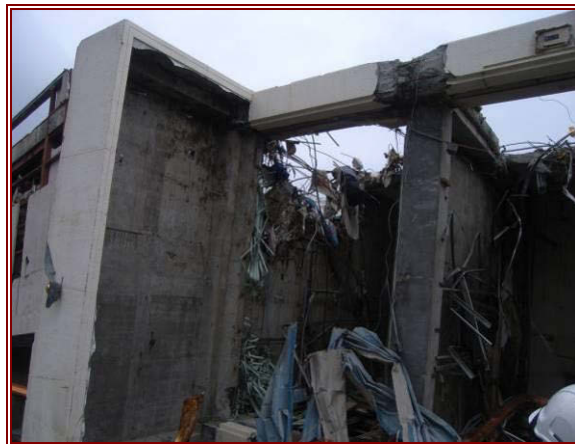
Figure 7.37 (right) Evidence of a large impact at the top of the building on its seaward side.

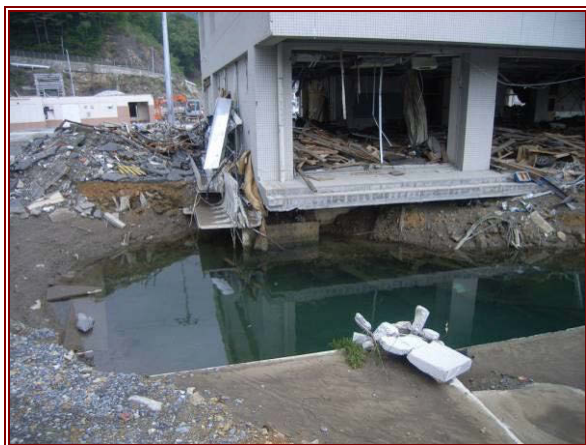
Liquefaction is believed to have played a significant role in the overturning failure. During liquefaction, soil shear strength is decreased thereby decreasing resistance between the pile face and the

surrounding soil. This would allow greater lateral movement of the piles while in the ground, and enable the piles to be extracted more easily from the ground when lateral forces are applied to the building. Physical evidence of liquefaction was eradicated in the tsunami, although significant scour was evident at the time of our survey (Figure 7.38).

Figure 7.38 (left) Scour may have contributed to the overturning failures of several RC buildings.

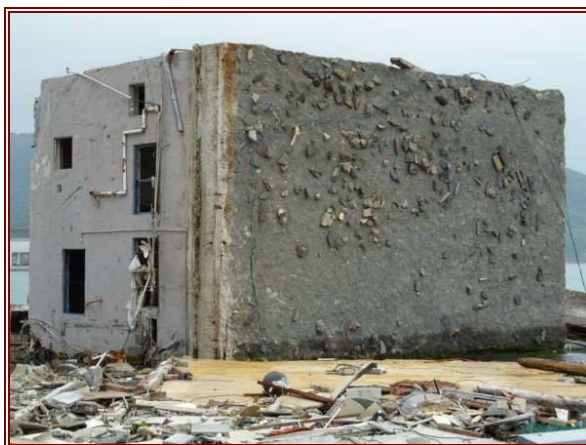
This structure is a 3-storey RC shear wall construction, with a raft foundation (Figure 7.39). Its final location (Figure 7.35) implies the building overturned seaward, however, it is suspected that the initial failure was landward (consistent with other structures) but then the building has been moved to this final position in the tsunami flow. The raft foundation observed at this structure is inadequate for resisting the effects of scour and tsunami flow.

Figure 7.39 (right) Building B with raft foundation.

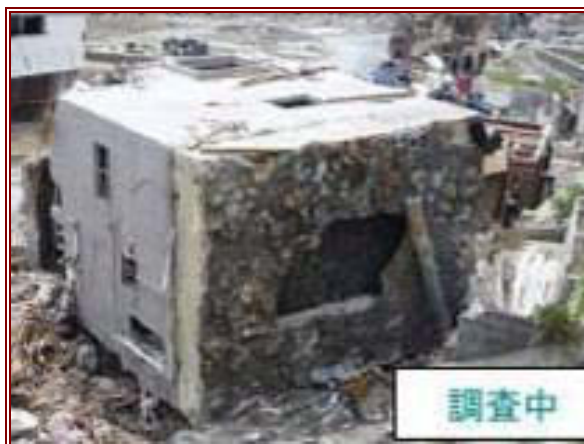
This structure is a 3-storey hotel of RC shear wall construction, with piled foundation (Figure 7.40). This structure lies approximately 30 m from its original position (Shuto, 2011); refer to Figure 7.35 for its final location.

Figure 7.40 (left) Building C (a hotel) transported 30 m landward from its original location (image from Shuto, 2011).

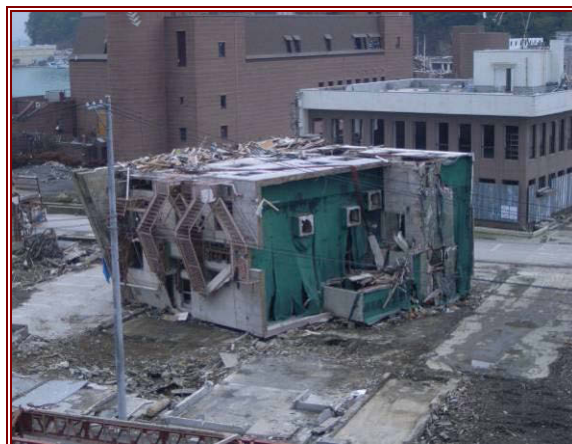
Figure 7.41 (right) Overturned steel frame structure (building D) viewed from the hospital car park.

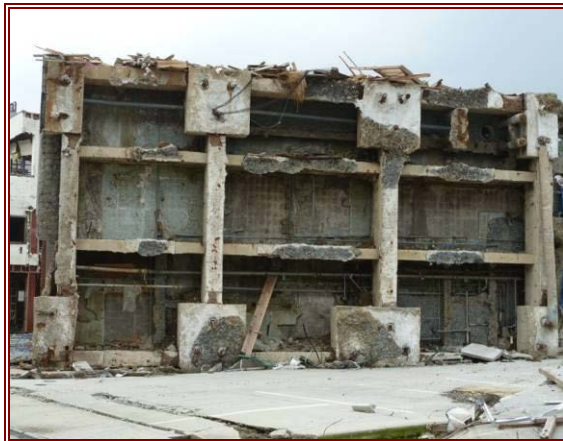
This 3-storey steel frame structure has a piled RC foundation with 2 to 3 piles at each of 8 pile caps. The RC pile that remains attached to the foundation beams by only reinforcement bars (right hand side of Figure 7.42). The failure of this building appears consistent with the explanation given for building A, although it is unclear why concrete cover remained on more of the piles in building A than building D. This may be due to a different grade of concrete or level of soil liquefaction at the two sites. Refer to Figure 7.35 for the final location of this structure.

Figure 7.42 (left) Foundations of the overturned building D.

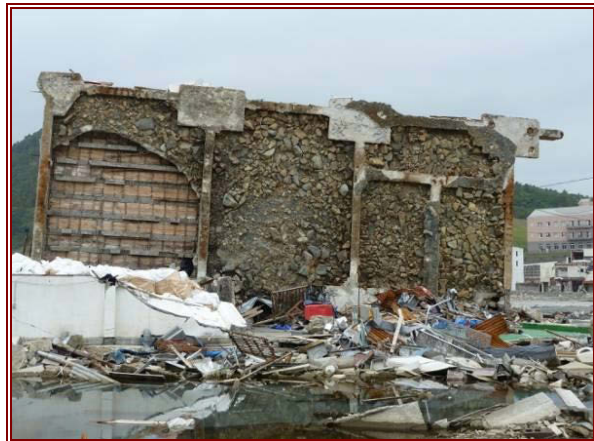
This 2-storey steel frame structure has a piled RC foundation (Figure 7.43 and Figure 7.44), similar to those in buildings A and D. No piles remain connected to the pile caps in this case, indicating a higher level of shear in the overturning motion than experienced at A and D. Refer to Figure 7.35 for the final location of this structure.

Figure 7.43 (right) Foundation view of building E.

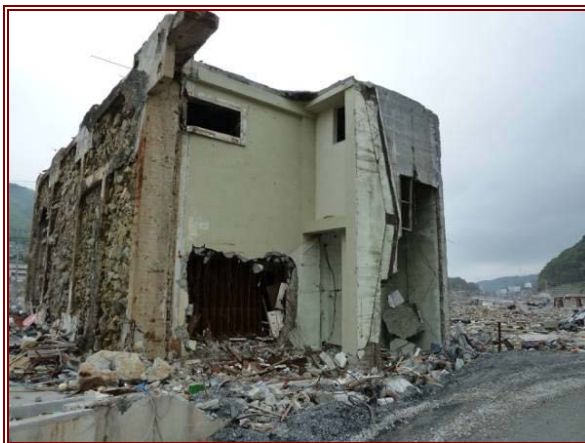
Figure 7.44 (left) View of building E showing out-of-plane failure of an infill wall.

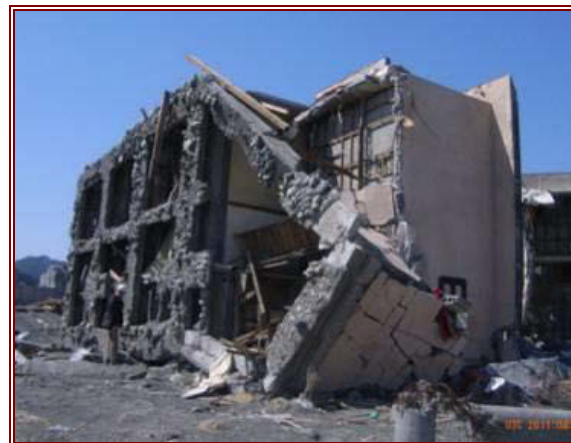
Figure 7.45 (right) An overturned RC dormitory building in Otsuchi (Chock, 2011).

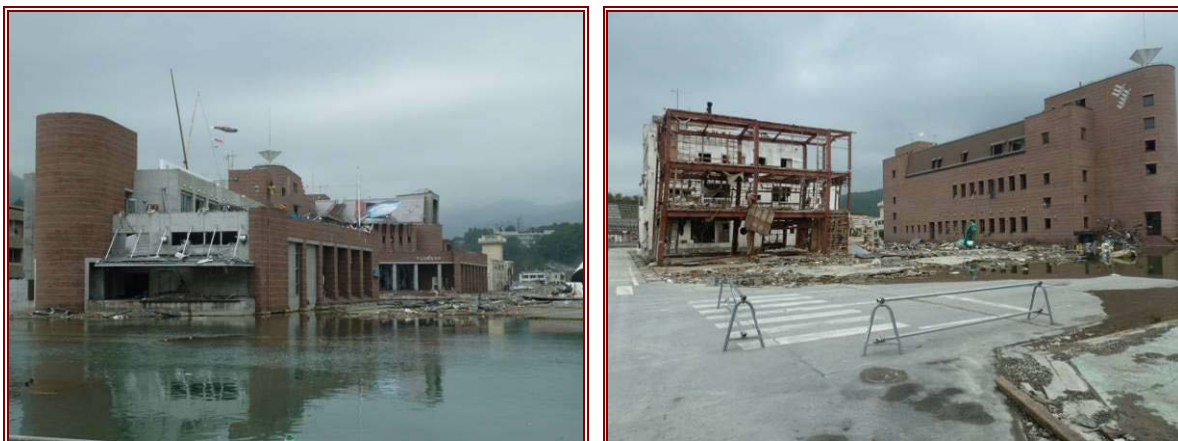
Despite extreme hydrodynamic forces in this survey zone, many buildings survived due to dense urban development affording a certain degree of sheltering. A 4-storey harbour-front complex of two buildings provided shelter to landward structures from incoming waves (Figure 7.46 and Figure 7.47). These structures suffered extensive damage to glazing, limited damage to masonry cladding, and the loss of an elevated walkway between the buildings. However, the pattern of surviving smaller buildings in the lee of these substantial structures suggests that sheltering occurred here (Figure 7.35). Of course the harbour-front structures would not have provided shelter in the return flow phase(s), but those buildings surviving the inflow phase would have exerted a sheltering influence during return flow.

Figure 7.46 (left) Seaward side of the harbour-front buildings.

Figure 7.47 (right) Landward side of the most northern of these buildings. Heavy non-structural damage to the steel frame building is believed to have occurred during tsunami return flow.

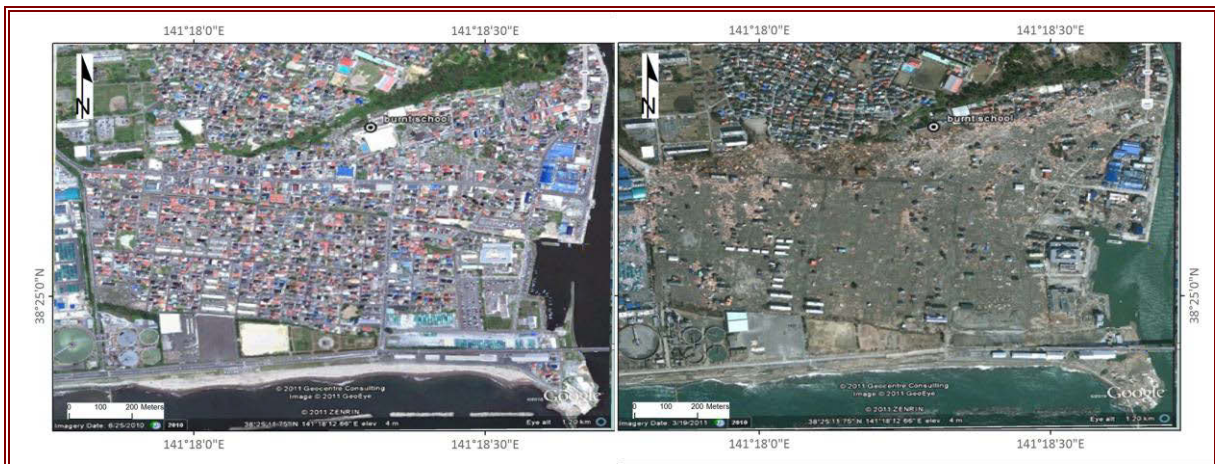
Examination of aerial photographs shows that the majority of structures remain standing in the inundated area of Ishinomaki, although there are some areas of almost entire destruction observed around the mouth of the river. Figure 7.48 shows the area immediately west of the river mouth) where significant subsidence was observed and only RC buildings remain standing. There is evidence of fire in this area, with one school building showing significant fire damage at the inland extent of inundation (see section 10.1.5) where higher land occurs. Subsidence occurred up to 0.78 m (GSI, 2011b) and flooding of land adjacent the river mouth and along the port front occurs at high tide. At the time of the EEFIT investigation new raised gravel roads were being laid and repairs were being made to the coastal defences.

Figure 7.48 Area of destruction west of the Kitakami River mouth in Ishinomaki (left image is dated 25th June 2010; right image is dated 19th March 2011). The burnt school, indicated, is discussed further in section 10.1.5. Land increases in elevation abruptly, initially to around 10 m at the line of trees in the north of this image.

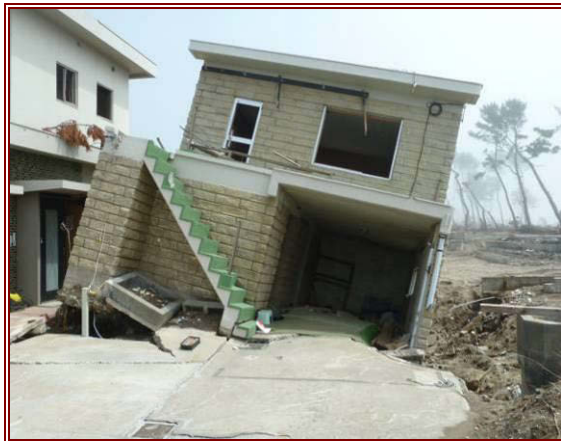
Inundation depth in this area was approximately 7.5 m, recorded at Arahama Elementary School. Significant scour of the sandy soil (old beach deposits) on the seaward side of buildings occurred in this area, causing tilting of several structures and exposure of foundations (Figure 7.53 and Figure 7.54). Scour up to 3 m depth resulted in the collapse of a tsunami warning siren behind the toilet block structure in Figure 7.55. Out-of-plane failure of infill walls of several RC and masonry structures (Figure 7.54) was observed further east at Nakacho, approximately 100 m landward of the concrete sea defences.

Figure 7.53 (left) Tilting due to scour on the seaward side of a residential building in Wakabayashi-ku.

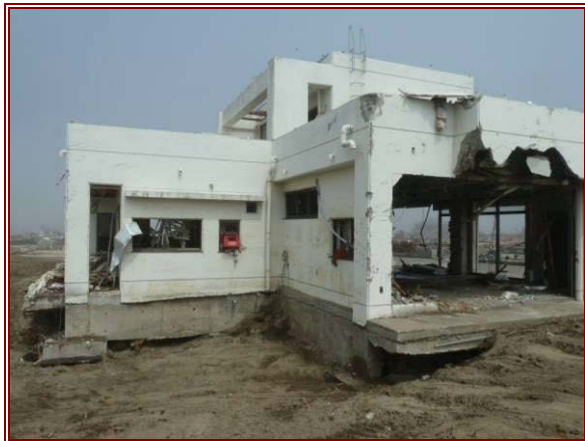
Figure 7.54 (right) Out-of-plane failure of RC residential structure in Wakabayashi-ku.

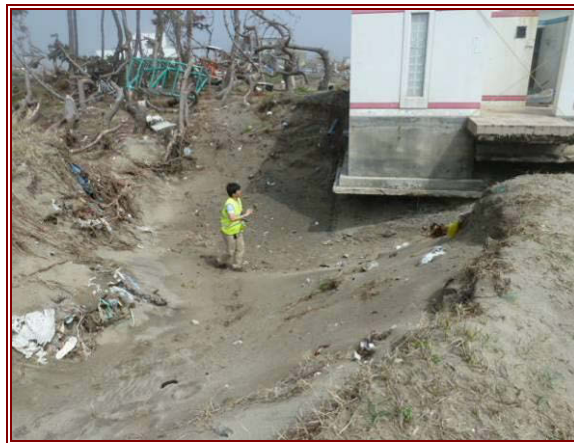
Figure 7.55 Extreme scour of approximately 86 m² around a toilet block constructed on sandy soil with shallow foundations. This building is 40 m landward of sea defences at Wakabayashi-ku.

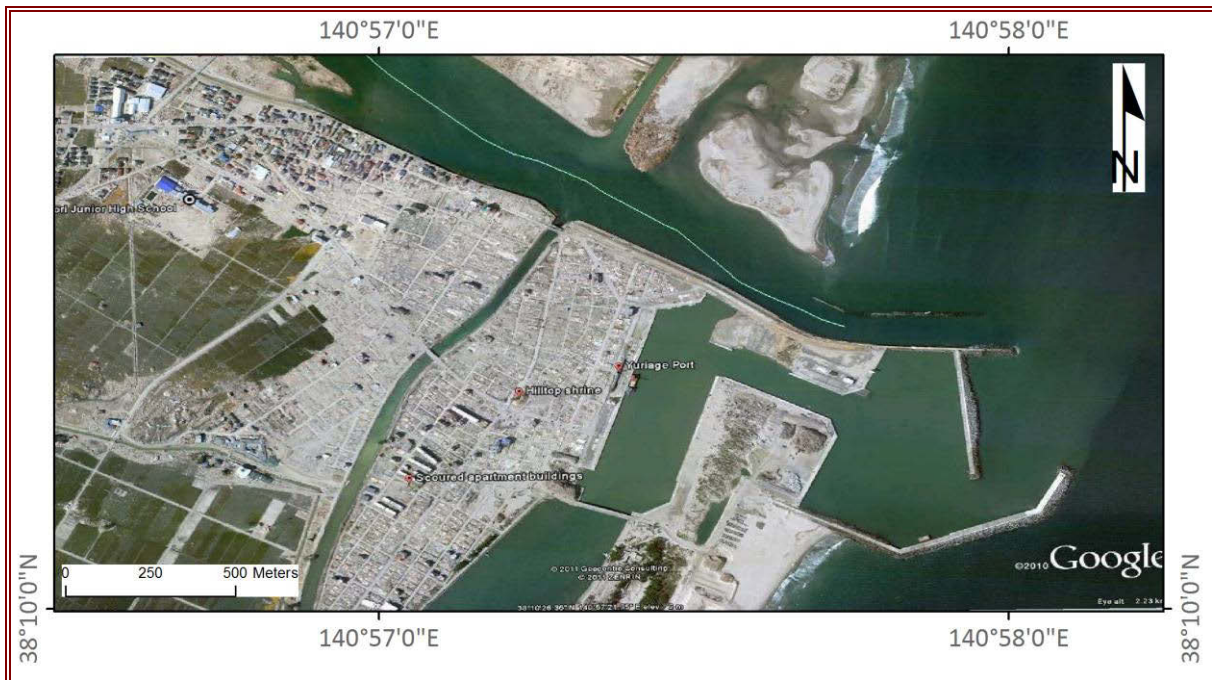
Figure 7.56 Post-tsunami aerial photograph of Yuriage, Natori City.

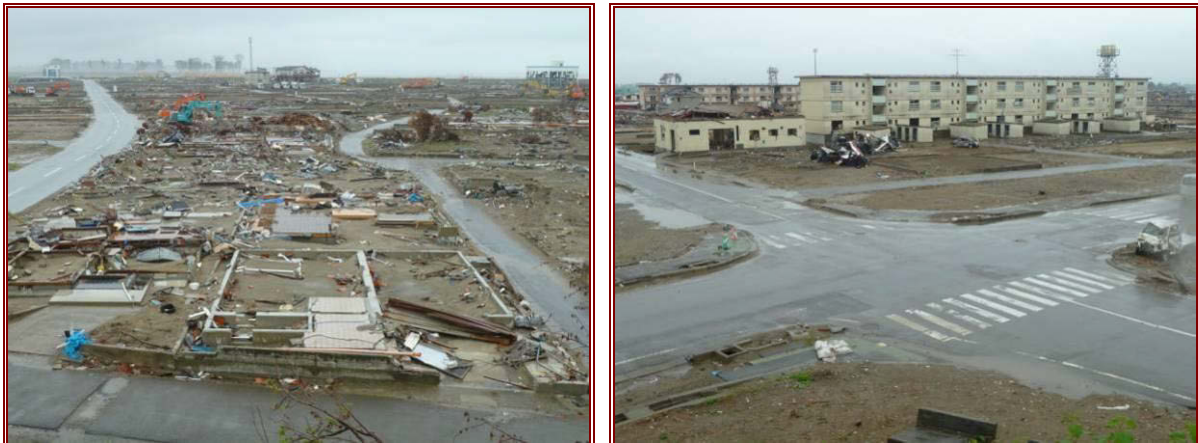
Figure 7.57 (left) View towards northeast from the hilltop shrine in Yuriage. Prior to the tsunami, this area comprised one and two storey residential buildings.

Figure 7.58 (right) View towards southwest from the hilltop shrine in Yuriage. Debris from collapsed residential and small commercial structures has been cleared from in front of these RC apartment blocks, which were inundated to the second storey.

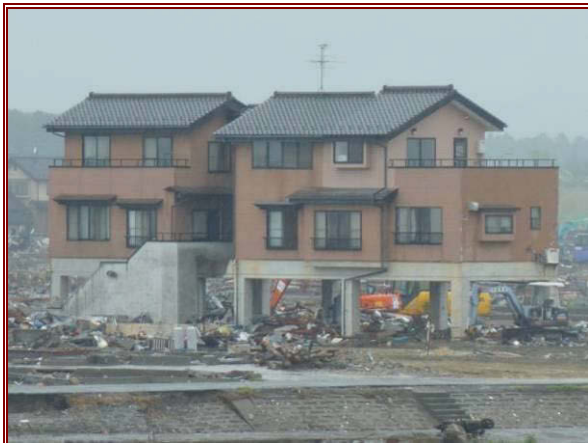
Almost all of the timber frame residential building stock in Yuriage sustained complete collapse (D4), while steel and RC structures sustained damage ranging from light (D1) to collapse (D4). Examples of residential construction with open ground floor were observed (Figure 7.59). These buildings, although sustaining minor debris-induced damage on the river-facing side, appear to have avoided significant damage. It was unclear whether scour occurred at the base of the RC columns.

Figure 7.59 (left) Residential buildings in Yuriage constructed with an open ground floor.

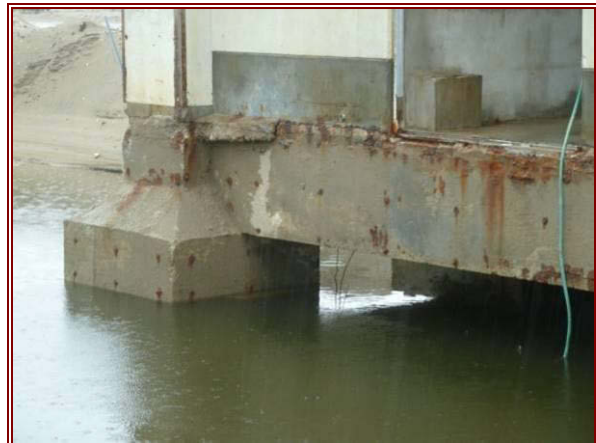
The port building and wharf sustained partial collapse in this event. Three large scour holes (e.g. Figure 7.60) occurred at the port with footprints measuring approximately 20 m*9 m, 12 m*7 m and 20 m*11 m respectively (and each at least 1.5 m deep). The RC port building remains standing, sustained out-of-plane failure of all hollow block masonry infill walls and the second storey has been removed. The majority of reinforcement of the concrete block infill walls is un-deformed rebar.

Figure 7.60 (right) Deep scour of foundations at the front left corner of Yuriage port building.

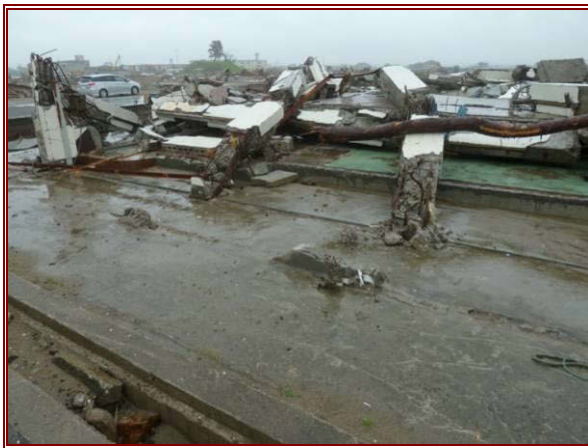
Another example showing collapse in RC construction is located immediately inland of the port building (Figure 7.61 and Figure 7.62). The consistent failure direction of columns indicates flow direction from the east (heading of approximately 260°), which indicates that the wave arrived approximately perpendicular to the coastline, directly into the river mouth and crossing Yuriage harbour where there are no significant coastal defences.

Figure 7.61 (left) Failure of RC columns showing flow direction adjacent to Yuriage port.

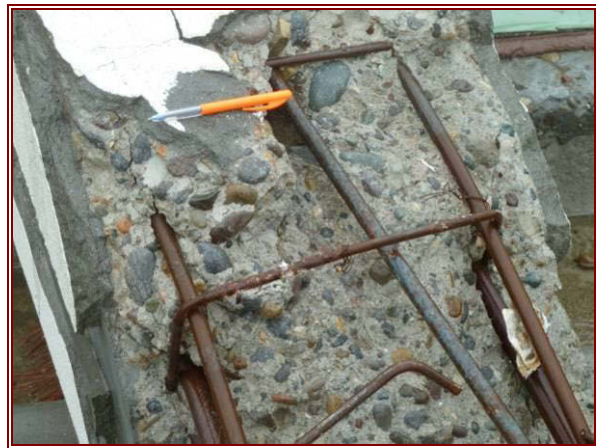
Figure 7.62 (right) Close-up photographs of un-deformed steel reinforcement (Pen for scale: 13 cm).

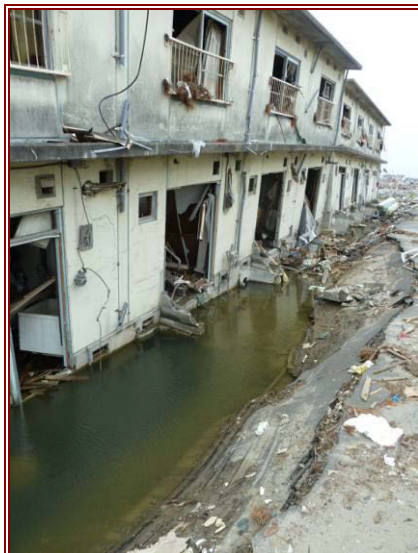
Significant scour was observed at a row of RC apartment buildings in Yuriage. The aerial photograph below shows the location of scour to depths of 2 m around the eastern (seaward) end and northern sides of the buildings, indicated by arrows and polygons in Figure 7.63. Some of the buildings have been undercut to the extent that they have tilted (Figure 7.64 and Figure 7.65). Scour along the edge of block D extended as much as 2.5 m from the edge of the building. The predominance of scouring on the seaward end of the buildings implies this scour is occurred during the return flow of the tsunami (scouring in rivers typically occurs on the downstream-end of pier columns).

Figure 7.64 (left) View along the north side of one apartment block, illustrating scour of the full length of building.

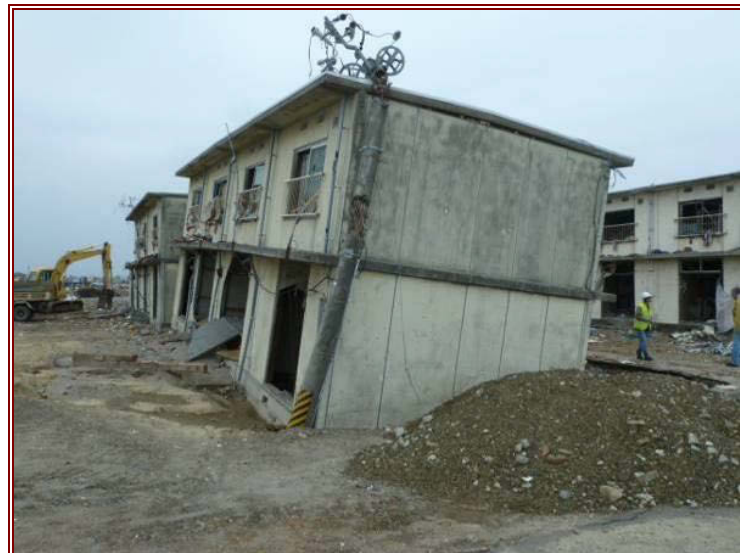
Figure 7.65 (right) Loss of soil providing bearing capacity to support the footings resulted in significant displacement of apartment building – note the displacement of building in foreground compared to building in background.

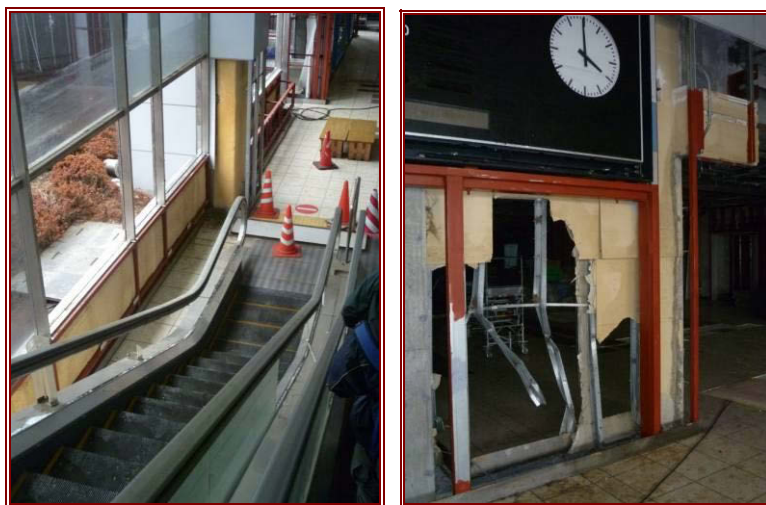
Sendai airport terminal, 1 km inland, is a 4- storey steel and RC construction with a significant amount of exterior glazing on all floors. Inundation depth at the airport was 5.7 m and caused damage to the ground floor of the terminal – inside the terminal steel frame partition walls had been bent by debris strike, and infill panels were missing from partition walls (Figure 7.66 and Figure 7.67). While the upper floors of the terminal were unaffected by inundation, non-structural earthquake damage (damage to the suspended ceiling) caused these areas to remain closed until at least 29th May 2011. The airport resumed business on 13th April 2011 with a limited number of flights operating and some parts of the terminal still closed.

Airport staff reported that the windows broke only when struck by debris, not due to wave loading alone. No large aircraft were located at the airport when the tsunami occurred (one plane was due to land and was diverted), reducing the potential for more extensive debris damage.

Figure 7.66 (left) View to ground floor showing damaged escalator and glazing, and 3.5 m high watermark on glazing.

Figure 7.67 (right) Damage to ground floor partition walls and clock recording the time of power outage due to tsunami inundation.

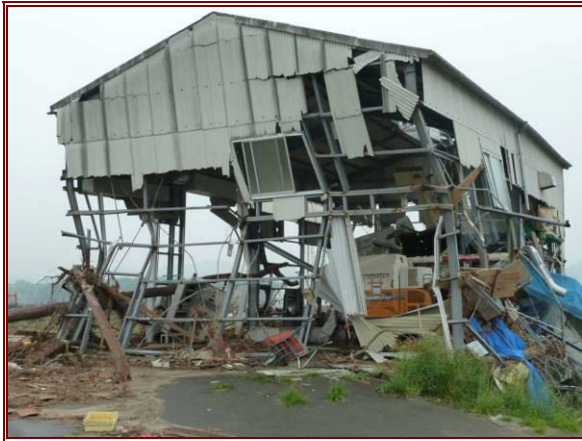
Observations from Yamamoto-cho and Watari provide examples of debris impact on steel structures. One steel frame agricultural building (Figure 7.68 and Figure 7.69) located 1 km inland (37° 57' 26.39" N, 140° 54' 18.44" E) was struck on the front left side by a tree trunk measuring 0.2 m in diameter close to the impact point. The source of this tree appears to be the coastal forest and provides an example of the damage that may be caused by such defensive mechanisms even far inland. The structural columns of this building measure 0.09 m * 0.18 m. We do not have an indication of flow velocity at this location from which to estimate the force of this impact, therefore the load applied by the debris. The front right structural column also appears to be bent to a lesser extent, as a result of the initial impact. The damage to the rest of this building was typical of steel structures observed throughout the mission: steel frame remaining intact with panel walls removed by the tsunami flow.

Figure 7.68 (left) View of the front of steel building, struck by tree trunk on left structural column. Tsunami flow inland was towards this face of the building.

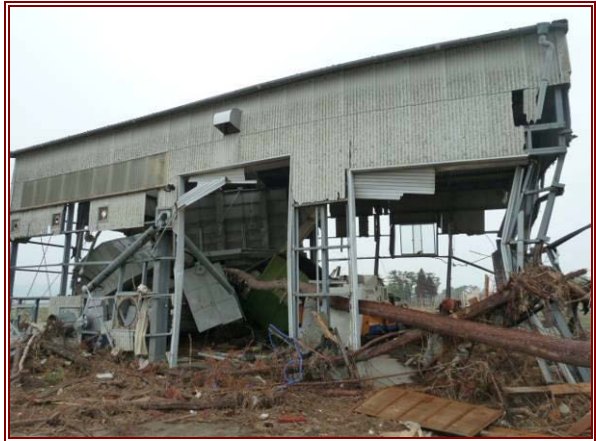
Figure 7.69 (right) View of the left side of steel building. All middle and rear structural columns are intact – only the front columns are bent by the impact of this tree trunk.

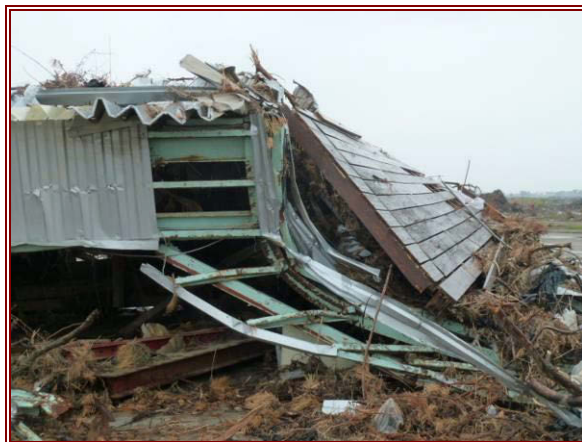
An example of total collapse of a single storey steel frame (small commercial) building was observed where an apparent debris impact or damming effect has caused bending failure of the structural columns (Figure 7.70 and Figure 7.71). Several of the structural columns show „S-bending“ of varying angle with fracturing at the base of the columns. The roof beam is also buckled as a result of the columns bending. There is no evidence of a debris impact from above – with the exception of a small hole (1 m*1 m approximately) in the corrugated roofing, there are no significant damages to the roofing material. We initially considered this to have been caused by an impact from a significantly damaged coach that was situated adjacent to the building. This conclusion was drawn from paint scratches on the coach matching the green paint on this building. However, review of satellite imagery shows no coach at this location in the days immediately after the tsunami, therefore we cannot

Figure 7.70 (left) View of the front left corner of the building, which appears to have been the column struck by debris.

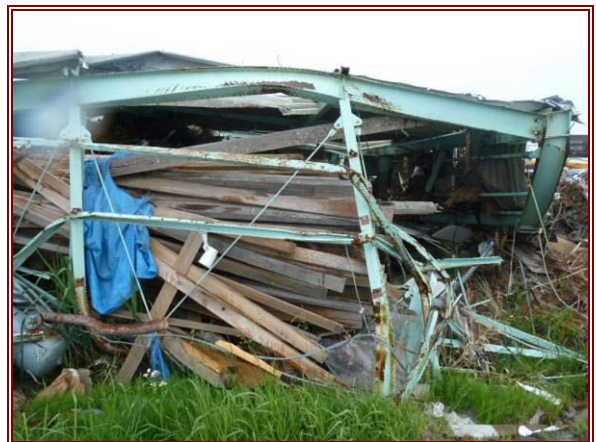
It is postulated that this coach may have struck the building during the course of the tsunami but then have been washed away. As the coach impact cannot be confirmed, an alternative hypothesis is presented: that the debris inside the structure (Figure 7.71) caused a damming effect with major loading on the rear right column, which dragged the rest of the structure towards it.

Figure 7.71 (right) The rear of the building. This shows the buckling of one corner column and the roof beam. The structure is full of wooden debris also contains at least 4 classic cars.

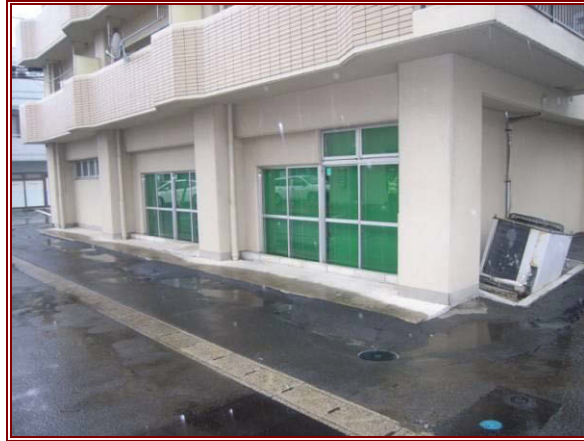
Several locations in the eastern outskirts of Sendai City (near to the coast) suffered ground settlements. Figure 8.2 shows a 6-storey reinforced concrete (RC) building where the structure has settled relative to the surrounding soil. The adjacent air-conditioner compressor was tilted, indicating weak soil condition. This is substantiated with the borehole data indicating low SPT values at shallow soil depth in Sendai as shown in Figure 8.3. Due to the high water table in combination with the sandy nature of the soil, such effects could also be the result of soil liquefaction. However, there was no other clear indication of liquefaction nearby to confirm the hypothesis. On the contrary, many high-rise buildings in Sendai suffered lower settlement relative to the adjacent soil as shown in Figure 8.4. The difference between the two cases could be due to the difference in pile penetration depth. At further locations, sand boils were observed within the vicinity of the K-NET station near the Oroshi district. The difference between the two cases could be due to the difference in pile penetration depth.

Figure 8.2 Settlement of a 6-storey building in Yamoto-machi, Sendai City.

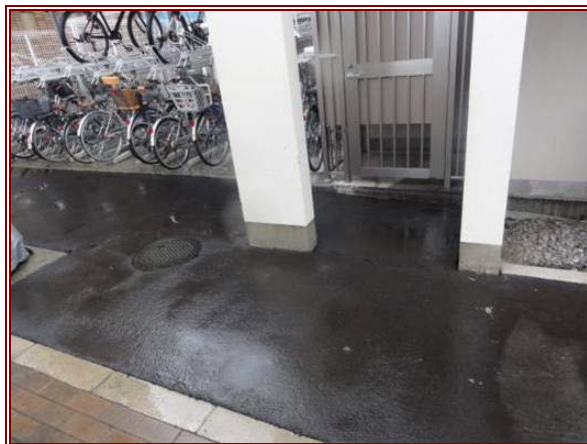
Figure 8.4 Lower building settlement relative to surrounding ground, in Yamato-machi, Sendai City.

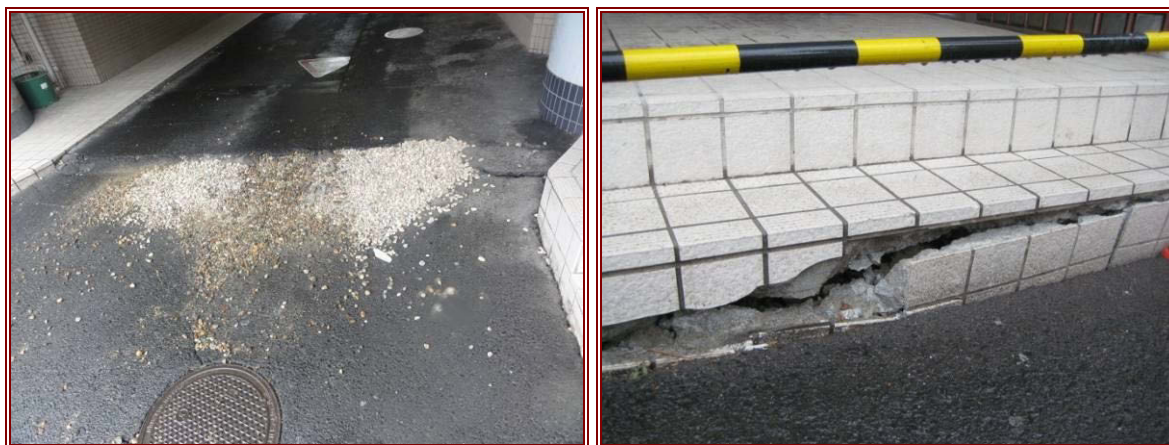
Some damage due to ground settlement was observed on external staircases, parapets and roadways leading to car parks at the ground level as shown in Figure 8.5. Significant settlements measuring as much as 70 mm were observed. However, these generally did not affect the structural integrity of these buildings, which are most likely sited on deep foundations. Some low-rise buildings founded on shallow footings suffered damage that rendered them unsuitable for occupancy. In the case of low-rise wooden structures, the damage was predominantly structural rather than geotechnical as illustrated in Figure 8.6.

Figure 8.5 Settlement-induced damage to (a) car park roadway and (b) external staircase.

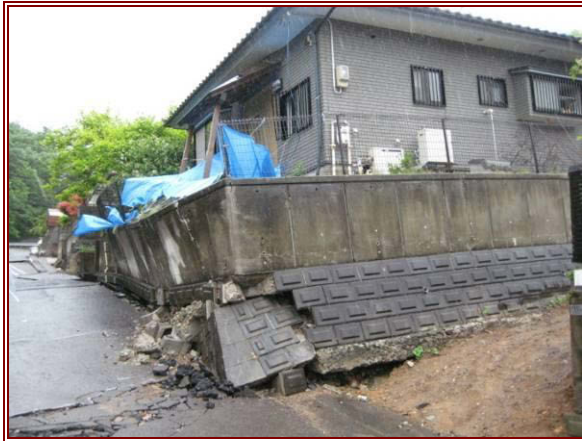
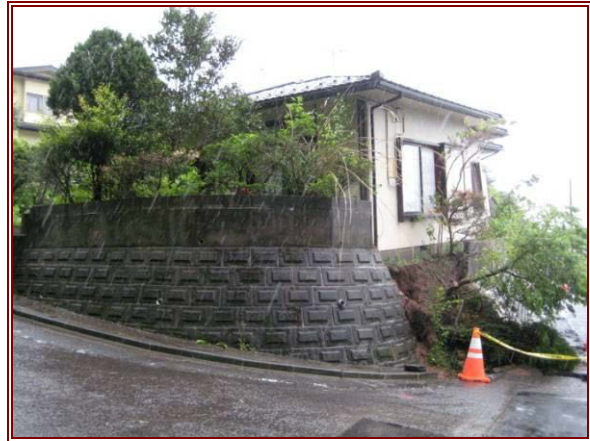
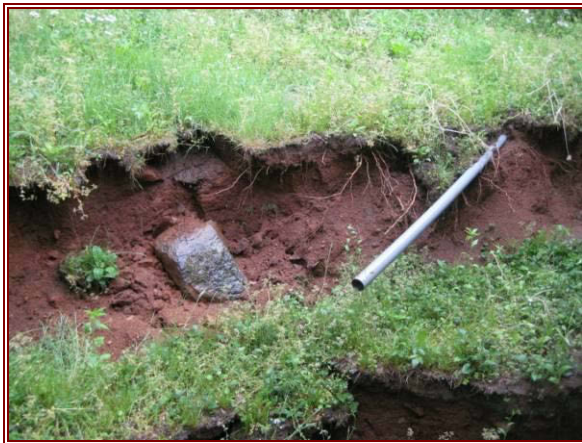
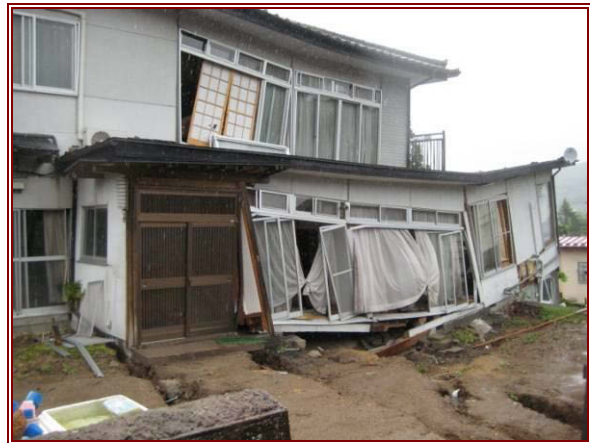
In the mountainous terrain of Sendai, several low-rise residential houses at Oritate suffered damage due to slope failure. These houses are relatively new and are sited on shallow foundations which displaced significantly due to movement of the soil surface layer during ground shaking (Figure 8.8). Tension cracks were also widely observed on the ground. The affected houses had been evacuated and labelled „unsafe“ for occupancy. EEFIT was informed by locals that the residential development was built on fill material. Houses sited at boundary areas between cut and fill can also result in significant differential strains, thereby causing more damage. Improvements to either the condition of the ground or to the foundations of these houses and retaining walls may be necessary to prevent similar slope failure in times of heavy rainfall and further strong earthquake shaking. A landslide warning siren was audible at the time of our visit, as it was raining heavily.

Figure 8.8 Damage to houses (a, b, d) and tension cracks (c) due to slope instability in Oritate, Sendai City.
