**THE M_w 9.0 TŌHOKU
EARTHQUAKE AND TSUNAMI OF
11TH MARCH 2011
A FIELD REPORT BY EEFIT**

A FIELD REPORT BY EEFIT

Mr. Antonios Pomonis, *CAR Limited, Global Earthquake Model* (Team Leader)

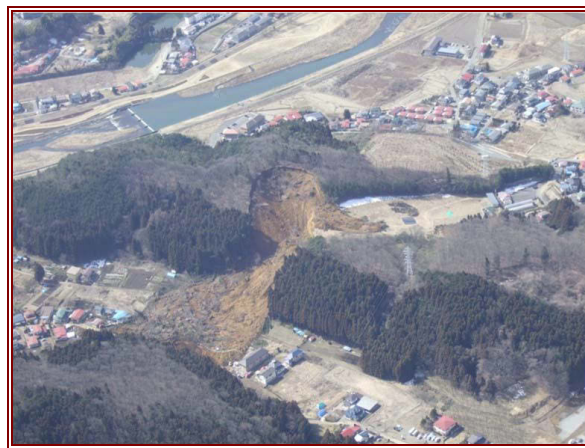
Another landslide was investigated in the village of Hanokidaira. This is the most significant earthquake-induced landslide reported in this region. The landslide was also reported with aerial photographs in the survey report by PWRI (2011) (Figure 8.10). The landslide killed 13 people and destroyed 10 houses along the path of the runoff. The estimated size of the landslide is 150 m in length and 60 m in width, and the runoff volume was about 10,000 m³ (Umemura, 2011). The size of the landslide is shown by the presence of an team EEFIT member in Figure 8.11a. Silty sand was observed at the exposed landslide slip surface. Only the foundations of these houses remain as shown in Figure 8.11b. A road adjacent to the debris runoff was also buried, but this had been repaired and the debris moved to the sides of the road at the time of the reconnaissance.

Figure 8.10 Aerial photograph of the landslide at Hanokidaira, Shirakawa (PWRI, 2011).

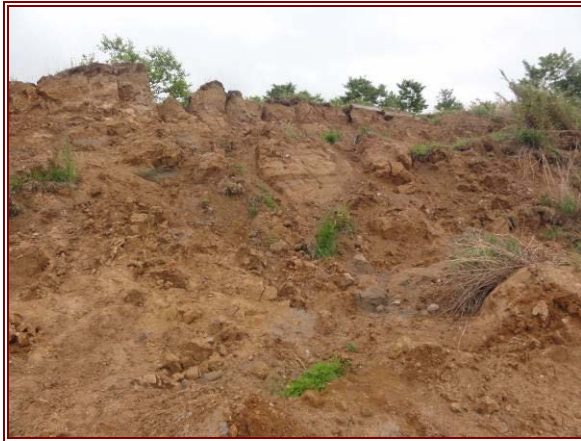
Another landslide was observed in Akasaka (Figure 8.12a). The road adjacent to the landslide was closed at the time of visit (Figure 8.12b). Based on Figure 8.12c, the landslide consisted of a few loose sections of soil mass displaced from the original slope profile. Tension cracks could also be seen further up the slope as shown in Figure 8.12d, where there is an agriculture plain. With more exposure of the soil to rainfall seepage through tension cracks on the surface of the slope, the loose sections of soil may move further downslope over time. This might be the reason for the apparent delay in road repair at this site.

(a) Landslide at Akasaka

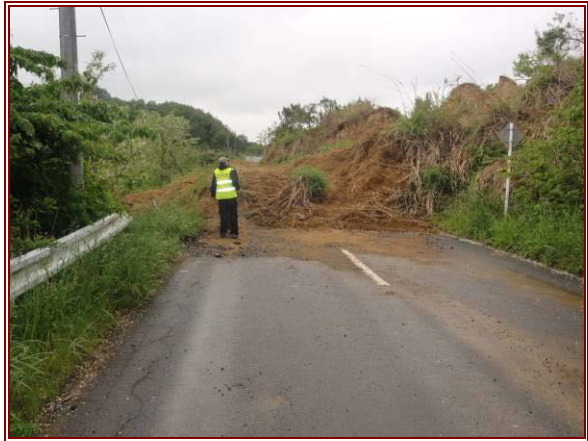
(b) Road buried by landslide debris

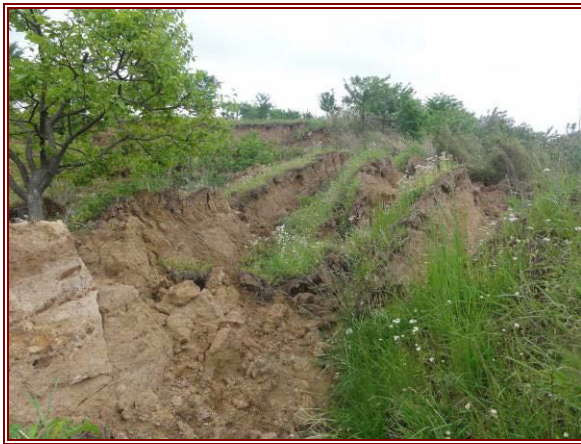
(c) Loose sections of displaced soil

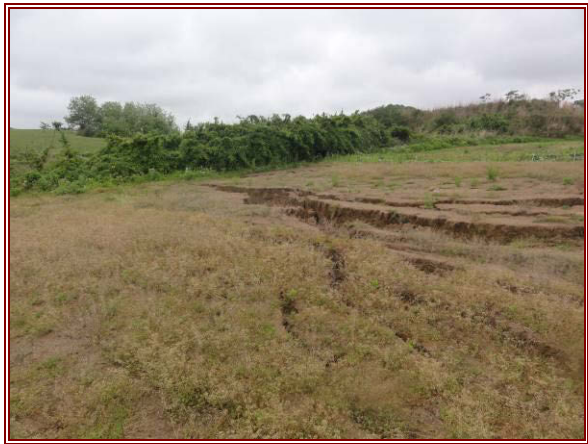
(d) Tension cracks near summit of slope

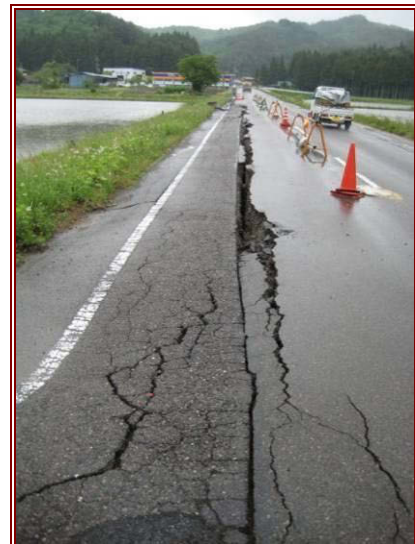
(b) Lateral spreading

Figure 8.13 Soil liquefaction induced damage in Nishishirakawa, Shirakawa, Fukushima Prefecture.

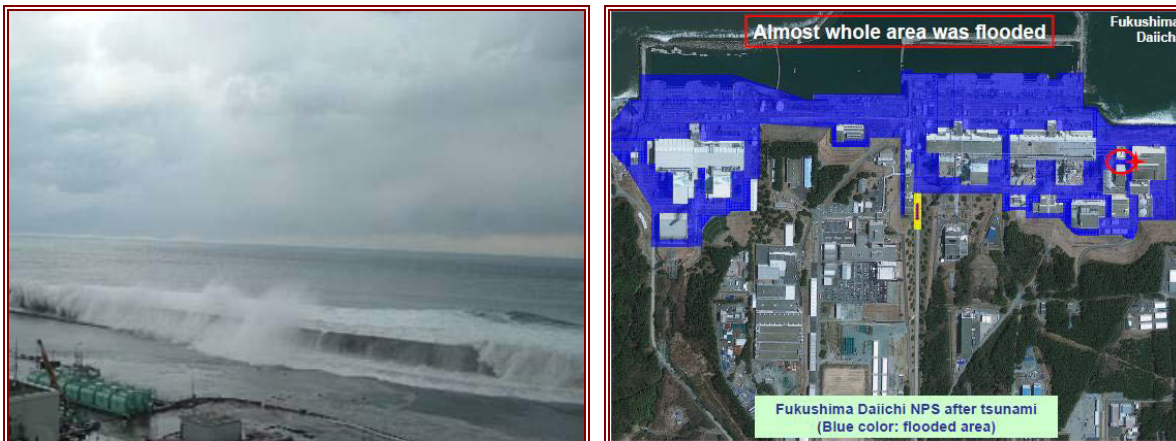
The design tsunami height was 5.4 to 5.7 m (JSCE, 2002) and to include a margin of safety the elevation of the plant was set higher (IAEA, 2011b) – the site elevation of Fukushima Daiichi NPS is 10 m at Units 1 to 4, and 13 m at Units 5 and 6. The tsunami on 11th March 2011 was 14 to 15 m high as it struck the sea defences and overwhelmed the sea protection walls of the plant shown in Figure 9.2 and Figure 9.3 (TEPCO, 2011b).

Figure 9.4 shows the extent of inundation at Fukushima Daiichi. As the sea water pump facilities for component cooling were at an elevation of between 5.6 to 6 m at Fukushima Daiichi NPS, all units were flooded by the tsunami. Emergency diesel generators and switchboards installed in the

Figure 9.3 (left) Tsunami overtopping sea defences at Fukushima Daiichi (TEPCO, 2011b).

Figure 9.4 (right) Areas of the Fukushima Daiichi NPS inundated by tsunami (TEPCO, 2011b).

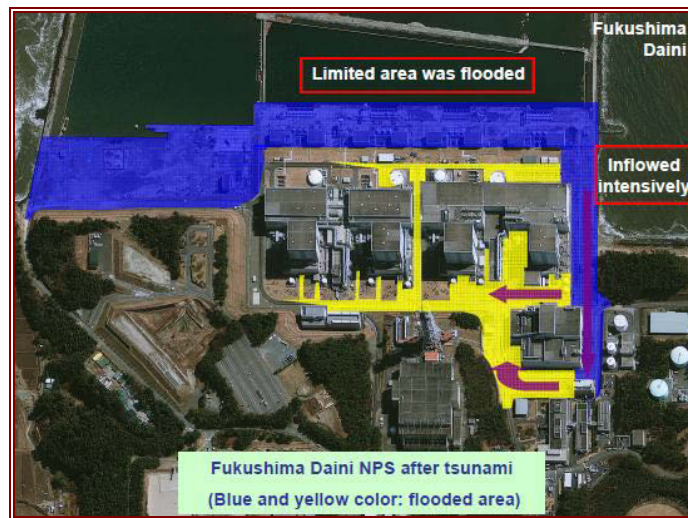
Tsunami inundation at Fukushima Daini is shown in Figure 9.5 and was not as significant as at the Fukushima Daiichi site (TEPCO, 2011b). The sea water pump facilities for cooling of all units (elevation: 6 m) were flooded by tsunami and stopped working at all units except Unit 3. The emergency diesel generators installed in the basement of the reactor buildings (elevation: 0 m) continued functioning for Unit 3 and 4, however, these failed for other units due to flooding (IAEA, 2011b).

Figure 9.5 Areas inundated by the tsunami at Fukushima Daini NPS (TEPCO, 2011b).

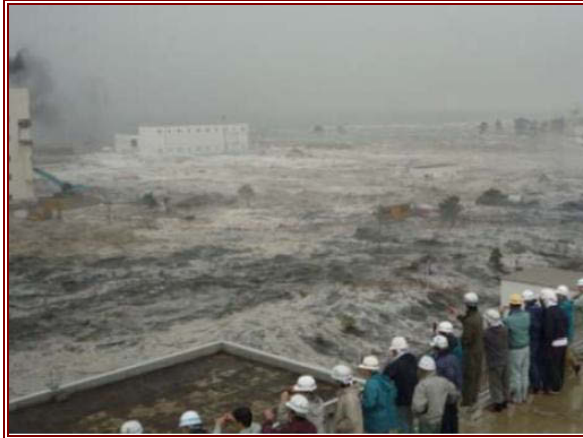
Minami-Gamou centre in Sendai was severely affected by the tsunami, as can be seen in Figure 9.9. The plant is constructed at an elevation of about 1.5 m above the beach level, behind a vertical concrete sea wall of the same height. The plant is located approximately 300 m from the sea. The height of the tsunami was approximately 7 m in this area.

Figure 9.9 (left) Tsunami at Minami Gamou Sewage Treatment Plant (Sendai City, 2011a).

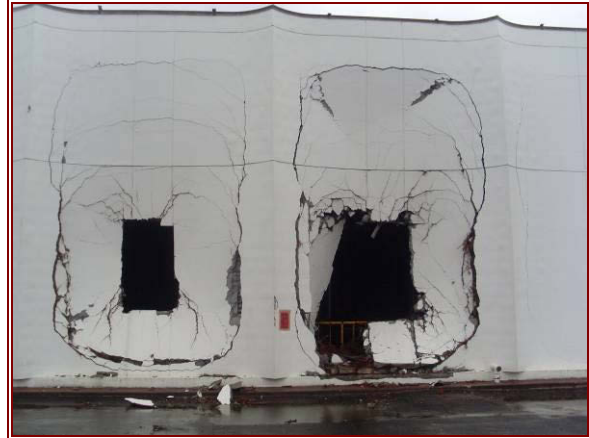
The earthquake and tsunami caused considerable damage to the structures of the site and Figure 9.10 shows plastic yielding of 300 mm thick wall panels at the „Reaction Place“ of the Sewage Treatment Plant. The span of the wall was approximately 4 m, and height approximately 6 m. The wall was reinforced in both directions with bars approximately 10 mm in diameter at approximately 250 mm centres. Similarly, across the sewage treatment plant there was considerable damage to pipework, building structures, roads, pumps, and electrical cabinets within the building structures (Figure 9.11).

Figure 9.10 (right) Plastic yielding (due to tsunami flow) of 300 mm thick RC panel at Minami Gamou Sewage Treatment Plant.

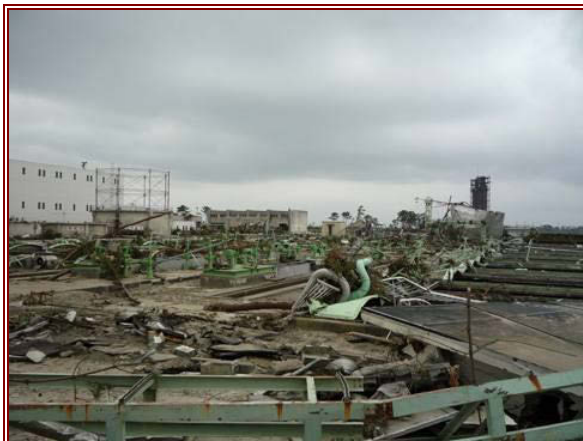
Figure 9.11 (left) Damage to Minami Gamou Sewage Treatment Plant (Sendai City, 2011b).

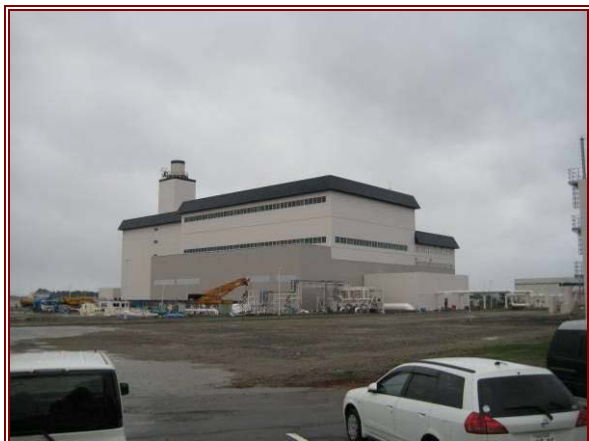
The site was visited on 30th May 2011, and can be seen in Figure 9.12. The station is approximately 300 m from the coast. The external appearance of the site at the time of inspection seemed to be in good order, however, it was clear from the damaged domestic properties across the street that the

area had been affected by tsunami, and the ground floor was submerged. The height of the tsunami in this area was approximately 12 m. Plant 4 stopped its operation automatically. Plant 4 is not restored as of June 2011 and will not be restored until the summer of 2011 (Anon., 2011).

Figure 9.12 (right) Sendai Thermal Power Plant at Shichigahama.

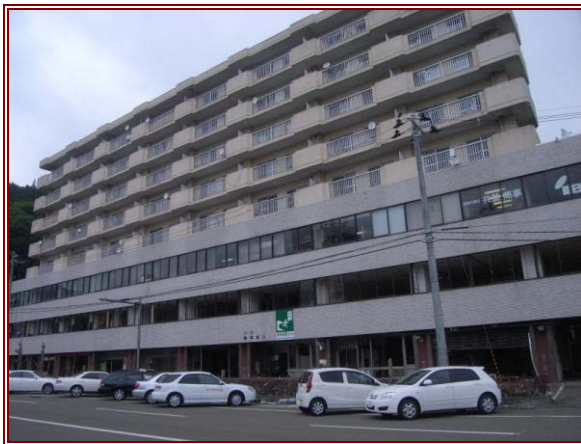
Figure 10.12 (left) Eight-storey RC frame evacuation structure with steel frame structure on the seaward face. Two external staircases for the fourth floor exist on the other side of the building.

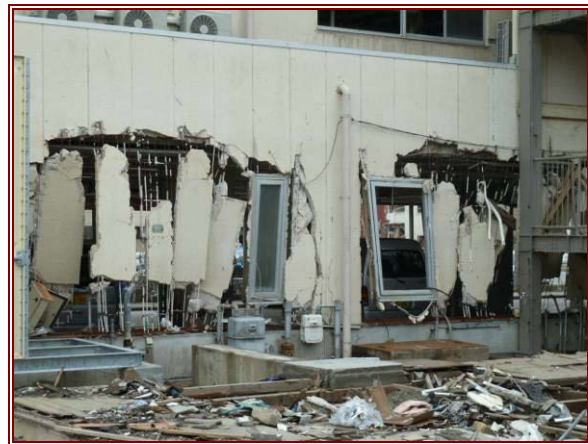
EEFIT investigated a designated vertical evacuation structure (8-storey RC frame construction) situated 70 m from the coastline (39° 16' 26.7" N, 14° 53' 17.6" E, Figure 7.5), with vertical evacuation signage at building entrances. The narrow side of this mixed-use office and apartment building faces seaward and a steel framed vertical structure is attached to the seaward face (Figure 10.12). Although it is unclear if this steel frame was deliberately designed as a sacrificial structure, but it has been damaged by debris impact with no damage to the main building behind. The ground floor towards the rear of the building is used as a car park and as such is open plan with RC infill panels which were damaged in the tsunami (Figure 10.13). This building was inundated to the 3rd floor, but occupants were able to evacuate to the designated evacuation area on the fourth floor and above.

Figure 10.13 (right) RC in-fill panels damaged by tsunami flow or debris impact.

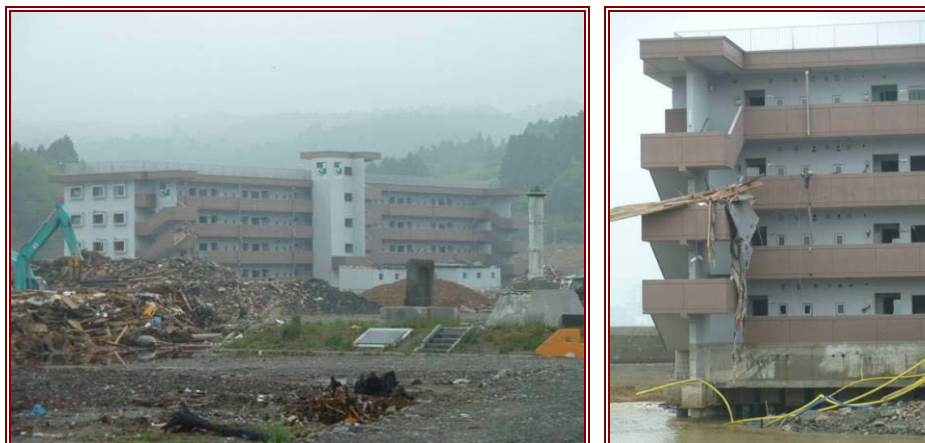
A 4-storey RC apartment block at the harbour front (south-side), constructed between 2002 and 2010, and was designated for vertical evacuation in Minamisanriku. The structure is built with its long side parallel to the harbour front, which does not appear to have affected its structural performance (from external observations only). Signage indicating its vertical evacuation function is well positioned on the central columns and external staircases (Figure 10.14). Inundation occurred to at least the third storey and the structure has remained standing despite scouring of the piled foundations to at least 2 m below previous ground level (Figure 10.15). Detailed investigation of this building was not possible due to subsidence-induced flooding in the area, and it is not known how many people evacuated to this building.

Figure 10.14 (left) Harbour-front designated evacuation structure. Vertical Evacuation signage (green) is visible on the landward (rear) side and at external staircases.

Figure 10.15 (right) Scour to over 2 metres deep exposing concrete piles at the north end of the building.

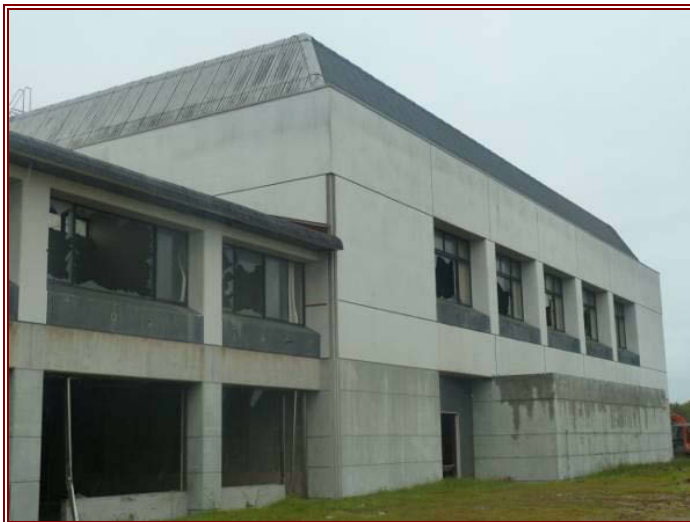
This precast concrete gymnasium building has a damaged sign at the car park entrance designating it as a vertical evacuation site, despite design for its everyday function being unsuitable for evacuation requirements. This structure is situated immediately south of Sendai port and is 380 m from the open ocean with a small estuary (150 m wide) on the inland side of the beach. A series of dykes separates part of the estuary into individual ponds for unknown use – the dykes were breached by the tsunami and had been repaired with sandbags at the time of investigation. The building appears as tall as a three storey building, but due to its function as a sports court (single storey, high ceiling) it has no upper floor in the main hall, and very little second storey floor space in the adjoining building. There is no easy external access to the roof (only a small maintenance ladder). Only non-structural damage is apparent: glazing, damaged wall cladding, minor scour and lifting of the gymnasium floor.

Figure 10.20 (left) Seaward side of the gymnasium building. The maintenance ladder to the roof is visible in the upper left of photo.

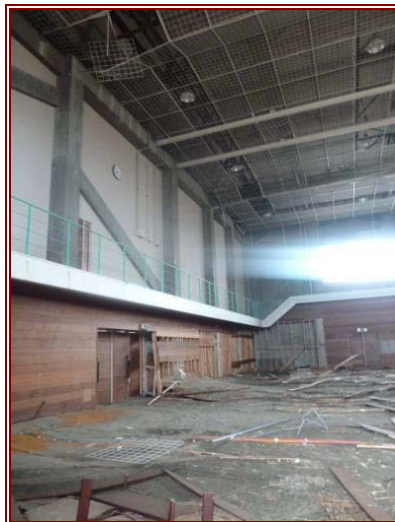
Figure 10.21 (right) Evidence of damage to the sports hall, indicating the lack of upper-floor capacity here.

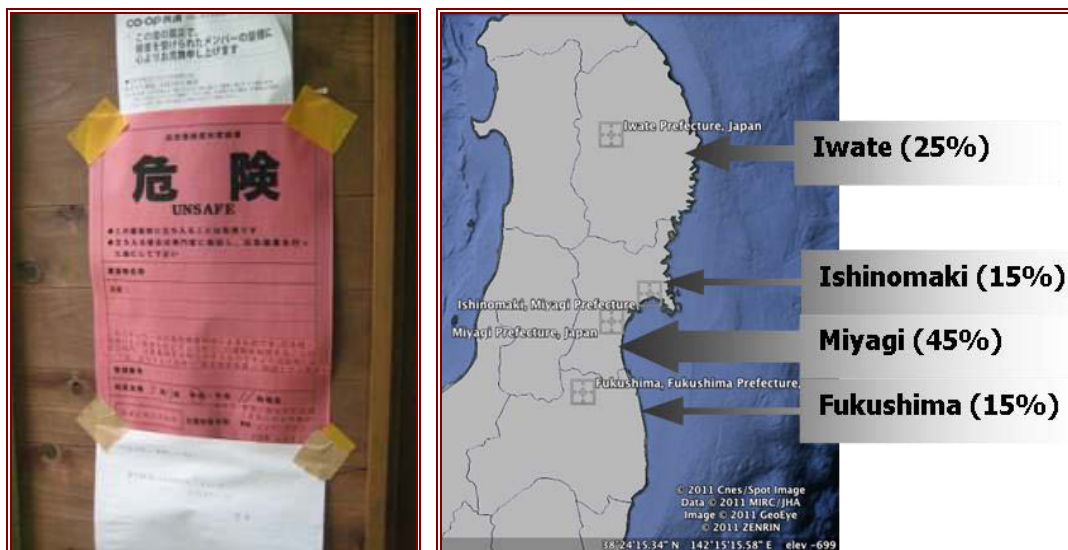
Figure 11.6 (left) Following engineering inspection unsafe buildings are labelled as shown, prohibiting entry. Similar green labels designate the building as „safe“ and yellow labels as „limited entry“, meaning for entry inspection purposes only.

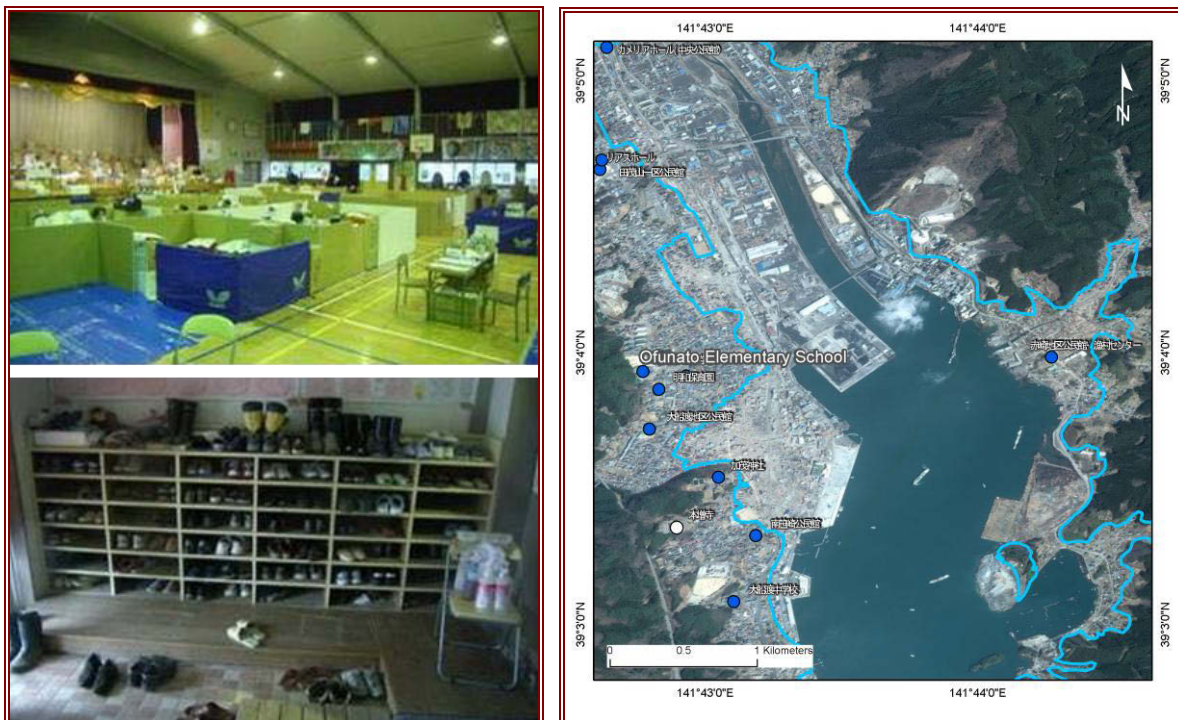
Figure 11.15 (left) Ōfunato Elementary School evacuation centre. Initially > 300 evacuees down to 70 by 30th May. In this centre cooking etc. is carried out by the evacuees themselves. People remove shoes when entering the centre, as is traditional in Japanese homes.
