# THE $M_w$ 7.8 GORKHA, NEPAL EARTHQUAKE OF 25 APRIL 2015

A FIELD REPORT BY EEFIT

August 2019

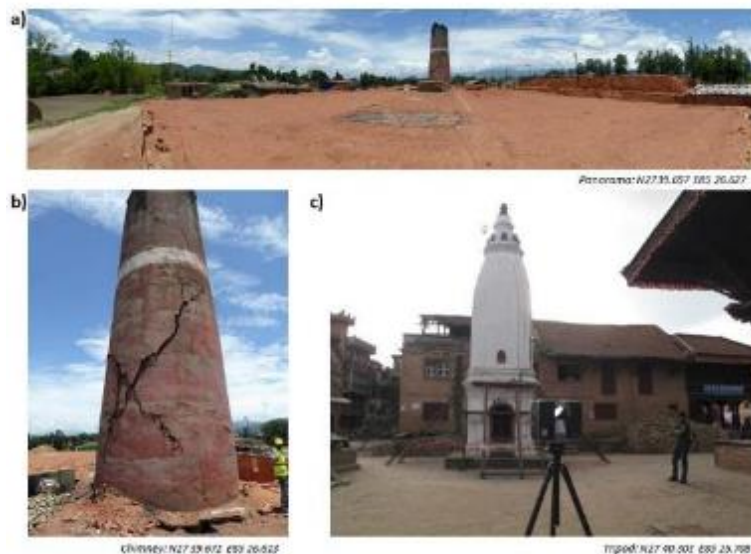
Figure 2-17 Kiln chimney and stupa, Kathmandu.

Kiln chimney and stupa, Kathmandu. a) Panorama of a brick making factory near to Kathmandu. b) Close-up of shear damage to the brick kiln chimney seen in panorama (a). The GPS waypoint coordinates given at the bottom of (a) and (b) are the photographer’s position. Waypoint (a) to (b) is 36 m. The bearing photographer-to-centre “X” damage is  $N08^{\circ}E$ . c) A damaged stupa in the centre of Kathmandu. On inspection the stupa shows damage similar to the kiln chimney. The stupa was imaged in detail using a 3-D laser scanner. The GPS waypoint is beneath the tripod supporting the 3-D laser scanner in the foreground of (c)

The panorama of Figure 2-17a shows a brick making factory near Kathmandu. This panorama was photographed from the south of the site. The brick baking kiln chimney is near the centre of the panorama, and seen close-to in the photograph Figure 2-17b. The distance between the two GPS waypoints taken at these two photographs is 36 m. Shear crack damage to the

brick kiln chimney is very visible in Figure 2-17b. The bearing from the photographer to the centre of the “X” shaped damage is N08°E. This chimney was photographed from all four quadrants (not illustrated).

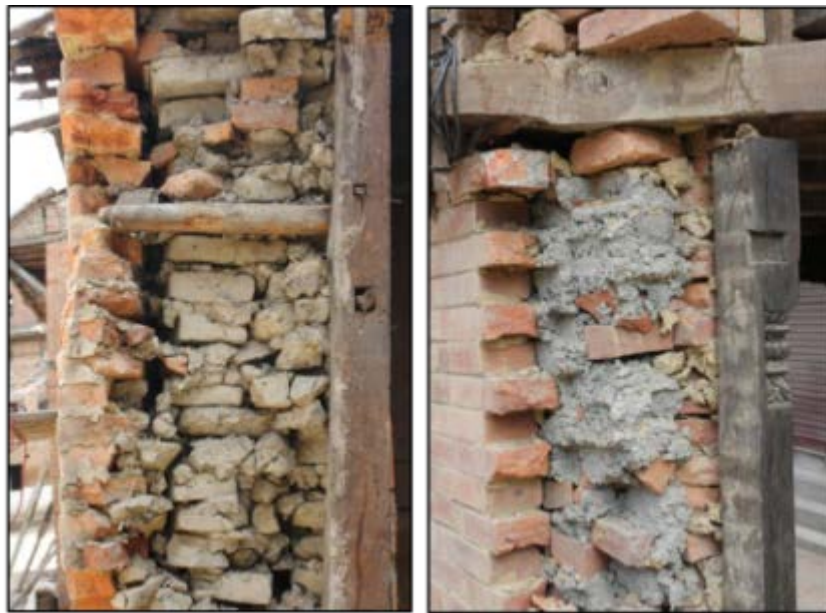
Figure 3-6 Insufficient timber connections and poor interlock.

Many masonry constructions were built with traditional techniques (Figure 3-5) named *Newari*. It is characterised by using quality construction materials, well detailed connections and evidence of good levels of maintenance. However, in the majority of structures, the quality of construction, detailing, and maintenance was poor. Figure 3-6 shows examples of insufficient timber connections and poor interlock between the exterior and interiors wythes of the masonry.

a) Bearing walls of one layers of fired bricks and two layers of sundried bricks tied with inadequate timber peg b) two layers of fired bricks filled up with cement mortar and bricks.

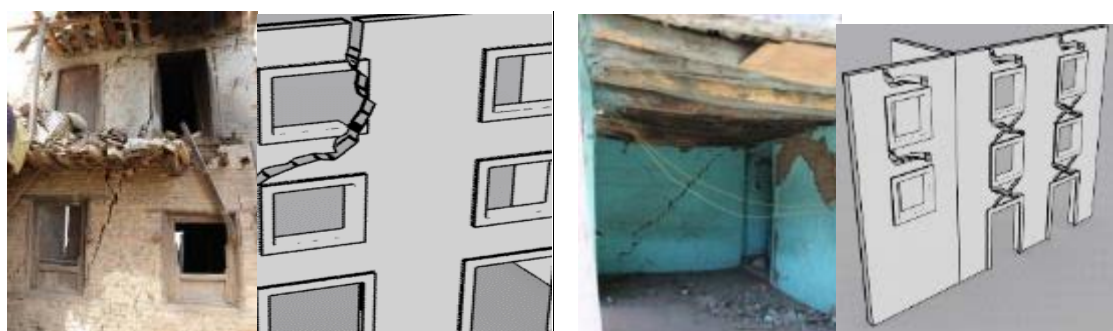
Another common type of damage observed in URM structures is in-plane shear failure of walls, which occurs when buildings have strong connections between adjacent bearing walls and between bearing walls and floors. These types of buildings, characterised by a box response to earthquakes, fail according to a crack pattern which involves the failure of the entire macro-element or by in-plane failure with X cracks on piers and on spandrels (see Figure 4-1a).

a) In plane failure (right: over multiple storeys; left: single wall beneath extremely heavy floor)

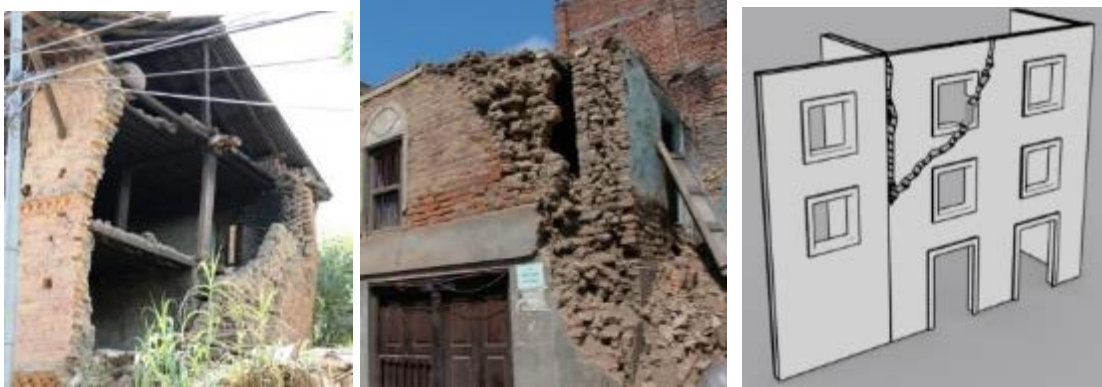
The majority of damage to URM buildings was out-of-plane failure, which typically occurs in structures with weak connections between adjacent bearing walls and between bearing walls and floors (see Figure 4-1b).

B1) Out of plane: Overturning due to insufficient connection of one side of the facade

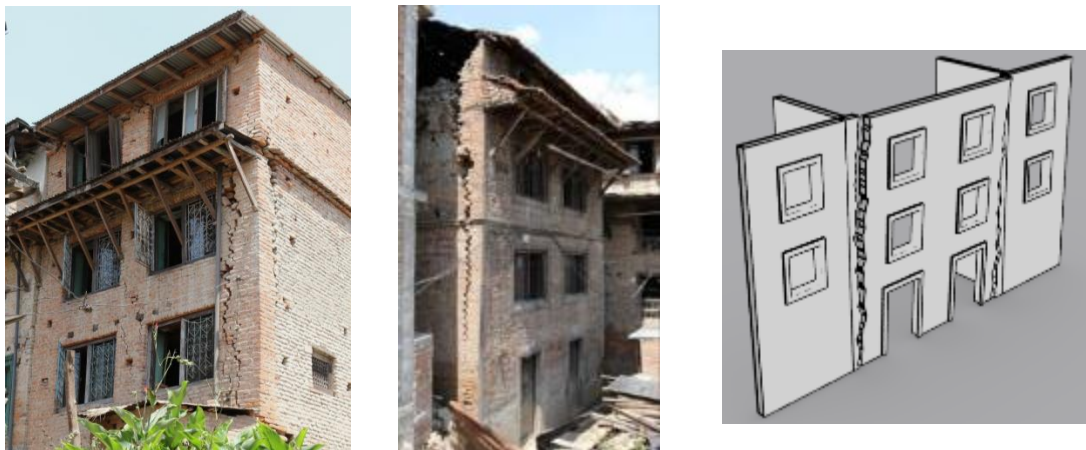
B2) Out of plane: Overturning due to insufficient connections on both sides of the facade

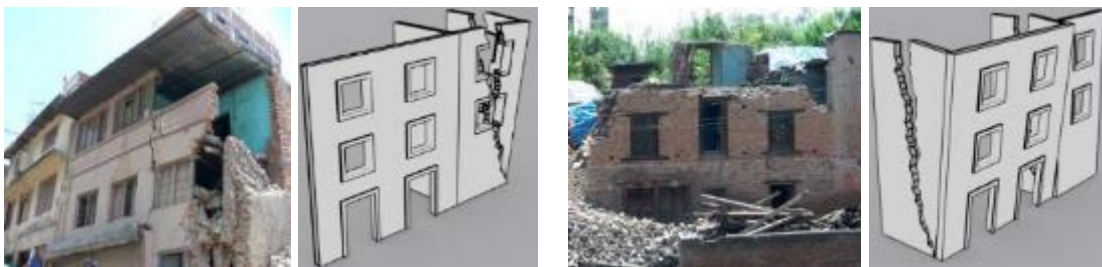
Combined mechanisms (Figure 4-1c) were also extensively observed. This type of collapse, which involves the overturning of one major element, tends to occur in structures, which have good connections between adjacent bearing walls, but where the connections between walls and floors or walls and roofs is inadequate.

C1) Combined failure: Corner failure overturning of two facades

C2) Combined failure: Overturning of three facades (left end of building)

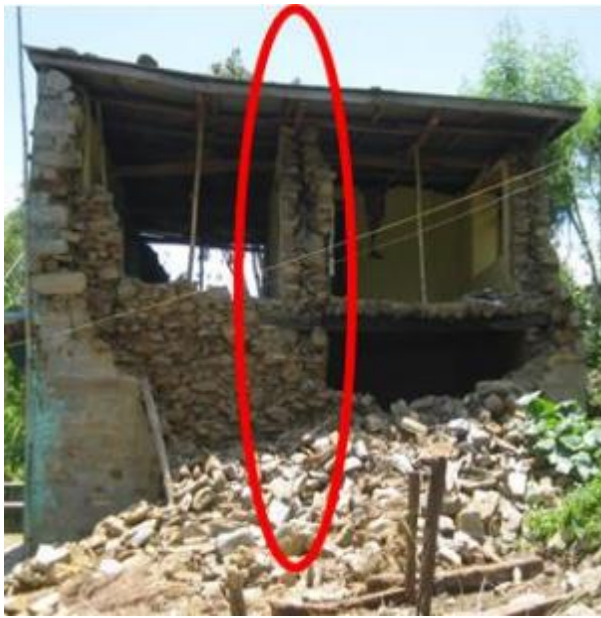
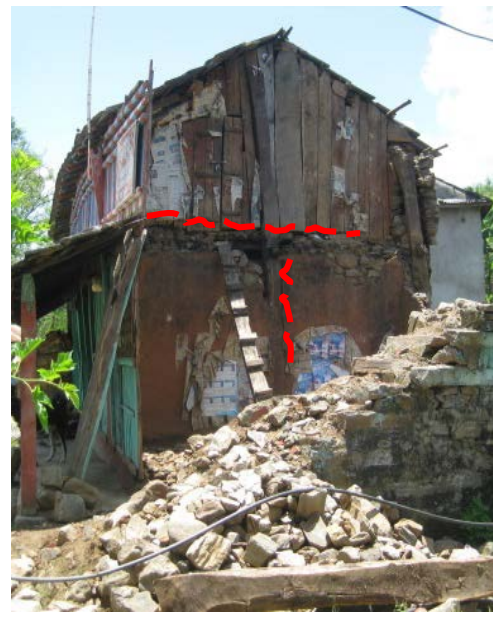
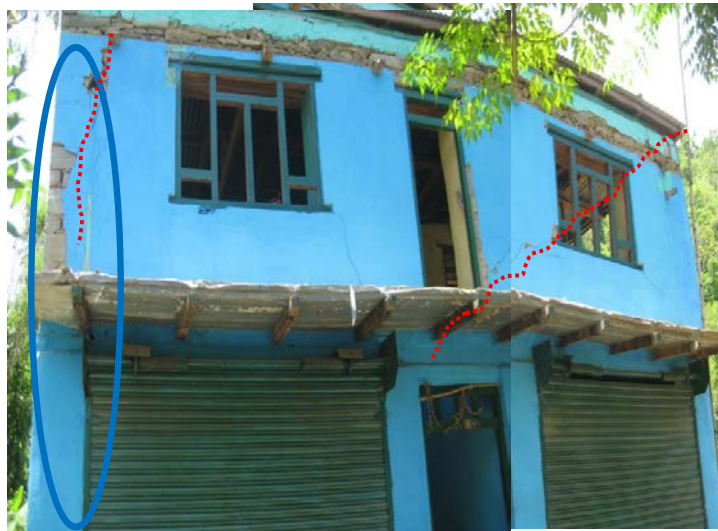
Figure 4-2 Lack of connections between the main structural walls.

The most typical failure observed in the rural areas was again out-of-plane collapse or wall delamination, due to: 1) very weak and badly bonded types of masonry (i.e. uncut stones in mud mortar) 2) the lack of connections between the main structural walls (see Figs. 4.2 & 4.3) and 3) out-of-plane arching failures due to the lack of connections between the main structural walls and floors and lack of connection between the wythes of the walls (see Fig. 4.4).

a) Lack of connection between bearing walls b) Lack of connection between bearing walls and inner walls c) Lack of connection between bearing walls and roofs.

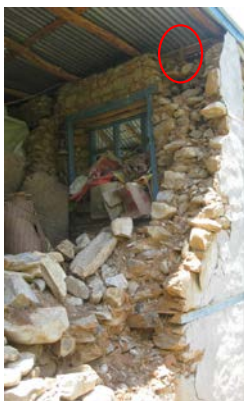
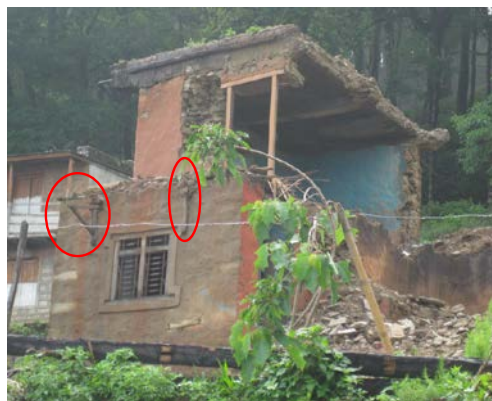
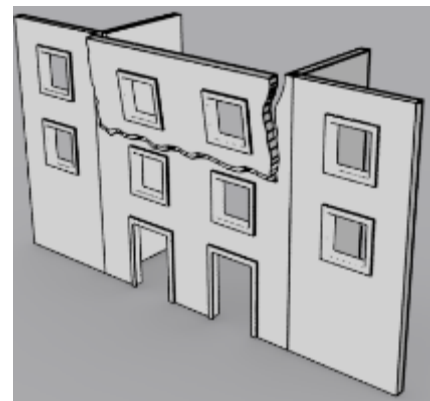
Figure 4-3 Out of plane failure.

Out of plane failure due to lack of connections between adjacent walls and inadequate use of timber pegs.

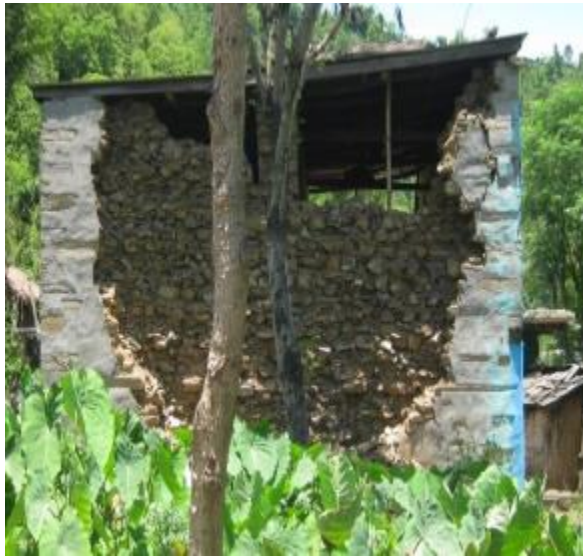
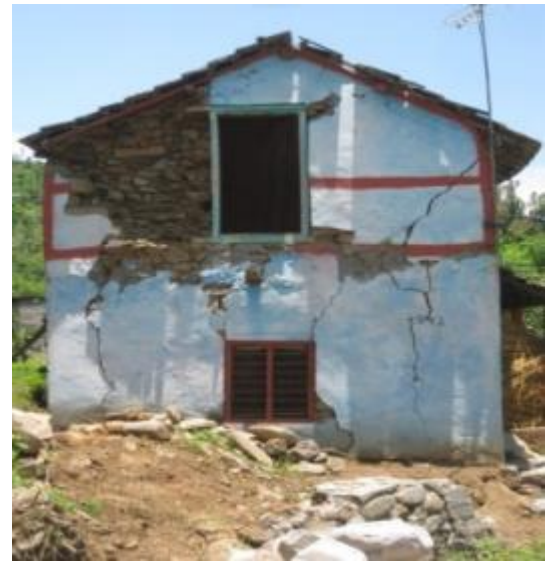
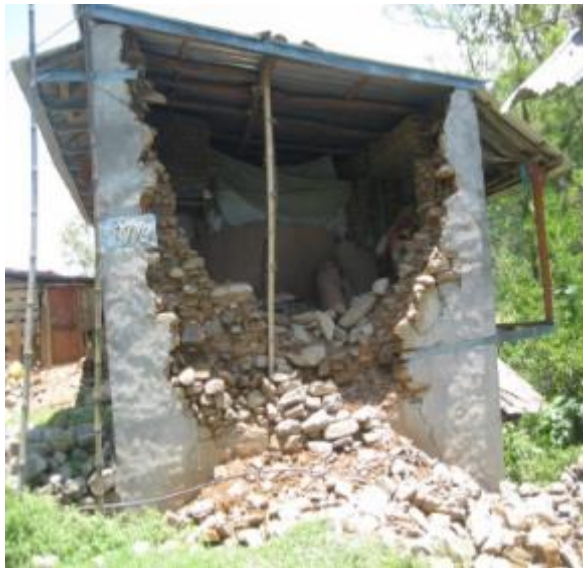
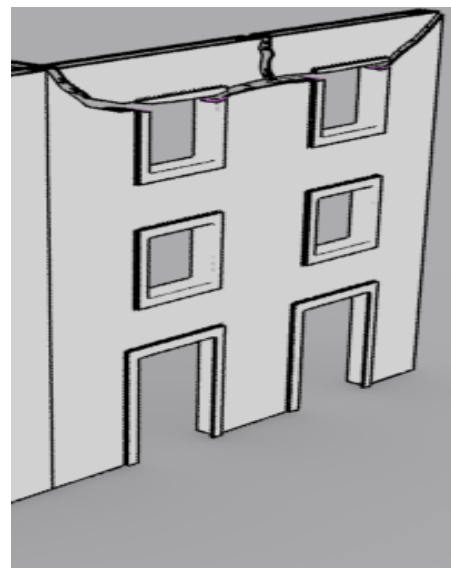
Figure 4-4 Arch failure.

Arch failure due to the lack of connection between the floor and bearing walls and lack of connection between the wythes of the walls.

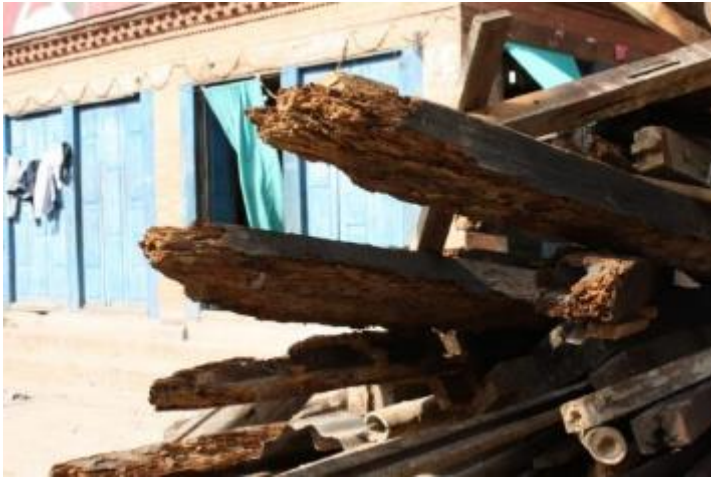
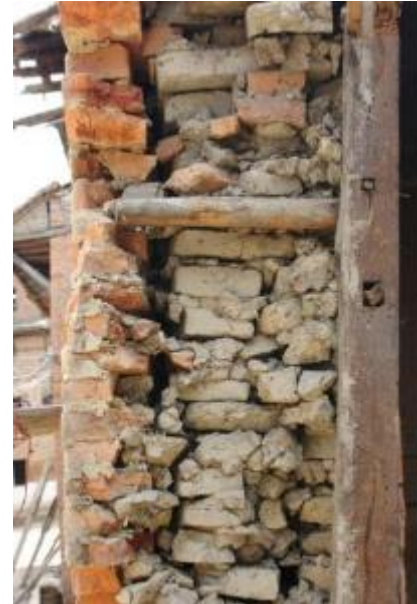
Figure 4-5 Decay and delamination between wall wythes.  
Examples of sorted timber that showed decay and delamination between wall wythes made from different materials.

Some signs of rot have been found in the sorted rubble (see Figure 4-5). But as mentioned earlier, there is no way to know whether a substantial amount of more rotted parts were discarded in the process of sorting out the rubble. Lack of maintenance could have been a cause of poor performance, but sufficient evidence could not be collected to make a definitive conclusion, nor what role site effects played.

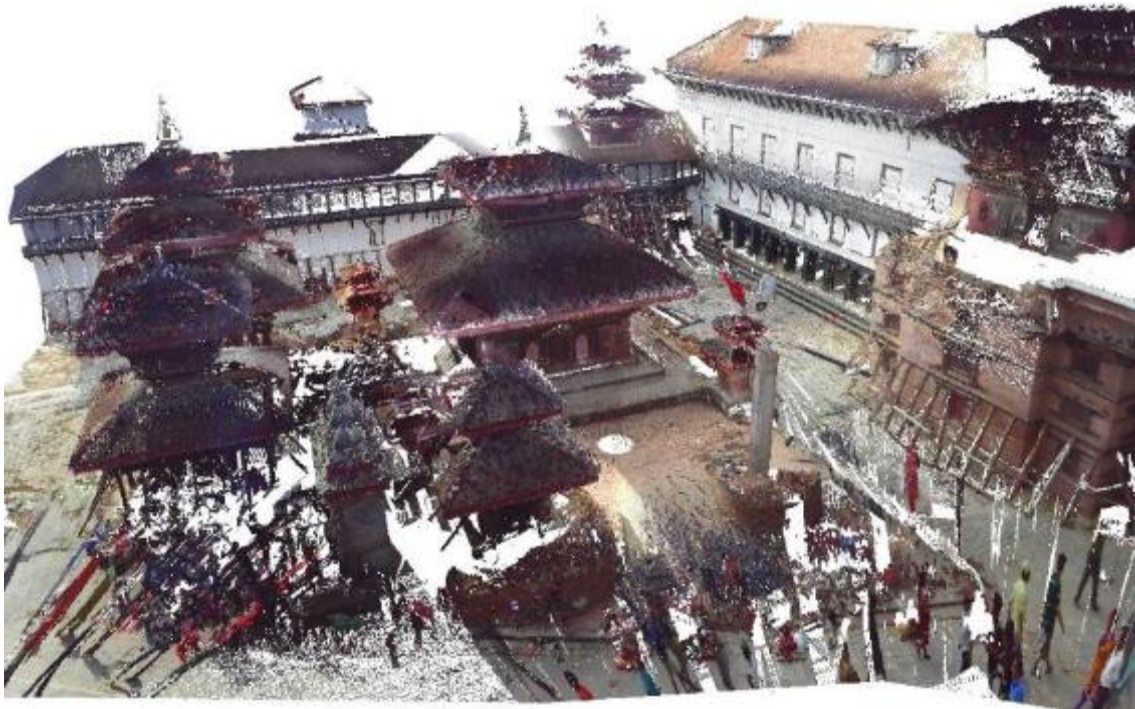
Figure 4-8 Multi-tiered dega.

The temples that remained standing appeared to be built with good materials, exhibited good craftsmanship, and appeared reasonably well maintained. Of these structures, in-plane damage (see Figure 4-8) was the most prevalent, and local out-of-plane failure of elements was rarely observed. This again indicated good connections within the structure. In order to document the damage in more detail, 3D laser scan data (see Figure 4-9) was collected in Kathmandu Durbar Square where extensive damage (but not collapse) had occurred.

Example of a multi-tiered dega, or temple (left), which survived the earthquake but exhibited in-plane damage and evidence disconnection at corners (magnified view of top storey, right).

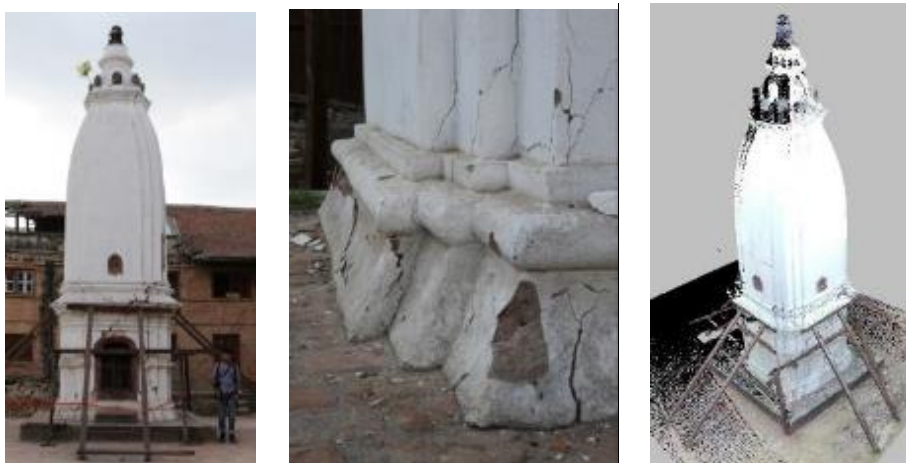
Figure 4-10 Evidence of rocking damage to a temple in Bachtapur Durbar.

For smaller monuments, evidence of direct rocking (Figure 4-10) or total or partial overturning (Figure 4-11) was also prevalent. The temple in Figure 4-10 had cracked diagonally in both directions, and showed evidence of toe crushing at the base, both indicative of rocking behaviour. This type of structural behaviour, for a monument of this size, was likely due to the very long period ground motion pulse, which could have generated significant rotational inertia for this structure, which appeared to be well connected. For smaller monuments (Figure 4-11), complete overturning was typical, also a potential result of long-period pulses in the ground motion, where the scale effect causes smaller monuments to be more vulnerable to overturning.) toppling (i.e. complete overturning) was typical, also a potential result of long-period pulses in the ground motion, where the scale effect would cause smaller monuments to be more vulnerable to overturning.

Evidence of rocking damage to a temple in Bachtapur Durbar Square in the form of diagonal cracking (left) and toe crushing (middle), and laser-scan image of the damaged structure after the earthquake (right).

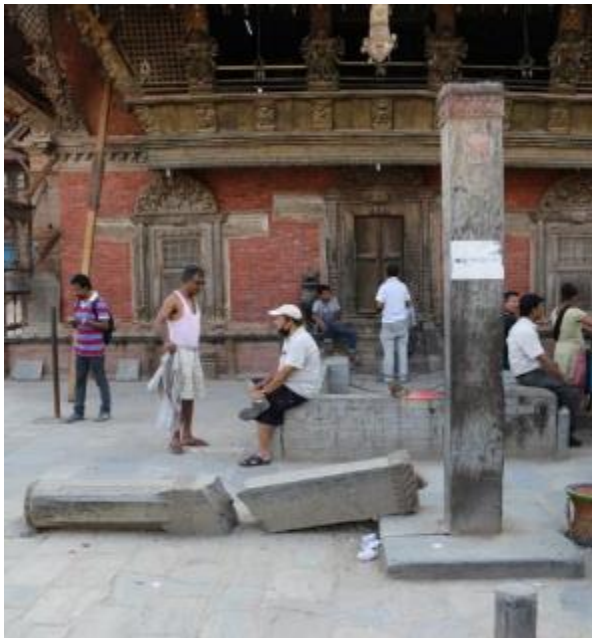
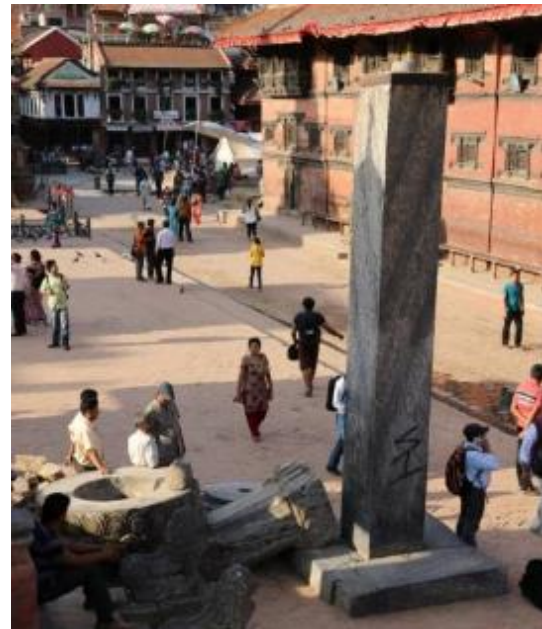
Figure 4-11 Evidence of rocking and overturning to monuments.

These base columns were embedded in the ground, so overturning occurred at the first joint above the ground.

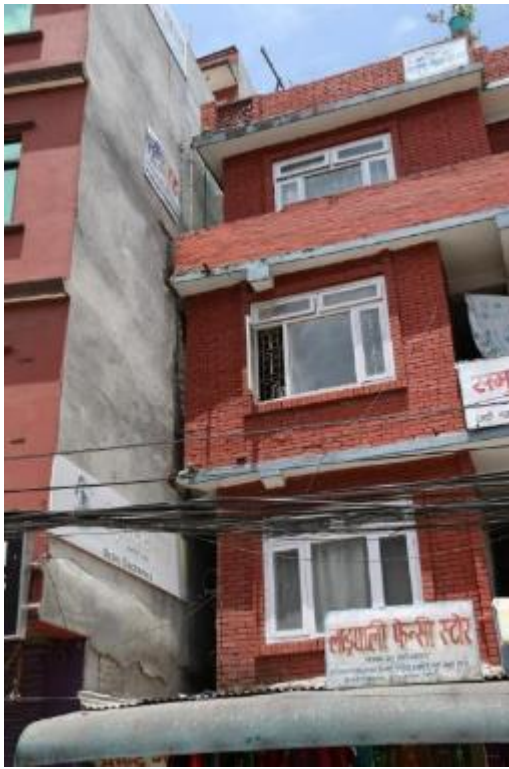
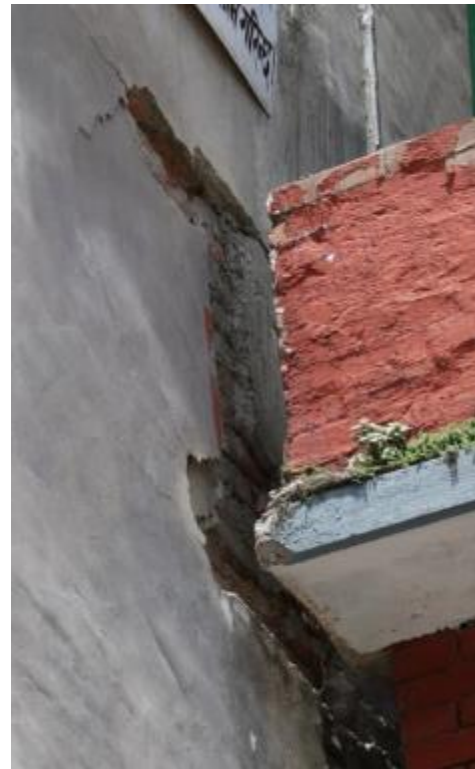
Figure 4-13 Evidence of pounding damage between adjacent concrete buildings.

In this same neighbourhood, pounding damage between adjacent structures was also observed (see Figure 4-15). This was a common feature in this earthquake for all building types.

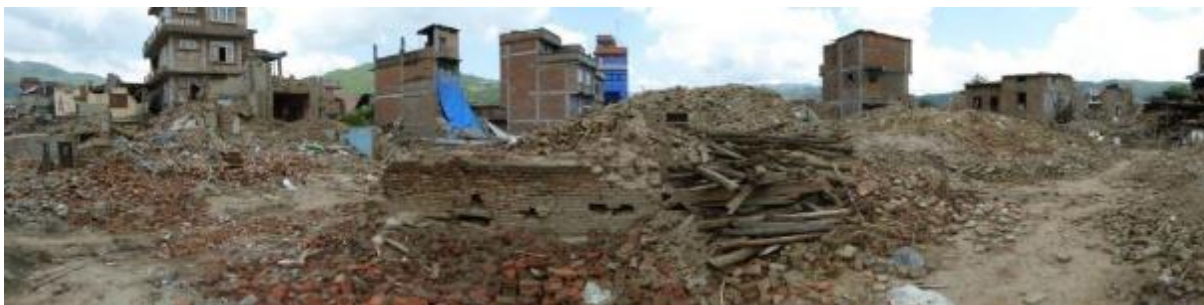
Figure 4-16. The Shankhu neighbourhood.

Other areas of the Kathmandu valley also experienced concentrations of damage, but all of these areas could not be visited by the team. One area that was very badly damaged was the Shankhu neighbourhood (see Figure 4-18). This area was characterised by a greater proportion of residential buildings, and fewer commercial buildings, that were lower rise than in the Siddhitol neighbourhood. This area again exhibited extensive and severe damage to what appeared to be poorly constructed URM structures, and extensive collapse of masonry infill within concrete frames was observed. As was typical with other areas, less damage was observed to the concrete frames themselves, and many of the buildings that were left standing had some degree of concrete framing (see Figure 4-18).

Panoramic view of the Shankhu neighbourhood. The majority of buildings had collapsed or been demolished, with primarily better quality concrete frame buildings still standing.

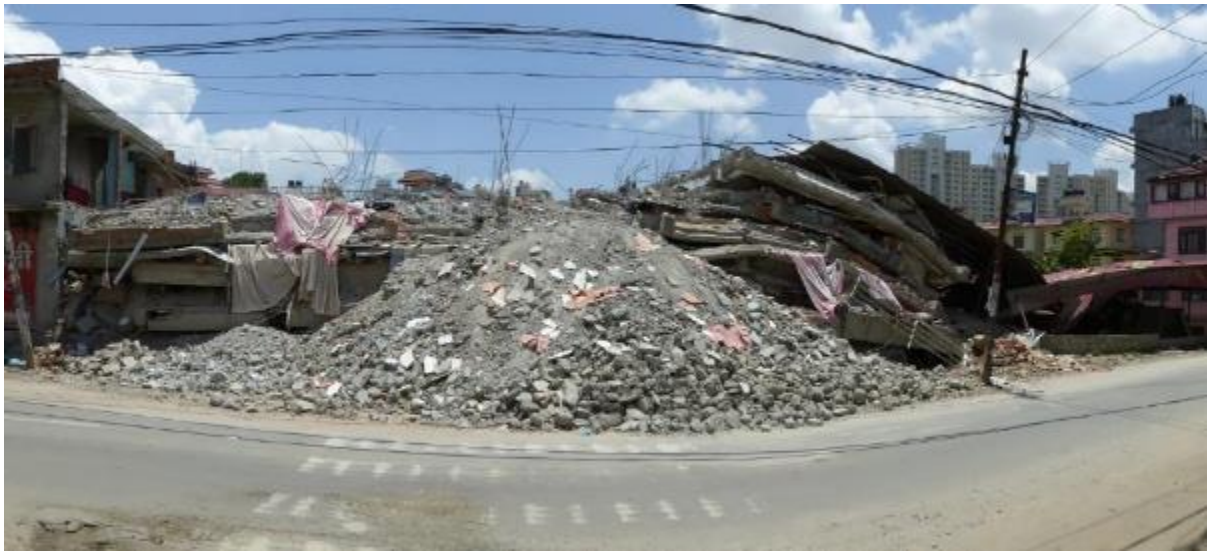
Figure 4-17 Pancake collapse of Morgan College -7-storey school in Tokha, Kathmandu.

In some instances, local severe damage was observed to individual buildings, while surrounding buildings appeared unaffected by the earthquake. The most striking example of this was the pancake collapse of Morgan College (see Figure 4-19) in the Tokha region of Kathmandu. The seven-storey structure was only a few years old, and it was still standing after the main earthquake but collapsed in an aftershock 45 minutes later.

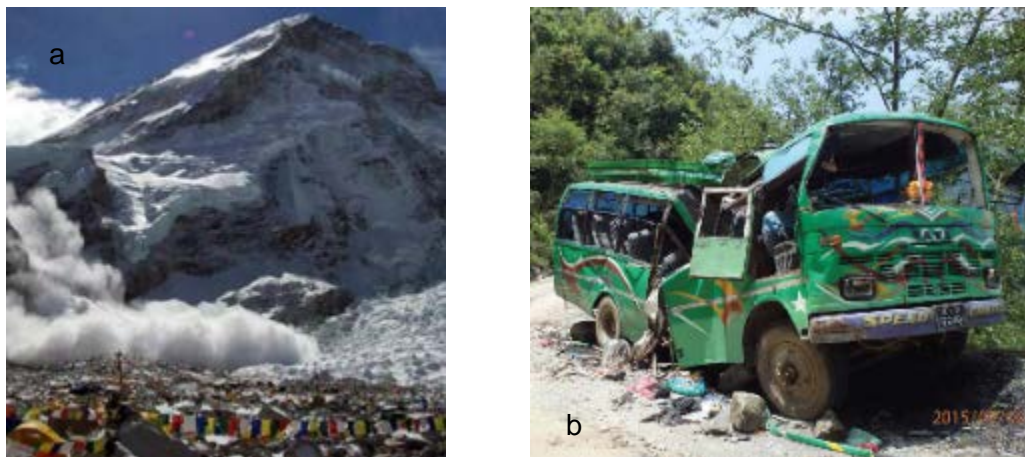
Figure 5-1 Avalanche, landslide and rock falls.  
(a) Avalanche reaching Everest Base Camp killing at least 17 people and injuring 61 more (Aydan and Ulusay 2015) (b) Damaged caused to a bus having been hit by a rock fall (Goda *et al.* 2015).

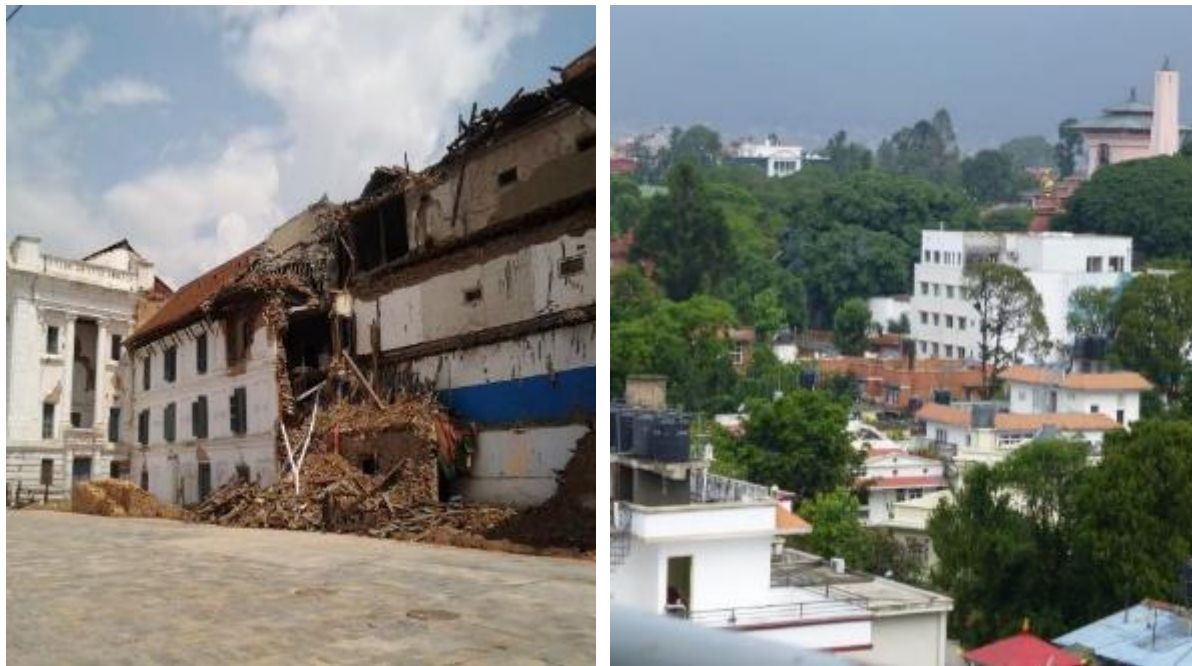
Figure 5-3 Damage in Durbar Square.

However, preliminary investigations found this was not the case. Goda *et al.*'s (2015) initial report noted devastating structural damage had occurred to the central historic buildings, but surrounding these the majority of the new buildings were structurally stable (Figure 5-3). It is speculated that due to the low-midrise nature of the buildings with a natural frequency of less than 1Hz, many escaped damage from the longer vibration periods the earthquake produced. In addition, the most critically damaged areas were localised conspicuously close to areas

Much of the debris had been removed at the time of survey, but the front wall of the building had collapsed and in the background the white building had suffered severe shear cracking. (Left) View of Central Kathmandu. Structures probably damaged but still erect. Temple in the background with chimney remained standing (Right).

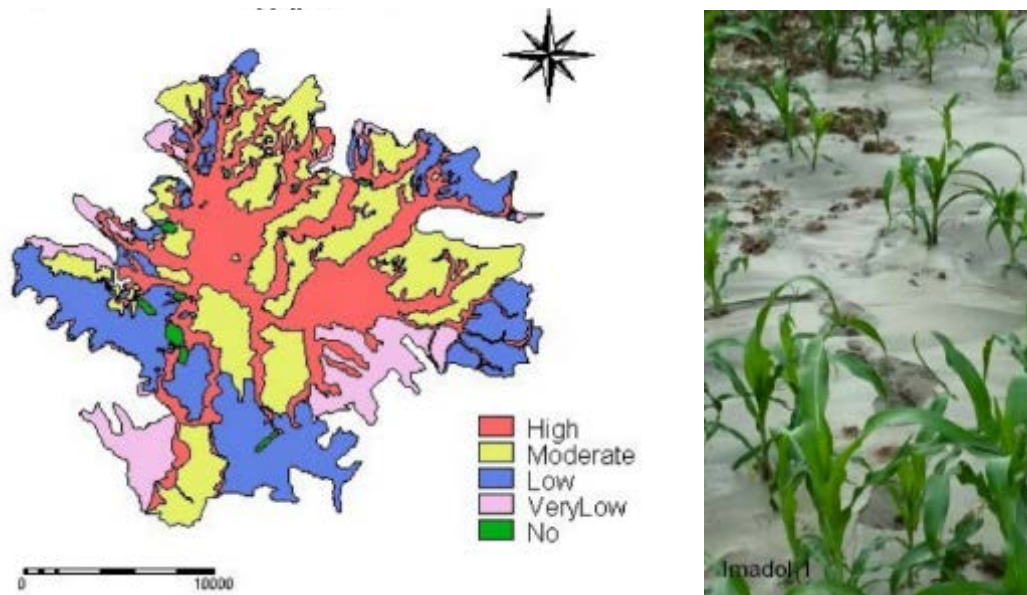
Due to the soft sediments of the valley, Kathmandu has high liquefaction potential, especially in the North Western and Central regions. The areas of high susceptibility follow the four major rivers in the valley (Piya 2004). During the survey, liquefaction had been found to occur during the earthquake, particularly in the region of Imadol (Figure 5-4) where lateral spreading is clearly visible.

Figure 5-4 Liquefaction susceptibility for the Kathmandu Valley. (Right) Piya's Map of Liquefaction Susceptibility for the Kathmandu Valley (2004) (Left) Liquefaction in the Imadol Region (Aydan and Ulusay) Agricultural land had been reported to be most affected by liquefaction (Right).

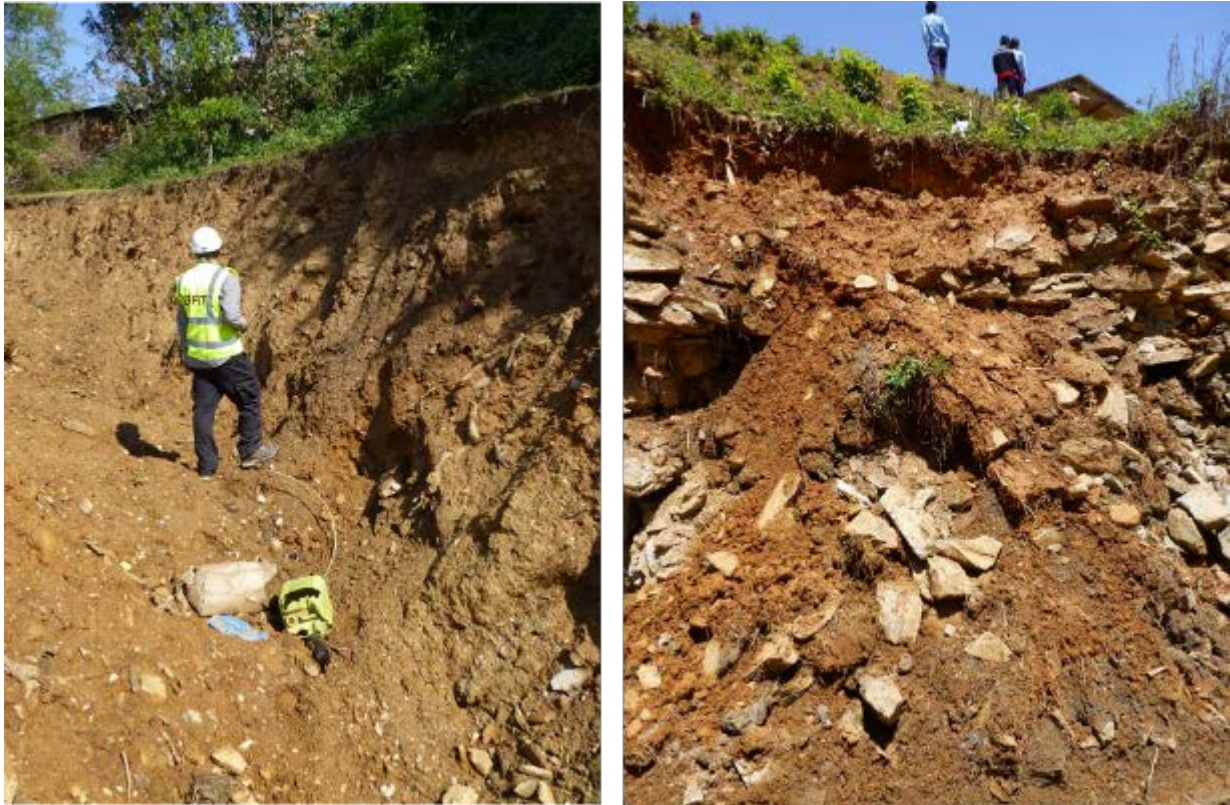
Initially, this was thought to have been caused by topographical site effects. Ridges have been known to focus waves, causing much larger ground acceleration experienced at the peak (e.g. Hough *et al.* 2010). These effects could have been compounded by the soil on the ridge tops. The surface deposits were found to be poor and surprisingly deep to reach engineering bedrock. From exposures in Dolalghat, the soil was at least a few metres in depth, Figure 5-12, while in Gorkha, a preliminary microtremor recording indicated that there could be up to 10 m of superficial deposits. Significant lack of foundations too was observed. However, these were not enough to explain the extent of the damage, particularly in Gorkha, the majority of damaged buildings were on slopes beneath the ridge top.

Figure 5-12 Exposures within villages of Dolalghat region. Soils were found to be clayey and containing angular pebbles, suggesting colluvial deposits.

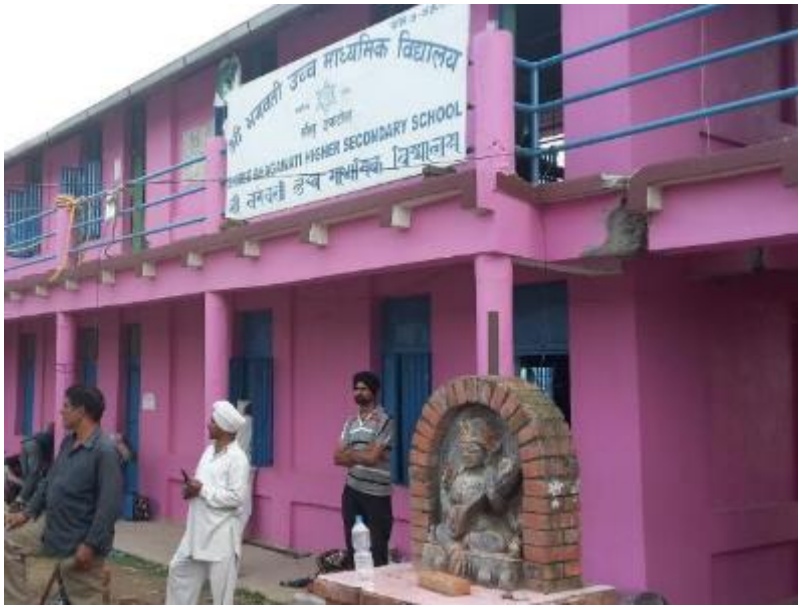
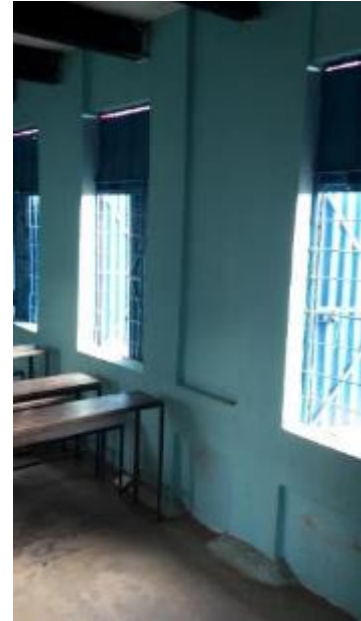
Figure 6-4 A fired clay brick building retrofitted.

NSET reported that they had been involved in the retrofit of 200 schools in the last five years at an approximate cost of 80USD/m<sup>2</sup>. Two of the school buildings visited had been retrofitted, one was adobe block and the other fired clay brick (Figure 6-4). Both survived undamaged and were rated green. The adobe building retrofit scheme was designed by NSET. The fired clay brick retrofit was designed by a private consultant and then reviewed by NSET. Encouragingly NSET reported that all of the school buildings they had retrofitted had survived without damage, except for one where the foundations had failed.

A fired clay brick building retrofitted by a private consultant, with the design approved by NSET. Seismic band beams are added either side of the walls. Consisting of reinforcement and concrete they are tied together through the walls. The building performed well incurring no damage (R) – Internal view of seismic bands running vertically either side of openings and at cill level. The discreet nature of the band beams means this is likely to be a more economical retrofit than the full jacketing NSET design.

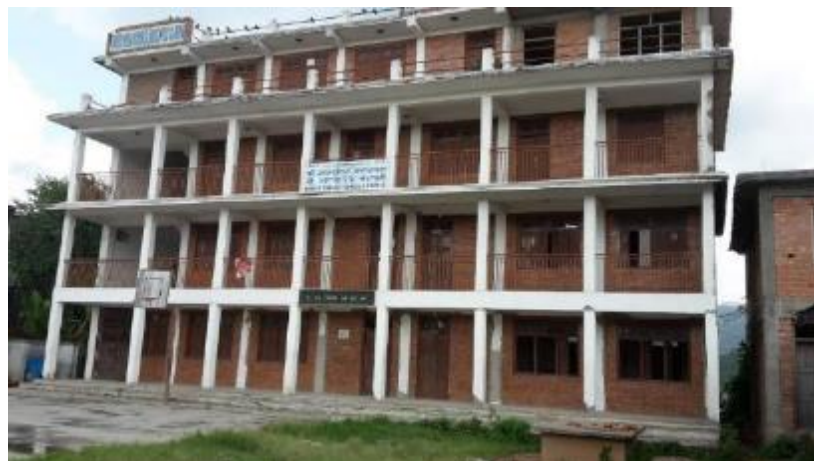
Figure 6-5 A Four storey RC framed building with fired clay masonry infill. Building constructed in 2010 without any seismic consideration. On the same site there is another school building designed with some limited seismic consideration following the 1988 earthquake, illustrating that seismic design awareness apparently reduced as the memory of the last earthquake dimmed. This is also symptomatic of weak enforcement of building regulations.

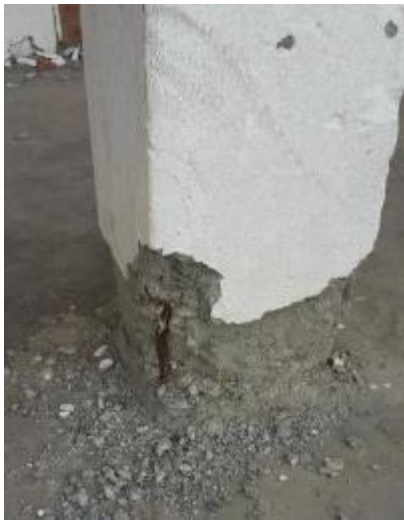
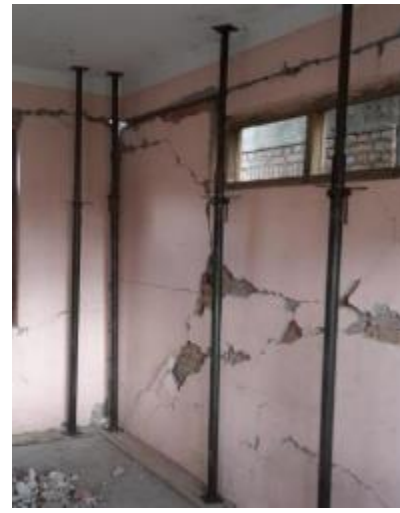
Figure 6-6 Damages in storey columns and walls in a RC-framed building.

Of the six RC framed buildings two were green flagged and 4 were red flagged. Both green flagged buildings had incurred no visible damage, one of which had been designed by NSET and constructed in 2012 with funding from an international donor. There was limited evidence of seismic design in the other five, which exhibited varying degrees of cracking and collapse of non-structural fired clay brick infill. At the four storey school (Figure 6-5) severe damage of beam/column joints was observed as well as damage to the base of the columns and cracking of masonry walls (Figure 6-6).

(L) Four Storey RC-framed building continued spalling of concrete and deformation of rebar at column nodes (R) Propping installed since earthquake and cracking of infill walls.

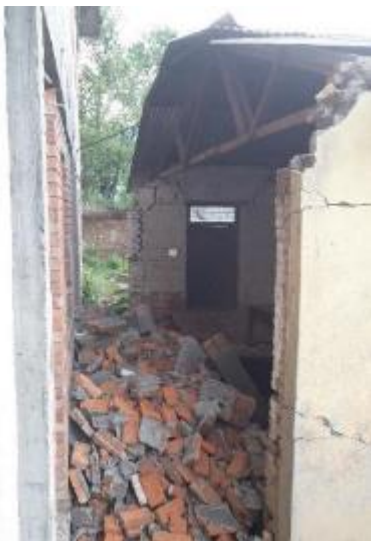
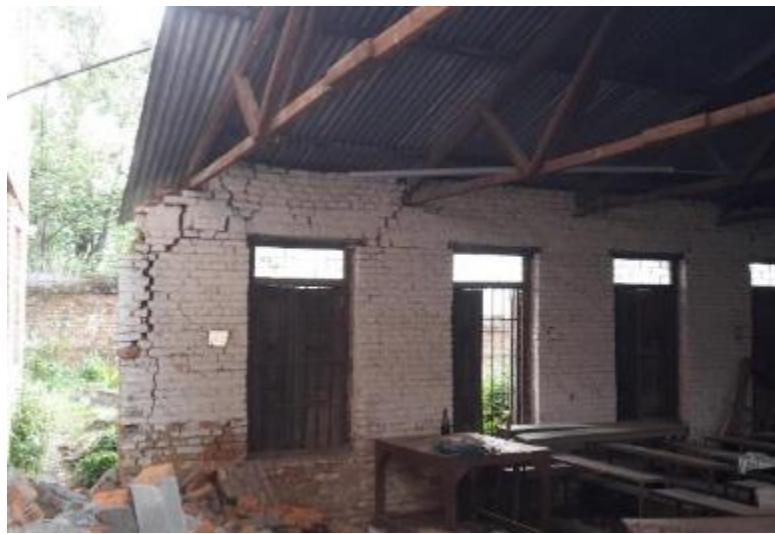
Figure 6-7 A fired clay brick school building with gable wall failure.

The end wall has collapsed due to insufficient bonding at the corners as testified by the clean break with the surviving wall.

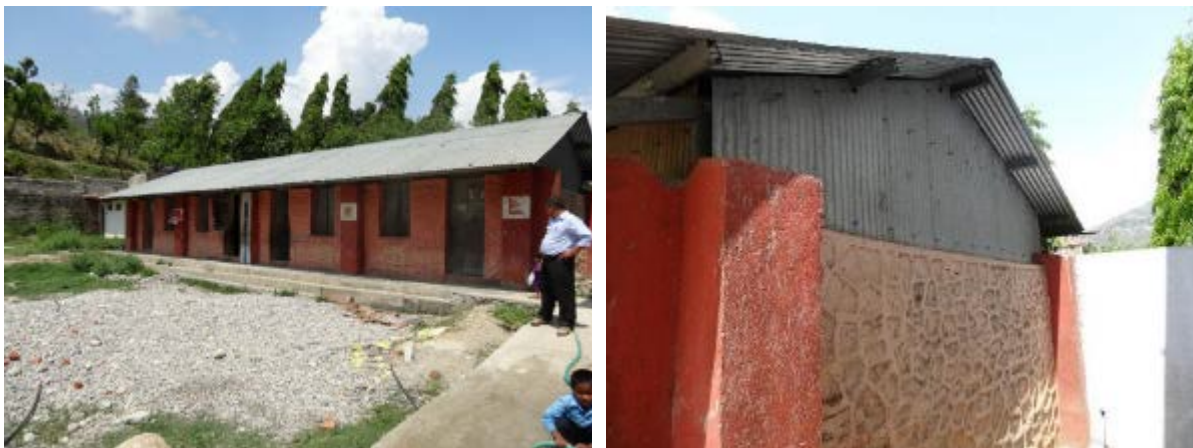
Figure 6-9 Stone rubble with mud mortar school.

(L) A stone rubble with mud mortar school implemented by an international aid agency, it bears similarities to the typical design seen in the photos on the previous page. (R) CGI sheeting has again been used in place of stone for the external walls.

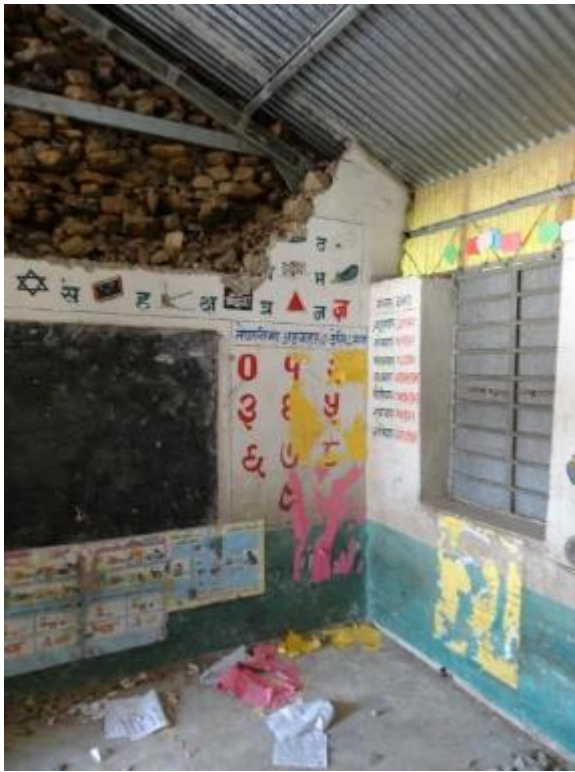
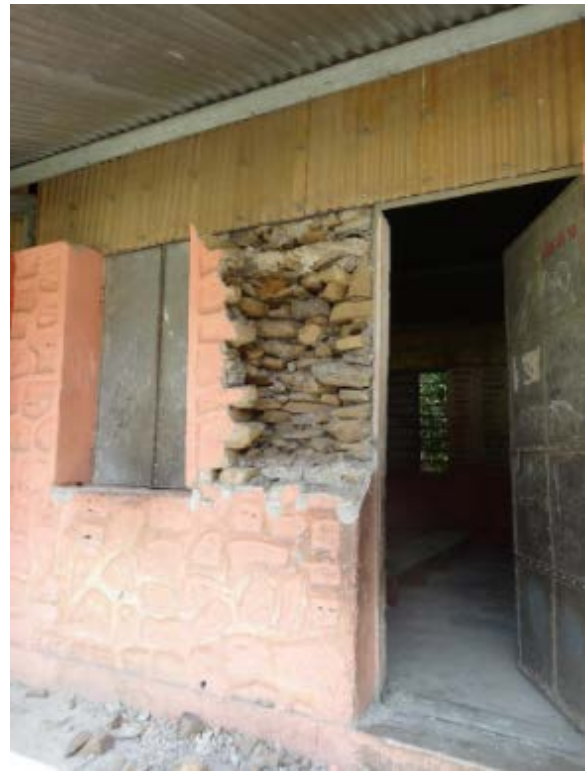
Figure 6-10 Interior view of stone rubble with mud mortar school.

(L) Unfortunately the detail was applied inconsistently with the result that the internal rubble stone gable wall has partially collapsed with potentially deadly results. (R) Again the absence of a ring beam at the top of the walls is a critical design flaw meaning that the wall shown is an un-restrained cantilever.

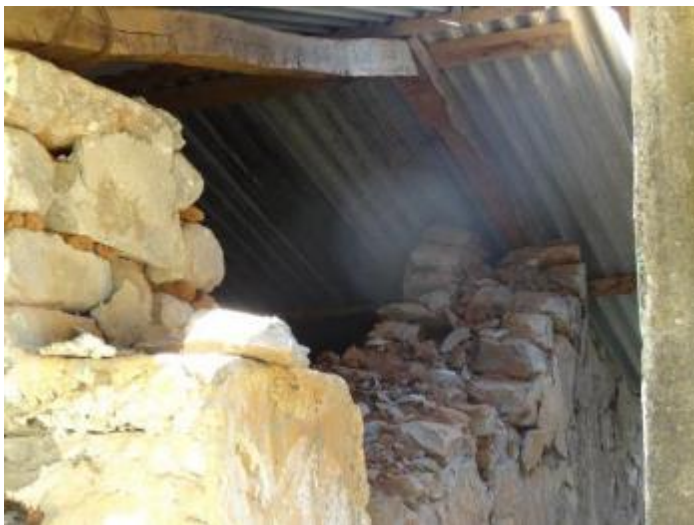
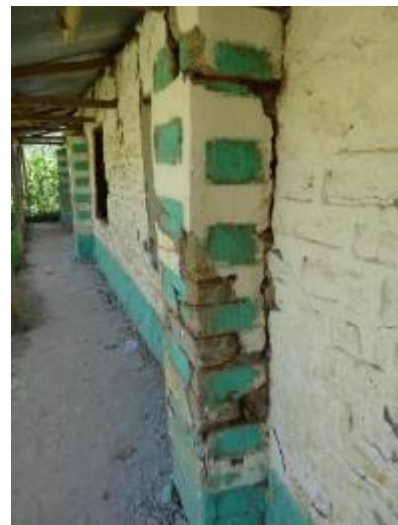
Figure 6-11 Stone Rubble Masonry.

(L) Gable wall collapse of a stone rubble with mud mortar building (R) Damage to butress

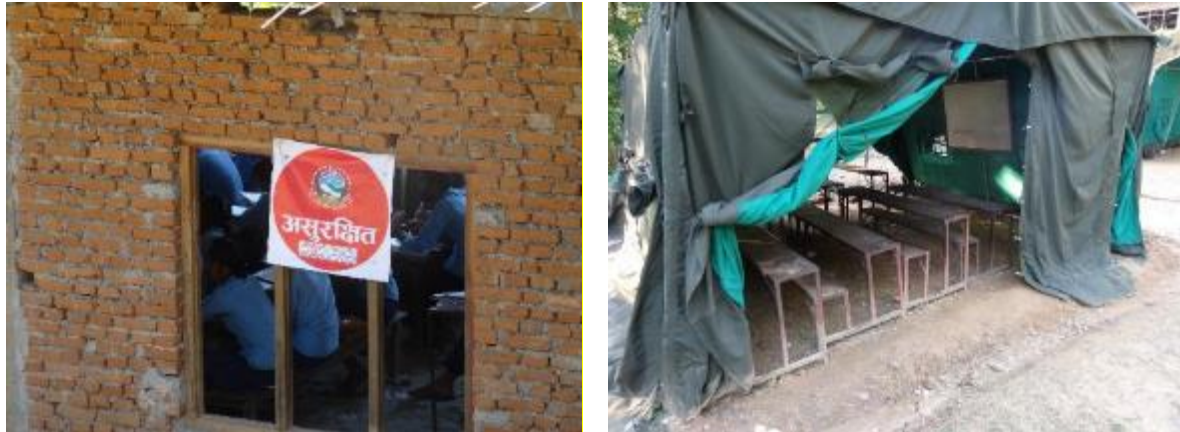
Figure 6-13 Temporary solutions.

(L) Red buildings are being occupied in cases where there is no alternative. (R) Tents being used as temporary classrooms.

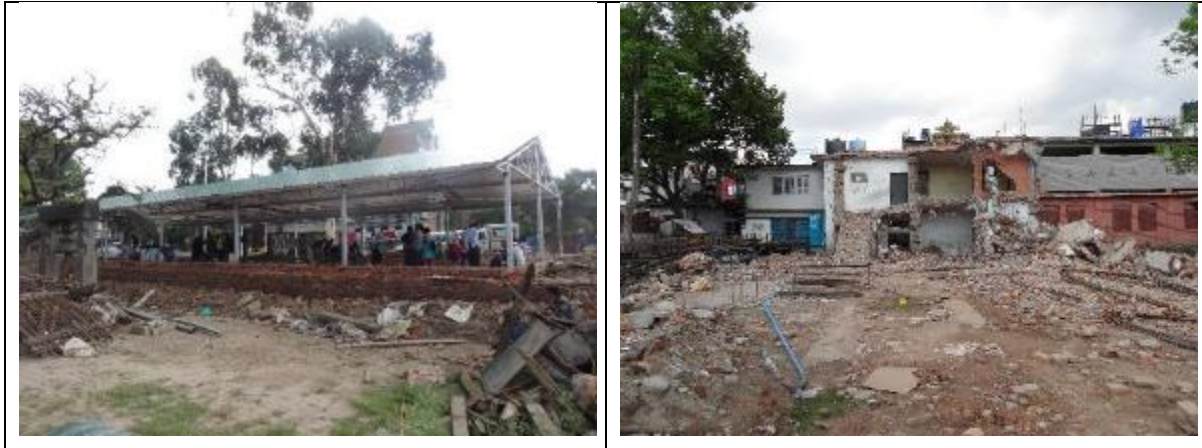
Figure 6-14 New prefabricated steel framed school vs. collapsed school.

are to be commended it appeared that in the rush to rebuild little consideration had been given to the location of the new buildings within the school site.

(L) A permanent prefabricated steel framed school building under construction in Kathmandu. (R) The remains of a school building demolished by the army at the same site in Kathmandu.

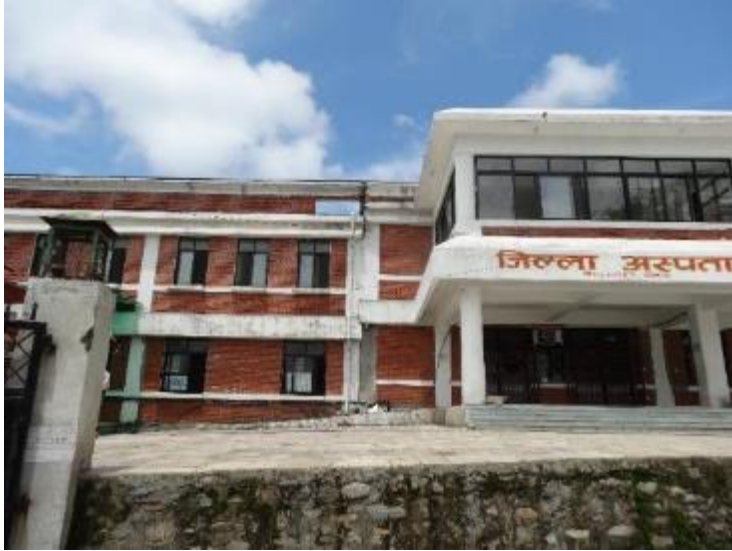
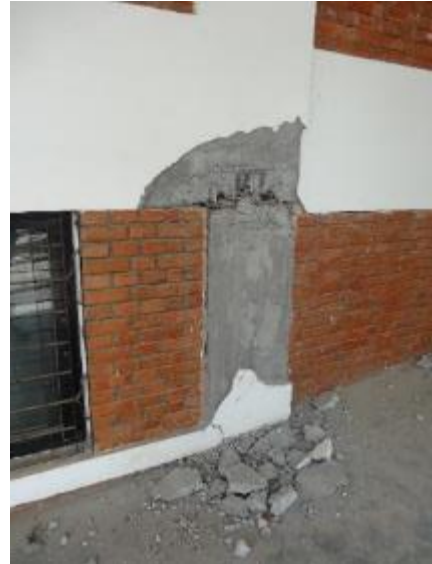
Figure 6-17 Damages in a two storey RC framed district hospital.

Chautara district hospital, consisting of an RC frame with fired clay infill, had incurred significant damage, with the main hospital building having been deemed unsafe by the DUDBC. The main building had been evacuated with operations moved to tents erected in the hospital grounds.

Two storey RC framed District Hospital with damage to beam/column nodes evident throughout. Fired clay infill was cracked but had remained intact.
