# THE $M_w$ 7.8 GORKHA, NEPAL EARTHQUAKE OF 25 APRIL 2015

A FIELD REPORT BY EEFIT

August 2019

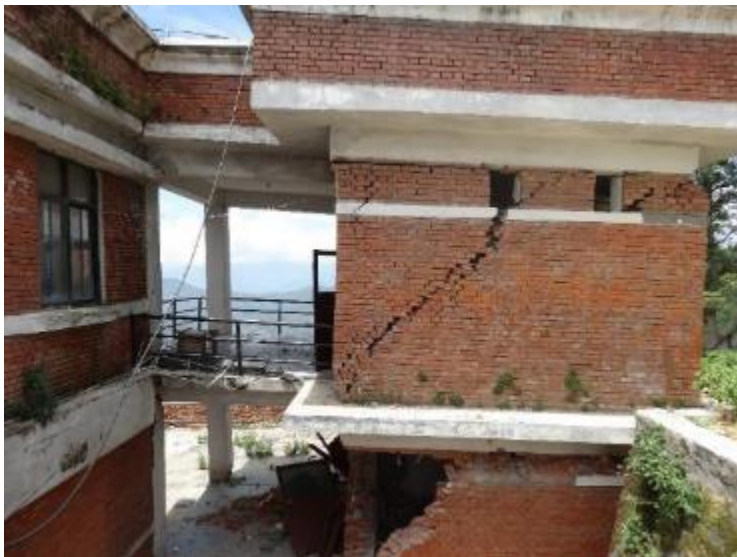
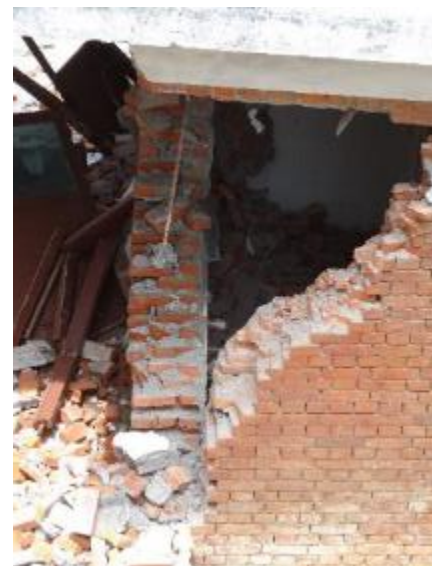
Figure 6-18 Damages in unreinforced masonry.

(L) This annexe building, consisting of unreinforced masonry, was particularly badly damaged (R) unlike the main building this structure had not reinforced concrete columns, instead relying on a single reinforcing bar in the corner.

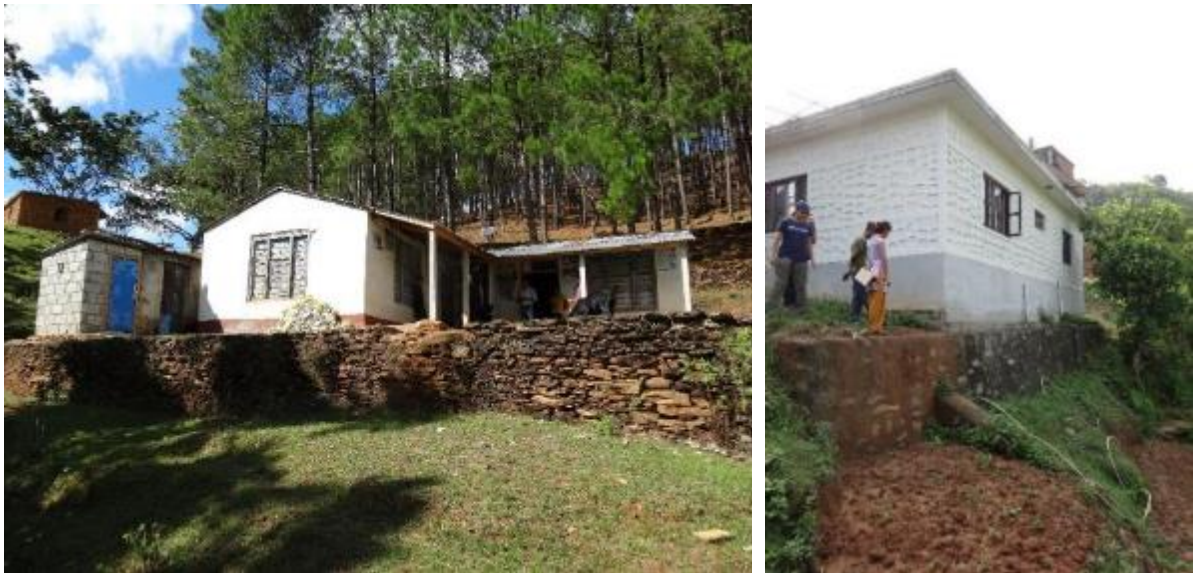
Figure 6-19 Health posts.

Each of the health posts sites visited were highly constrained by the topography, with flat ground at a premium. Of the nine health post buildings visited all were within 3-4m of a retaining wall or an unreinforced earth face, with three immediately on top or at the bottom of a retaining wall. Three of the five sites visited had cracks in the ground or in retaining walls, as a result of one of the earthquakes. Three of the buildings visited exhibited cracking that could be attributed to ground movement, two of these were built immediately above a retaining wall. This could be caused by movement of the wall and or settlement of fill placed behind the wall to generate the terraces.

With flat ground at a premium in rural areas Health posts were commonly located close by to retaining walls and often within made ground associated with man made terraces.

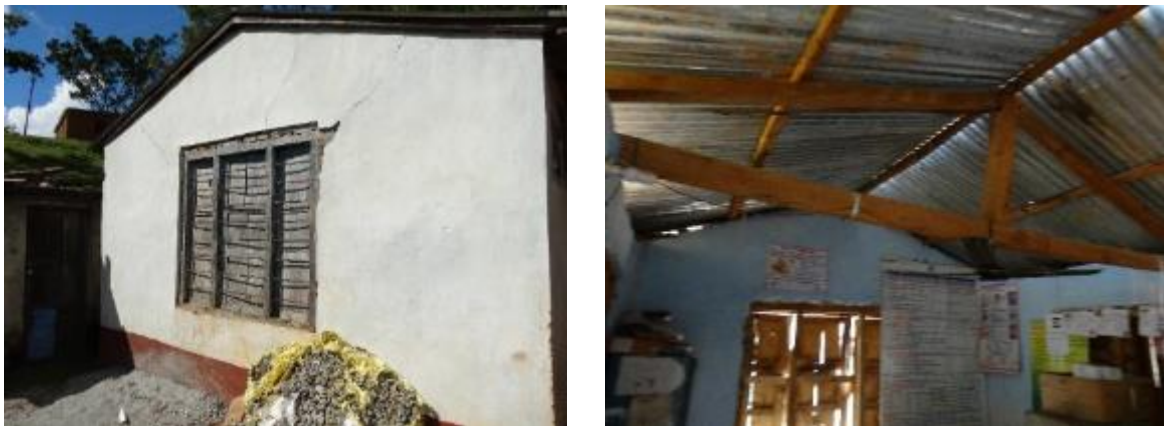
Figure 6-20 Dhole health post.

(L) Cracking can be seen around opening in the plaster. The walls are stone rubble with mud mortar (R) Dhole health post is the furthest site from Kathmandu visited. In the absence of government support the community had designed and built a non-engineered building.

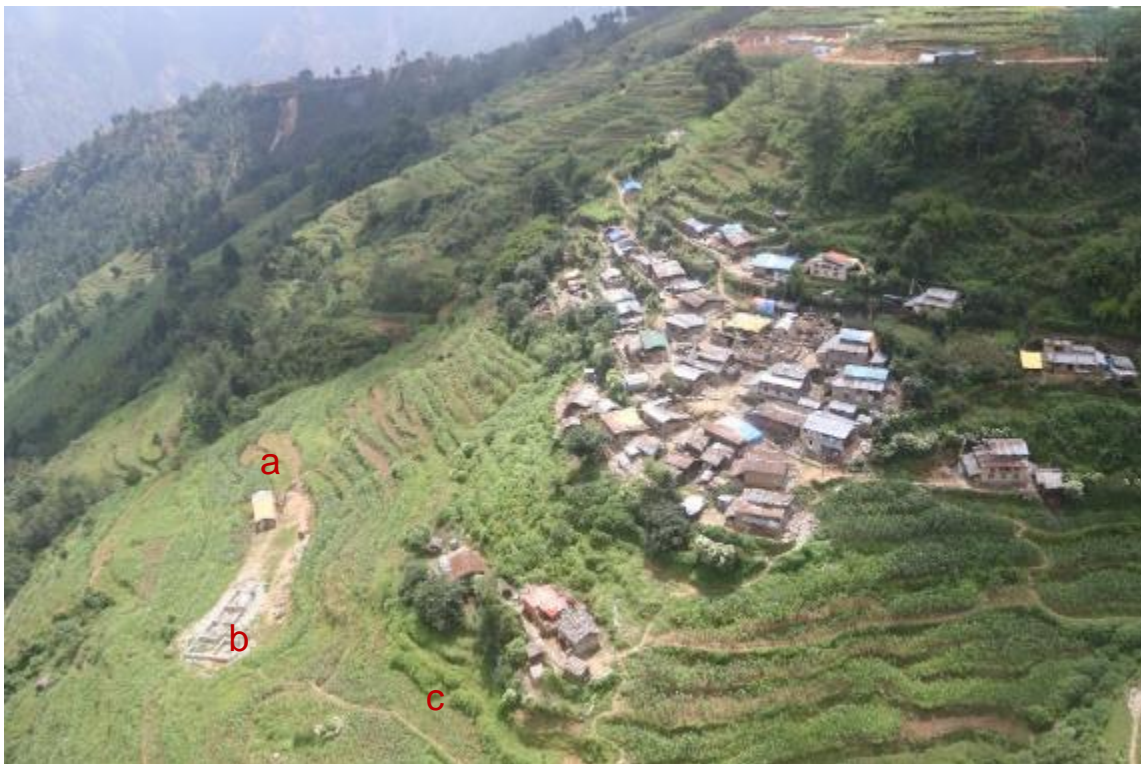
d) The village of Yamagaum. The buildings of this village were surveyed and are displayed in later figures. The locations of the various buildings mentioned in the report are indicated on this figure as a) new school building, b) temporary school building c) path to devastated school building (just out of shot).

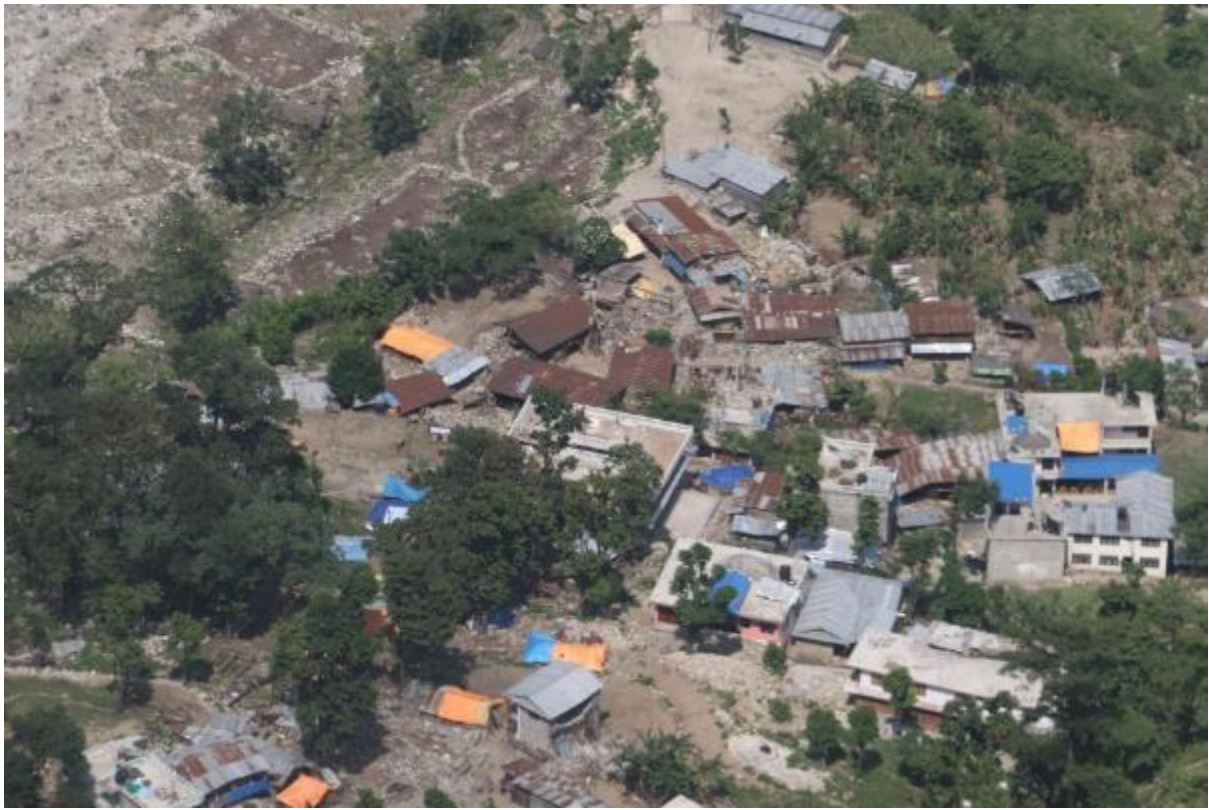
e)The village of Machikhola. A survey was due to be conducted here, but was cancelled due to the ongoing threat of landslide

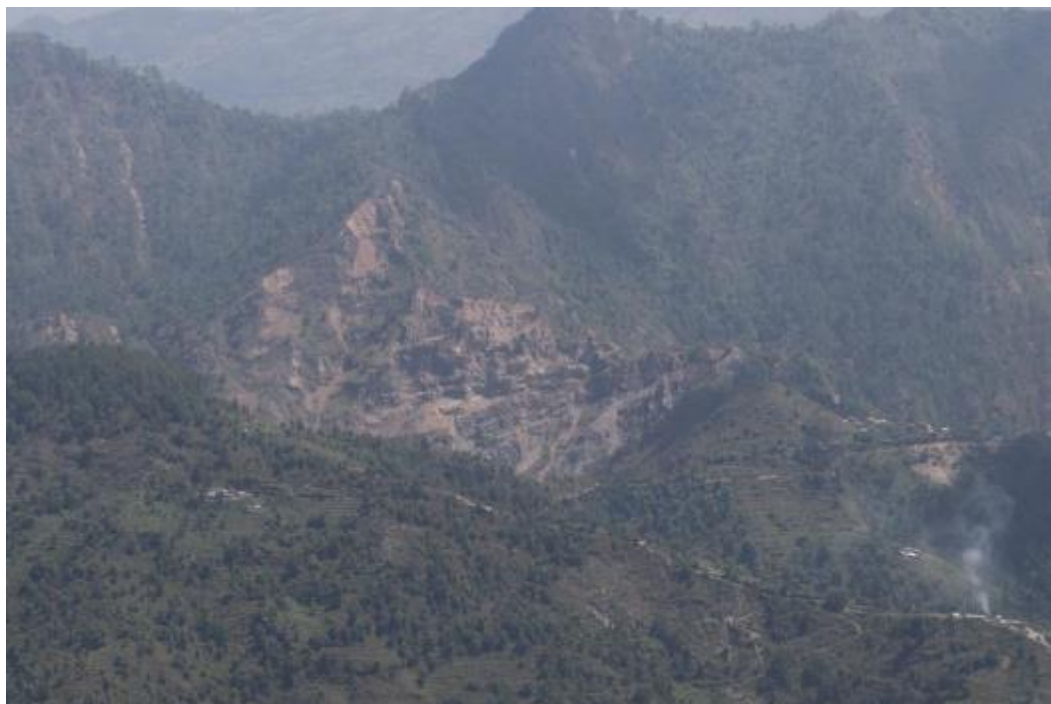
a) Large Scale Landslide (scale can be judged from buildings in a small village on the right mid ground. Supply paths are also visible in the image and the landslides severed most of these

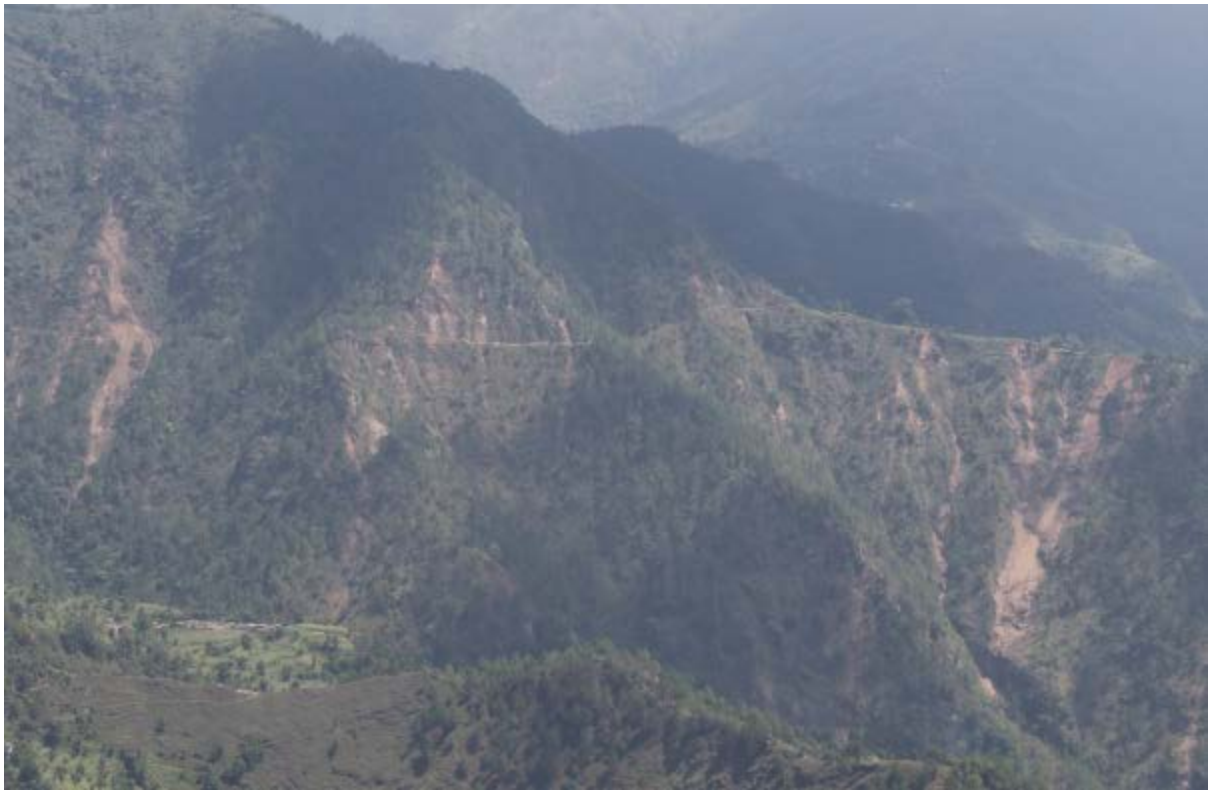
b) Landslide that has destroyed supply roads at a number of locations. This was reported to be extensive and a continuing threat which was severely hampering relief observations.

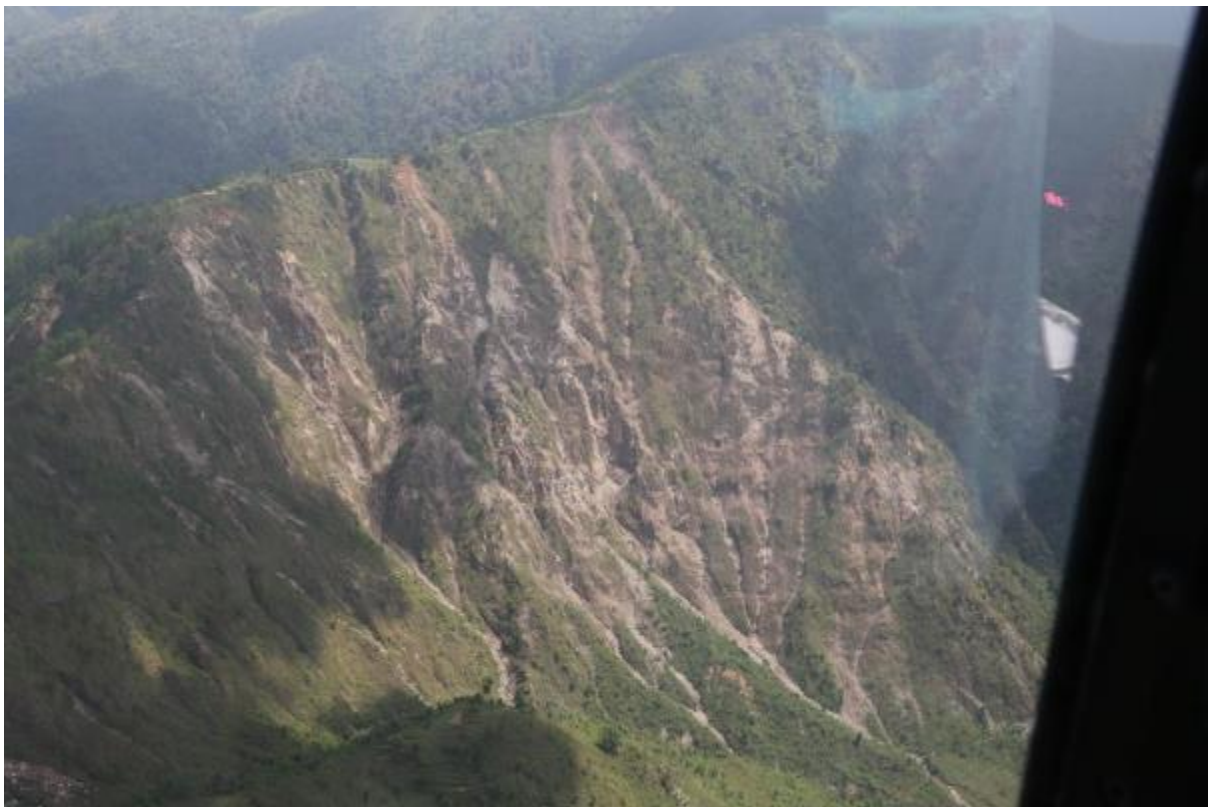
c) Shallow landslide of a similar size to the landslide in the above image.

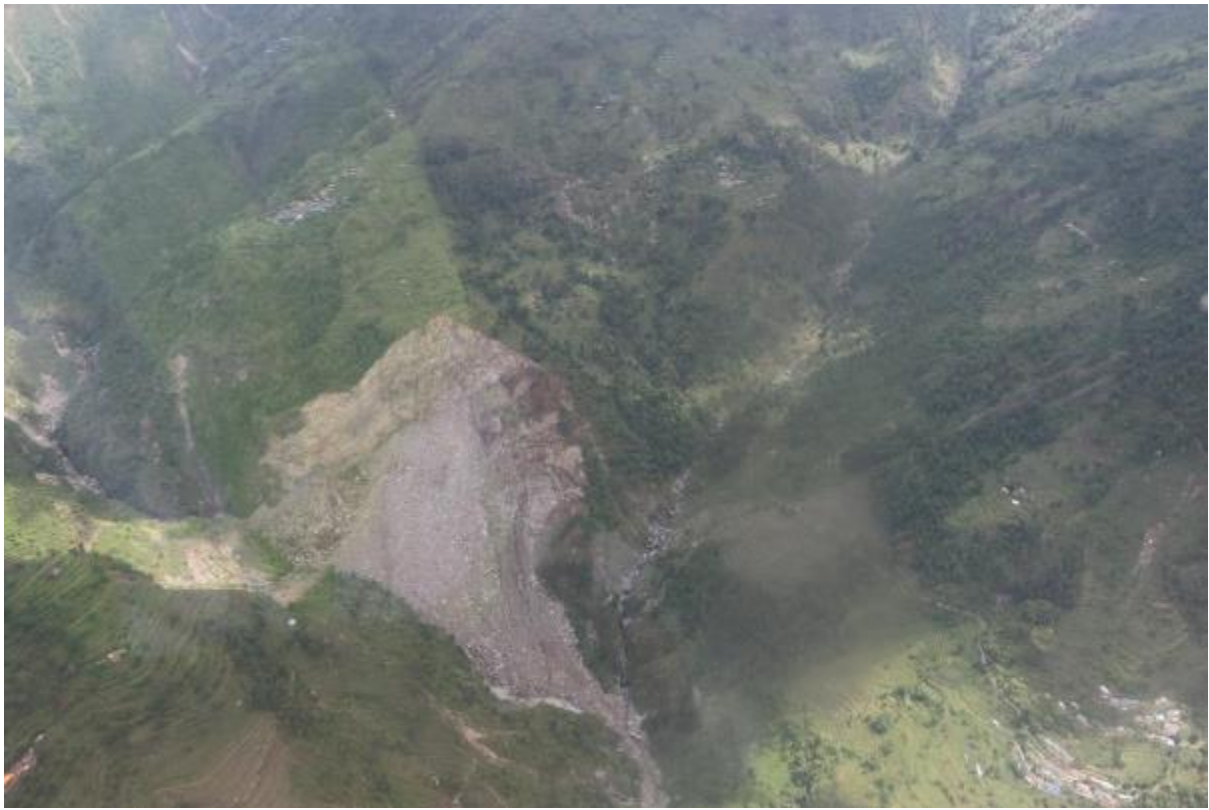
d) Large landslide, size can be estimated from village at bottom right of the picture and the village above the landslide.

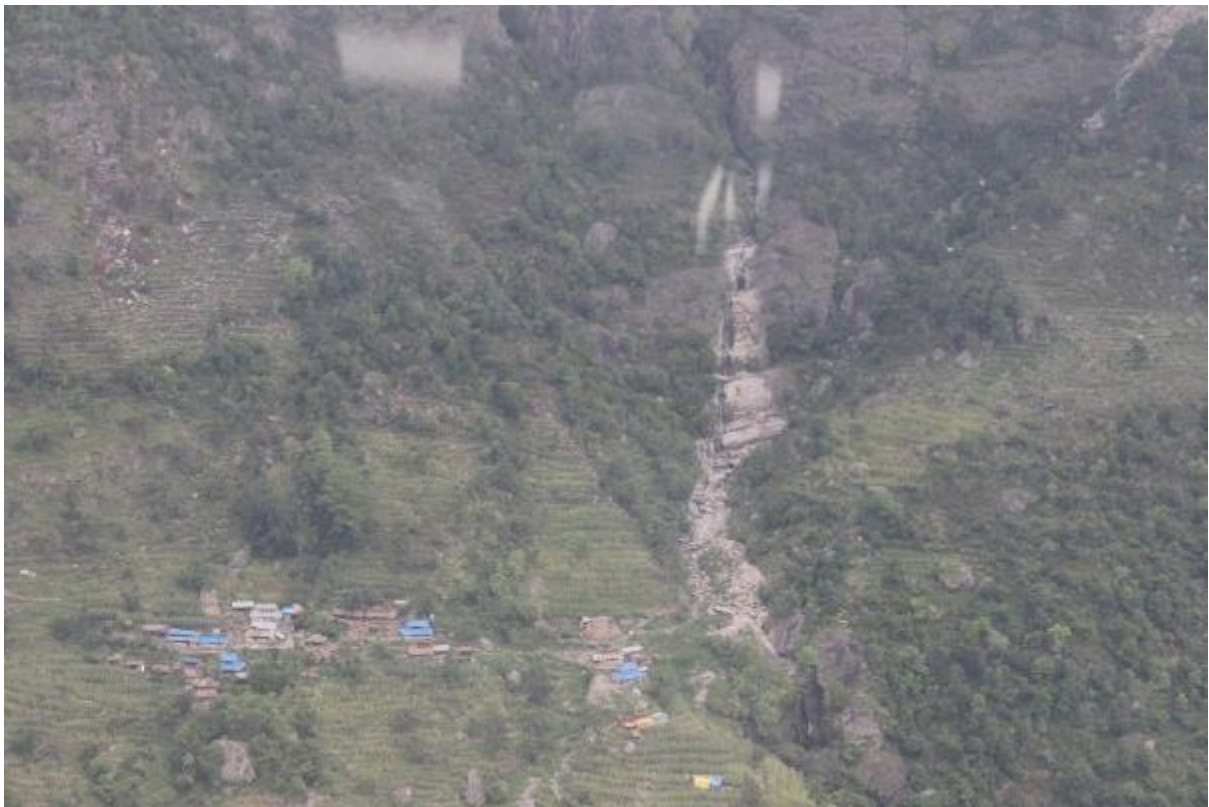
e) Thin landslide in close proximity to a village. Although most villages that were overflown by the helicopter were a reasonable distance away from the landslide, a number of villages were observed very close to significant landslides.

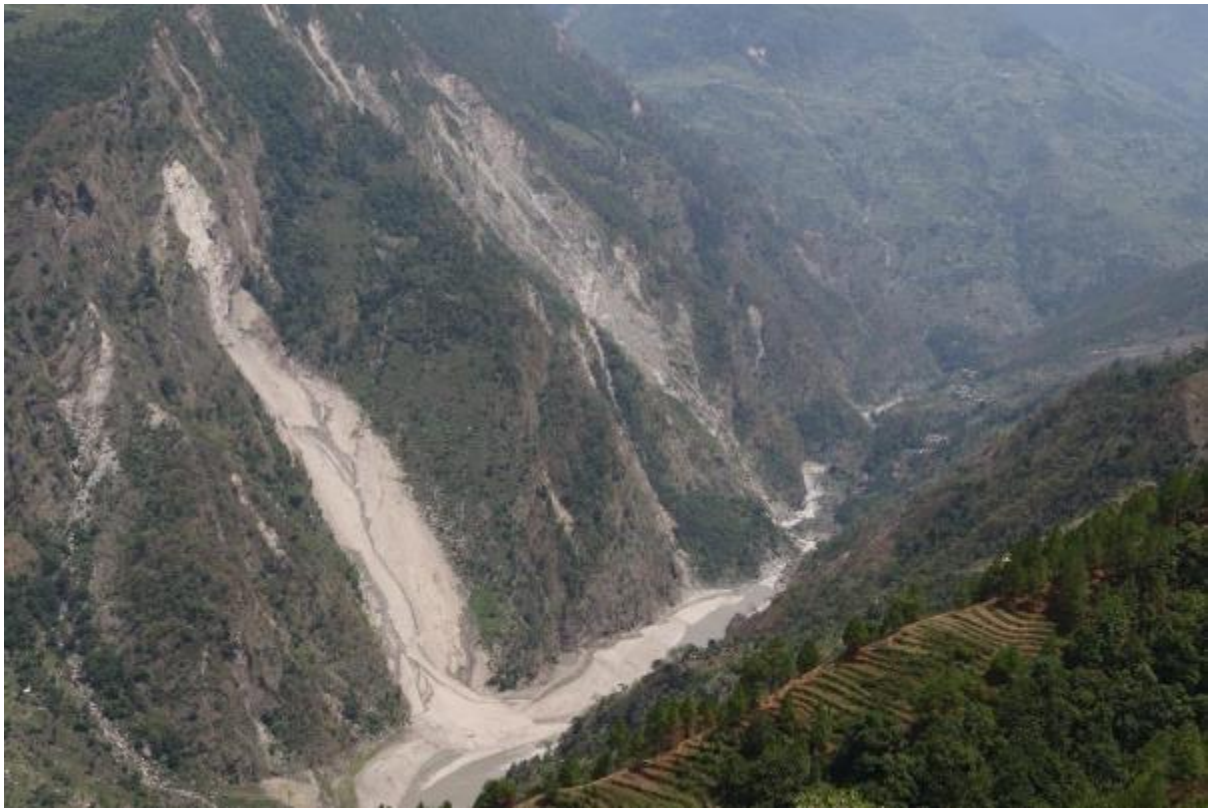
f) Deep landslide estimated to be over 200m in length.

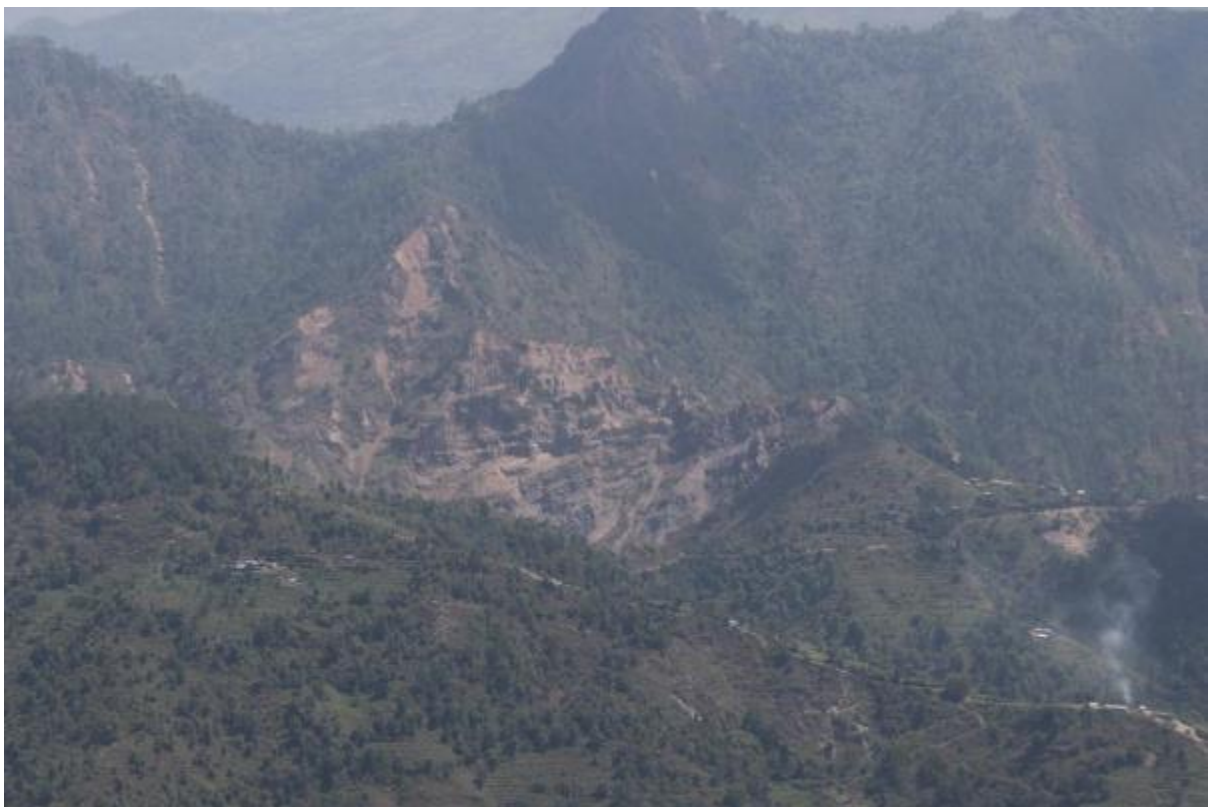
g) Large scale landslide (scale can be judged from buildings in a small village on the right mid ground). Supply paths are also visible in the image and the landslides severed most of these.

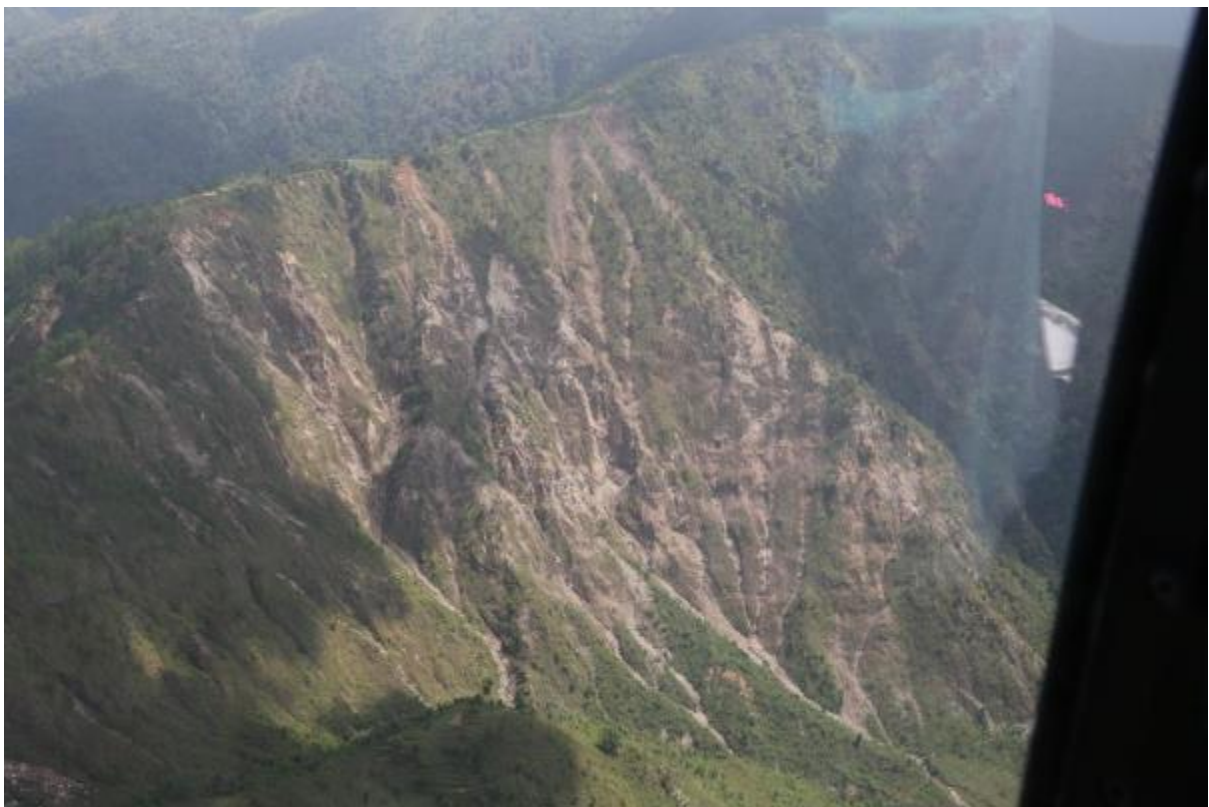
i) Shallow landslide of a similar size to the landslide in the above image.

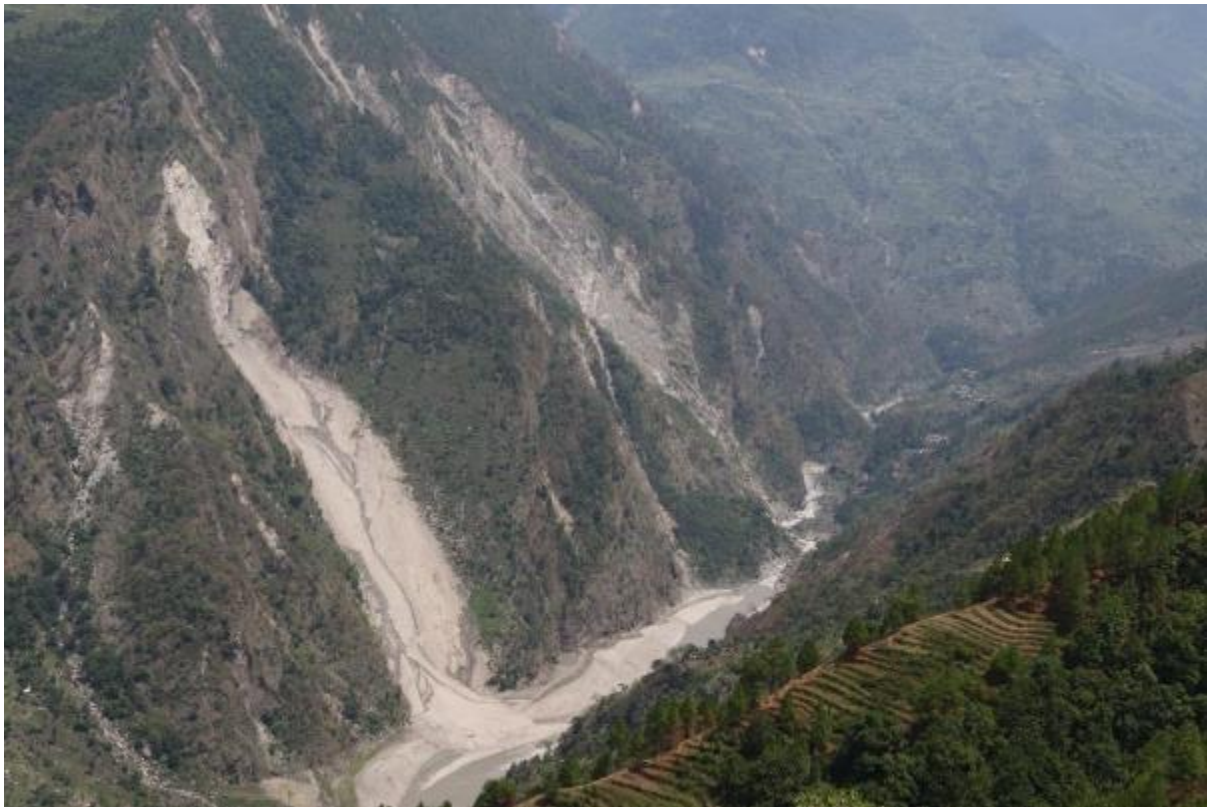
L) Deep landslide estimated to be over 200m in length.

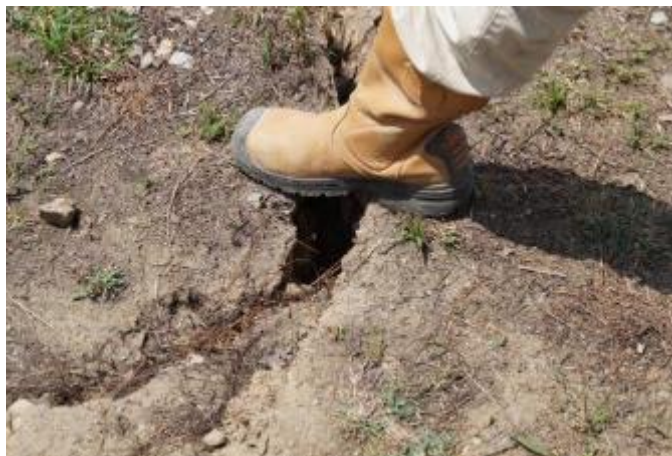
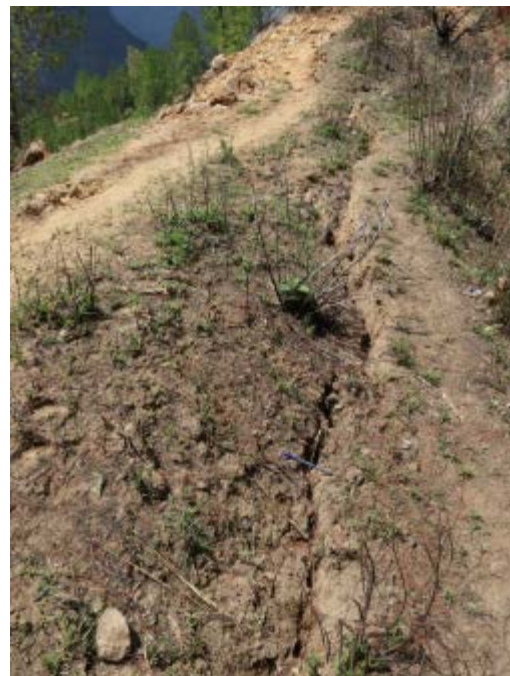
Above the village, tension cracks were observed in the terraced hillslope. The width of the cracks varied between approximately 10mm and 40mm and they ran parallel to the slope for approximately 50m. It should be noted that accurate observations of crack widths were hampered as locals had attempted to fill in the cracks with clay. This operation was both observed and reported by locals who stated that the purpose was to prevent ingress of water. Other cracking was observed lower down the slope. Due to time constraints the exact extent and nature of observed cracks was not established.

Once beyond the village (seen at the left of the picture) significant tension cracks could be seen along the entire route traversed, although these were not necessarily continuous. Examples of these cracks are shown in Figure 7-10.

Figure 7-10 Tension Crack on the survey route.

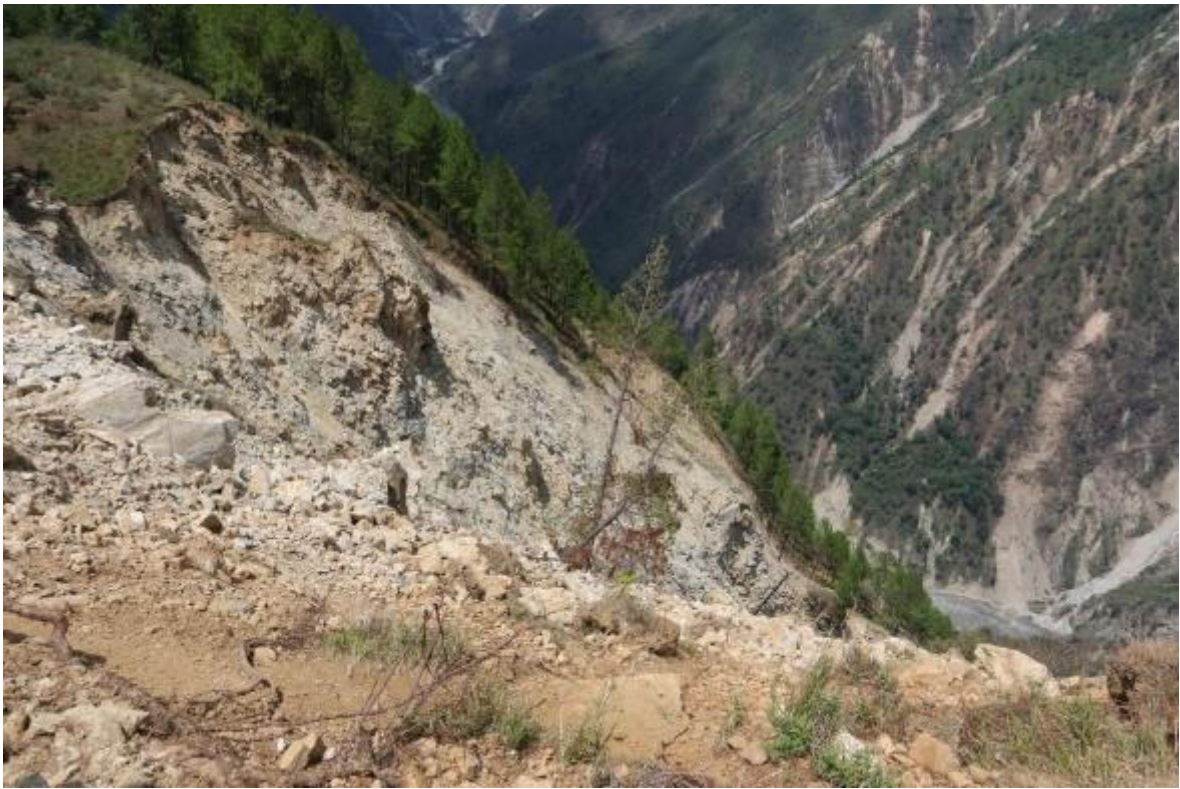
Figure 7-11 Landslide at the termination of the survey.
