Engineering Aspects of
**THE MANJIL, IRAN EARTHQUAKE OF
20 JUNE 1990**

A FIELD REPORT BY EEFIT

OCTOBER 1990

Mahmoud R. Maheri
WS Atkins Engineering Sciences

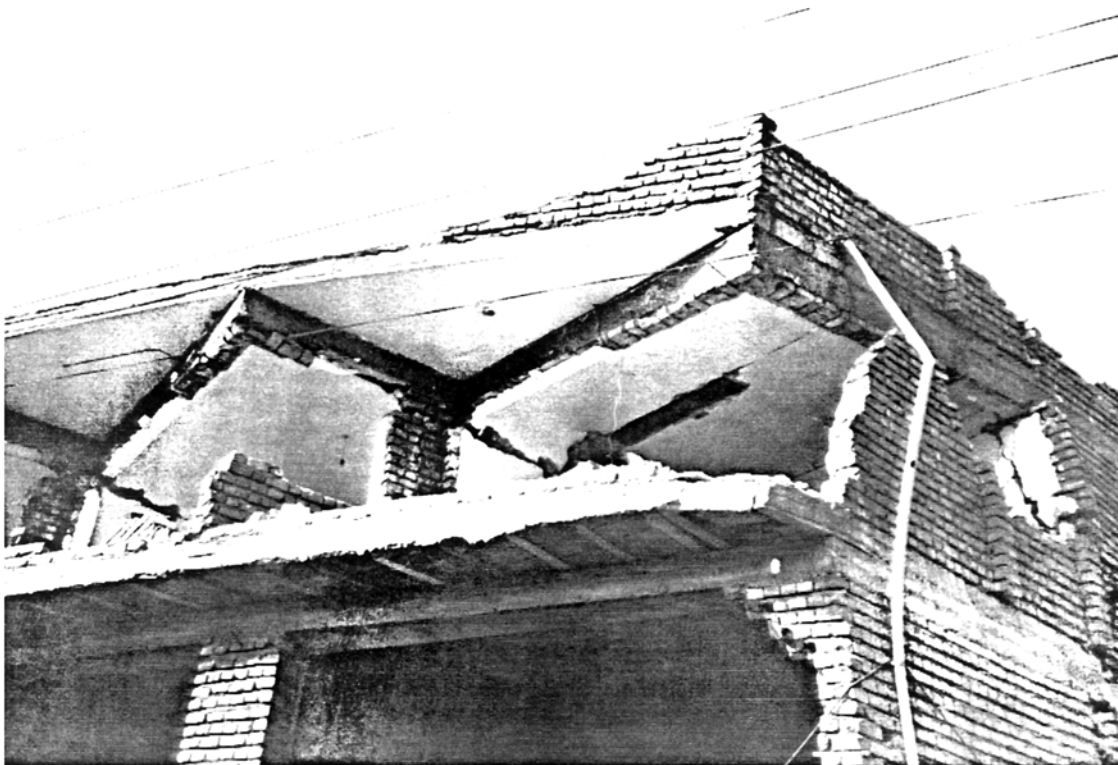
In the west side (Picture 3.11), although a large portion of the load-bearing wall has collapsed, a combination of ring-beam and concrete beam-block slab made the roof to act as a homogeneous unit, being kept in place by a minimum of surviving wall support. On the east side however the total destruction of the load-bearing walls of the upper floor resulted in the failure of the unsupported ring-beam and collapse of the roof.

Picture 3.12 Two-storey Brick Building, Manjil
Despite loss of load bearing west wall elements
the concrete ring beam has kept the roof in place

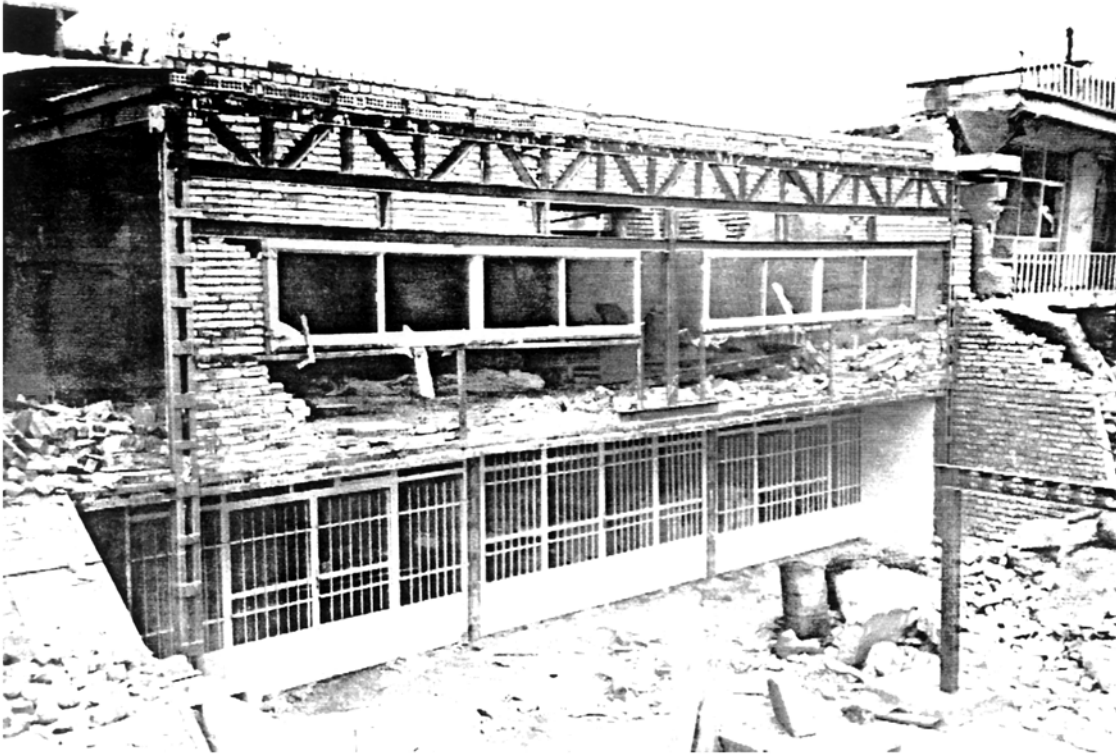
The steel frame of this building (Picture 3.15) is a good example of building construction by instinct, carried out by self taught builders rather than engineers, designing according to engineering principles.

Picture 3.15 Two-storey Steel Frame Building, Rudbar
Long unsupported span of the steel frame sagging
under the load of the quake

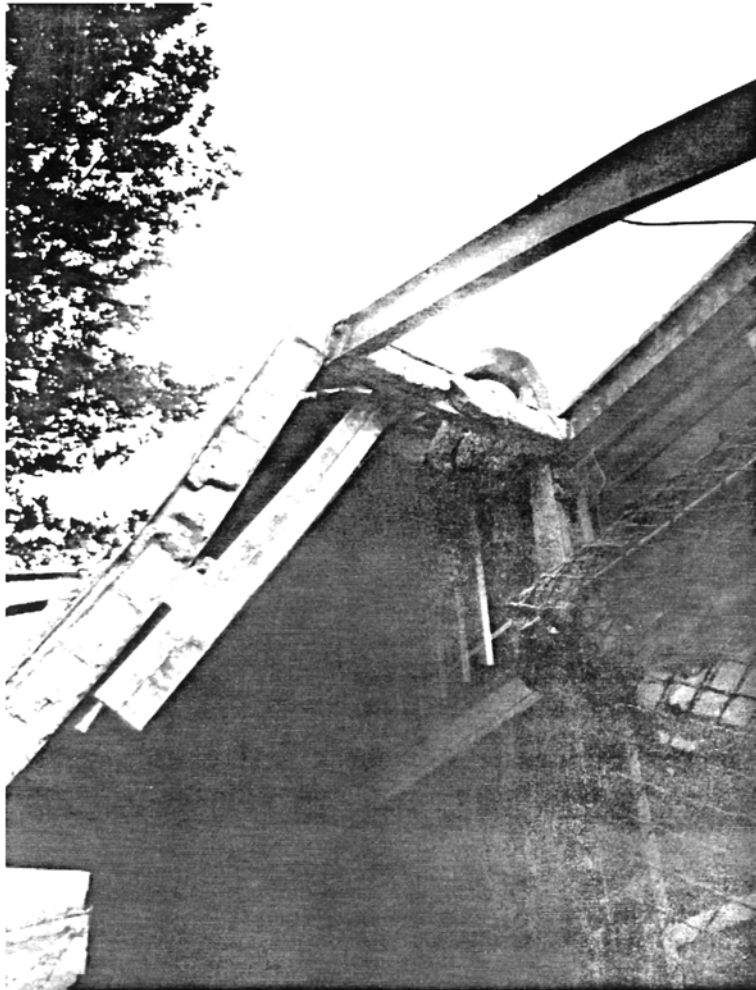
Under the east-west component of the quake, the weak brick walls of the upper floor (north and south sides) failed in bending and shear and collapsed. After the loss of shear resisting walls the inadequate steel columns could not support the cantilever action of the roof and failed in bending. The inertia force of the now unsupported roof then caused it to be thrown westwards into the pavement, bending further the western columns under its heavy weight (Picture 3.18).

Picture 3.18 Steel Frame Jack-arch Roof Building, Rudbar
Excessive bending of upper floor column under the weight of the roof

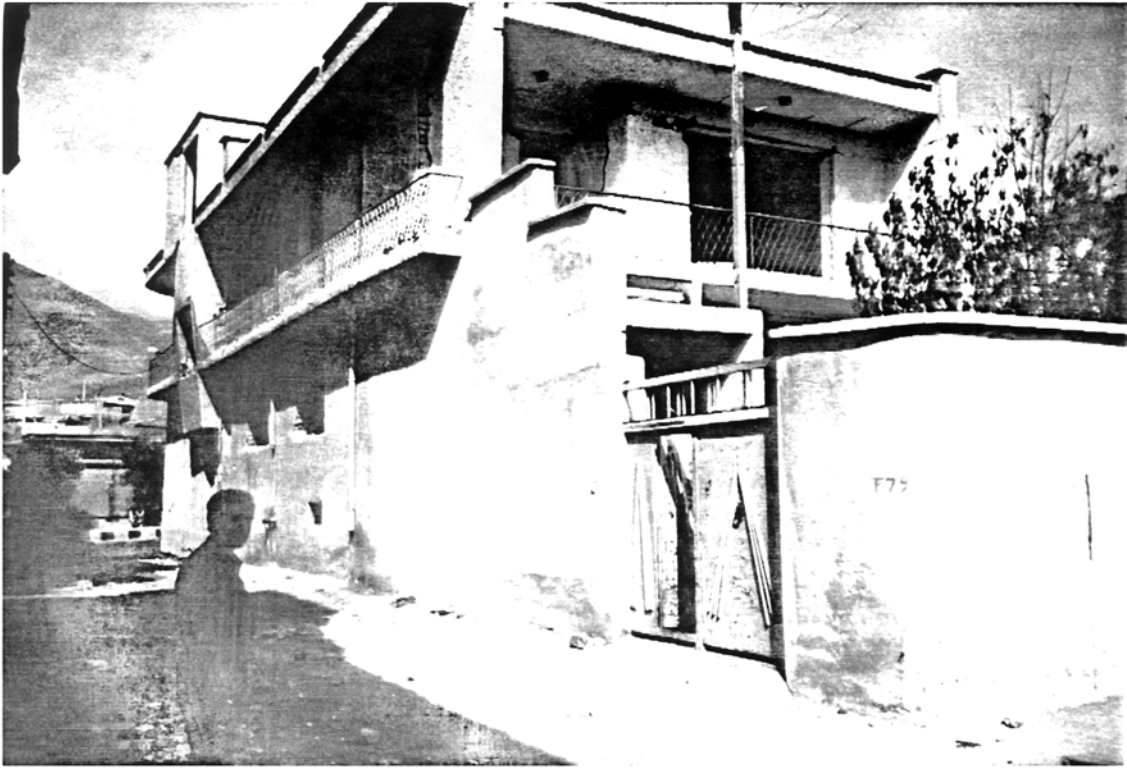
This 3-storey house (including the basement) appeared, at first, to have escaped the earthquake with only little damage visible from outside (Picture 3.19). However, the extent of damage became clear when visiting the interior of the building. Parts of the first floor had collapsed and non-load-bearing partition walls of both the first and second floors had failed and partially collapsed.

Picture 3.19 Three-storey Building, Manjil
Exterior of the house shows little sign of damage

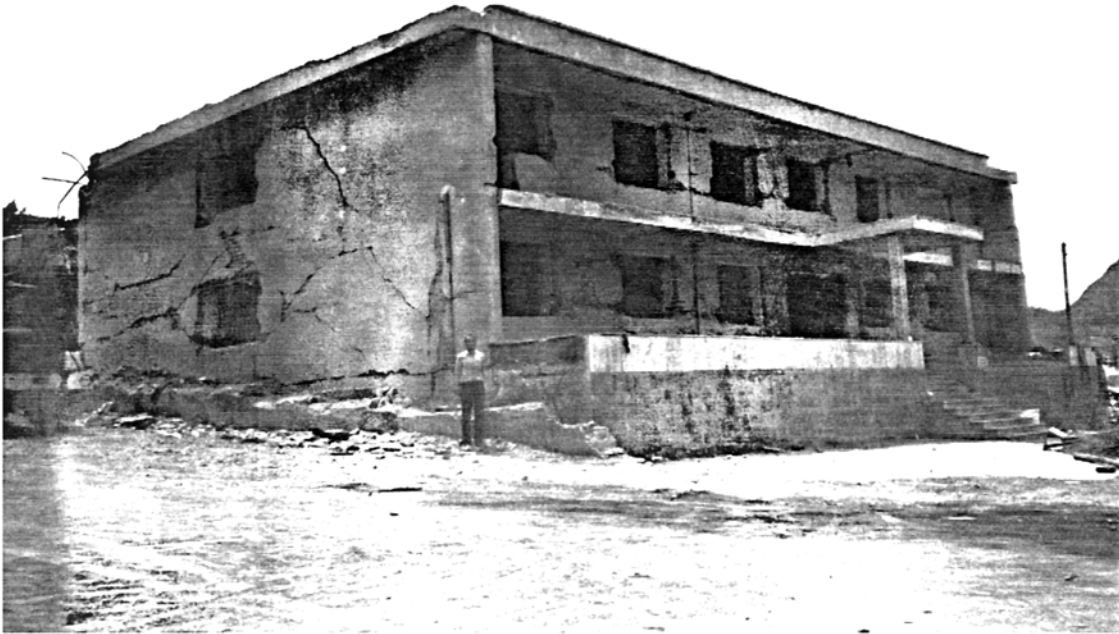
Picture 3.21 Two-storey Government Building, Rudbar, General view

This two-storey semi-engineered building in Rudbar (Picture 3.21) consists of load-bearing brick walls and steel I-beam jack-arch slabs, supported by concrete ring-beams placed directly on the walls. There are however four reinforced concrete columns at the four corners of the building and one steel column supporting the relatively large span of the floor in the middle of the building. The I-beams of the first floor and the roof are restrained at their ends by transverse steel beams. This composite of steel and concrete created a relatively strong frame for the building which is the reason why it was still standing.

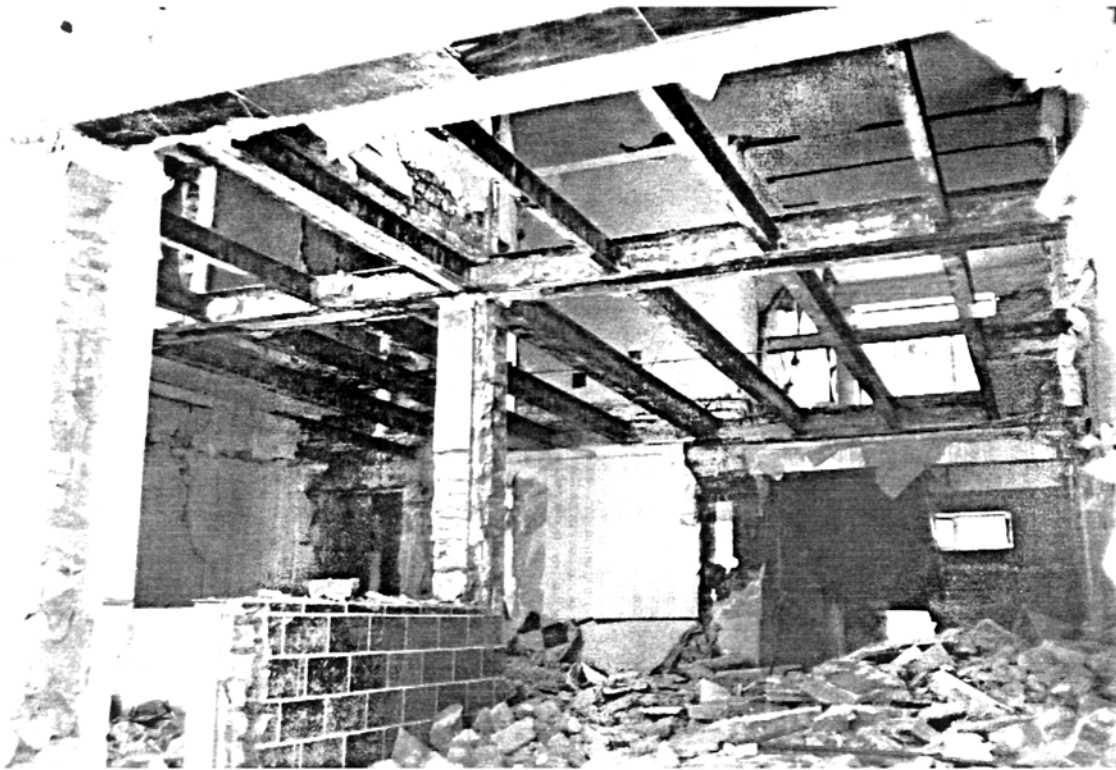
In the visible section no failures could be seen in either the concrete beams and columns or the steel work. However, the walls were heavily damaged and the brick jack-arches of the first floor had completely collapsed in many sections (Picture 3.22). The brick arches of the roof, on the other hand, remained intact. This behaviour, as is already noted in case study 3.2.10, can be attributed to the out-of-plane vibration of the floor slab which, as its edges are placed between the ground floor and first floor walls, acted as a fixed-side slab. The brick arches were incapable of out-of-plane bending and therefore crashed and collapsed. On examining the fallen debris of the brick arches it was also noted that weak lime mortar and poor quality bricks had been used which did not help the resistance of the brick arches. The roof slab however is simply supported. As a result it was capable of displacing horizontally. This reduced the local vibration of the steel frame hence the bending forces exerted on the brick arches.

Picture 3.22 Two-storey Government Building, Rudbar
Collapse of first floor jack arches without dislocation of I-beams

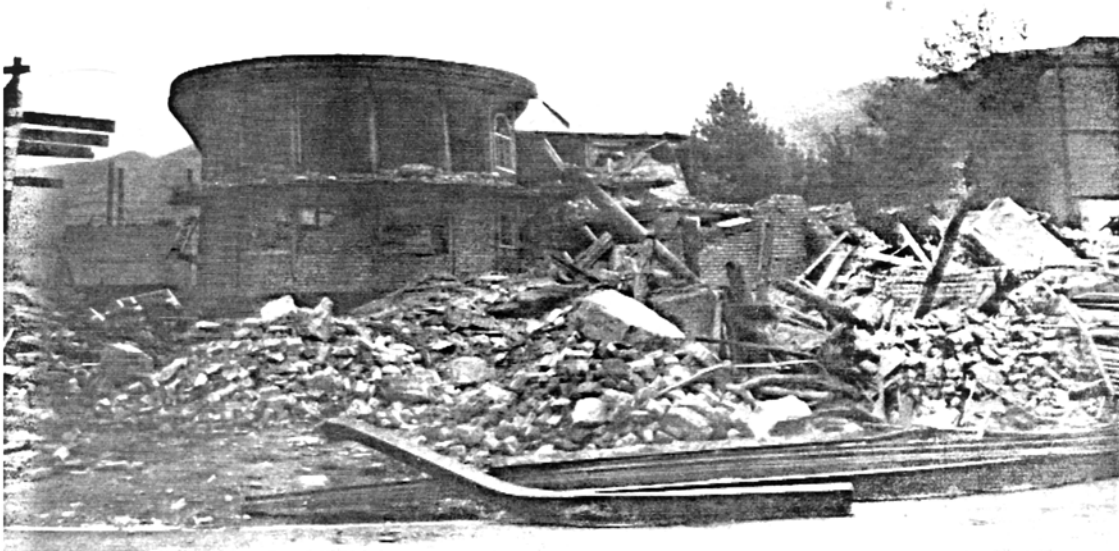
Picture 3.24 Two-storey Steel Frame Building, Rudbar
Bending failure in upper floor due to lack of shear elements

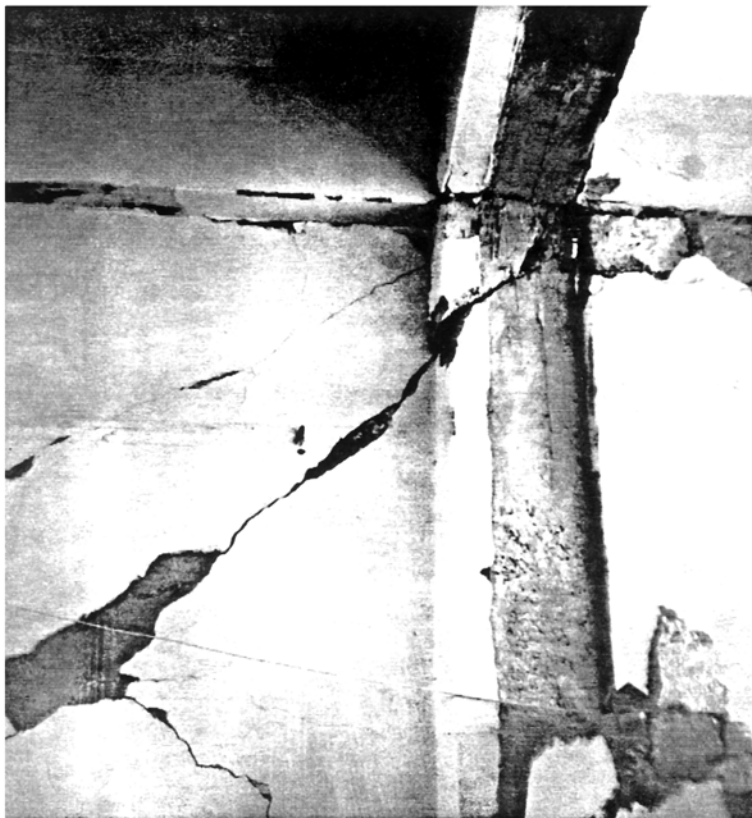
Picture 4.5 Telecom Centre, Manjil
Diagonal shear failure in the concrete block masonry wall extending to the reinforced concrete column

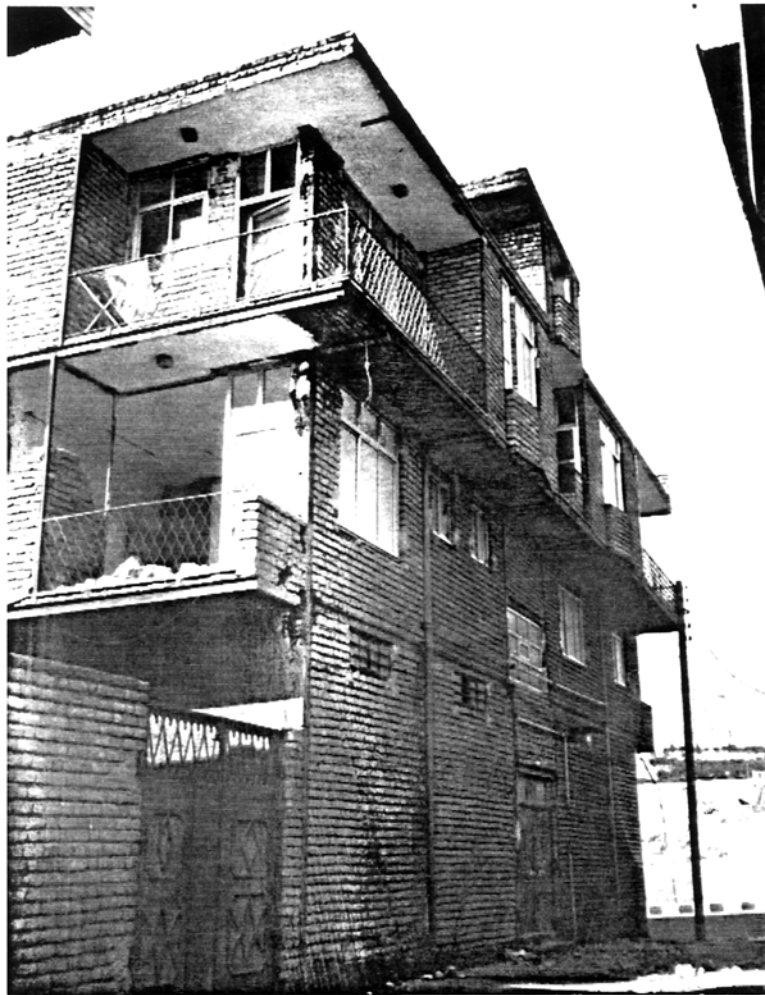
Picture 4.7 3-4 Storey Steel Framed Building, Manjil
The good behaviour of this relatively well constructed building was probably due to its flexibility

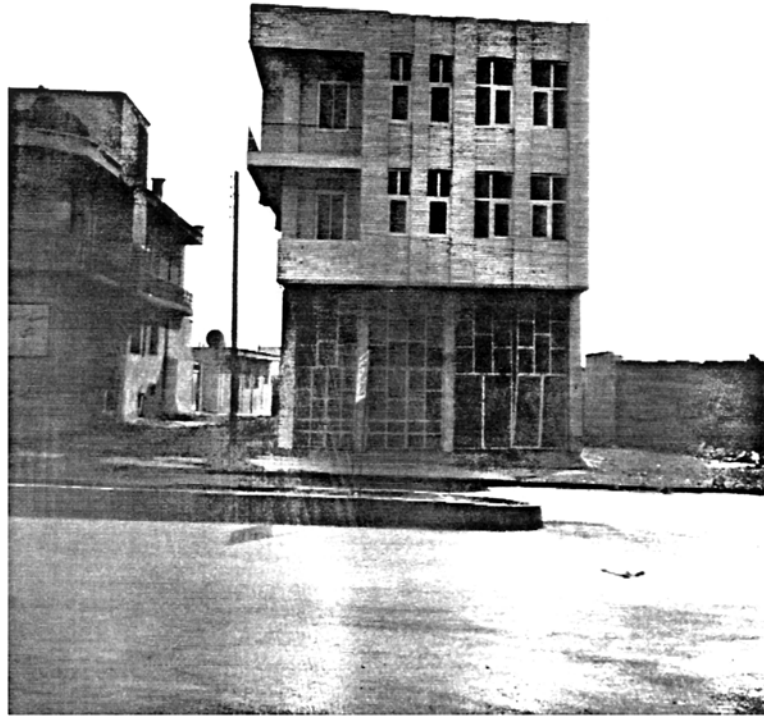
Picture 4.9 3-4 Storey Steel Framed Building, Manjil
Lack of transverse shear walls at ground floor causing slight sway in that direction

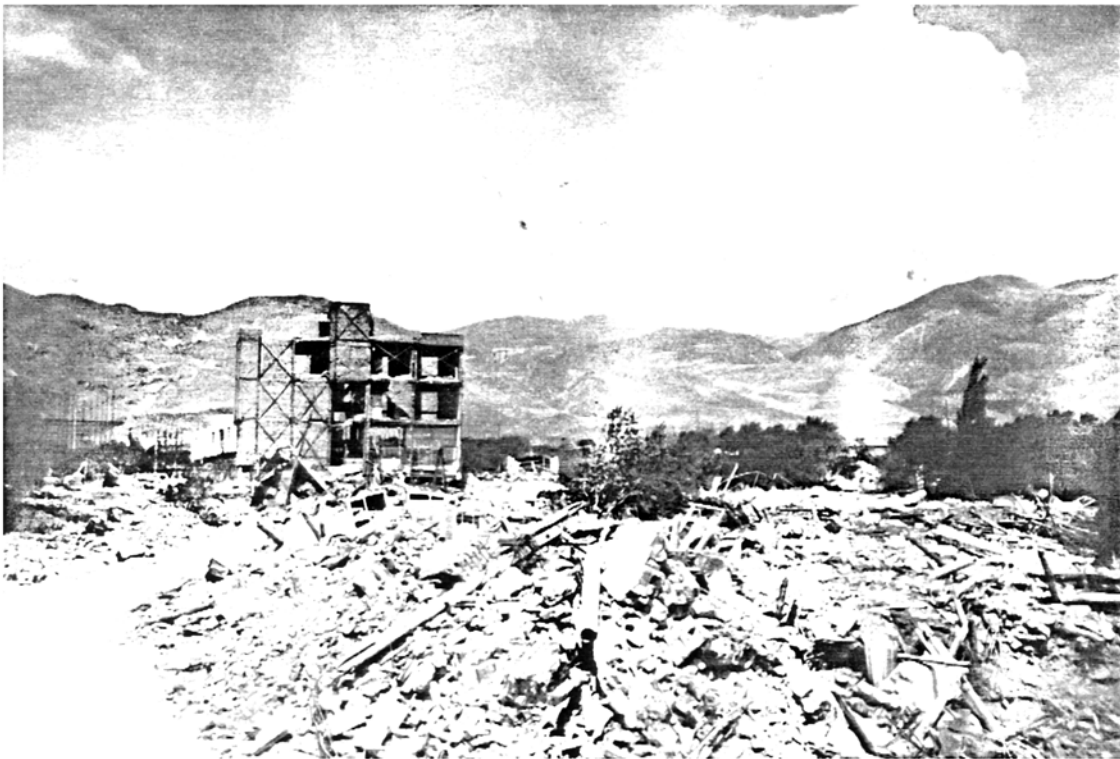
Picture 4.10 Better behaviour of this flexible steel frame building was as much due to its lower natural frequency of vibration as its relatively better construction, Manjil

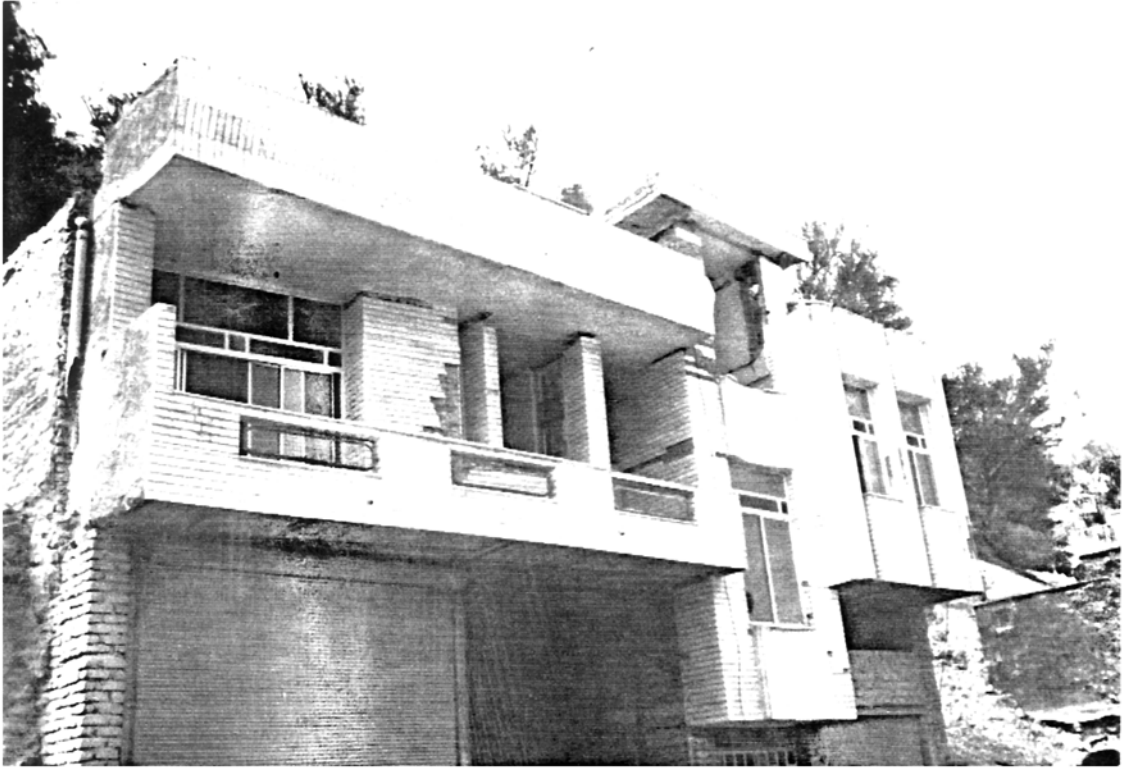
Picture 4.11 Two-storey Stone Clad House, Rudbar
This relatively flexible steel frame house, founded on hard ground survived the quake with little damage

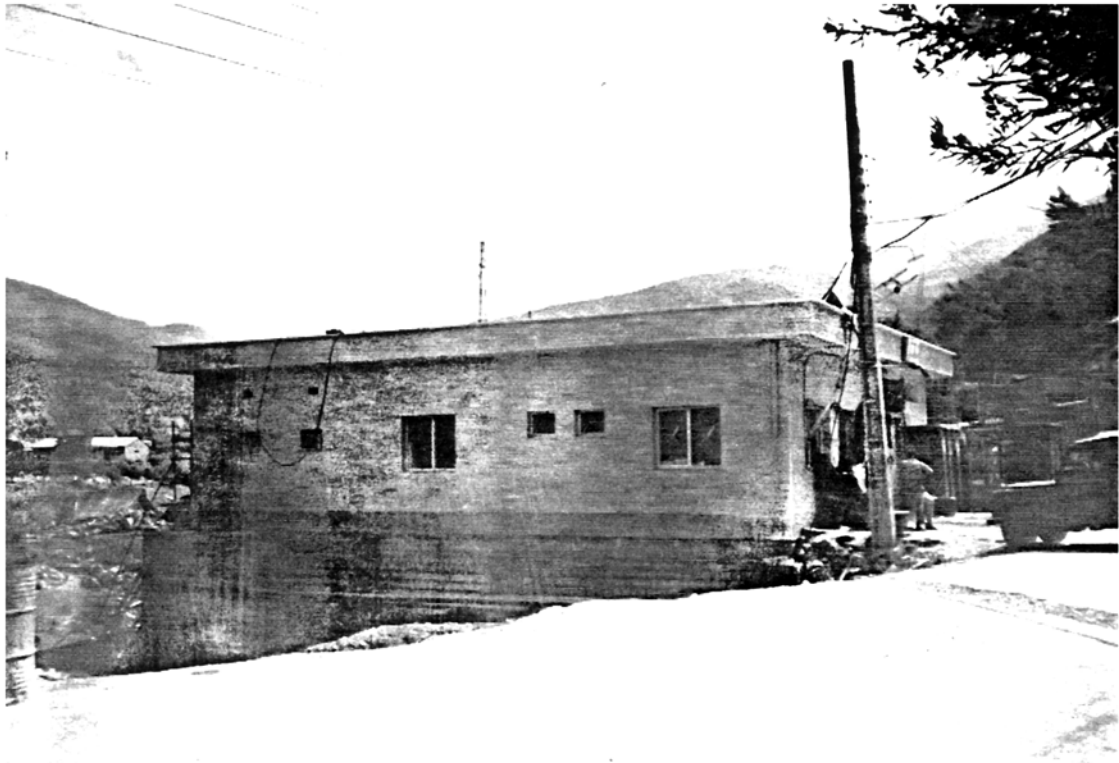
Picture 4.15 New Post Office Building, Rudbar
The only visited building in Rudbar without damage,
good example of an earthquake resistant building

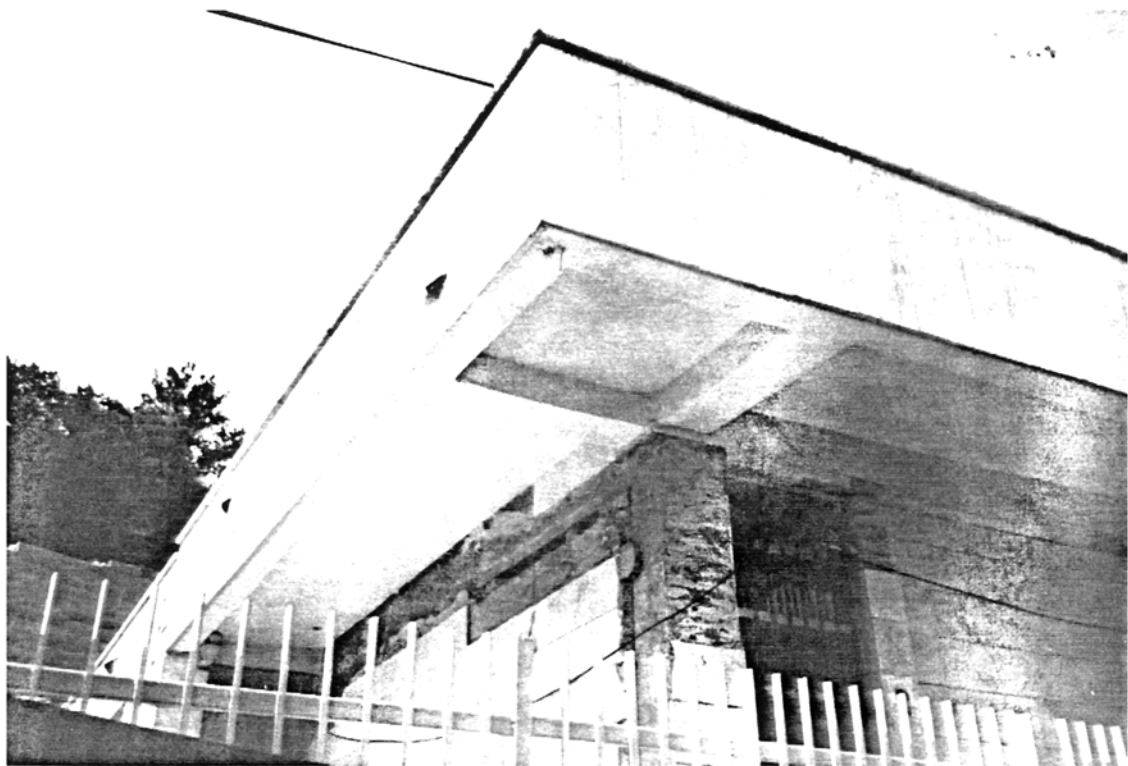
Picture 4.16 Bank Melli Iran, Rudbar
Good behaviour of reinforced concrete frame saved
this one-storey brick building from major damage

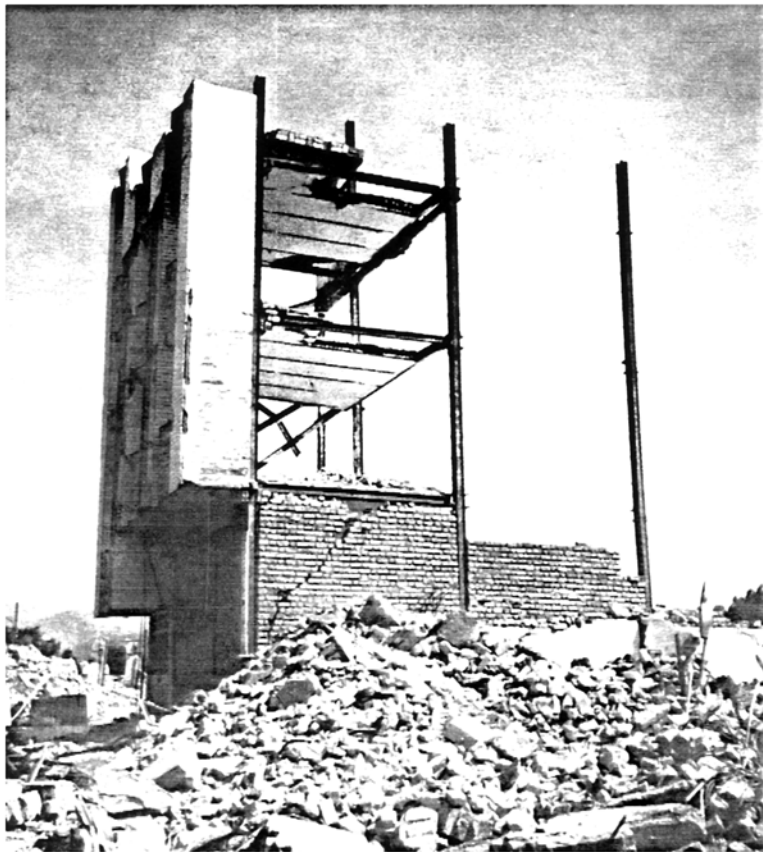
Picture 4.17 Three-four Storey Steel Frame House, Manjil
Amplification of response at the back of the building
due to lateral-torsional coupling caused by both mass
and stiffness eccentricities in the building

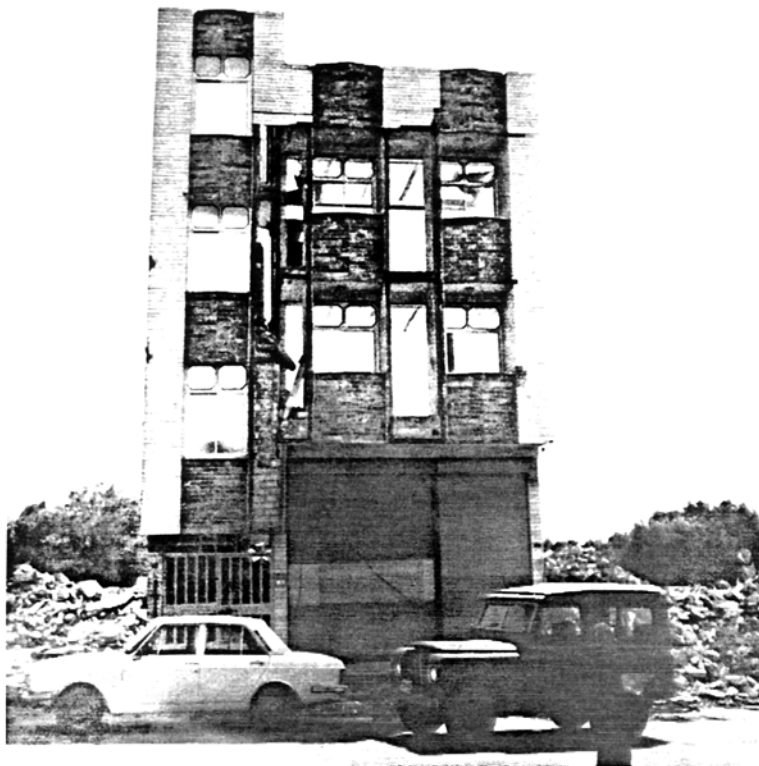
Picture 4.18 Three-four Storey Steel Frame House, Manjil
Front of the building relatively undamaged
whilst the back completely collapsed

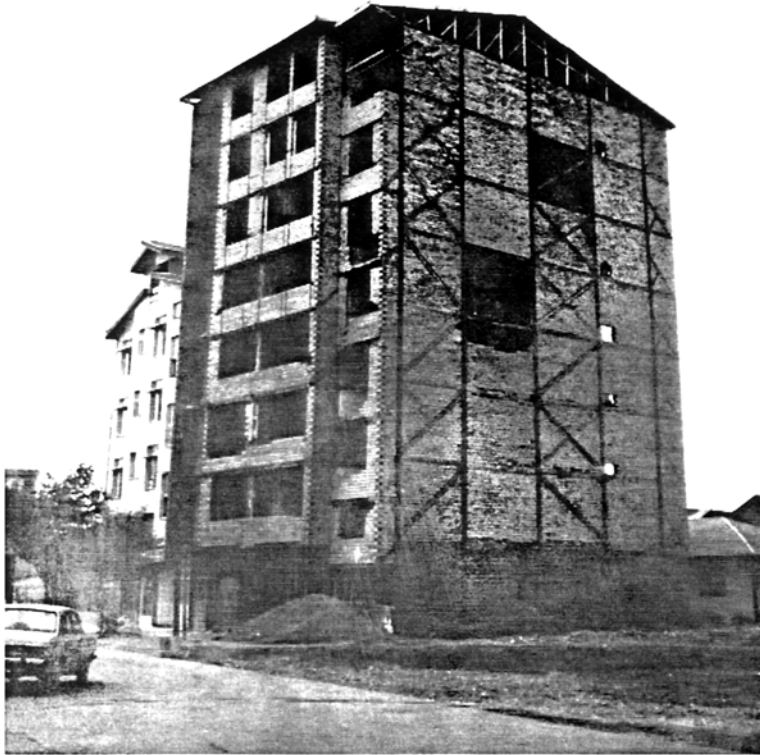
Picture 4.19 Unfinished Steel Frame Building, Rasht
Lateral-torsional coupling amplification in response
of the building due to its eccentric stiffness

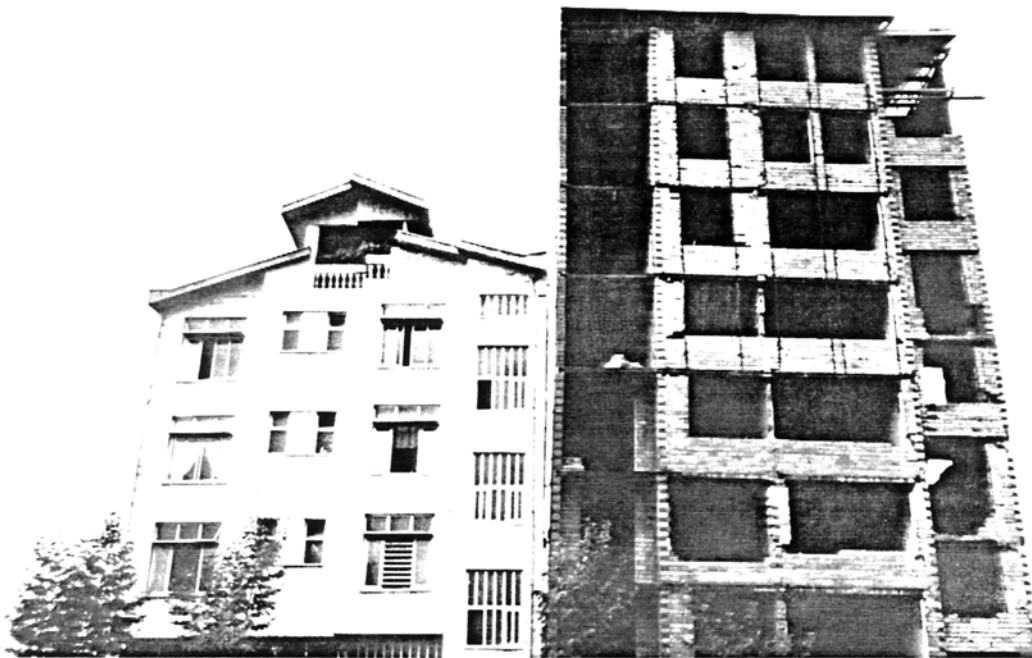
Picture 4.20 Unfinished Steel Frame Building, Rasht
Large sway of the building as a result of lack of
shear resisting elements

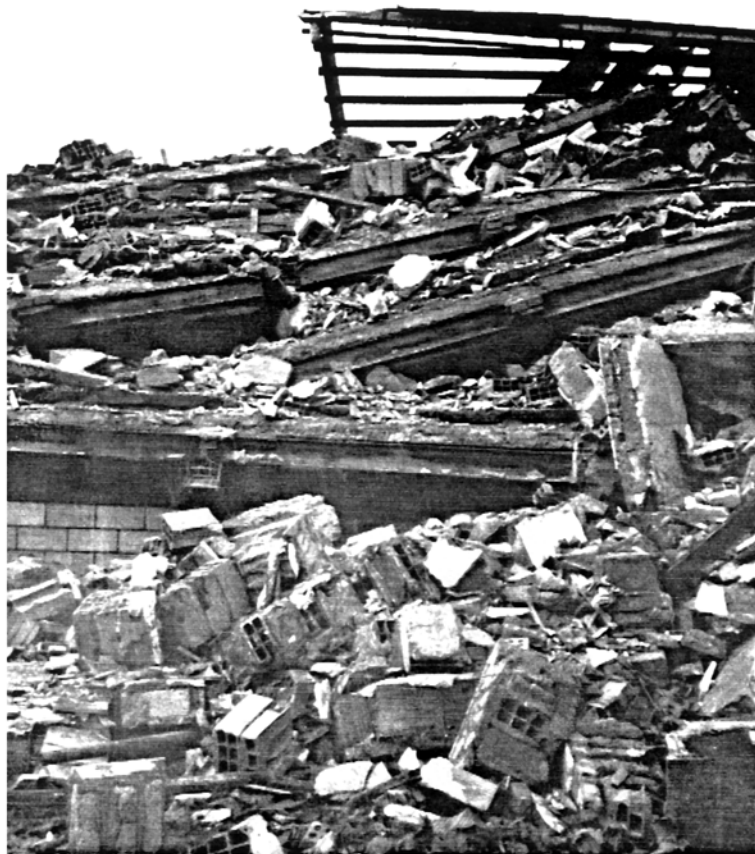
Picture 4.23 Six-storey Steel Frame Building, Rasht
Concrete beam-block floor slabs maintaining their integrity after collapse

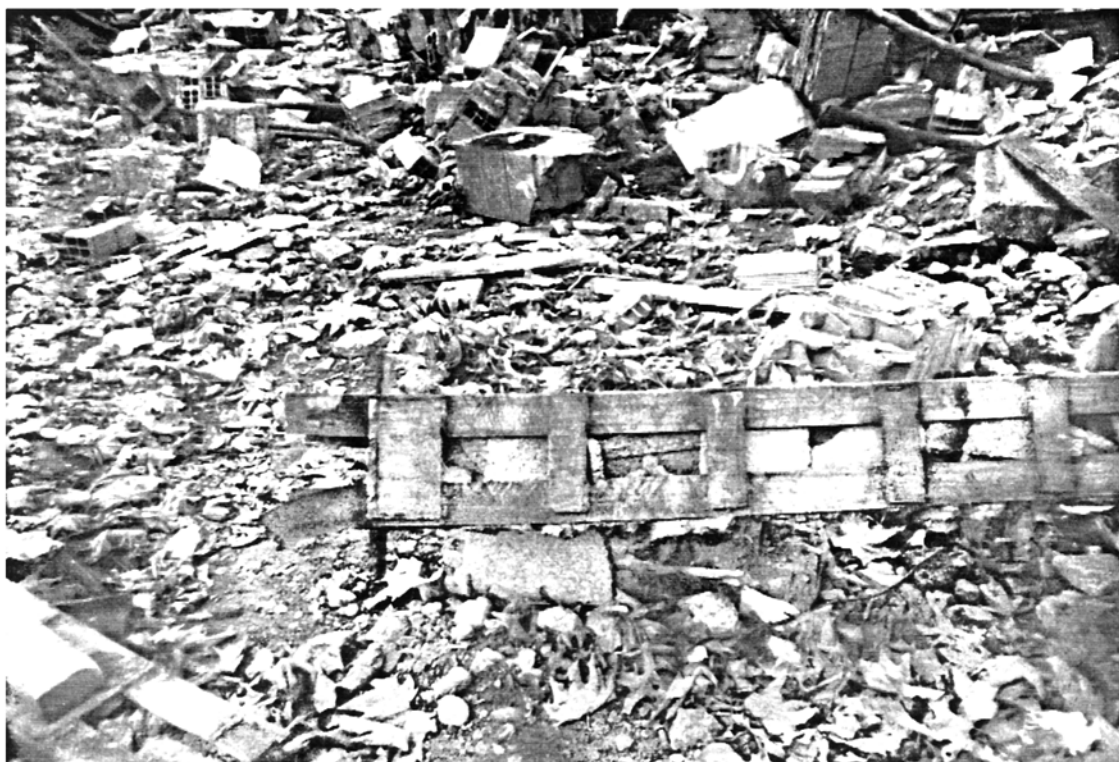
Picture 4.24 Six-storey Steel Frame Building, Rasht
Weak steel column consists of two undersize I-beams

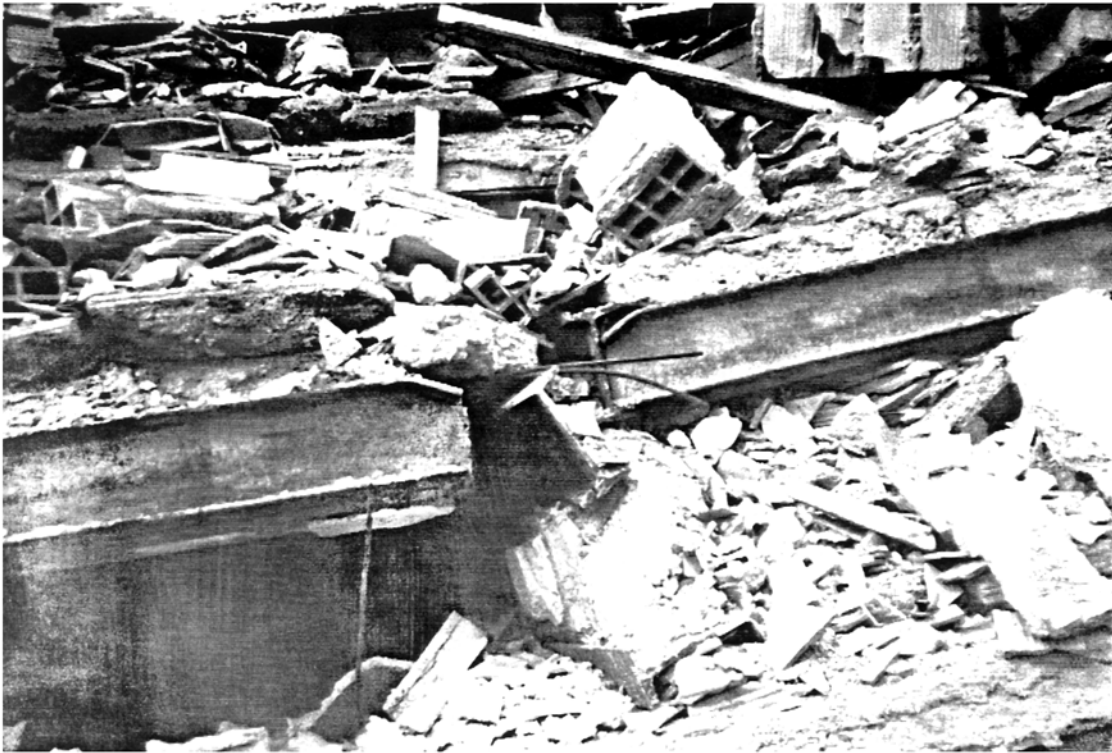
Picture 4.25 Six-storey Steel Frame Building, Rasht
Weak welded joints simply snapped under small stresses

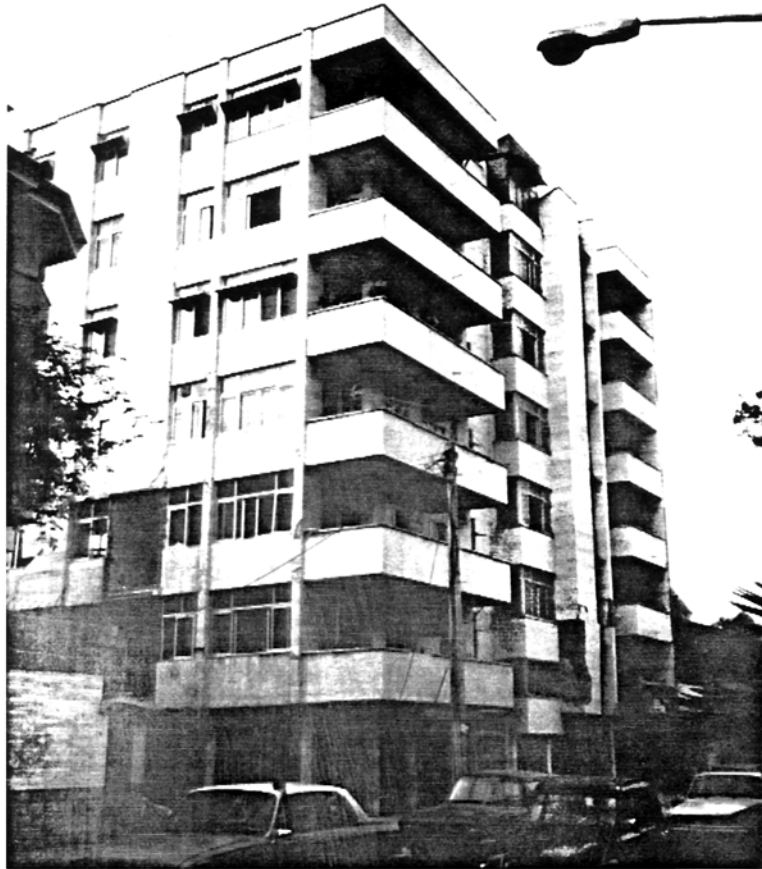
Picture 4.27 Seven-storey White Stone Clad Building, Rasht
A steel frame building with better design and workmanship

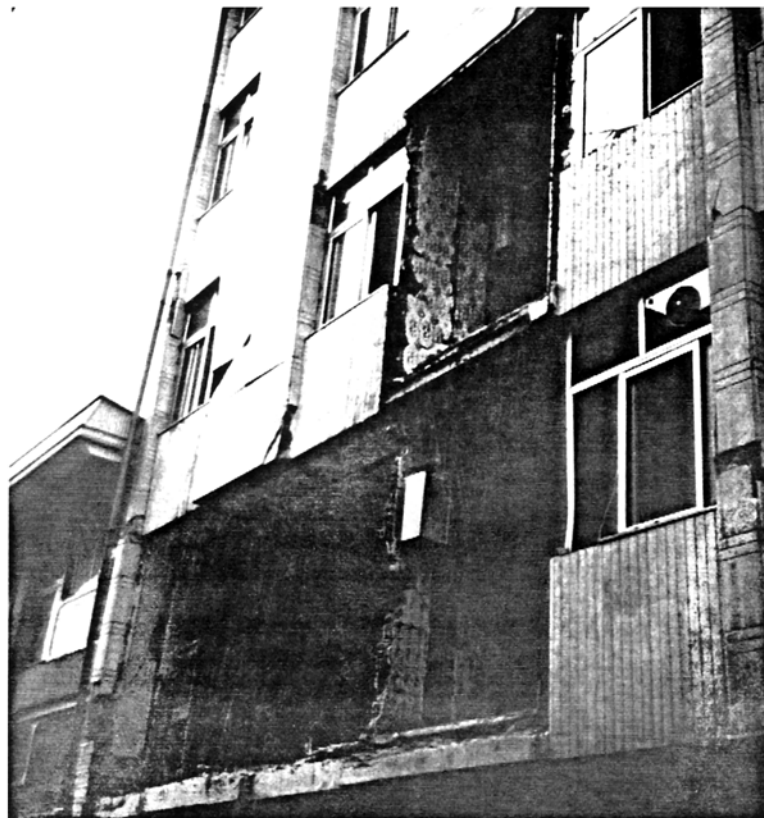
Picture 4.28 Seven-storey White Stone Clad Building, Rasht
Collapse of a number of the unsupported infill walls

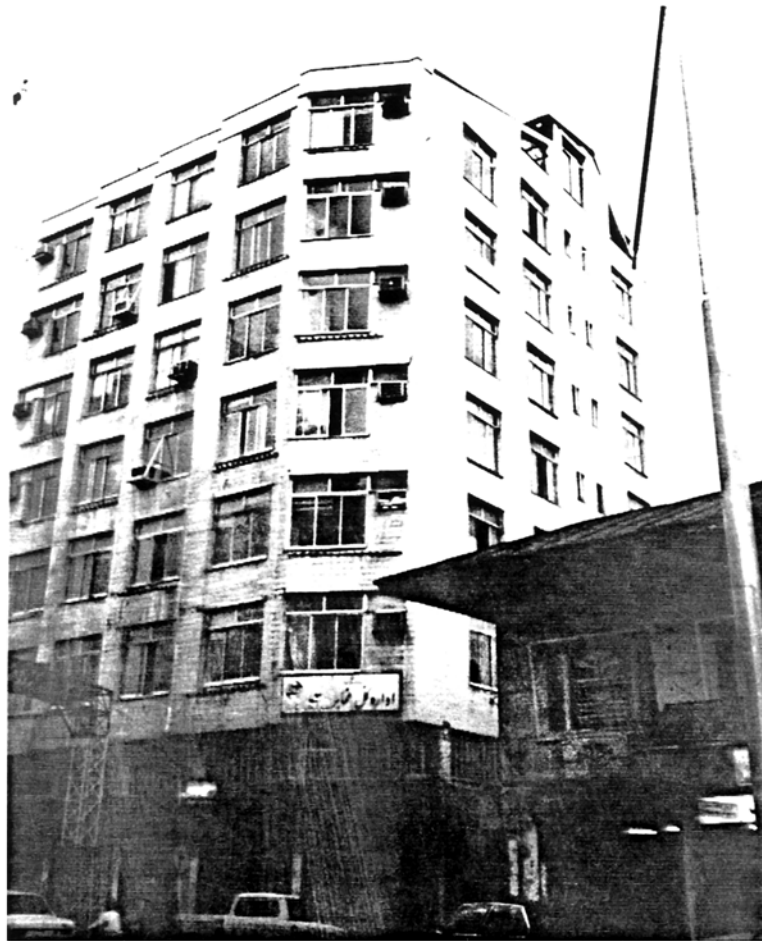
Picture 4.29 Telecom Building, Rasht
A well behaved steel frame building with minor damages

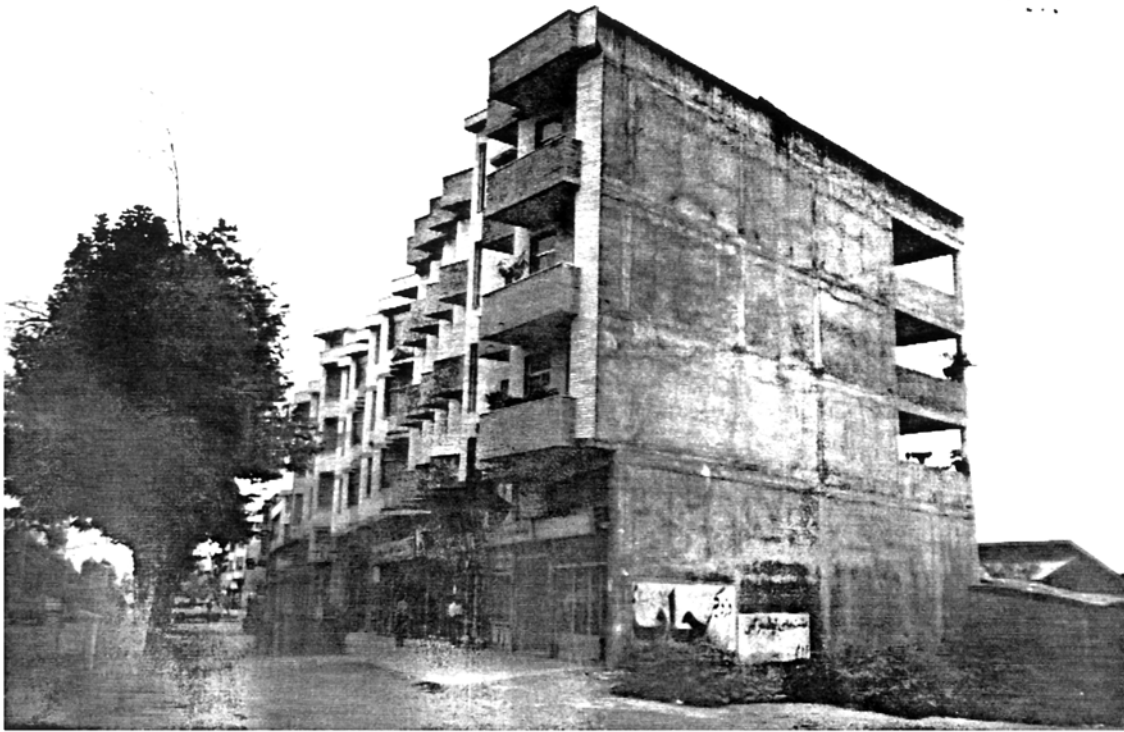
Picture 4.31 4-6 Storey Concrete and Steel Frame Buildings, Rasht
The better behaved concrete frame building also supported the weaker neighbouring steel frame buildings

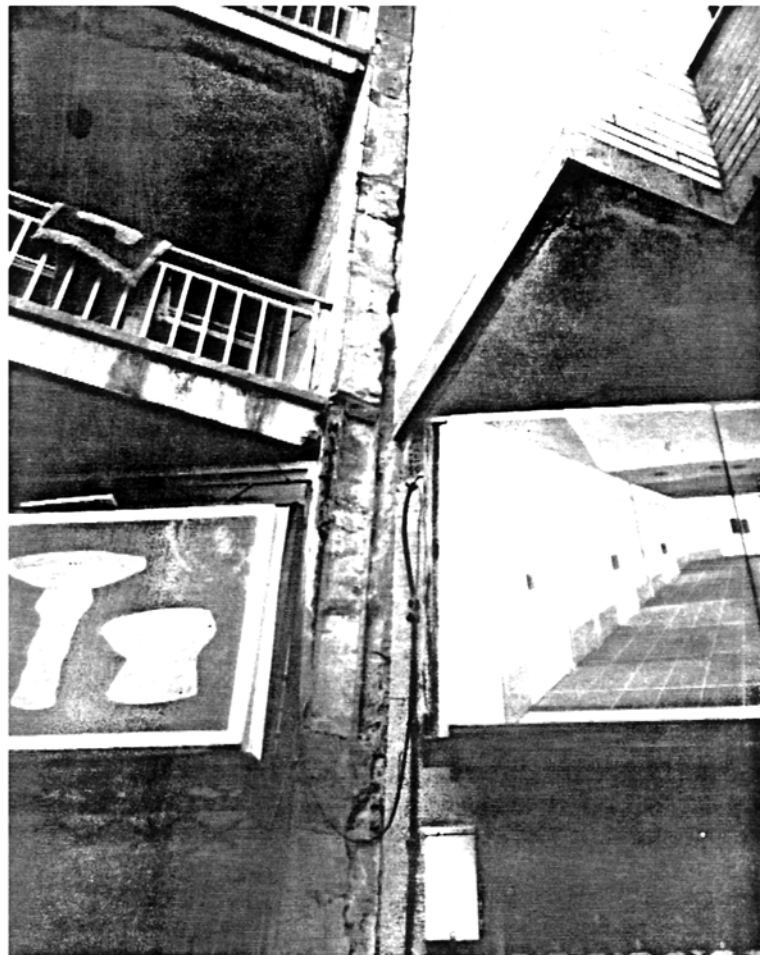
Picture 4.32 4-6 Storey Concrete and Steel Buildings, Rasht
Separation due to differential responses of the relatively stiff concrete building and the more flexible steel frame building

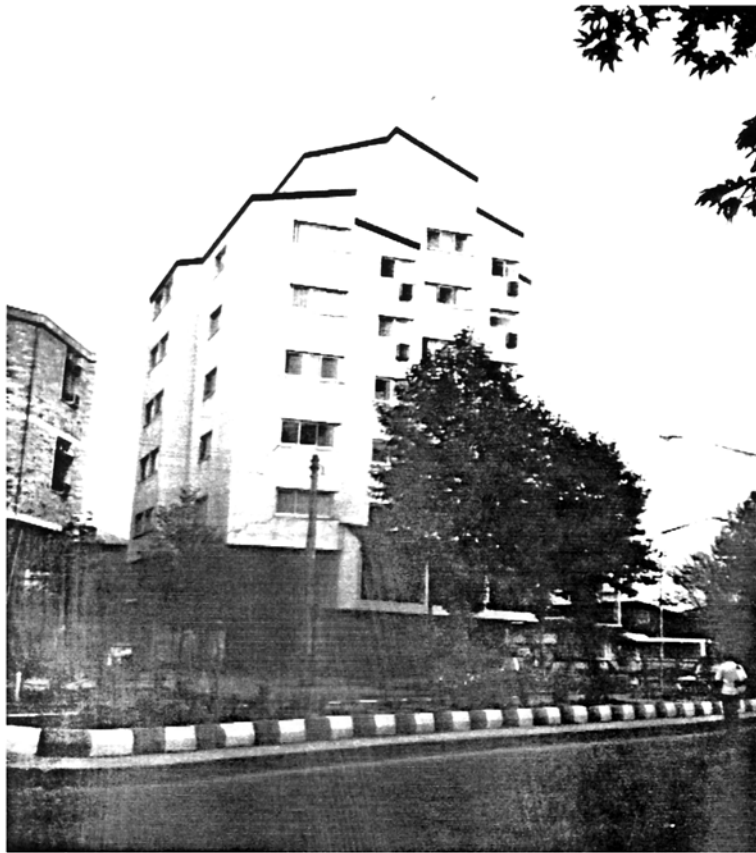
Picture 4.33 Nine-storey Apartment Block, Rasht
The concrete frame behaved well

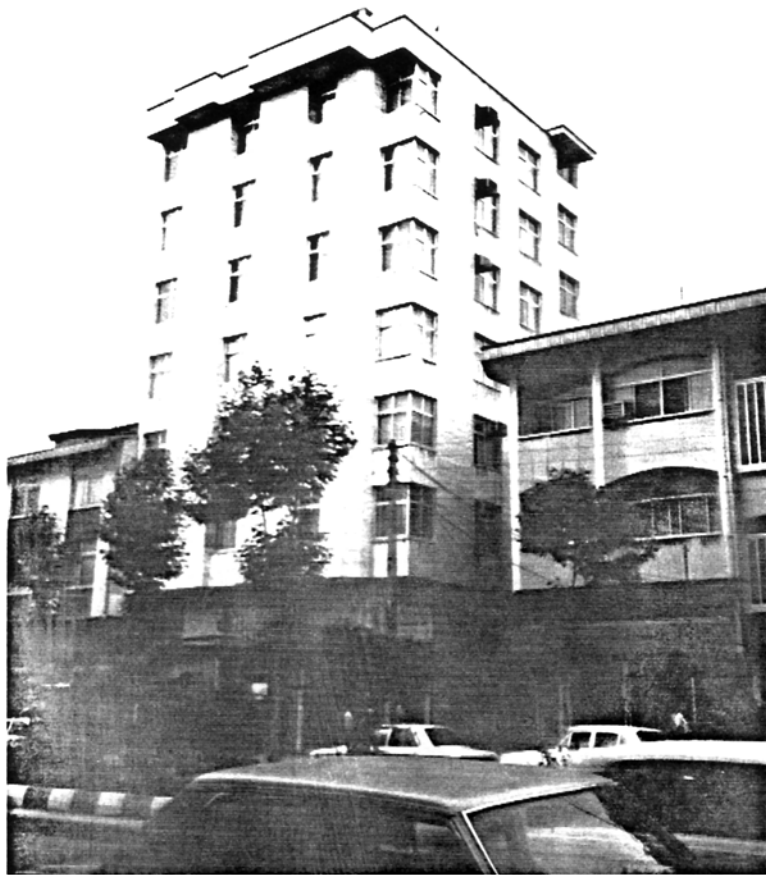
Picture 4.35 Eight-storey White Stone Clad Building, Rasht
This well designed and constructed reinforced concrete frame building survived the quake undamaged

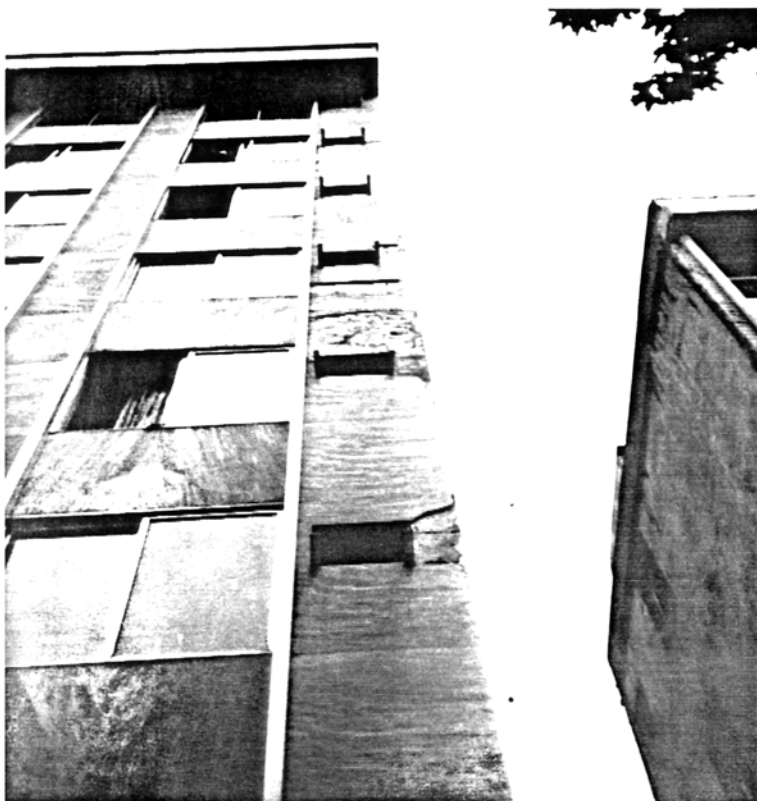
Picture 4.38 Eight-storey Grey Stone Clad Building, Rasht
Collapse of sections of stone cladding the only
failure in this building
