Engineering Aspects of
**THE MANJIL, IRAN EARTHQUAKE OF
20 JUNE 1990**

A FIELD REPORT BY EEFIT

OCTOBER 1990

Mahmoud R. Maheri
WS Atkins Engineering Sciences

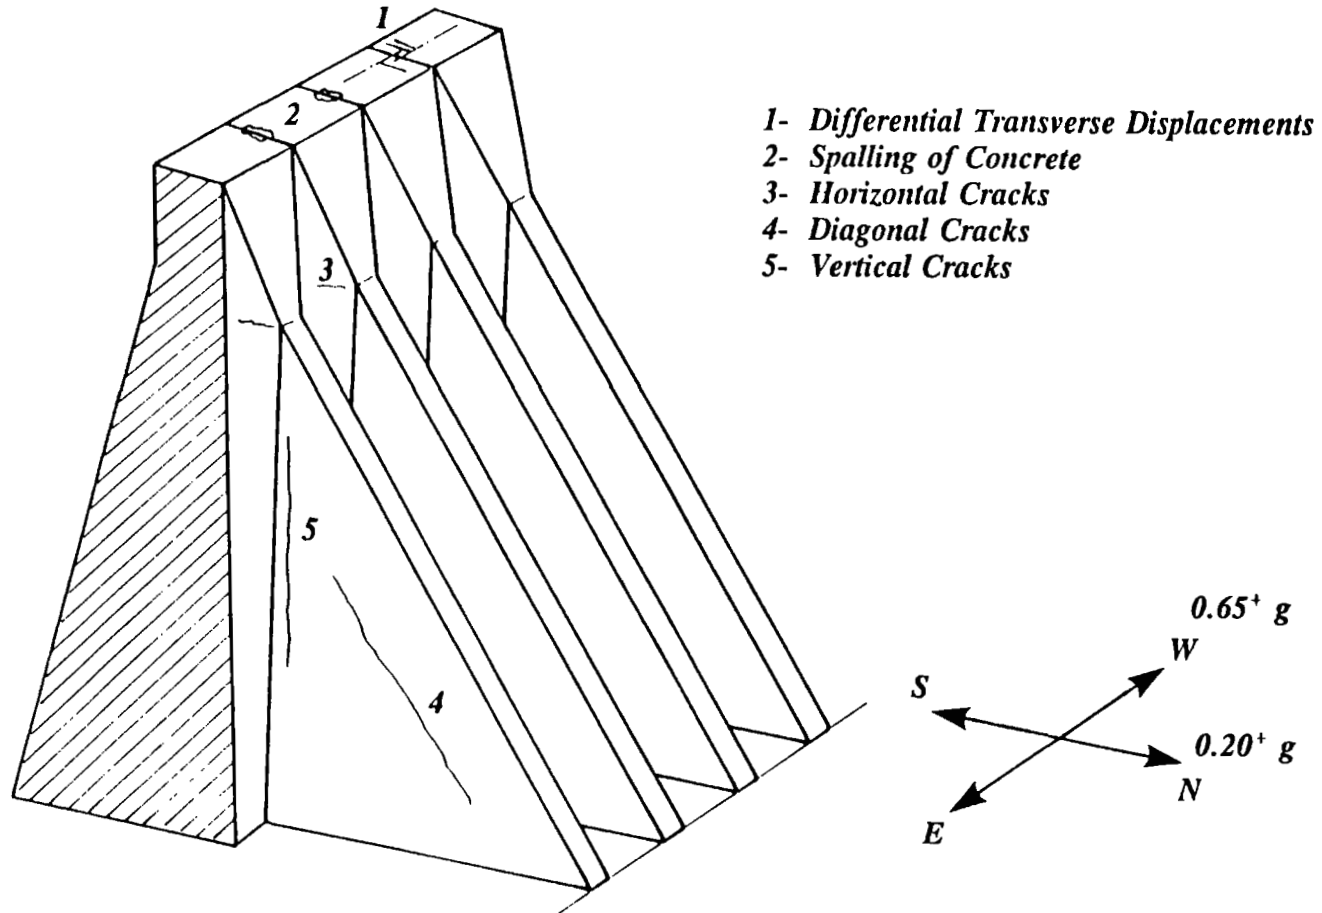
Fig. 5.1

1. Horizontal cracks; These were observed mainly in the upper parts of the buttresses at their intersection with the crown (Picture 5.5). Most of the 23 buttresses developed these cracks. The cracks were probably extended to the upstream (reservoir) face of the dam where at the same level some horizontal cracks were just visible. The cracks, associated in places with spalling of concrete at the surface to a width of 7 to 10cm, were probably caused by the out-of-plane bending (overturning) action of the crown under the North-South component of the quake. As the drainage of the reservoir was revealing more of the upstream face of the dam, more horizontal cracks could be seen at lower levels.

FAILURE MODES OF THE SEFID-RUD DAM

2. Diagonal cracks; In a few central buttresses there were also a number of diagonal shear cracks. As the height of the dam in its central sections is more than the end sections the overturning and flexural responses of the structure under the North-South component were higher in those sections, hence resulting in shear failures in the supporting buttresses.

4. Pounding of sections; Evidence of pounding of the dam sections against each other could be seen on the crest in the form of spalling of concrete at the joints (Picture 5.7). The spalling could be seen in most joints, however, the extent of the pounding damage at the interface of the adjoining sections could not be investigated. The type and size of seismic joints, if they were at all a consideration in design of the dam, were inappropriate to mitigate the damaging effects of pounding.

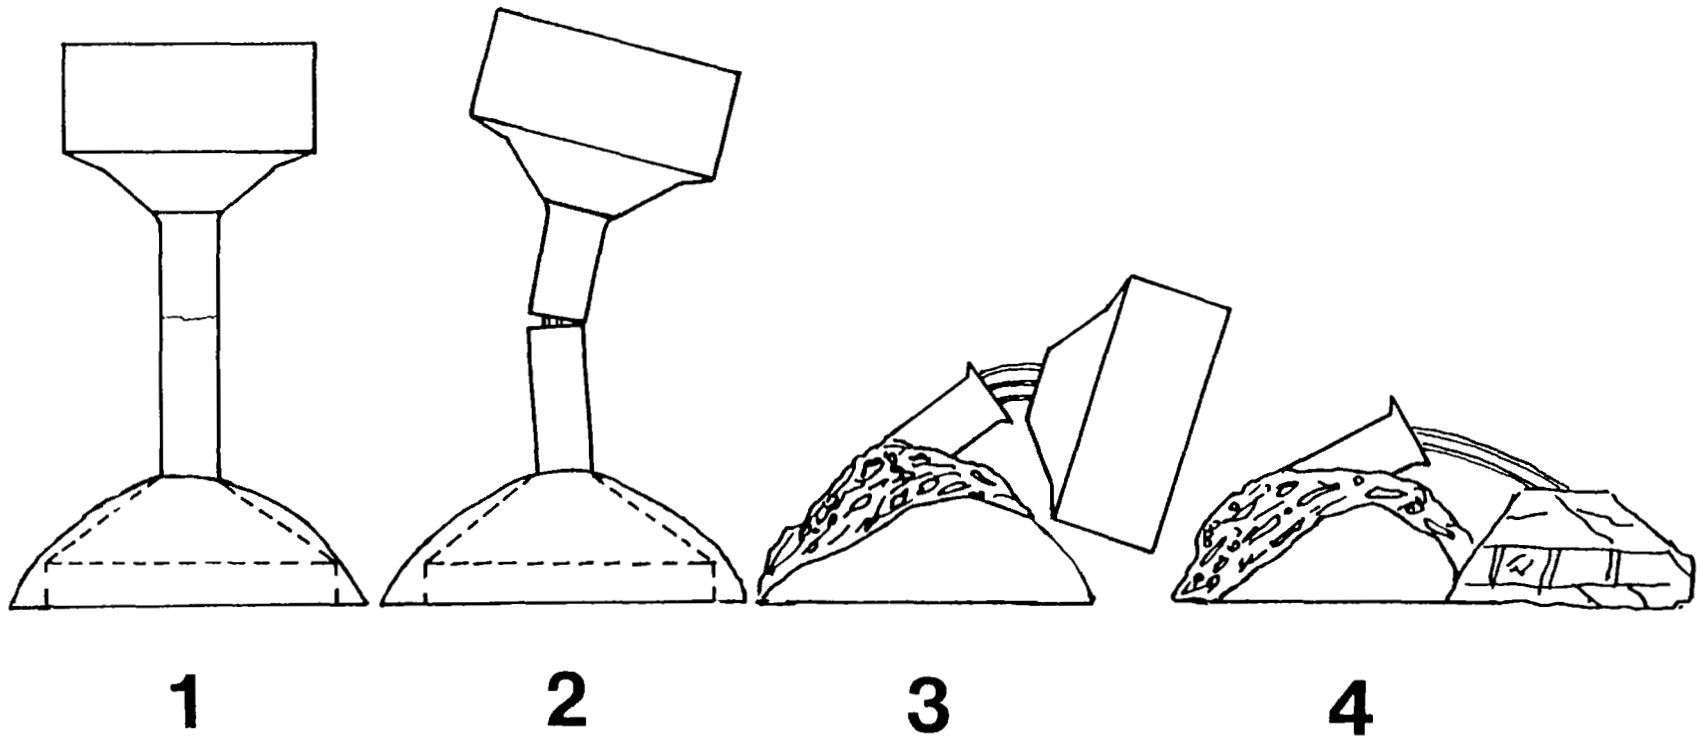
Fig. 5.2

- 1) Possibly at the onset of the earthquake the bending stresses in the shaft exceeded the tensile capacity of the reinforcement bars, leading to bending failure in the shaft. The position of the bending crack, to judge from the remains of the shaft, appears to have occurred at about its mid-height.
- 2) The inertia force of the quake then forced the tank and upper section of the shaft westwards, opening the crack in the process and pushing the lower part of the shaft in the opposite direction.

MODES OF FAILURE OF RASHT WATER TOWER

- 3) Under the heavy compression and bending forces the lower half of the shaft crushed and disintegrated into a heap of broken concrete. The tank and upper part of the shaft, meanwhile, followed a free-fall mode, during which time the tank was separated from the shaft, turning over in process.
- 4) The final damage to the tank and upper part of the shaft was as a result of impact with the ground. On this impact the half of the upper shaft coming into contact with the ground also crashed whereas the other half remained relatively intact (Pictures 5.28 and 5.29). The fall of the heavy tank on the other hand caused multiple bending, shear and buckling failures in various concrete sections of its structure (Picture 5.30).

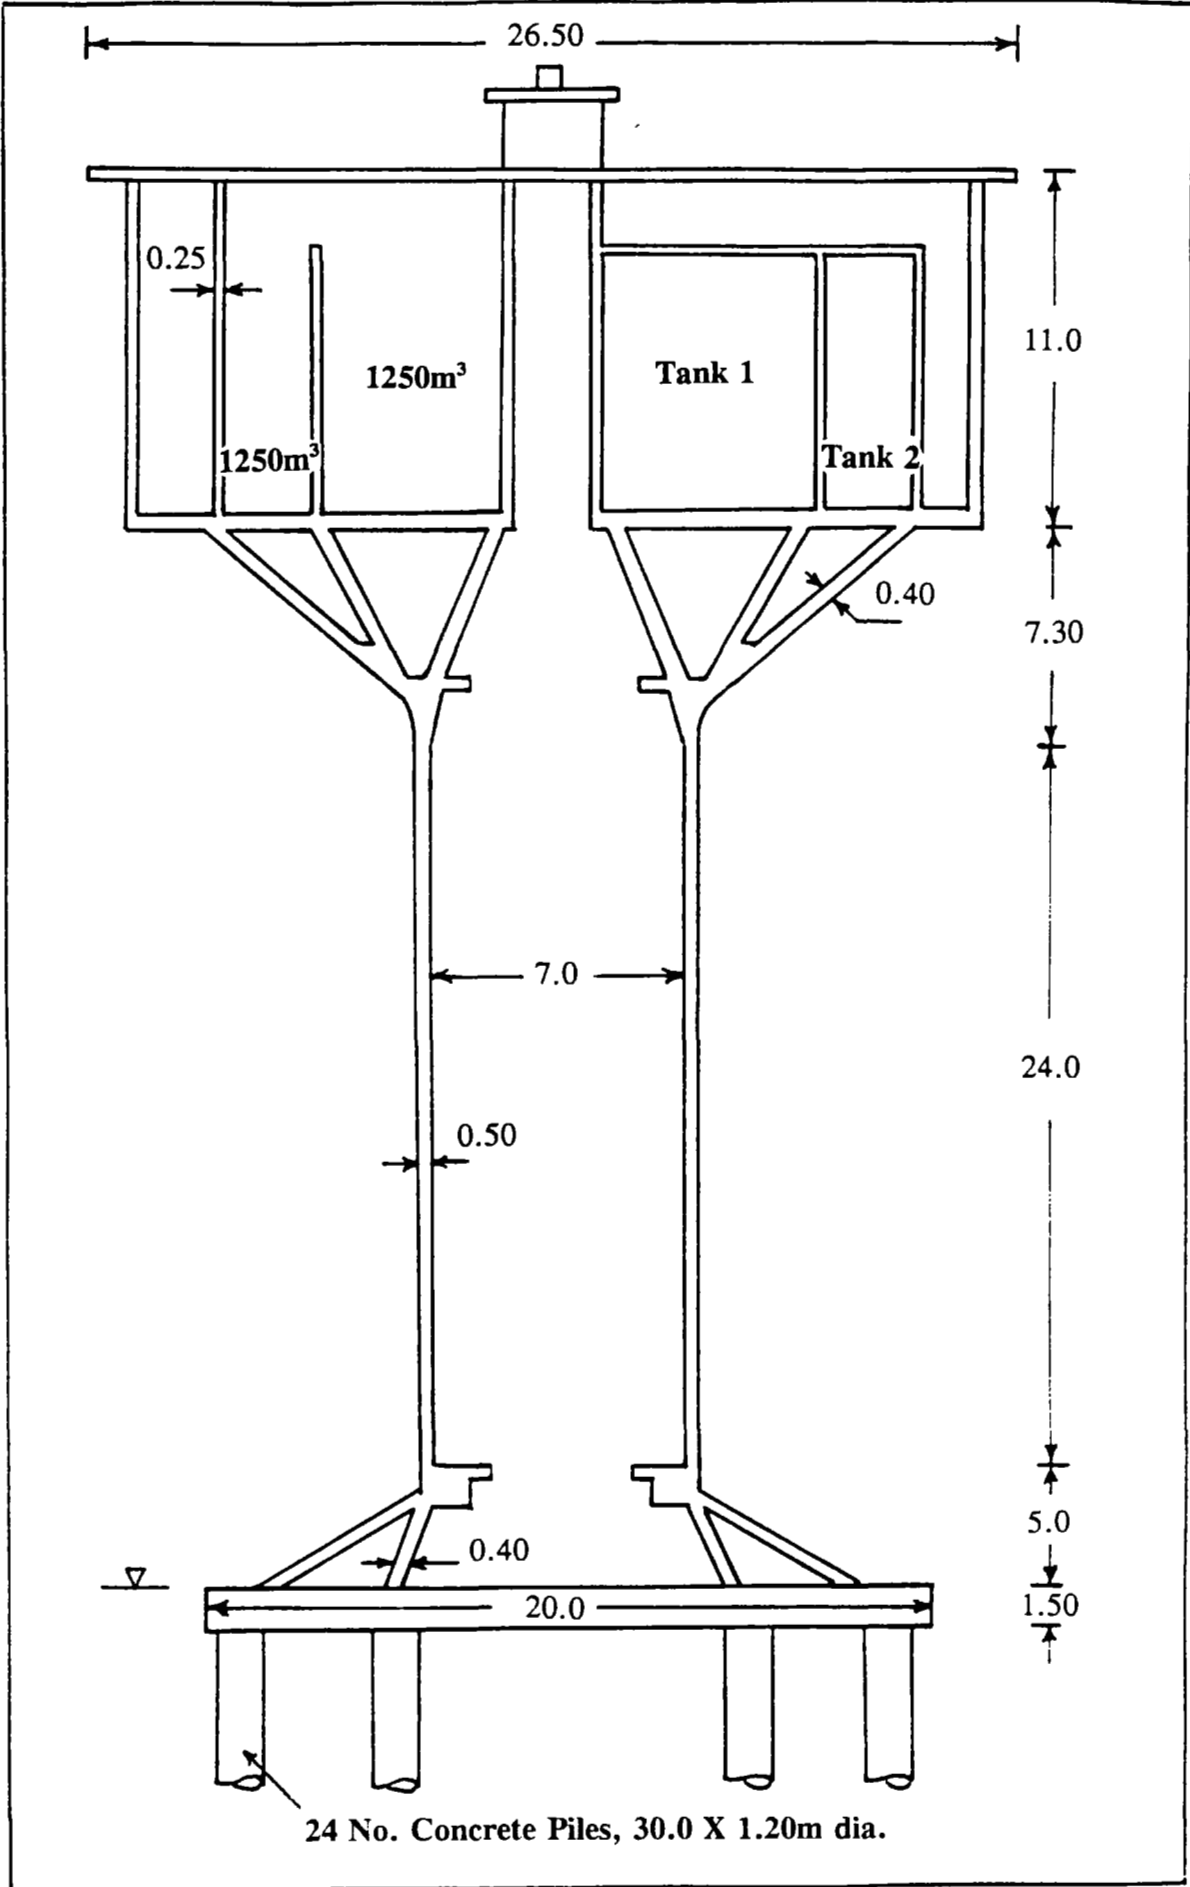
Bending failure in the form of horizontal cracks could be seen all around the circumference of the shaft (Picture 5.33). The level of this continuous ring-crack varied at different sections of the shaft's circumference between 1.45m and 2.25m above the base of the shaft (Picture 5.34). The adjoining horizontal cracks running at different levels were joined together by short vertical cracks. One exception to this cracking pattern was an inclined form at the staircase (The reinforcement arrangement in the shaft adjacent to the staircase accounts for this). As already

Fig. 5.3 A Schematic Illustration of Tanks No. 2 and 3.

mentioned, the cracks developed due to the high bending stresses in the section of the shaft with the weakest flexural capacity. In fact the crack line coincides with the construction joint between the base and the shaft, where the reinforcements from the two sections overlap.

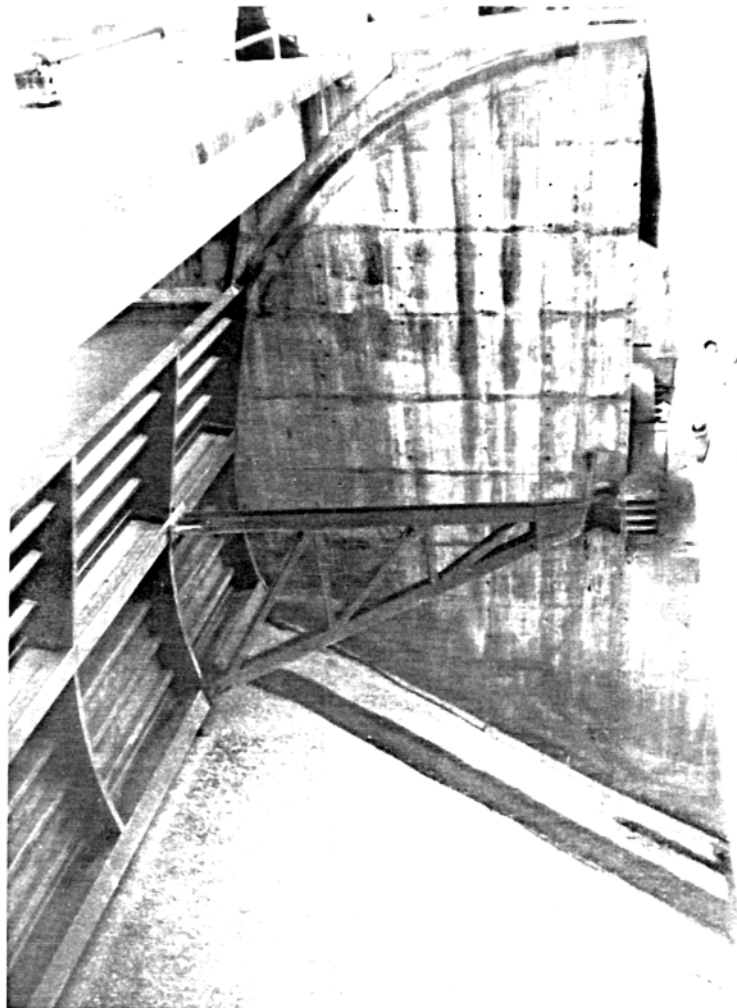
A close inspection of the upper parts of the piers above the water line revealed no direct failure of concrete under earthquake loading. The steel gates joined to the concrete pier via rotating steel arms also stayed in place without damage. At the time of the main event, two of these gates were open allowing the water through. This must have greatly reduced the high levels of impulsive hydrodynamic forces on the steel gates induced by the movement of dam against the mass of reservoir during the earthquake.

Picture 5.12 Tarik Diversion Dam, Saravan
The gate's arm and pier connection not designed to withstand the earthquake induced hydrodynamic forces

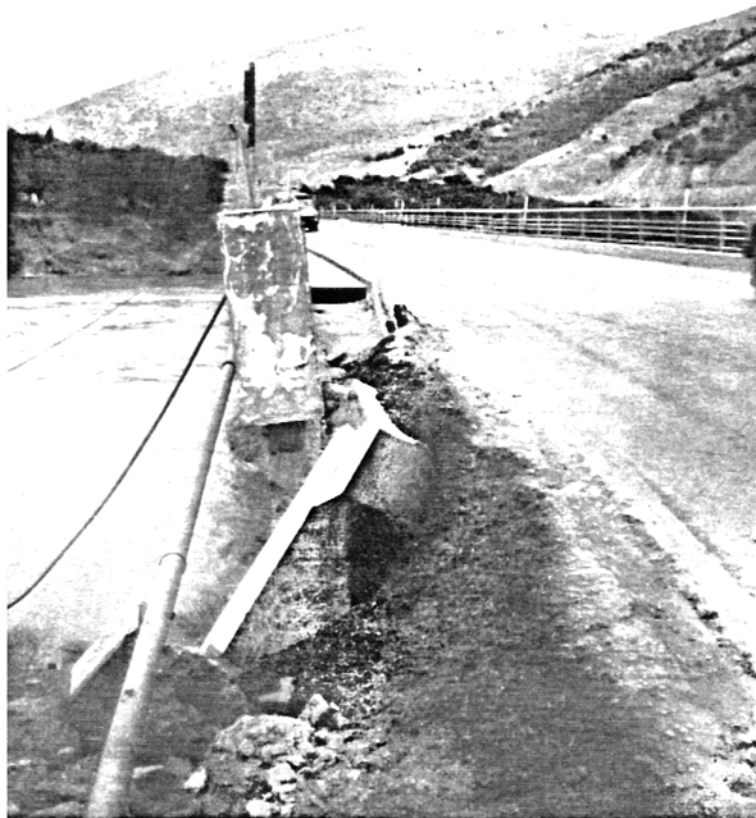
Other non structural failures in and around the bridge include the collapse of a reinforced concrete retaining wall next to the south end-pier (Picture 5.18) and an uncharacteristic shear

Picture 5.18 Concrete Bridge, Rudbar
Failure of the south-west retaining wall

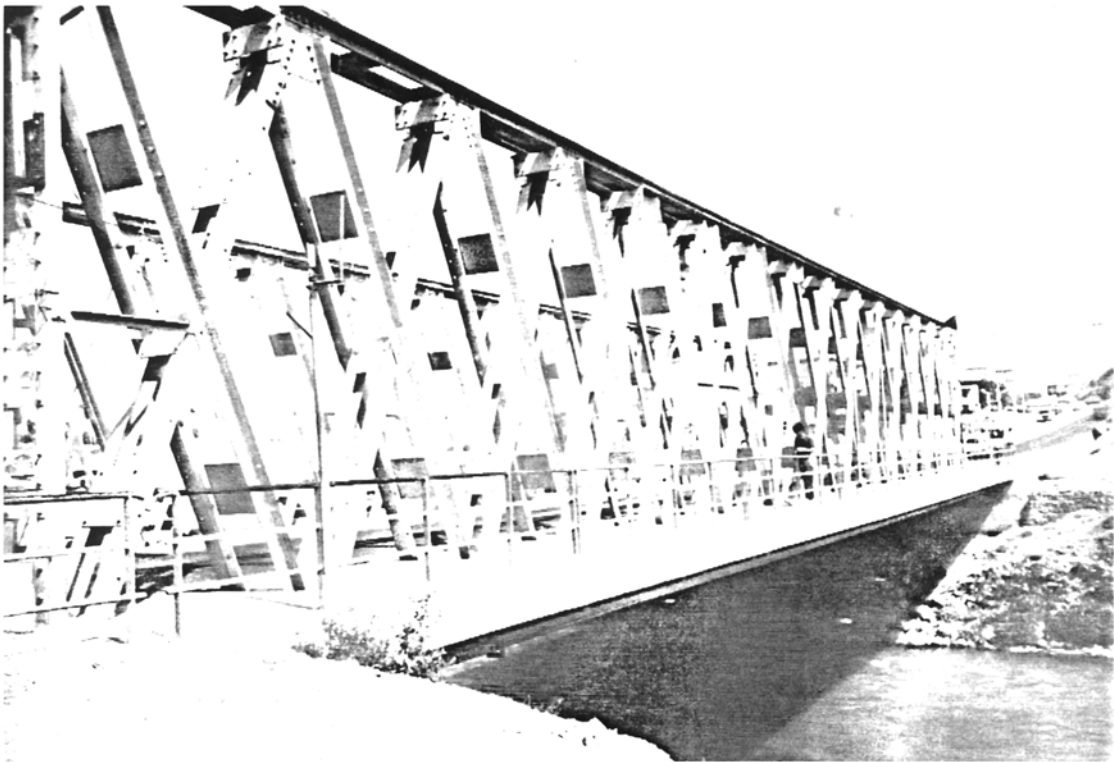
There were a number of small steel bridges in the epicentral area of the earthquake. Three of these bridges were investigated none of which showed any signs of failure or damage. These included Lushan bridge (Picture 5.20), Manjil bridge (downstream of the Sefid-rud dam) and Rudbar bridge (Picture 5.21). The bridges, all of a similar design and construction, have varying lengths of between 70m and 100m and widths of between 8.0m and 12.0m.

Picture 5.20 Steel Bridge, Lushan. No damage to this bridge

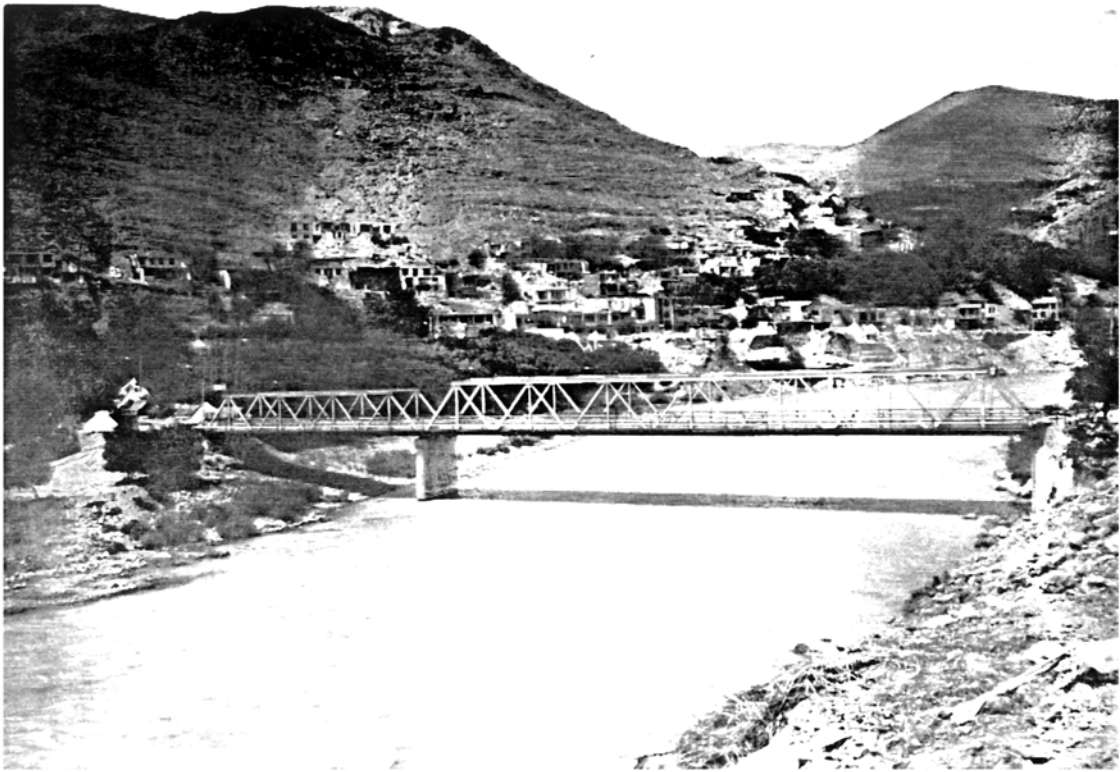
Picture 5.21 Steel Bridge, Rudbar. It behaved well during the earthquake

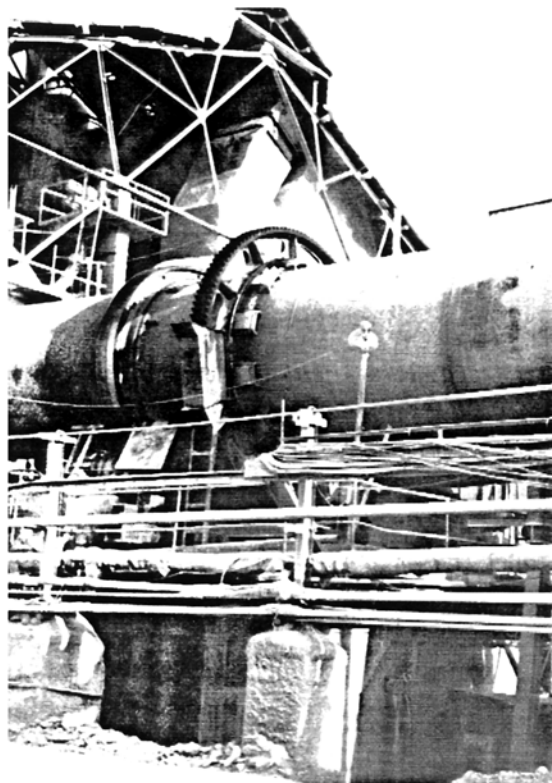
Picture 5.24 300-Tonne Cement Factory, Lushan
The 300 tonne furnace was slightly thrown off position by the force of the quake, some horizontal (bending) cracks in the two massive concrete bases of the furnace

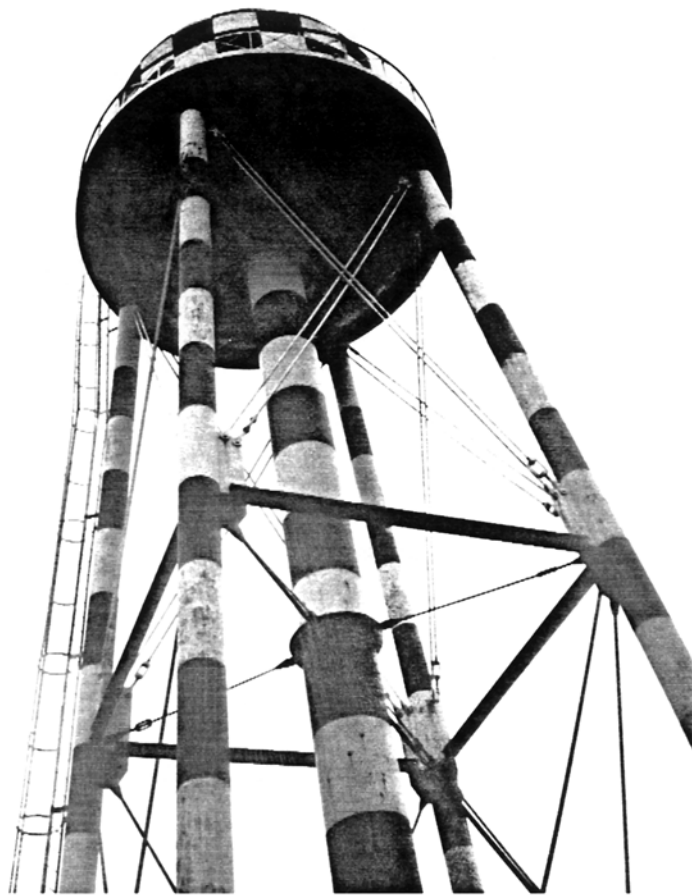
Picture 5.35 Elevated Steel Water Tank, Rasht
No damage to this well supported elevated water tank

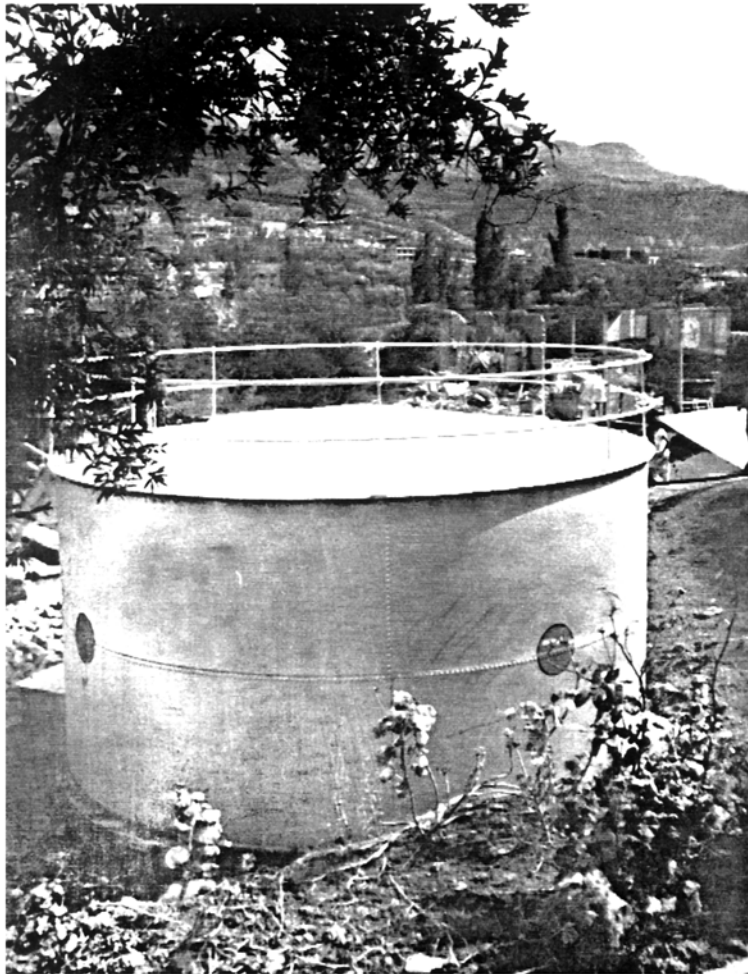
Picture 5.37 Cylindrical Petrol Tank No. 2, Rudbar
The steel tank standing amidst collapsed buildings
