**THE NORTHRIDGE, CALIFORNIA EARTHQUAKE
OF 17 JANUARY 1994**

A FIELD REPORT BY EEFIT

1. INTRODUCTION

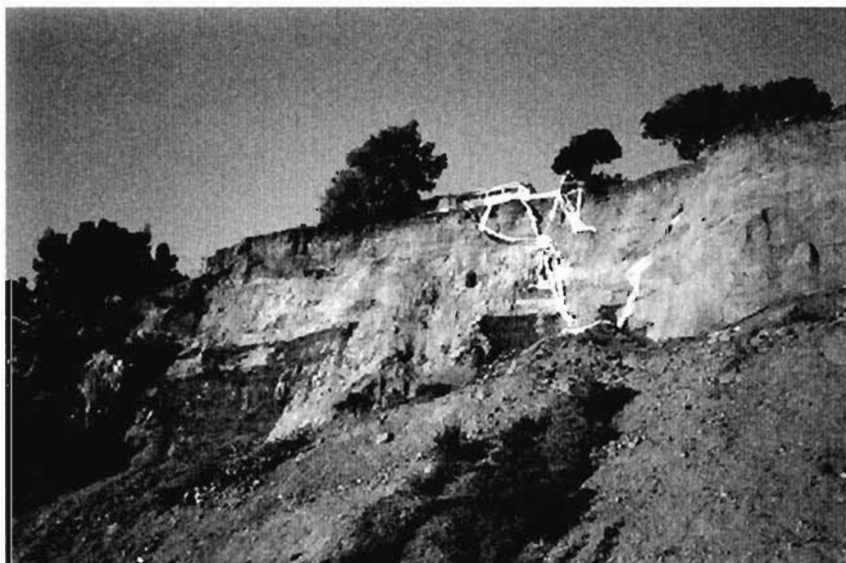
Plate 3.3: Northern end of land slide on Pacific front; plate shows wetting of soil, possibly due to a broken water main

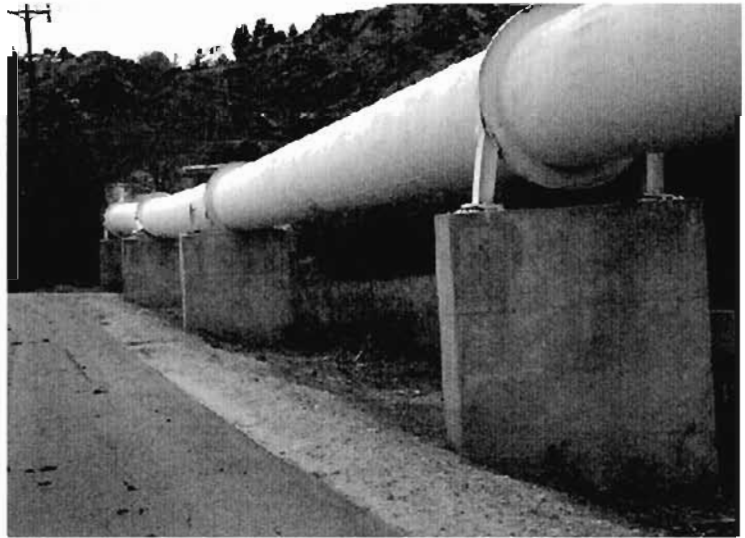
The elevated outlet pipeline supported on columns on the downstream side of the Upper San Fernando Dam (Plate 3.5) is another example which deconstructed the interaction effects. During the present earthquake the pipeline-column-foundation system functioned as a single unit until the columns rotated

Plate 3.5: Pipeline on downstream side of Upper San Fernando Dam; the ground motion at this site was along the pipeline

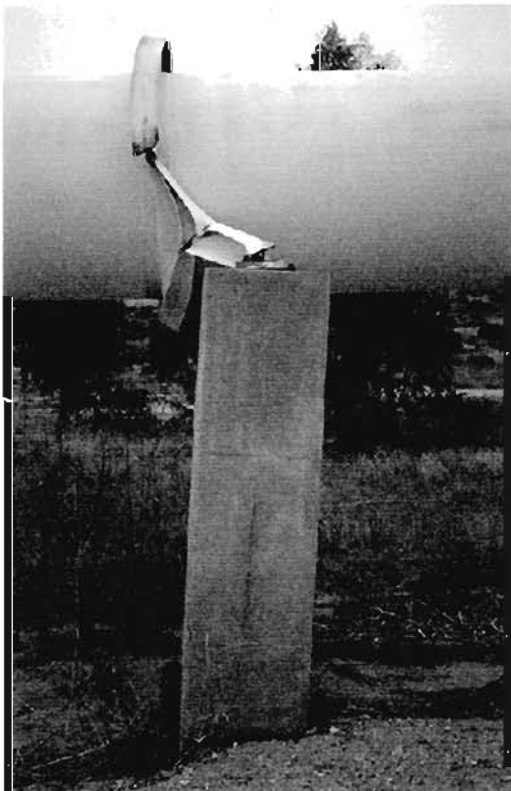
and the fixings securing the pipe to the column failed (Plate 3.6). Wide gaps opened in the soil adjacent to the base of the column.

Plate 3.6: Sheared connection between the pipe and column; plate also shows leaning of the column and the gap between the column and foundation soil

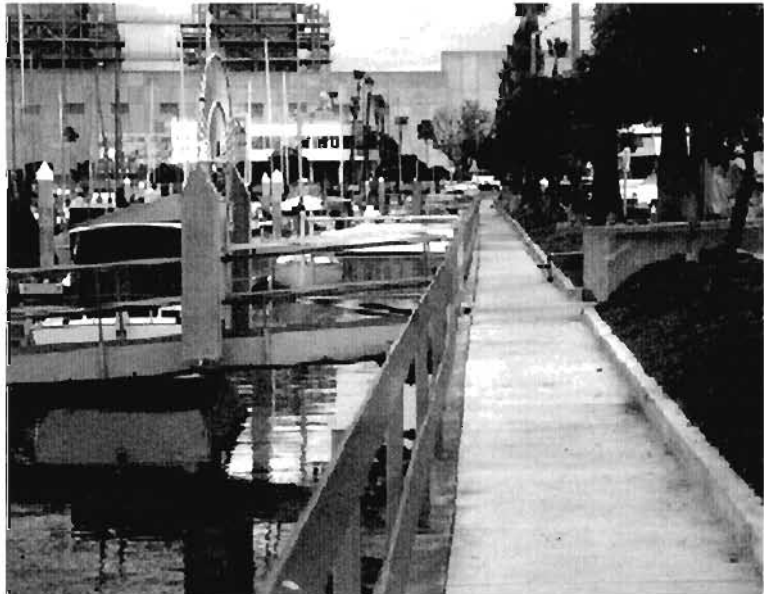
Plate 3.8: Quay wall at the King Harbour before the earthquake

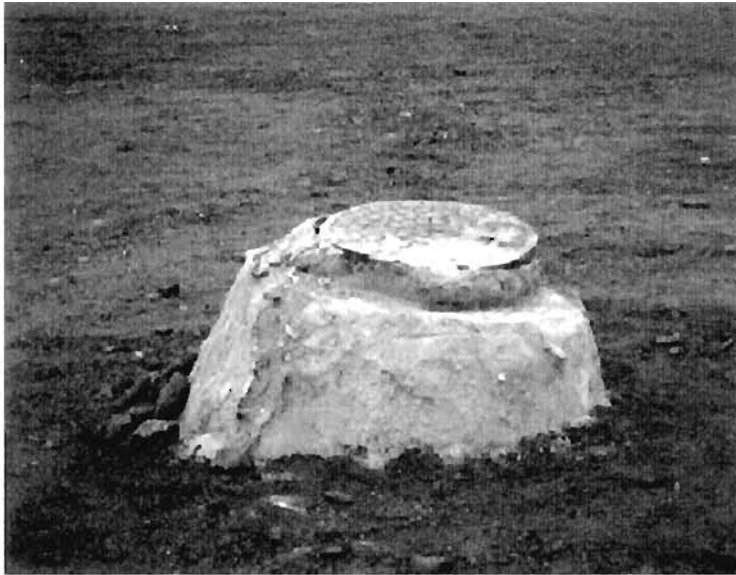
Plate 3.10: Subsidence between the quay walls; plate shows original level flush with the manhole cover and the subsidised ground level

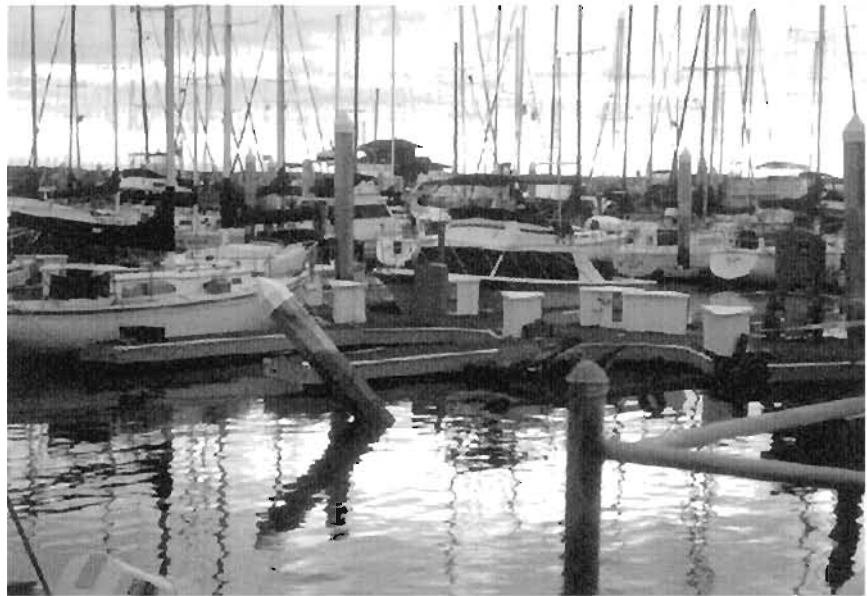
Plate 3.11: Bent concrete anchor pillars indicate direction of soil flow following liquefaction

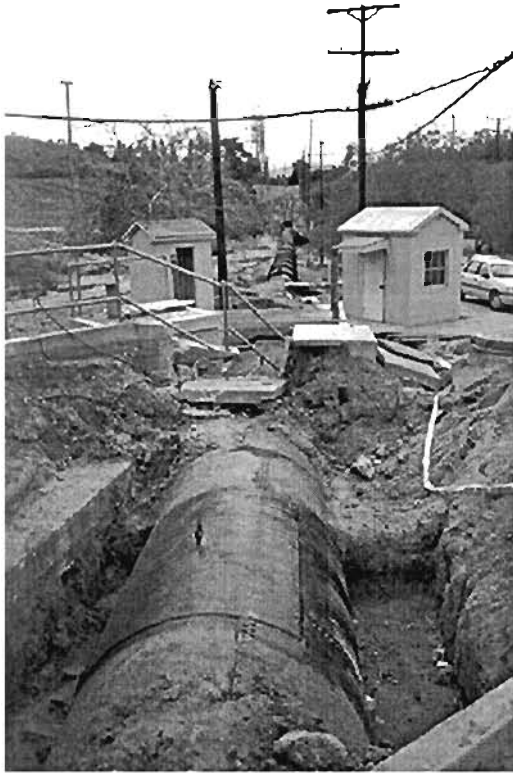
Large ground movements and extensive cracking resulted in severe damage to the pipelines. The most significant of these was the damage to the outlet pipe from the Los Angeles reservoir (Plate 3.14). The erosion resulting from the pipe breakage removed the traces of ground cracking but the cracks in the foundation of the pump house indicated the ground movement (Plate 3.15). The ground movement across Balboa Boulevard resulted in the upward buckling of the lifelines (Plate 3.16). This is further confirmed by the upward movement of up to 225mm of the pavement blocks (Plate 3.17).

Plate 4.5: Los Angeles Reservoir
Repaired outlet pipe

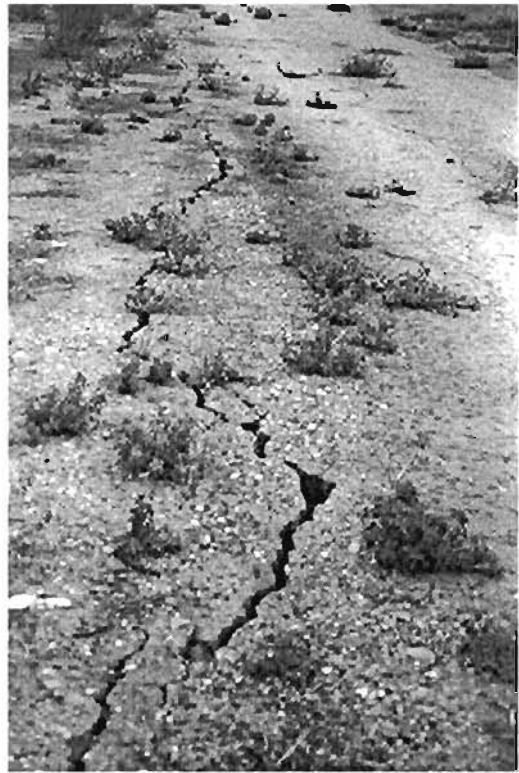
Plate 4.6: Lower San Fernando Dam
Longitudinal crack in crest

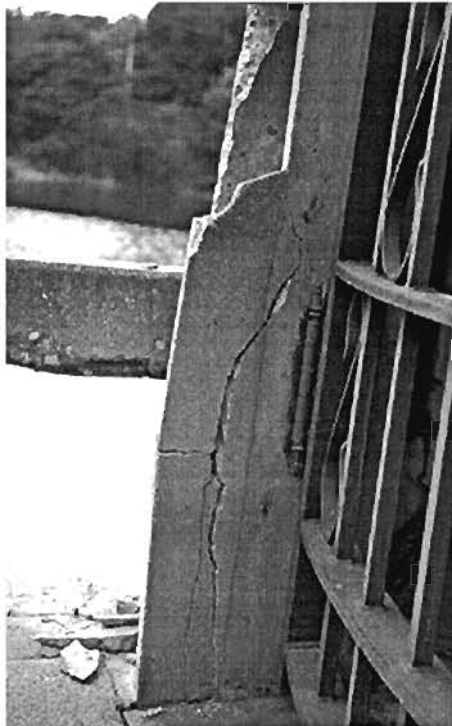
Plate 4.11: Upper Hollywood Reservoir - Damage to face of tower

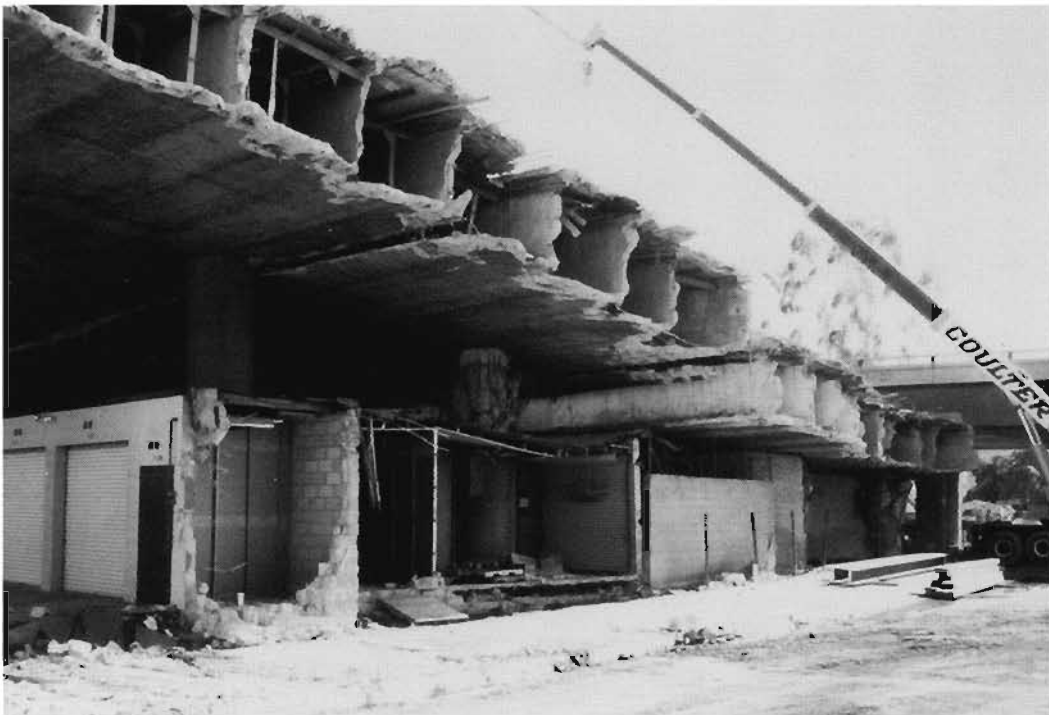
Plate 5.10: Santa Monica Freeway at La Cienega and Venice

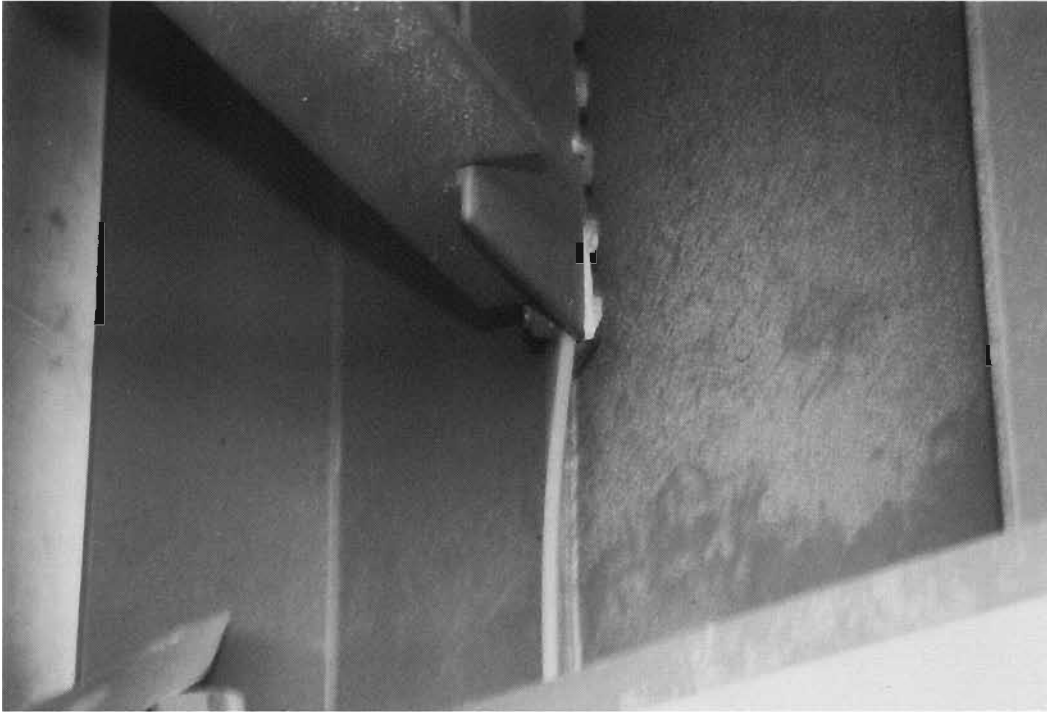
Plate 5.11: Santa Monica Freeway at La Cienega and Venice - influence of column height

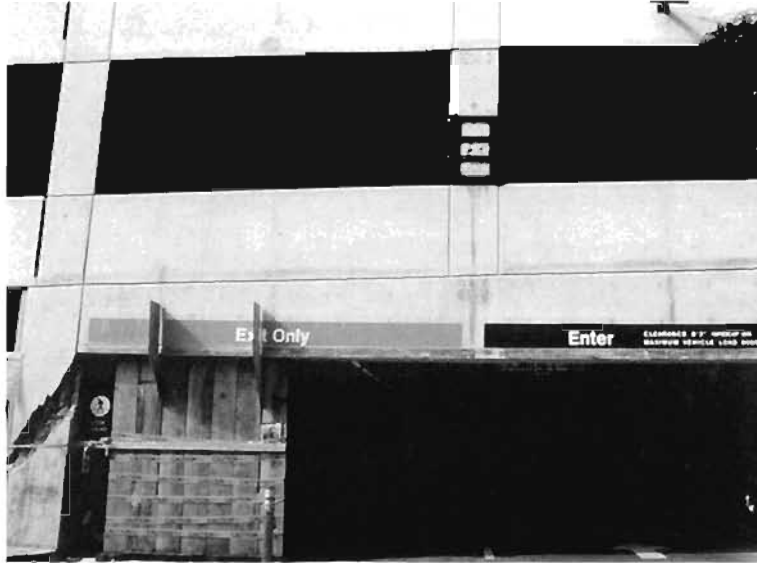
Plate 6.27: Extreme vertical irregularity at entrance

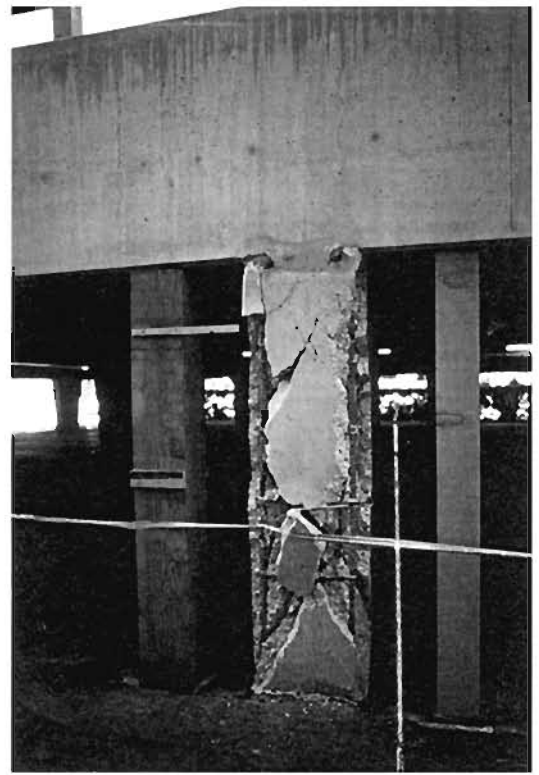
Plate 6.31: Shear cracking in columns on south side

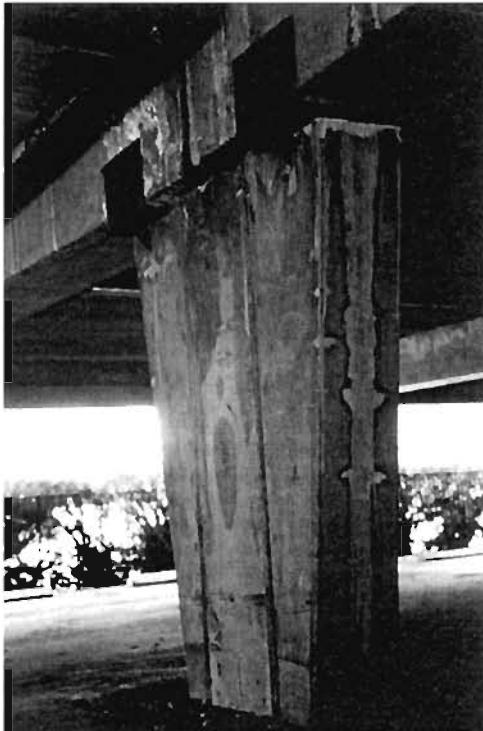
Plate 6.33: Internal columns sandwiched between replacements

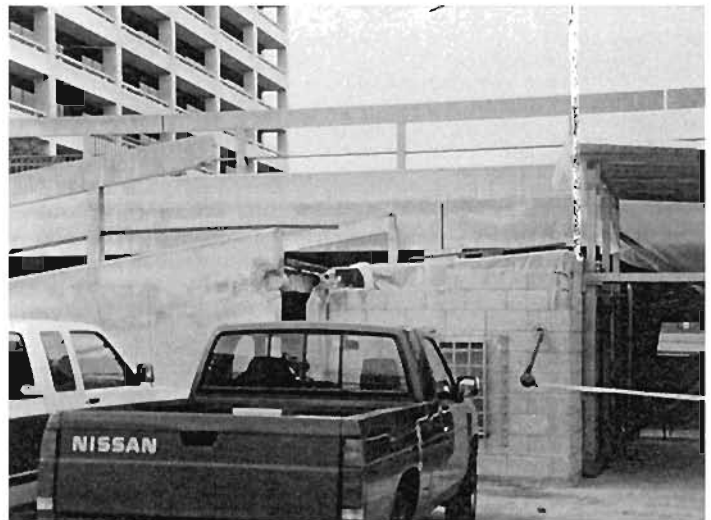
Plate 6.32: Collapsed car park ramp

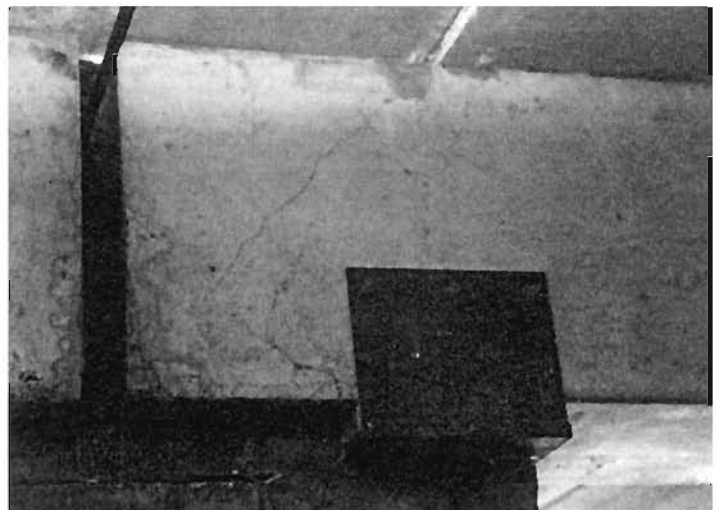
Plate 6.35: Old cracking at end of beams

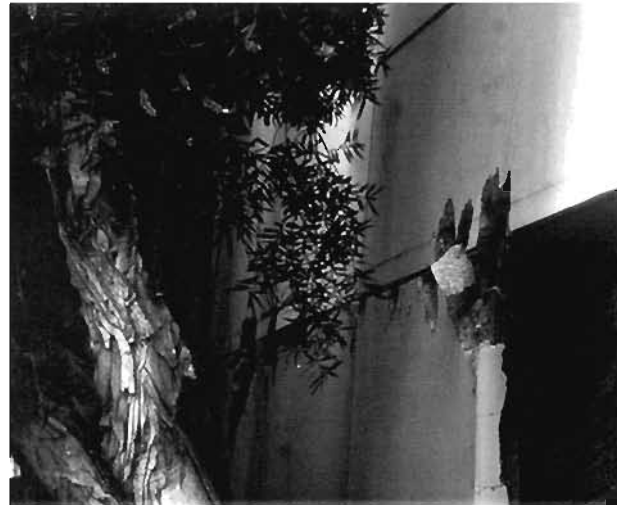
Plate 6.39: St. John's Hospital car park : cracked concrete at corners of opening in walls.

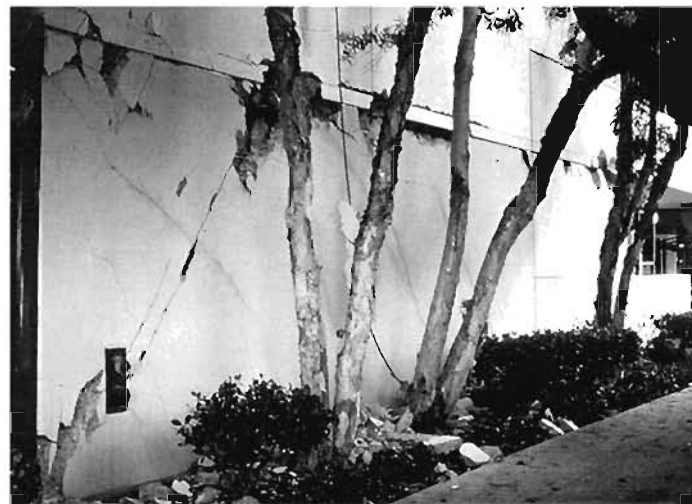
Plate 6.40: X cracking in shear wall panels at St John's Hospital car park

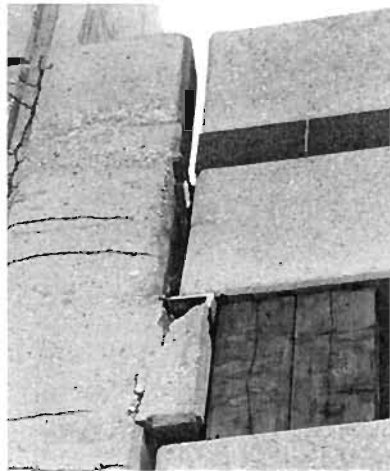
Plate 6.43: Sprung corner at Cigna Garage

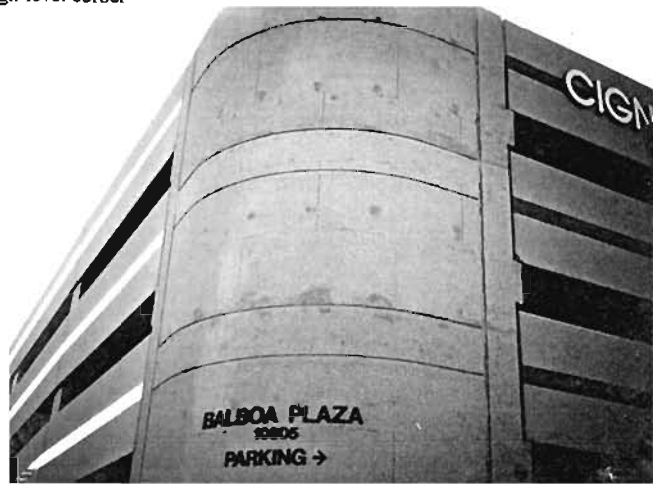
Plate 6.46: Elevation showing variation of corbel damage with height

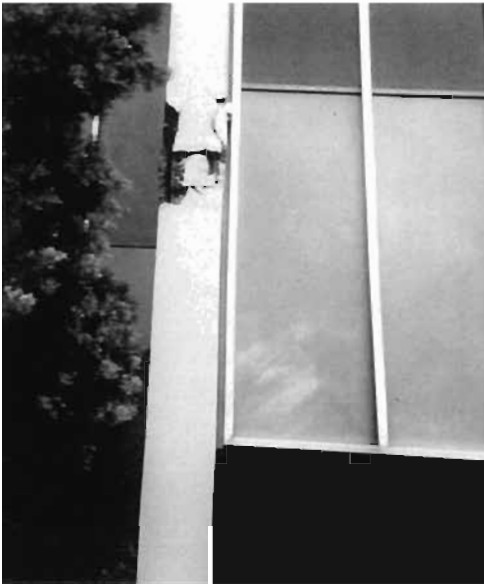
Plate 6.65: Rear view showing spalling at end walls

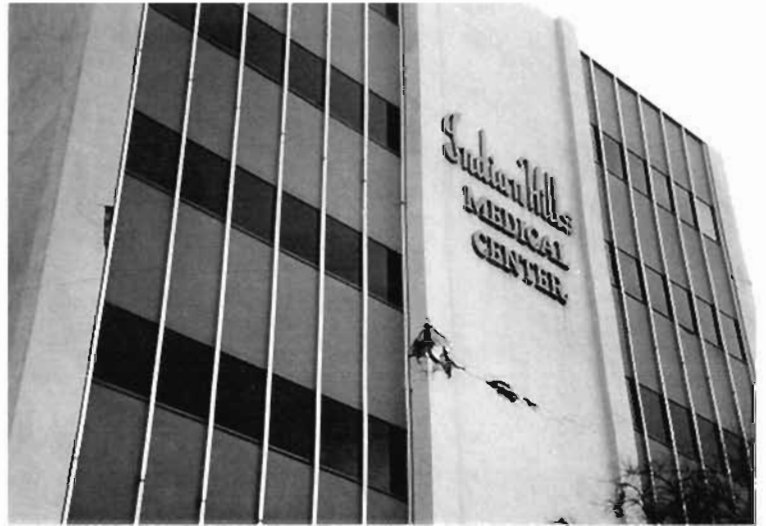
Damage was mainly concentrated at the shear walls and columns of the fourth level (Plates 6.66 to 6.68), but there was some damage also lower down (Plate 6.69). It is considered that the damage in Plate 6.62 at least is due to insufficient splice lengths, rather than the more usual lack of confinement, responsible for comparable damage in 6.6.7. Elsewhere diagonal cracking and spalling around main reinforcement is reported. Some crushing took place at the ground level in the side-columns of the shear walls. The building had to be evacuated.

Plate 6.69: Side wall damage at front on first floor

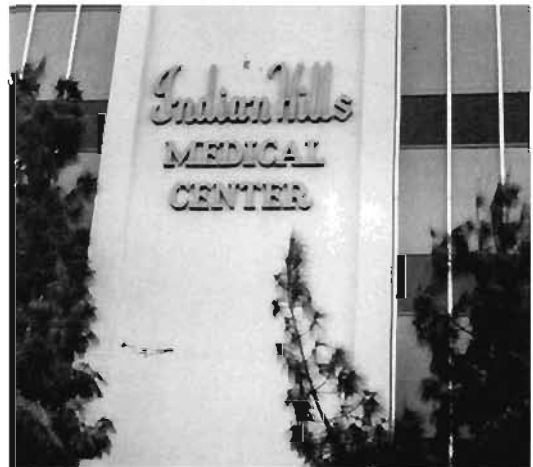
Plate 6.67: Close-up of damage in Plate 6.66

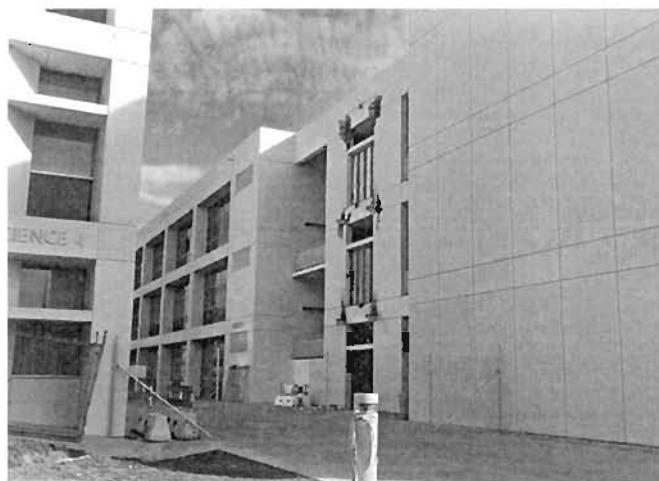
Plate 6.87: Engineering block

In the engineering building there was only minor damage, but there was so much asbestos scattered around that no one was allowed inside (Plate 6.87).

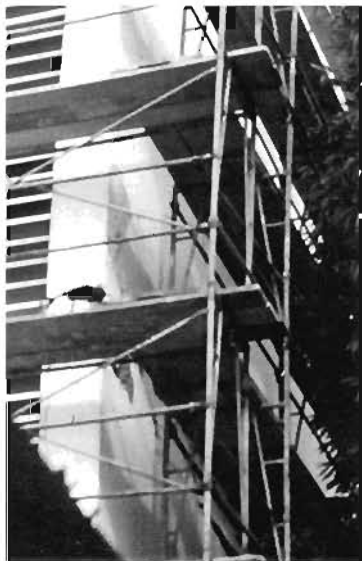
Plate 6.120: Flexural compression failure at first floor level

The building is located at the Santa Monica Boulevard crossing 20th Street, about 23km from the epicentre. At the closest recording station (CSMIP No. 24538, Santa Monica City Hall Grounds) peak values of 0.93g horizontal and 0.25g vertical acceleration were measured. It is a six storey dual frame/shear wall structure with the shear walls, which had openings, located at one end (Plate 6.118). These shear walls had flexural/shear cracks (Plate 6.119), with flexural/compression failure at the tips (Plates 6.120 and 6.121). The frame-shear wall connection failed at the first storey.

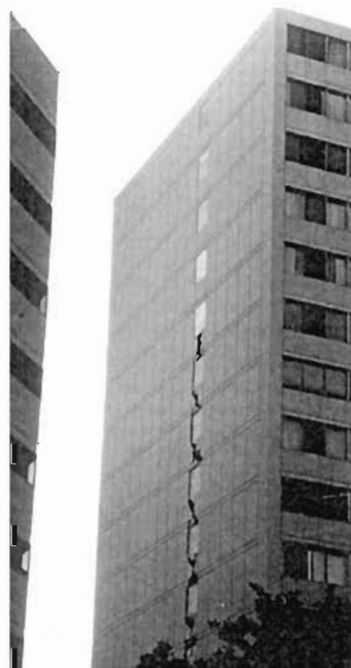
Over the lower part of the building the columns have severe X-cracking on the north-east face (Plate 6.129, 6.131 to 6.133), as did the coupling beams on the south-east shear wall up to the 12th floor (Plate 6.134). The damage could have occurred due to the stiff lower storey (as in the Holiday Inn) on the north-east face (not visible in Plate 6.129 due to a low building in front), in which case it would have propagated from the second storey upwards. A contributory cause of the damage is the stiff parapet beam on the damaged face cast monolithically with the columns (Plate 6.129), in contrast with the flexible rail on the undamaged west face (Plate 6.130). This alone may have been sufficient to cause the cracking on the facade, but it could not have produced different forces in the connecting beams in the shorter faces either end. With all the structure on one facade stiffer than on the facade opposite it could have induced a torsional response. However, since the internal layout is unknown, torsional behaviour could have been caused by an eccentric core.

Plate 6.134: X-cracking in coupling beams on South face

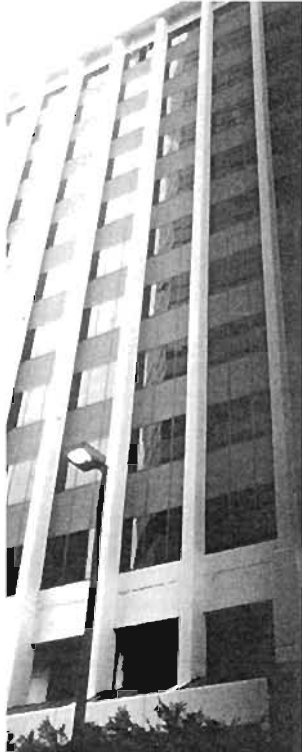
Of the tall office buildings in downtown Santa Monica, up to just over 20 storeys a number were slightly damaged lower down, as in an 11-storey office building and a 13-storey apartment building, both of which had predominantly horizontal cracking in and around window panels in the lower storeys, probably of no structural significance (see Plates 6.135 and 6.136).

Plate 6.135: Horizontal cracking around window panels in first floor beam in office building,

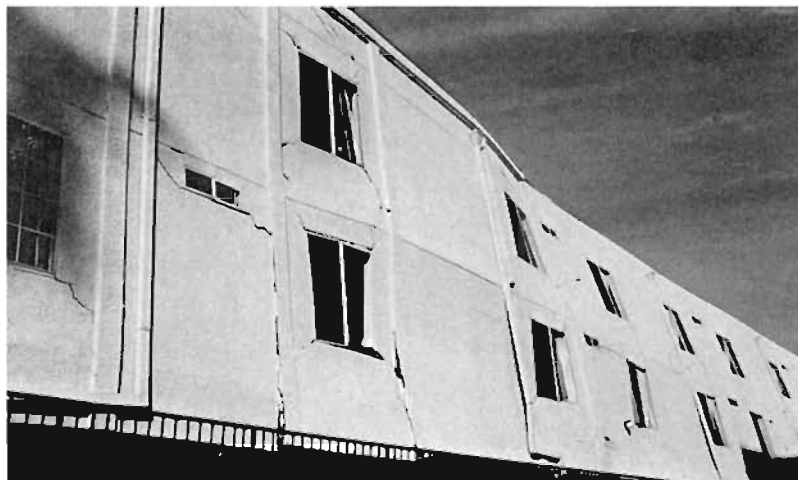
Plate 6.143: Close-up of East wall

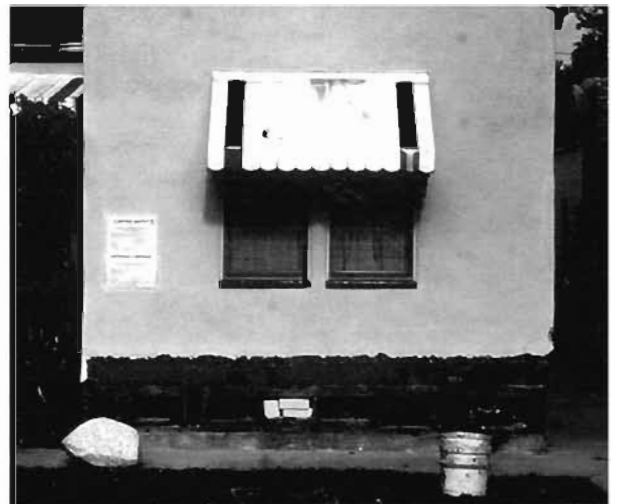
The apartment blocks, frequented by students and by the recently arrived Hispanic community, are typically wood framed buildings of two or three stories without insulation and with weather protection provided by stucco. In the earthquake this was often damaged (Plate 6.155) and sometimes detached over the height of the crawlspace, and just above it (Plates 6.156 and 6.157). The thin timber backing to the stucco, common in new and old houses alike in North California, is apparently used for its insulation properties and is therefore considered to be unnecessary in the warmer climate of Southern California. Most of the buildings in the Northridge area had the construction form shown in Figure 6.18 and Plate 6.157. Insulation, when used, took the form of soft packing, providing no additional support (Figure 6.18 and Plate 6.157). However, this is an older form of construction, and unacceptable without bracing under current regulations. In the San Fernando Valley cracking of the stucco was commonplace and occasionally it had entirely collapsed. Most of the newer buildings (and some older ones) have plywood sheets or thin timbers nailed onto the timber frame (Figure 6.19 and Plate 6.156) in order to provide greater horizontal stiffness and strength.

Plate 6 155: Stucco damage at crawl space in apartments

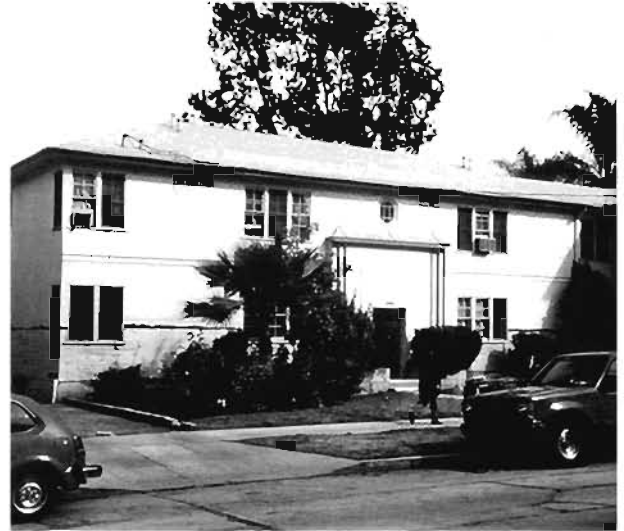
Plate 6 157: Stucco fallen from insulated timber frame apartment

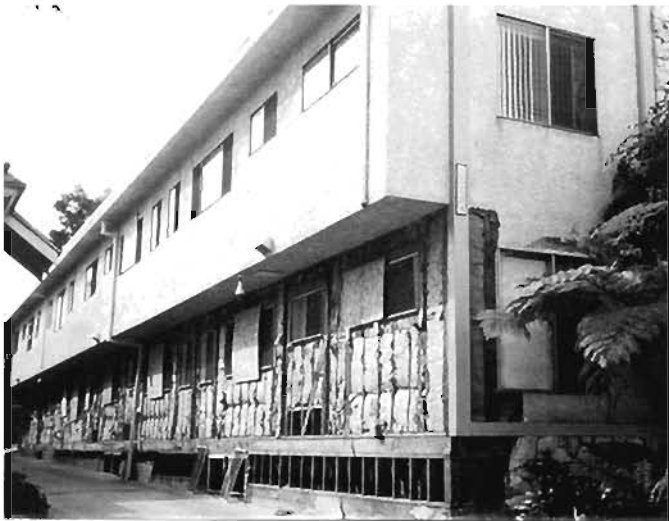
A number of smaller apartments along Dickens Street (running east-west), one block south of Ventura Boulevard, were badly damaged. The buildings along this street were mostly two to four storey timber framed houses/apartment buildings with concrete basement walls. About a quarter had open parking areas at the bottom of the structure (Plate 6.159). Many had suffered stucco cracking, most often in the form of horizontal cracks at the interface between the timber structure and the concrete basement walls. Diagonal cracking from window corners was also common. One had suffered some damage in a soft storey area at the front (Plate 6.159), but much more severe damage at the rear, where a three storey section of the structure had broken away from the remainder, and dropped by a storey, with collapse of the part between (left hand building in Plate 6.158 and the building in the rear in 6.160).

Plate 6.158: Collapsed part and part with collapsed soft storey

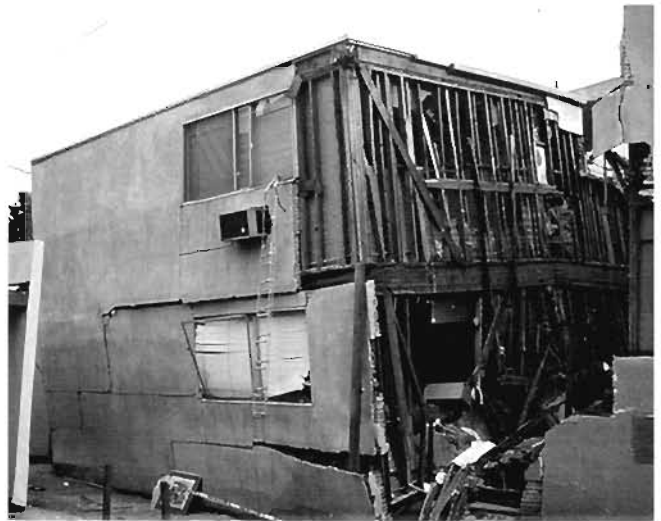
Plate 6 159: Ground floor weak storey accommodating car ports

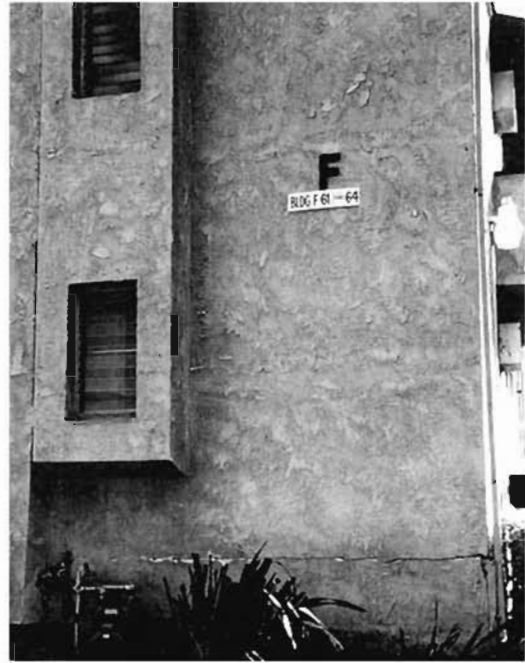
A close inspection was made of the damage in a three storey condominium (Plate 6.161) in which substantial timber posts were part of the main vertical load bearing system. The structure was weakened by car ports (Plate 6.162). The damage was concentrated in a band close to the ground (Plates 6.162 to 6.165) with damage somewhat higher up only in a wall in the car port (Plate 6.166). The building is of principal interest because of its close similarity to the Northridge Meadows Apartments, the collapse of which caused the most concentrated fatalities in this earthquake. An interesting feature was the vertical splitting of the timber of the post in the car port, which carried the upper floors. The metal in the bolted connection was undamaged (Plate 6.165).

Plate 6.162: Damaged wall of car port

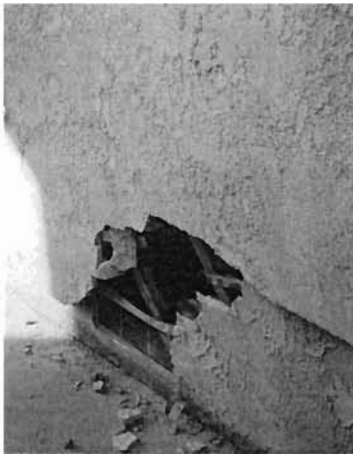
Plate 6.166: Damaged wall other end car port

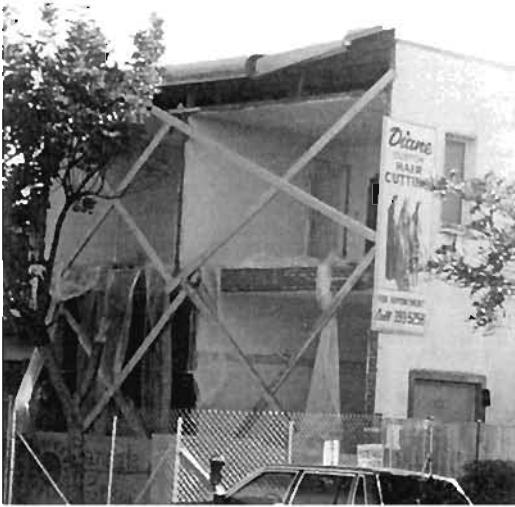
Plate 6.169: Top storey side wall collapse

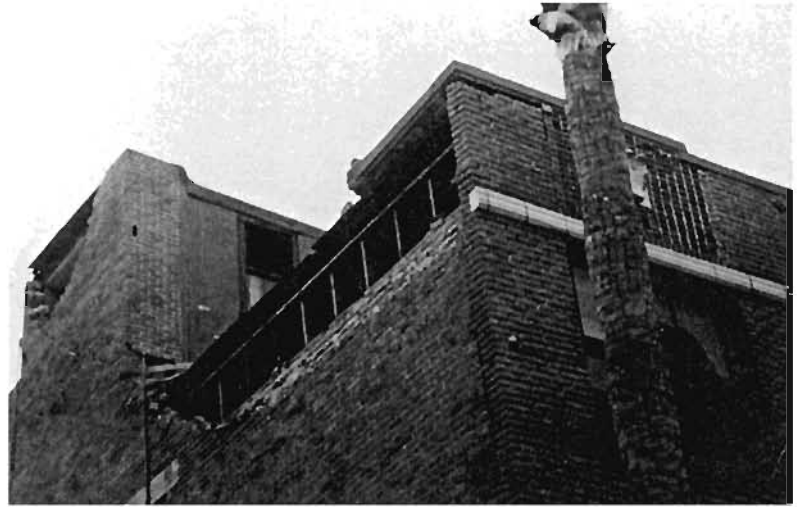
The brick walls in Los Angeles are generally of two leaves without ties or cross-bonded bricks but an old wall was found in Santa Monica which had one cross-bonded course every seven courses. These were effective in holding the wall together, but in one cross-bonded course some bricks failed and the outer leaf was lost down to the cross-bonded course below, (Plate 6.170 and 6.171). Lower down the mortar had cracked and the pointing spalled away (Plate 6.172).

Plate 6.170: Brick wall in Santa Monica

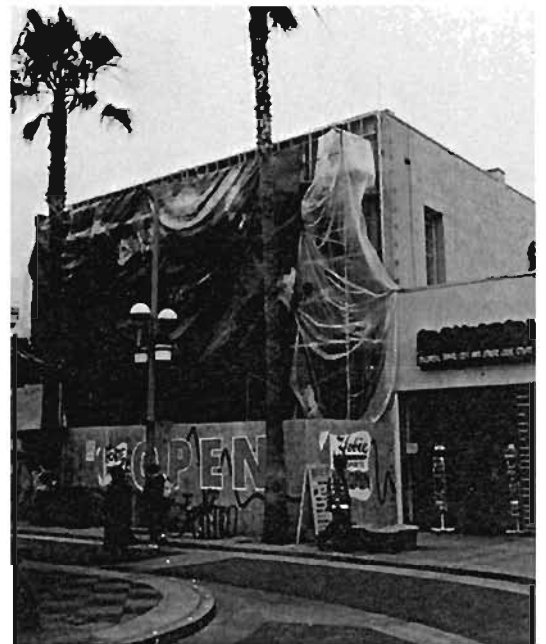
Plate 6.171: Delaminated outer skin

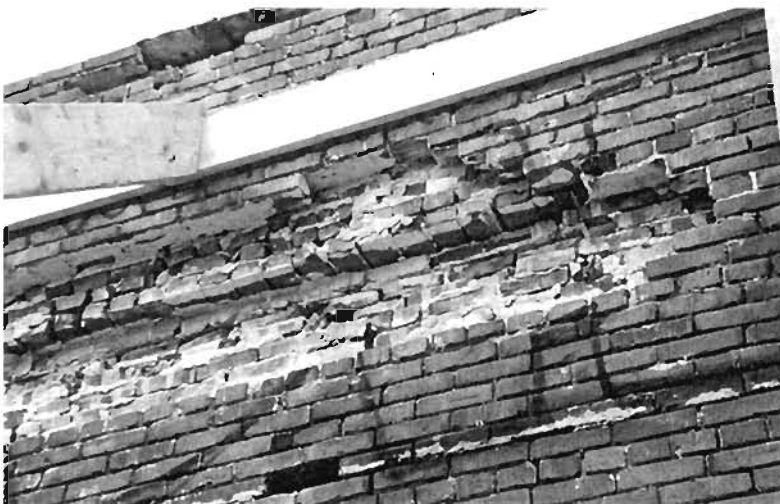
Plate 6.172: Cracking lower down

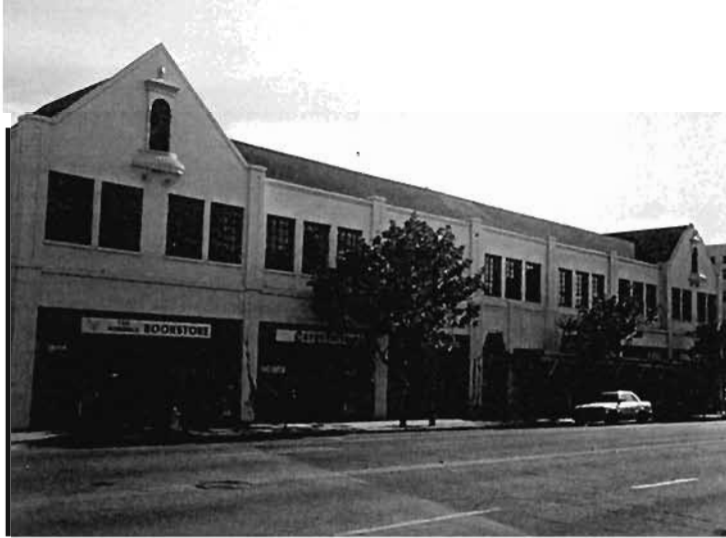
Plate 6.174: Disintegrating columns with steel posts

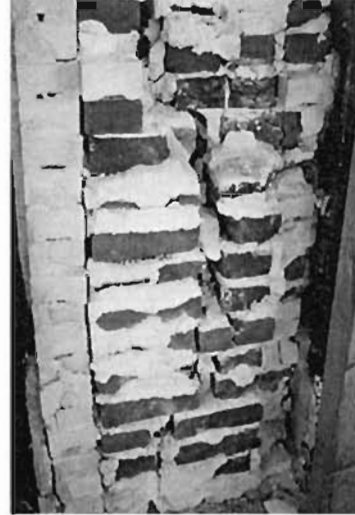
Plate 6.175: Corroded steel post

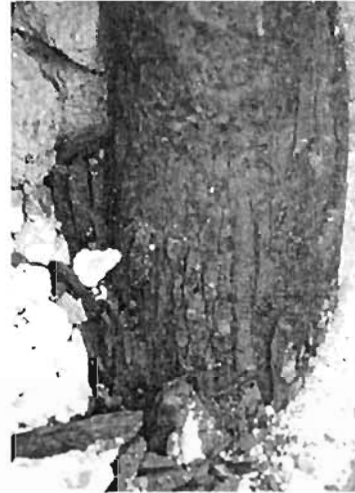
Some of the columns in the facades of old masonry shops when heavily damaged were found to be an early form of reinforced masonry. These were possibly as old as 1920 or were constructed soon after the Long Beach Earthquake of 1933 (also see 6.5.1) (Plate 6.173). In these the masonry columns had cores comprising substantial steel posts of diameter about 75 mm. These were unbonded to the masonry and impacting of the posts upon the masonry is undoubtedly the cause of the pronounced longitudinal splitting of such columns (Plate 6.174). Indeed this form of damage may be considered a good indication of the presence of these posts, except when the cracking is confined to the column feet, when it is likely to be caused by the indirect tensile stress. Where unprotected (in Santa Monica) the iron posts were corroded to a depth of 3 mm (Plate 6.175), but they were also found (in San Fernando) protected by a tar-based fabric which was undamaged in the earthquake (Plates 6.176 to 6.178).

Plate 6.176: Similar construction in San Fernando

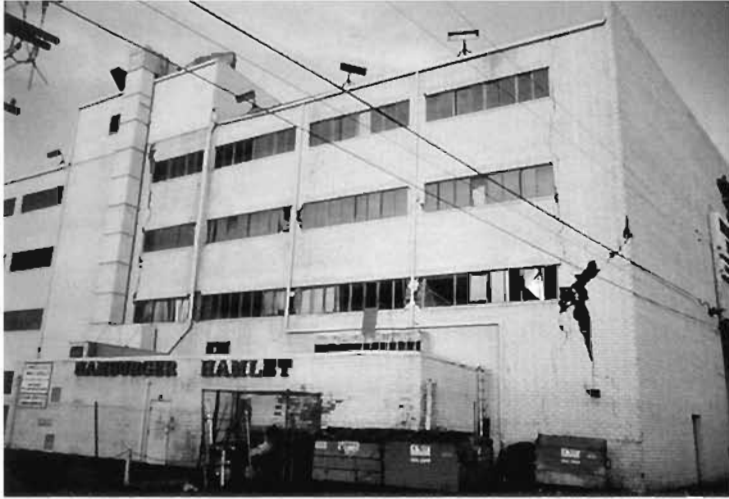
A large modern brick masonry building with very long clerestory type windows (Plate 6.179) reinforced in every bed course suffered in-plane cracking at the corner of a window, followed by local out-of-plane failure of the zone affected (Plate 6.180). As this was along the Hollywood Boulevard the ground acceleration is likely to have been in excess of 0.30g and the movement of the ground at the base of a tree due to root tensions (somewhat unusual for this earthquake) in the street suggests it may have been higher (Plate 6.181).

Plate 6.179: Reinforced masonry building

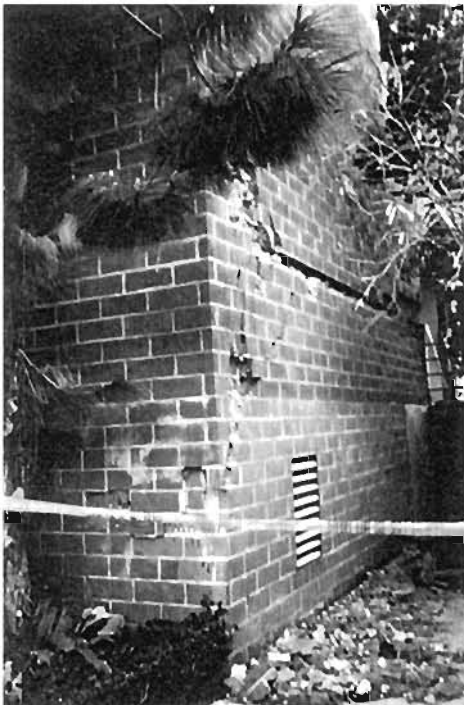
Plate 6.185: Low level disintegration of reinforced masonry

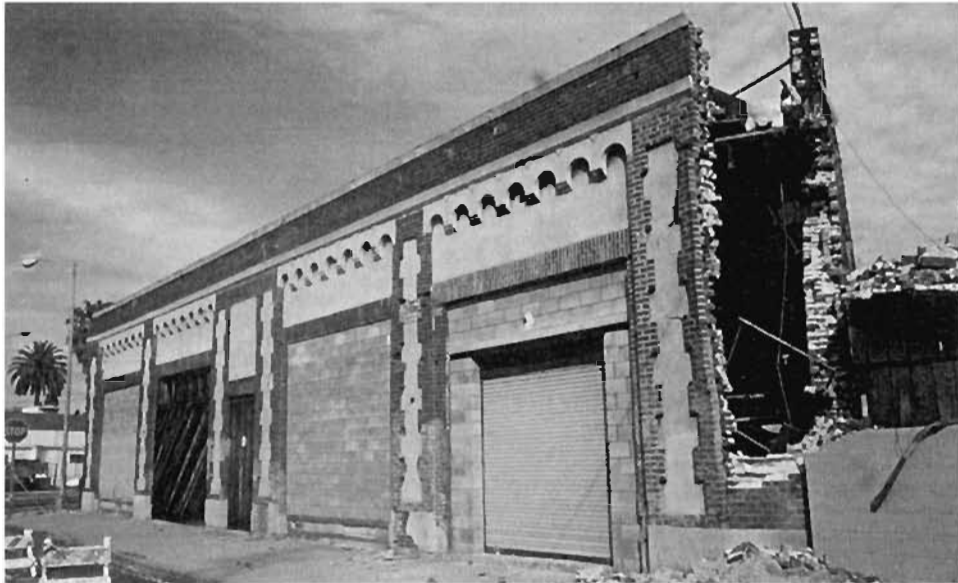
One failure of a two storey building occurred on Washington Boulevard, approximately 25 km from the epicentre where peak values of 0.24g horizontal and 0.10g vertical acceleration were measured at the closest station Baldwin Hills. The building had been strengthened only at roof level (Plates 6.189 and 6.191); therefore the outer walls suffered out-of-plane failure as they bowed away from the unconnected first floor diaphragm (Plate 6.190).

Plate 6.189: Local collapse in building retrofitted only at roof

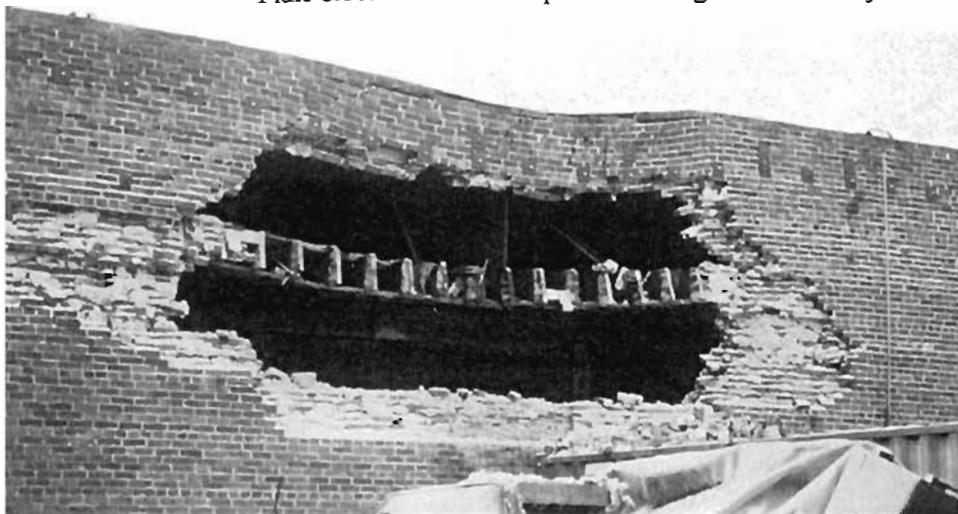
Plate 6.190: Wall collapse at unretrofitted intermediate floor

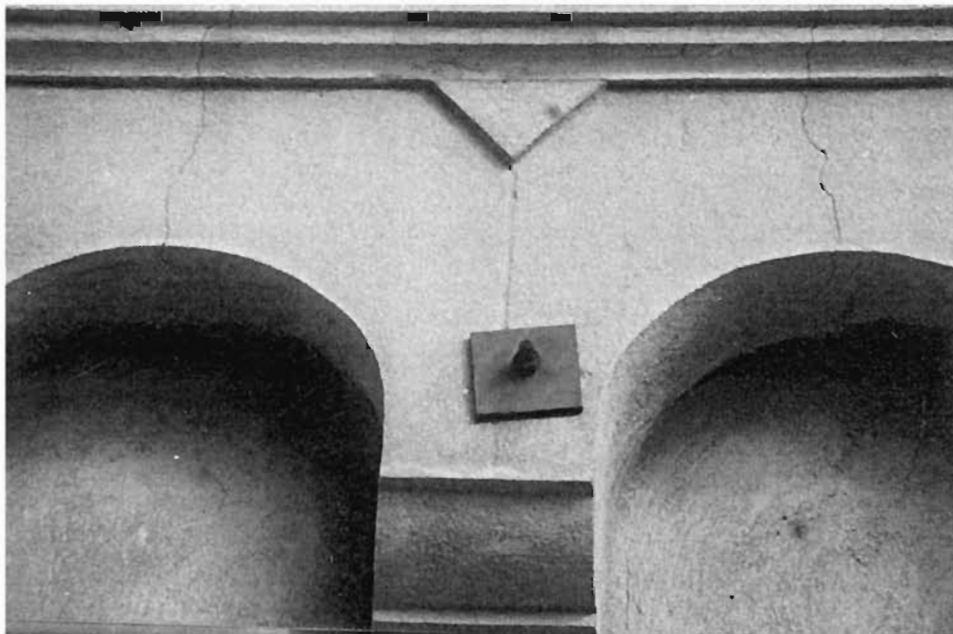
Plate 6.191: Anchor plate of tie

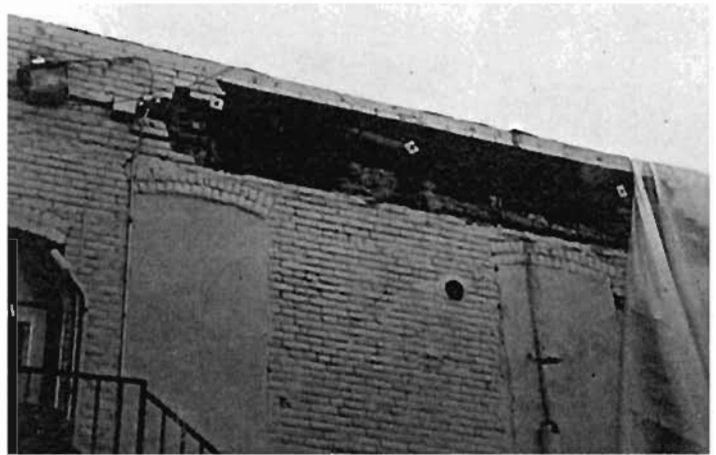
Cases were noted where the anchor plates at roof level in wide buildings appeared to have pulled through the wall, contributing to the damage (Plates 6.193 and 6.195). The most common feature was the failure away from the anchors, either in areas without anchors or where they were insufficiently close to hold the outer wall to the floor diaphragm. When flats had been used instead of anchor plates on a few buildings, they had performed well (Plates 6.198 and 6.207). Some of the larger and discretely retrofitted buildings in Santa Monica which performed well are shown in Plates 6.208 and 6.211.

Plate 6.193: Fallen masonry in vicinity of wall ties

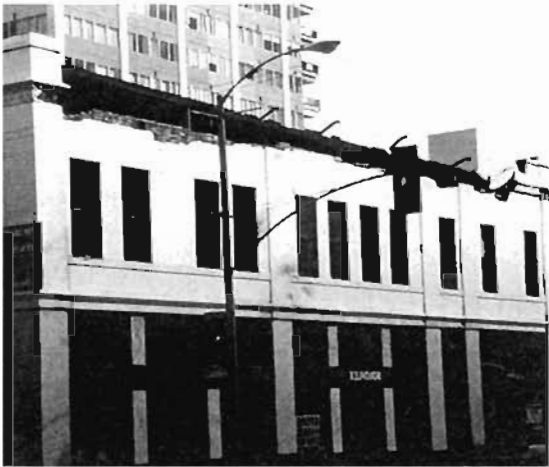
Plate 6.194: Fallen parapet with stays but no roof ties

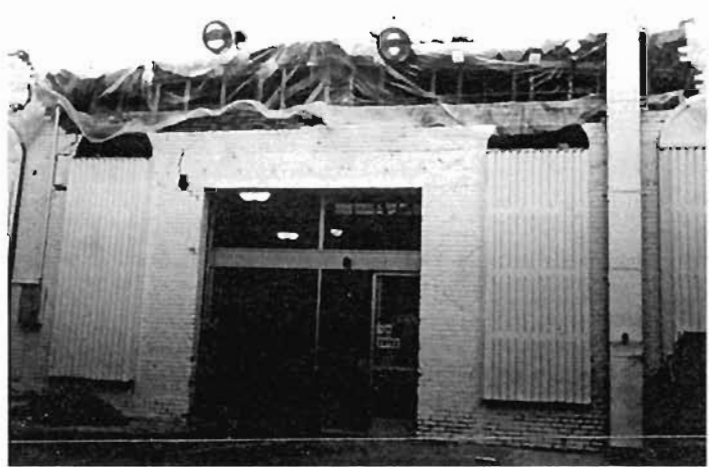
Plate 6.195: Failure of masonry in vicinity of wall ties

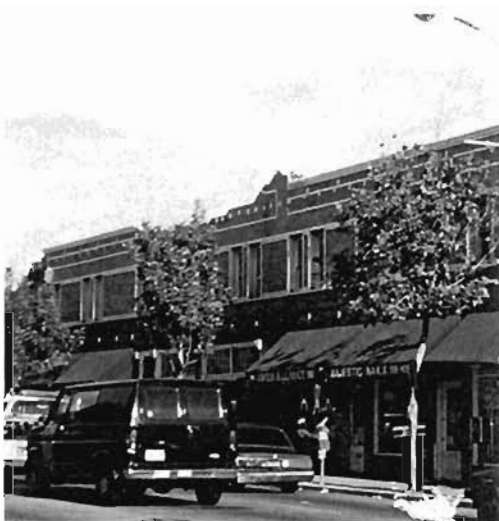
Plate 6.196: Partial collapse of retrofitted parapet

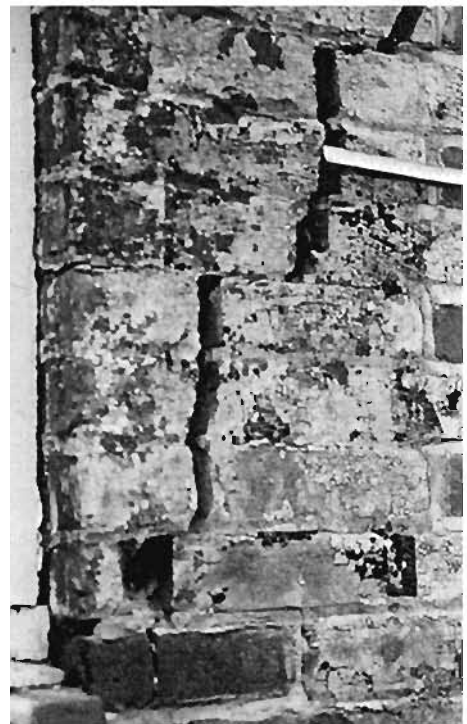
Plate 6.199: In-plane cracking of masonry by door

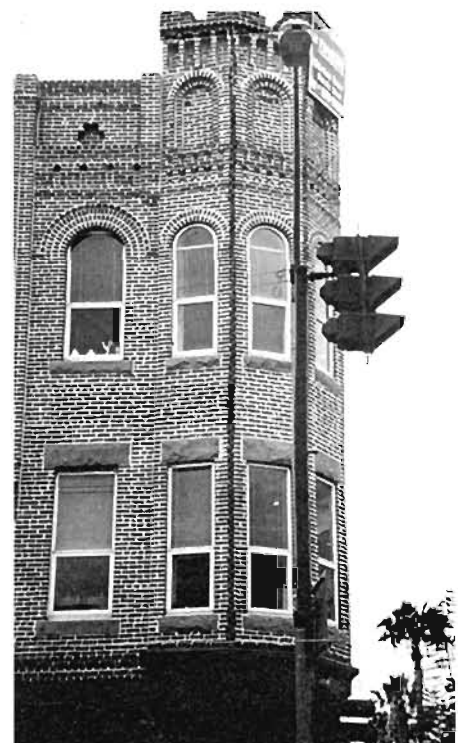
Plate 6.202: Retrofitting and separation at corner

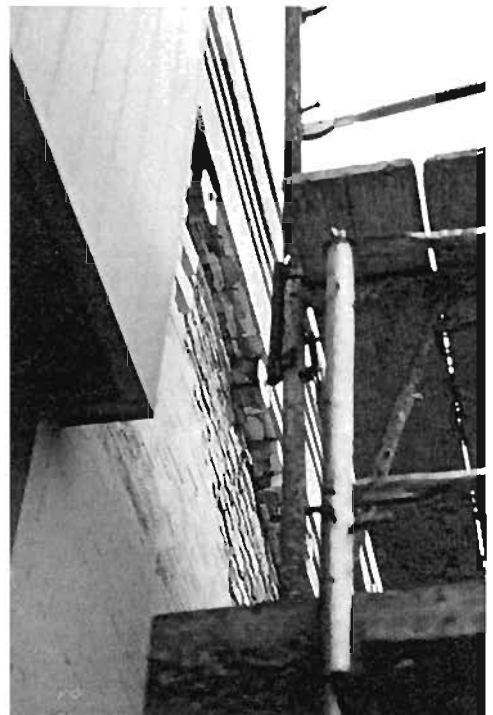
Plate 6.204: Plane of delamination and ties limiting extent of failure
