**THE NORTHRIDGE, CALIFORNIA EARTHQUAKE
OF 17 JANUARY 1994**

A FIELD REPORT BY EEFIT

1. INTRODUCTION

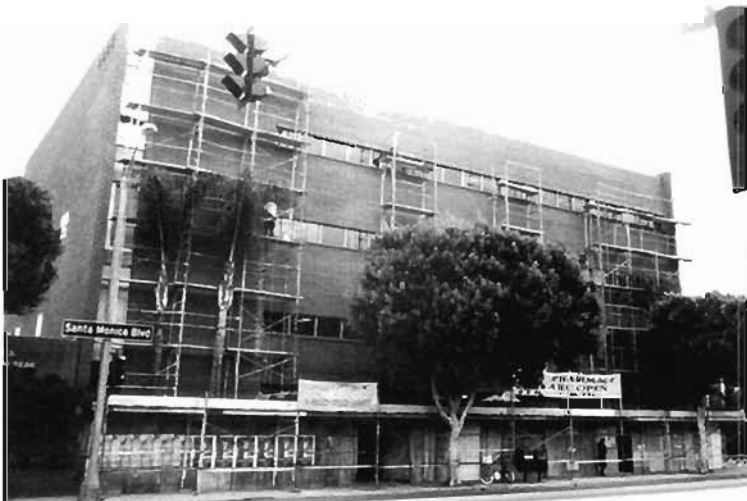
Cladding in its various forms suffered particularly at discontinuities, as in a masonry clad office building with continuous fenestration generally, except at an unperforated service core one end. The masonry had a vertical crack between the core and the offices which was emphasised visually by the mismatch of the colour of the bricks used in the repair (Plates 6.212 and 6.213).

Plate 6.212: A masonry clad framed building with continuous fenestration except one end

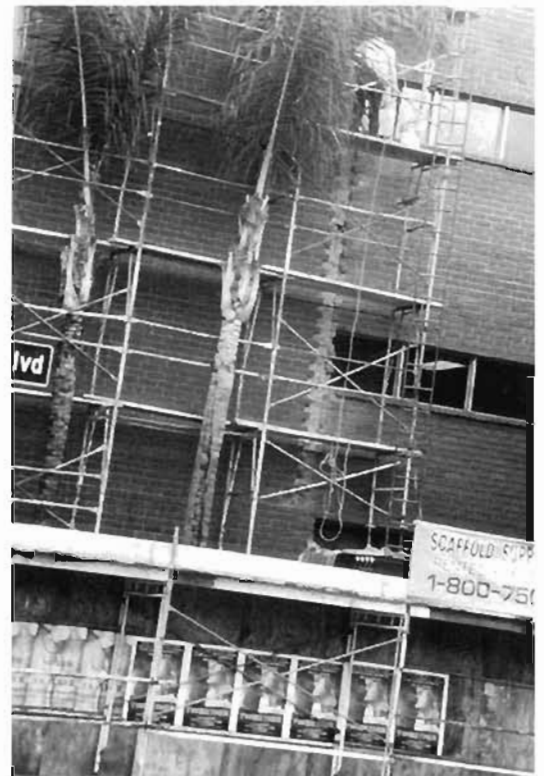
Plate 6.213: Structural damage at end of fenestration

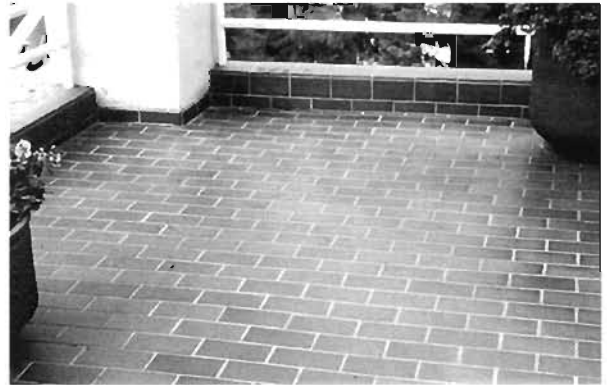
The only damage found in an exceedingly irregular shopping complex on the coast in Santa Monica was a diagonal crack in the first floor tiling at a corner column; evidence of diaphragm action from the discontinuities in the vertical load resisting structure (Plates 6.216 and 6.217).

Plate 6.217: Diagonal crack in floor

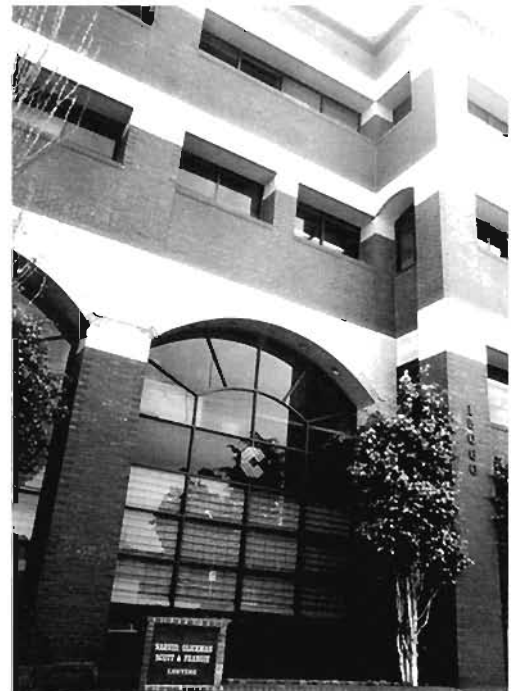
Two masonry clad buildings with abnormal vertical discontinuities are shown in Plates 6.214 and 6.215. The lower was undamaged and the taller suffered minor cracking through the column cladding at the springing points of the arch.

Plate 6.215: Undamaged masonry clad building with vertical irregularity

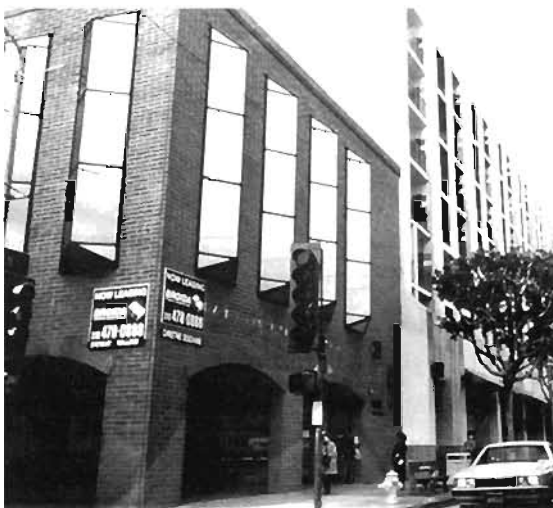
Plate 6.214: Undamaged building with extreme vertical irregularity

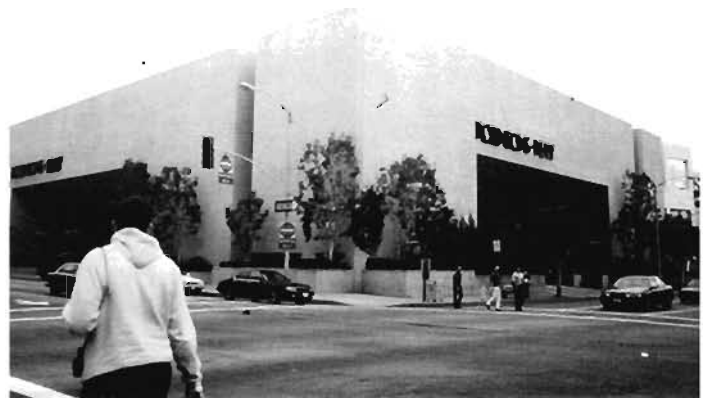
The two exceptionally irregular buildings shown in Plates 6.218 and 6.219 were undamaged, remarkable because even earthquake resistant design assumes some damage.

Plate 6.218: Undamaged building with extreme vertical irregularity

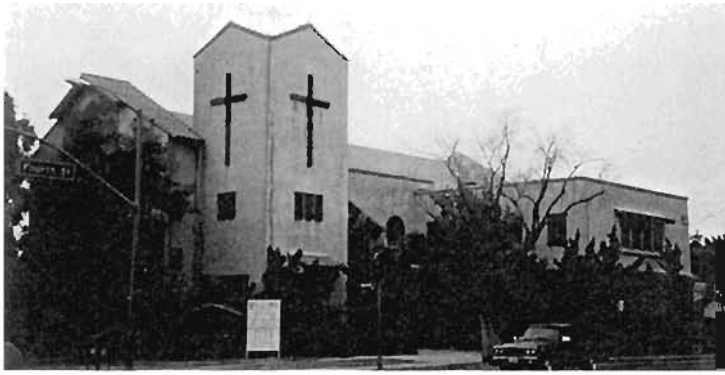
Plate 6.220: Church of light construction in San Fernando

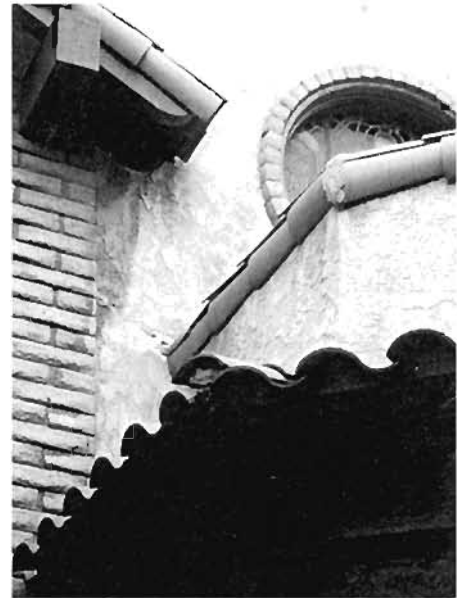
Plate 6.221: Cracking in irregularity above porch

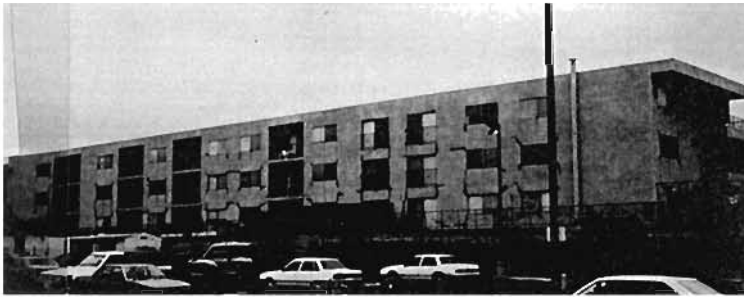
Vertical irregularity of low rise buildings with stiff external walls and irregular penetrations led to extensive cracking. In a very long low building with stiff unperforated cores each end, rotation of the core foundations probably contributed to diagonal cracks from the corners of windows and vertical cracking of spandrel beams over the entire length of the building (Plate 6.222). In a shorter building with an unperforated wall one end, damage was less severe and more evenly distributed, with possible wall rotation occurring from a compression failure in the wall (Plate 6.223). In a comparable building with a car port at one end, damage was confined to cracking at the external wall above the entrance (Plate 6.224). The features responsible for such damage are generally clear and they may sometimes be justified by such overriding architectural considerations.

Plate 6.222: Long low apartments with rigid walls bolt end in Santa Monica

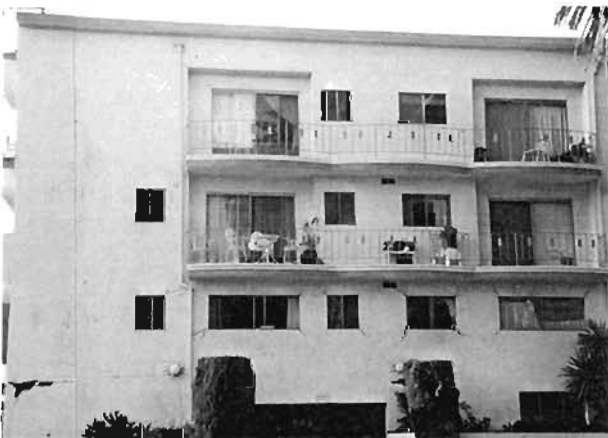
Plate 6.223: Damage in end shear wall in apartments in Santa Monica

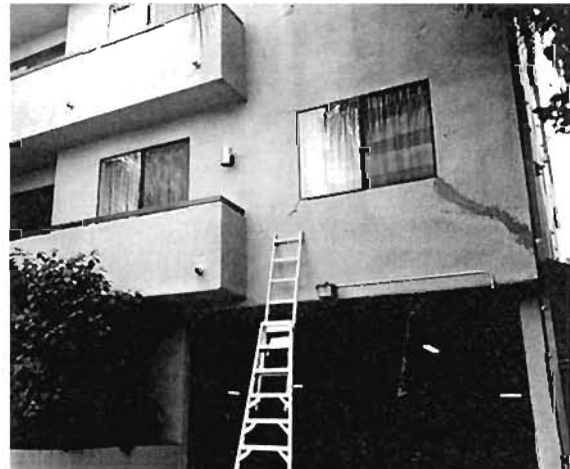
Plate 6.224: Crack above car park entrance at end of building

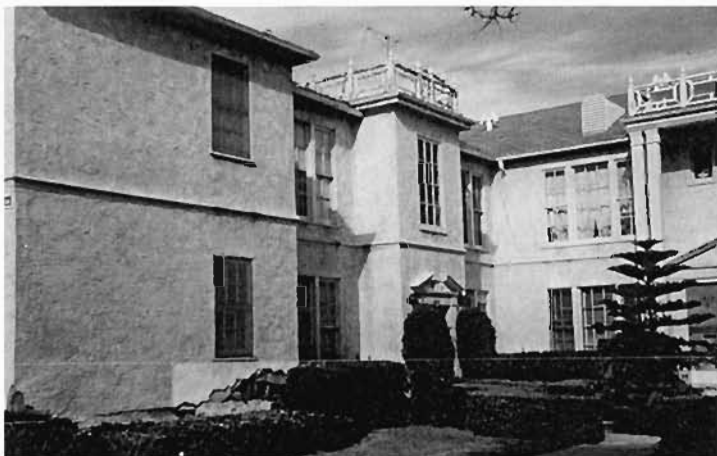
Some low rise buildings (timber framed, reinforced concrete and masonry) were highly irregular in ways other than the soft ground storey defect responsible for so much damage in the Loma Prieta earthquake. Considering the generally greater severity of the ground shaking in this earthquake, damage to such structures was less common than might have been expected (cases are considered in 6.10.3). The penalty for extreme irregularity in plan was minor damage. For example, in a church in San Fernando (Plates 6.220 and 6.221) there was cracking in the stucco at the change in horizontal and vertical geometry above the porch. In one of the wings of an attractive U-shaped masonry building in Santa Monica (Plate 6.225) there was local loss of stucco over the height of the crawl space

Plate 6.225: Stucco damage in old decorative U-shaped building in Santa Monica

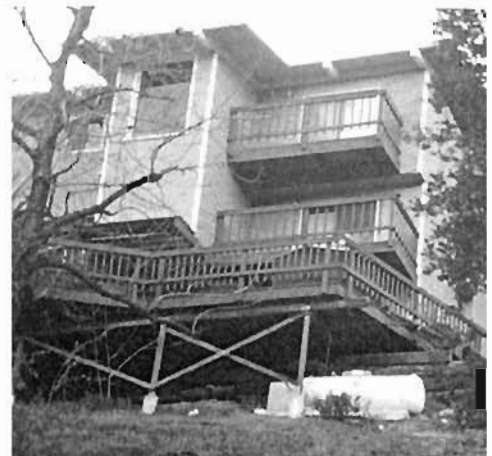
Even a house perched precariously on the ridge of an escarpment in a similar location to that causing the collapse of houses in the Loma Prieta earthquake was undamaged (Plate 6.226), presumably on account of it being founded on rock. This was close to the landslips of the Palisades.

Plate 6.226: Undamaged building on crest of hill

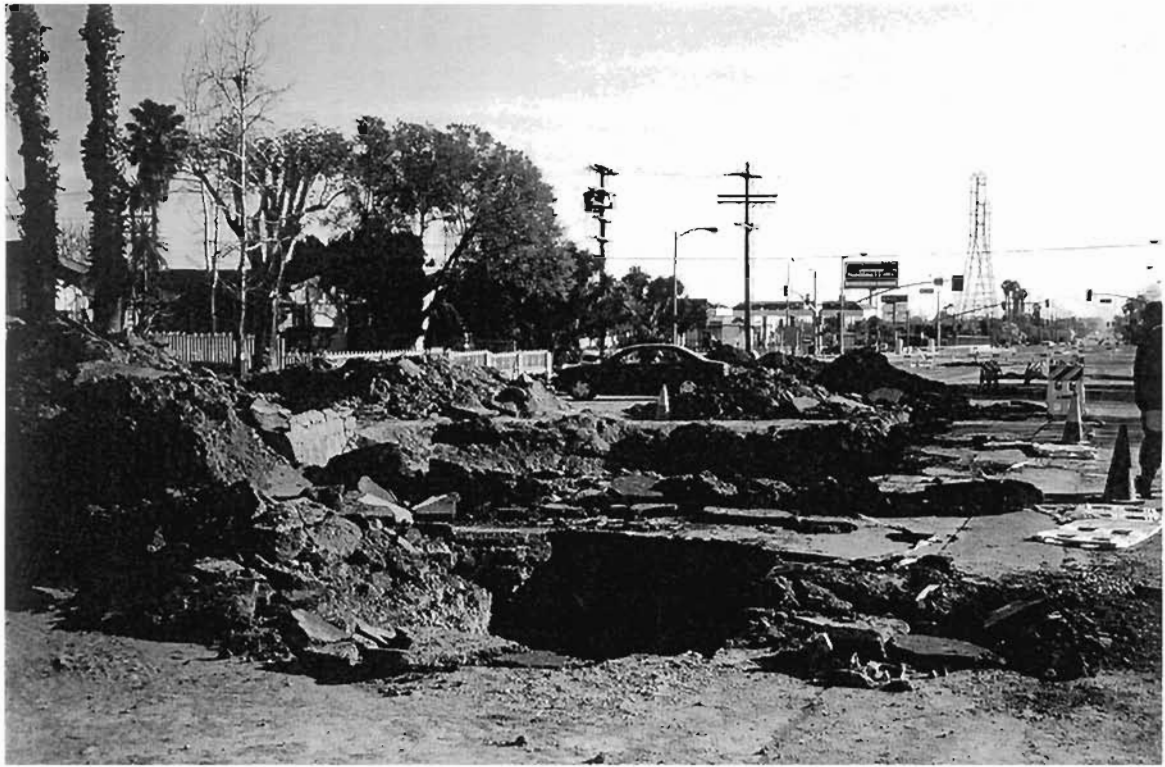
Plate 8-13 : Typical location of gas and water pipe breakage, Granada Hills
