# **THE UMBRIA MARCHE EARTHQUAKES OF 26 SEPTEMBER 1997**

## **A FIELD REPORT BY EEFIT**

October 1998

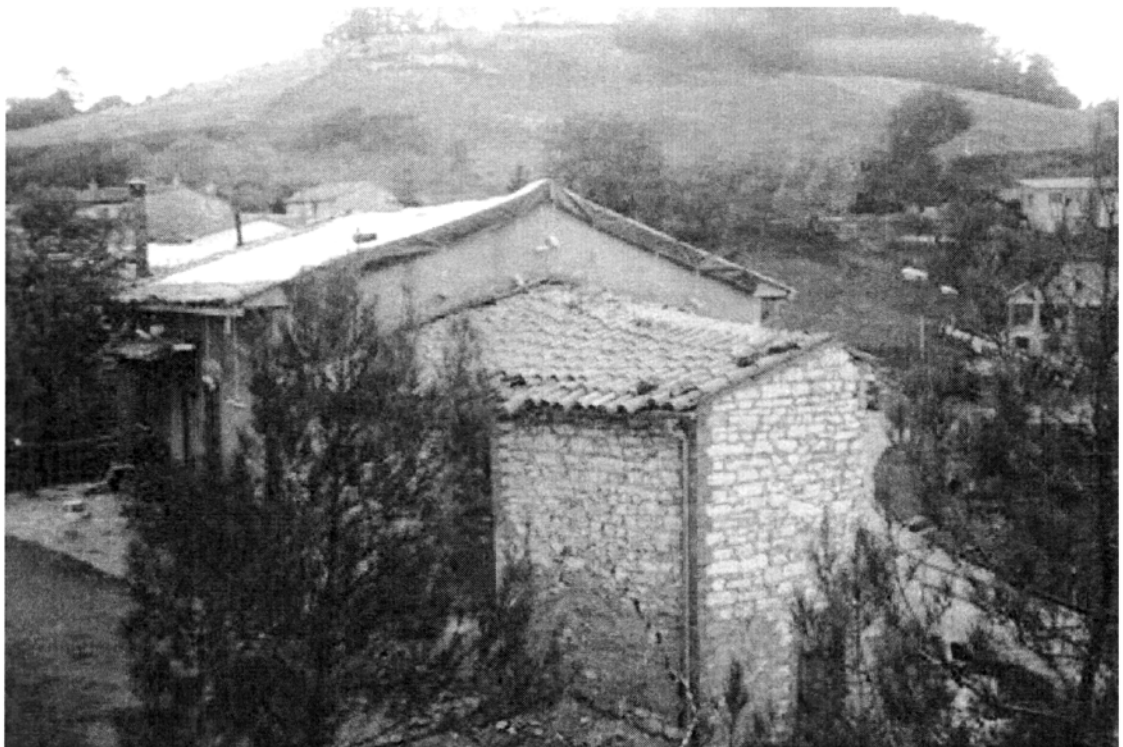
Plate 2.2: Stone masonry wall construction: example from Annifo village

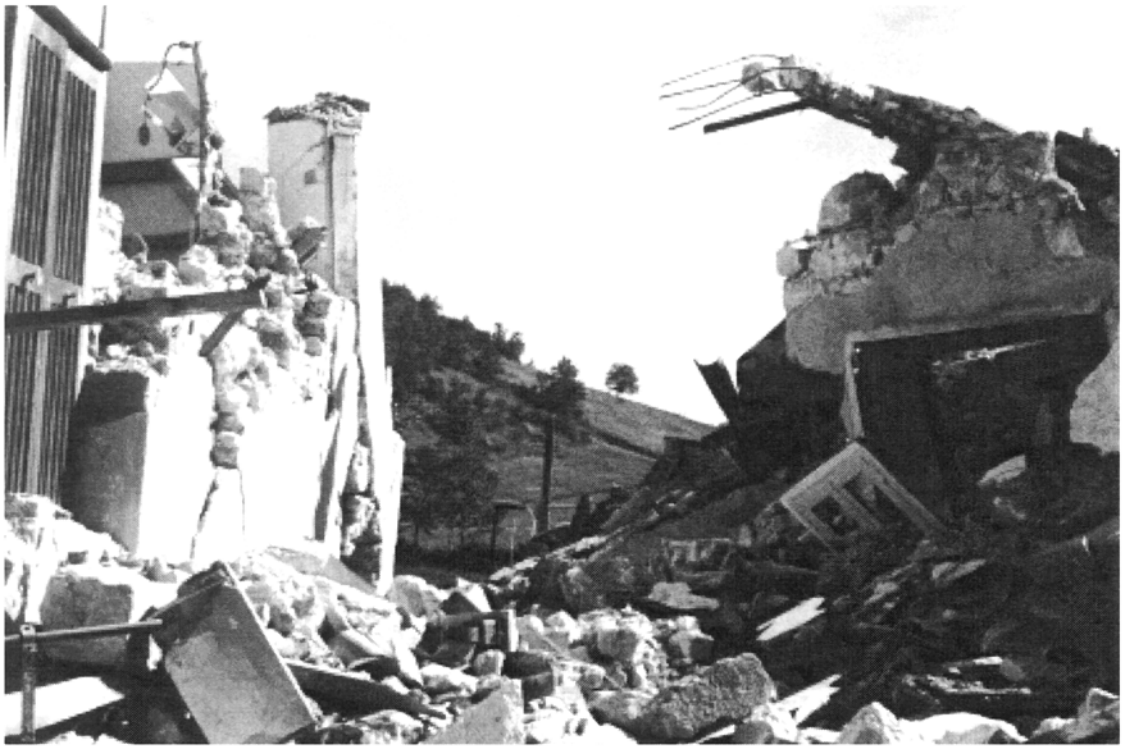
Plate 2.9: Collapsed house with inserted reinforced concrete beam: Collecorti

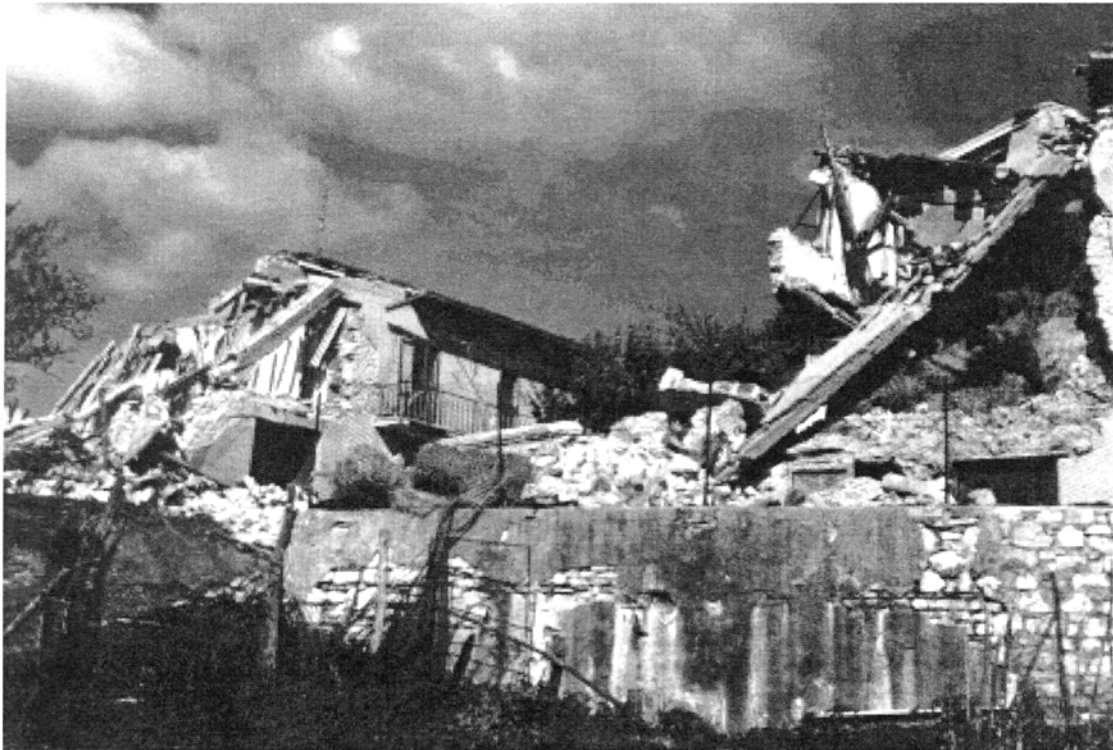
Plate 2.11: Collapsed buildings with modifications in newer masonry

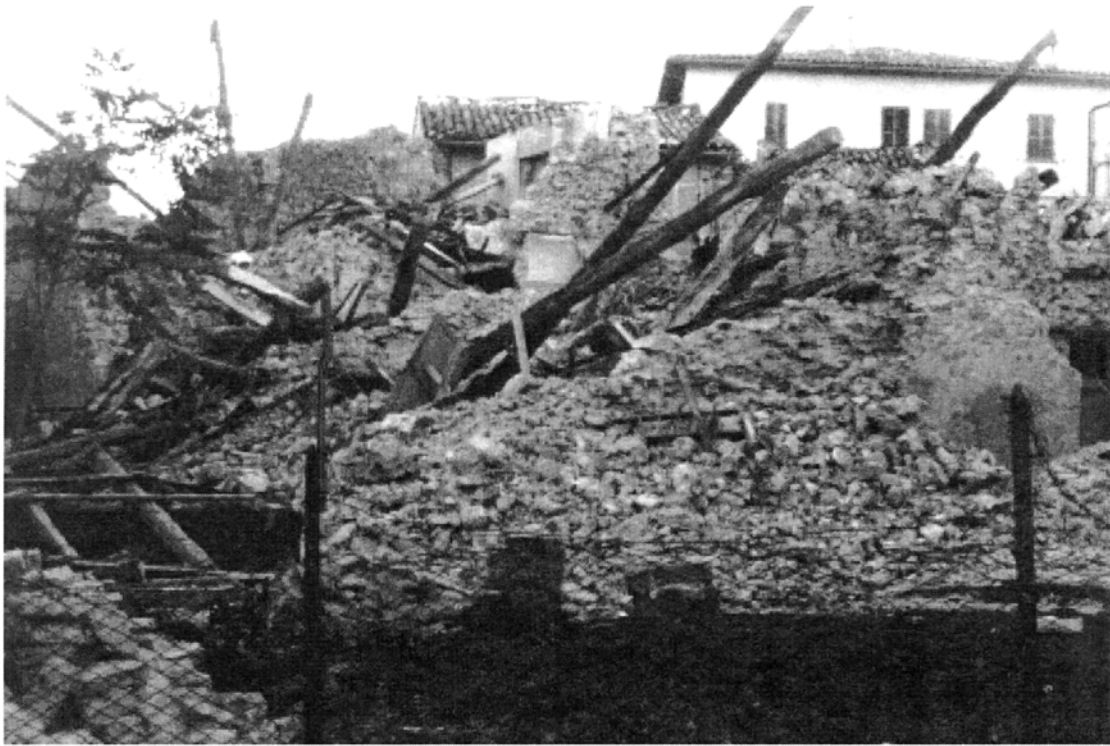
Plate 2.15: Totally collapsed unreinforced masonry building: Annifo

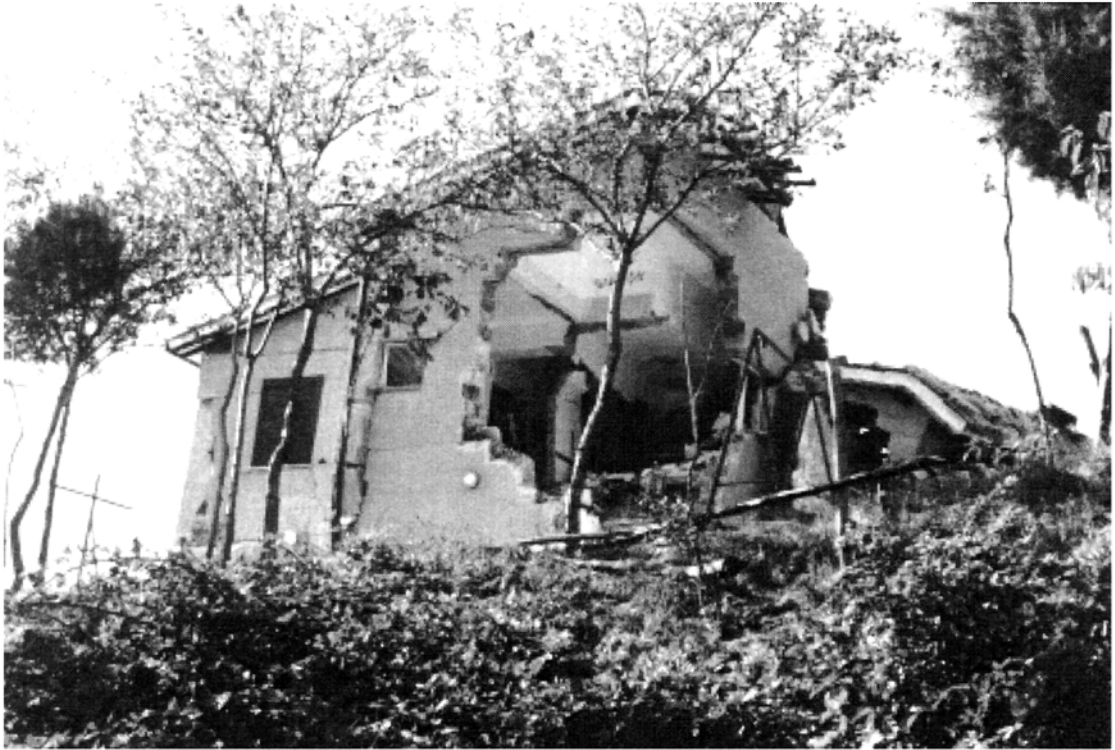
Plate 2.17: Clay block masonry with corner failure: Collecurti

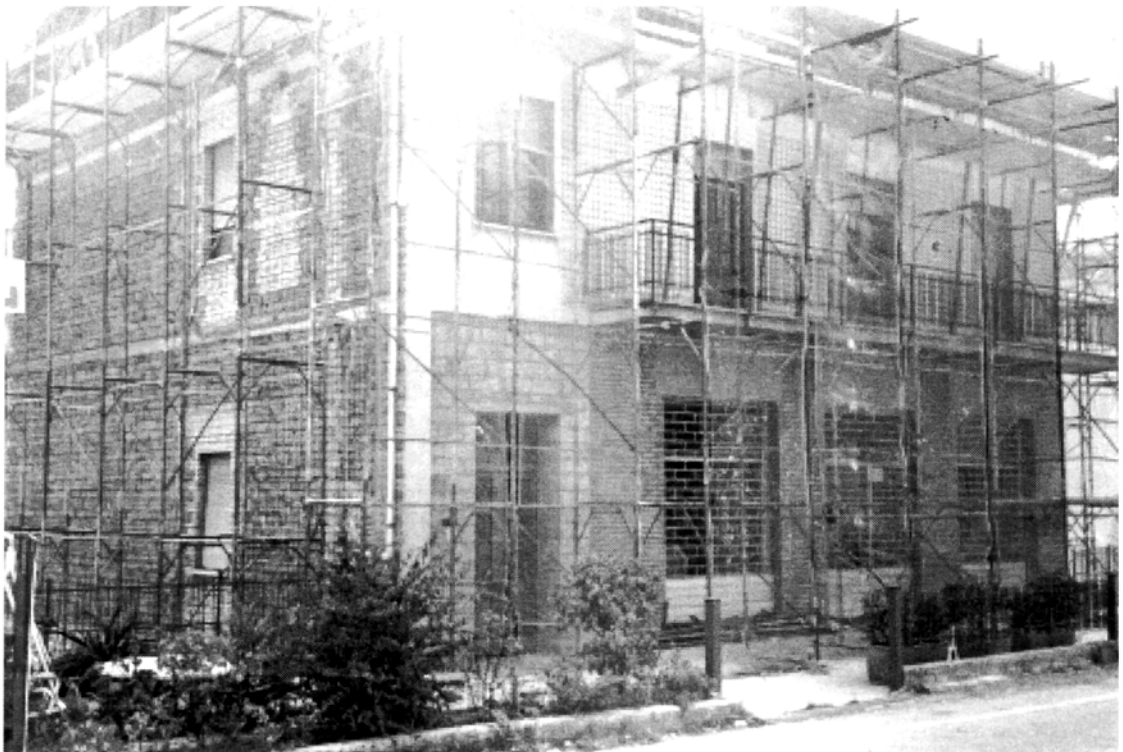
earthquake undergoing strengthening by jacketing (reinforced plaster layer on both sides of wall) (Plate 2.22). This building showed no external evidence of damage.

Plate 2.22: Undamaged masonry building undergoing strengthening: Nocera Scalo

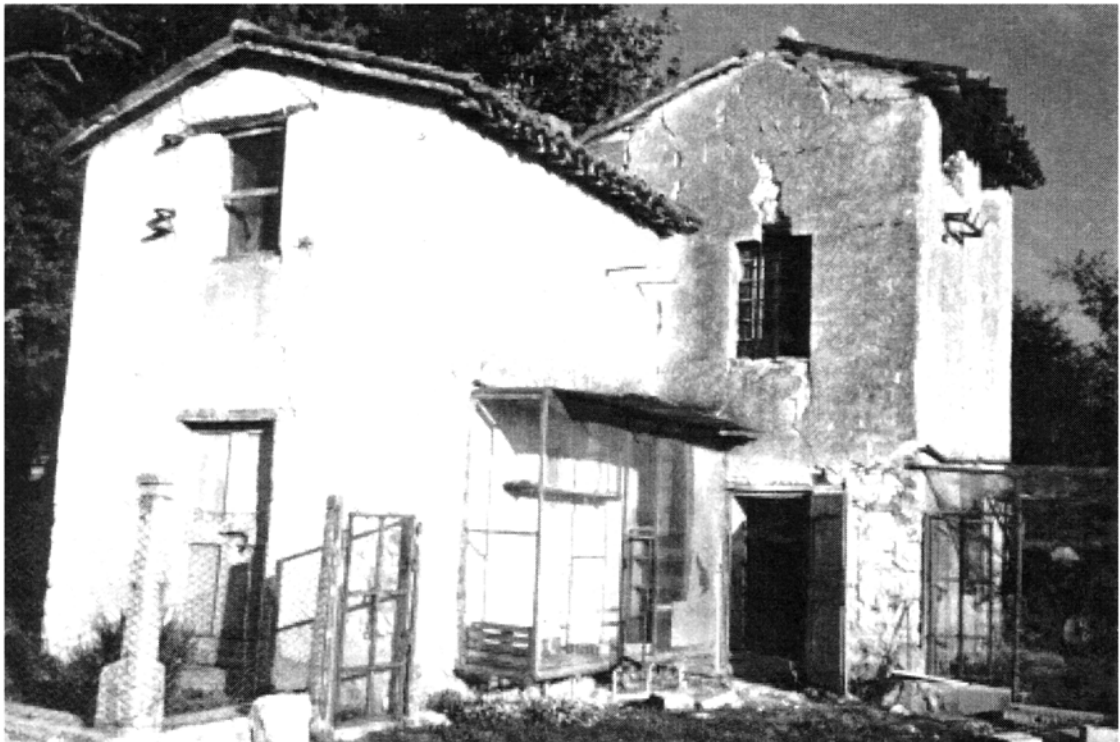
Plate 2.30: Damage to masonry buildings: Colfiorito SMI site

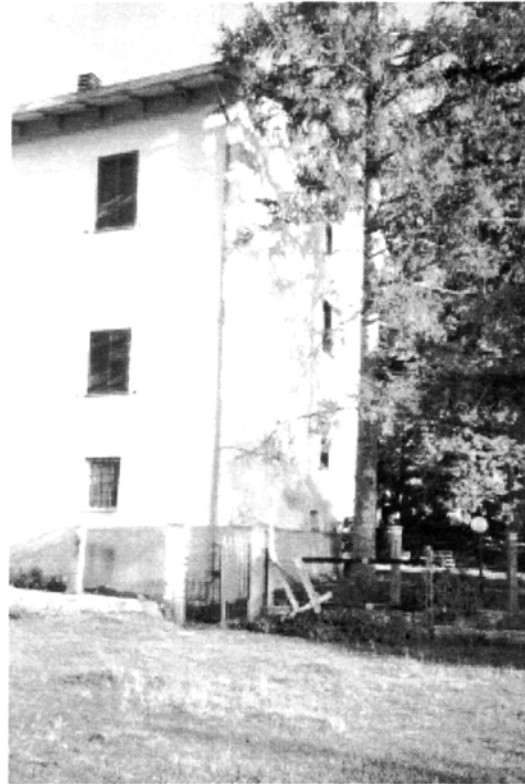
Plate 2.32: Damage to farmhouse:  
Colfiorito SMI site

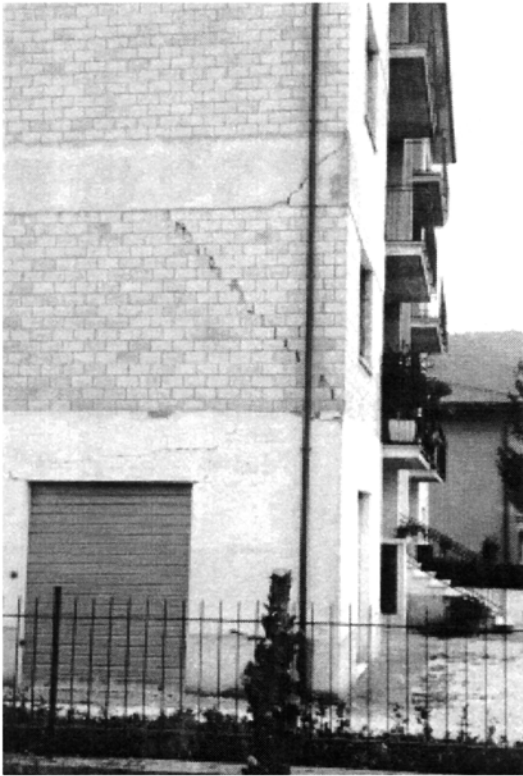
Plate 2.35: Building damage: Nocera SMI site

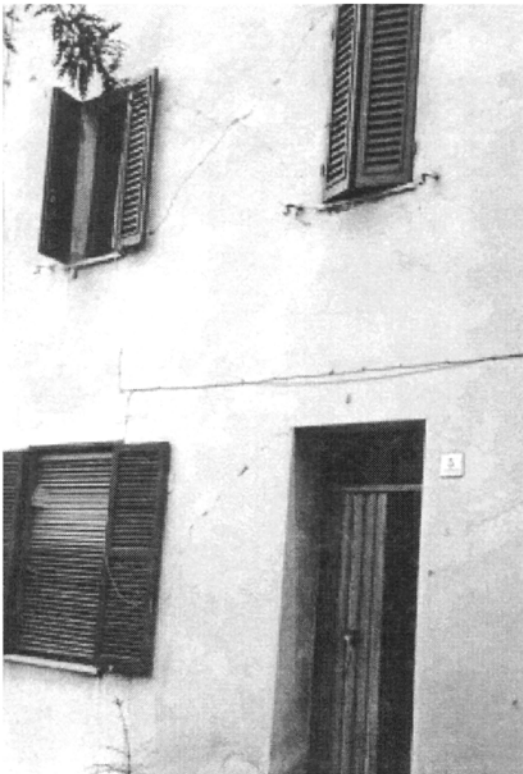
Plate 2.36: Building damage: Nocera SMI site

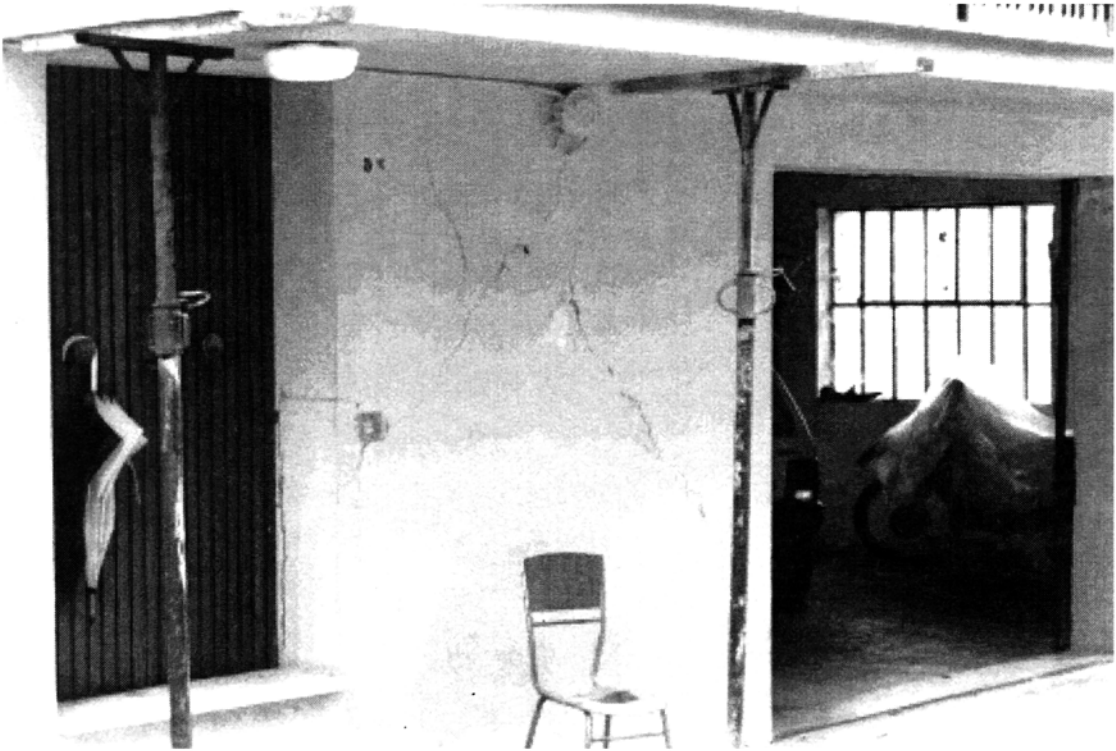
Plate 2.39: Building damage: Nocera SMI site

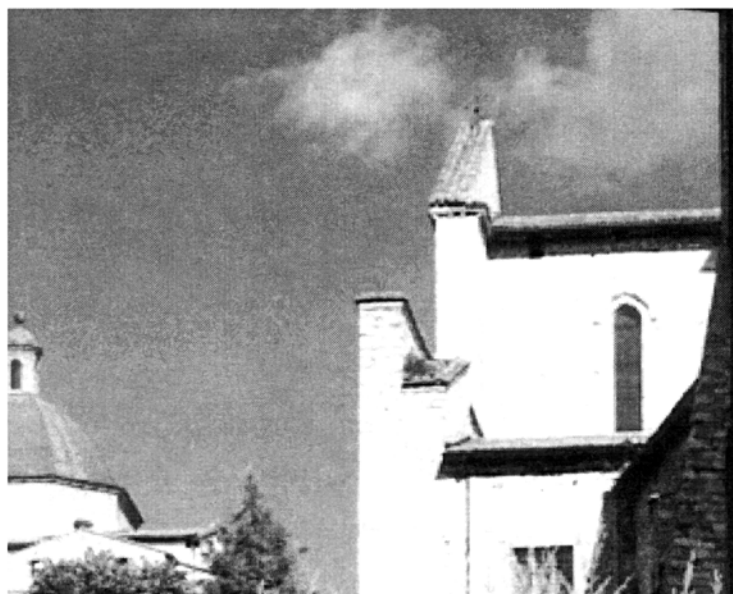
Plate 3.8: Santa Chiara Basilica: subvertical cracks on the southern longitudinal wall

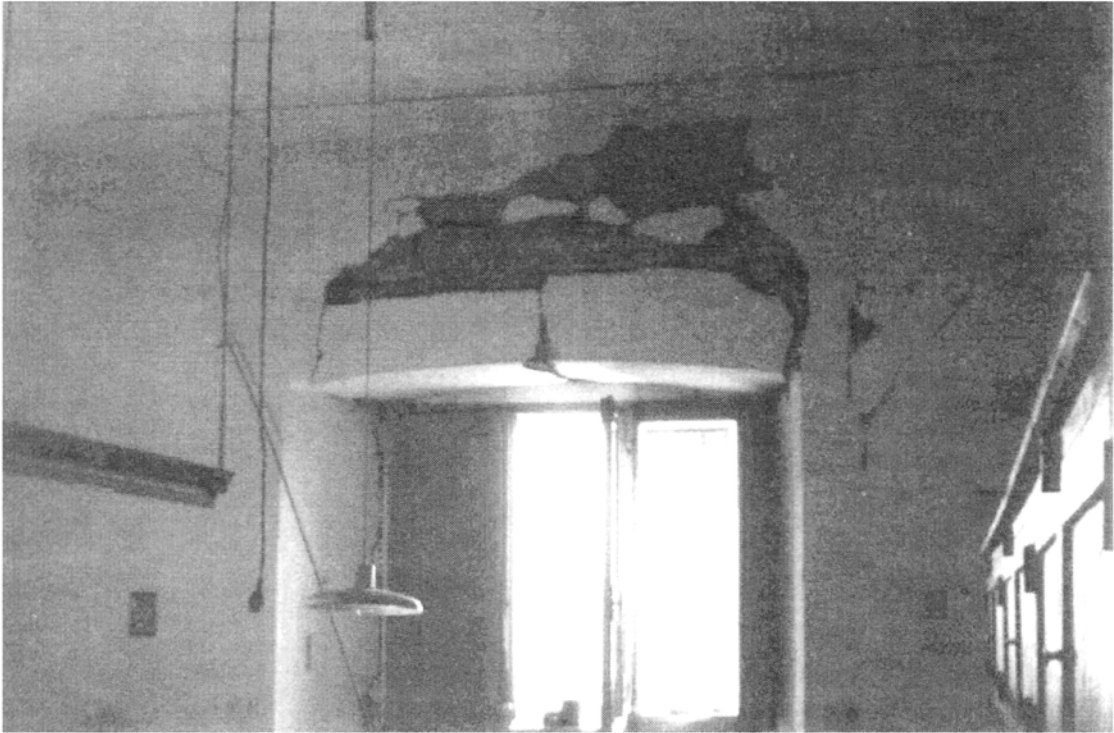
Plate 3.15: Santa Chiara Convent: the internal elevation of the south wall

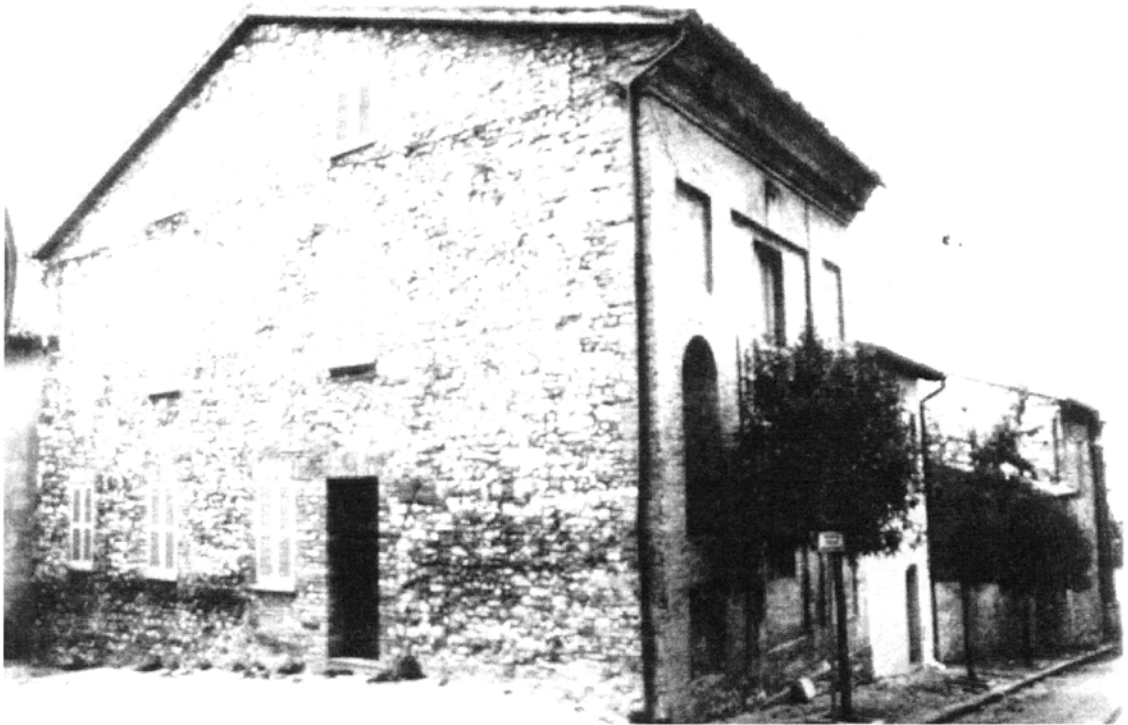
Plate 3.35: Nocera Umbra: out-of-plane overturning of the Civic Archive façade

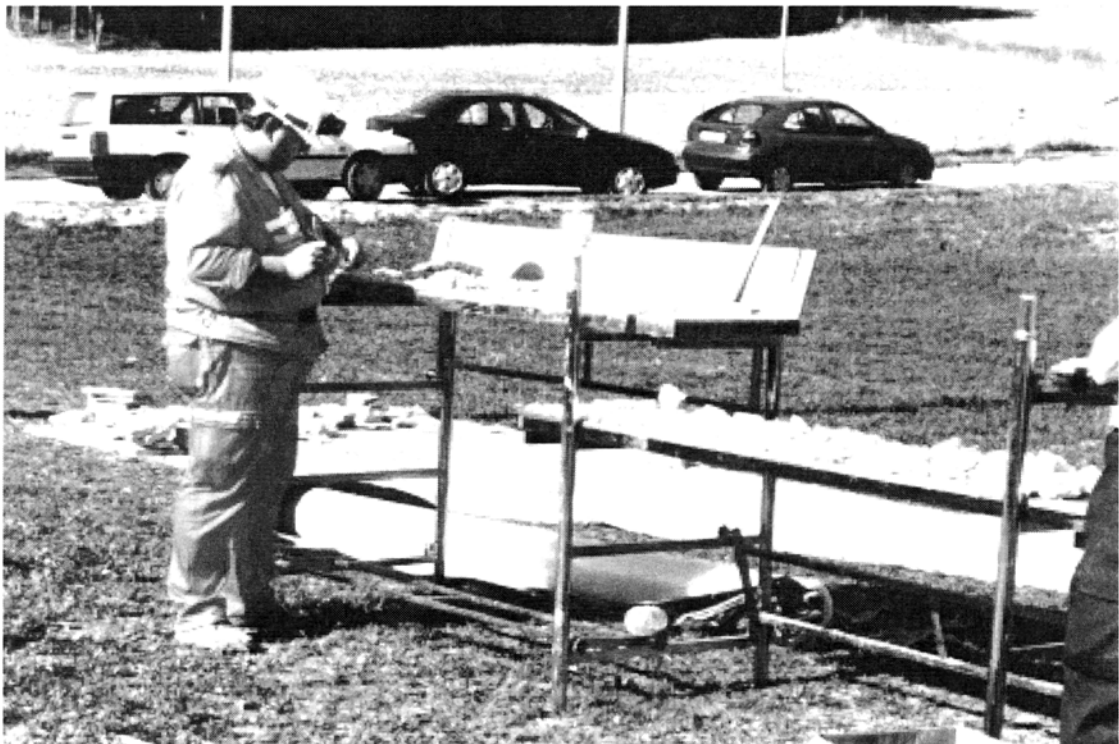
Civil Defence units and Fire Brigades from all over Italy were involved in the emergency activity, a total of 4,500 workers, supported by around 2,000 volunteers. In addition to the temporary accommodation, action taken in the immediate aftermath of the earthquake included shoring dangerous buildings (Plate 4.6), removing damaged and dangerous masonry and loose roofing material (Plate 4.7), providing tarpaulins to cover damaged roofs, identifying and controlling access to areas considered unsafe (Plate 4.8), and surveying and classifying buildings. In several areas, a special unit of the Protezione Civile was engaged in careful removal of rubble from damaged churches, and identifying and organising the remains of damaged frescoes (Plate 4.9).

Plate 4.9: Emergency activities 10 and 11 October: retrieving damaged frescoes: Cesi church

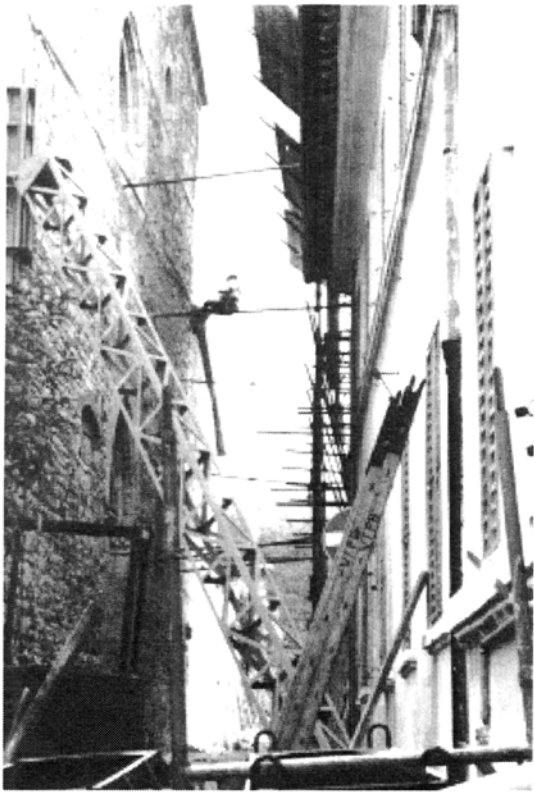
Much of this work was in progress during the EEFIT visit. In Nocera Umbra, for instance, the Alpine Mountain Rescue attempted to secure a large piece of damaged masonry wall of the cathedral of Santa Maria Assunta with webbing straps to prevent further collapse (Plate 4.10).

Plate 4.10: Emergency activities 10 and 11 October: strapping dangerous masonry: Nocera Umbra
