# Damage assessment and monitoring for buildings on the Elizabeth line

**Deborah Lazarus**

Consultant, Arup, London, UK

This paper looks at the damage assessment and monitoring of buildings around the stations, focusing in particular on the new station at Tottenham Court Road. It also provides an overview of the two very different tunnel construction methods used on the project – the so-called tunnel boring machine (TBM) and sprayed concrete lining (SCL) methods – and describes how these lead to the ground movement that is the principal source of potential damage to the buildings.

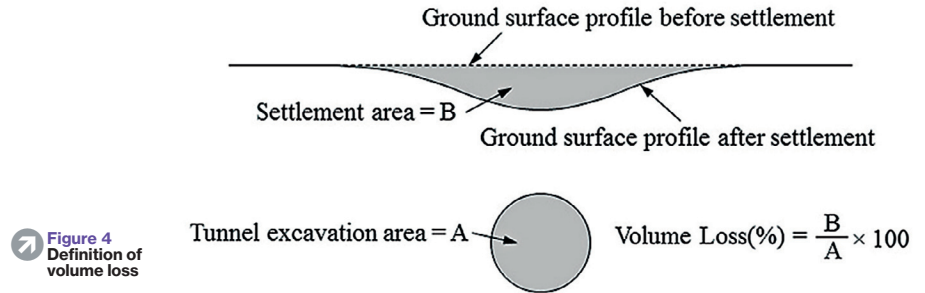
Figure 4  
 Definition of volume loss

Movements along the tunnel alignment were generally predicted to be small, with correspondingly minor impacts on buildings. This correlated with the results recorded during the works; volume losses (Figure 4), particularly on the western drive (between Paddington and Farringdon) through London Clay, were generally lower (<0.5%) than the fairly conservative value of 1% assumed in the damage assessment calculations. Around the stations, the predicted values were higher; horizontal movements around the deep excavations were greater than those around the bored tunnels, and the larger platform tunnels and cross-passages were constructed using SCL techniques which also produce larger movements. Volume losses for SCL works were assumed to be 1.5% for the purposes of assessment. Further explanation of volume loss can be found in Burland<sup>7</sup>.

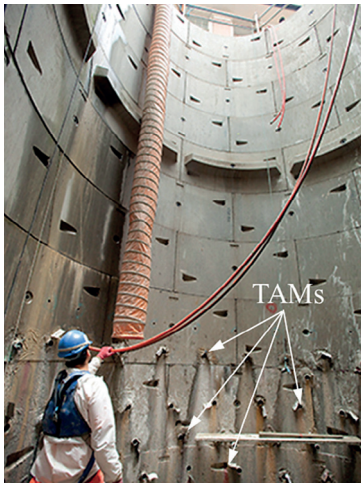
Figure 6 Compensation grouting shaft with TAM array installed<sup>14</sup>

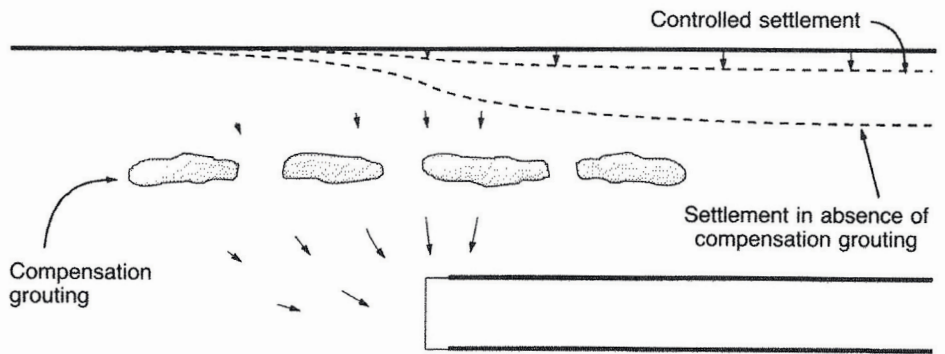
Figure 7 Principles of compensation grouting<sup>15</sup>

Compensation grouting is described in more detail in other papers (e.g. Bezuijen, 2010)<sup>13</sup>, but a brief outline of the technique is included here. A grout shaft is installed at a specified location to enable an array of *tubes à manchette* (TAMs) to be drilled out horizontally to lengths of up to 80m from the shaft. The tubes are installed radially at a number of depths within the shaft (Figure 6). Grout is injected through a selected TAM using two rubber packers which select the part of the tube where the grout will be injected. The grout is injected at high pressure so that the ground is fractured horizontally, then the grout penetrates through the fractured cracks and heaves the ground to compensate for settlements (Figure 7).

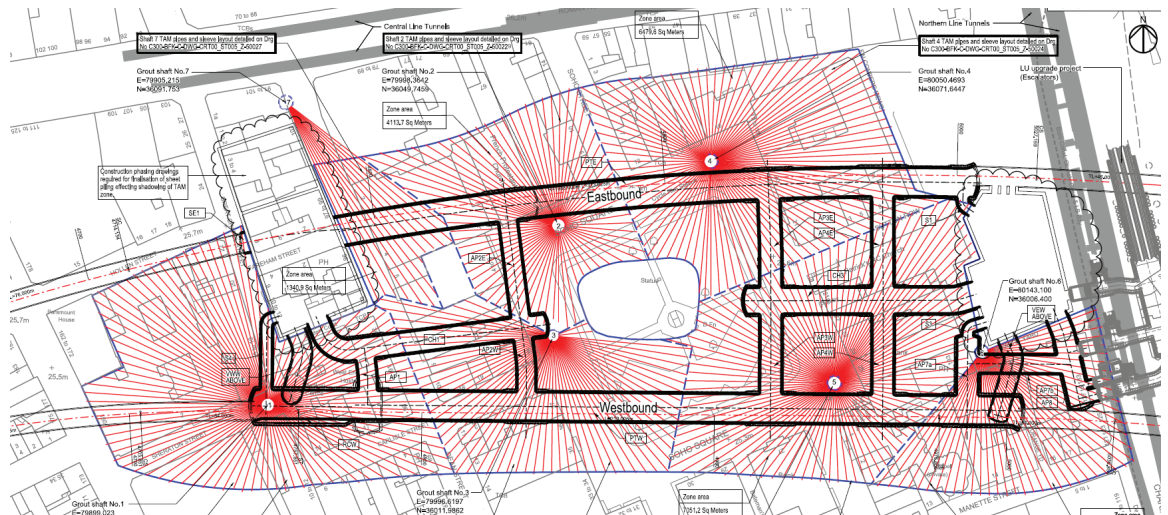
Figure 8 TAM array in Tottenham Court Road station; radially located red lines indicate TAMs from compensation grout shafts (indicated as o on plan)

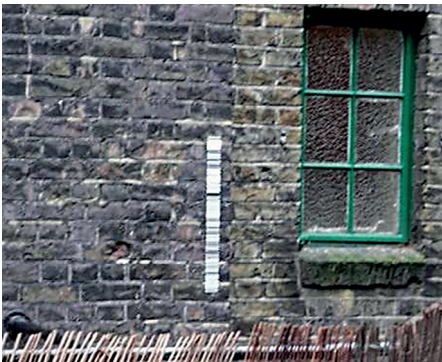
a) Invar scale on building facade – used for precise manual levelling

Techniques used included manual monitoring using studs and Invar calibrated scales (Fig. 9a); automated monitoring of prisms (Fig. 9b); hydrostatic levelling cells (Fig. 9c) and tiltmeters; and, at a later stage, satellite technology to look at ground movements in specific areas. This is an area where there are continuing developments and some changes might be anticipated for subsequent projects.

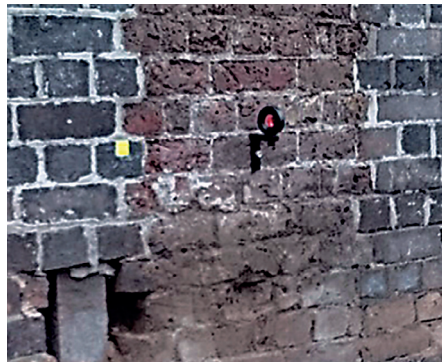
b) Prism on building facade – part of automated monitoring installation using Automated Total Stations

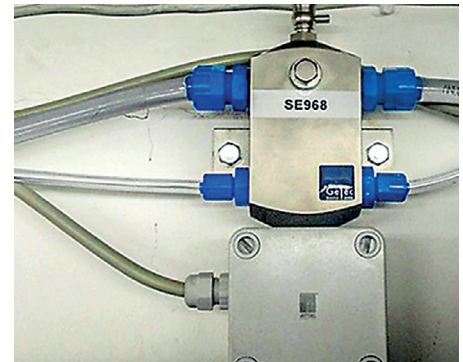
c) Hydraulic levelling cell – part of automated monitoring installation used to control building slopes

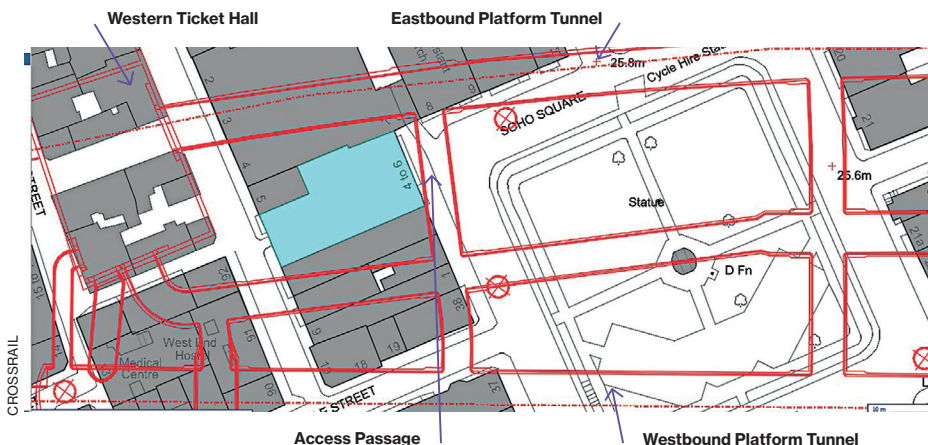
Figure 11 Plan location of 4-6 Soho Square showing new station tunnels below

The building at 4-6 Soho Square is located at the northwest corner of the square (Figure 11). It is one of a number of buildings on 'mixed foundations', i.e. a combination of deep (piled) and shallow foundations. There is no prescribed methodology for buildings on 'mixed' foundations and the damage assessments were carried out on a building-specific basis. Due to its unusual form, the assessment and protection of 4-6 Soho Square are described in some detail.

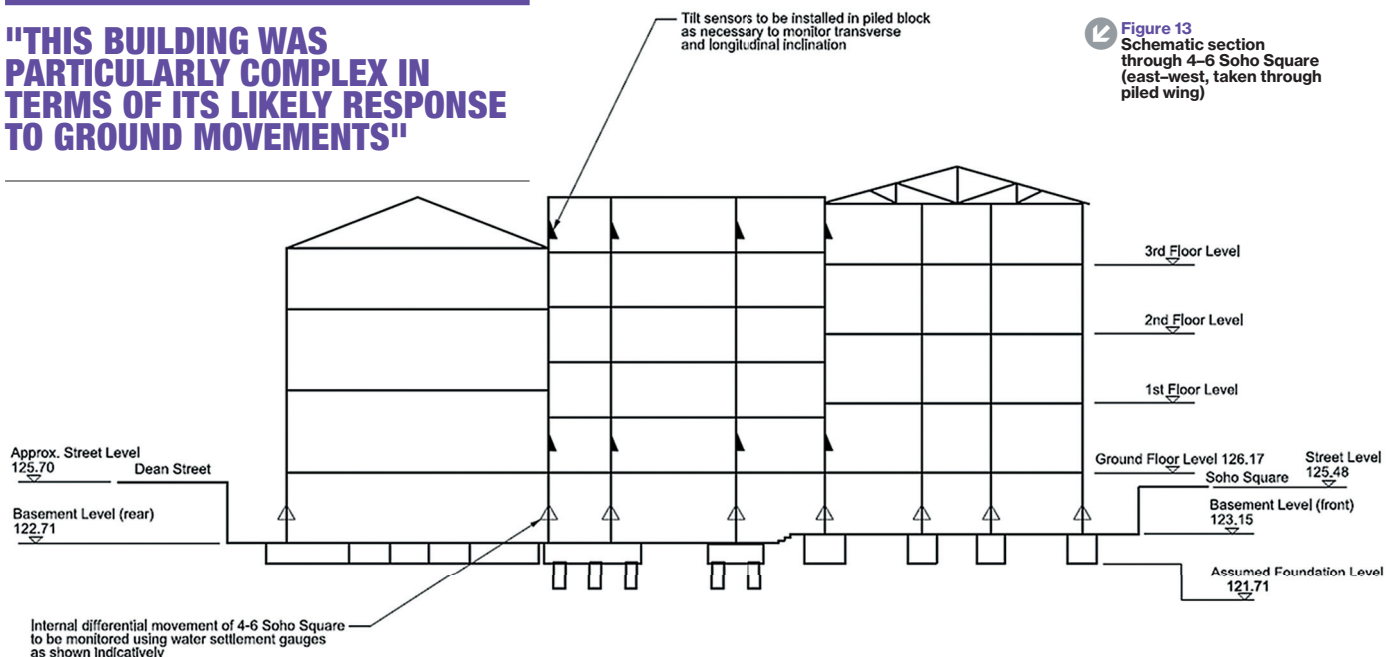
Figure 13  
Schematic section through 4-6 Soho Square (east-west, taken through piled wing)

Figure 13 provides a schematic section through the building looking north, providing an overview of the different foundation systems.

The foundations of the original buildings are corbelled brick or stone strip and pad footings, although some walls were underpinned during construction of the 1980s link blocks. Foundations to the link blocks are piled, with the steel frame taken through the vaulted substructure. Trial pit information from the refurbishment shows strip footings under the original brick walls/vaults are typically founded at approx. 500mm below basement level, with various local deepening at the original timber column positions to approx. 1500mm below basement level. The latter approximately matches the founding level of the pad

footings under internal timber columns. Pile caps and ground beams for the new foundations are set just below the basement slab. Record drawings indicate that the walls adjacent to the new foundations were underpinned to a level approx. 1500mm to 2000mm below basement level, to enable the construction of the pile caps and ground beams. Crossrail archive information shows piles under the link blocks extend 22m below ground-floor level, although there is no record of pile diameters.

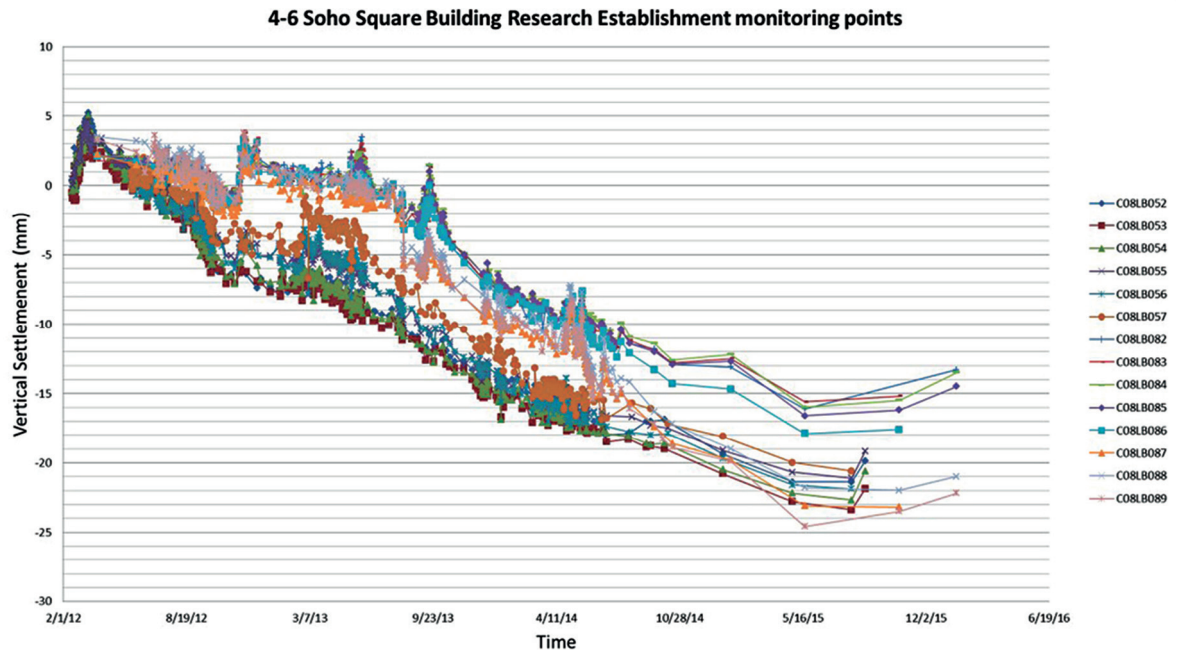
Figure 14  
 Time-settlement plot  
 for 4-6 Soho Square

of the construction contract. This was for control of the compensation grouting process and movements of the building. This instrumentation comprised hydraulic levelling cells in the basement with prisms, Building Research Establishment (BRE) studs and Invar scales on the external facades. Tiltmeters were also installed on internal columns. Figure 14 shows the time–settlement plot for the BRE studs at ground-floor level. This provides some indication of the monitoring data obtained during the project; such plots enabled the impact of particular construction activities to be assessed.

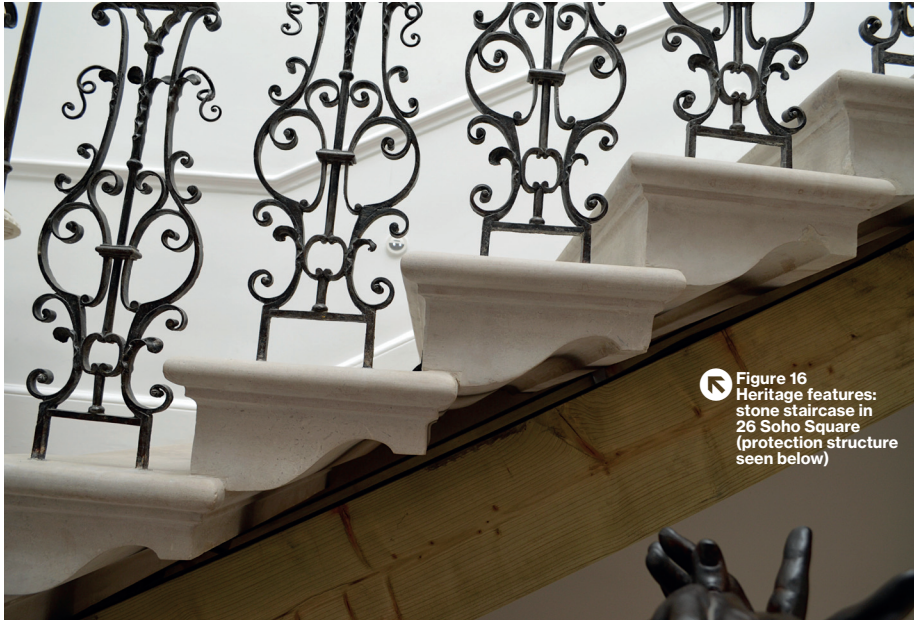
Figure 16  
Heritage features:  
stone staircase in  
26 Soho Square  
(protection structure  
seen below)

Immediately to the north of the House of St Barnabas, the building at 26 Soho Square is Grade 2\* listed. It also contains decorative plasterwork and another fine staircase (Figure 16). A protection structure was installed below the stairs until such time as ground movements were shown from the monitoring to have diminished to the specified level (<2mm per year).
