## **CROSS Safety Report**

# **Durability issues with engineered timber**

This month's report concerns durability issues with engineered timber due to water ingress or condensation issues. Engineered timber appears to disintegrate more quickly than conventional timber, resulting in structural failure rather than distortion.

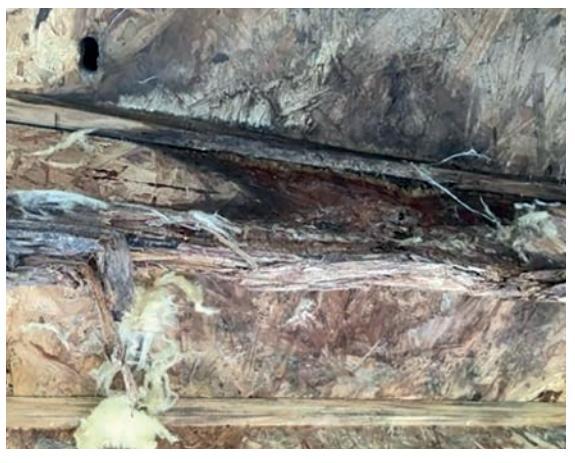
★FIGURE 1: An example of OSB board deterioration

**Figure 1** shows a top floor property within a development less than 15 years old. Water ingress and possibly condensation issues have resulted in significant deterioration of the engineered timber rafters and oriented strand board (OSB) sheeting. Figure 2 also shows a top floor property within a development again less than 15 years old. Water ingress and possibly condensation issues have resulted in significant deterioration of the OSB sheeting. The engineered rafters have been saturated but they are still sound in this case, although they have areas of cracking after drying out.

- →| Detailing to ensure watertight construction is particularly important with engineered timber components
- →| The introduction of high levels of insulation can lead to condensation build up and subsequent deterioration of engineered timber components

If a material is only suitable for a dry environment, then it is essential that water ingress is prevented by sound detailing and correctly applied coverings. Maintenance is similarly essential and owners should be vigilant in taking action if there are observable leaks or excessive condensation.

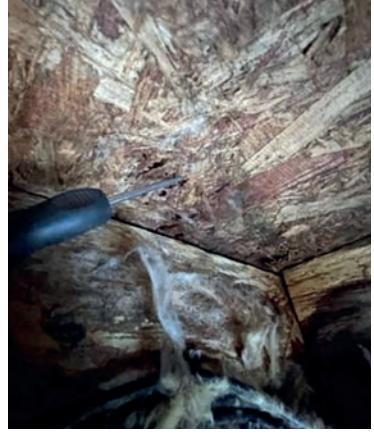
**↑FIGURE 2:** Another example of OSB board deterioration

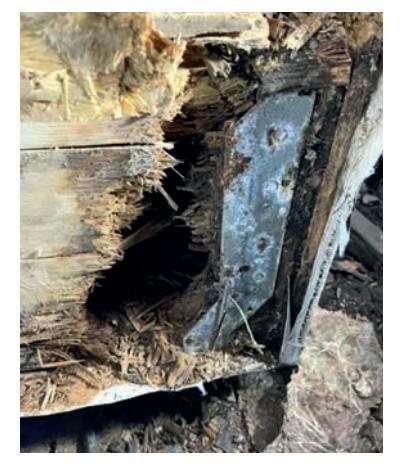
**Figure 3** shows a dwelling less than 13 years old. Again, this issue is likely a combination of water ingress and possible condensation issues because it has been designed as a passive house with high levels of insulation and cold bridging may have resulted locally. Engineered timber products were specified on the original plans, with glulam ring beams which the reporter notes have deteriorated significantly.

▲FIGURE 3: Engineered timber joist deterioration
