Working with Low Carbon Brick Alternatives for repairs to Imperial Sized Bricks in Historic Buildings

*With Glasgow School of Art, Kenoteq and
Heriot Watt University*

Summary

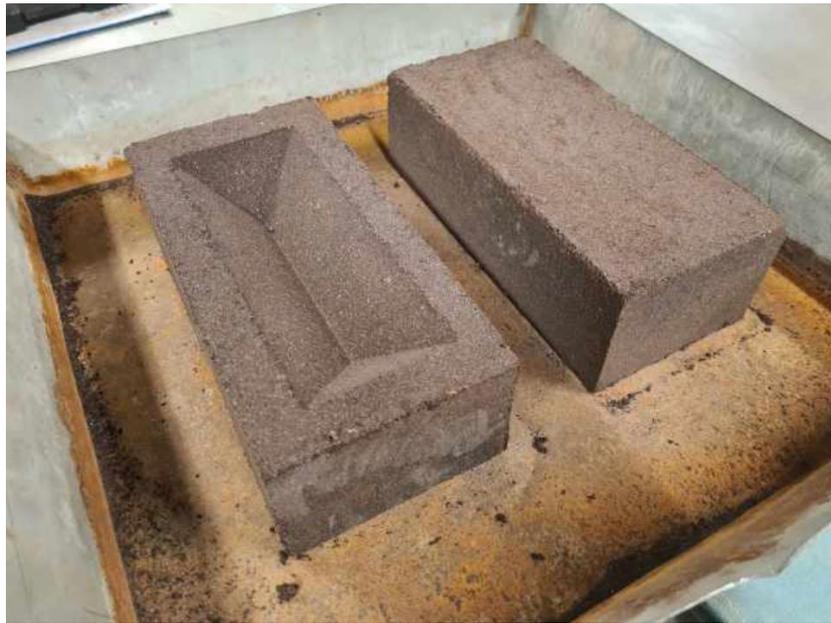
Image 2: Prototype frogged bricks developed using feedstock from existing damaged GSoA bricks

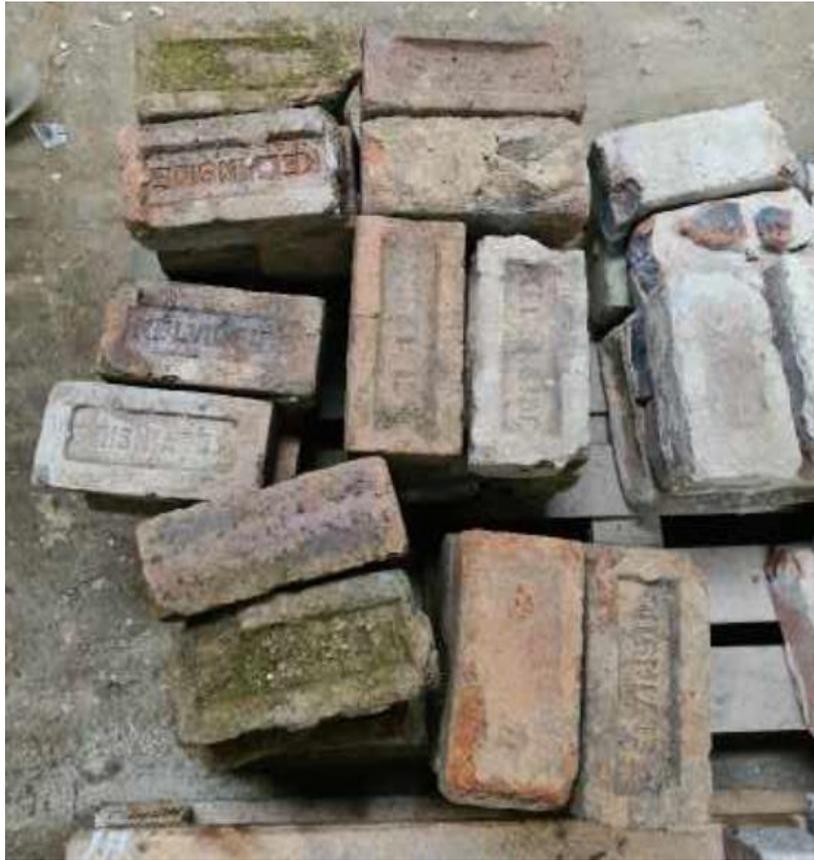
Image 3: Example of salvaged brick units From the Mackintosh Building

The investigation showed that there was significant variability of the material properties of the salvaged bricks, even though all samples had been taken from the Mackintosh Building itself and therefore had experienced similar conditions throughout their service life including the fire itself and the salvage process. This further highlighted the challenge of compatibility listed above.
