Working with Low Carbon Brick Alternatives for repairs to Imperial Sized Brickwork in Historic Buildings

*With Glasgow School of Art, Kenoteq and
Heriot Watt University*

Summary

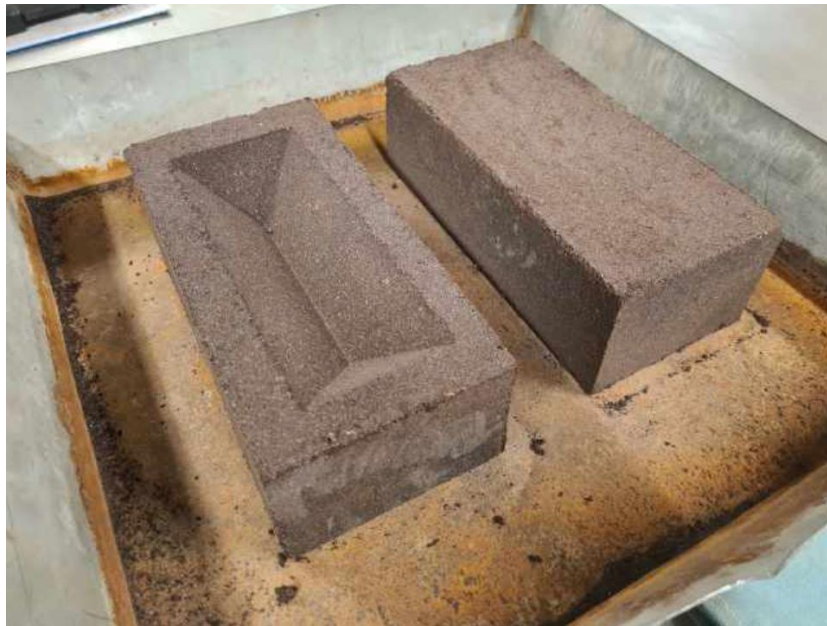
Image 2: Prototype frogged bricks developed using feedstock from existing damaged GSoA bricks

The formulation is such that it would be possible to use crushed debris from the clearance of the building, or any down takings required for stabilisation as the feedstock for new bricks providing a very clear illustration of the potential for circular economies.

New moulds can be developed to provide units to match desired dimensions – including those of the imperial bricks.

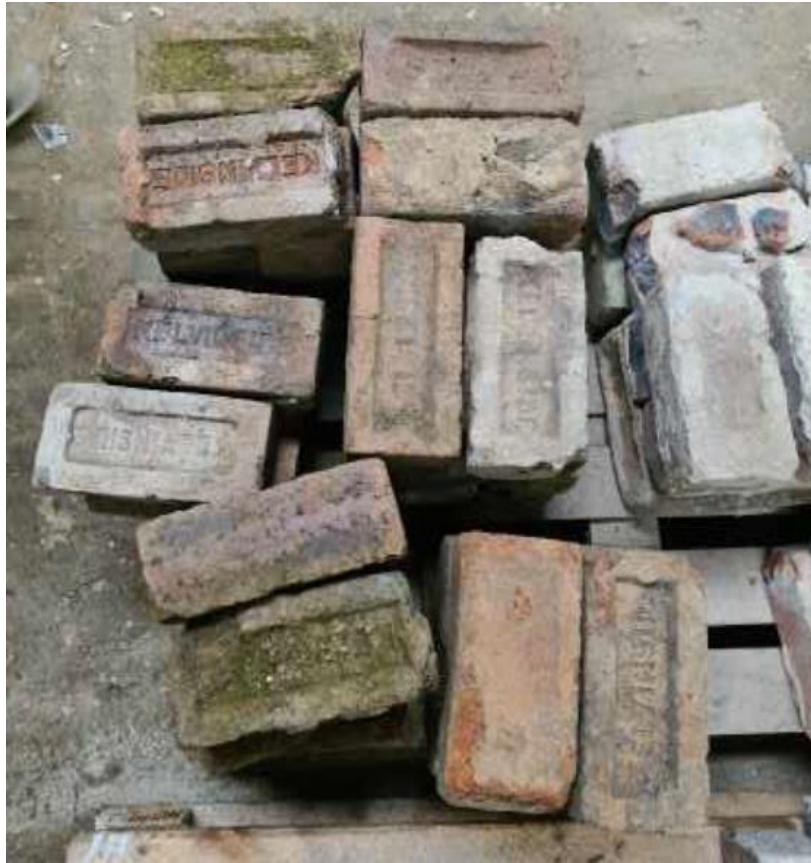
Image 3: Example of salvaged brick units From the Mackintosh Building

The investigation showed that there was significant variability of the material properties of the salvaged bricks, even though all samples had been taken from the Mackintosh Building itself and therefore had experienced similar conditions throughout their service life including the fire itself and the salvage process. This further highlighted the challenge of compatibility listed above.
