THE QUINDÍO, COLOMBIA EARTHQUAKE OF 25 JANUARY 1999

A FIELD REPORT BY EEFIT

August 2000

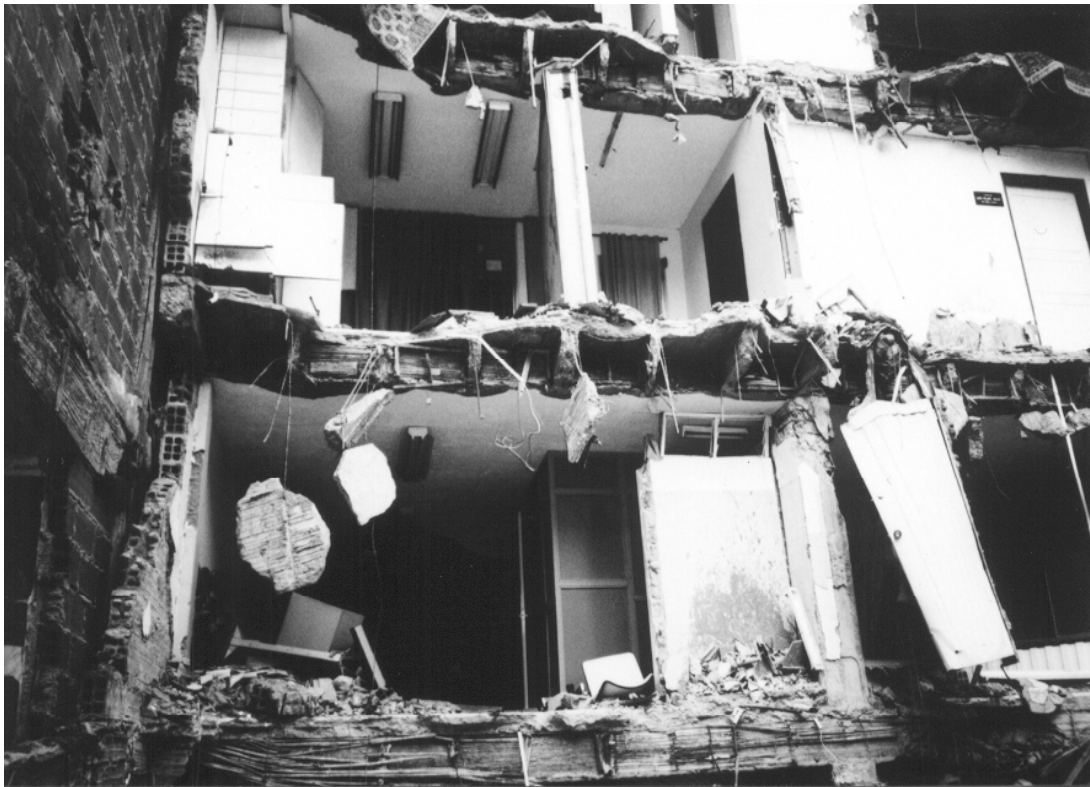
Figure 4.2: T-shaped slab

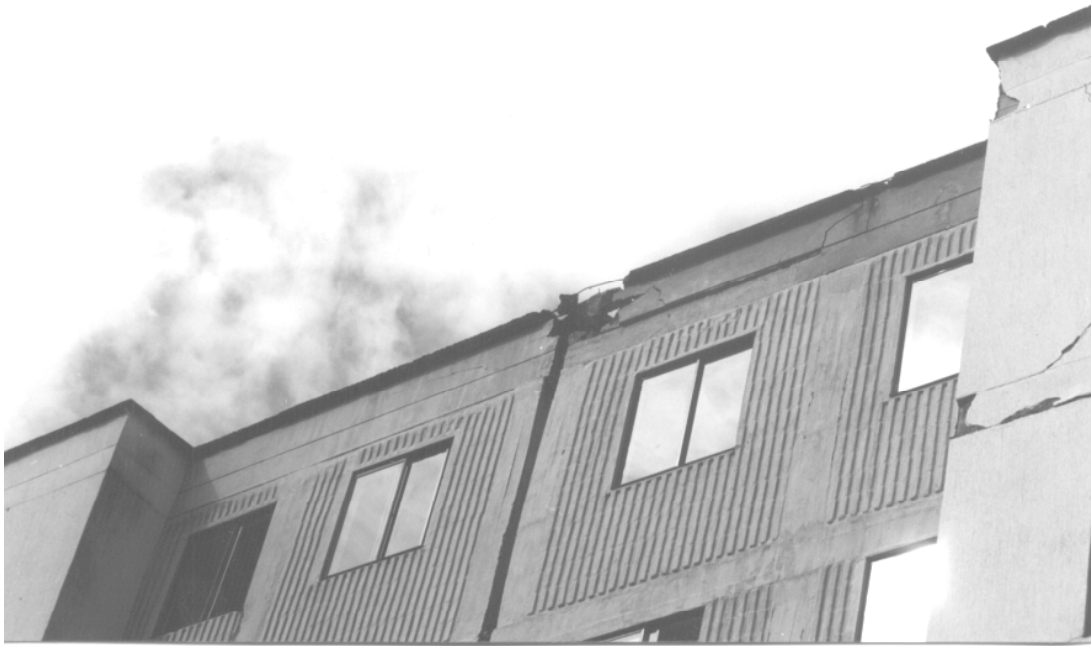
Figure 4.9: Buildings with tie spanning seismic gap

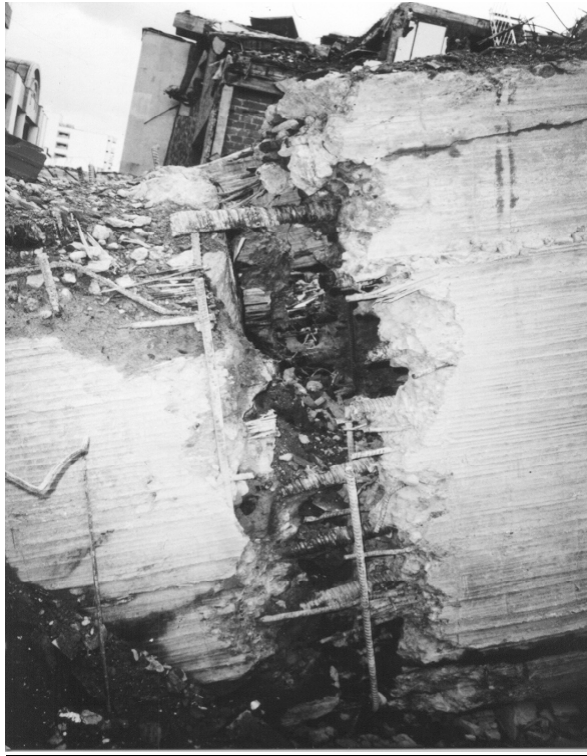
Figure 4.11: Unusual structural design

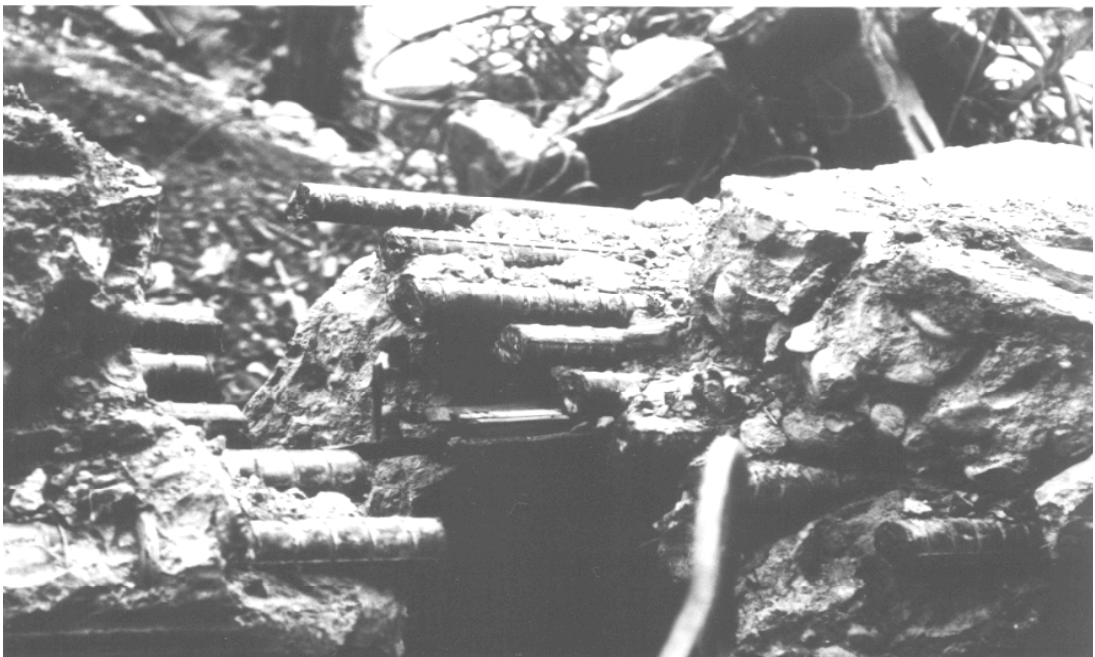
Figure 4.12: Detail of reinforcement in unusual structural design

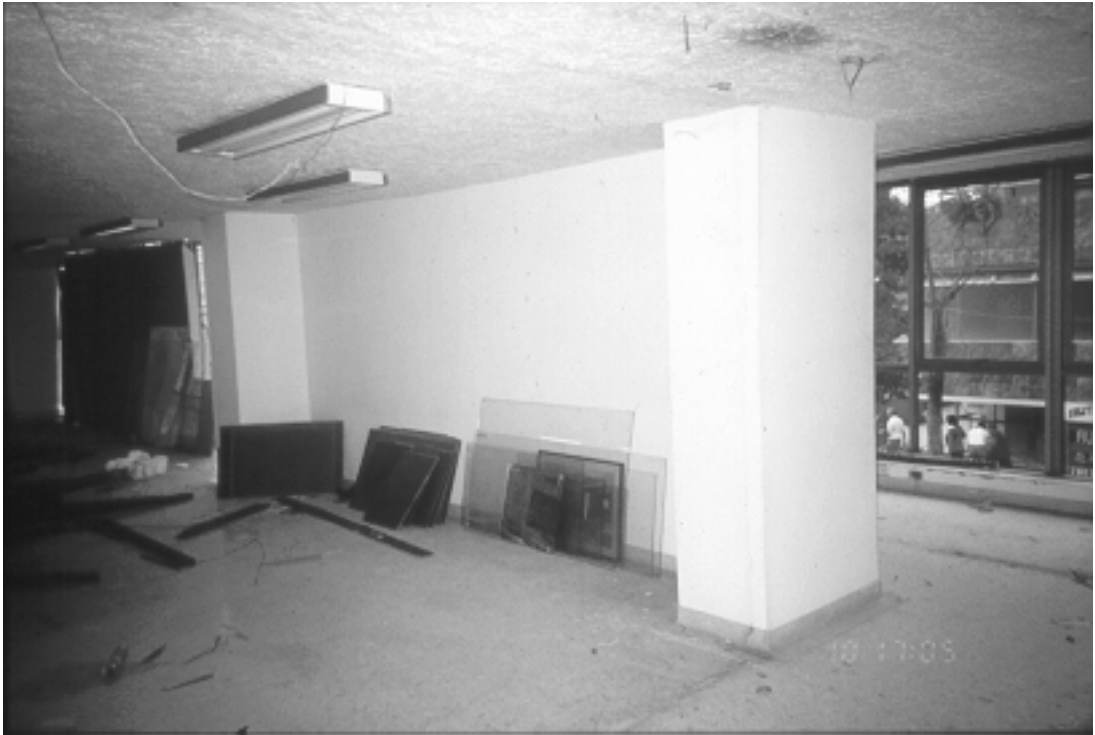
Figure 4.19: Retrofitted shear wall

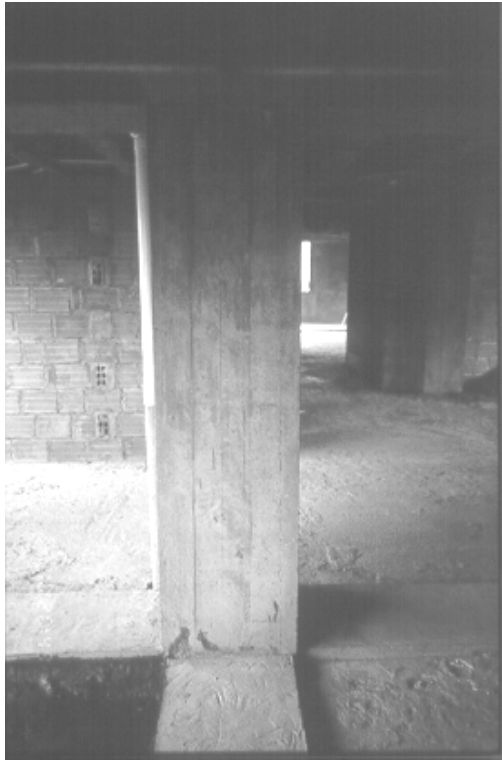
Figure 4.25: Retrofitted column, type C1

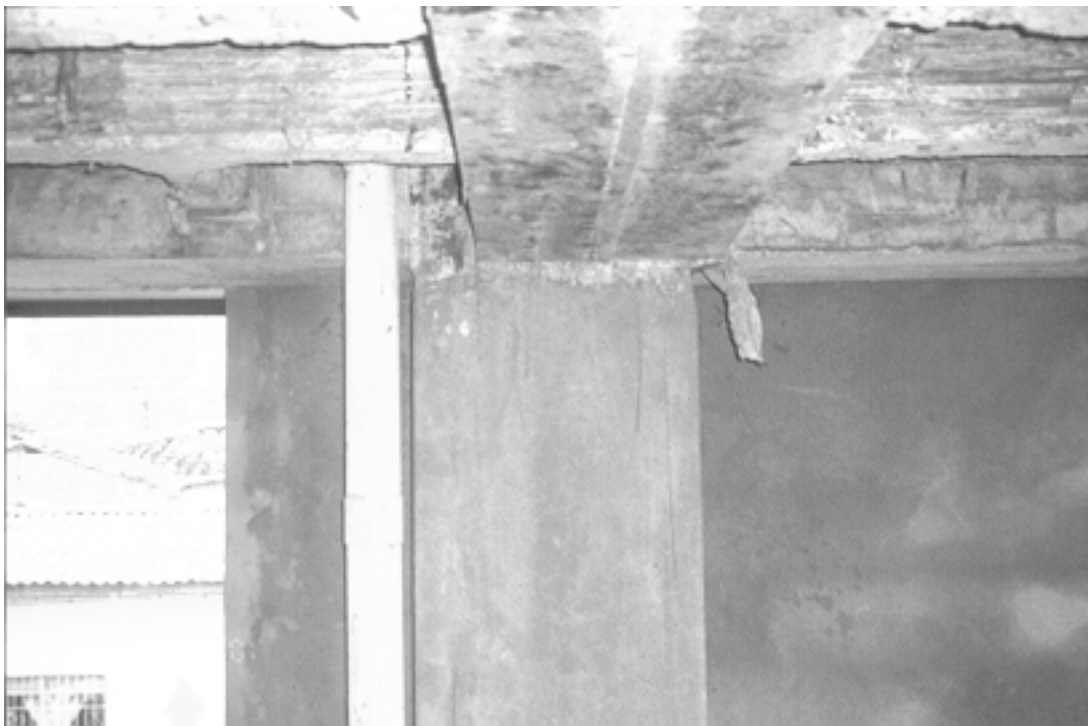
Figure 4.26: Eccentric retrofitted beam and column connection

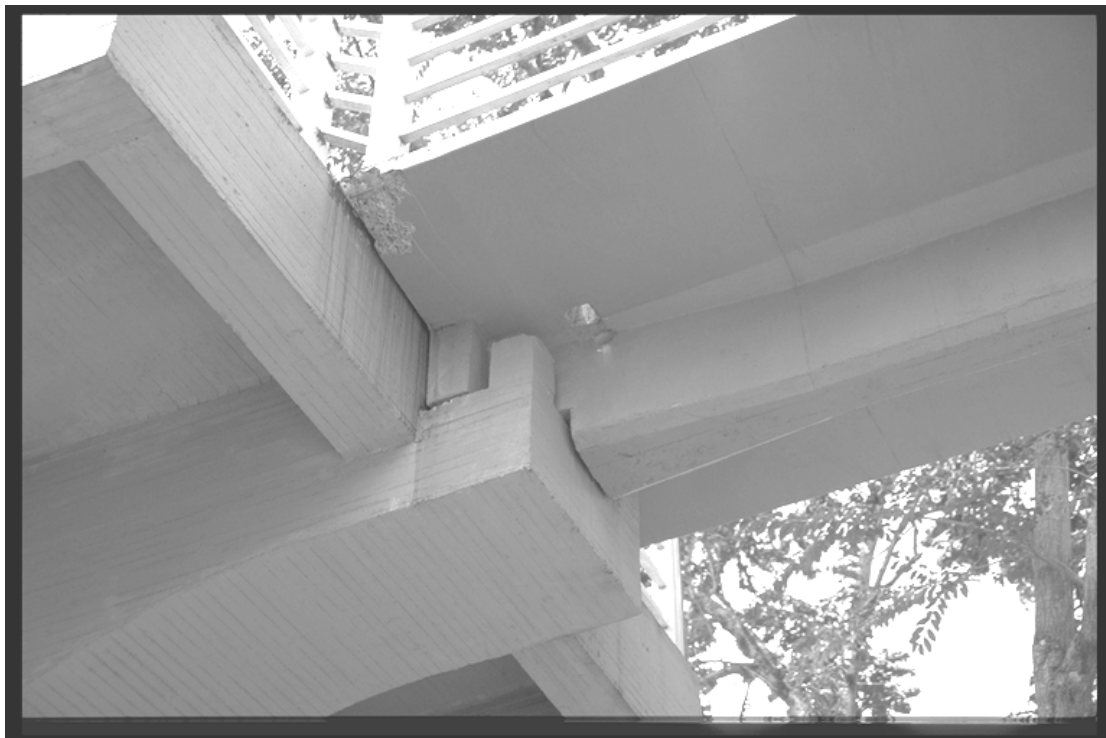
The bridges had precast prestressed T-beam decks with end details as shown in Figure 7.14. The bearings were designed to allow longitudinal movement, apparently at both ends of the deck. Shear keys were intended to limit the displacement both longitudinally and transversely. Since the deck was not fixed relative to the piers, it was able to slide and impact the shear keys, causing failure. The damage on one bridge was as shown in Figure 7.15, where there had been longitudinal displacement causing failure of the shear keys on one pier on both sides of the deck. On another bridge of the same design the failure was similar, but this time in the transverse direction and at both piers (Figure 7.16). A third bridge experienced the same type of failure in the transverse direction.

Figure 7.14: Undamaged shear key detail
