**THE NORTHRIDGE, CALIFORNIA EARTHQUAKE
OF 17 JANUARY 1994**

A FIELD REPORT BY EEFIT

1. INTRODUCTION

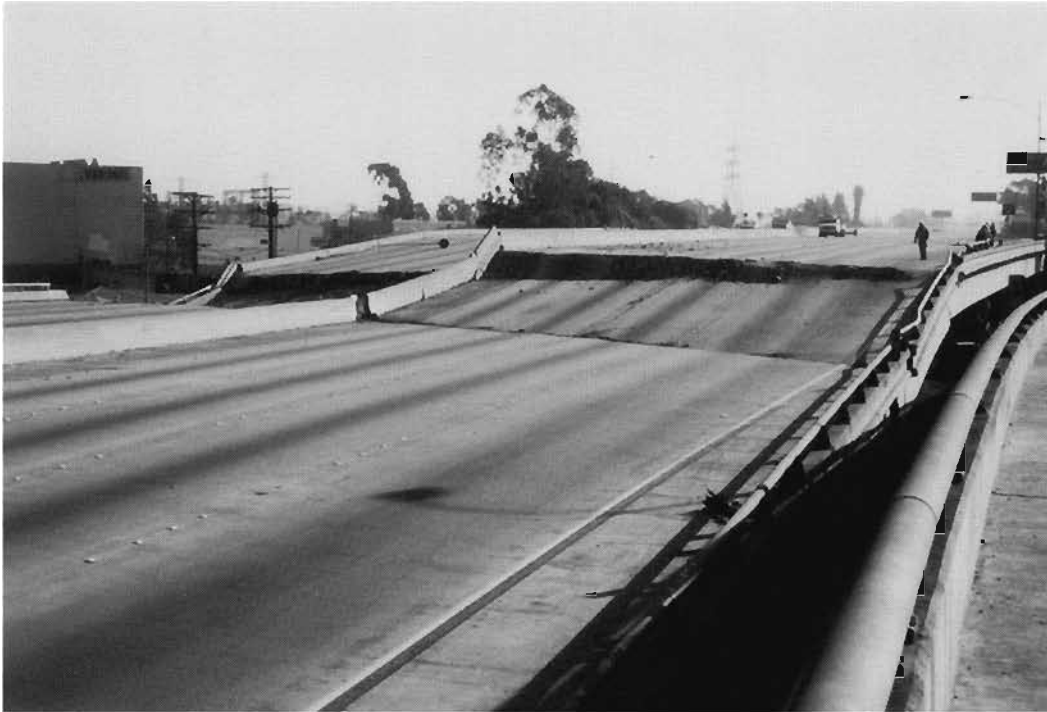
Plate 5.9: H118 at Mission and Gothic - column failures in Bent 2L

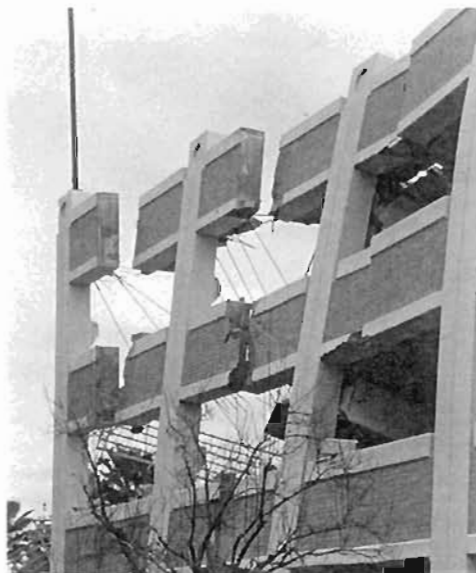
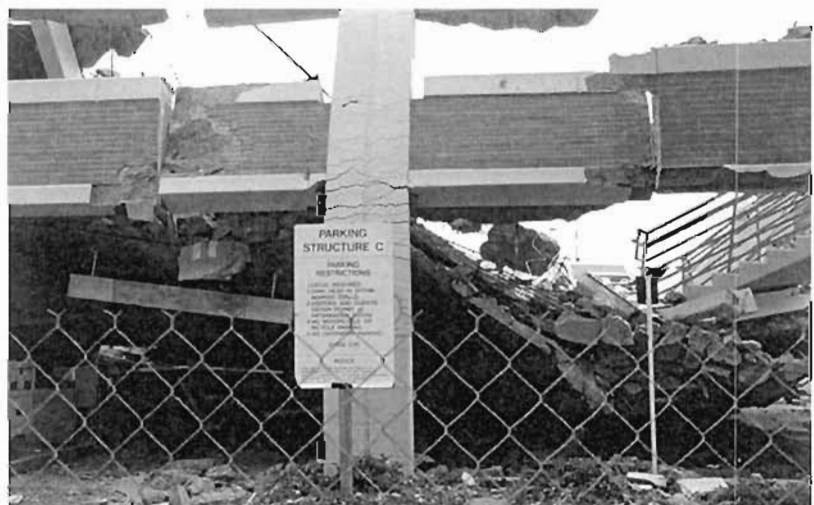
Plates 6.18/19: Out-of-plane separation between precast column units, showing minimal longitudinal continuity, suggesting low beam shear resistance

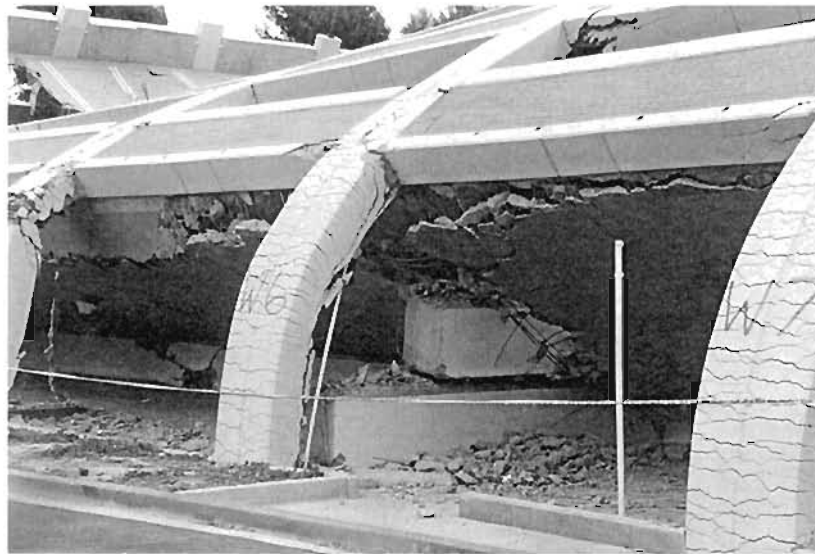
Plate 6.20: Distributed out-of-plane inelasticity in columns

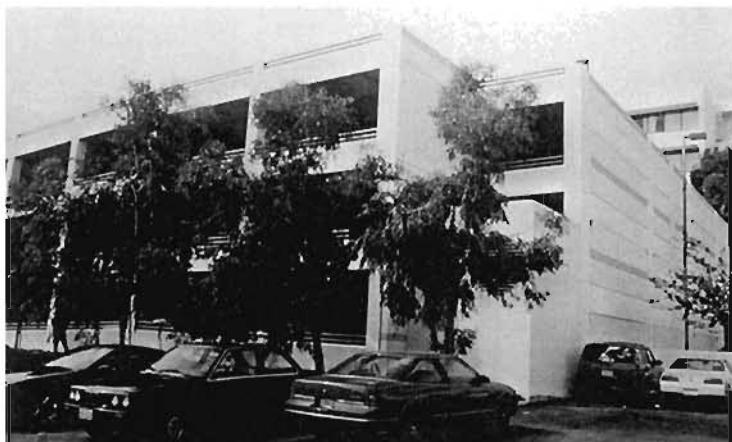
Plate 6.42: Undamaged corner without corbel construction

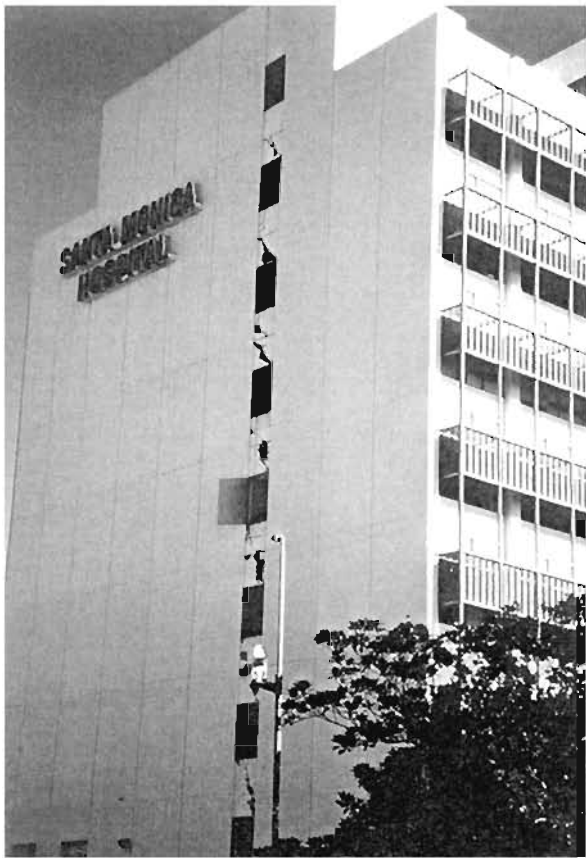
Plate 6.59: X-cracking in columns

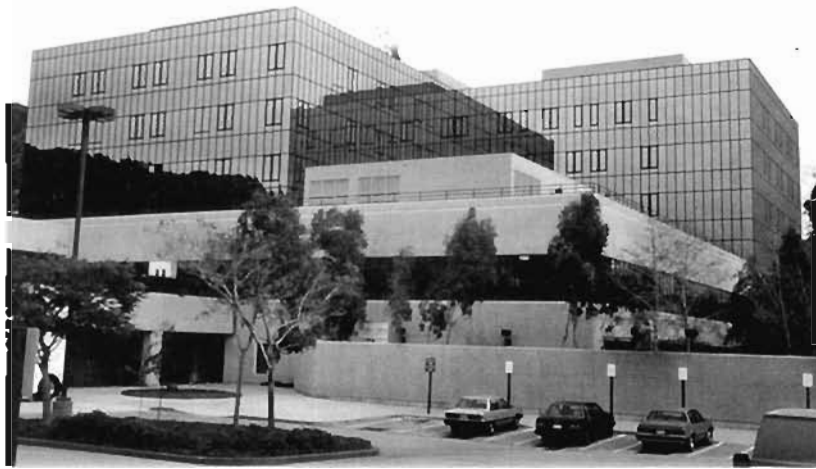
Damage was mainly concentrated at the shear walls and columns of the fourth level (Plates 6.66 to 6.68), but there was some damage also lower down (Plate 6.69). It is considered that the damage in Plate 6.62 at least is due to insufficient splice lengths, rather than the more usual lack of confinement, responsible for comparable damage in 6.6.7. Elsewhere diagonal cracking and spalling around main reinforcement is reported. Some crushing took place at the ground level in the side-columns of the shear walls. The building had to be evacuated.

Plate 6.68: Side wall damage on opposite face

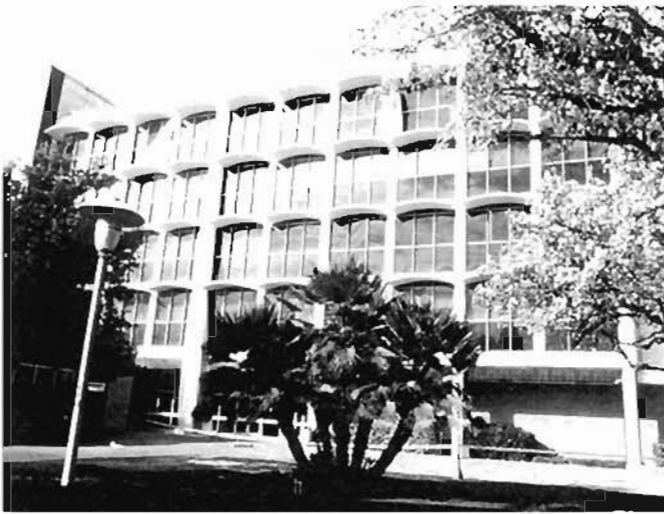
Other structures which were even earlier were also damaged (Plate 6.77). No buildings collapsed as in 1971 (Jennings, 1971).

Plate 6.77: Damage to lightly clad older building

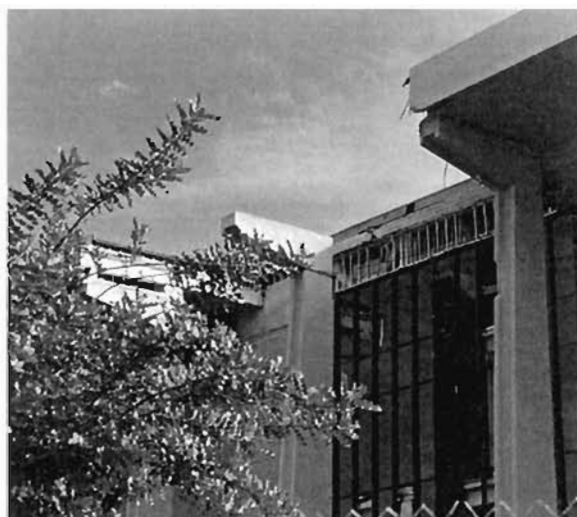
Plate 6.81: Front facade : fallen canopy

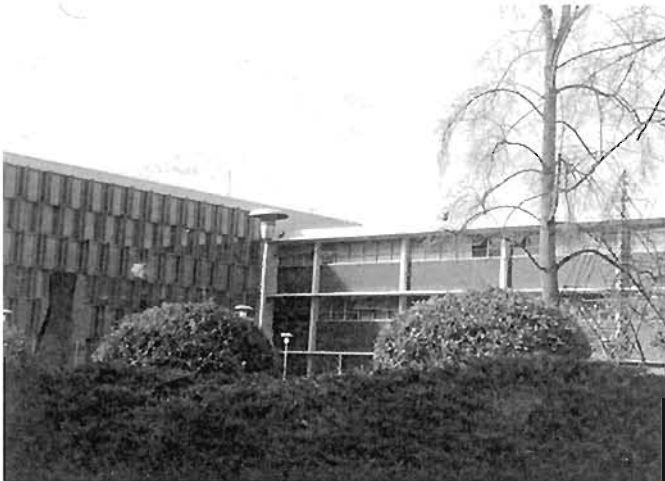
Plate 6.83: Fallen canopy in re entrant corner at rear

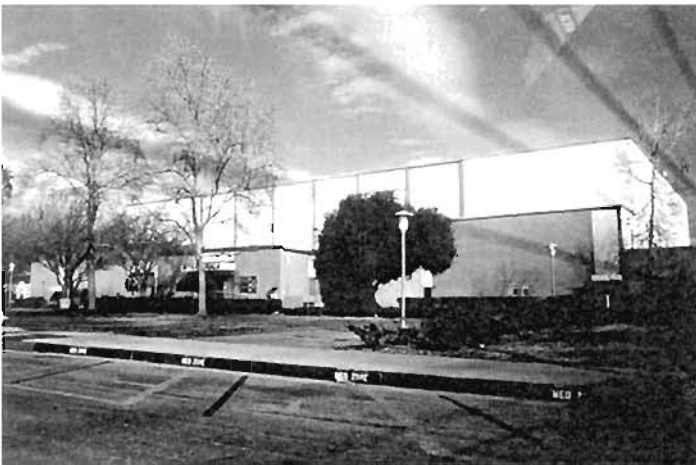
Plate 6.85: Old South Library with damaged shear walls

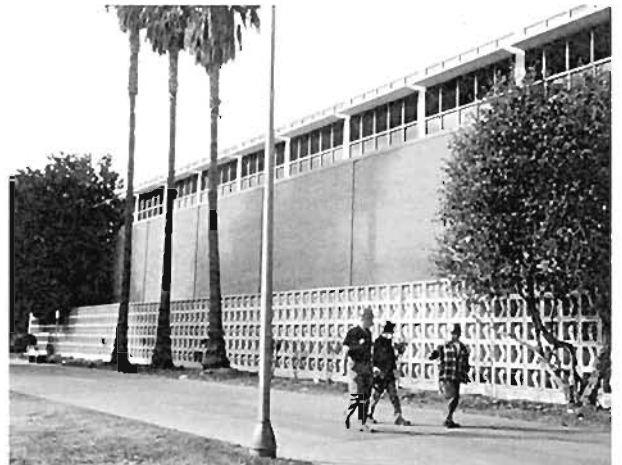
Plate 6.86: Physical Education Centre

The physical education block, with one large gym in the lowest storey and two smaller gyms in the second “performed well”. It was described as “ductile”, though from its facade it appeared to be largely unperforated masonry at the lower level with light metal cladding above (Plate 6.86).

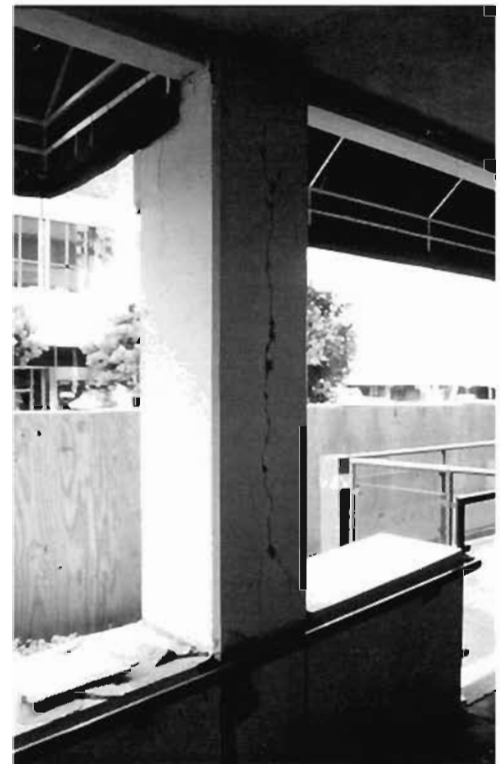
Plate 6.123: Transverse crack in column

In the frame at ground floor level on the north side (facing the street) a column had split down the centre, from top to bottom (Plate 6.122), damage which could only be attributable to axial compression. The adjacent column however was cracked transversely top and bottom (Plate 6.123) due to direct tension suggesting that there was a local couple between the two columns. A couple could be induced here by the upstand beam along the street, which terminated at the column cracked in direct tension. High vertical acceleration may have contributed to the damage.

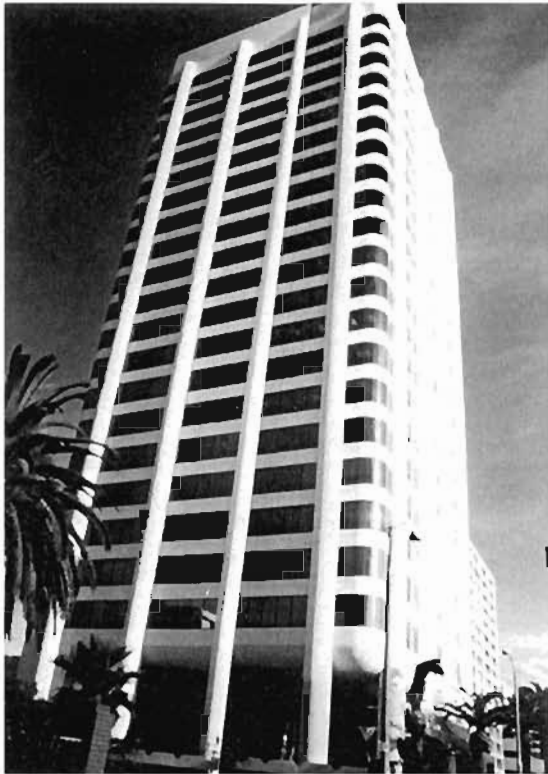
In the Sumitomo Bank in Santa Monica (the more northerly of the buildings next to Champagne Towers, see 6.6.8) in Plates 6.125 and 6.126, damage occurred in a particularly irregular first storey, where there were massive columns on each corner and where one side was infilled. It is probable, however, that the damage was confined to a part of the structure which was neither part of the intended vertical nor horizontal load resisting systems (Plates 6.127 and 6.128).

Plate 6.125: Sumitomo Bank. North face

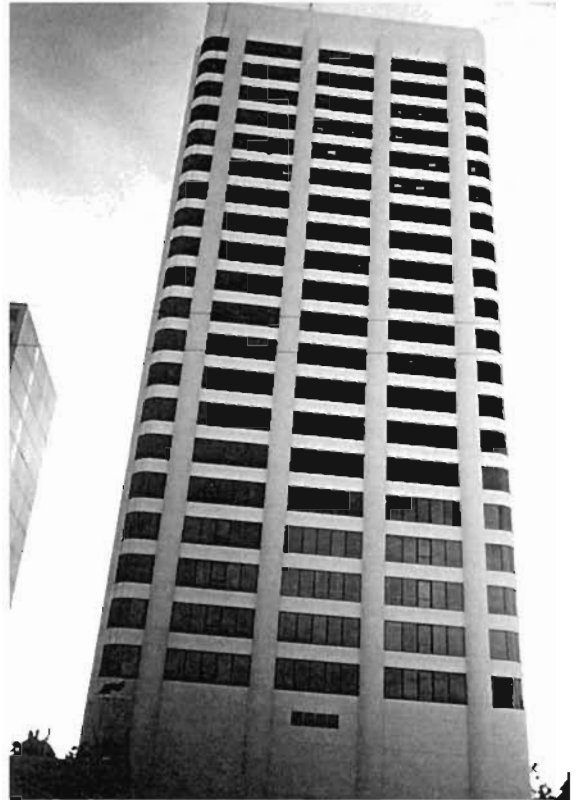
Plate 6.126: East face

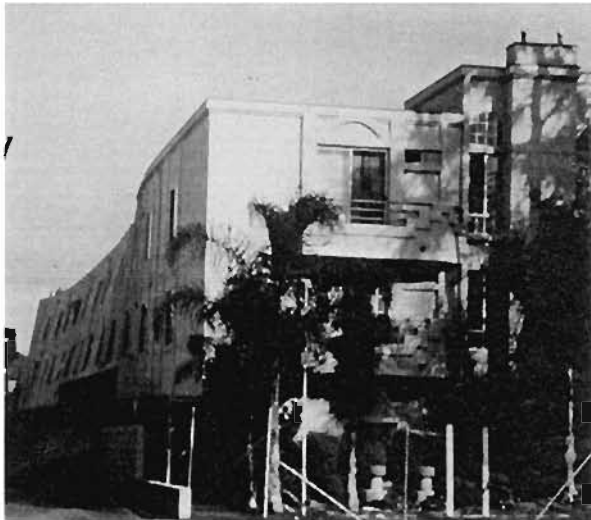
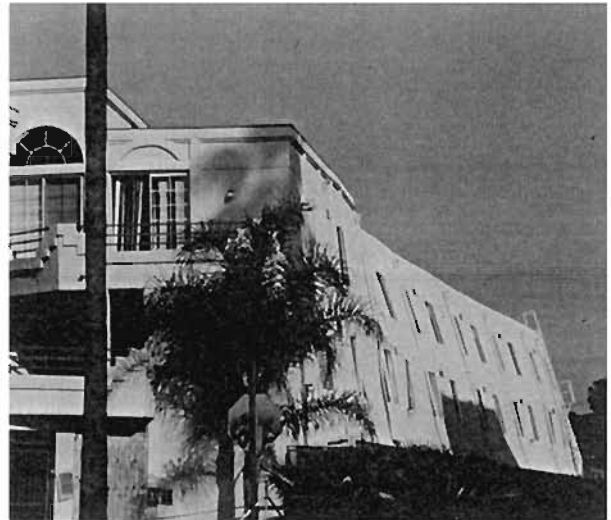
Plates 6.141/142: Triad Apartments: Inwards list of East and West walls after internal collapse

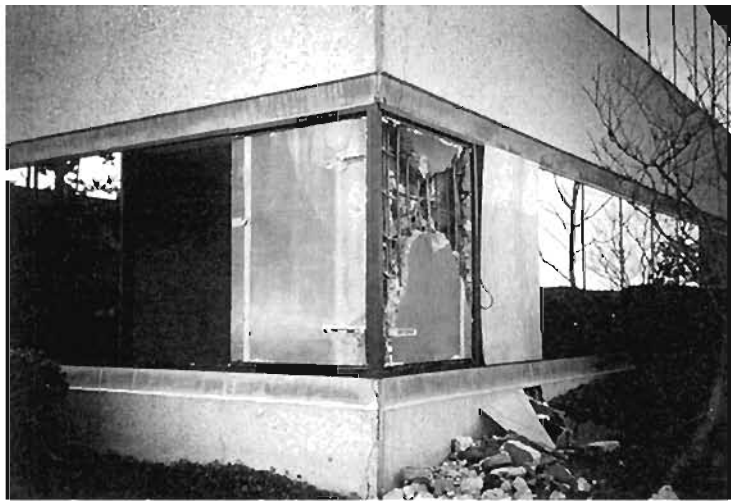
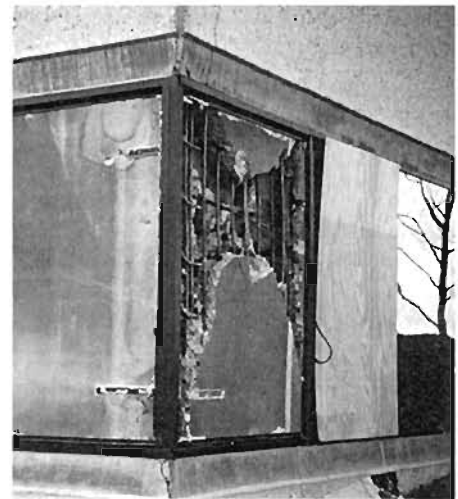
In a large two-storey tilt-up with semi-continuous fenestration irregularly dispersed around the perimeter, the shear over the height of the windows was carried in isolated RC panels. The side on which the first floor slab had been replaced by a light service floor fell (Plate 6.144), revealing a lack of horizontal ties. One of the corners opened (Plate 6.145) and some of the shear panels suffered shear cracking so severe that the concrete had fallen leaving only the reinforcement exposed (Plates 6.146 to 6.148).

Plates 6.146/148: Failed shear panels over height of ground floor fenestration

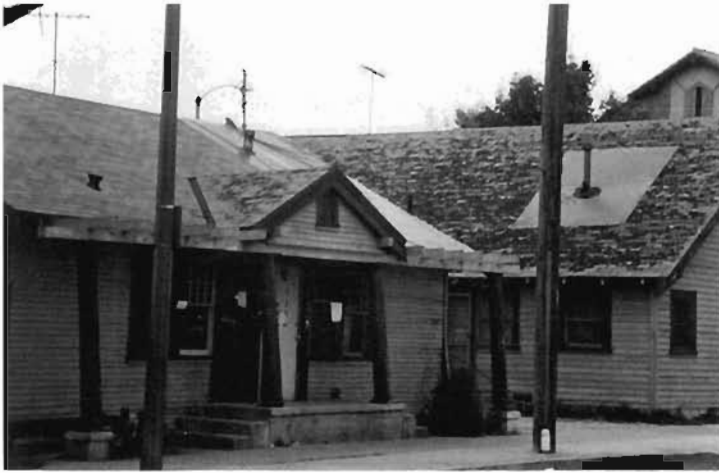
Plate 6.150: Damaged roof

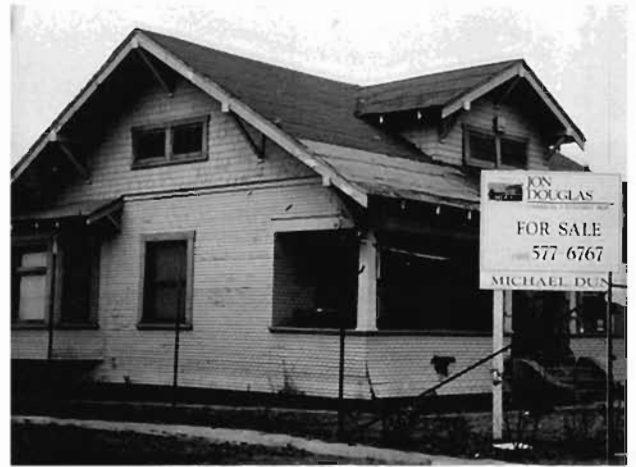
Northridge than in the Loma Prieta earthquake (EEFIT, 1993), which is attributable to the higher proportion of flexible chimneys in Southern California. Roof damage however was observed around undamaged chimneys (Plate 6.149). It is understood there were appreciable numbers of failures of internal brick chimneys and there were also many separated external brick chimneys, some of which collapsed, as in the Loma Prieta earthquake. However collapsed and severely racked porches were by far the most common form of damage (Plates 6.151 and 6.152).

Plate 6.151: Collapsing porch

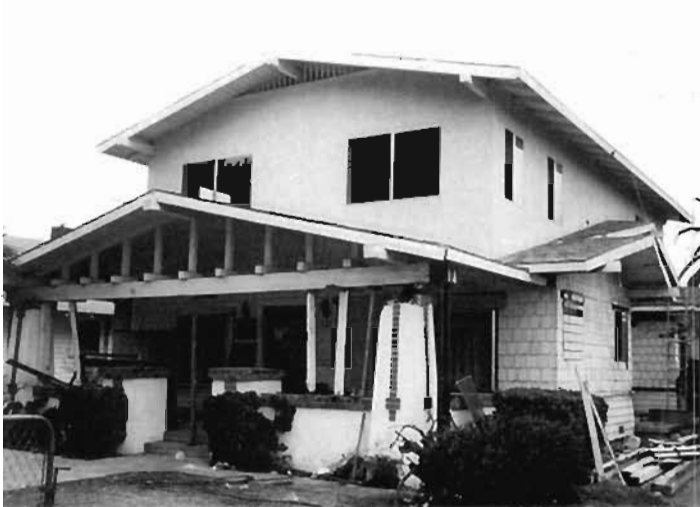
Plate 6.152: Racked porch columns

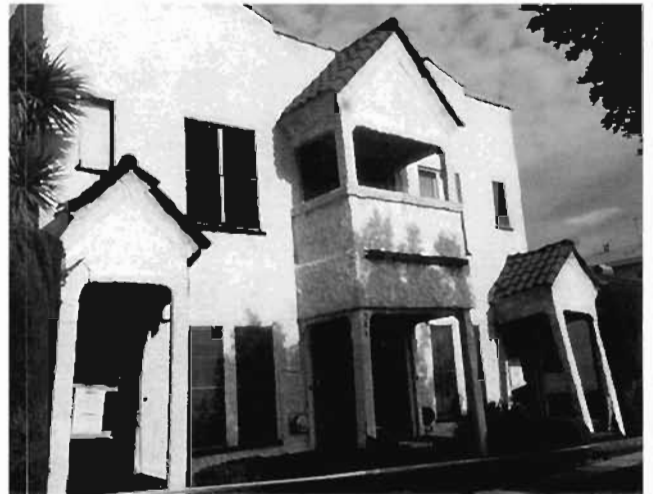
In the San Fernando Valley, single storey timber framed houses (Plates 6.149 to 6.154), more often than not with timber cladding, are the most common buildings. The major development occurred after the 1960s, but the oldest (which were the more prone to damage due to their condition and construction) are up to 40 years older. Therefore, there are fewer houses without braced crawl spaces (the under floor area), which constituted a soft storey, than in the Loma Prieta earthquake. So collapse of the crawl space was rare in Los Angeles, though cases were noted (Plate 6.153). Overall, chimneys performed better in the

Plate 6.153: Collapsed crawl space

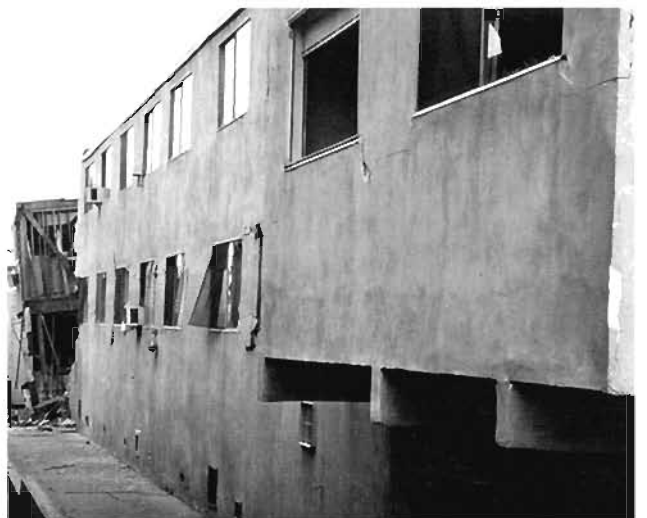
A close inspection was made of the damage in a three storey condominium (Plate 6.161) in which substantial timber posts were part of the main vertical load bearing system. The structure was weakened by car ports (Plate 6.162). The damage was concentrated in a band close to the ground (Plates 6.162 to 6.165) with damage somewhat higher up only in a wall in the car port (Plate 6.166). The building is of principal interest because of its close similarity to the Northridge Meadows Apartments, the collapse of which caused the most concentrated fatalities in this earthquake. An interesting feature was the vertical splitting of the timber of the post in the car port, which carried the upper floors. The metal in the bolted connection was undamaged (Plate 6.165).

Plate 6.161. 3-storey condominium

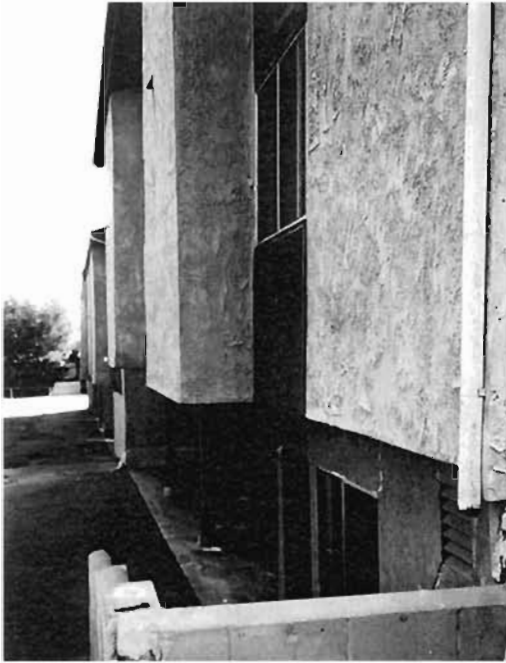
Plate 6.163: Low level horizontal crack despite absence of crawl

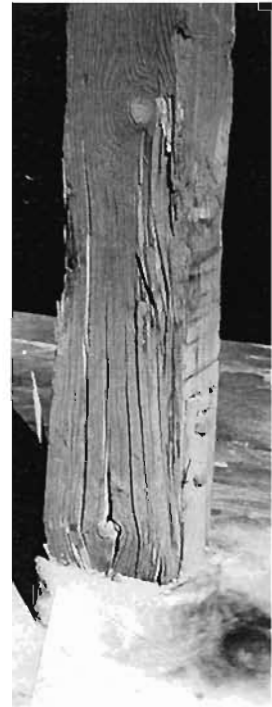
In the few masonry buildings, mostly of older construction and some with shop fronts, the rafters, trusses and floor beams generally span from side to side, so the back and front, being unloaded vertically are more vulnerable than the sides and transverse walls. For this reason the fronts of an occasional house and shop collapsed (Plates 6.167 and 6.168). Often however the roof construction would appear from the number of side walls fallen away below an undamaged roof (Plate 6.169) to span the other way. Even so parapets are the feature of masonry buildings most vulnerable to collapse (as discussed in 6.11.2.).

Plate 6.167: Collapsed house front

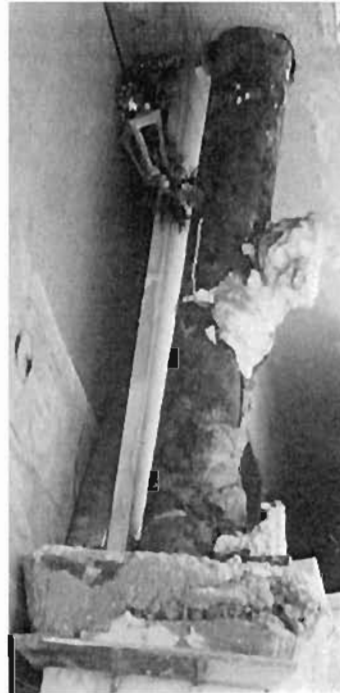
Some of the columns in the facades of old masonry shops when heavily damaged were found to be an early form of reinforced masonry. These were possibly as old as 1920 or were constructed soon after the Long Beach Earthquake of 1933 (also see 6.5.1) (Plate 6.173). In these the masonry columns had cores comprising substantial steel posts of diameter about 75 mm. These were unbonded to the masonry and impacting of the posts upon the masonry is undoubtedly the cause of the pronounced longitudinal splitting of such columns (Plate 6.174). Indeed this form of damage may be considered a good indication of the presence of these posts, except when the cracking is confined to the column feet, when it is likely to be caused by the indirect tensile stress. Where unprotected (in Santa Monica) the iron posts were corroded to a depth of 3 mm (Plate 6.175), but they were also found (in San Fernando) protected by a tar-based fabric which was undamaged in the earthquake (Plates 6.176 to 6.178).

Plate 6.178: Corrosion protection

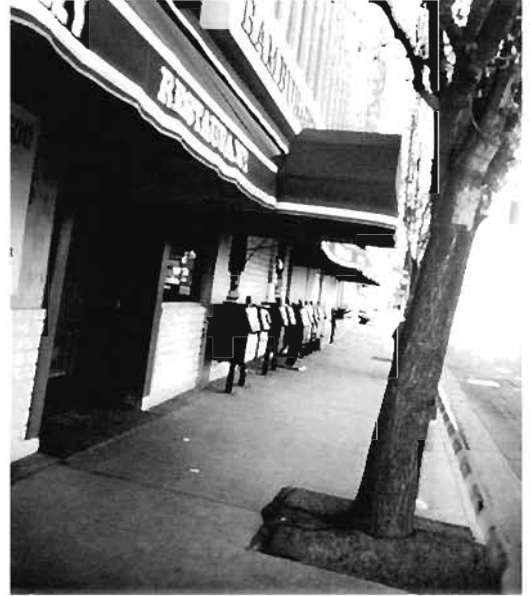
Plate 6.181: Tilted tree at the Hamlet

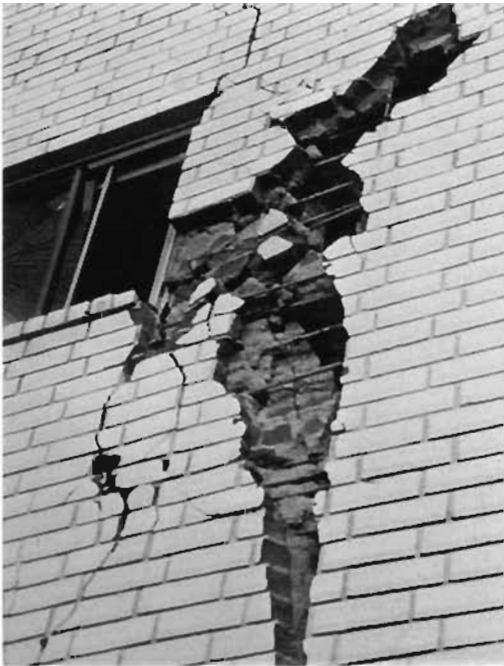
A large modern brick masonry building with very long clerestory type windows (Plate 6.179) reinforced in every bed course suffered in-plane cracking at the corner of a window, followed by local out-of-plane failure of the zone affected (Plate 6.180). As this was along the Hollywood Boulevard the ground acceleration is likely to have been in excess of 0.30g and the movement of the ground at the base of a tree due to root tensions (somewhat unusual for this earthquake) in the street suggests it may have been higher (Plate 6.181).

Plate 6.180: The damage

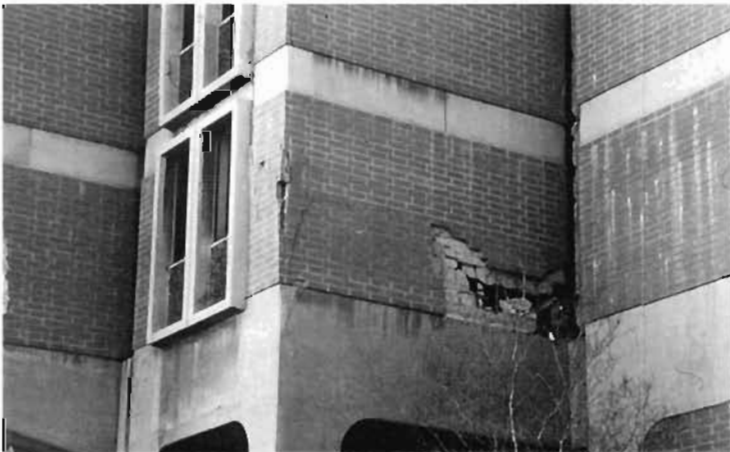
Plate 6.182:
Low level disintegration of reinforced masonry

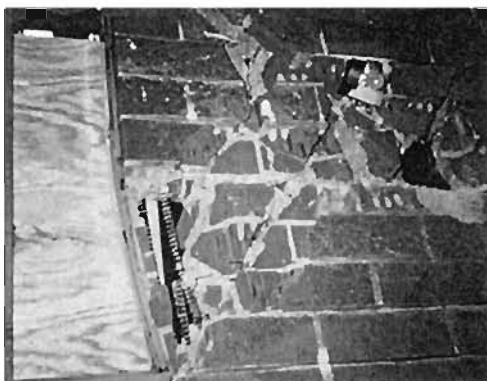
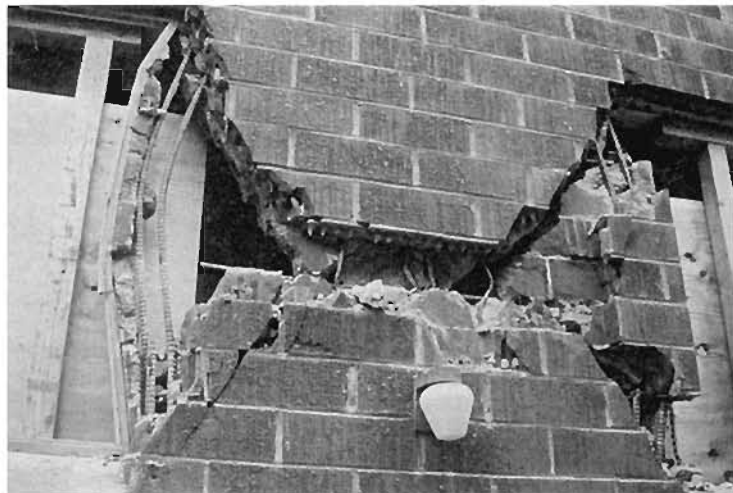
Plates 6.186/187: Buckling of unrestrained vertical bars between windows

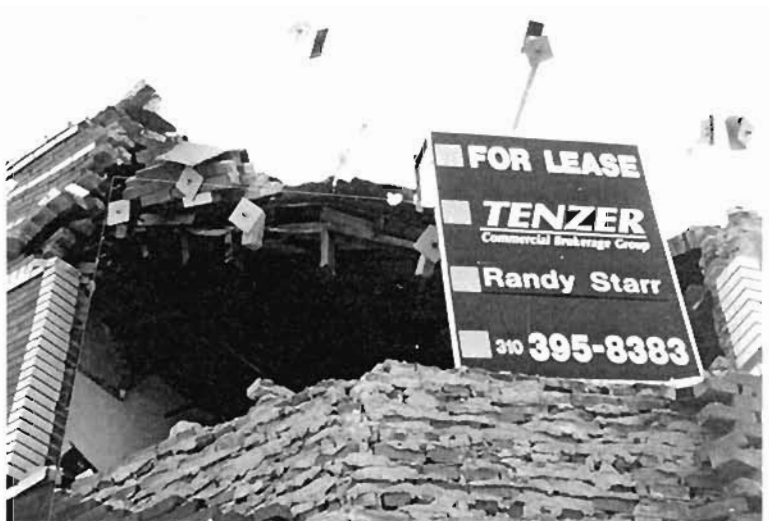
Plate 6.197: Parapet/upper wall failure at rounded corner

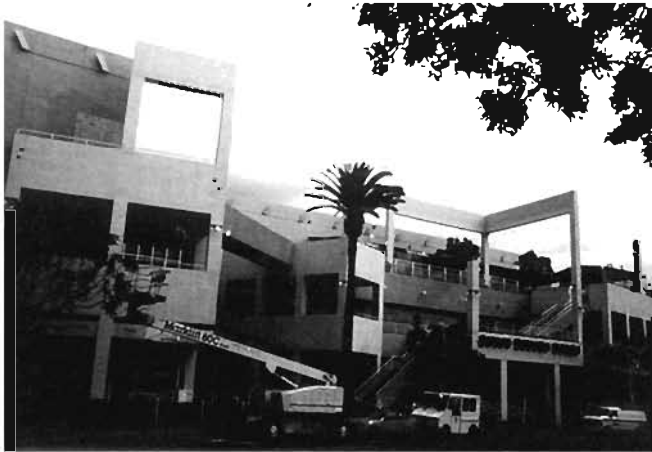
The only damage found in an exceedingly irregular shopping complex on the coast in Santa Monica was a diagonal crack in the first floor tiling at a corner column; evidence of diaphragm action from the discontinuities in the vertical load resisting structure (Plates 6.216 and 6.217).

Plate 6.216. Highly irregular shopping area. Santa Monica
