# **THE UMBRIA MARCHE EARTHQUAKES OF 26 SEPTEMBER 1997**

## **A FIELD REPORT BY EEFIT**

October 1998

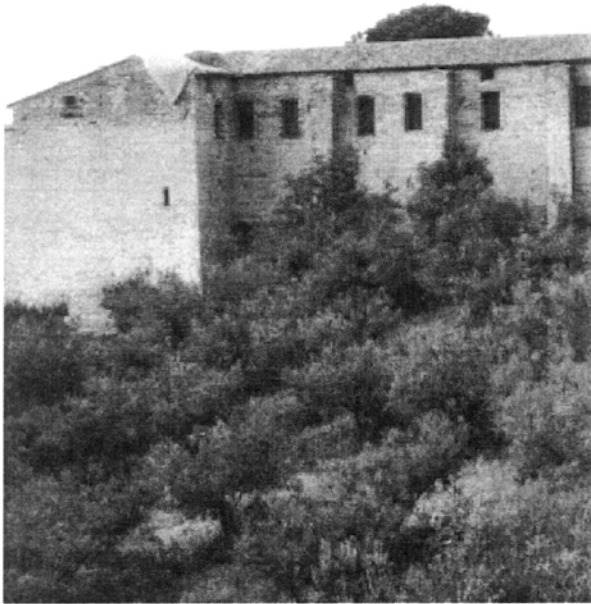
Plate 3.11: Santa Chiara Convent: external wall of the eastern wing

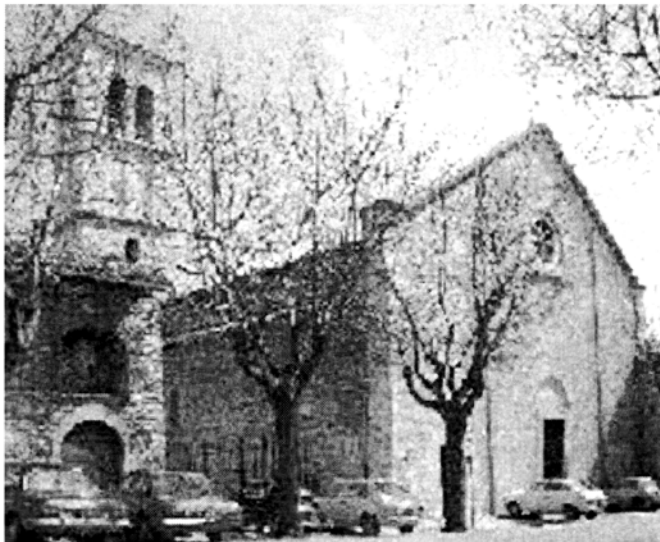
Plate 3.20: External elevation of Santa Maria Maggiore

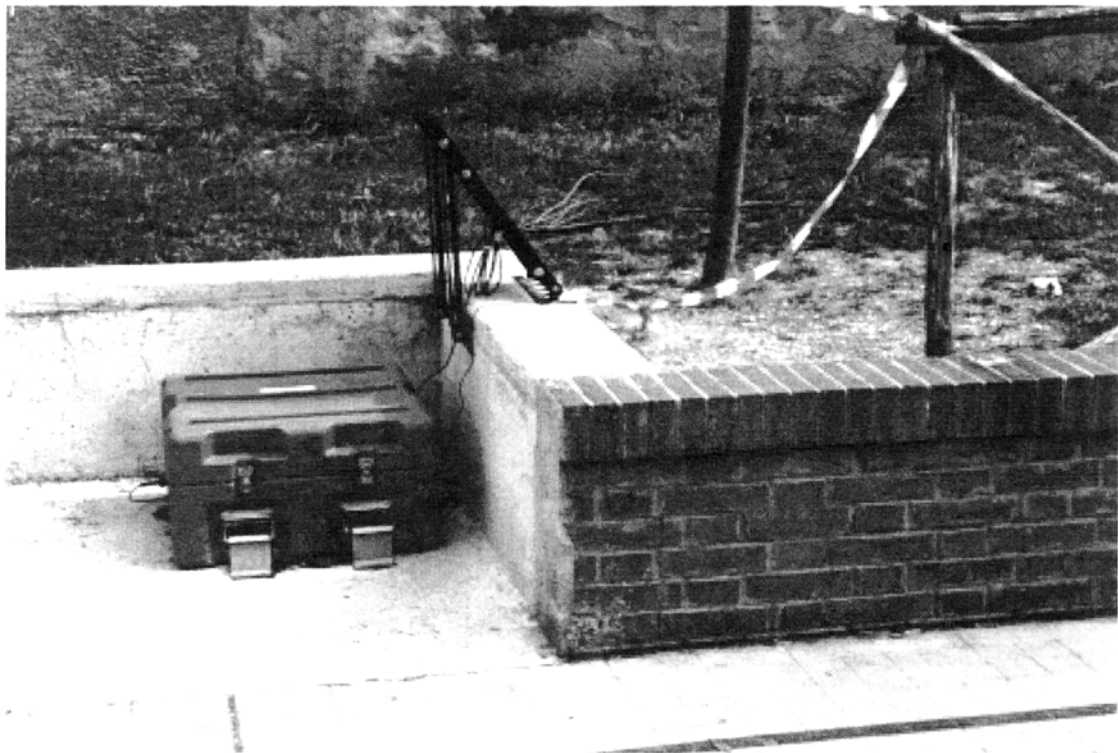
SSN also installed a mobile array of strong motion recorders in the epicentral area soon after the earthquake, (Plate 4.11). Data from these instruments which was captured in the long aftershock sequence will be valuable in establishing the significance of site effects, details of which will be published in due course.

Plate 4.11: Temporary strong motion instrument: Nocera Umbra
